**GEOTECHNICAL ASSESSMENT OF
WATER TREATMENT PONDS,
PART LOT 1 DP 3350 WHAKAMAHIA ROAD, WAIROA**

Project Reference: 13322
17 August 2017

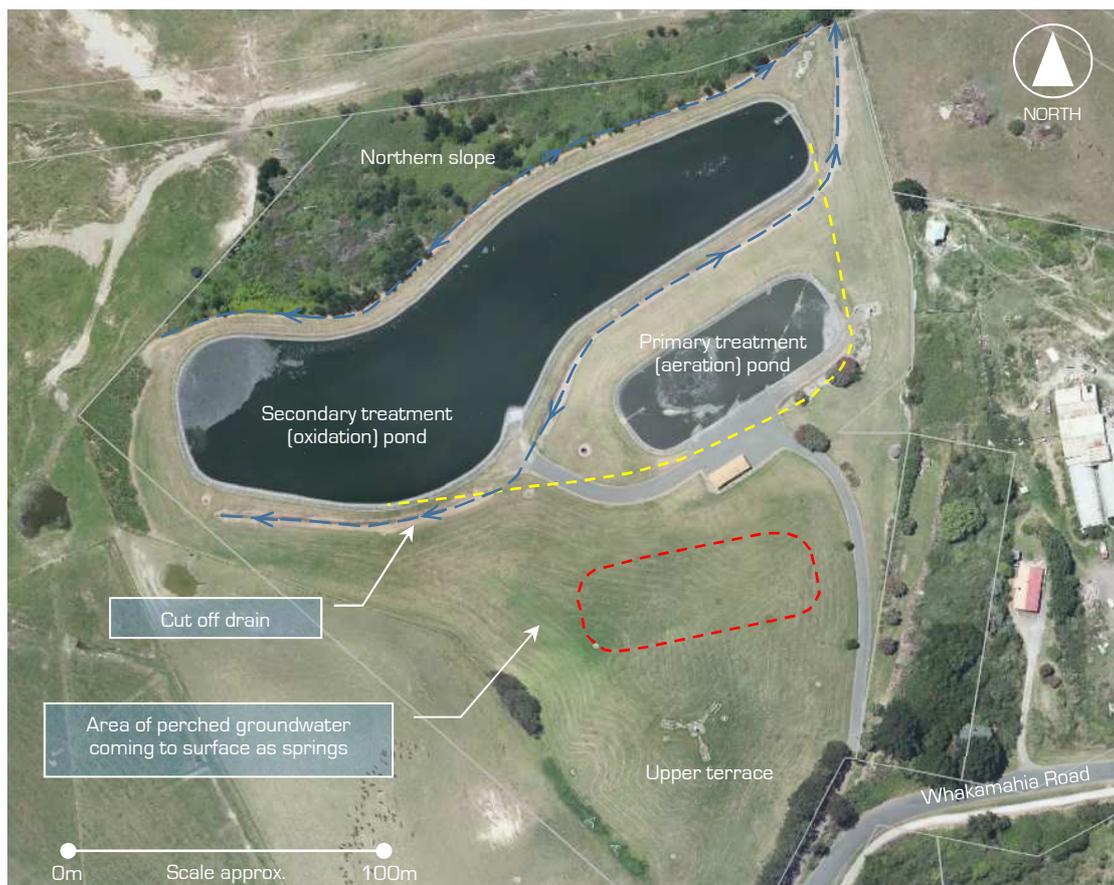
Figure 2: Aerial image of site, with potential location of primary pond (red) and potential extension area of secondary pond (yellow).

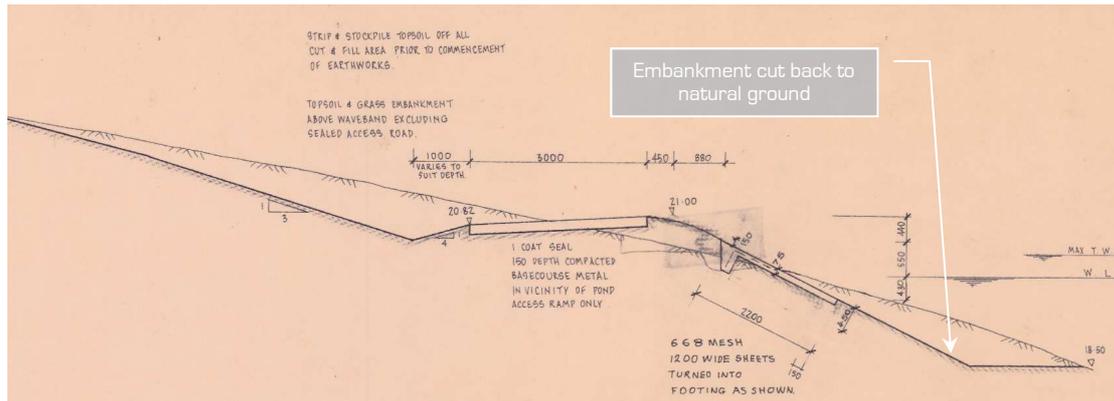
Figure 3: As built construction plans (Note: no liner material is documented).

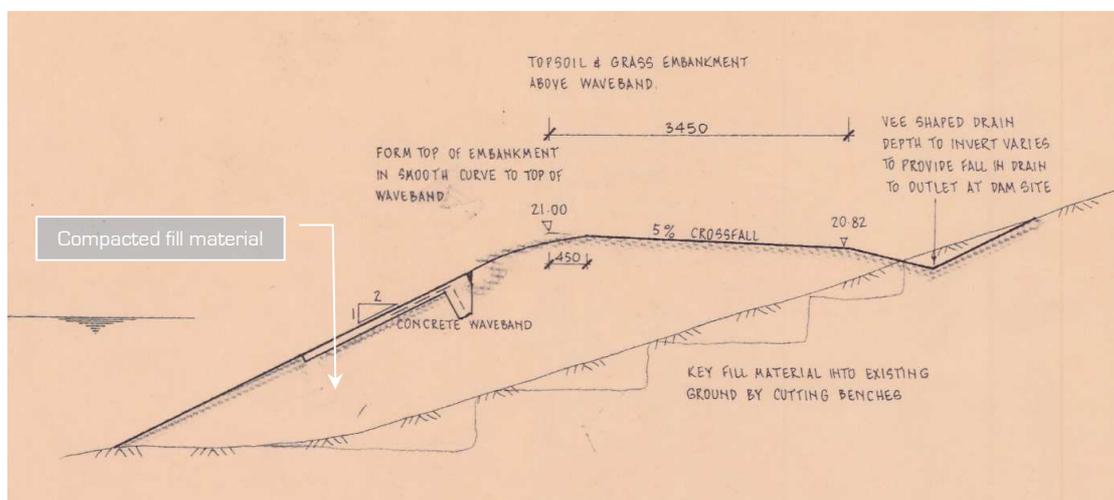
Figure 4: As built construction plan showing keyed in fill material to northern slope.

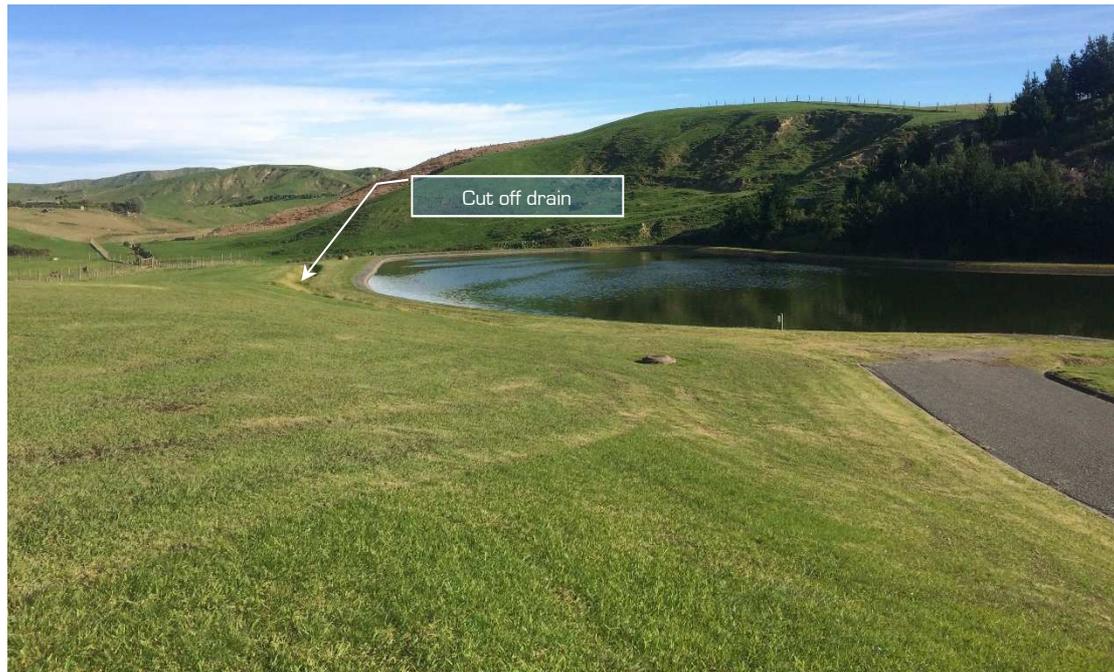
Figure 7: Western limit of secondary treatment pond. Note cutoff drain and northern slope.

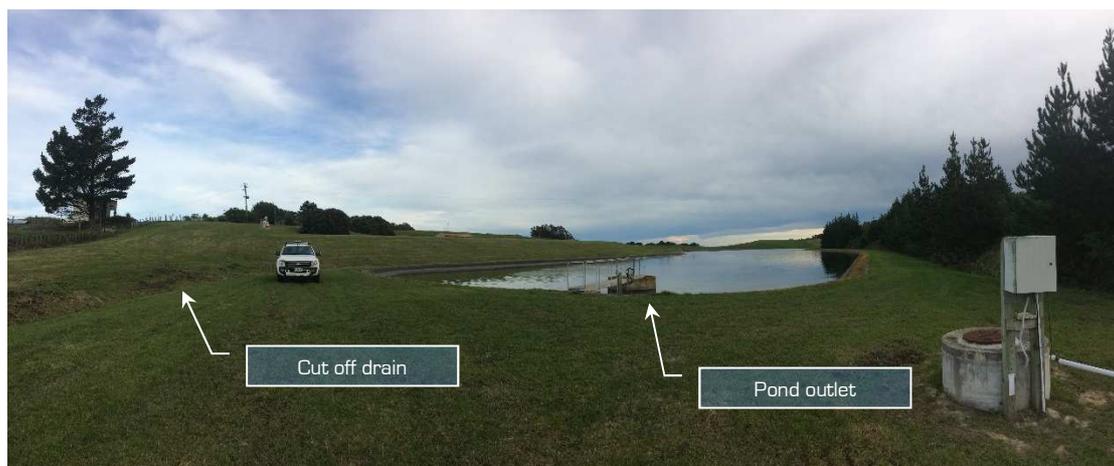
Figure 8: Panoramic view southwest. Note cutoff drain behind vehicle and pond outlet.

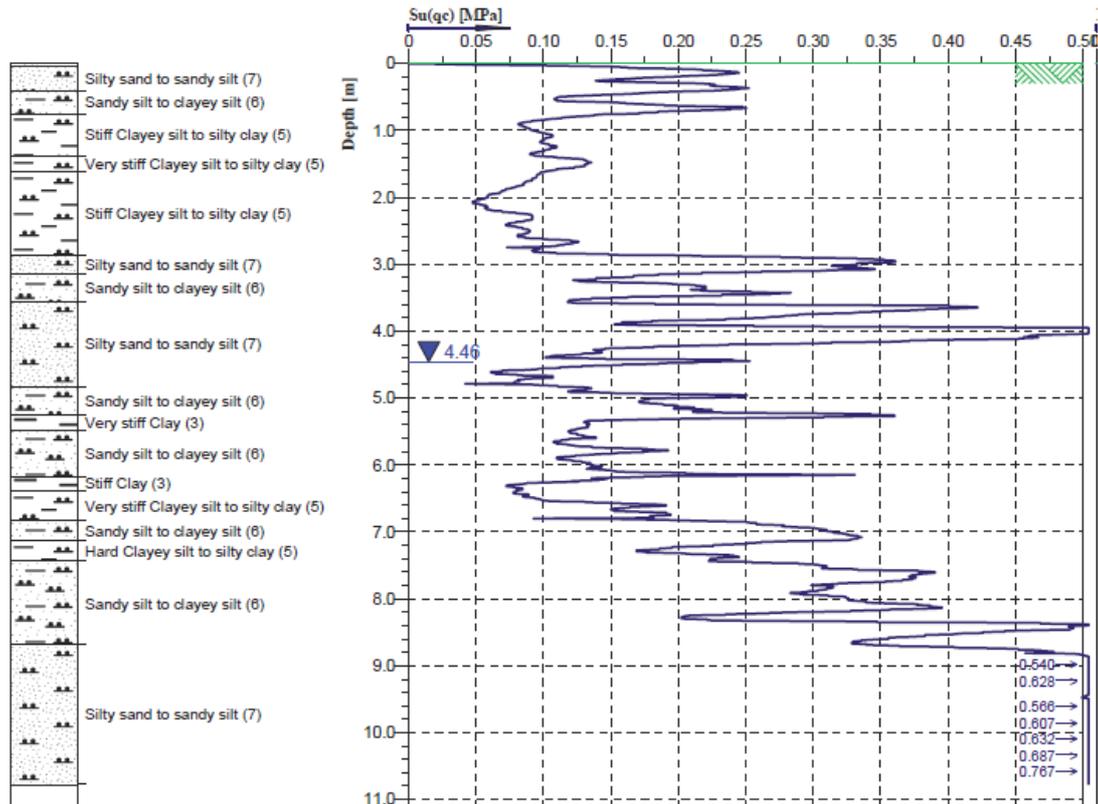
Figure 9: material and strength profile of ground at western end of secondary pond showing layered and stratified nature of ground typically beneath the property.

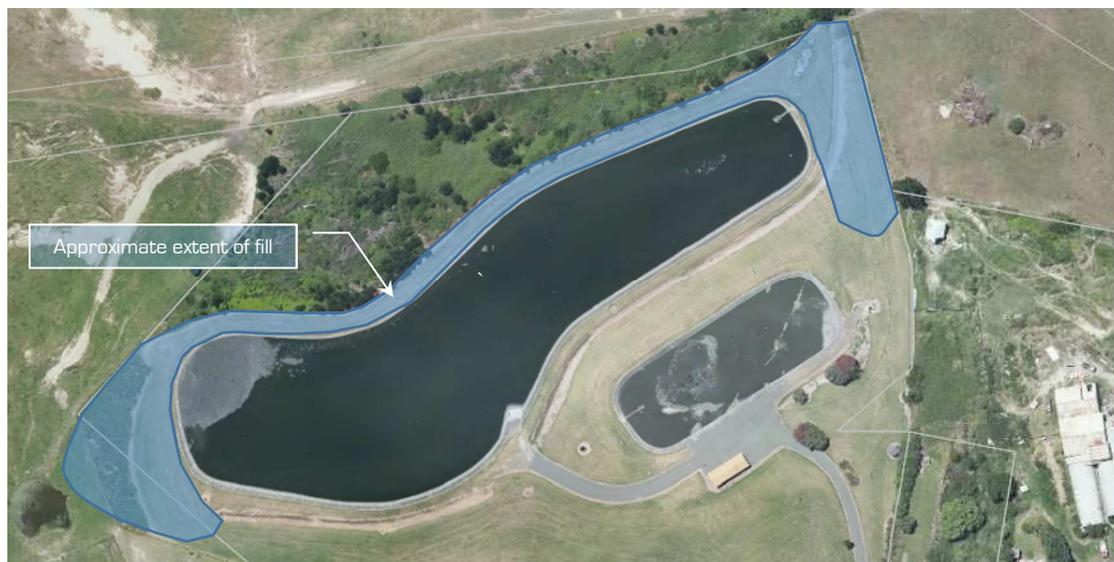
Fill materials up to 2m in thickness, were generally encountered adjacent to both the eastern and western end of the pond (Figure 10). The fill appears to have been used in landscaping and levelling the site at the time of the ponds construction, as the investigations adjacent to the oxidation pond indicate the presence of buried topsoil beneath the fill.

Figure 10: Approximate extent of landscape fill surrounding oxidation pond.

A review of as-built construction documents, CPT and machine boreholes (put down adjacent to the eastern and western end of the oxidation pond), reveals that the landscape fill material behind the main pond embankment typically consists of (stiff to very stiff) compacted and blended clays silts and sands from the ponds excavation. However there is no indication that the material was intended to be engineered fill or how compaction was achieved. Construction plans show the ponds embankments either consist of excavated natural ground or keyed in fill material. It is likely that the embankment fills are compacted to a reasonable level of compaction. In contrast, fill placed behind the pond embankments is possibly compacted to a lesser degree.

Fill adjacent to the oxidation pond was typically moist to wet down to 2.4m to 4.8m depth where perched groundwater was encountered in the tephra layer. Soil moisture content generally returned to being moist to wet beneath this depth to the extent of the subsurface investigations.

The moist to wet nature of near surface soils identified in the machine boreholes adjacent to the oxidation pond may identify seepage is occurring. However from estimated permeability values (Section 4.4) and seepage analysis, small amounts of seepage is expected to occur through the ponds base and embankments. There is a strong likelihood that fluid from the ponds is seeping horizontally through the tephra layer and into surrounding watercourses.

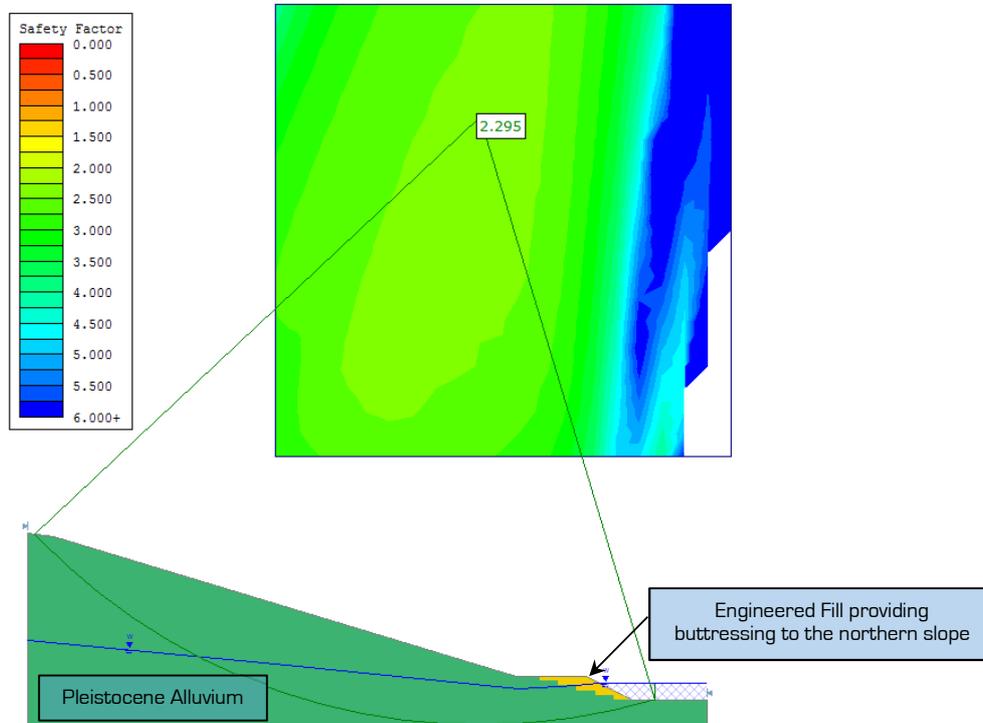
shorter slopes directly to the north of the secondary pond have been improved by the buttressing provided by the northern pond fill embankment and the presence of pond fluid (Figure 11). The steeper elevated hillside to the northwest of the pond is also isolated from the pond.

Figure 11: Numerical slope stability of northern slope above oxidation pond

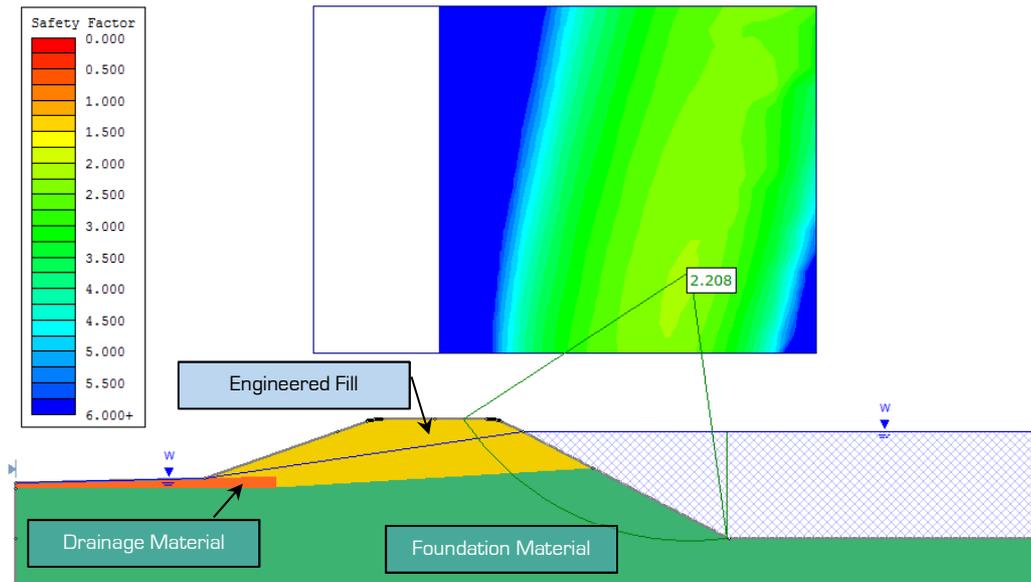
Under design conditions (modelled using maximum pond storage level), numerical analysis identified the raised embankment to have a minimum factor of safety of >1.5 (Figure 12).

Figure 12: Minimum raised embankment factor of safety under design conditions

The embankment shall have a minimum crest width of not less than 4.0m and slope angles of 2h to 1v for the ponds internal embankment and 3h to 1v for the external embankment slope. The non-organic portion of excavation material may be used for embankment fill, provided the recommendations given in Section 6.4 are adhered to.

We recommend a material coarser than gravelly sand with a permeability higher than 1×10^{-3} [m/s] shall be used for downstream drainage, which is required for piezometric drawdown within the raised embankment to prevent piping or erosion in the embankment.

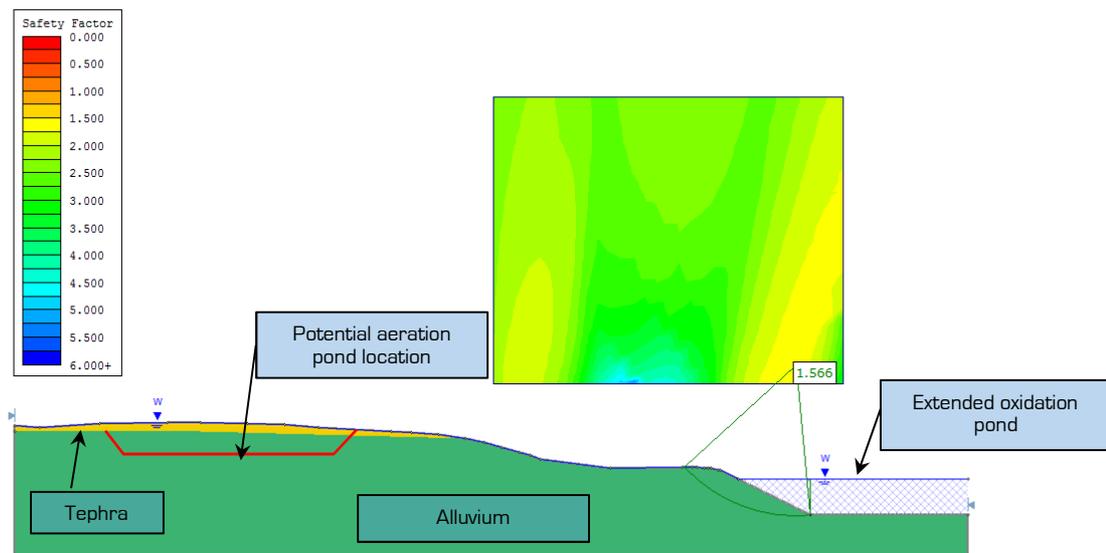
Numerical stability analyses were undertaken for the southern slope taking into consideration the secondary pond extending into the position of the primary aeration pond. The analyses showed that the slopes leading into the secondary pond would have a factor of safety >1.5 under fully saturated conditions and >1.0 under ULS seismic loading, both well above minimum accepted factors of safety.

Figure 13: Worst case, fully saturated conditions for potential pond alterations
