**NAPIER INNER HARBOUR  
and  
LOWER AHURIRI ESTUARY AREA  
POINT SOURCE DISCHARGES**

**NOVEMBER 2000**

**Investigation and Report undertaken and Prepared by  
Charles Rycroft  
Harbourmaster  
HAWKES BAY REGIONAL COUNCIL**

HBRC Publication No. 4877  
Report No. RM16-58

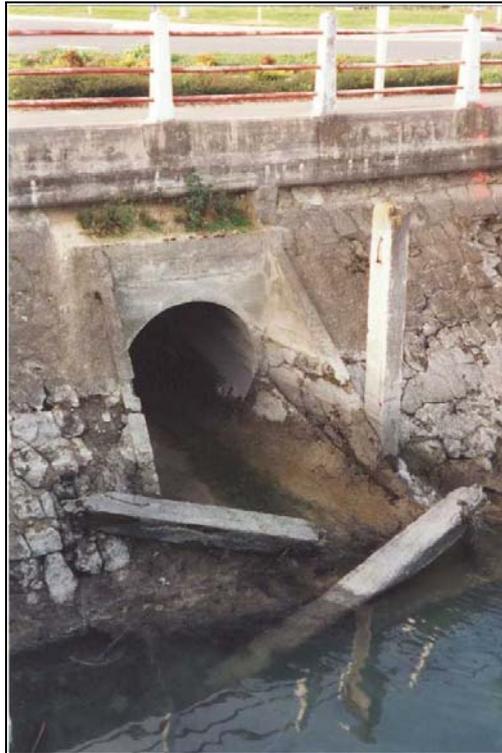
Two stormwater discharge pipes are discharging water continuously – one at the eastern end of Iron Pot (ID No. 01) and the other at West Quay (ID No. 02, approx. 150 metres north of the Maintenance Berth). Both discharges appear to be clear water discharging at rates of < 1 litre/sec and > 5 litres/sec respectively. Investigations indicate that they may be discharging as a result of leaking water mains and reticulation pipes.

**ID No. 01** Iron Pot, Discharge Pipe – stormwater discharge with continuous discharge from an unidentified source

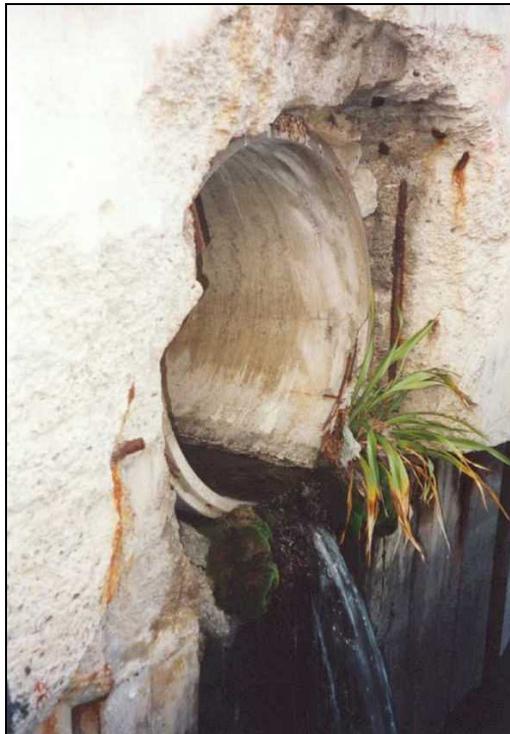
**ID No. 02** West Quay, Discharge Pipe – stormwater discharge with continuous discharge from an unconfirmed source

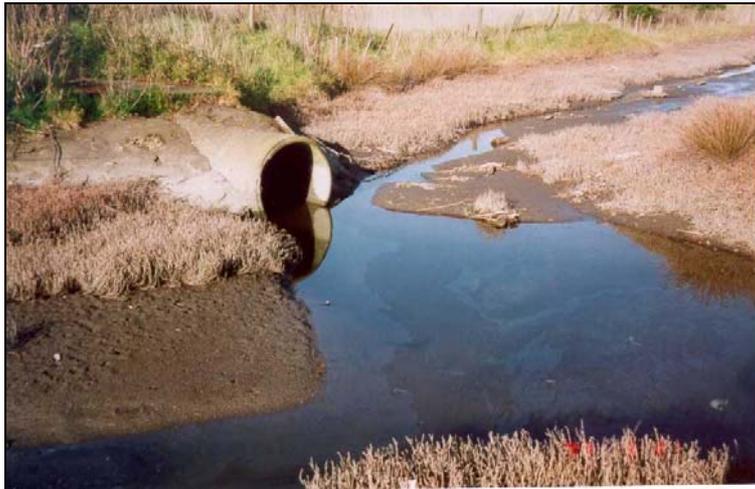
**ID No. 03** Tyne Street, s/w discharge from Corunna Bay. Note: oil sheens on water surface

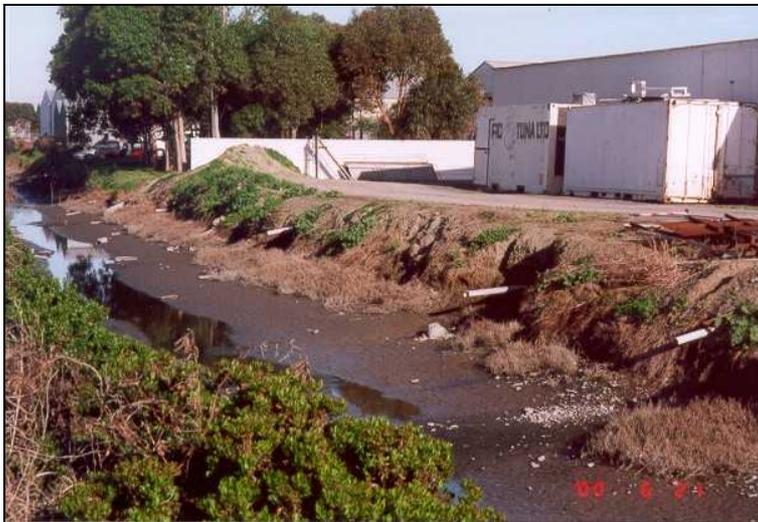
**ID No.04** Unsourced discharges from Mersey St. abattoir into Tyne St. Drain

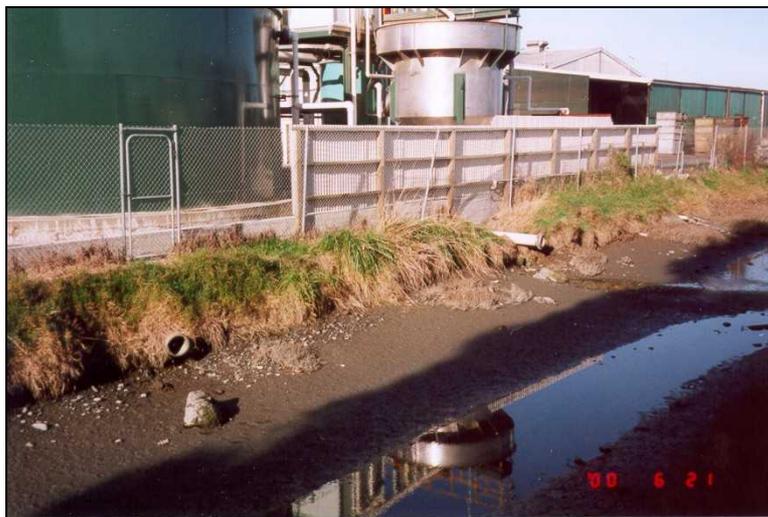
**ID No.05** Tyne St.- unsourced discharges from industrial site

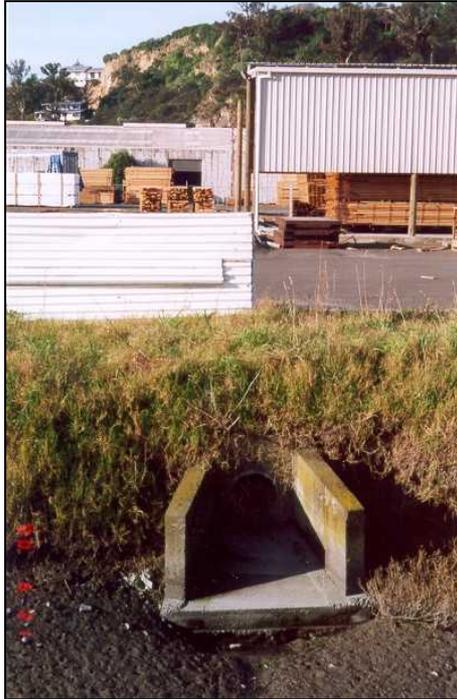
**ID No.05** Tyne Street, stormwater discharge, (one of two similar discharges).

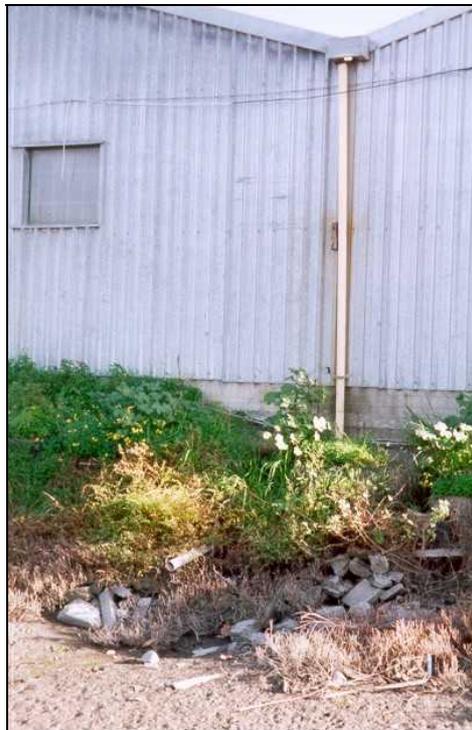
Downpipe discharge into Tyne St drain (from Mersey St site)

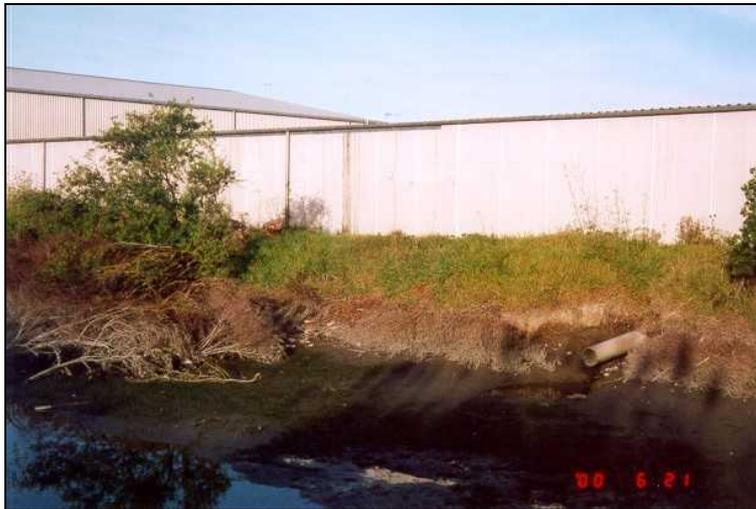
This intertidal drain is also part of the Ahuriri Estuary habitat and discharges into the Tyne Street Drain. Several roof water discharges were observed at various sites into this drain (see photo on page 15).

Thames Street, downpipe discharge

This drain is also littered with used tyres, redundant pipes and rubbish, which should be removed.

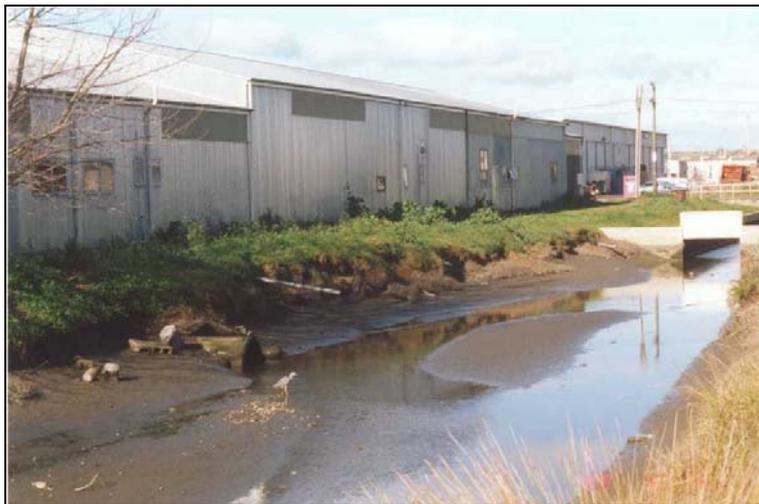
**ID No.09** Northern end of Tyne Street drain. Note two roof downpipe discharges

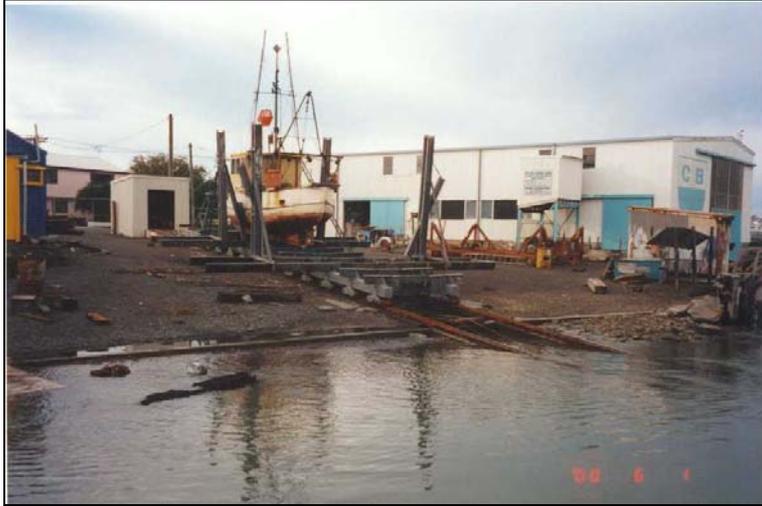
The slipway haul out bunded area and sump was inspected visually and found to be clear of debris. The sump effectively traps sediments but like the boatshed slipway sump is intertidal and would release soluble toxins into the CMA (see photo page 15). The haul out area is surfaced with loose metal. Charter Boats Ltd have taken a number of steps to restrict the contamination of the Napier Inner Harbour but are required to comply with the consent conditions of consent CD950404W.

Charter Boats, Main Slip. Note bunding awash at waterline (high water).

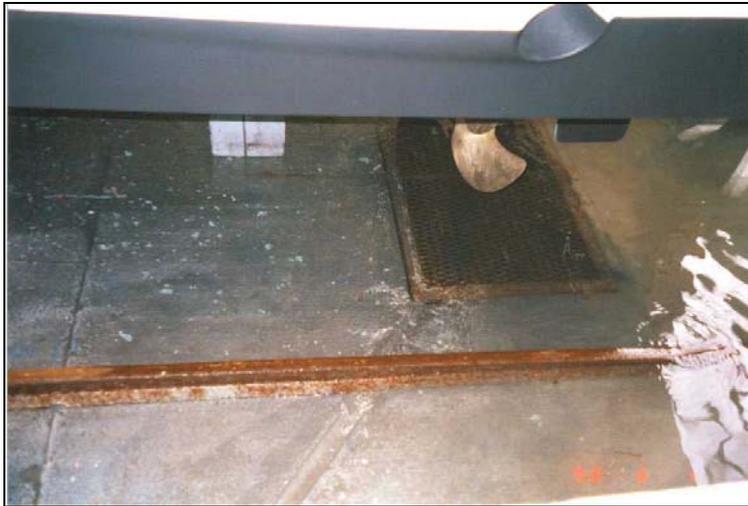
Solid and liquid contaminants from scraping, sanding, and water blasting etc drain from the concrete sealed surface into a non-consented sump situated between the slipway cradle rails. The sump is also located in an intertidal area and is flooded every high tide (see photo on page 16). Sediments would be contained in the sump effectively but soluble toxins (mainly antifouling) would be released into the CMA at high water.

The boatshed slipway is hosed down at periods of low tide into a sump. A submersible pump is used to pump out any material from the sump into the sewer. This is carried out at low tide to avoid material from being discharged into the Coastal Marine Area.

Charter Boats, Boatshed slip. Note sump (behind propeller blade) awash at high water

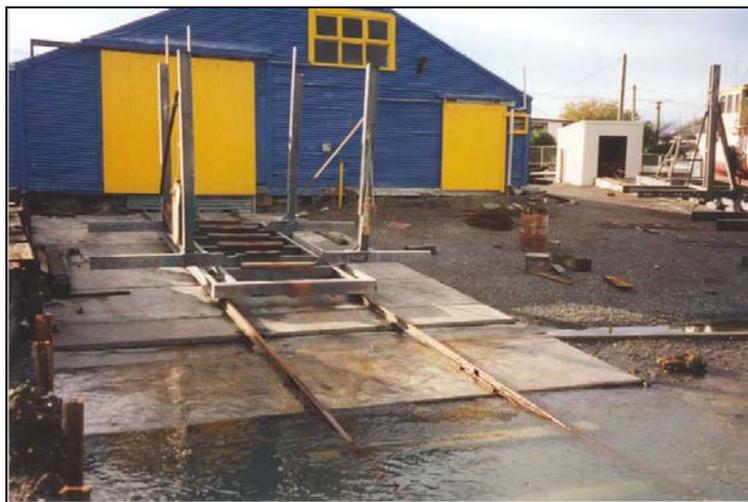
This slipway, located immediately west of the main slip, is also owned and managed by Charter Boats Ltd. The haul out area for this slip is sealed and is bunded in common with the main slipway (see photo on page 16).

Charter Boats, "Northey" slipway. Note sealed haulout area and bunding at waterline

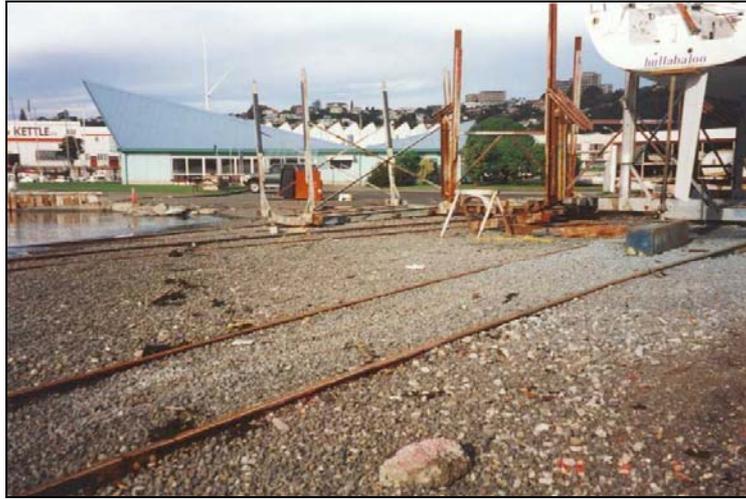
**ID No.12** Napier Sailing Club slipways.

Napier Sailing Club operates three slipways, which are used for recreational boat maintenance. The wash down area for all three slips is covered with loose metal. There is no bunding or sump provided. The slipway structures are permitted but no consent to discharge into the CMA has been granted (See photo ID No. 12)

Note that area is unsealed, not bunded, nor provided with a collecting sump.

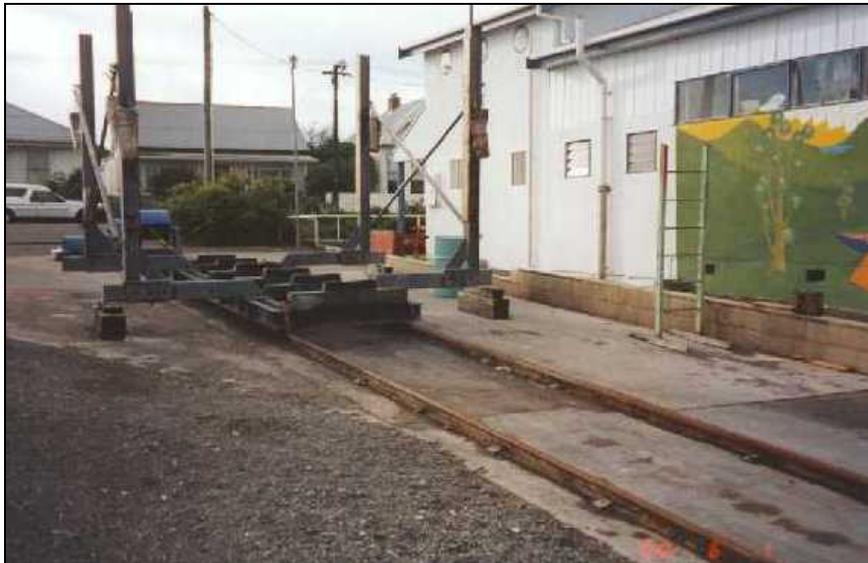
**ID No. 13** Hawkes Bay Sport Fishing Club slipway

Hawkes Bay Sport Fishing Club operates one slipway west of the Sea Scout shed. This area is sealed but is not bunded or provided with a sump. The slipway structure is permitted but no consent to discharge to water has been given (See photo ID No. 13).

Note that area is sealed but is not bunded or provided with a collecting sump.
