ANTIFOULANT AND TRACE METAL CONTAMINATION OF SEDIMENTS FROM THE NAPIER INNER HARBOUR

REPORT PREPARED FOR:
HAWKE'S BAY REGIONAL COUNCIL

BY:
JASON STRONG MSc (Hons)
ENVIRONMENTAL ASSESSMENTS &
MONITORING LIMITED.

JULY 2005

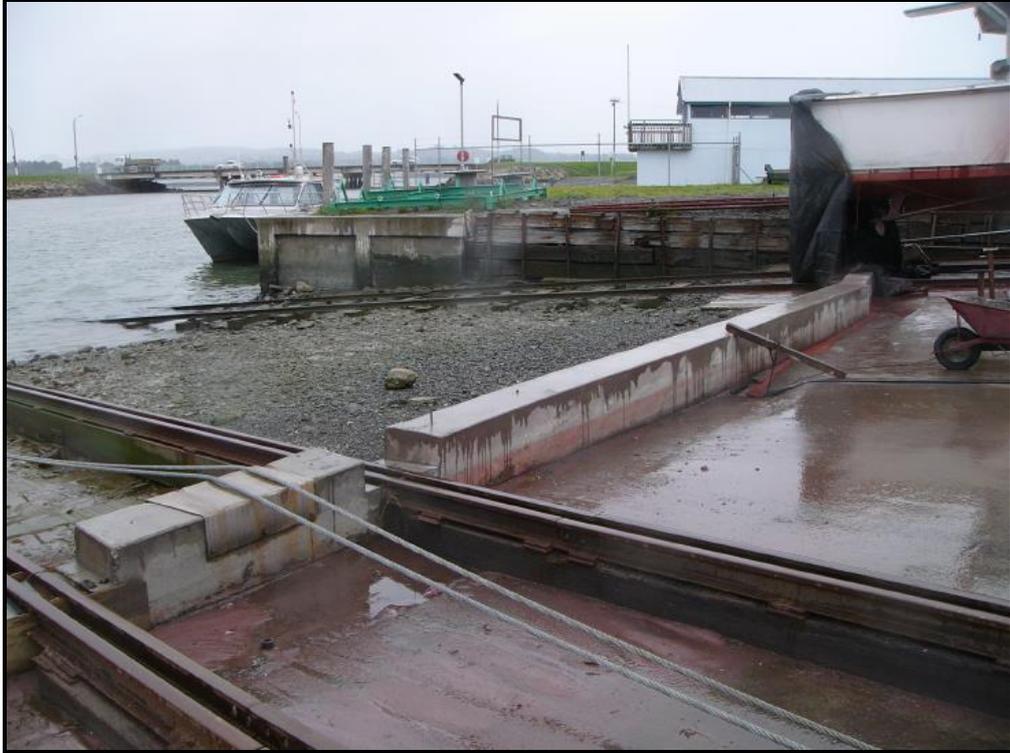
Photo 1: Commercial Slipway (Site #2)

High concentrations of Chlorothalonil were found in sediment samples collected from the commercial slipway at site 2 (19500 ng/g), the marine club slipways at sites 1 (6550 ng/g) and 3 (920 ng/g). There were no detectable amounts of Chlorothalonil in sediments collected from around the Boat Ramp or Iron Pot sites. It is most probable that the high sediment concentrations of Chlorothalonil are also due to the presence of discrete particles particularly as it only has a half-life of 2.8 days in its free form in seawater. This scenario is supported when comparing these results with those from areas of no direct point sources (Boat Ramp and Iron Pot) that did not indicate Chlorothalonil contamination.

The commercial slipway at site 2 again indicates the highest level of contamination (2360 ng/g total DDT isomers) followed by the marine club slipways at site 1 (30 ng/g total DDT), and site 3 (60 ng/g total DDT isomers) sites while only small traces of DDT (10 ng/g total DDT isomers) were detected at the Iron Pot site. Sediments from the Boat Ramp site were non detectable for DDT.

Sediments adjacent to the commercial slipway at site 2 were shown to have extremely high concentrations of mercury (4.02 mg/kg) in comparison to all other sites sampled in this survey. Concentrations of mercury in sediment samples from sites 1, 3, 4 and 5 are similar with lower concentrations of 0.11, 0.12, 0.16 and 0.08 mg/kg Hg found respectively. Mercury contamination of these sediments is likely to be from historic antifoulant paints treated with mercurial compounds and/or from fuel oil/hydrocarbon discharges.

- Determine whether there are any effects to community structures around the areas of boat maintenance sites and if so, to what extent.
- Conduct shellfish sampling (for trace metals and antifoulants) particularly near areas of main contamination. Shellfish gathering has been noted within 50 meters of the commercial slipway at site 2 where the highest contamination occurs.

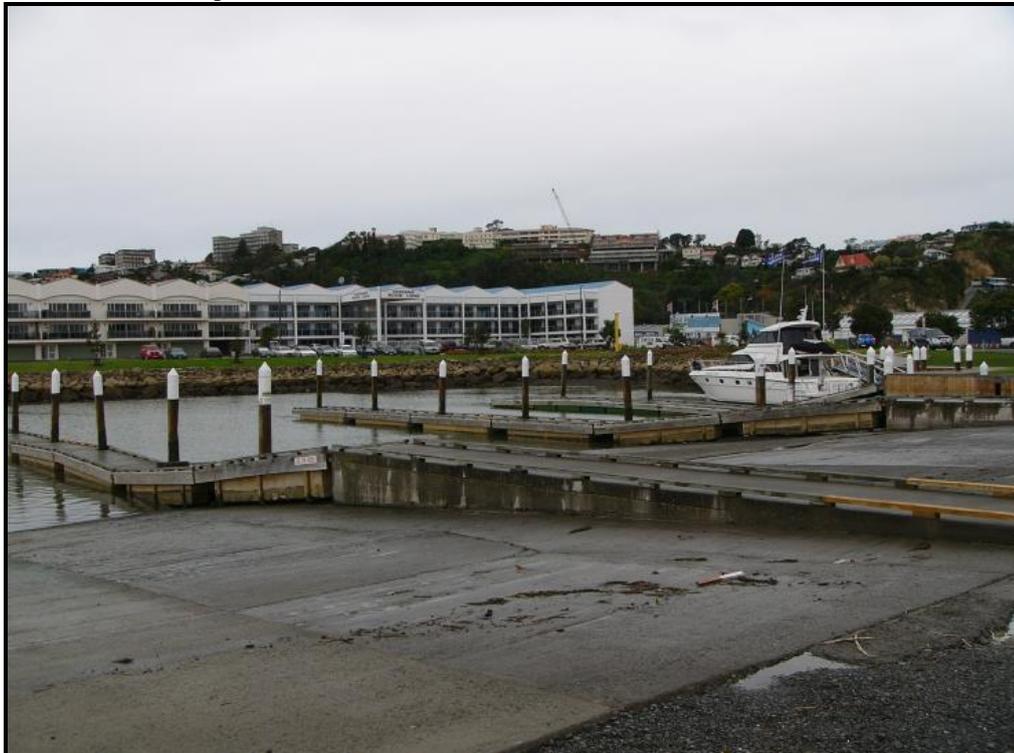
Photo 4: Boat Ramp (Site #4)

Sediments from Boat Ramp site (11 ng/g) exceeded the ISQG-Low guideline limit suggesting further investigation may be warranted while the Iron Pot sediments indicated concentrations below guideline limits.

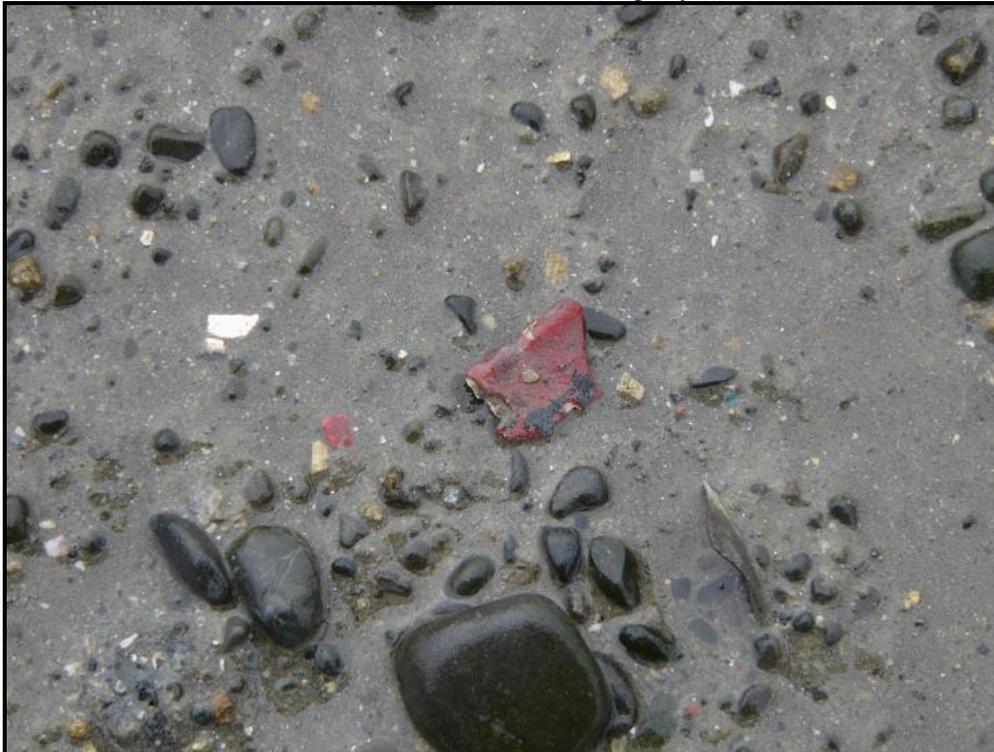
Photo 6: Paint flakes in sediment from the Marine Club Slipway (Site #1)

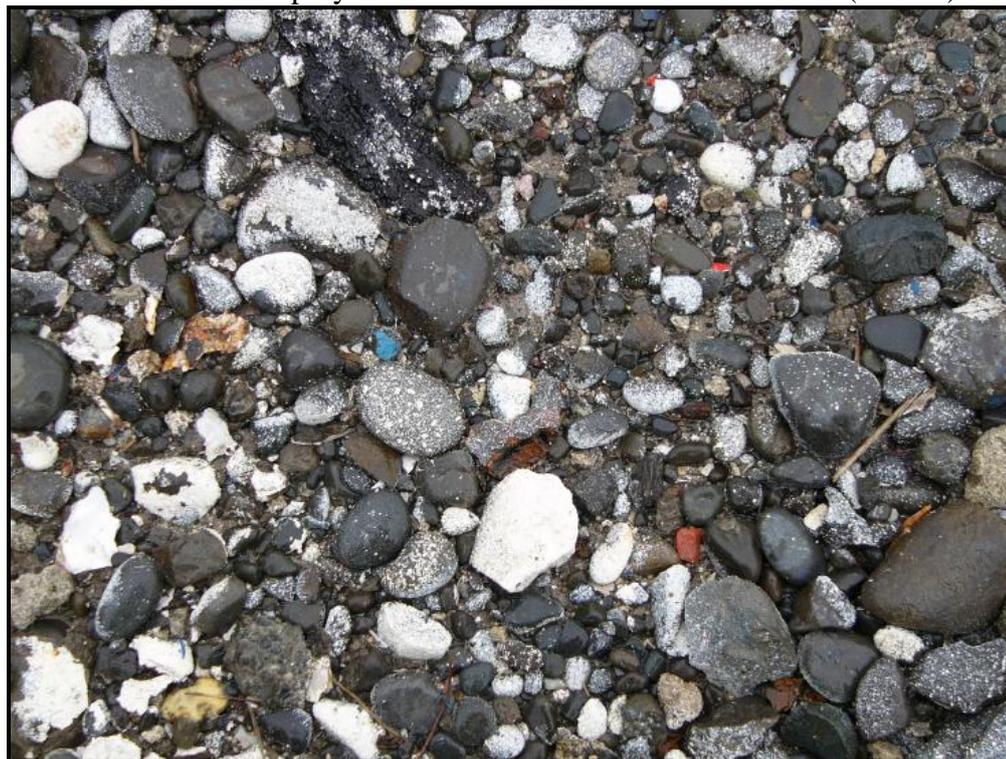
Photo 7: Paint Flakes and over-spray at Marine Club & Maintenance Berth (Site #3)
