Hawkes Bay Regional Council

Ruataniwha Water Augmentation
Scheme

Advanced Prefeasibility Geotechnical
Investigation Report

T&T Ref: 27195/V04

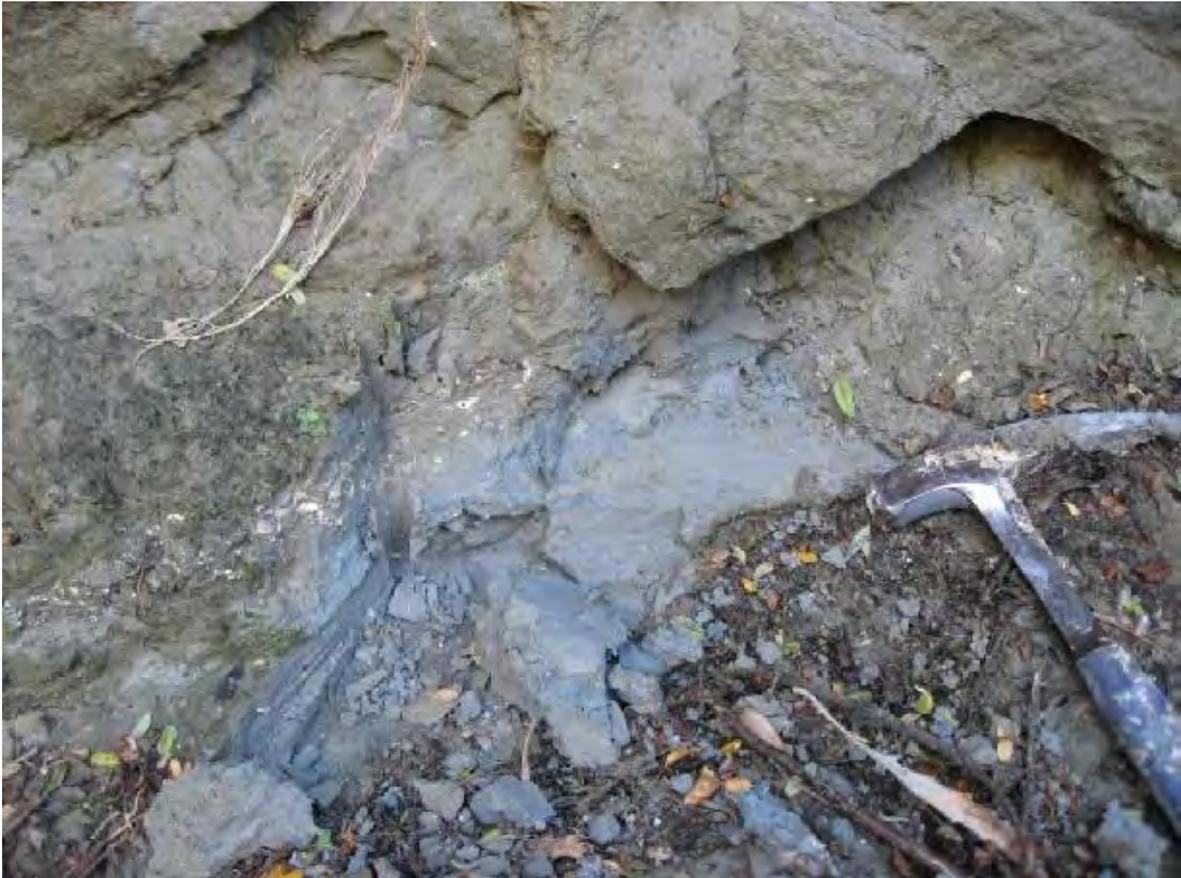
In particular, landsliding on a shear zone dipping at 40° towards 285°-290° was mapped within the footprint of the original dam site (refer Figure 3-6) and 250m downstream (refer Figure 3-4). The two observations of the shear zone plot on a straight line and it is likely that the defect is continuous between the two observations. If so, the shear zone may indicate the presence of faulting subparallel to the nearby major Ruahine and Mohaka faults.

Figure 3-6 Landsliding on a low angle bedding plane defect

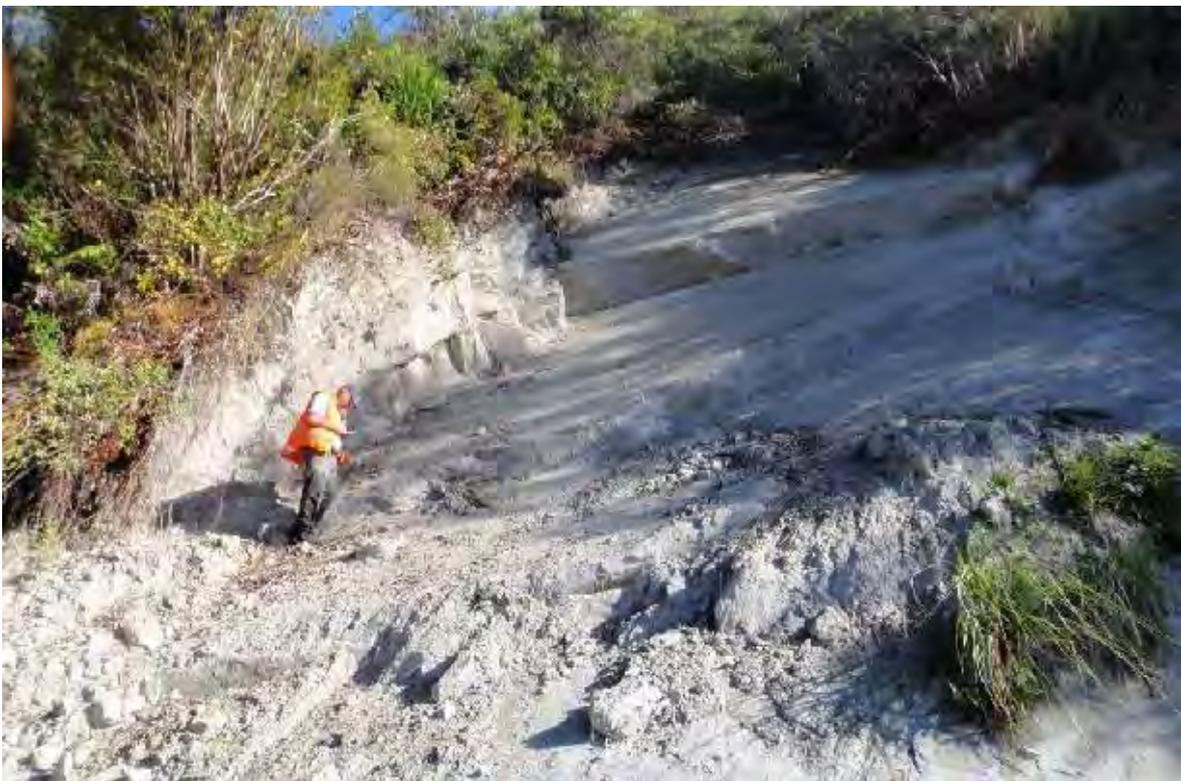
Landsliding and tectonically disturbed zones in the rock mass were observed at many places along Dutch Creek. Shearing was evident on defects and in particular on low angle downstream dipping bedding planes and on steeper dipping joints (refer Figure 3-7).

Figure 3-7 Slope failure on steep joints 85 degrees to 360 degrees

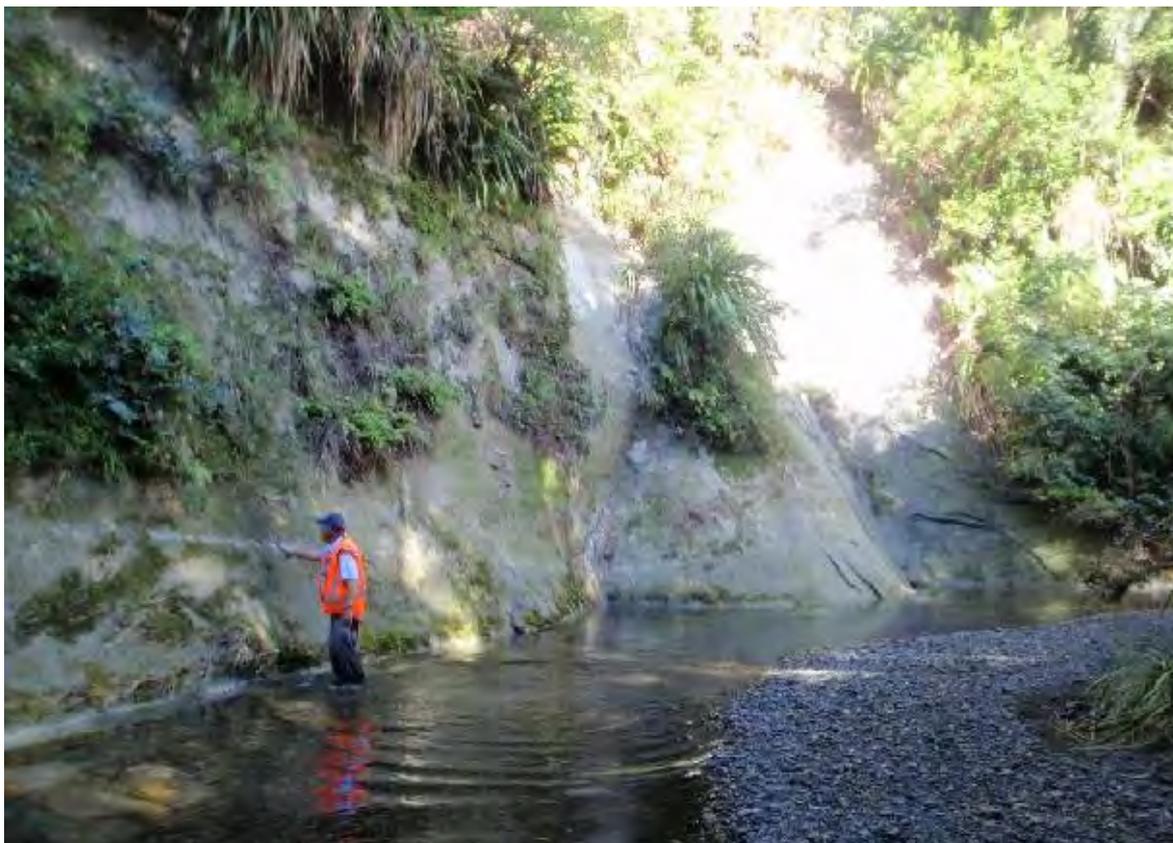
Figure 3-8 Bedding plane measurement near upstream toe of original dam location 16 degrees to 170 degrees

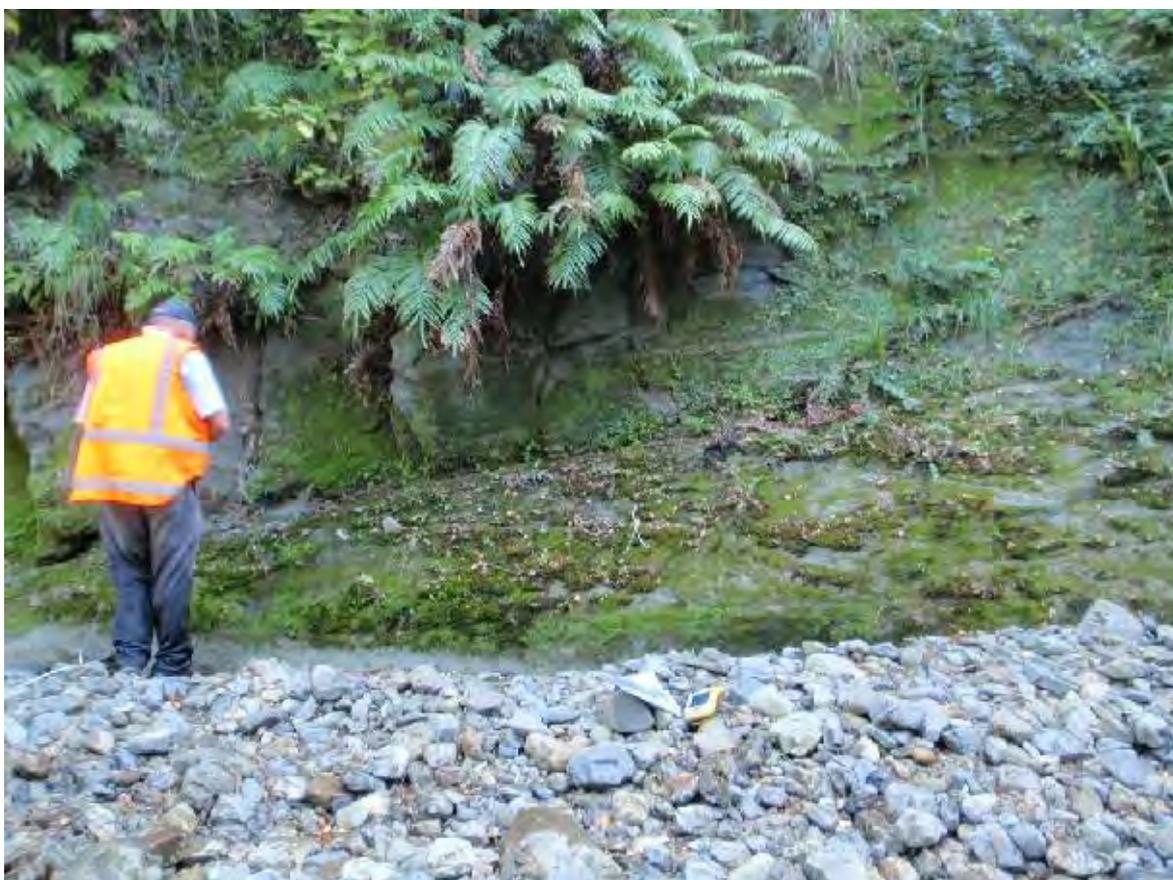
Figure 3-13 Defects developed above bedding plane shear at 16 degrees to 150 degrees (at upstream extent of survey)

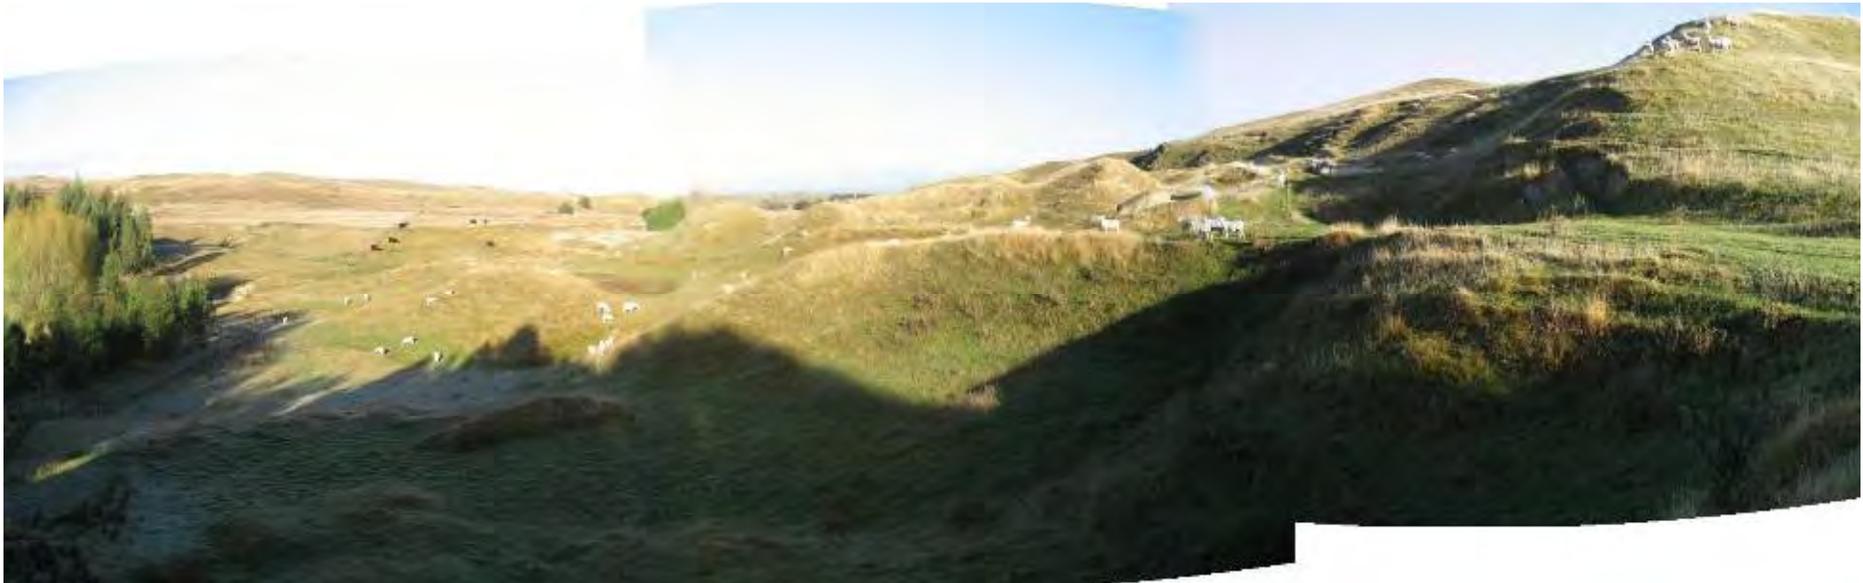
Figure 3-27 Eastern landslide, scarp at right of photo, smaller than landslide to west

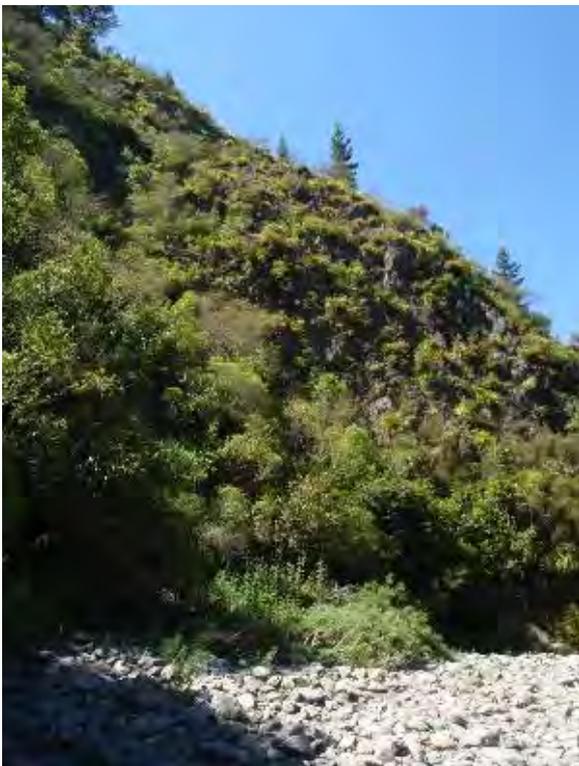
Figure 3-34- Dilated rock mass seen from river bed – looking south

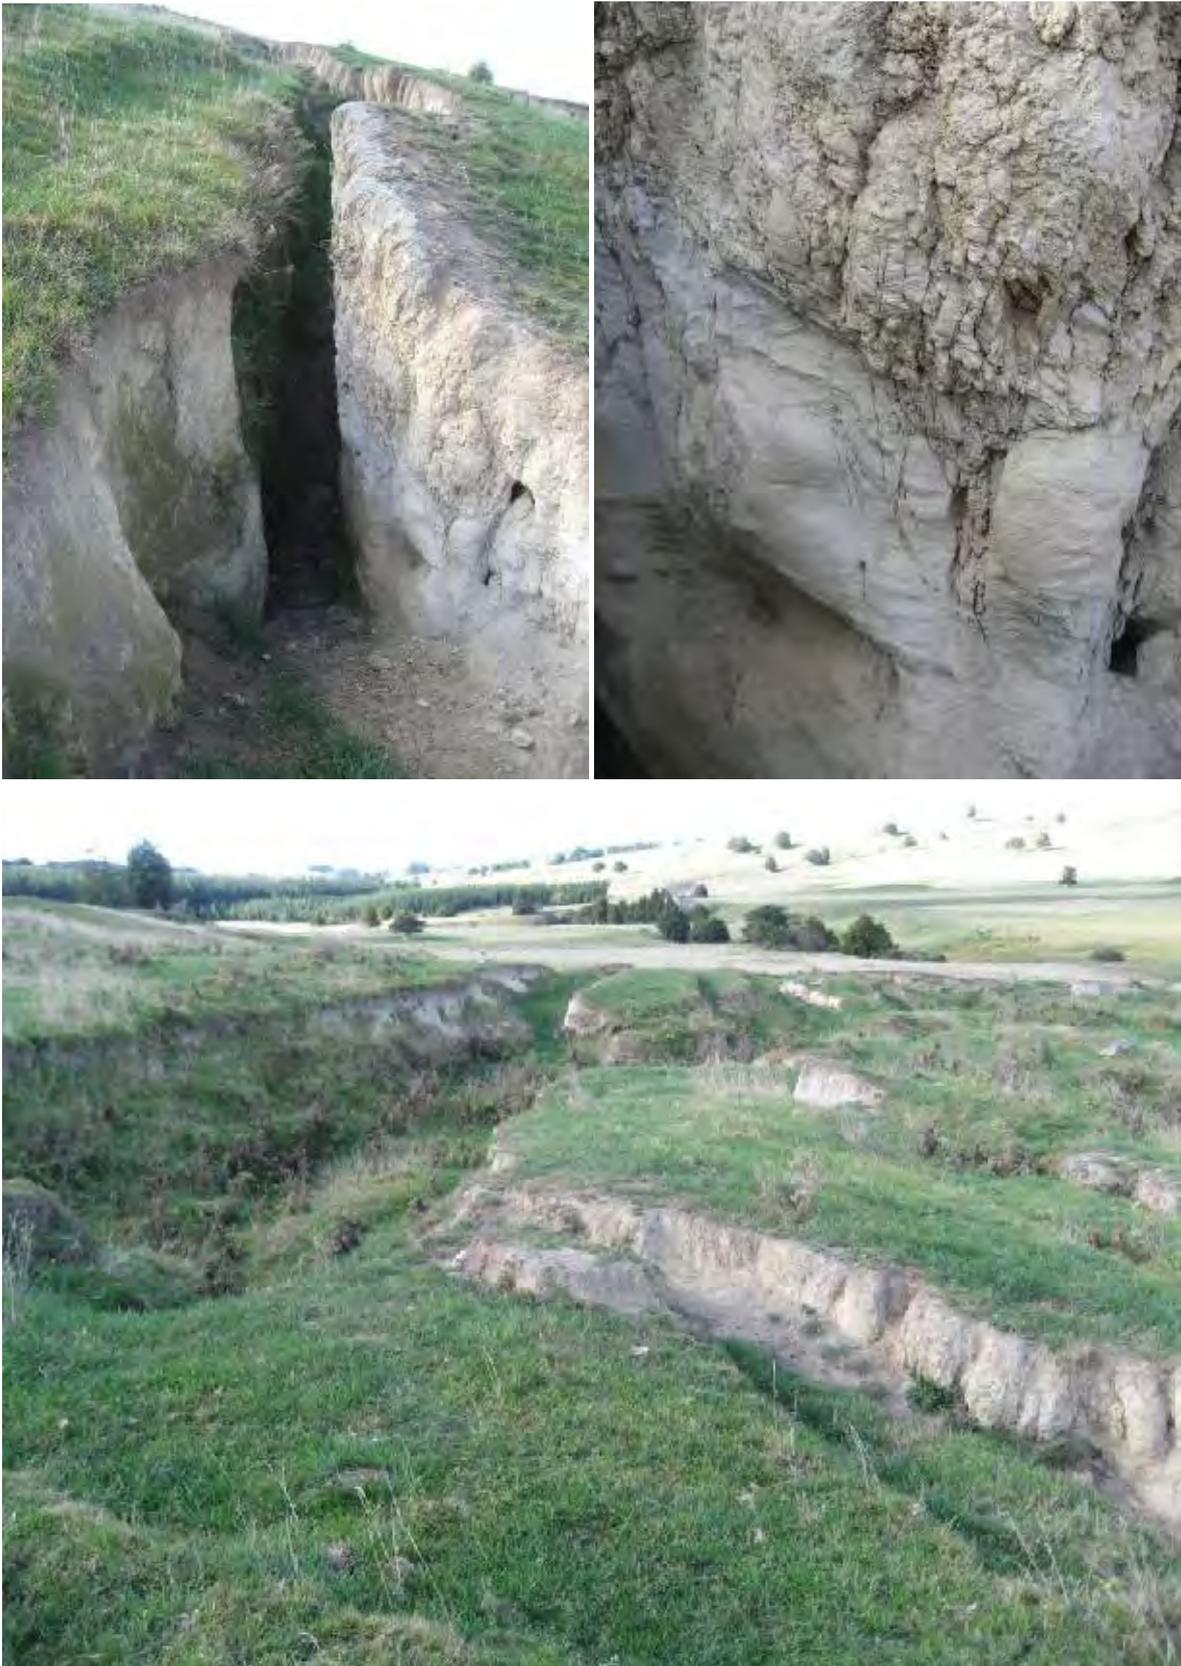
Figure 3-42 Pumiceous siltstone exposed in cracks associated with instability in left side of valley

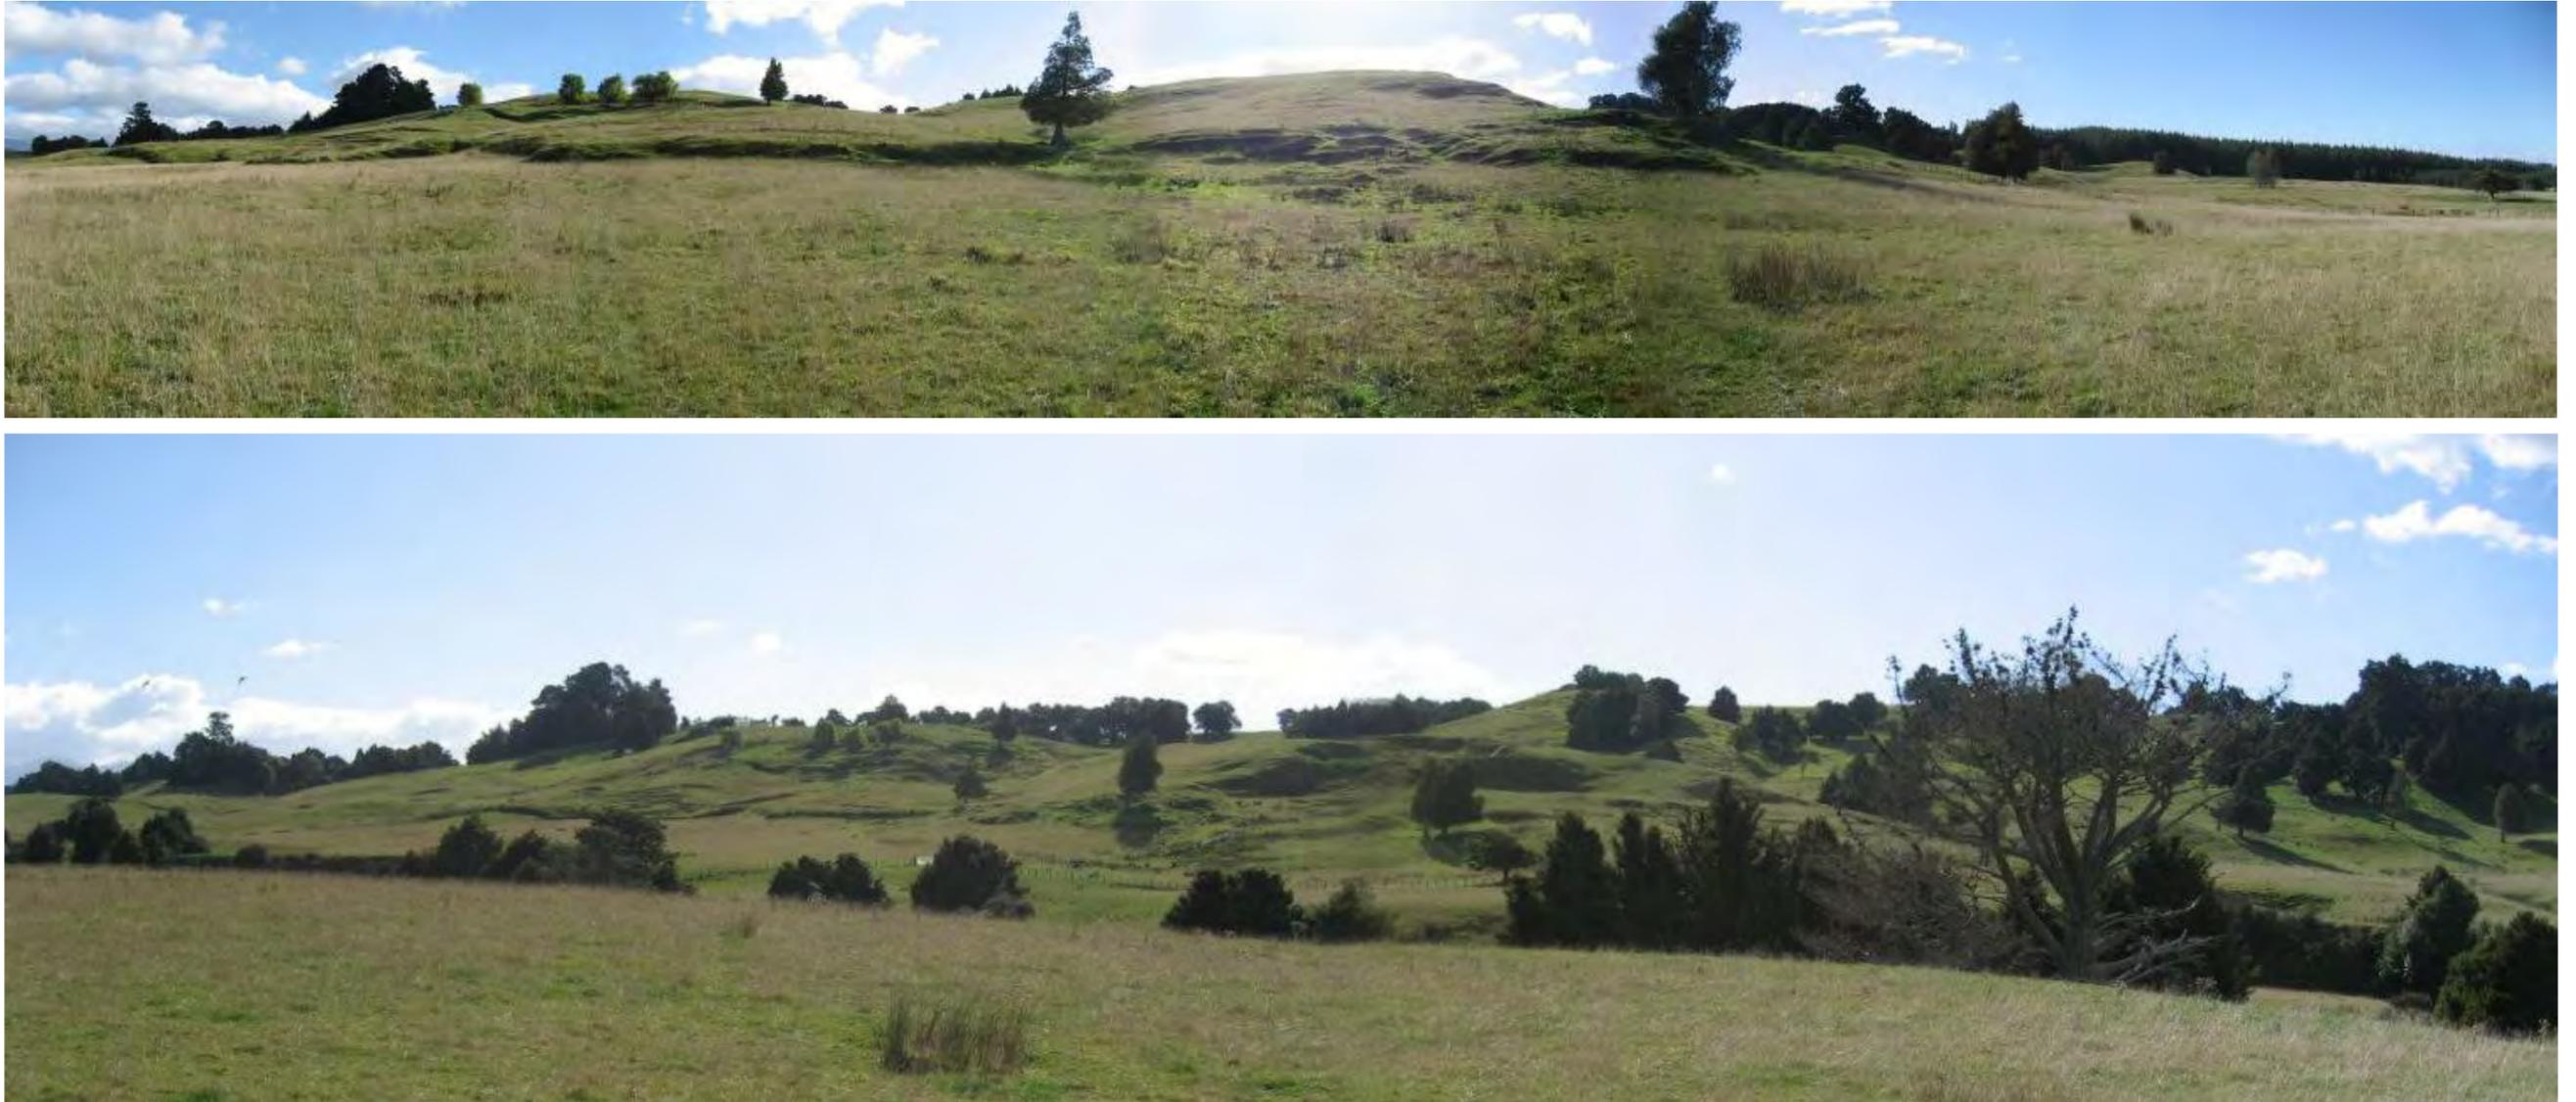
Figure 3-43 Toe of landsliding in left side of valley - instability limited to above 312mRL approximately

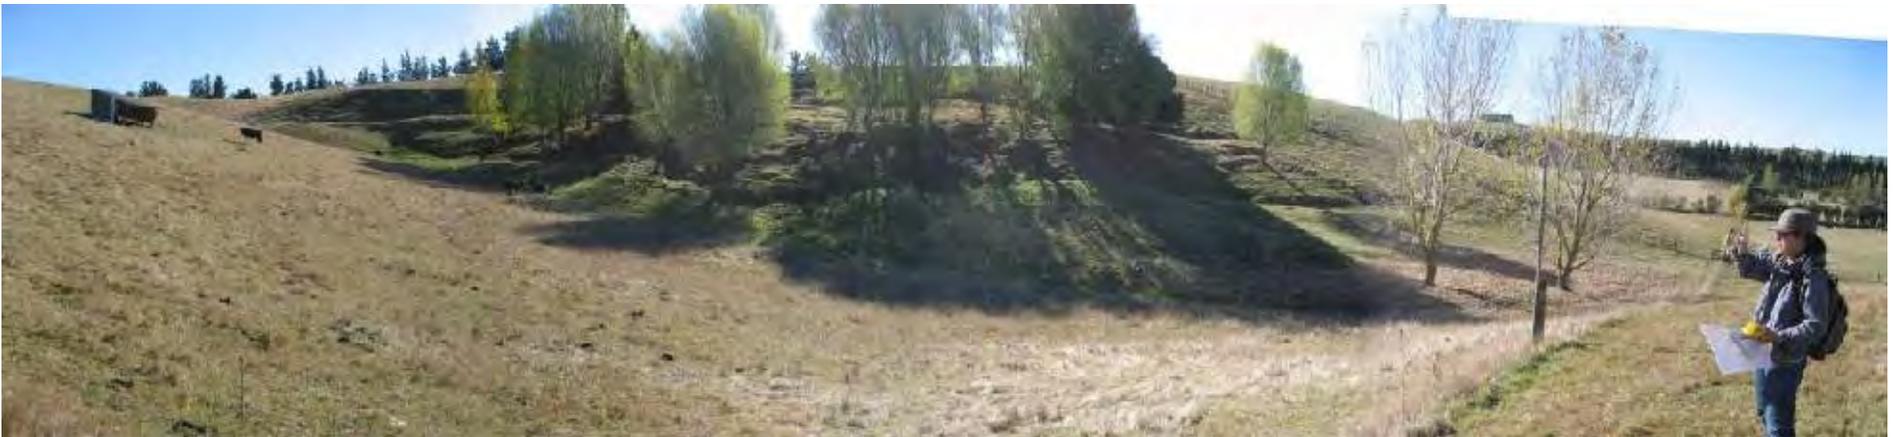
Figure 3-56 Landslide in southeast face of ridge at right abutment

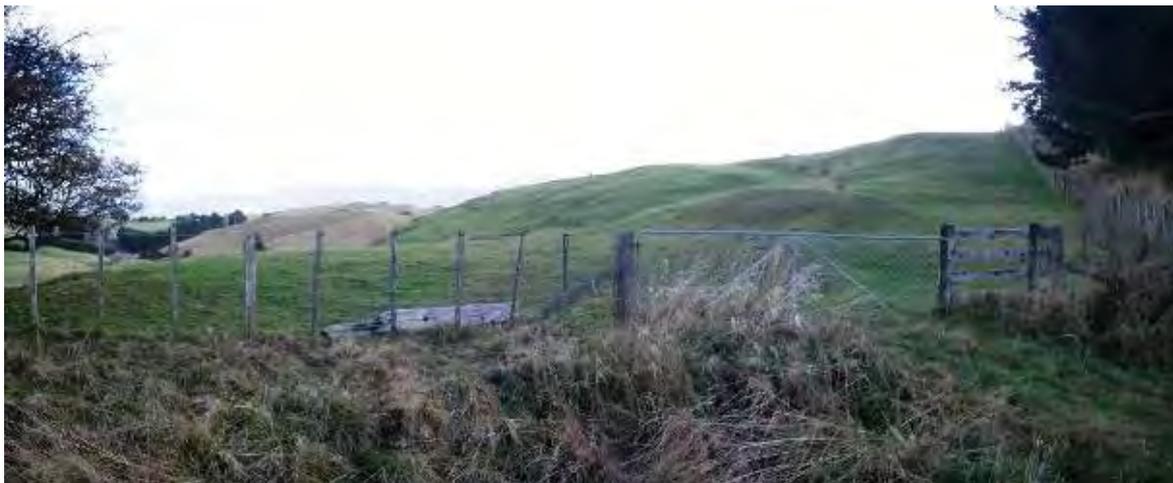
Figure 3-62 Landslide upstream of left abutment photographed from road

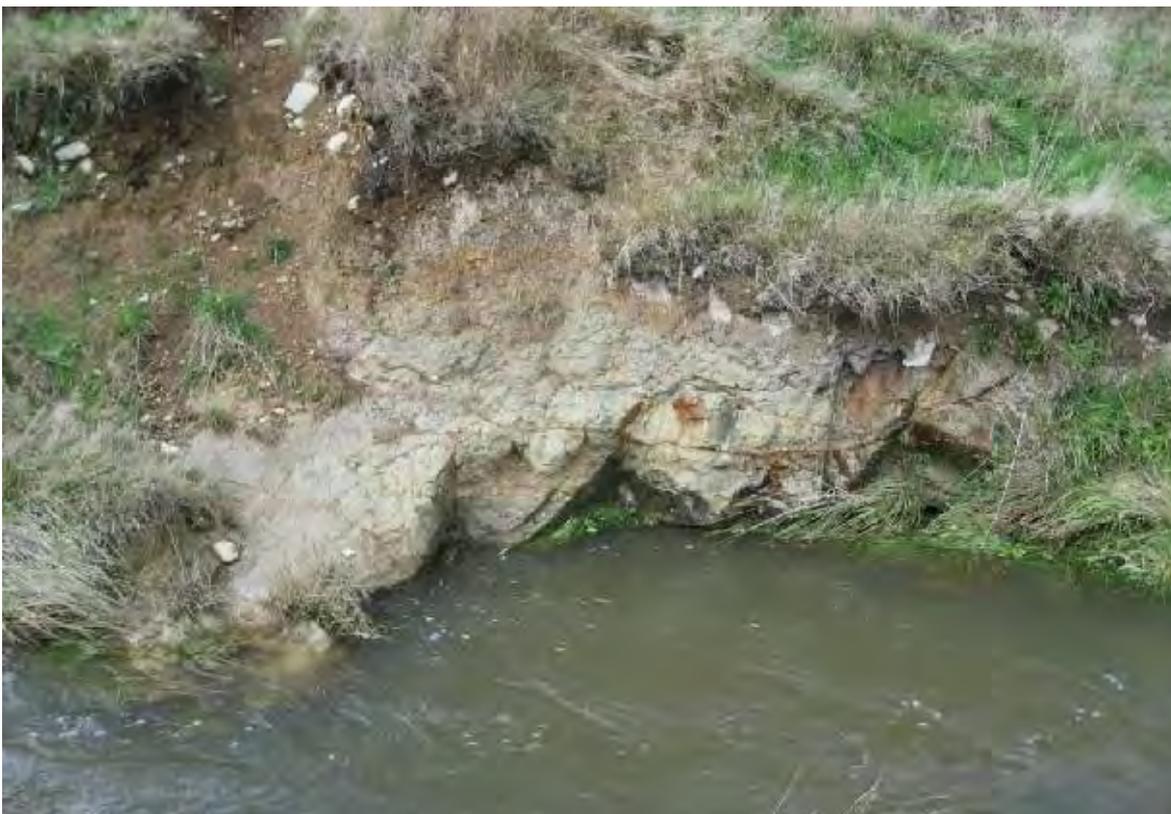
Figure 3-67 In stream bed close to upstream toe of embankment: Highly jointed, iron stained siltstone

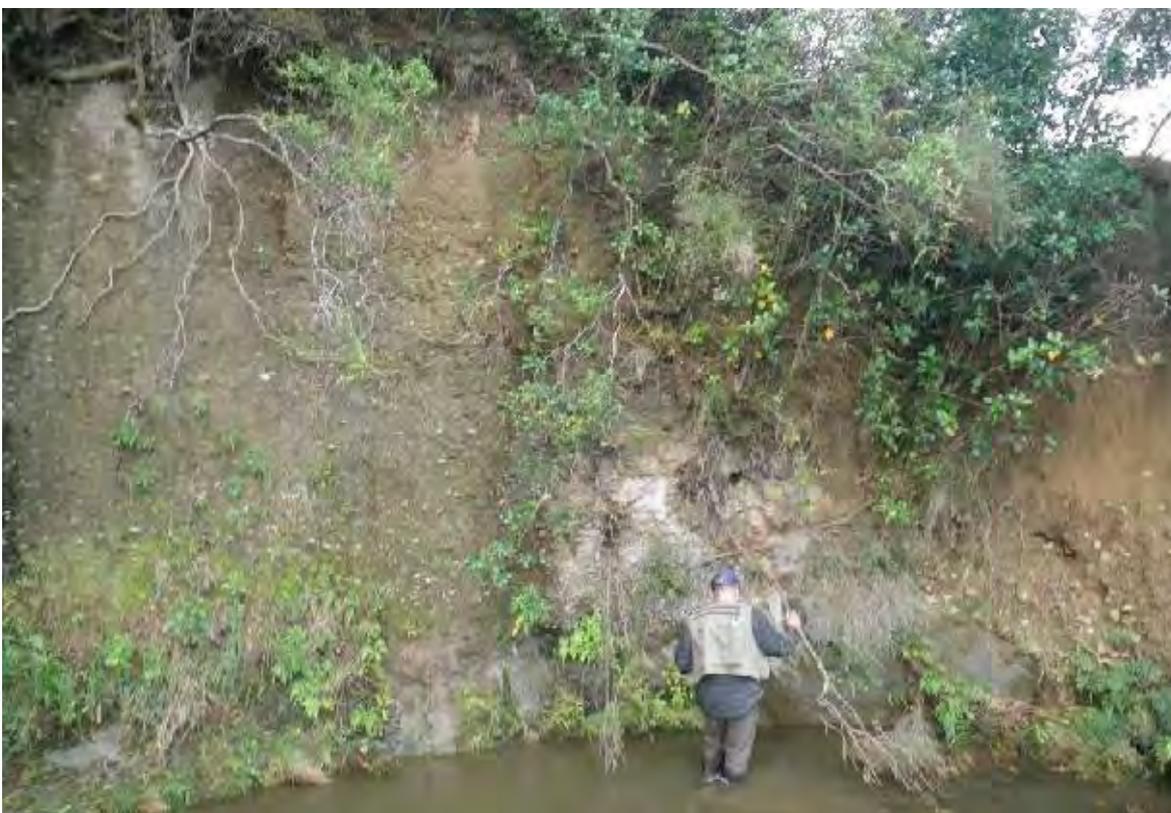
Figure 3-68 Upstream of Tukituki Makaretu Road: Highly fractured siltstone in creek overlain by cemented red metals

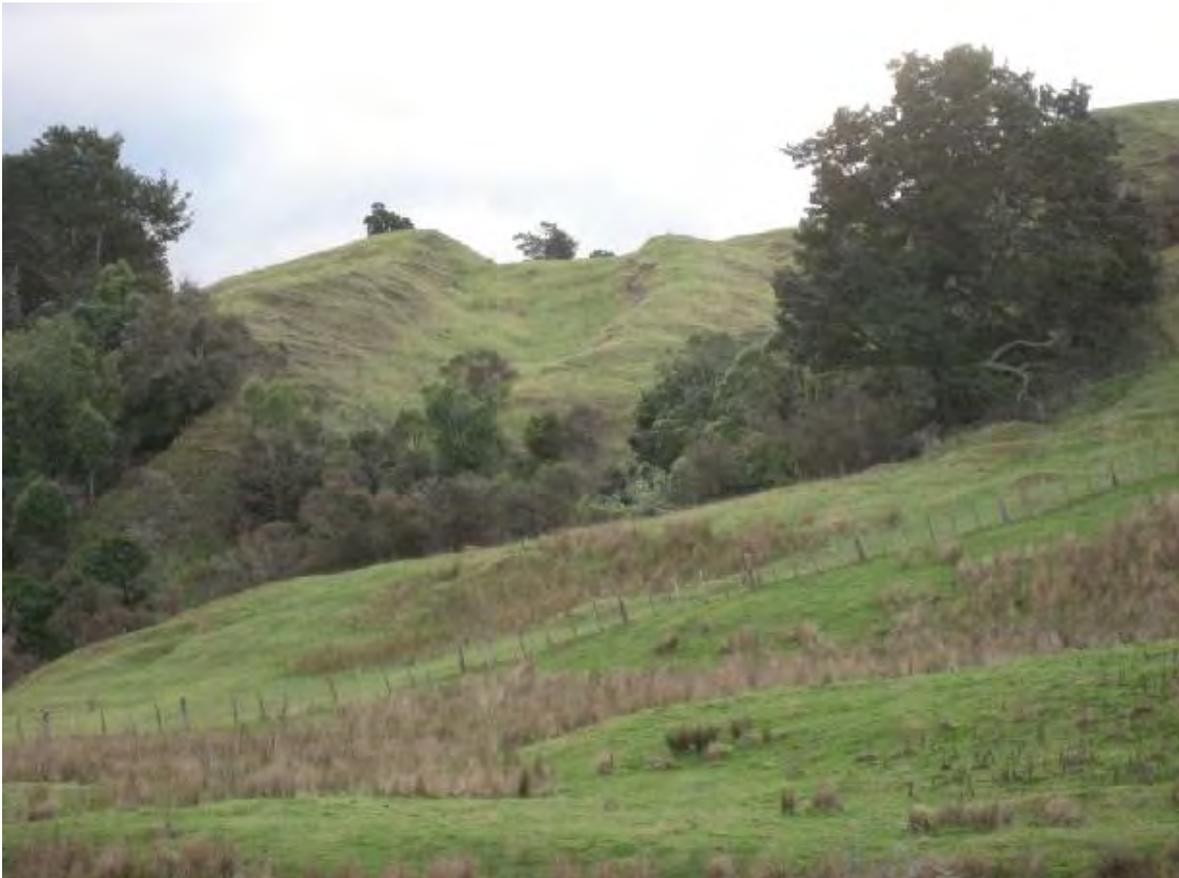
Figure 3-69 Graben of detached block

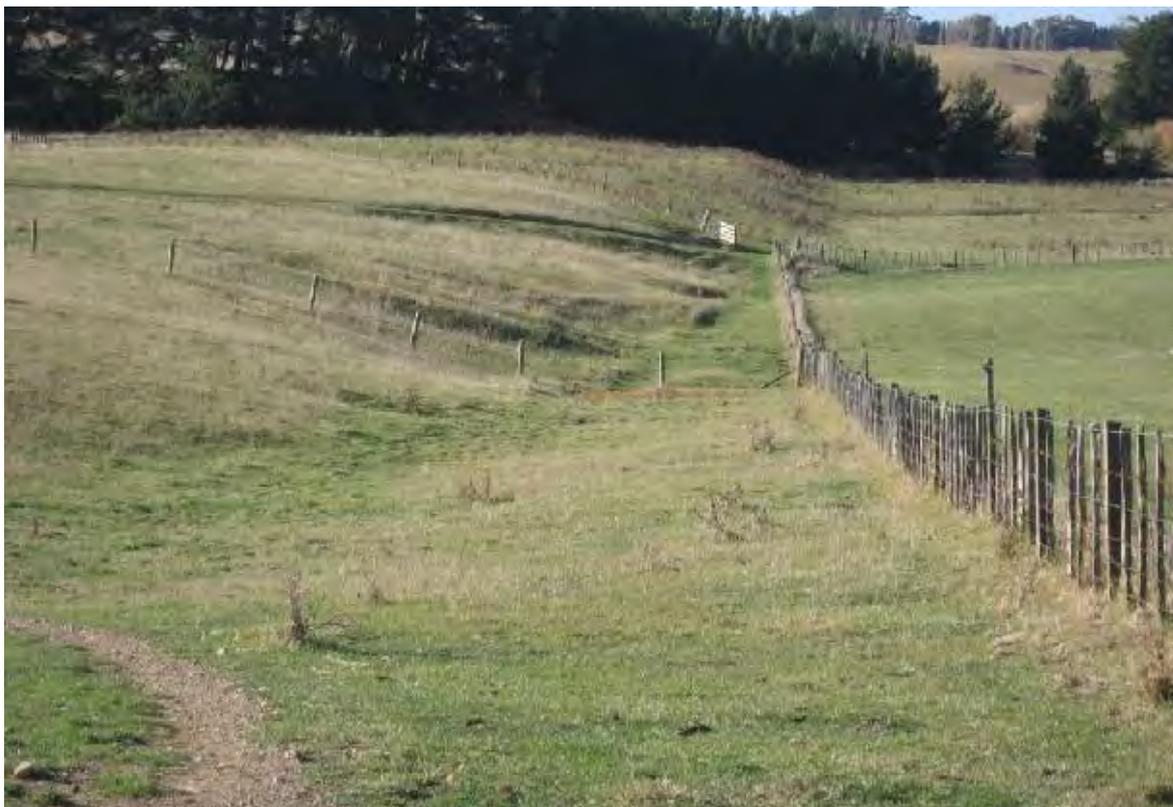
Figure 3-87 Looking NE along the most recent fault rupture (the upthrown side is on the left)

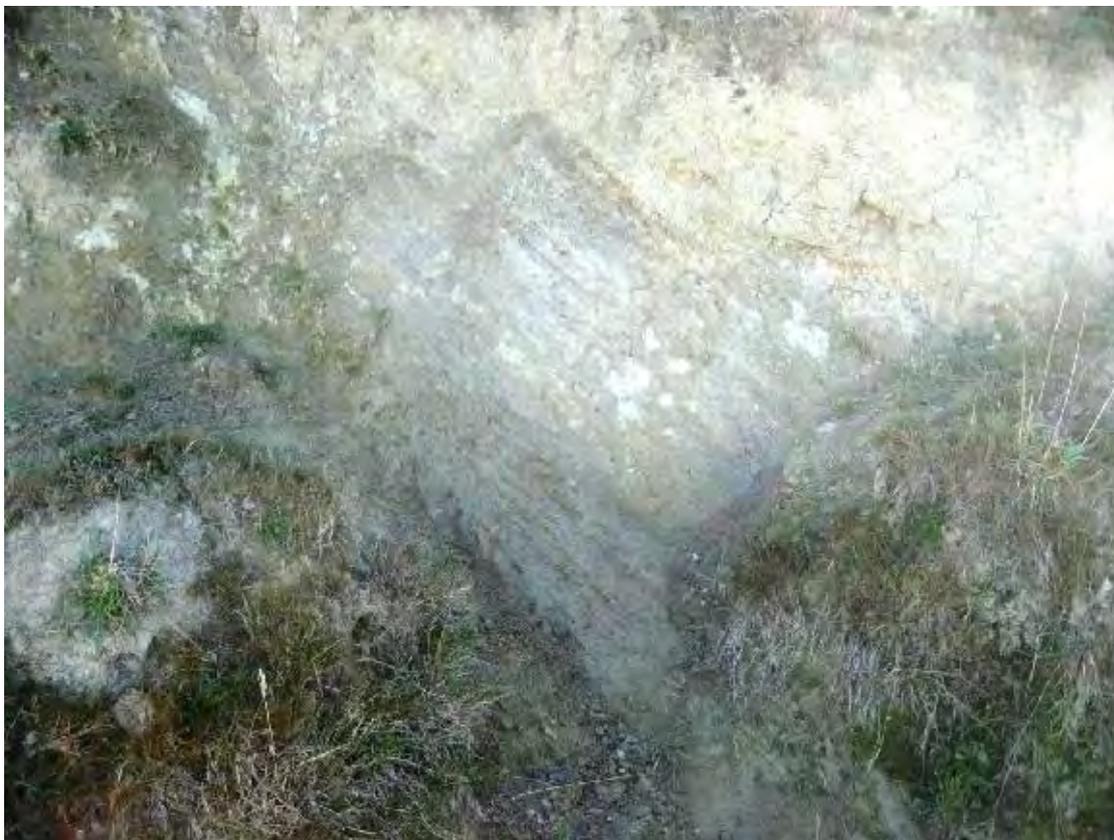
Figure 3-88 Bedding dipping at 40 degrees towards 092 degrees in slightly to moderately weathered SILTSTONE, thinly fissile, highly fractured, likely related to fault

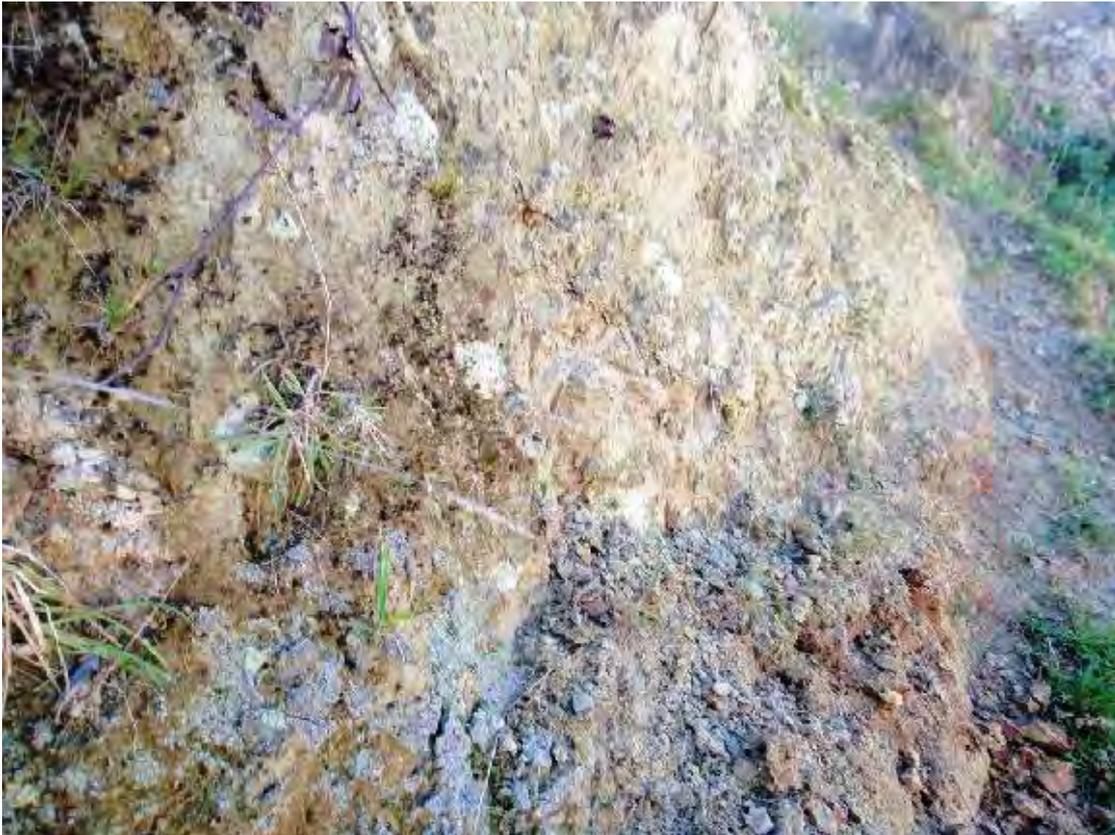
Figure 3-89 Disrupted coarse siltstone, most likely related to mapped fault
