9 November 2017

Our File Ref: HDC17001

**Clifton Revetment (CL17034C & Others) - Response to Request for Further Information**

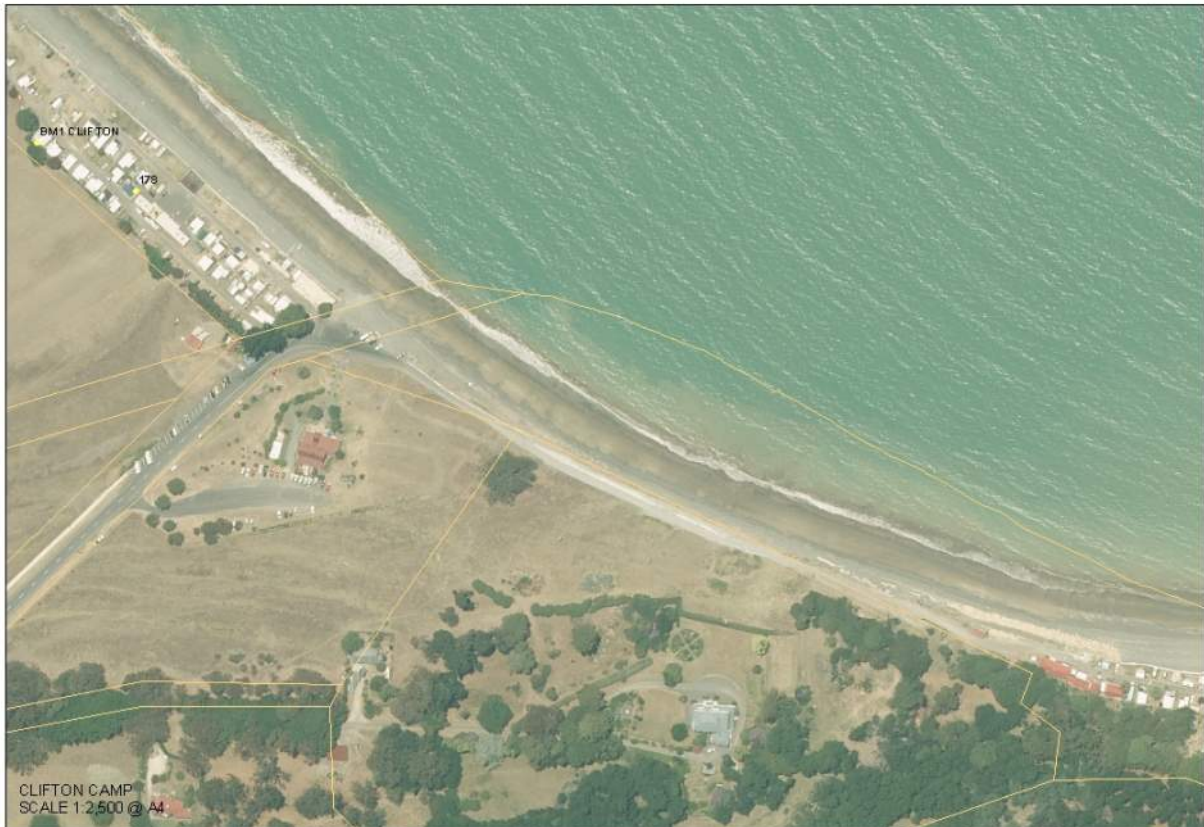
Beach profile data at HB1 has been periodically taken at Clifton beach since 1972. The location of this profile, labelled below as BM1 Clifton, can be seen in Figure 2.6. Figures 2.7 and 2.8 show the results of the beach profile monitoring. Most notably from these results, the beach profile has retreated 32m since 1972 (i.e. 0.69m/year).

*Figure 2.6: HB1 (labeled BM1 Clifton) Cross section profile location, Clifton, New Zealand.  
Image obtained from the Hawke's Bay Regional Council*

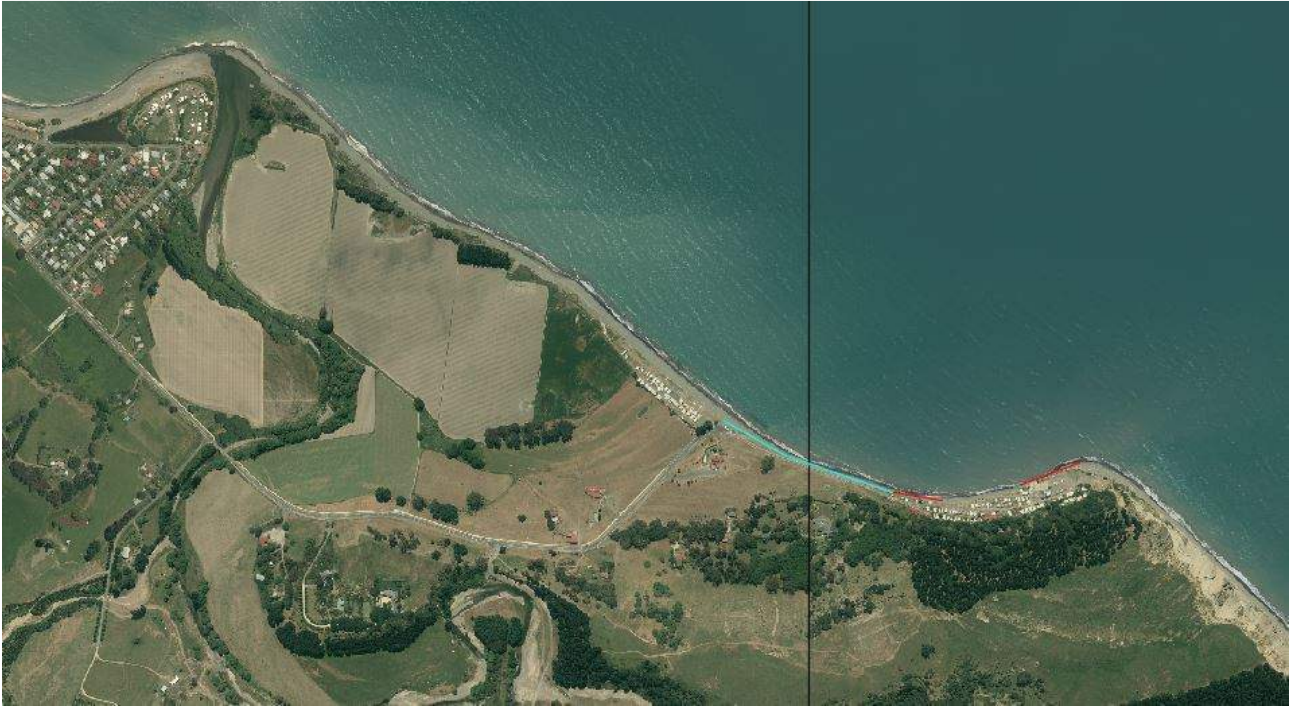
Figure 3.3: Hard point and Revetment Positions (red) and proposed revetment (cyan)

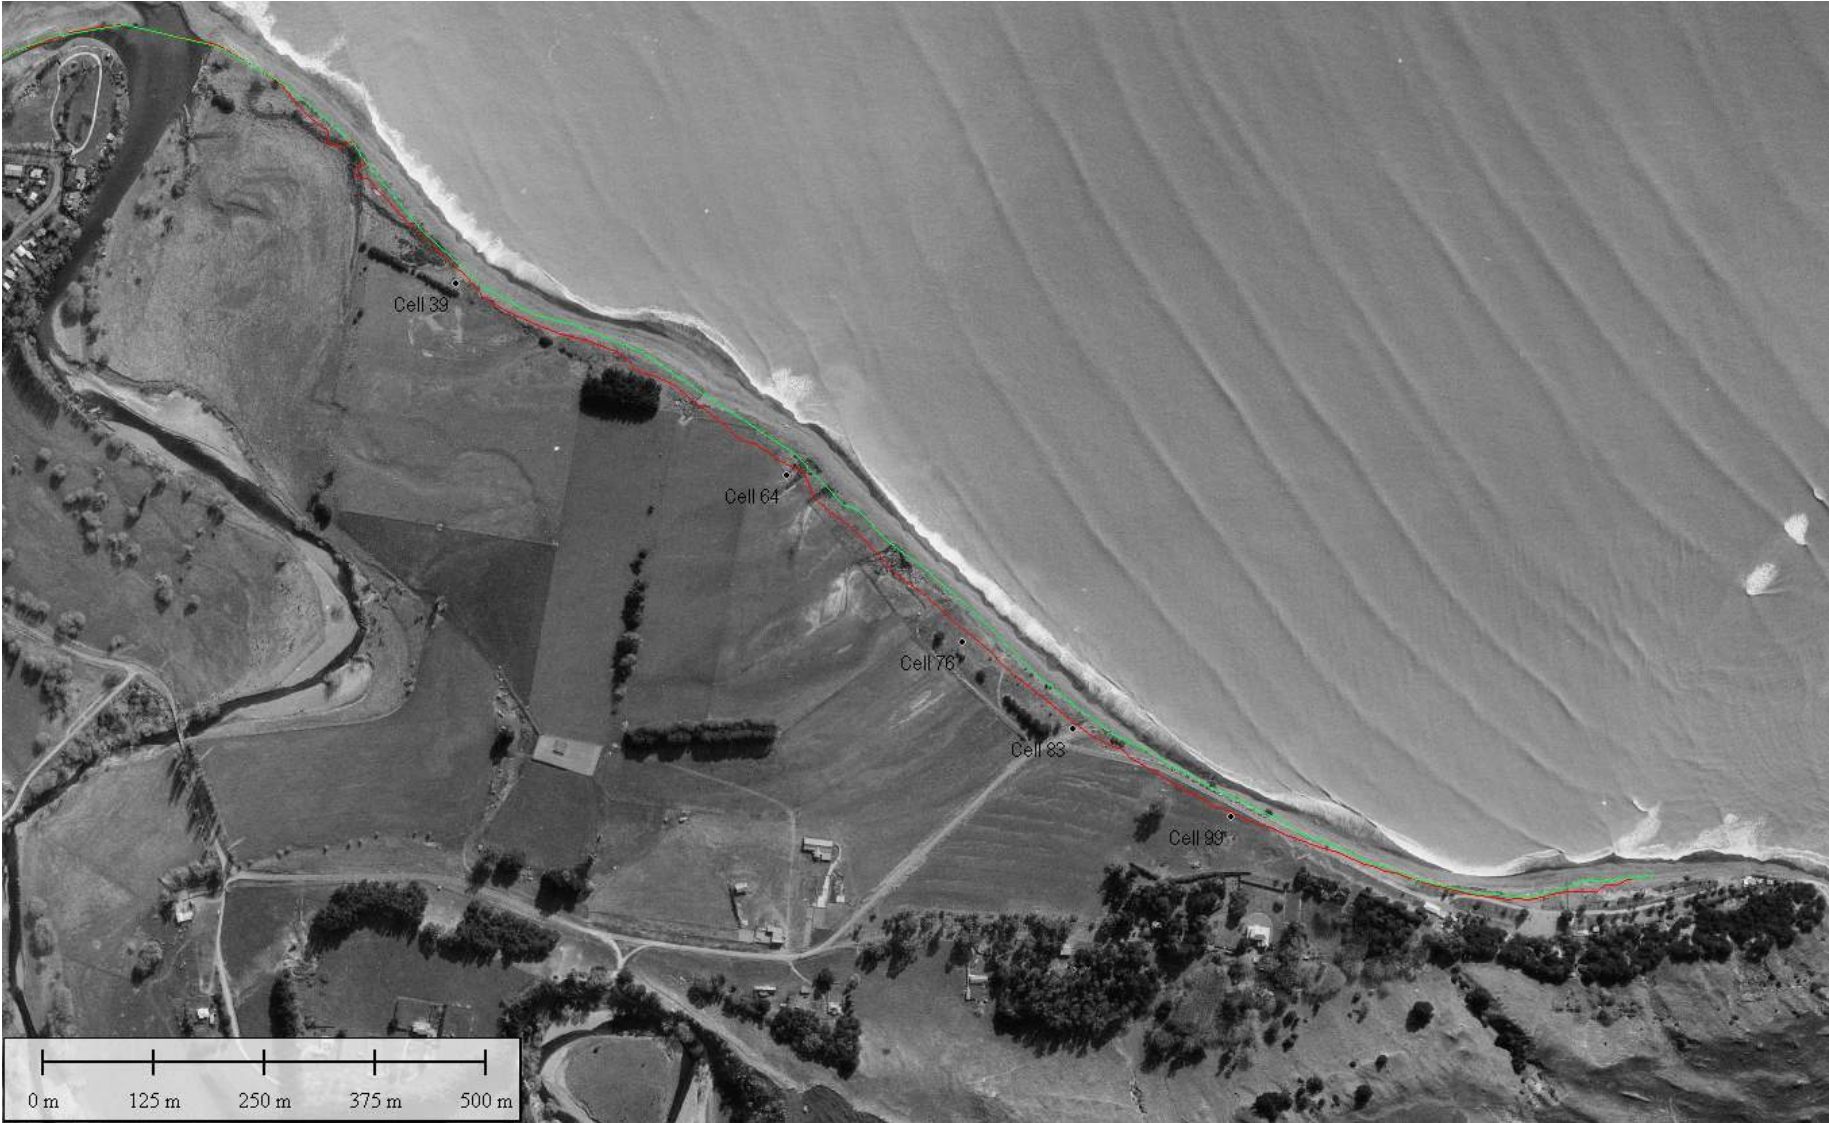
Figure 3.4: Historical shoreline movement – Base photograph 1963, 1980 vegetation line (green) and 2009 vegetation line (red)

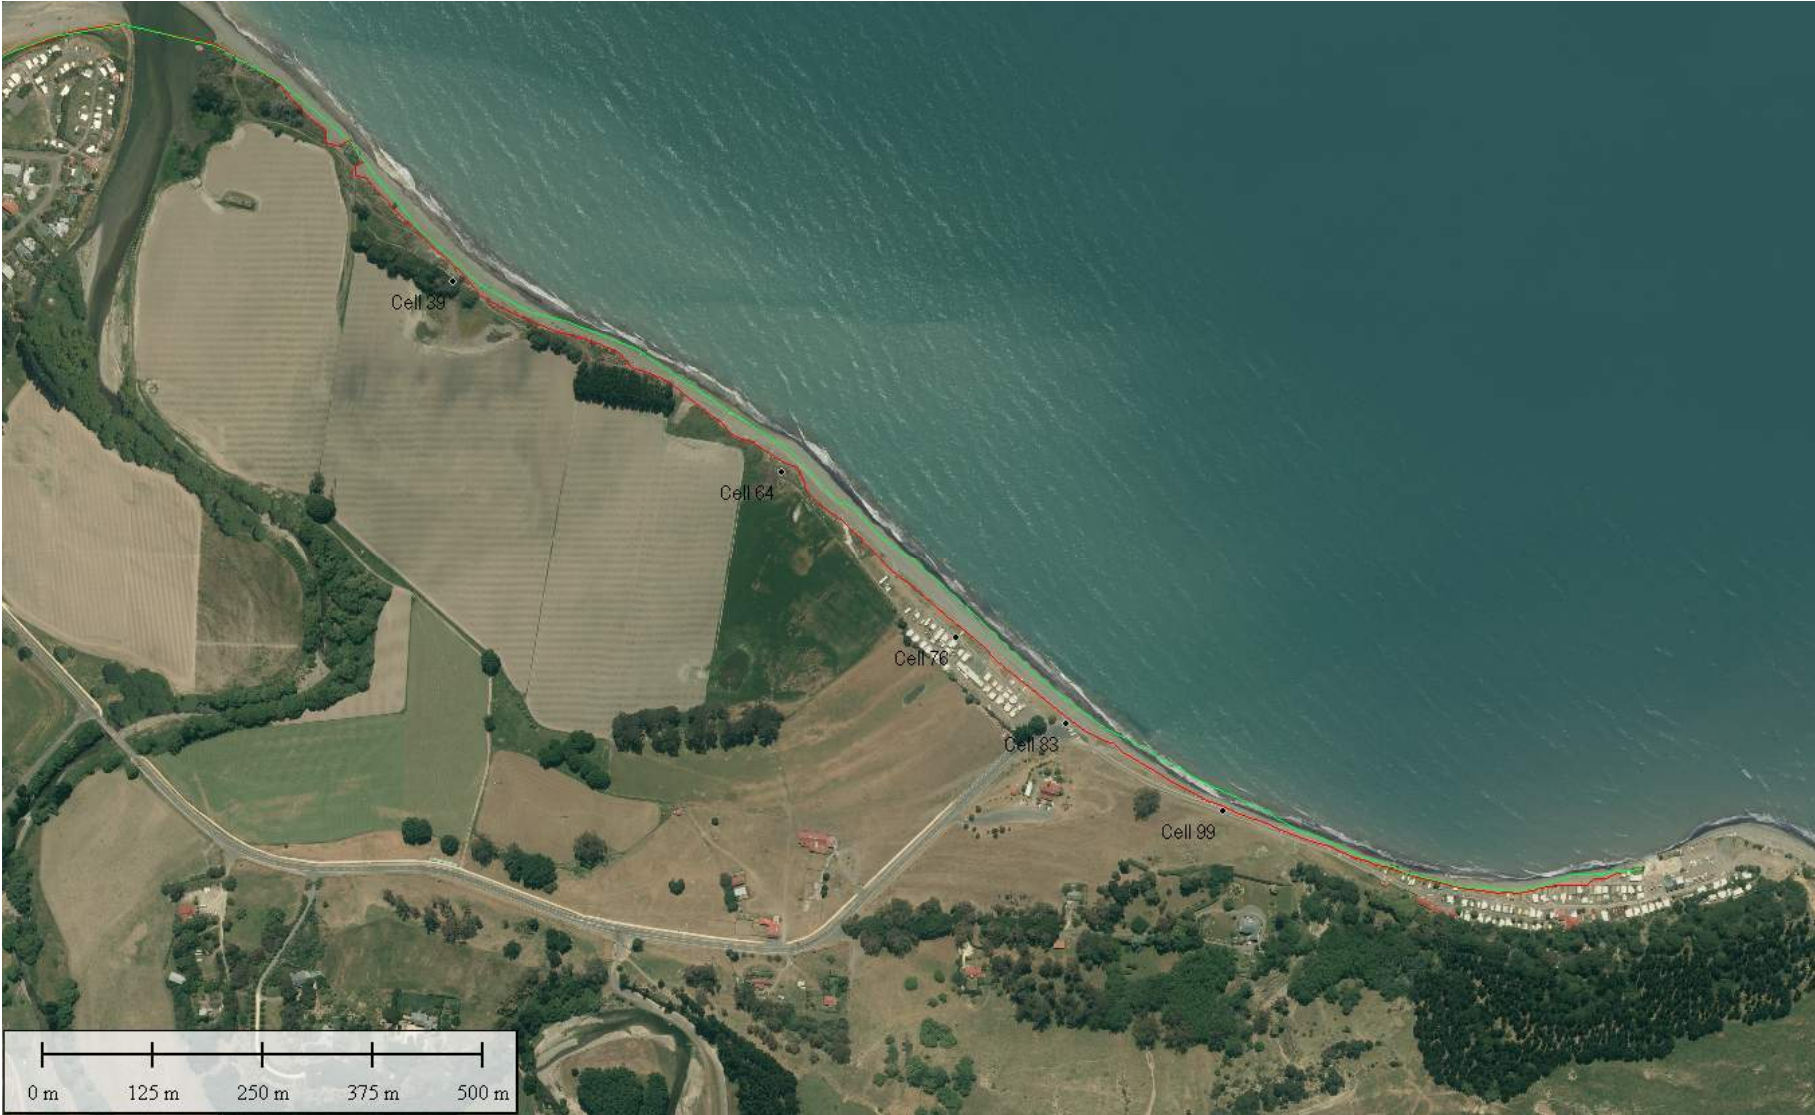
Figure 3.5: Historical shoreline movement – Base photograph 2009, 1980 vegetation line (green) and 2009 vegetation line (red)

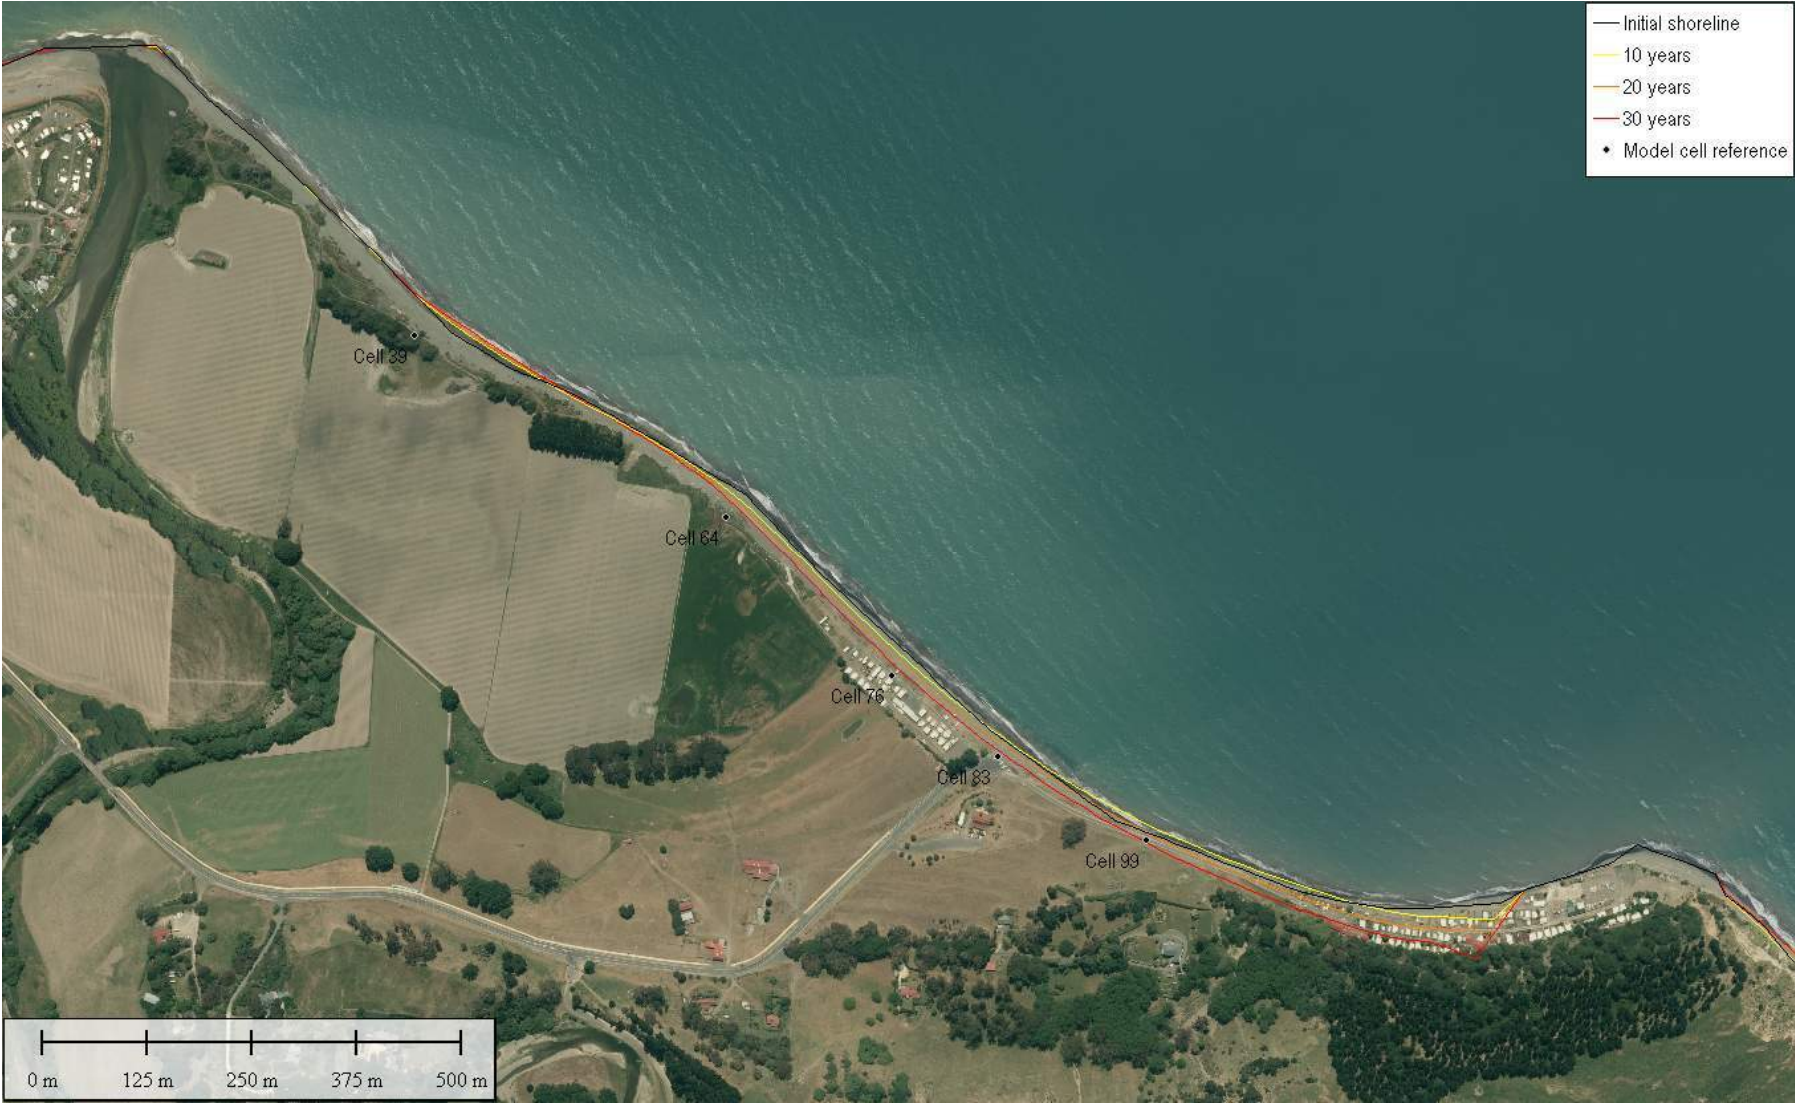
Figure 3.8: Coastline Evolution, No Protection Case (Scenario 1)

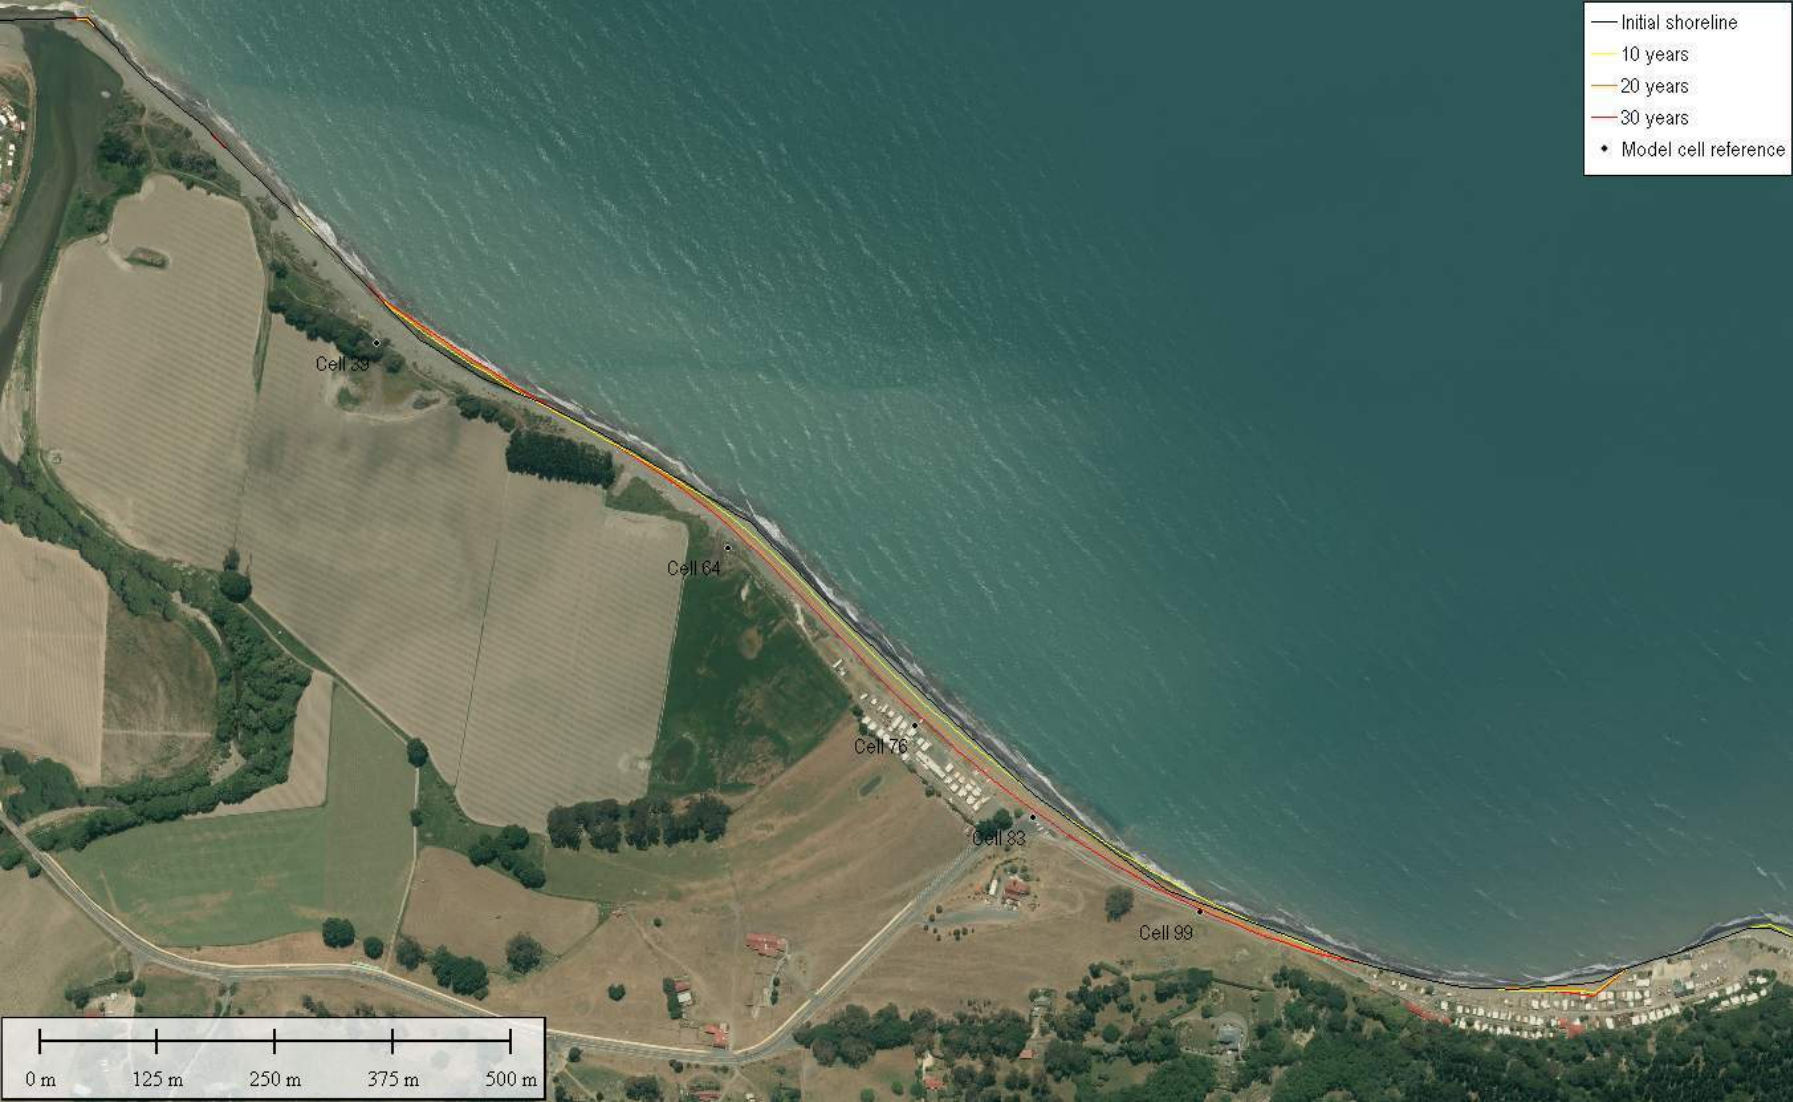
Figure 3.9: Coastline Evolution, Existing Conditions Case (Scenario 2)

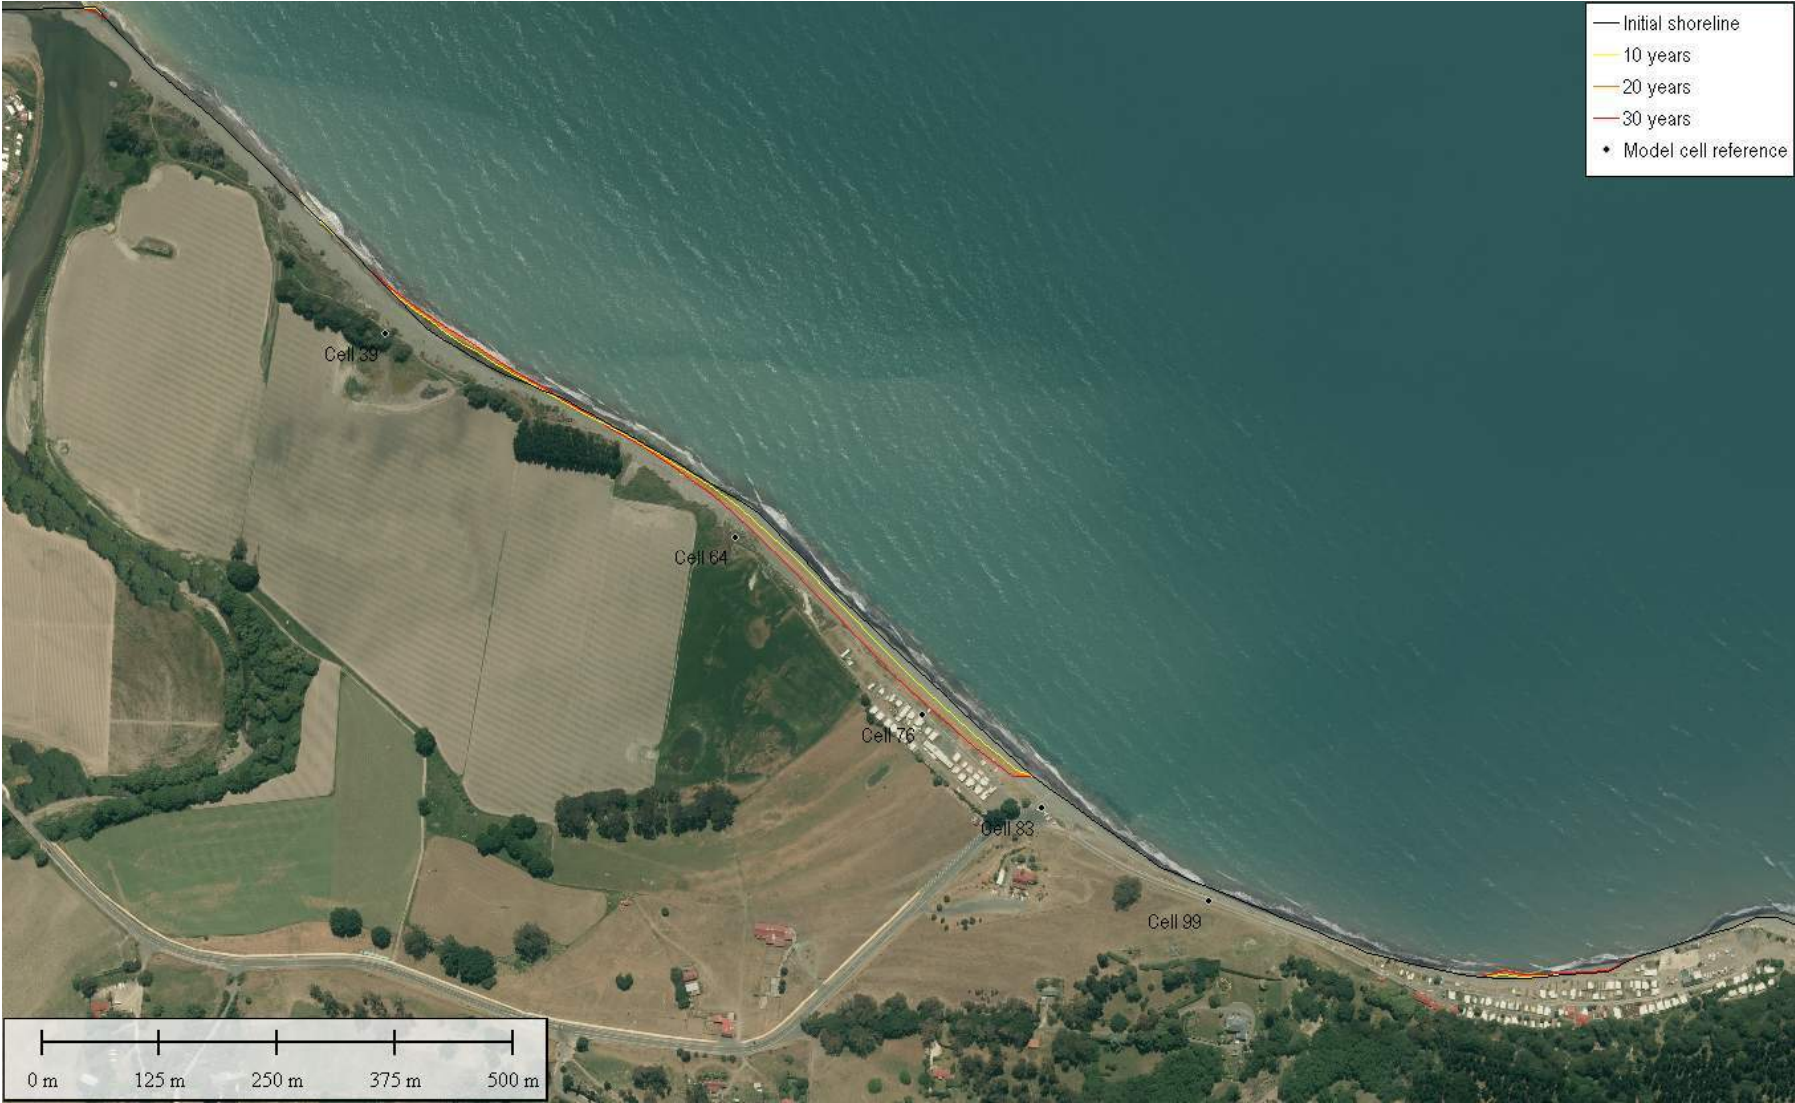
Figure 3.10: Coastline Evolution, Proposed Conditions Case (Scenario 3)

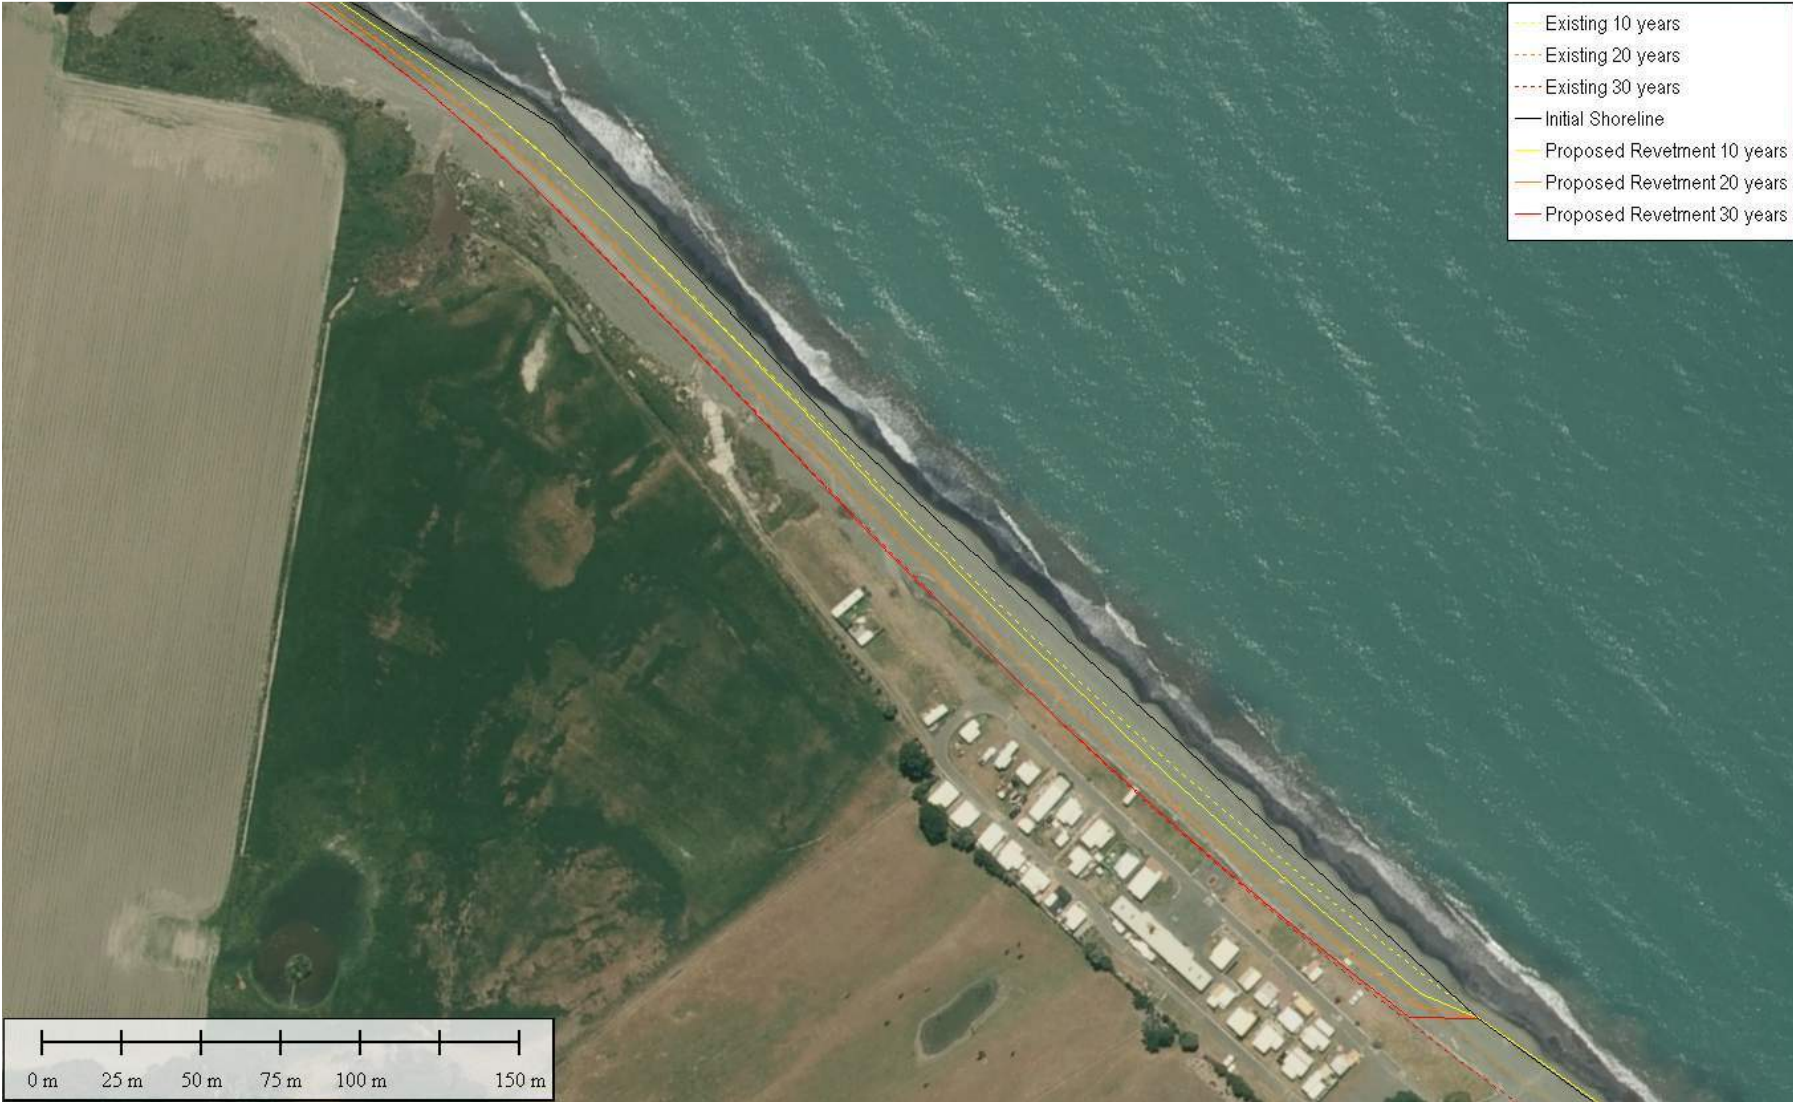
Figure 3.11: Shoreline evolution - Existing and Proposed Revetment Cases at Campground 1
