**RUNANGA LAKE  
ECOLOGICAL  
MONITORING  
2006**

**June 2007  
EMI 0711  
HBRC Plan No. 3951**

## **Environmental Management Group Technical Report**

# **Runanga Lake Ecological Monitoring 2006**

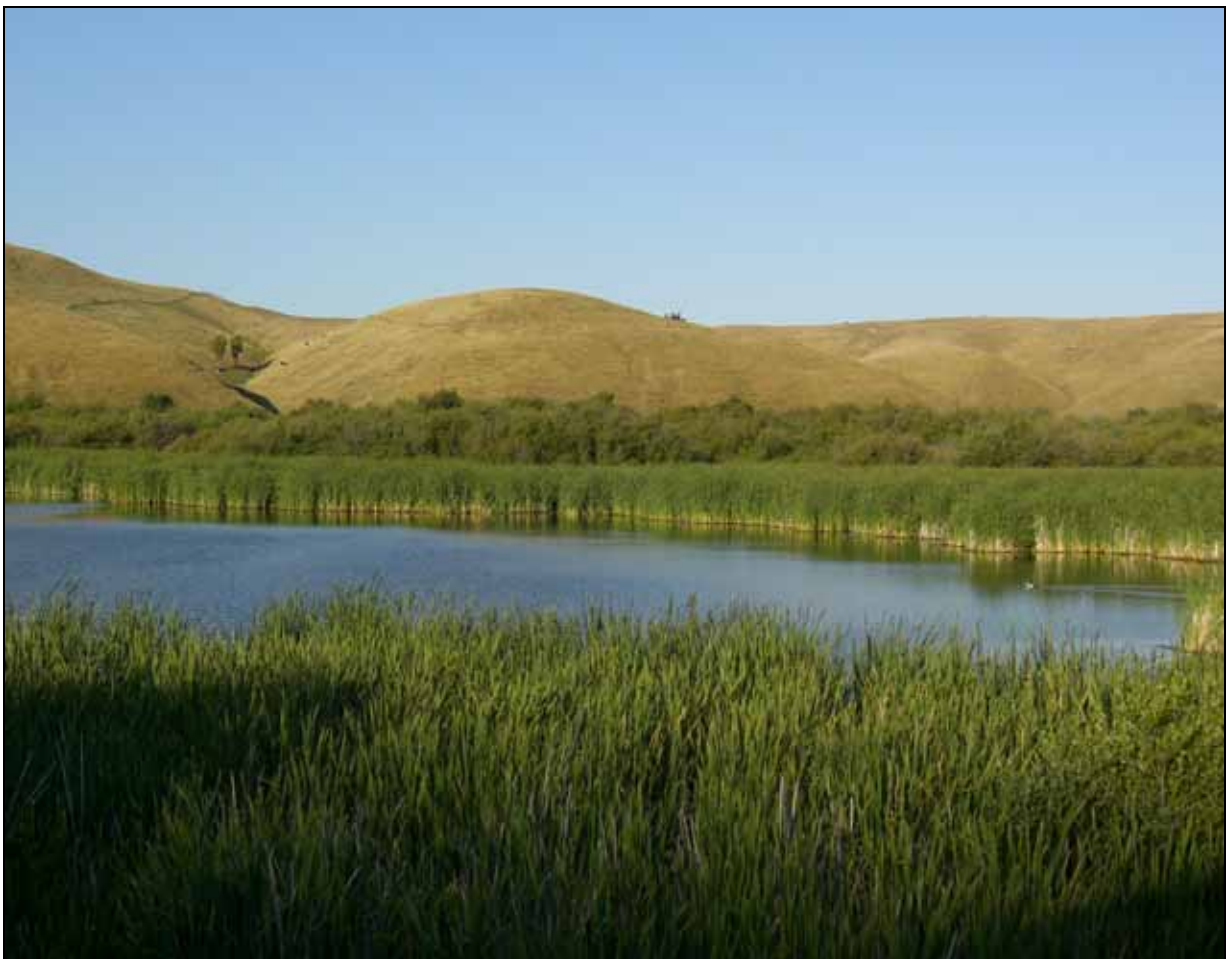
Cover photo View across the southern end of the lake showing lush raupo growth backed by a low forest of willow. A juvenile paradise duck can be seen making its way across the water in the lower right hand corner.
