The State of our Environment Summary Report 2014-15

This State of our Environment summary report covers two years of monitoring and investigations in 2014 and 2015.

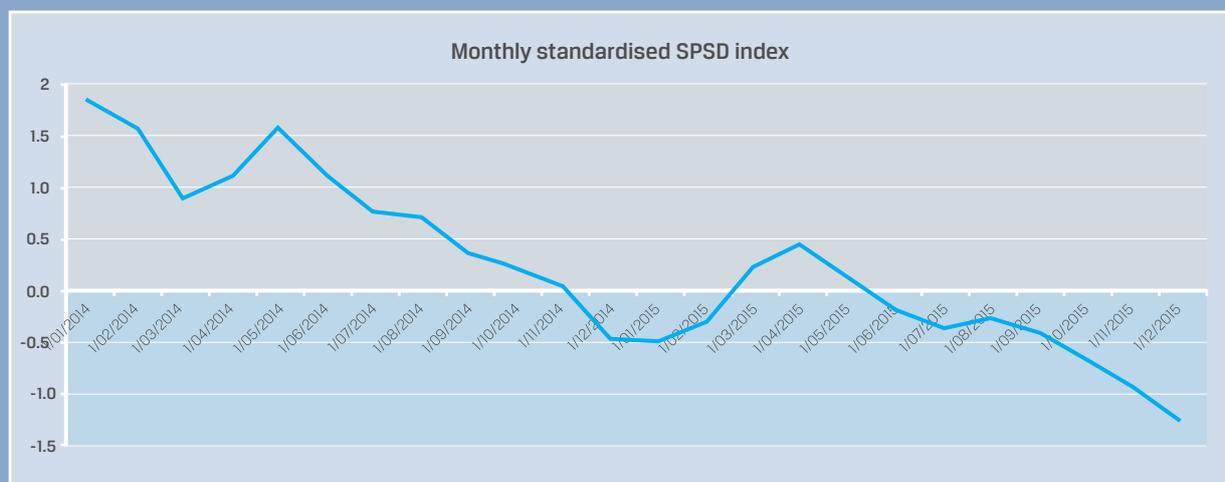
Figure 1 Monthly values of the South Pacific Subtropical Dipole (SPSP) index, standardised to 1981-2010 climatology. (Index values were sourced from NIWA).

Positive values of the index increase the chances of warmer and wetter than usual seasonal weather, while cooler and drier conditions are associated with negative values. The SPSP was positive for most of 2014 but was negative towards the end of that year (Figure 1). It was negative through most of 2015, apart from autumn.

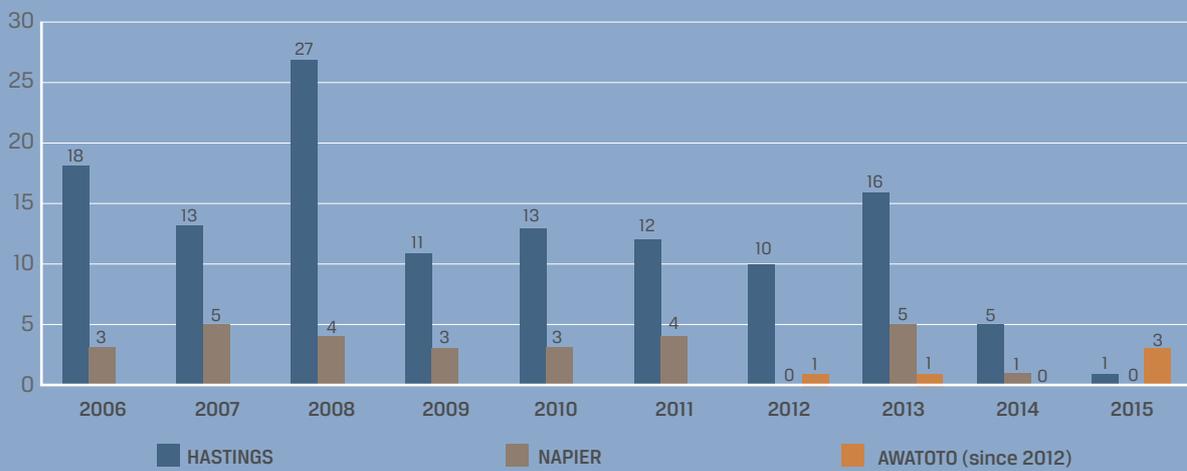
Figure 6 The number of occasions, by year, the NES for PM10 was exceeded in Napier, Hastings and Awatoto.

Hastings exceeded the NES 5 times in 2014 and only once in 2015. Hastings' exceedances are a significant drop from previous years. In Awatoto, the NES was not exceeded in 2014 but was exceeded 3 times in early 2015. Sea salt and wind-blown dust are thought to be the main causes of these exceedances.

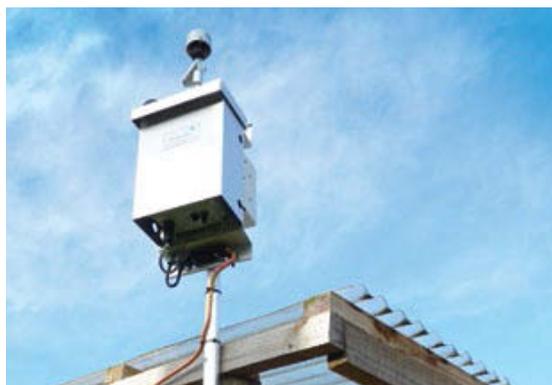
Figure 11 Maximum daily PM10 concentrations measured at the temporary and permanent monitoring sites during June and July 2014. Also shown are modelled maximum winter PM10 concentrations based on 2010 emissions data (Golder Associates (NZ) Ltd, 2012). Airshed modelling 2012 of exposure to particulate in the Hawke's Bay region, A report prepared for HBRC).

Measurements from 2014 and modelling from 2010 data are similar, particularly for Hastings, despite the data being from different years (Figure 11).

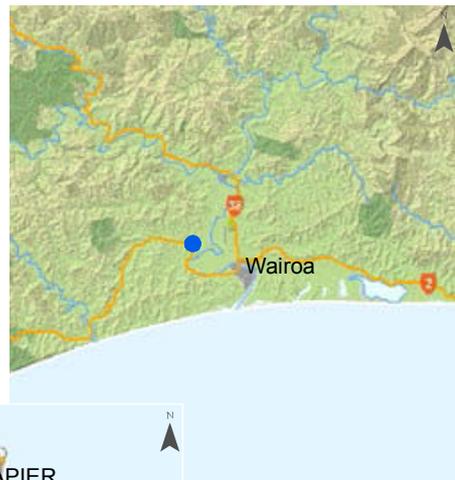
Figure 12 Location of soil quality sites sampled in 2014 and 2015 in Hawke's Bay.

The SQM programme looks at a different land use every year across a range of soil types. There are 74 sites representing five different land uses in Hawke's Bay. We plan to have approximately 100 sites by 2017. During 2014 and 2015, 32 sites were sampled for soil quality - 15 under cropping, 11 orchards, and 6 vineyards (Figure 12).

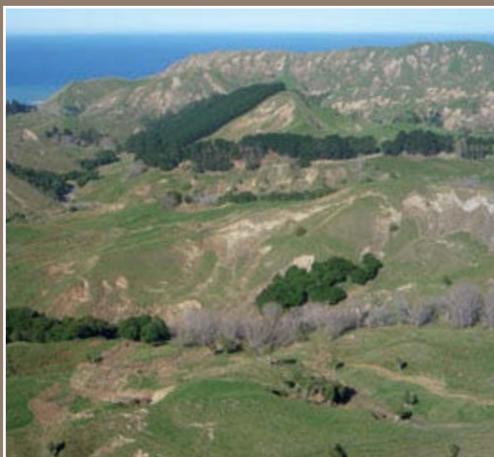
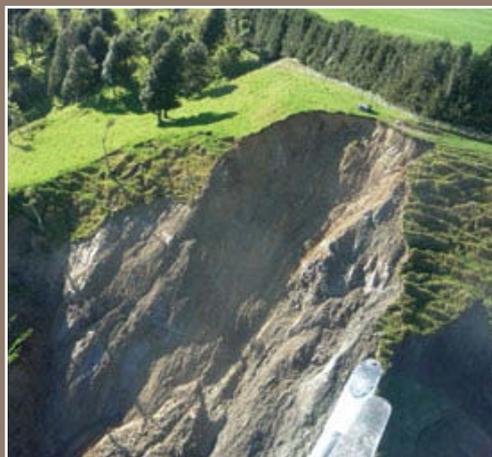
Figures 20 & 21
Soil erosion on east coast hill country following 2011 storm.

The vulnerability of these eastern areas was evident during a significant storm event in 2011, when heavy rains caused severe erosion in the eastern Tukituki catchment and neighbouring coastal catchments (Figures 20 & 21 below).

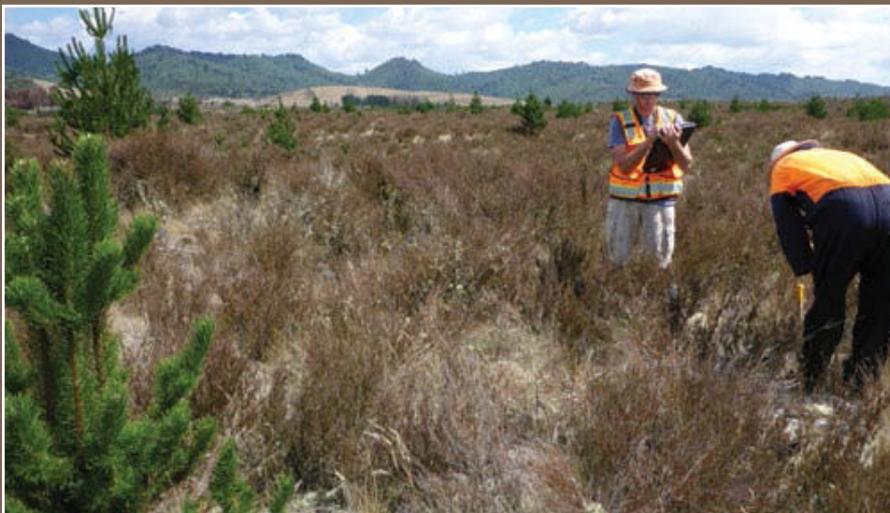
Figure 25
Waipunga frost flat,
the focus of the
wetland inventory.

A frost flat is a heathland comprising of short (or dwarfed) shrublands dominated by monoao (*Dracophyllum subulatum*) on very infertile volcanic soils (Figure 25). It is also known as 'old tephra plains', created by volcanic activities.

The Waipunga frost flat remnant (Figure 26) has typical frost flat species. Stunted manuka (*Leptospermum scoparium*) is the only native forest precursor species present. This indicates that succession to native forest species is not likely in the near future.

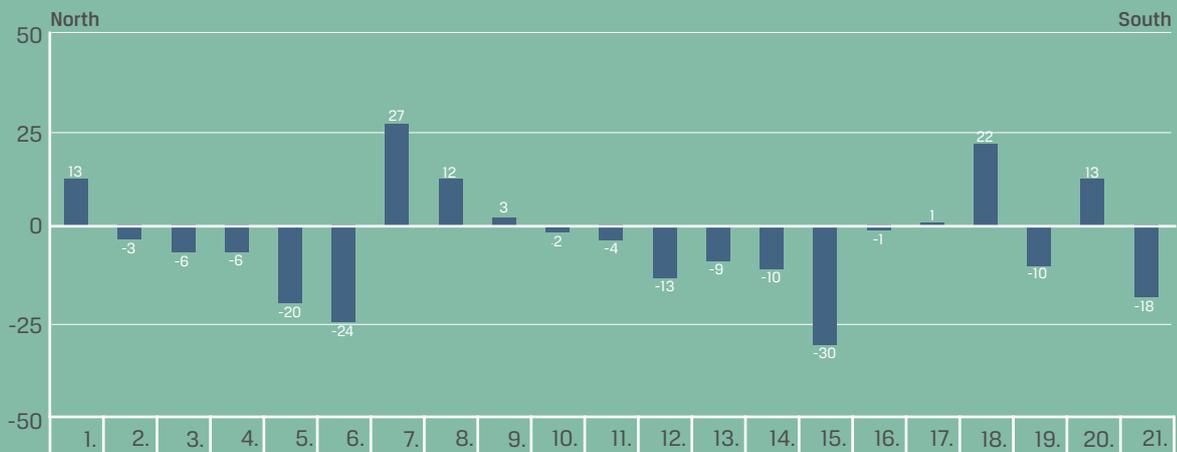
Percentage deviation at each site (see Table 2).

Figure 28 2014 Percentage deviation from Long-term mean river flow (refer Table 2).

Annual mean river flows for the 2014 calendar year were mostly within the normal range of flow (Table 2, Figures 27, 28). There were only two sites with annual mean flows outside the normal range - the Esk River at Berry Road was 27% above the long-term mean and the Irongate Stream at Clarkes Weir was 30% below.

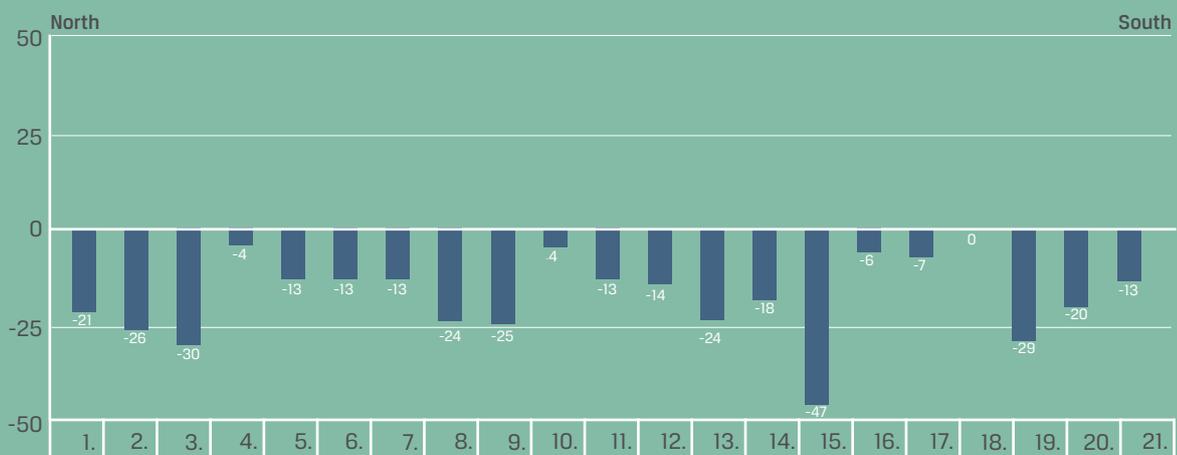
Percentage deviation at each site (see Table 3).

Figure 30 2015 Percentage deviation from long-term mean river flow (refer Table 3).

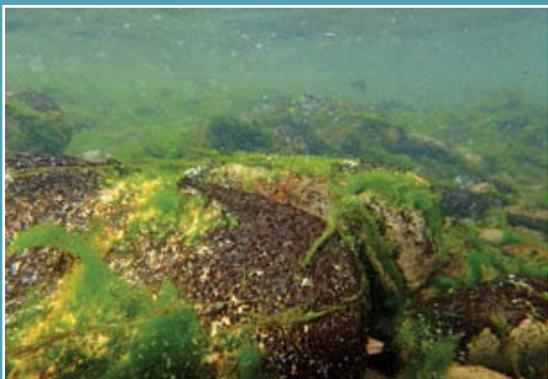
Figure 45
Bright green filamentous algae can form extensive carpets in Hawke's Bay rivers, but it is not toxic.

'Slime algae' periphyton looks like bright green hair smothering the rocks (Figure 45). It's not a health risk to people, livestock or dogs, but it is a nuisance for fisherman and other river users, and may indicate issues with ecosystem health.

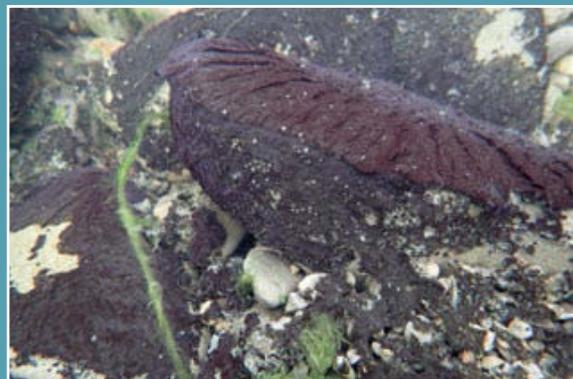
Figure 46
Phormidium is a dark brown or black mat that can be a problem during summer low flow periods.

Phormidium is a problematic variety of periphyton. Phormidium grows as a black or brown mat in the river (Figure 46). When it dies off it can form floating rafts along the river shallows, and when it dries out on the

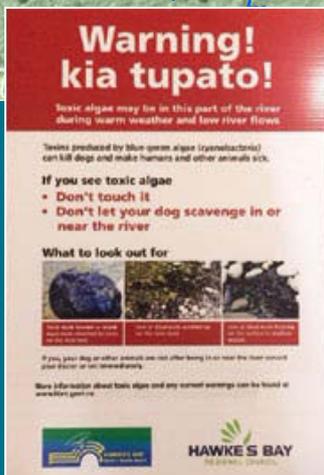
Figure 48
Keep an eye out for signs placed by Public Health at key river access points where monitoring indicates phormidium can be a problem.

The Hawke's Bay Public Health Unit puts up warning signs as needed (Figure 48), after HBRC provides the monitoring data.

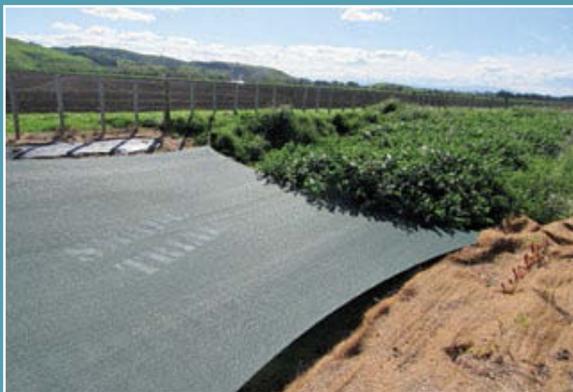
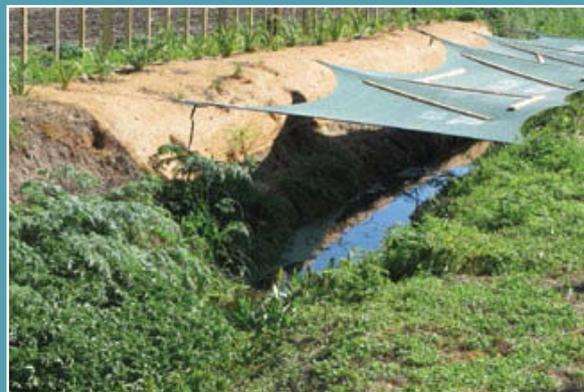
Figure 49 (left and right): HBRC shade trial in 2015 used cloth to simulate trees planted alongside the drain, suppressing weed growth.

Cooling down wider rivers will be difficult, particularly braided rivers which can be more than 200 m wide, because trees can't cast enough shade over the entire channel. HBRC continues to explore options such as finding out how much the cooled narrow tributaries can help cool the main river, or if reducing the 'muddiness' on the river bed will allow greater movement of water through 'cooling' underground gravels.

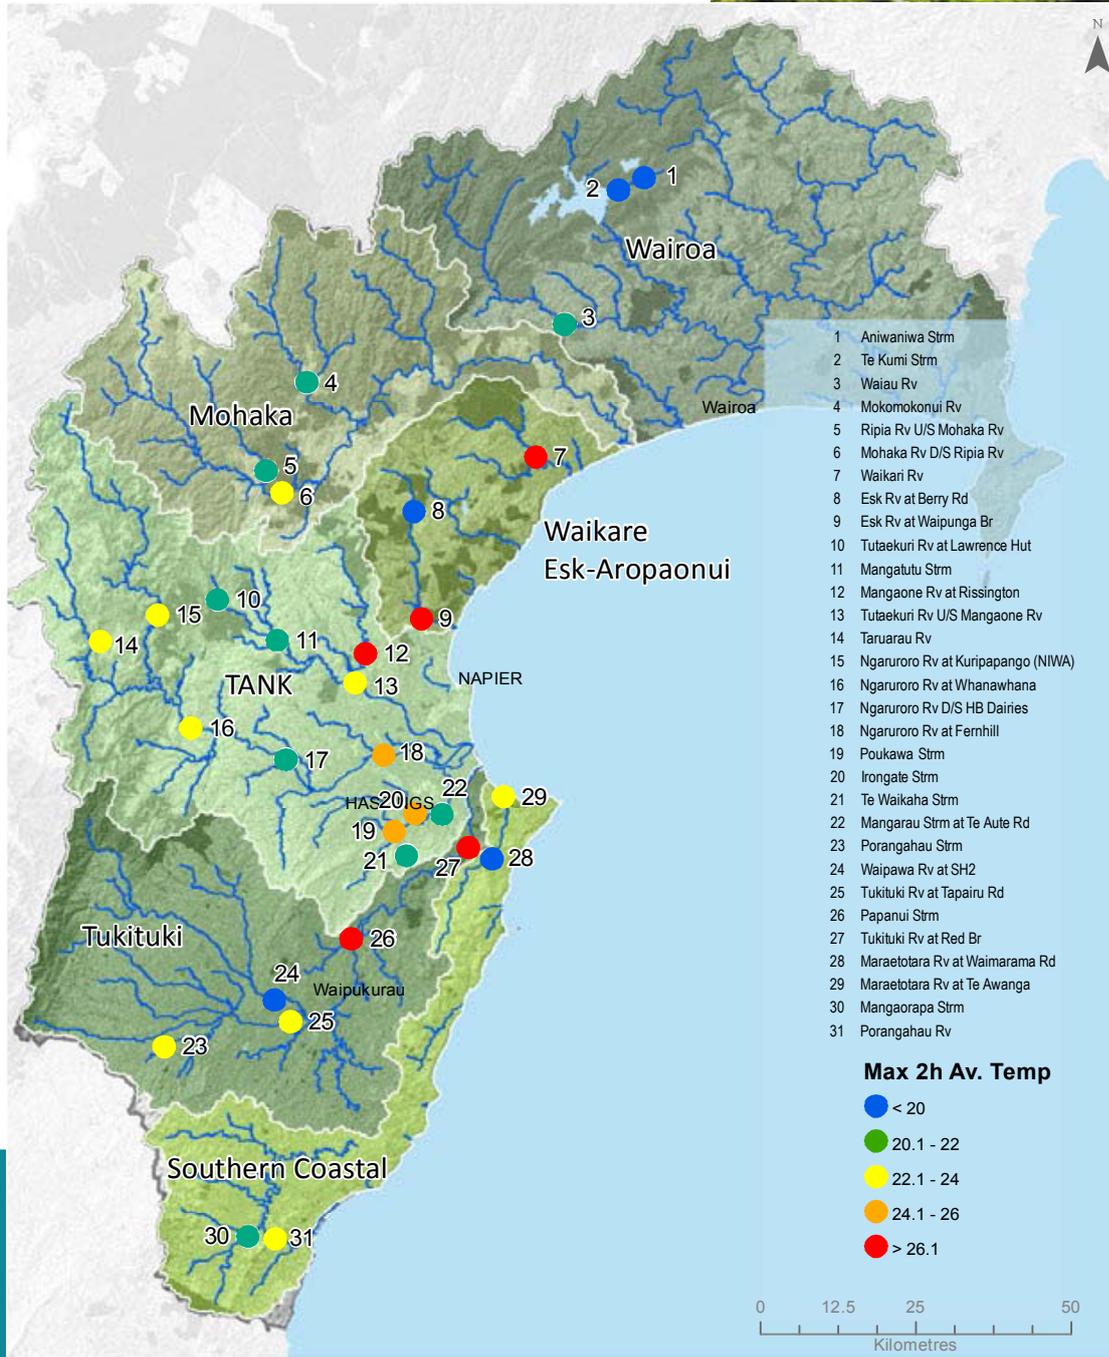
Figure 50 Temperature monitoring at sites around Hawke's Bay (2014-15) show many of our streams get so hot, they may stress aquatic plants and animals.

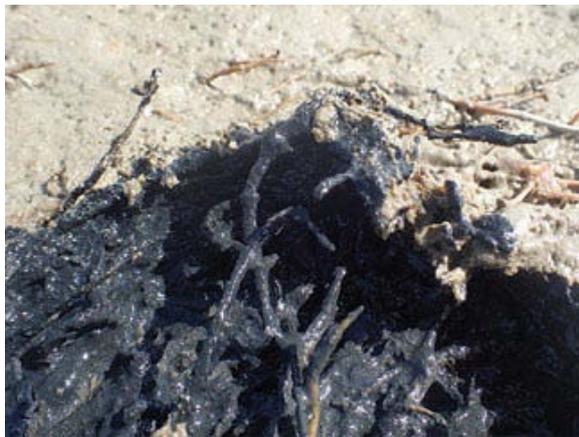
Figure 53 Fine anoxic sediment in the Ahuriri Estuary.

Deposited sediments pose one of the biggest risks to marine life. 'Mud' washed off the land can smother animals and plants living in the estuary, making it difficult for organisms to feed and breathe (Figure 53).

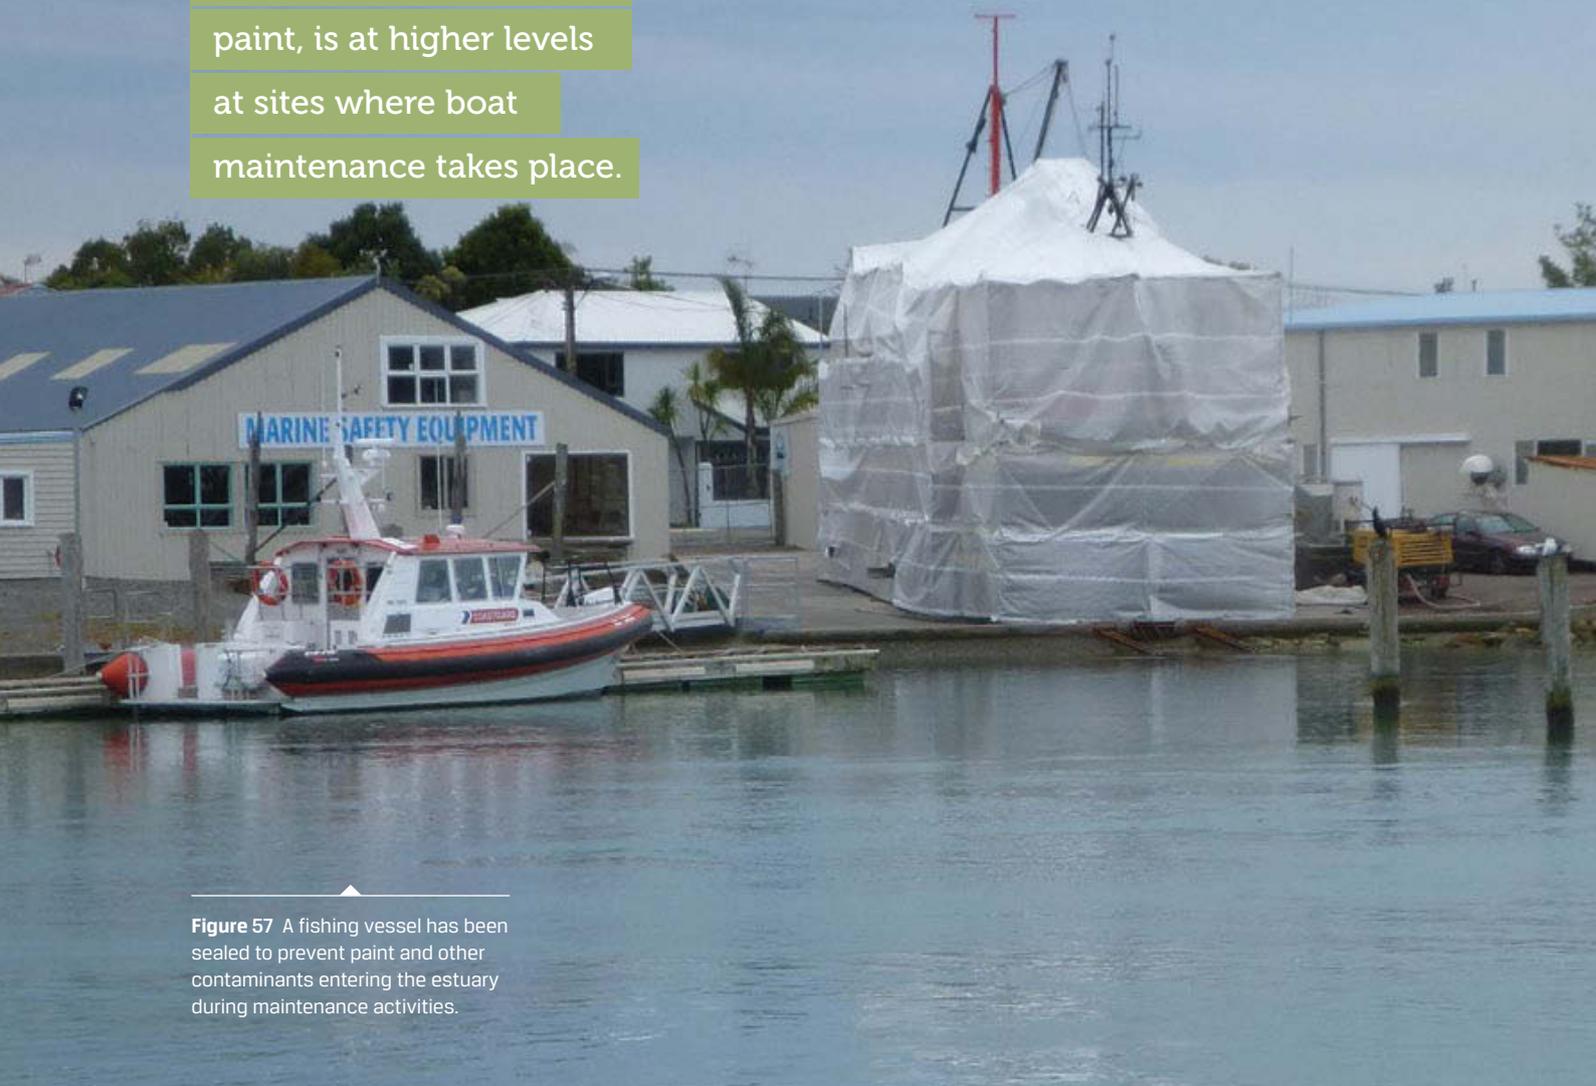
Figure 57 A fishing vessel has been sealed to prevent paint and other contaminants entering the estuary during maintenance activities.

Copper, which is a common ingredient of antifouling paint, was elevated at sites associated with boat maintenance activities (Figure 56). HBRC has been working with business owners to stop contamination occurring, for example by totally covering vessels when abrasive blasting is taking place (see Figure 57).

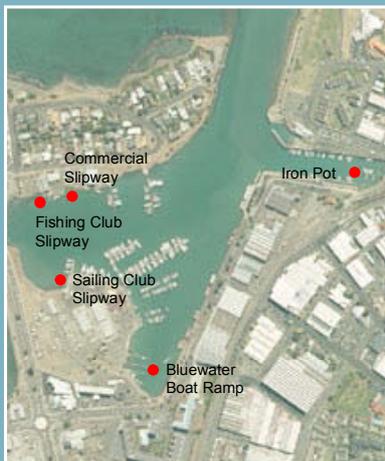
Figure 55 Inner Napier Harbour monitoring sites in the Ahuriri estuary.

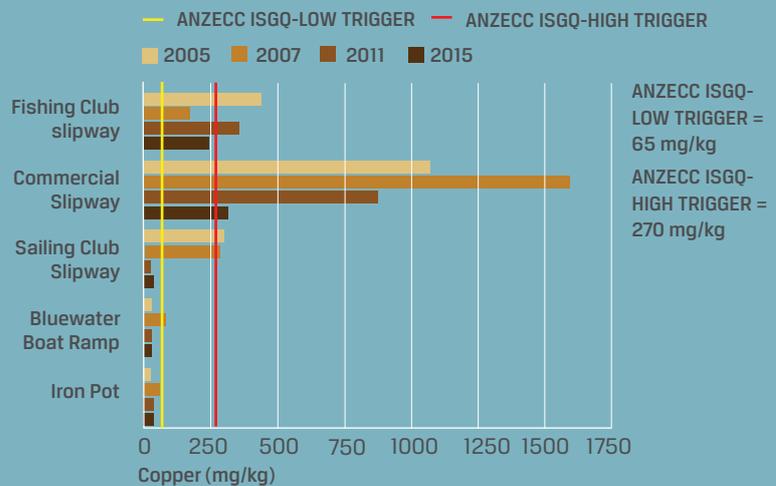
Figure 56 The concentration of copper at monitoring sites in the inner harbour.

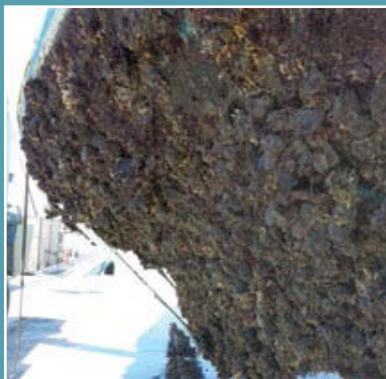
Figure 57 Fouled vessel hull in Napier.

Marine invasive species are typically carried from place to place on the hulls of ships and boats. If boat hulls are not kept clean, they can be even more of a risk (Figure 57). Napier has a busy commercial port, an active fishing fleet and a popular recreation boating harbour, so there is always a chance of a new invasive species being introduced into the region.

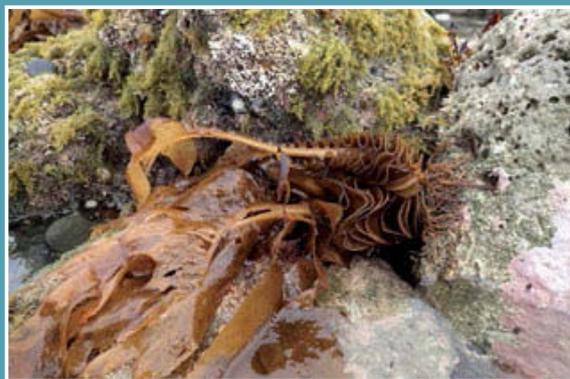
Figure 58 The invasive pest *Undaria* is spreading. It is easily identified by the frilly sporophyll (reproductive tissue) at the base of the stem.

One of the most invasive marine algae is the Japanese seaweed wakame (*Undaria pinnatifida*) (Figure 58). This algae can displace native species and it is widespread on Hardinge Road Reef in Ahuriri. HBRC monitors algal cover at this reef and has found that the population of wakame is increasing.

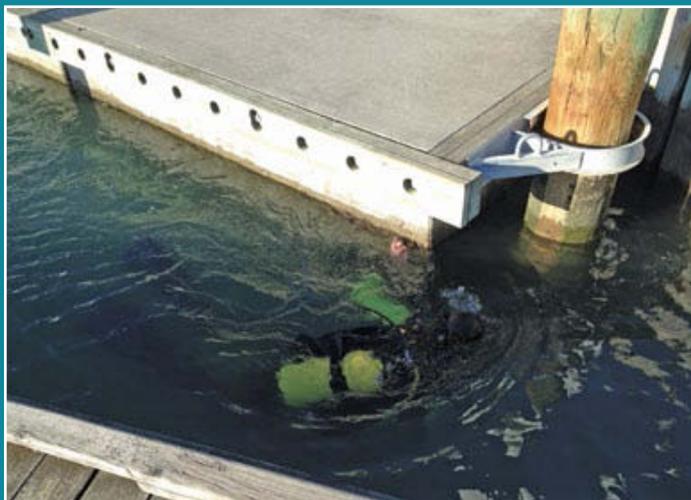
Figure 59
Marine biosecurity diver checking wharf piles in Napier.

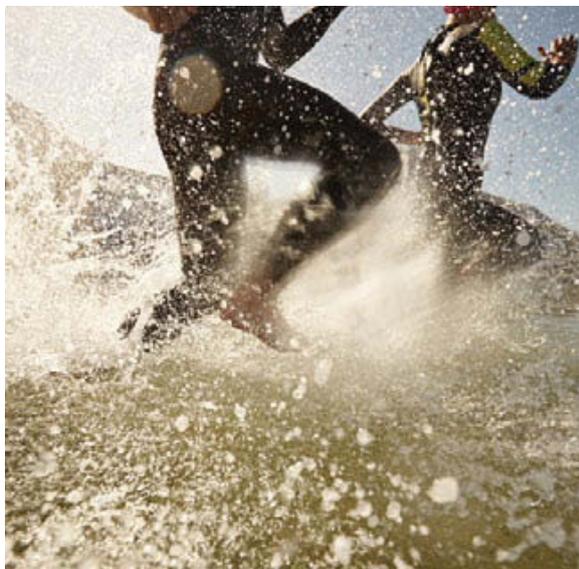
Figure 64
Beaches and river swimming spots monitored for suitability for recreation.

To help people make informed decisions about where they choose to swim, HBRC calculates the Suitability for Recreation Grade (SFRG) for each site monitored (Figure 64, Table 4). The SFRG combines results from weekly sampling over the previous 5 years, with a catchment risk assessment to produce a grade between ‘Very Good’ and ‘Very Poor’.

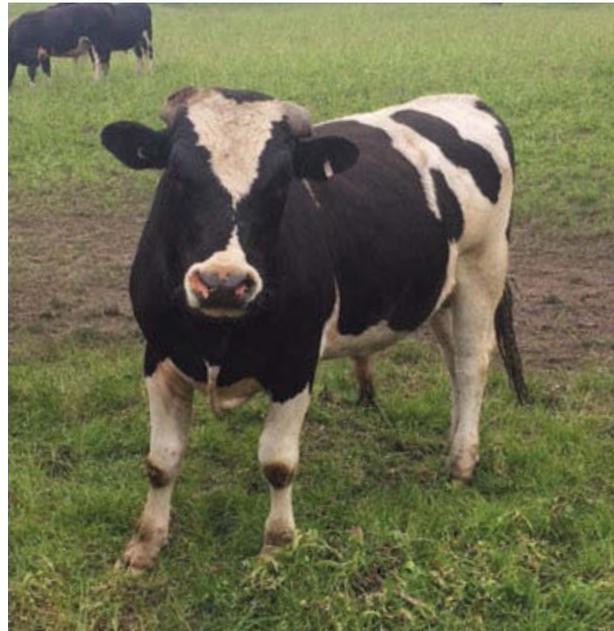
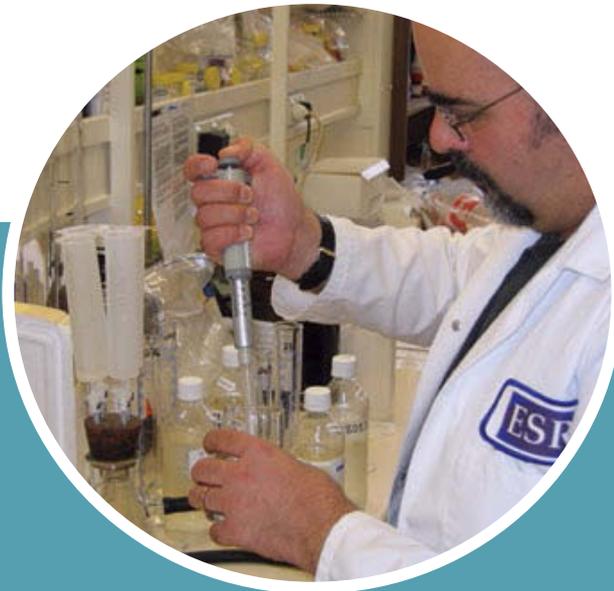
Figure 65 Faecal Source Tracking results indicated that ruminant animals (e.g. cows, sheep, goats or deer) were the dominant source of faecal contamination. Avian and plant sources were also identified.

In the 2014/15 and 2015/16 seasons, faecal source tracking was undertaken at 9 sites throughout the region. Ruminant (cows, goats, sheep and deer) sources were most commonly identified (Figure 65), followed by birds, plant material (non-faecal sources) and dogs.
