Purpose

This report presents results for the first year of uninterrupted monthly monitoring of the Puhokio Stream in Waimarama. Monitoring commenced on 11/09/01 and finished on 10/09/02. The purpose of this report is to:

Water quality and ecology

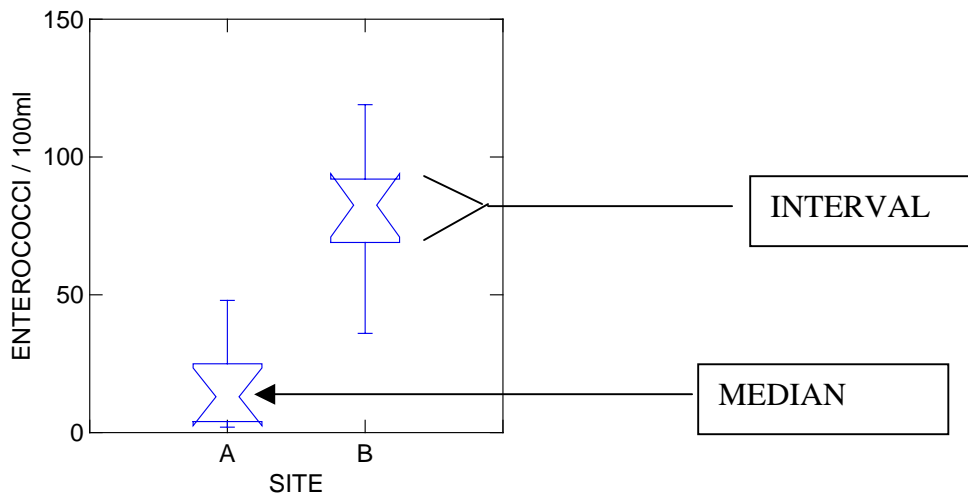
Figure 2: Box and Whisker Plot

The water quality results in this section are presented as box and whisker plots. A diagrammatical explanation of a box and whisker plot follows.

A significant difference is detectable (with 95% confidence) if the confidence intervals around two medians do not overlap (McGill , Tukey, & Larsen 1978). Figure 2 shows that site B has significantly higher Enterococci concentrations compared to site A. This is depicted by the intervals around the two medians not overlapping.

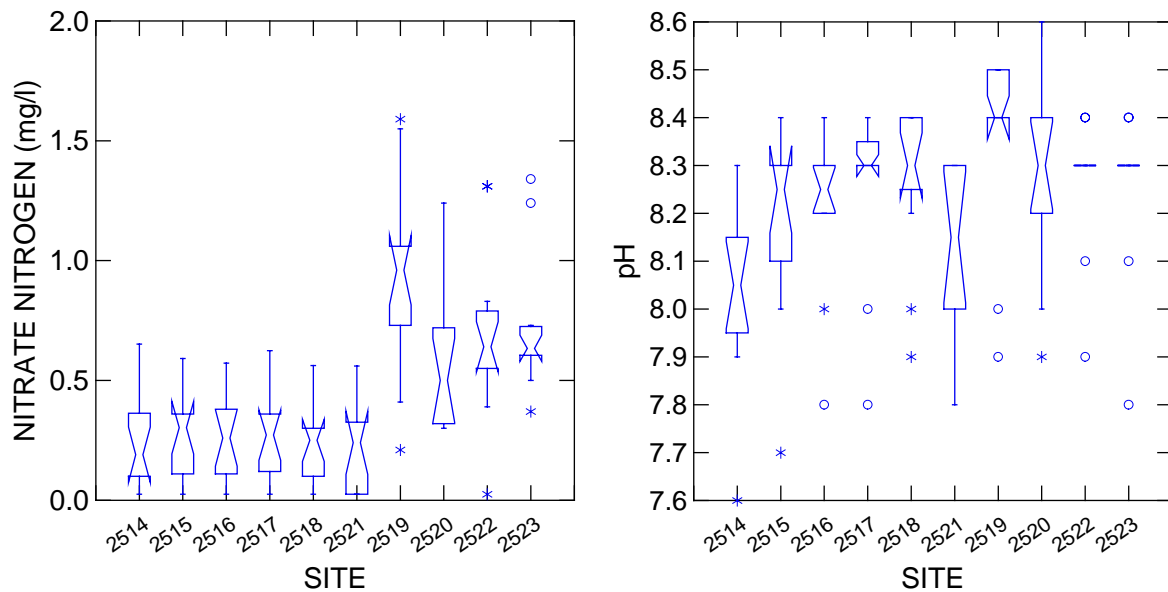
Figure 2: Nitrate Nitrogen and pH

Figure 2 shows that nitrate nitrogen concentrations are significantly higher at the Kaikopu Stream, which gives rise to significantly higher concentrations downstream of the confluence of the Kaikopu Stream with the Puhokio Stream. The reason for the elevated nitrate nitrogen concentrations in the Kaikopu Stream is unclear although intensive beef farming within the Kaikopu Stream Catchment could be contributing to this. pH levels in figure 2 show that the Puhokio Stream becomes increasingly alkaline as you head downstream until site 2521 is reached when pH levels drop again. The western tributaries (2515 and 2519) show high pH levels when compared to Puhokio Stream sites located upstream. It is likely that the geology of the western tributary catchments results in a more alkaline pH compared to the main stem of the Puhokio Stream, as it comprises more limestone.

The reason the Kaikopu Stream has significantly higher concentrations of nitrates compared to the main stem of the Puhokio Stream is unclear and determining the cause is beyond the scope of this study. The higher suspended sediments loading experienced in the Kaikopu Stream is likely to be due to the fact that it flows through an unconsolidated alluvial valley infill.

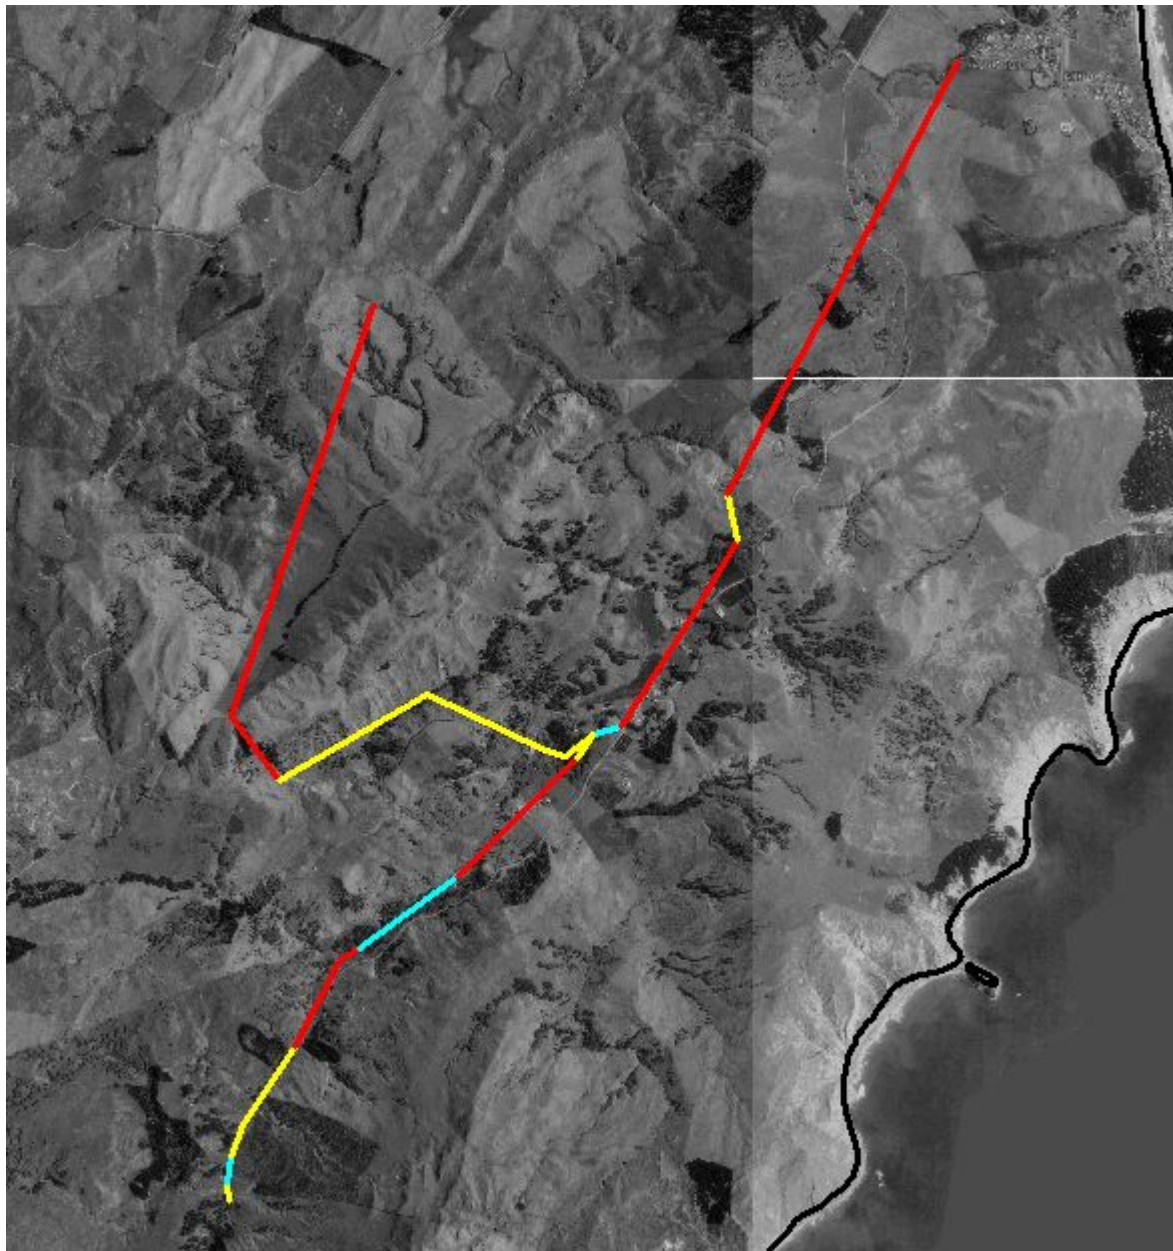
Figure 3: Habitat Classes of the Puhokio Stream and Kaikopu Stream

Habitat classes for stream reaches were plotted on GIS using ARC View to produce an aerial map of the Puhokio Stream catchment. The following map shows the habitat classes for the Puhokio Stream.

Figure 3 shows that both the Puhokio and Kaikopu Streams have a lot of very poor habitat. The following table displays the percentage of stream length in each habitat class. In all cases lower habitat values were attributable to stream bank damage caused by stock access and a lack of riparian shading.

This study has provided an important baseline from which future comparisons of stream ecology and water quality can be compared. In its present state the Puhokio Stream catchment has a large amount of riparian habitat that is in poor to very poor condition. Improvements to this riparian habitat are likely to result in improved ecology and biodiversity of the stream and its catchment but is unlikely to result in significant improvements in the water chemistry.

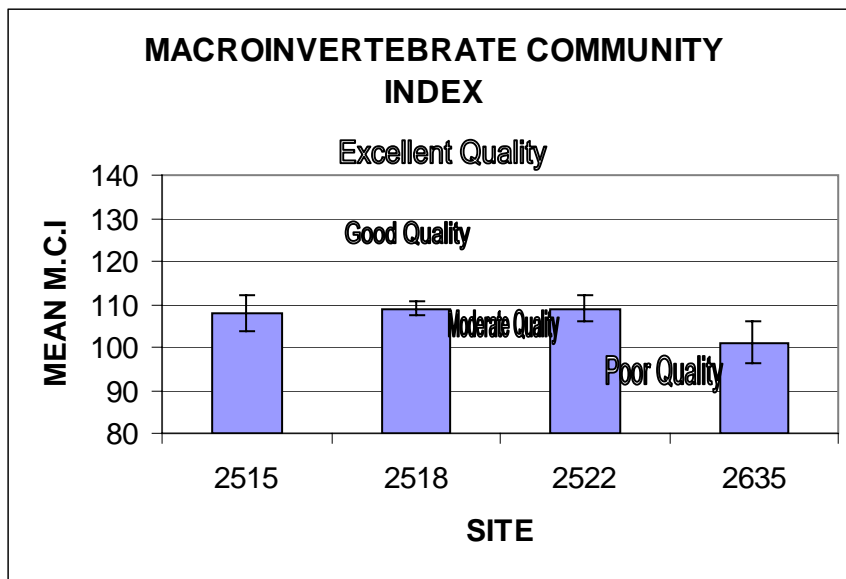
Figure 4: Macroinvertebrate Community Index Values

Macroinvertebrates were sampled from 4 sites of the Puhokio Stream. Four Surber samples were taken from representative riffle reaches of the stream sites. Samples were sent to Water Care Laboratory Services for taxonomic identifications. The data was condensed into a commonly used biological index of water quality namely the Macroinvertebrate Community Index (M.C.I). Analysis of variance of mean M.C.I values were undertaken to determine whether significant differences ($p < 0.05$) in mean MCI values were detectable between any sites.

The macroinvertebrate sampling indicates macroinvertebrate community structure that is characteristic of moderate nutrient enrichment. An analysis of variance of the mean MCI values indicated no significant differences between any of the four sites ($p > 0.05$).

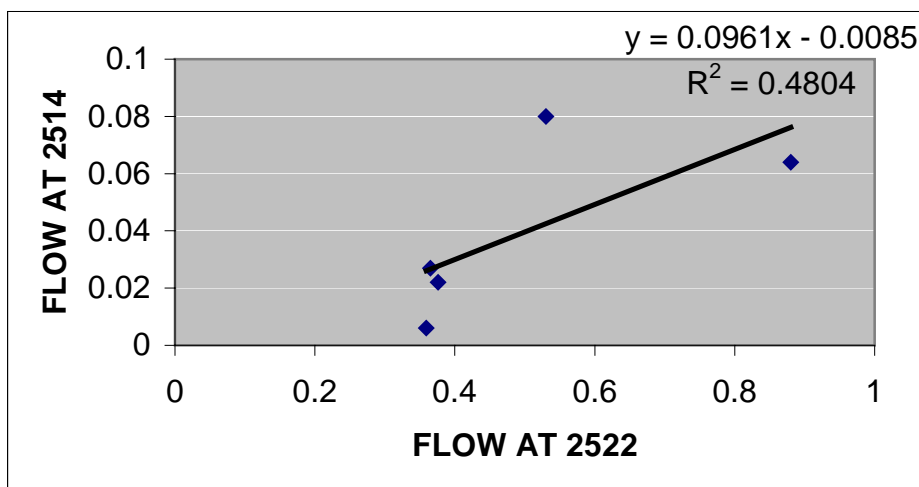
Flows recorded at the top site (2514) were not well correlated to site 2522 ($R^2 = 0.48$). The reason for this may be due to the shallow nature of this site (often less than 10 cm maximum depth) and the unstable nature of the substrate. It is very difficult to gauge shallow streams that have an unstable substrate as this produces errors in flow velocities and cross sectional area calculations.

Site 2514 could be taken out of the programme as the shallow nature of the site and the non-uniform nature of the streambed makes it difficult to gauge flows there.

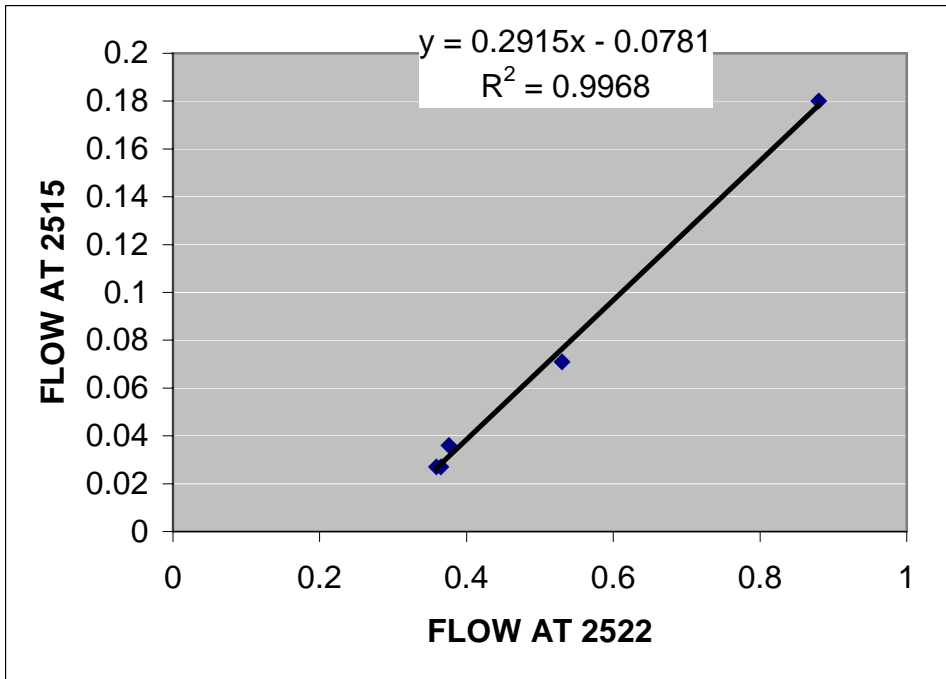
Flow gaugings at site 2515 showed a good correlation with flows measured from site 2522 ($R^2=0.99$). The uniform nature of the streambed and greater depth at site 2515 provided for more accurate estimates of flow.

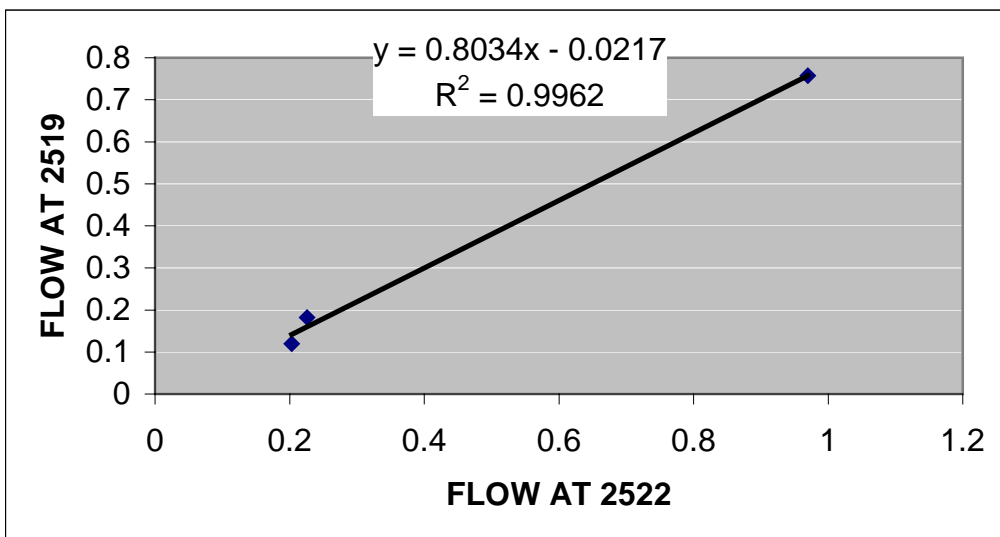
The site at Kaikopu Stream (site 2519) also had a uniform channel with good depth. The flows generated from here showed a good correlation with site 2522.

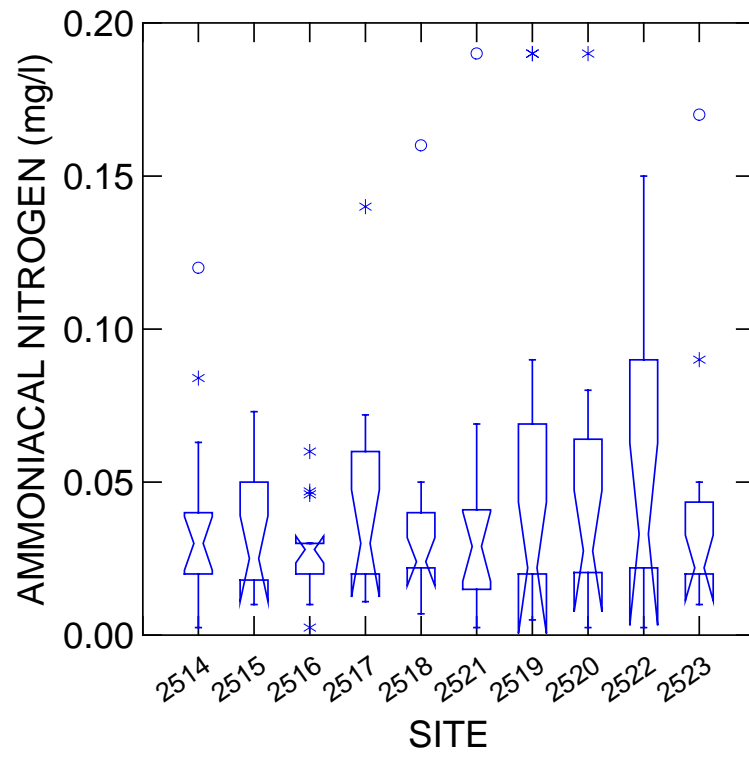
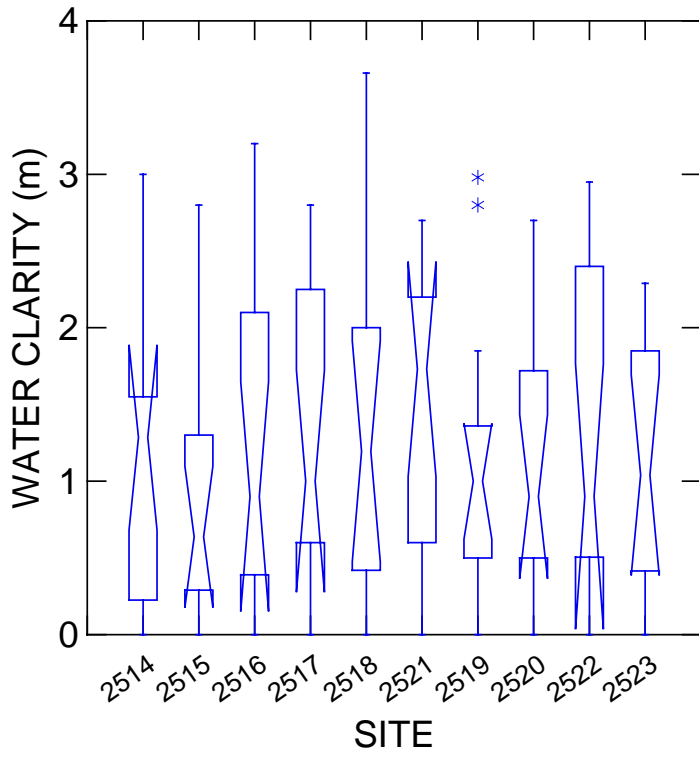
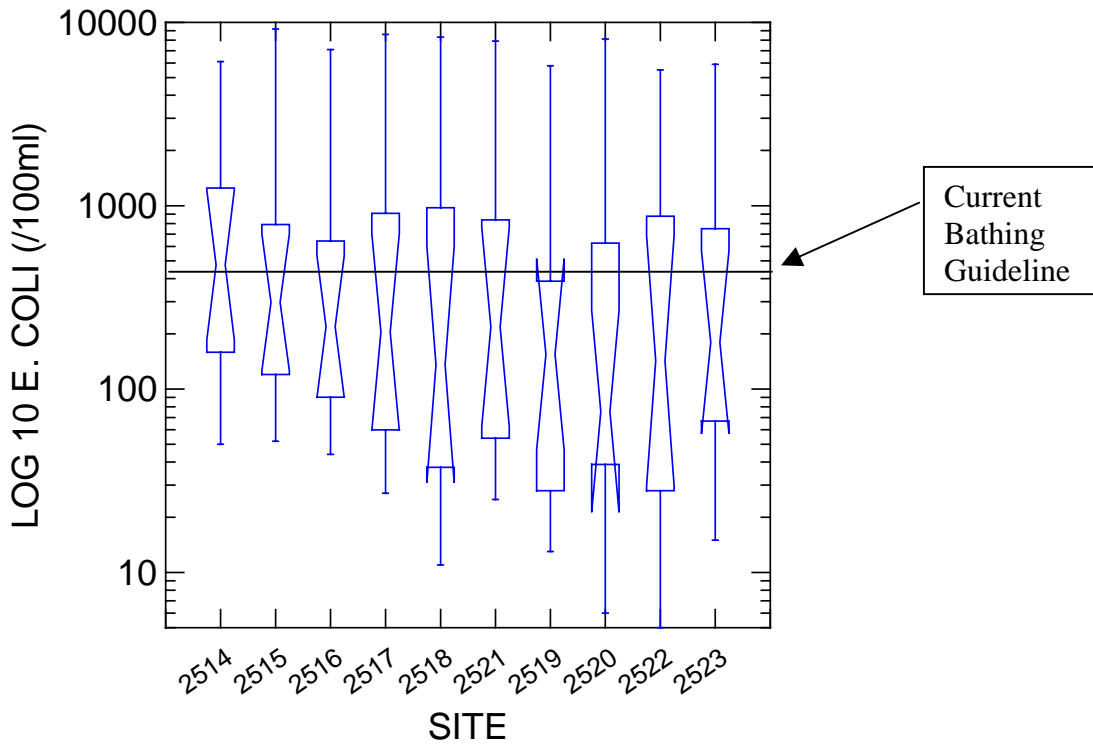
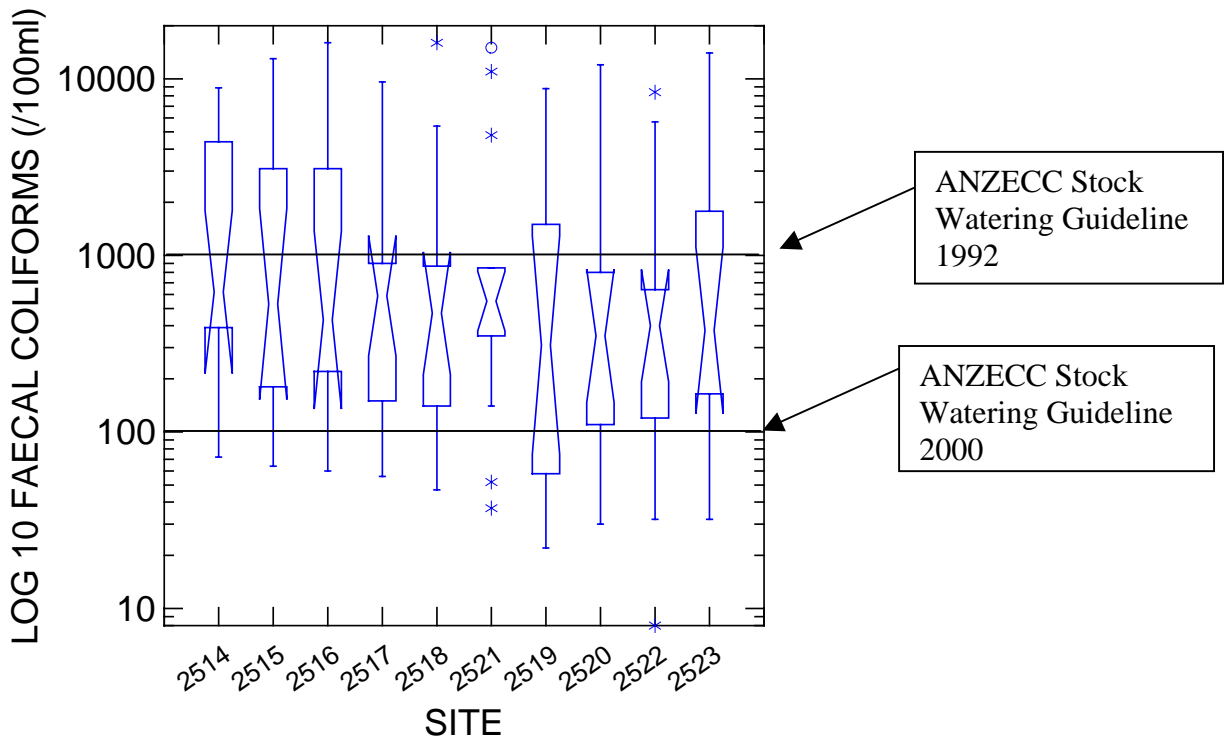
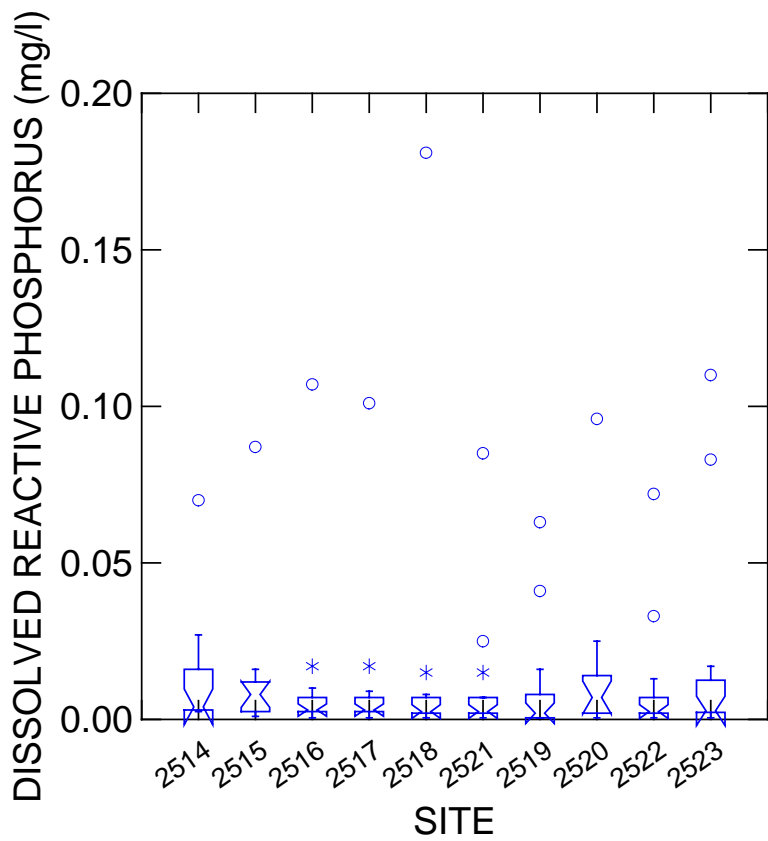
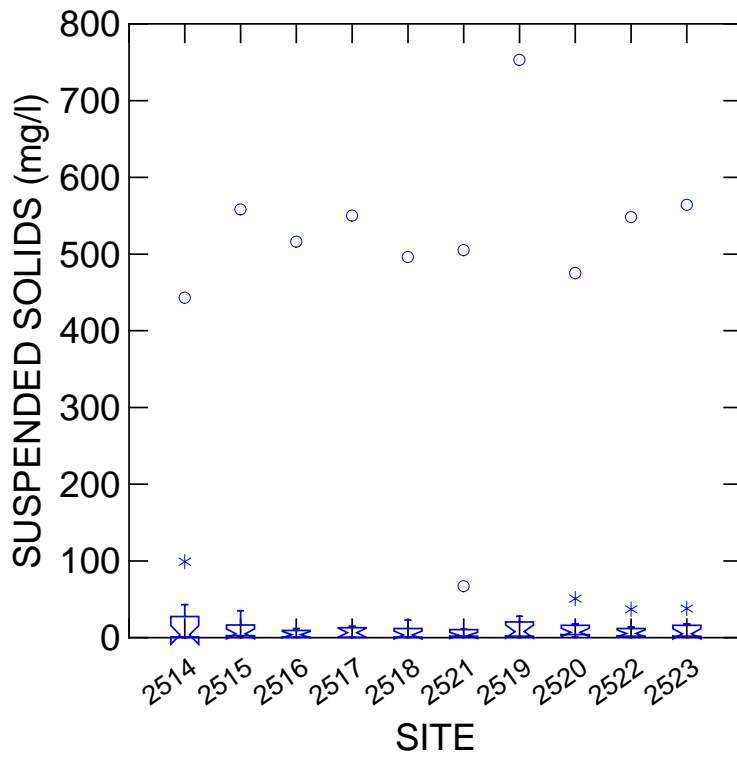
Appendix 1

No significant differences were found between the sites for ammoniacal nitrogen, water clarity, E. coli, Faecal coliforms, Dissolved Reactive Phosphorus, Suspended Solids, Total Kjeldahl Nitrogen, Total Phosphorus or Temperature. The box and whisker plots for these water quality variables are in Appendix 1.
