In the matter of Application by Hastings District Council and Napier City Council to
Hawke's Bay Regional Council for resource consents authorising
the operation of Area B at Ōmarunui Landfill (**consent application**)

Reply evidence by Philip Doolan in response to evidence of Danny Bearsley

Dated 19 October 2021

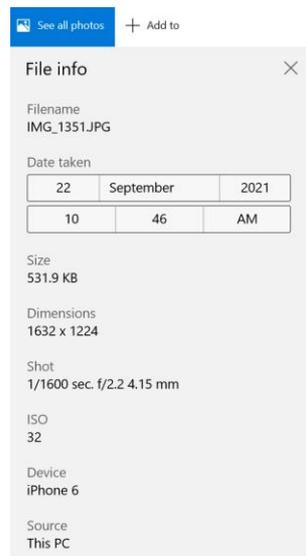
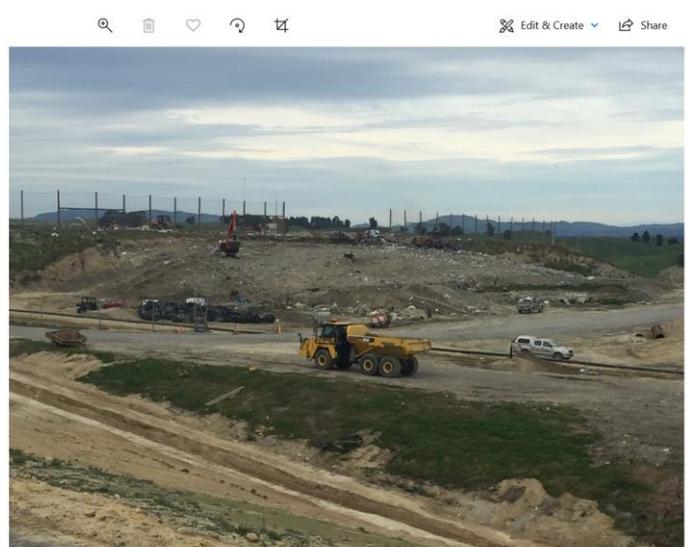
9. Moreover, on this date, the Hawke's Bay was at Alert Level 3 and the Landfill was operating with skeleton staff. Mr Bearsley has taken advantage of the reduced staff on site, particularly on a Sunday, to obtain access onto the site without being noticed.
10. In any event, his photo shows the start of a new tip face, with approximately 2 days' worth of rubbish in it. A gas well needed to be extended upwards and a cylinder installed which was delayed by the Covid restrictions, so there were limitations on being able to cover this part of the face. The situation was not to our usual standard but was quickly remedied. The following photo was taken on 22 September 2021, when the Hawke's Bay was back at Level 2, and able to be fully staffed.

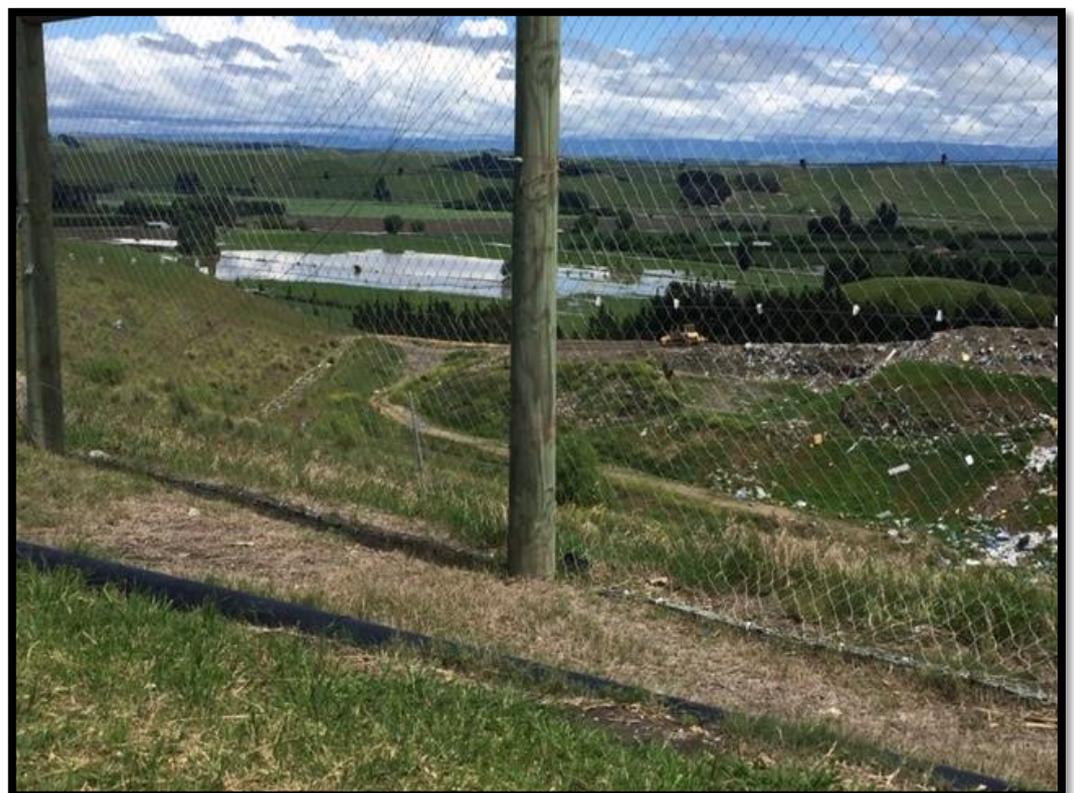
21. The Applicants specifically commissioned expert evidence on stormwater and flooding from Mr Hansford. Mr Bearsley does not refer to that evidence in his statement.
22. Mr Hansford has prepared further evidence to respond specifically to Mr Bearsley's evidence, and I defer to his expertise. From my perspective, I note that the rain event Mr Bearsley describes was significant and a number of properties were flooded – an example being the property at 384 Swamp Road, over paddocks that are usually dry.

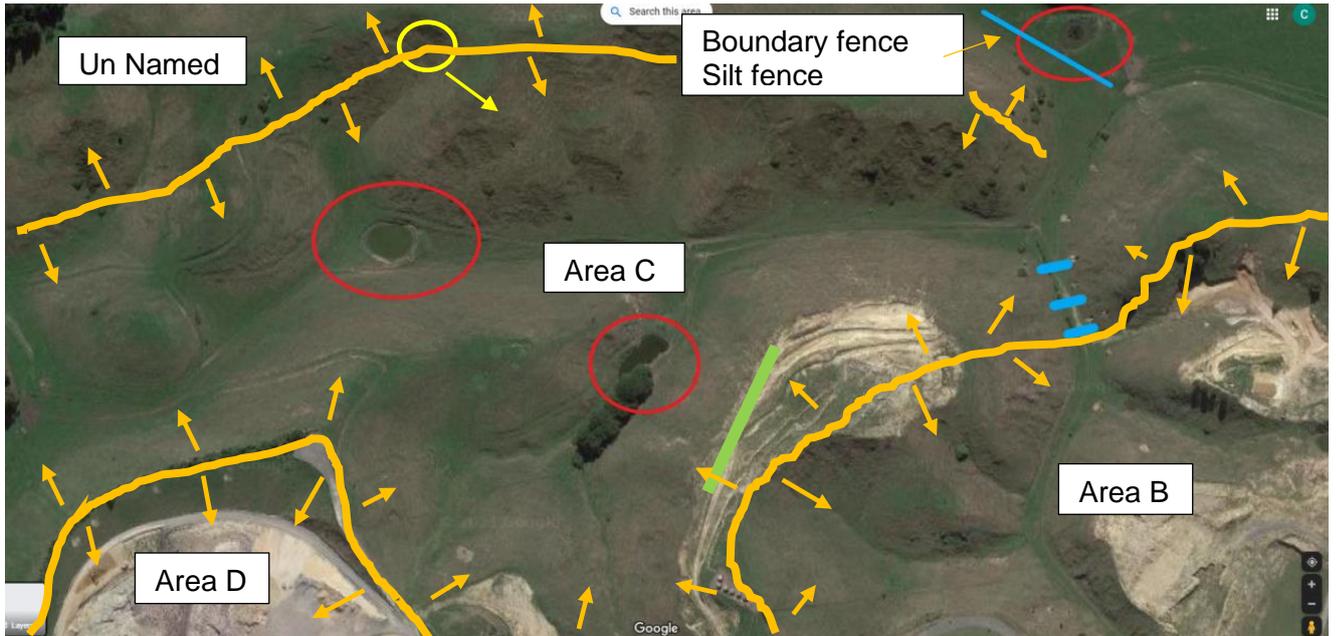
Attachment A

Yellow is where Mr Bearsley is taking photo from and the direction, looking across Area C.

Green is the face that the photo has been taken of.

Red is sediment ponds.

Blue is silt fencing in place for Valley B excavation works, which have been sighted and approved by HBRC staff

Orange is approx. ridgelines and approx. flow path of rainfall between Unnamed Valley and Area C, Valley B and Valley C and Valley D and Valley C

11. At para 7 Mr Bearsley refers to earthworks which he says fail to implement sediment control. The photo he refers to at para 8 is a track that is at the top of the ridge at Area C and has been in place since before I started work at the Landfill in 2014. This track has a windrow to the outer edge which prevents water and silt from going directly over the side. Any water and silt that does go over the side is diverted to the sediment pond which is at the bottom of the valley C shown in Photo 1.

12. Any water which goes through the sediment ponds then goes through a silt fence which was installed on the boundary fence between the Landfill and the Bearsley property, 200 – 300 metres further down the Valley. This sediment fence has been installed as per HBRC recommendations and also inspected and approved by the Regional Council.

13. Mr Bearsley's photo 2 shows Area C. Any water and sediment from Area D as shown in Mr Bearsley's first photo flows down the other side into the Area D sediment ponds, away from the area shown in his second photo. The lines visible in the centre of the second photo are just tyre tracks from the farmer who leases Area C for grazing.

14. To illustrate how Mr Bearsley's evidence on this issue is wrong, I have produced the diagram and explanation attached as **Attachment A**.
15. Sediment controls are taken seriously at the Landfill and I am satisfied that all earth working areas are appropriately treated.

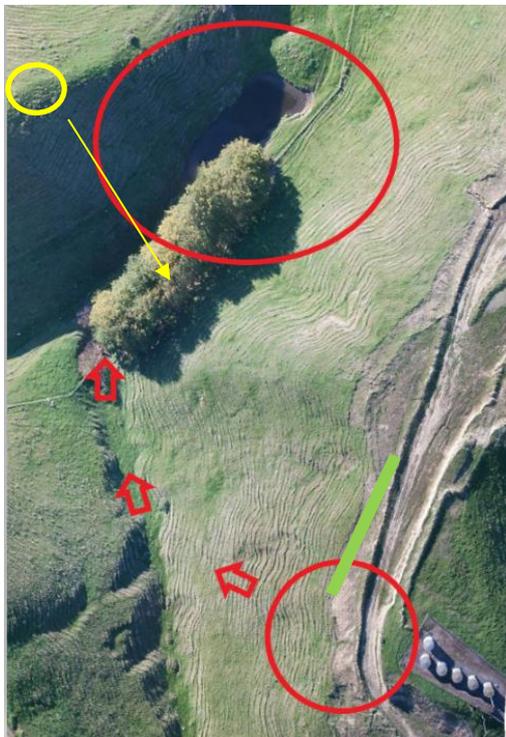
Yellow is where Mr Bearsley is taking the photo from and the direction, looking across

Valley C

Green is the face that the photo has been taken of.

Red is sediment ponds and flow path down the face
