Pōrangahau Wastewater Discharge to Land - Ecological Impact Assessment

Prepared for Central Hawke's Bay District Council

Prepared by Beca Limited

Document ID: P:D.66

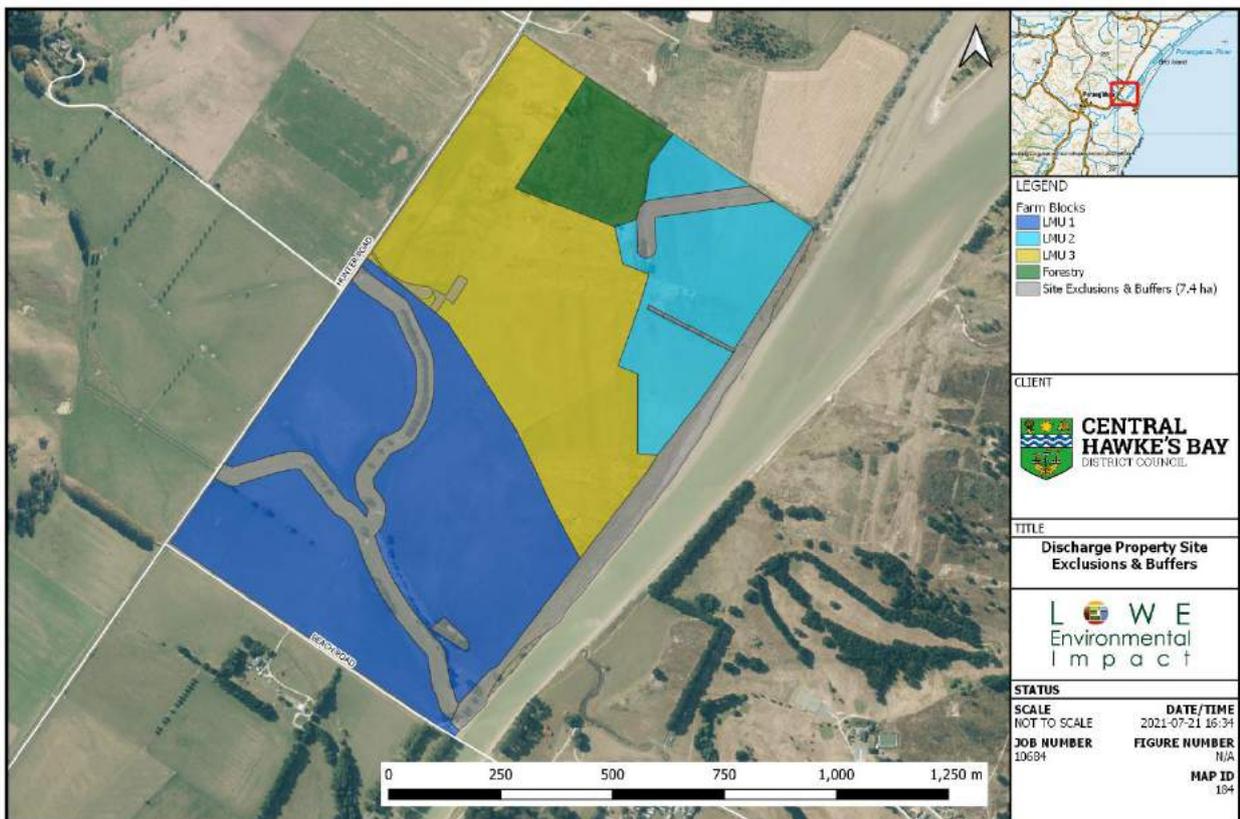
Figure 1. Proposed discharge area and exclusion areas (buffers) (LEI, 2021:P:C.15).

The proposed staging and irrigation areas is outlined below in Table 1 and Figure 1.

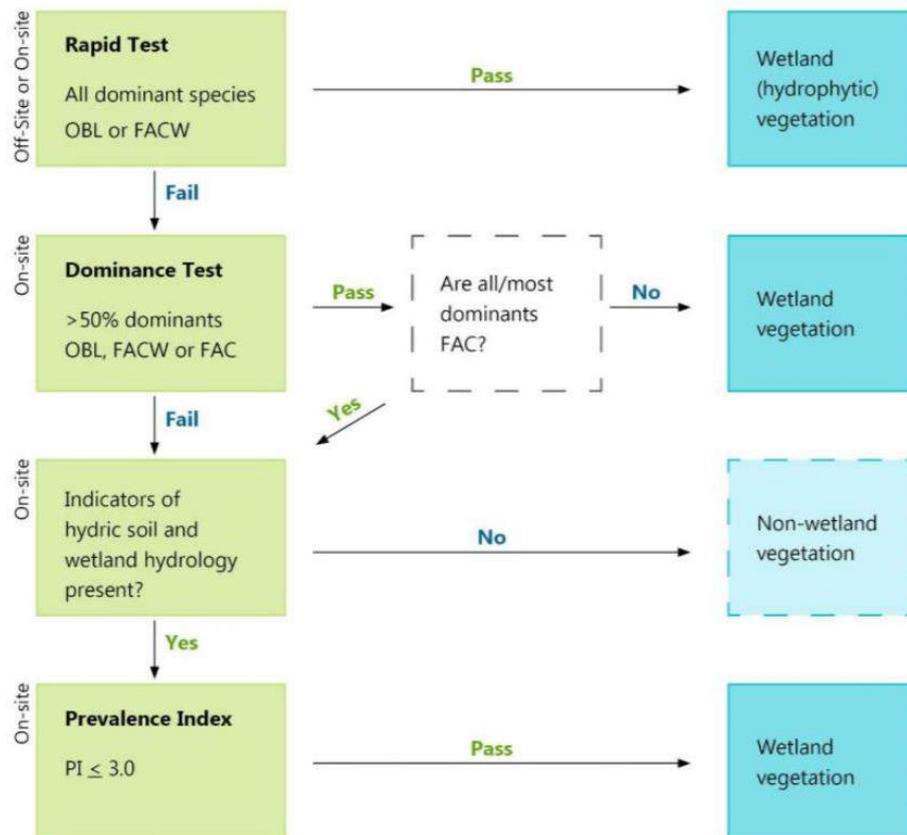
Figure 3. Landcare Research hydrophytic (wetland) vegetation delineation tool. Wetland indicator status abbreviations: FAC = facultative; FACW = facultative wetland; OBL = obligate wetland.

A desktop and field assessment of ecology, hydrology, wetland and catchment characteristics was undertaken to classify the potential wetland (e.g. non-wetland, artificial wetland, or natural wetland) in accordance with the Landcare Research wetland delineation procedure (Figure 3; Clarkson, 2018)

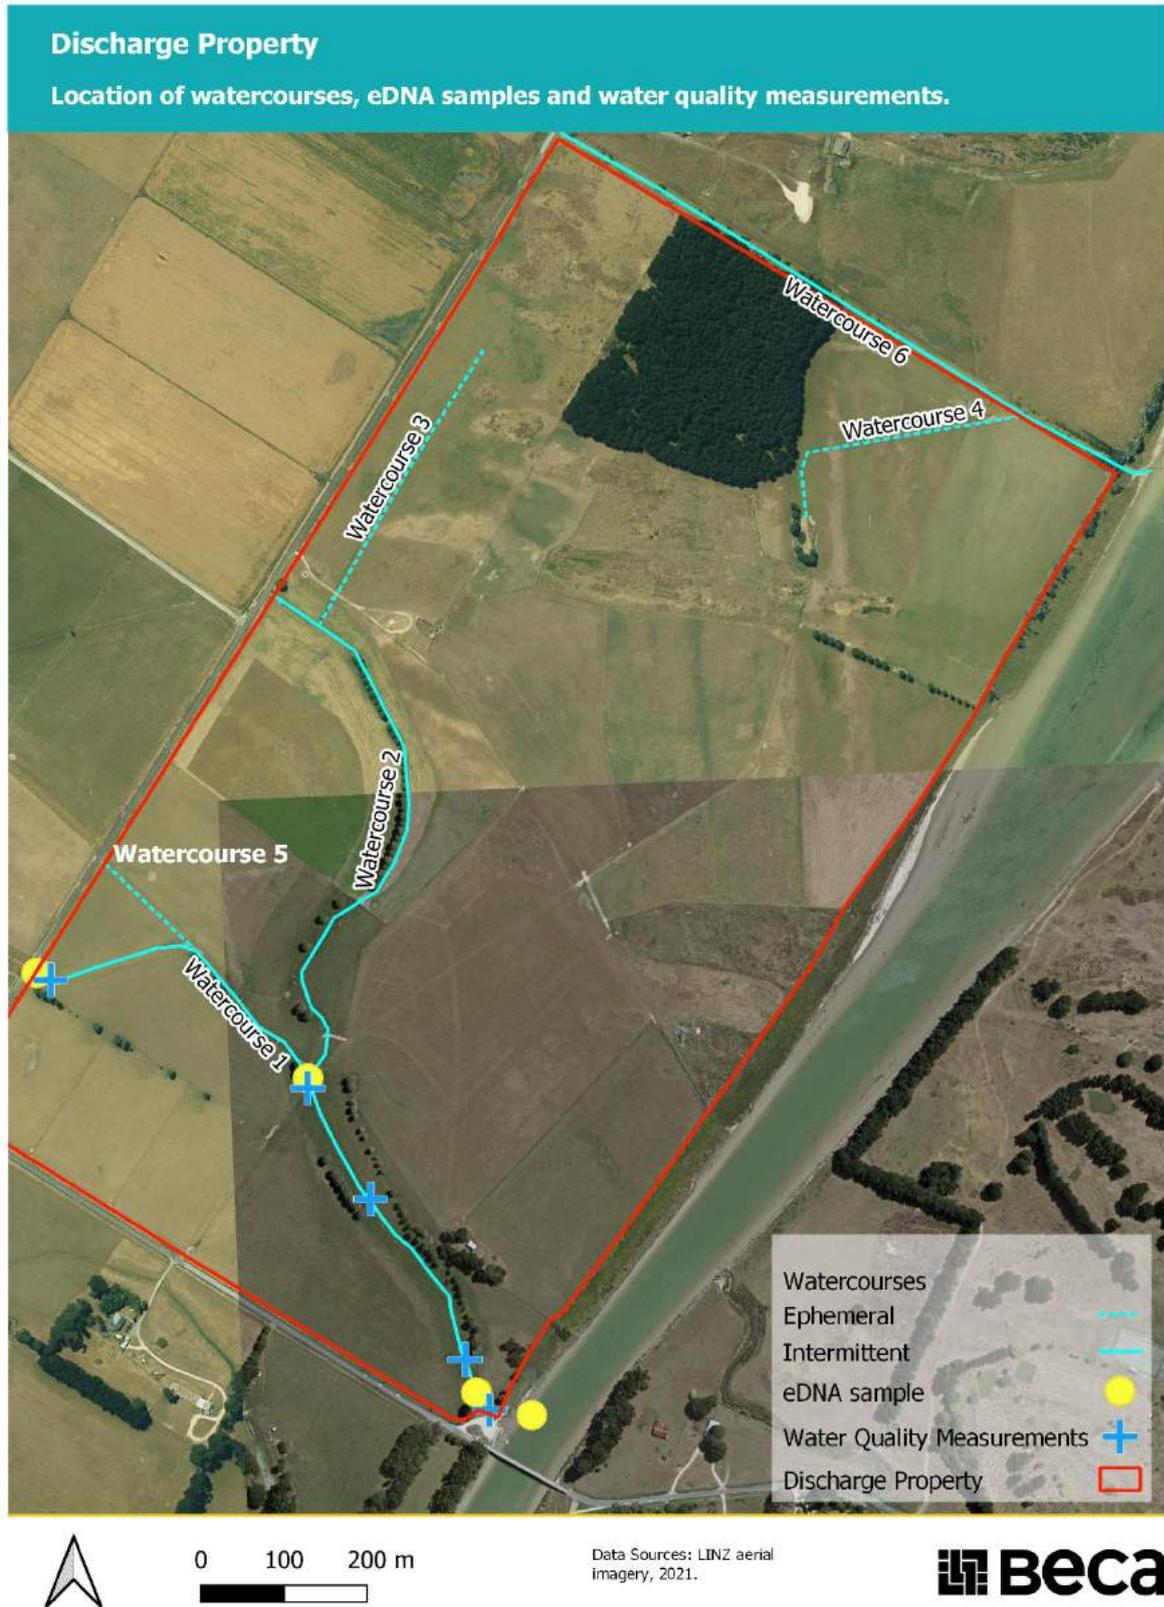
Figure 4. Location of watercourses and field measurements taken during the site visit on the 23rd June, 2021.

Field water quality measurements were recorded on the 23rd June 2021 for pH, dissolved oxygen (DO), conductivity and temperature using a hand-held meter (YSI Plus) at sample locations marked in Figure 4.

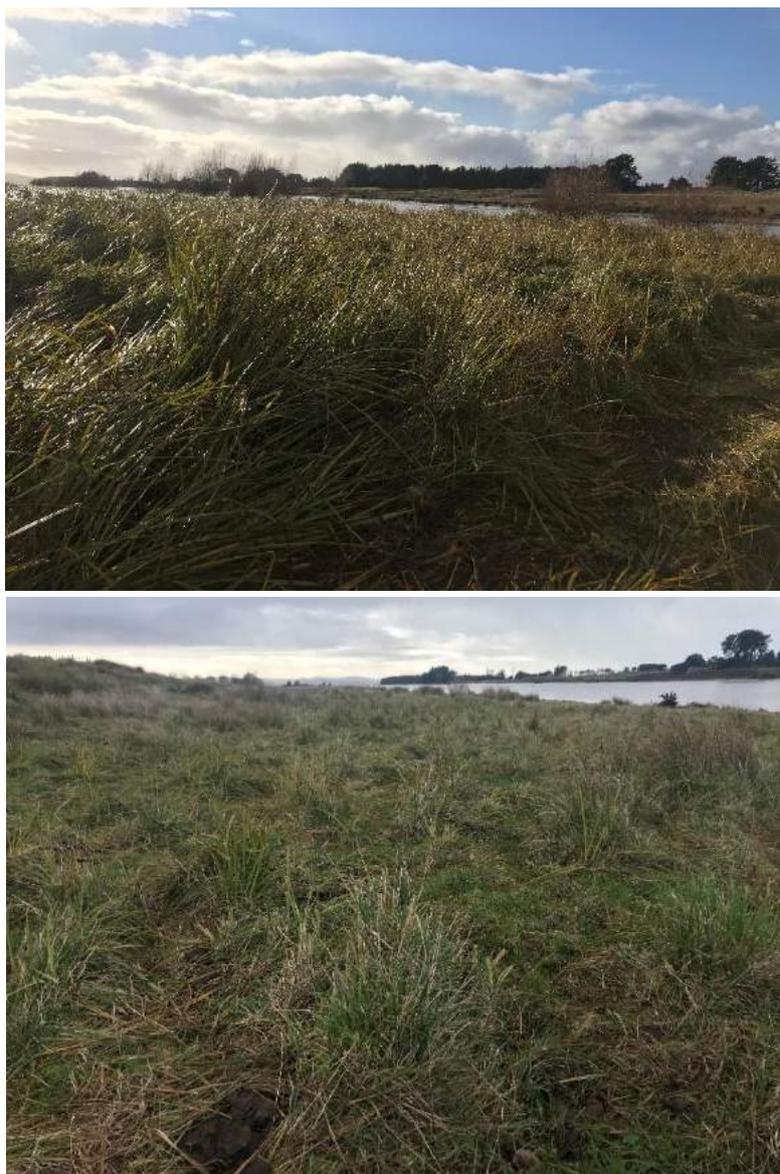
Figure 5. Site 1 (top) and site 2 (bottom) along the true left bank of the Pōrangahau River.

Carex geminata and orchard grass (*Dactylis glomerata*), were dominant at Site 2. Other species included sea rush, clover (*Trifolium repens*), creeping buttercup, slender clubrush (*Isolepis cernua*), giant umbrella sedge (*Cyperus ustulatus*), and knobby club-rush. This site failed the rapid test and the dominance test, but the Prevalence Index (PI) was less than 3.0, indicating hydric vegetation is present (Table 2).

Soils in this area are described in the 'Evaluation of Soils to Receive Porangahau and Te Paerahi's Wastewater' (LEI, 2020:P:B.15). Soil on the alluvial plain adjacent to the Porangahau River has a sand texture but is noted as having a greater profile available water and/or lower permeability status compared to those on the dunes (LEI, 2020:P:B.15). At 65 cm depth, this soil contains heavy clay and therefore represents a combination of the Kairaki Sandy Loam (topsoil) and the Kaiapo Silt Loam (>65 cm) (LEI, 2020:P:B.15).

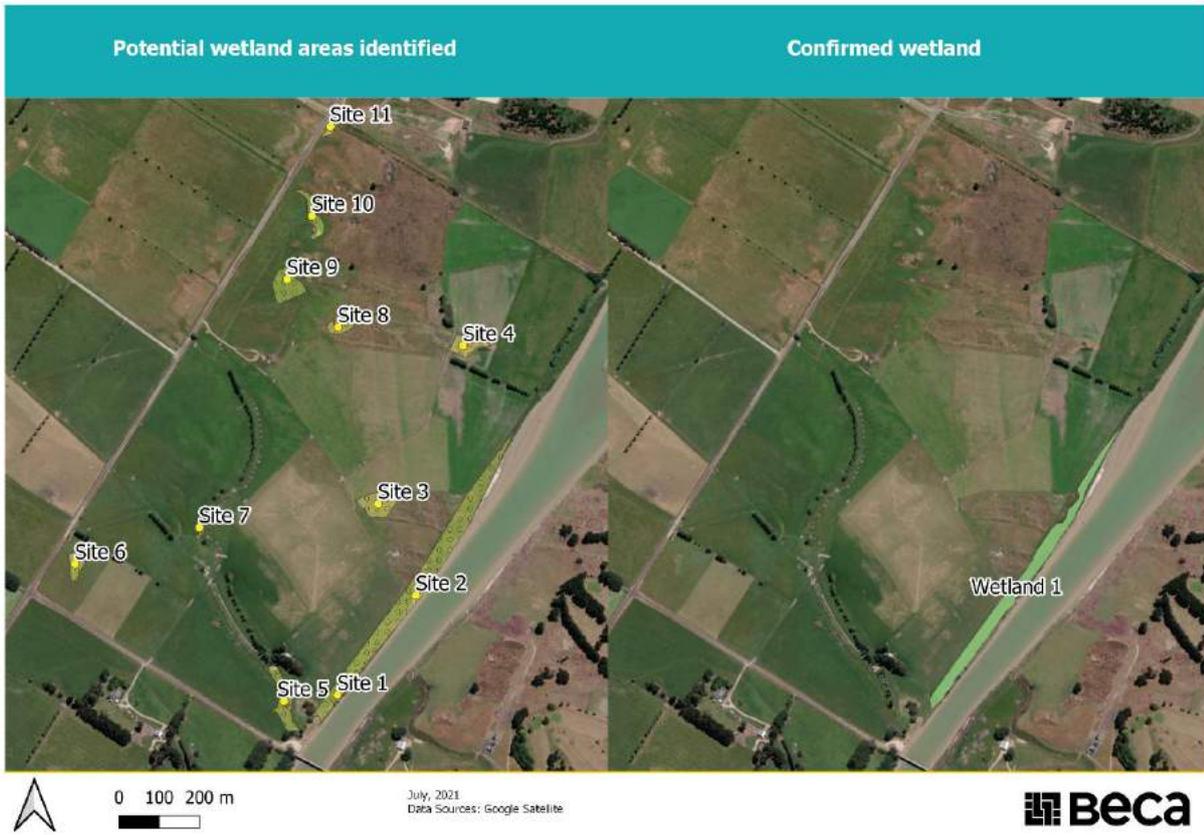
Figure 6. Potential wetland areas identified via desktop, and confirmed wetlands identified during the site visit.

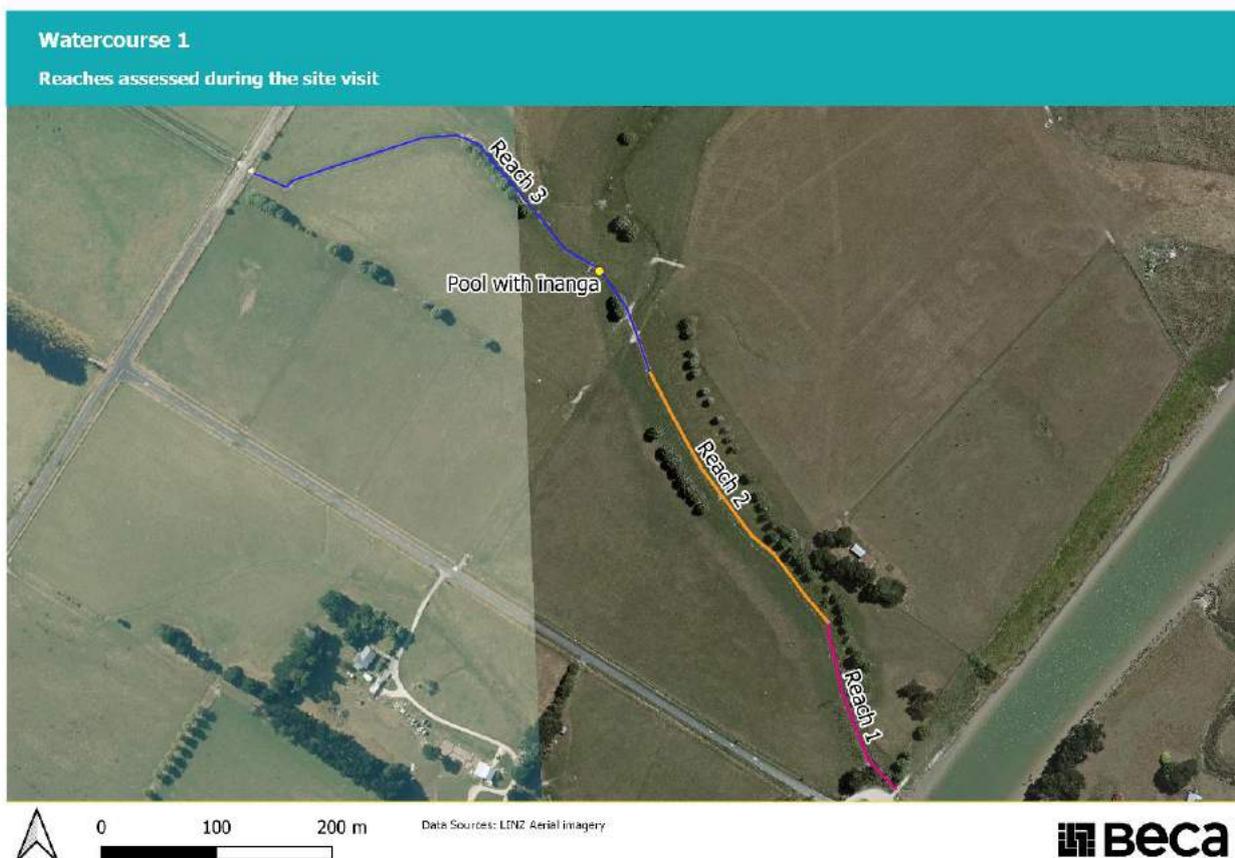
Figure 7. Sections of Watercourse 1 assessed during the site visit on the 23rd June, 2021.

Watercourse 1 is an unnamed 2nd order stream with a soft-sedimentary geology that runs through a primarily agricultural catchment. Total rainfall preceding the site visit was slightly higher than typical mean rainfall for June in the Pōrangahau area (~143mm vs. 104mm mean total rainfall for the month of June over the previous five years; NIWA, 2021). The site was not able to be visited during summer months, but photographs from previous site visits provide evidence that the watercourse is periodically dry, excluding the lower section which is tidally influenced. Watercourse 1 is classified as an intermittent stream based on the presence of: a well-defined channel, the presence of surface water more than 48 hours after a rain event, evidence of substrate sorting, and the absence of rooted terrestrial vegetation across the majority of the channel. The tidally influenced section (Reach 1) is classified as a permanent stream.

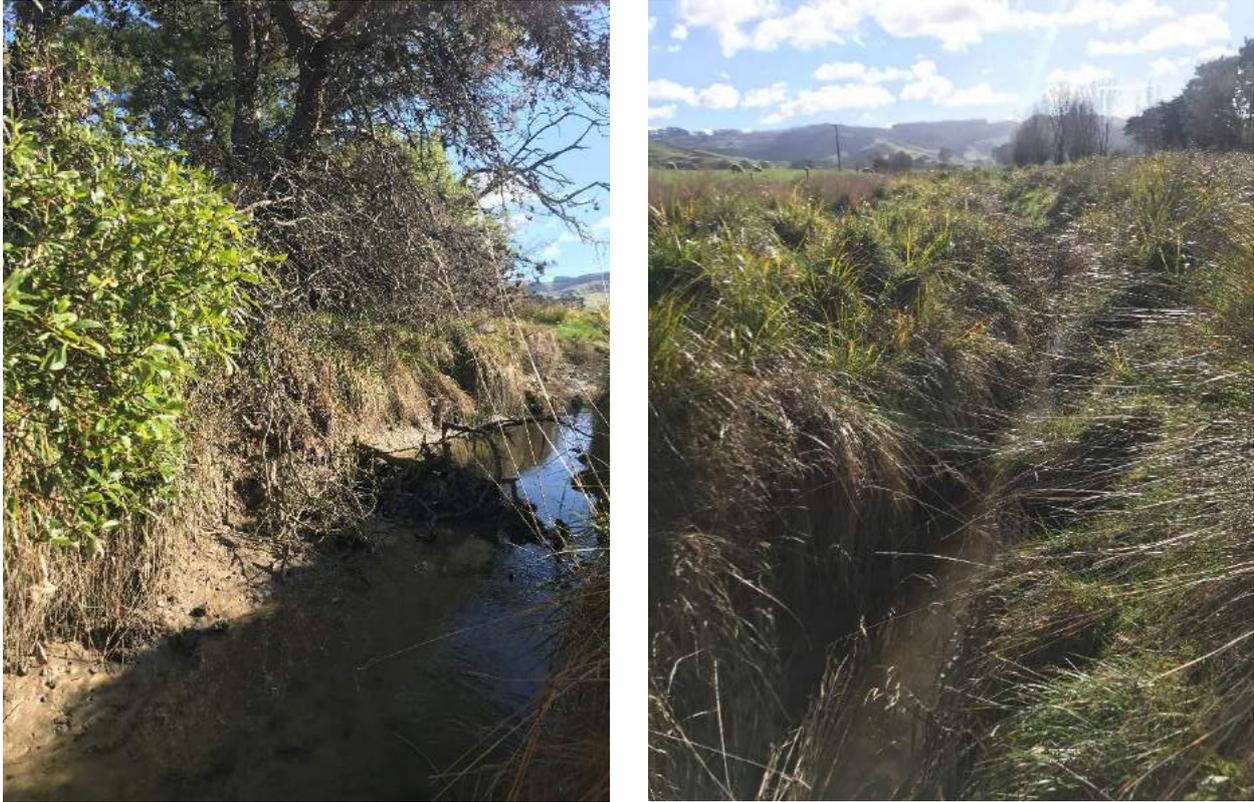
This section of the stream has a wetted channel width of ~2m and a depth of 30cm. Stream banks are approximately 1.5m high, banks are steeply incised, and erosion is present along much of the reach with some areas of mass wasting.

Substrate consists of silt/mud/sand and a small amount of emergent macrophytes are present within the channel. The stream consists predominantly of run habitat. This reach is fenced to exclude stock and riparian vegetation consists of ngaio (*Myoporum laetum*), kōwhai (*Sophora* sp.), harakeke (*Phormium tenax*), giant umbrella sedge, *Carex geminata*, *Juncus kraussii*, and orchard grass. Vegetation provides limited shading.

Figure 8. Reach 1 of Watercourse 1 at the time of the site visit (23 June, 2021).

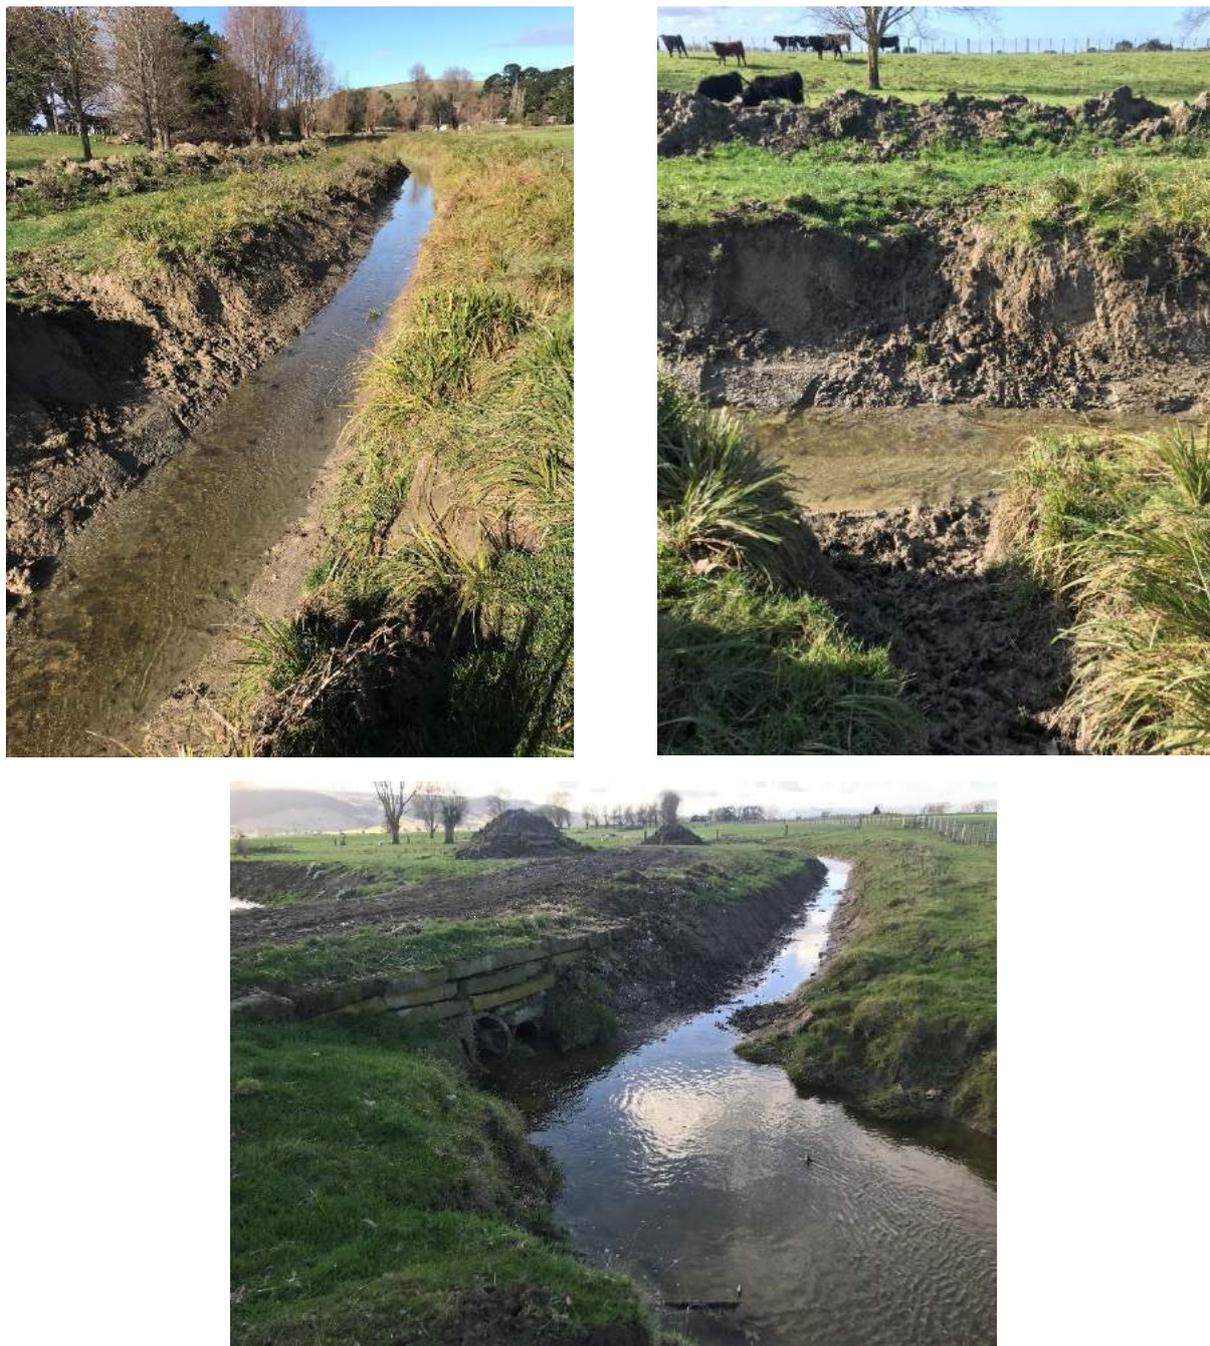
Riparian vegetation consisted predominantly of pasture grass and sedges which did not provide any shading.

At its confluence with Watercourse 2, a deeper (40-80cm) pool area is present and the stream is culverted under a vehicle crossing (Figure 9). The culverts do not present a barrier to fish passage.

Figure 9. Reach 2 of Watercourse 1 at the time of the site visit (23 June, 2021).

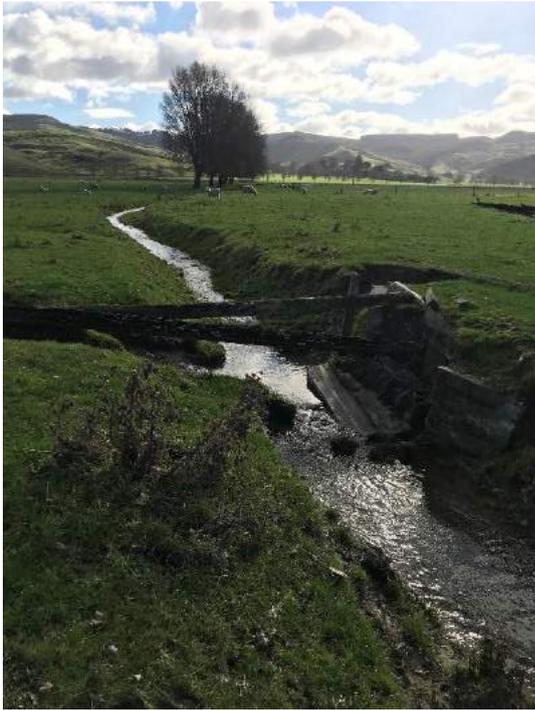
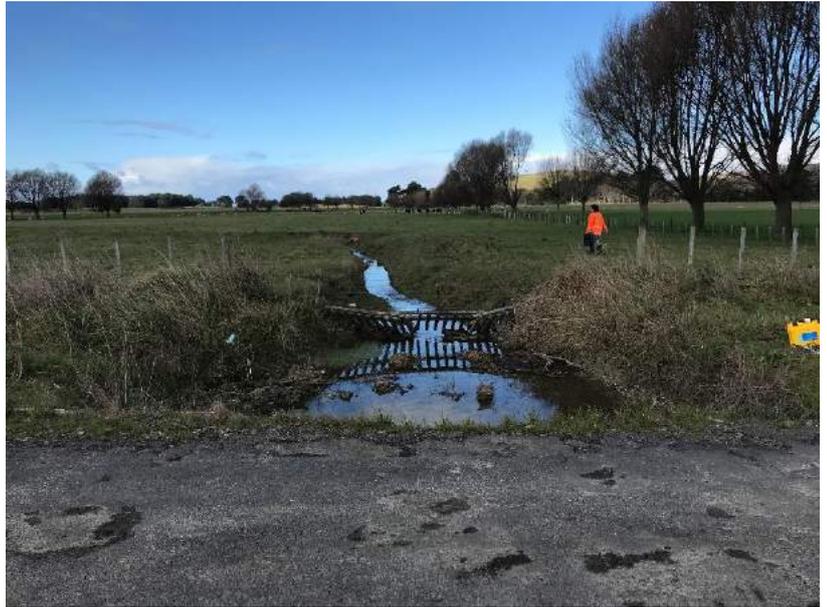
The upper section of Watercourse 1 running through the Discharge Property has a wetted channel width of 50cm and a depth ranging from 10 – 50cm. It had also been excavated, but not as recently as Reach 2. This section of the stream has been constructed and is not present in historic aerials (see Figure 12). The majority of the stream reach consists of run habitat with a small amount of riffle and pool habitat. Substrate consists predominantly of silt and mud with gravel present in some areas. Riparian vegetation consists solely of pasture grass that provides no shading. Stream banks are approximately 1m high and have a steep gradient with evidence of erosion. This section of the stream is not fenced to exclude stock. Īnanga were observed in a small pool within this reach (see Figure 7 above for location).

Figure 10. Reach 3 of Watercourse 1 at the time of the site visit (23 June, 2021).

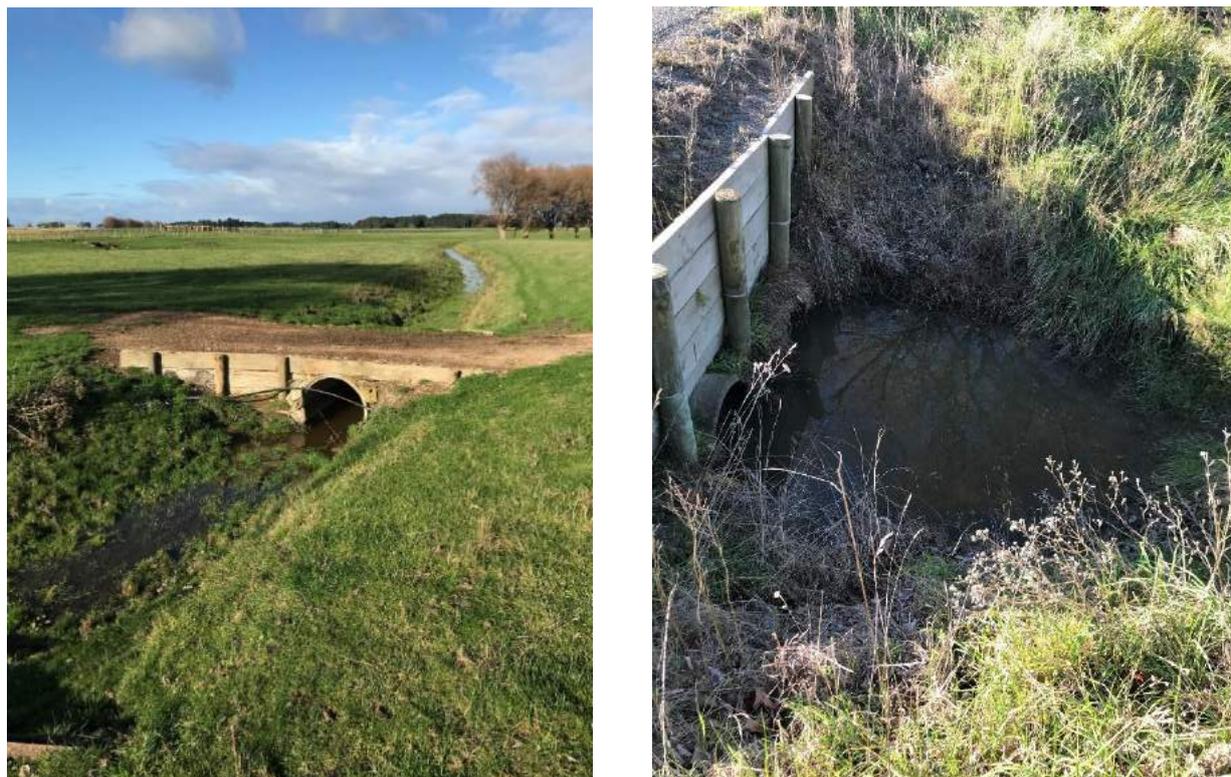
Figure 11. Watercourse 2 at the time of the site visit (23 June, 2021).

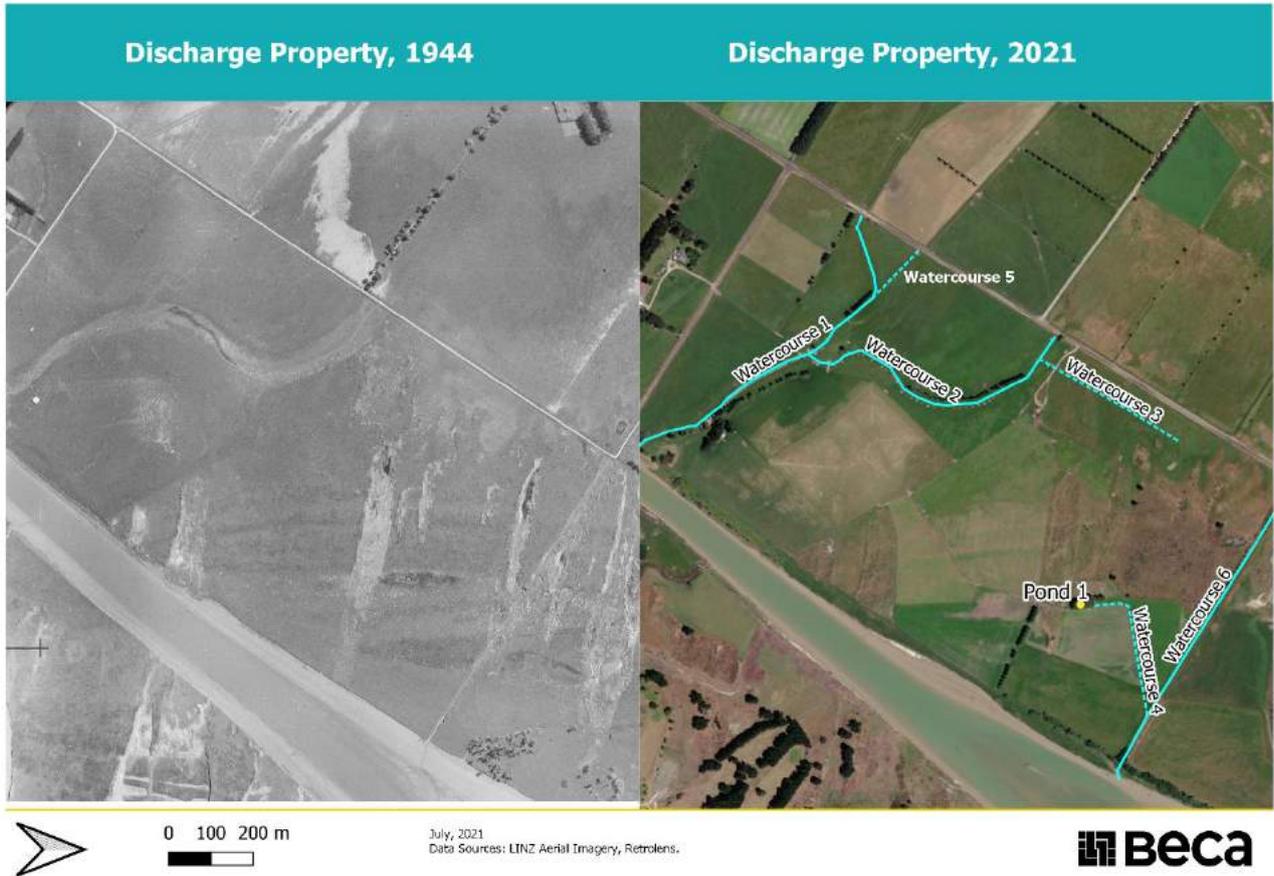
Figure 12. Aerial imagery of the site from 1944 (Source: Retrolens), and watercourses identified on the site during the site visit.

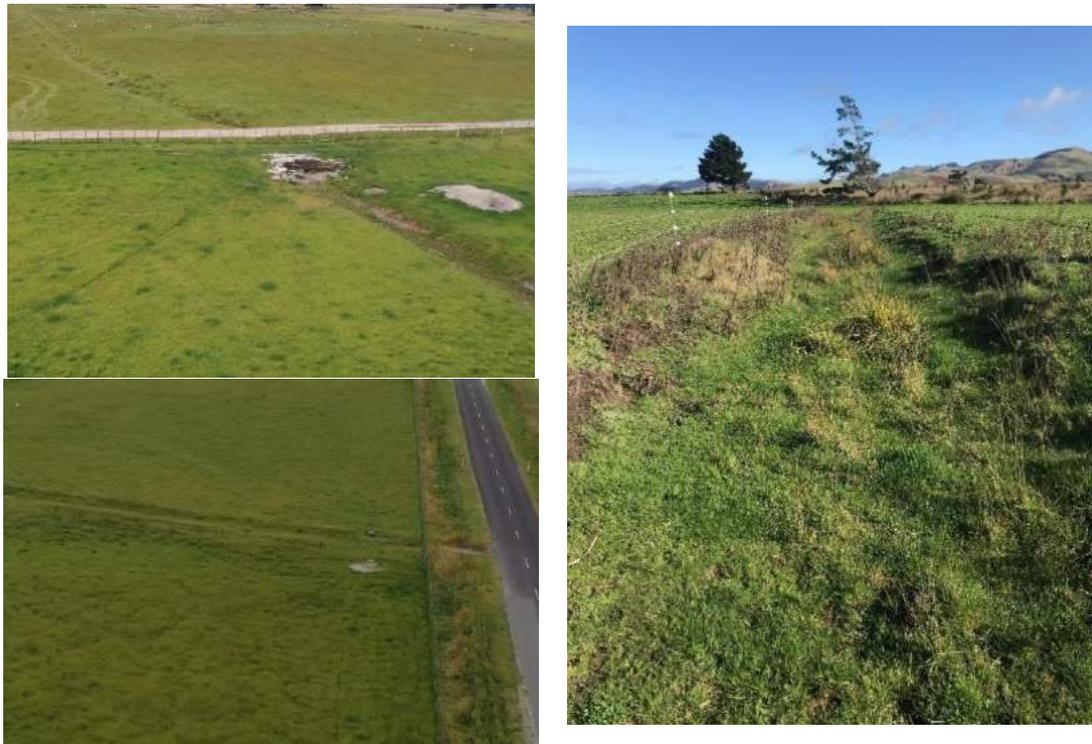
Watercourse 5 has a channel width of 1m and grass is established across the cross-sectional width of the channel.

Figure 13. Clockwise from top left: Watercourse 3, Watercourse 4, and Watercourse 5.

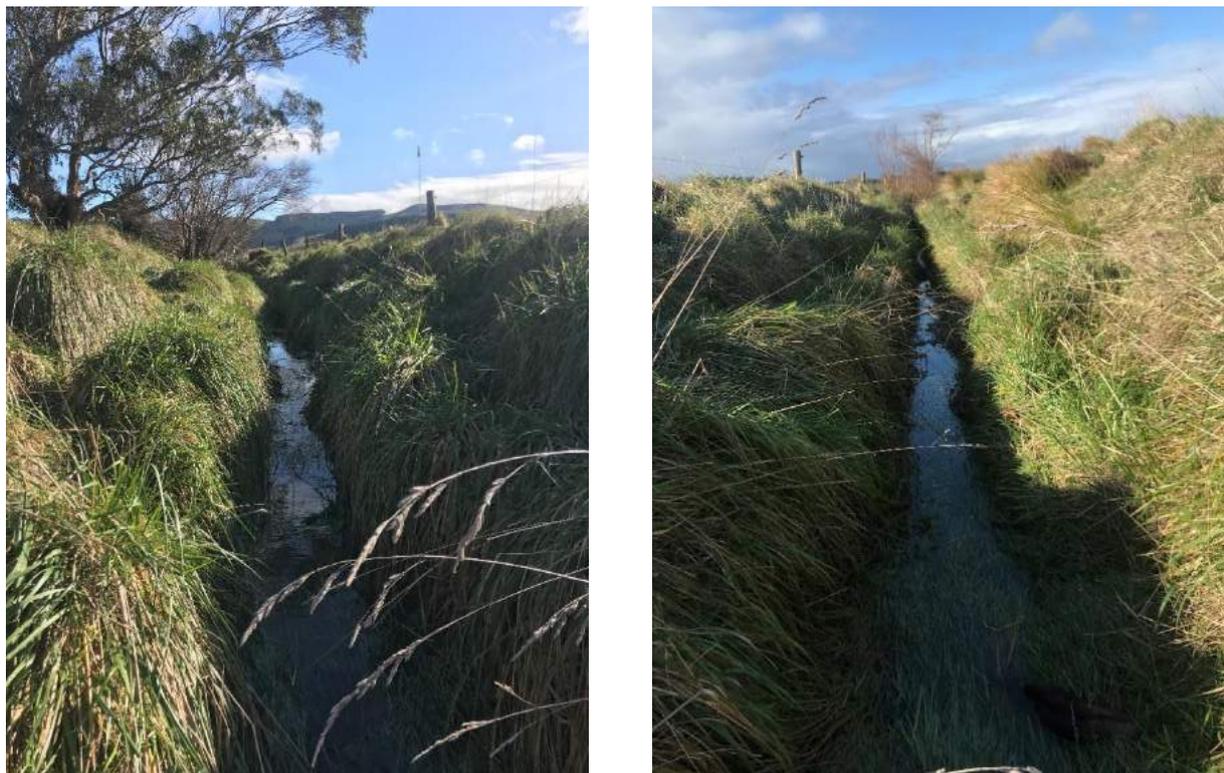
Figure 14. Watercourse 6 at the time of the site visit (23 June, 2021), looking upstream (left) and downstream (right).

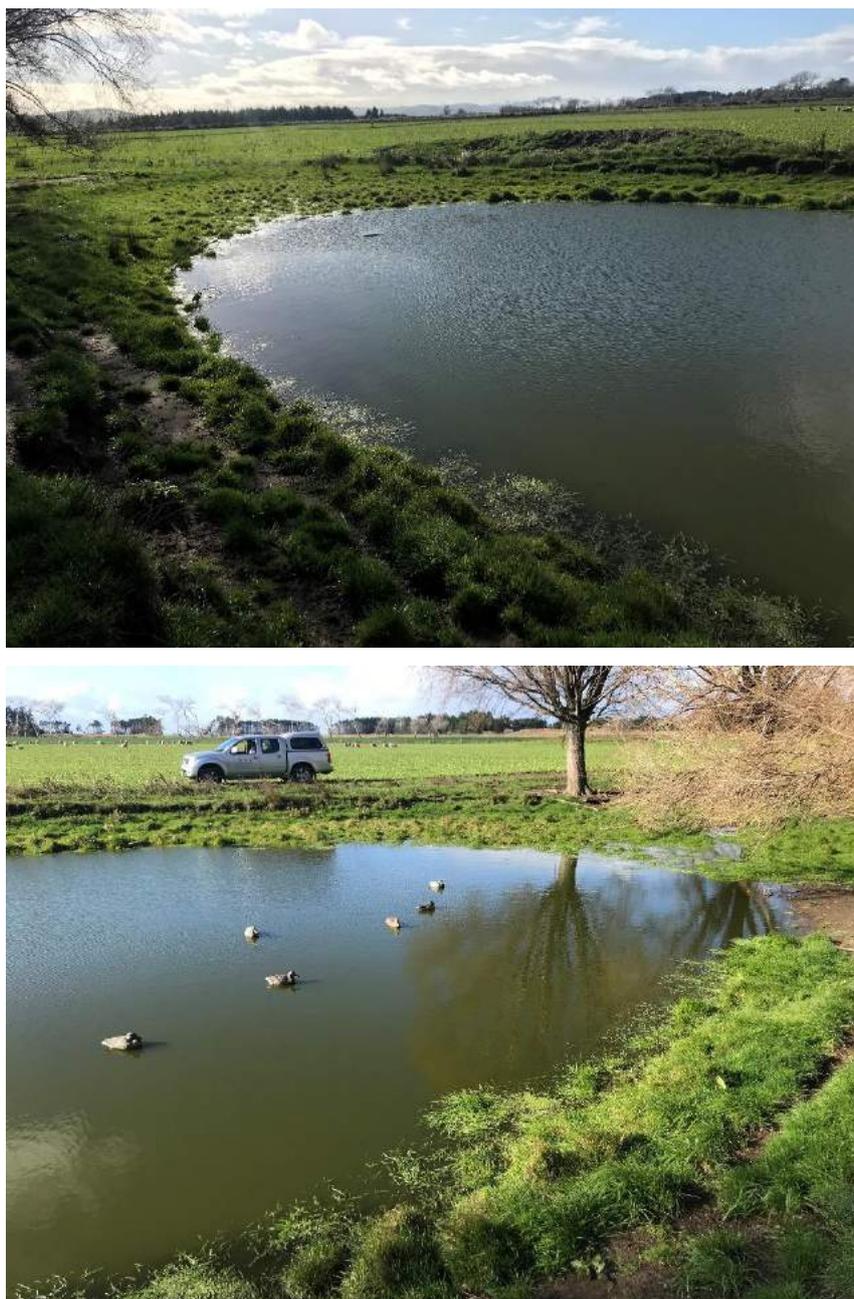
Figure 15. Pond 1 at the time of the site visit (23rd June, 2021).

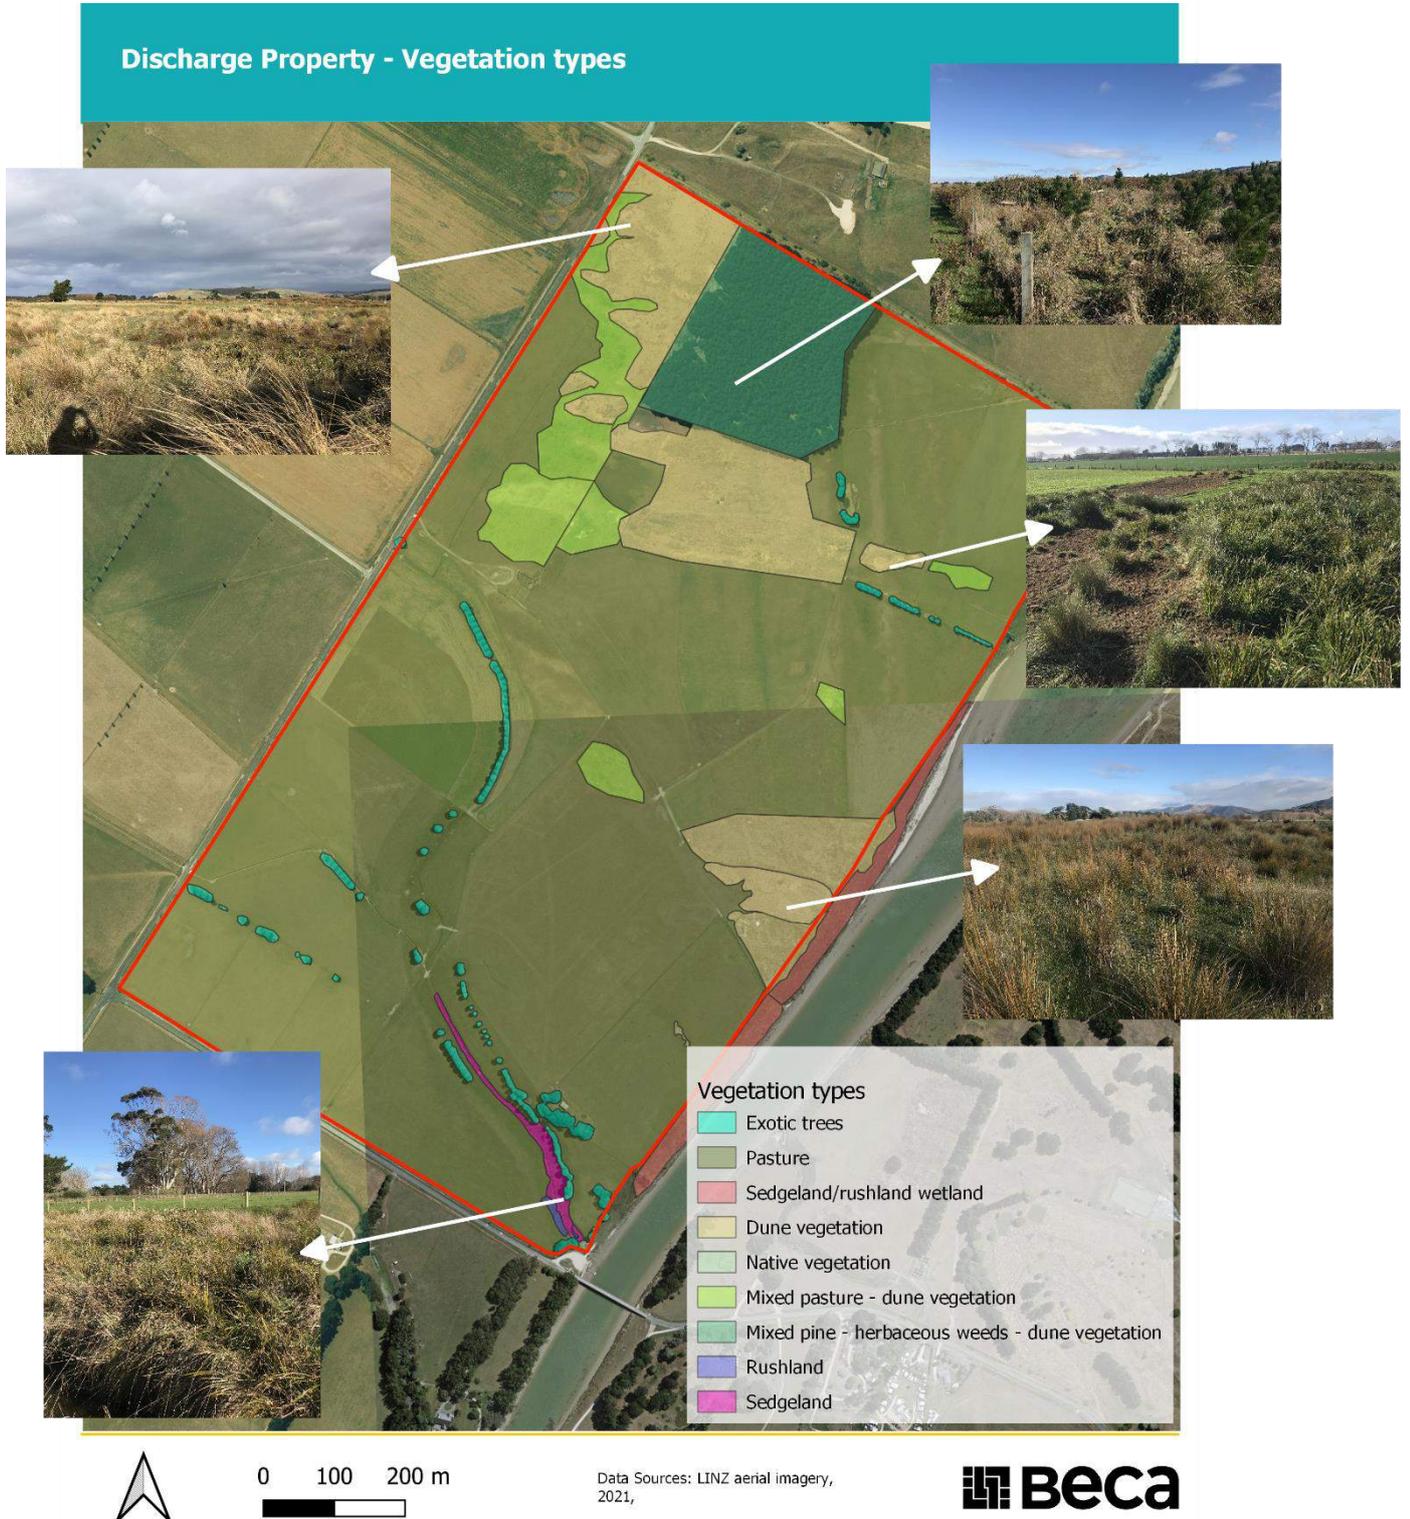
Figure 16. Approximate extents of vegetation types present on the Discharge Property.
