MEMORANDUM

Job 10684

Subject: P:B.14c – 474 Beach Road, Porangahau – Hydrogeological Assessment

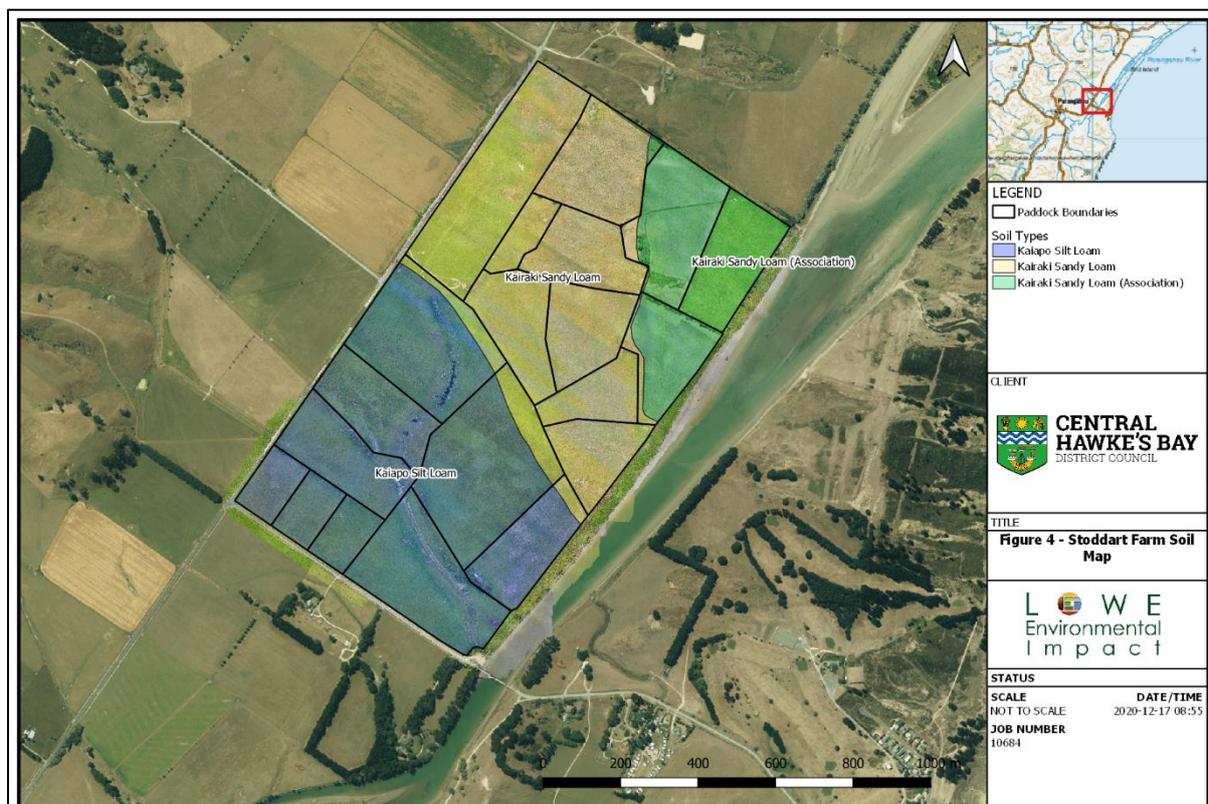
Field investigations were undertaken by Lowe Environmental Impact (LEI) on June 23, 2021, with the aim to better understand the underlying stratigraphy of the Stoddart Farm and ideally locate the fine grained gravelly layer noted in bore logs surrounding the WTP by T&T. Previous investigations by LEI identified soil types of the property to 1 m depth to which a fine grained gravel layer would underlie (Figure 2).

Figure 2: Stoddart Farm – Site Soil Map

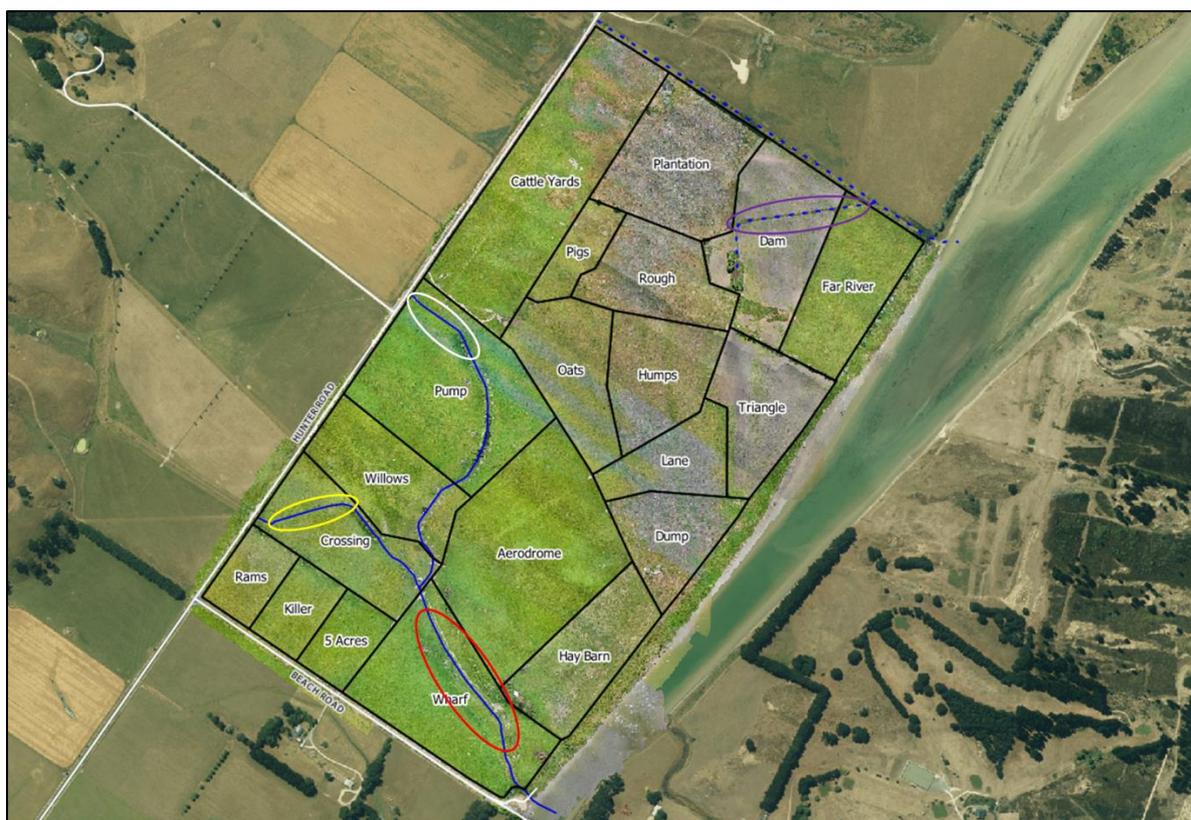
underlying material where layering can be identified. Figure 3 shows the waterways running through the property to which investigations were undertaken at. The two solid blue lines represent the main flowing drains, with dashed lines representing ephemeral drains. The drain flowing through the Crossing paddock will be referred to as the Crossing Drain, with the drain flowing through the Pump paddock referred to as the Pump Drain. Downstream where these merge will be referred to as the Wharf Drain. Coloured circles show the location of field investigations to be discussed below. In the days prior to field investigations, the property had received approximately 80 mm of rainfall meaning these drains were flowing high and had flushed out any previously accumulated finer sediments.

Figure 3: Stoddart Farm – Site Waterways and Investigation Locations

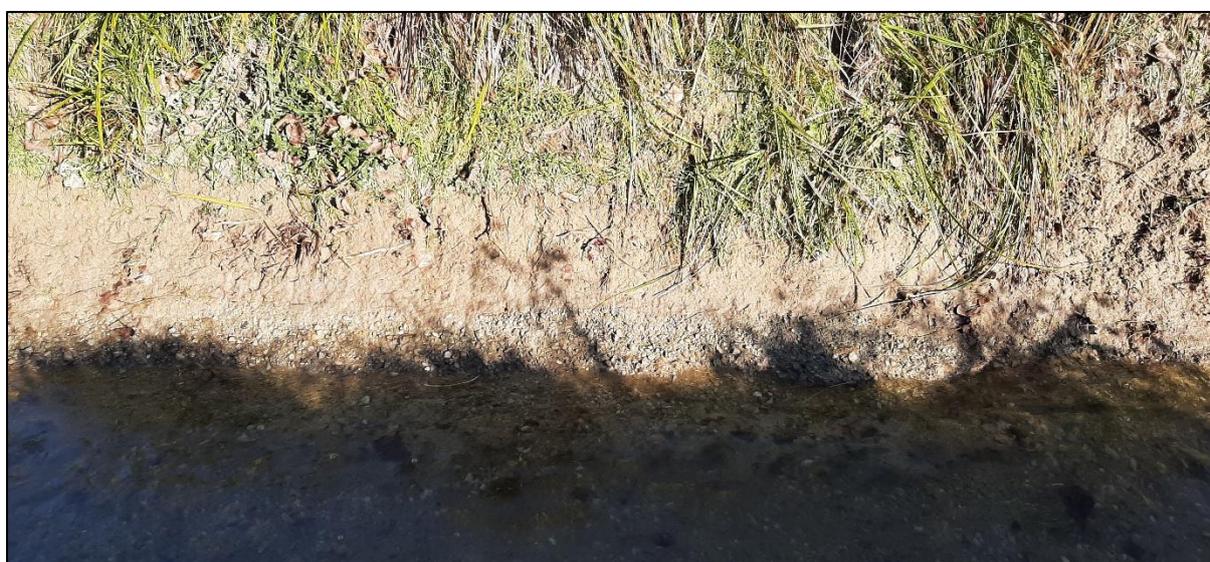
Field investigations were undertaken along the lower reach of the drain flowing through the Wharf paddock (red circle). The entirety of this channel flowing through the Wharf, Willows and Pump paddocks (minus the upper 200 m of the channel in the Pump paddock), has recently been excavated to deepen and widen the channel. Where excavated in the Wharf paddock, as well as the confluence with the Crossing Drain, the drain depth here from the bed to ground level is approximately 1.5 m. Fine gravels were located at approximately 1.4 m in depth with these largely all being <2 cm, with a few between 2-5 cm. Fine gravels were rounded, although maintained a degree of angularity.

Figures 4 and 5 represents the fine gravels noticed along the stream channel in the Wharf paddock, with Figure 6 and 7 showing the gravels noticed at the confluence of the two main streams upstream of the Wharf paddock site.

Figure 4: Fine gravel layer exposed near channel bed

Location of an underlying gravel layer was identified in the drain channels on the southern area of the Stoddart Farm. In the Wharf paddock drain, fine sub-angular gravels were located at approximately 1.4 m in depth, underlying a heavy clay subsoil. Previous excavation works to widen and deepen this drain has exposed this gravelly layer with gravels noticed on the lower drain walls and bed, alongside within the final upturned digger bucket on the adjacent drain bank that has scoured the surface of this gravel layer.

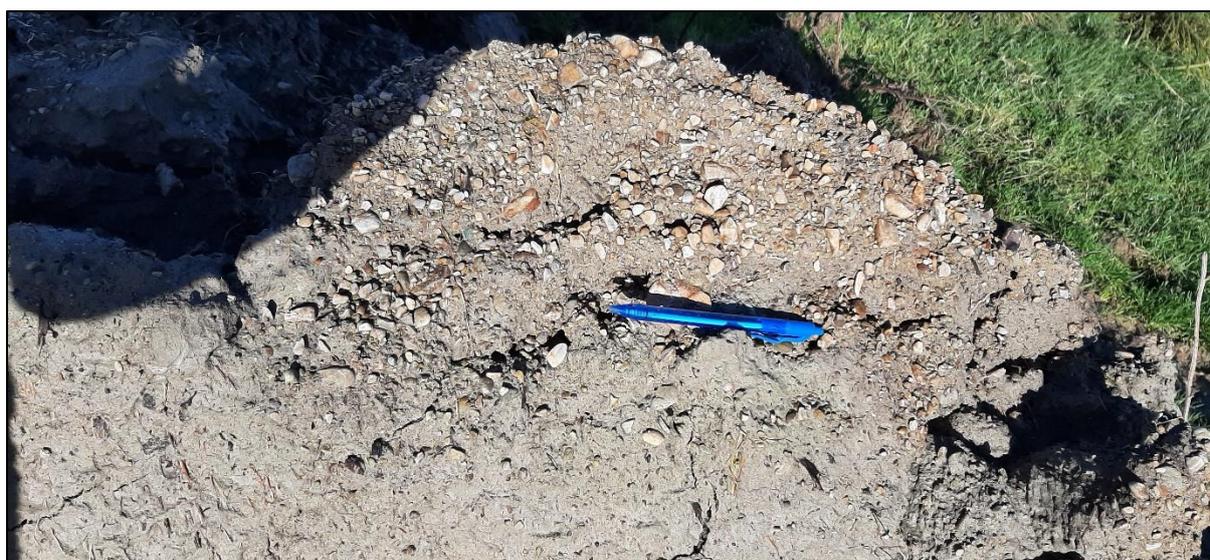
Excavated material from the drain had been upturned and dumped on the adjacent bank. Here, fine gravels dominated the final scoop of upturned excavated material, indicating the excavation to deeper the channel had skimmed the surface of this gravelly layer underlying

Figure 5: Fine gravels within upturned digger bucket

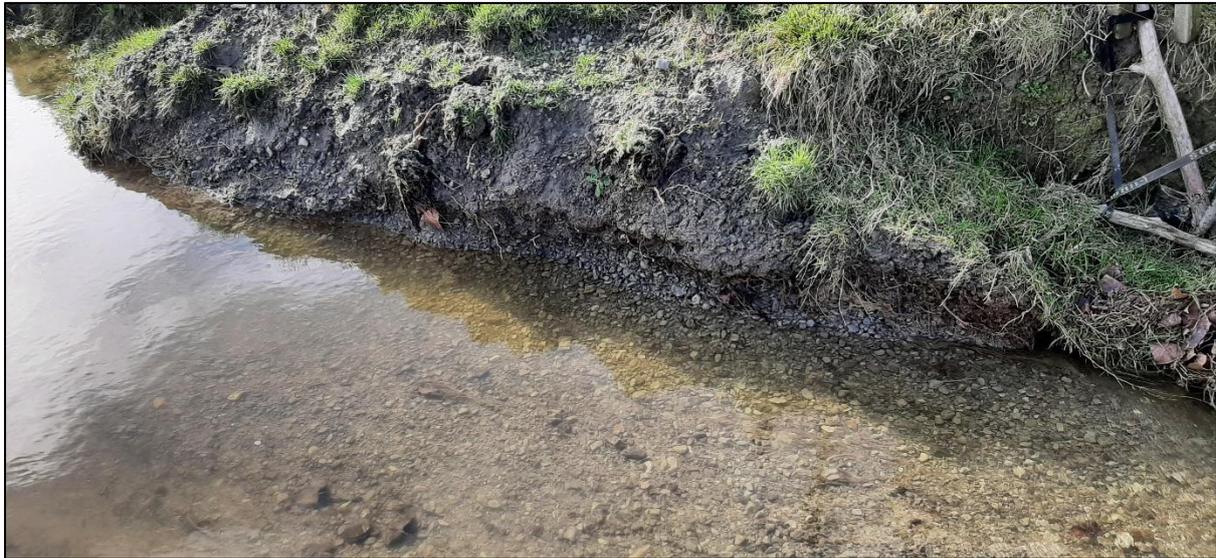
Additionally, at the confluence of the two drains upstream of the red circle, the gravel layer is exposed again. Here, gravels appear to be more prevalent and of a larger nature (higher % of 2-5 cm gravels, as compared to downstream).

Figure 6: Exposed fine gravel layer at the confluence of the two main streams

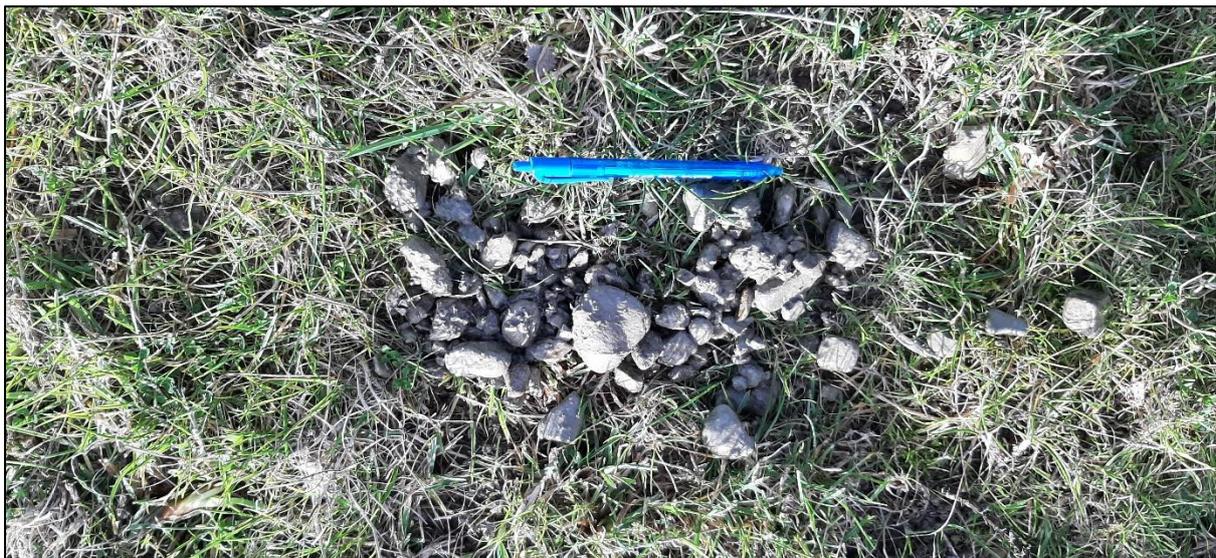
Figure 7: Fine gravels at the confluence of the two main streams

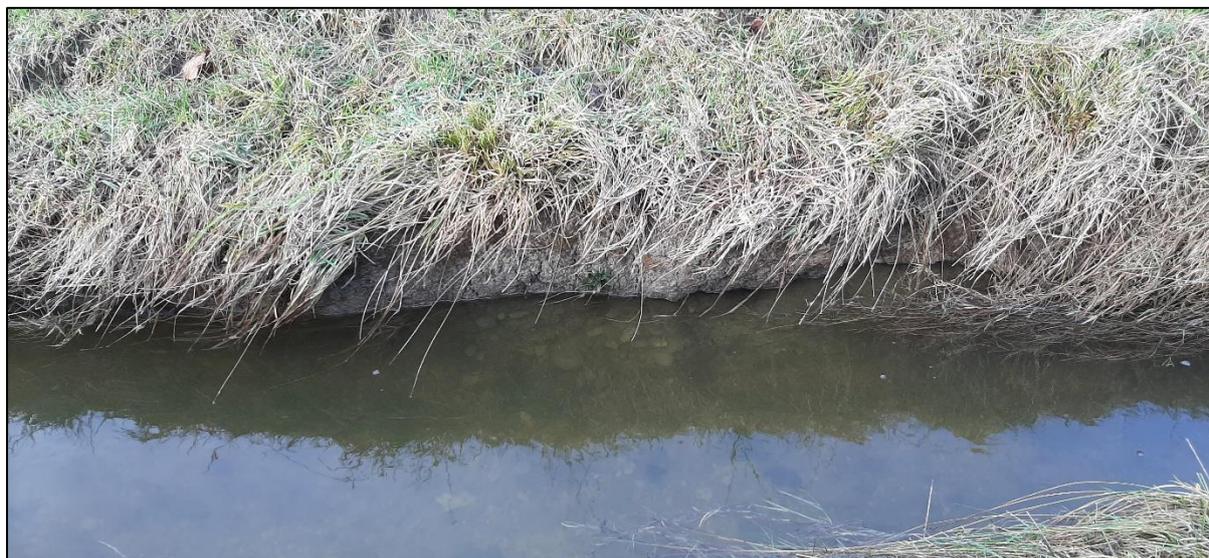
Investigations were also undertaken along the Crossing Drain, upstream of the Wharf paddock site. This stream appeared to flow significantly higher and faster than the Pump Drain. As with the previous site, gravels were exposed within the drain channel, however these differed to downstream in both size and depth. Exposed beneath the flowing water level, gravels reflected typical river gravels and were larger (typically 5-10 cm in size) than those downstream, however maintained an equal degree of angularity. This gravelly layer was noticed at 1.2 m in depth, approximately 20 cm higher than that noticed downstream. This difference in depth of gravels cannot be the result of elevation variation between the sites with the Wharf paddock site being at a lower elevation than the upstream Crossing paddock site.

Figures 8 and 9 represent the gravelly layer within the stream channel and gravels pulled from the exposed surface.

Figure 8: Exposed gravel layer within Crossing Drain

Upstream, these gravels are noticed within the Crossing paddock drain, however at a shallower depth and greater size. Gravels here are larger at 5-10 cm, at a depth of 1.2 m and appear to differ to those noticed downstream. Although the degree of angularity of these gravels between the sites appears to be similar, these differ significantly in that no large 5-10 cm gravels are noticed downstream, and equally minimal fine gravels <2 cm are noticed upstream.

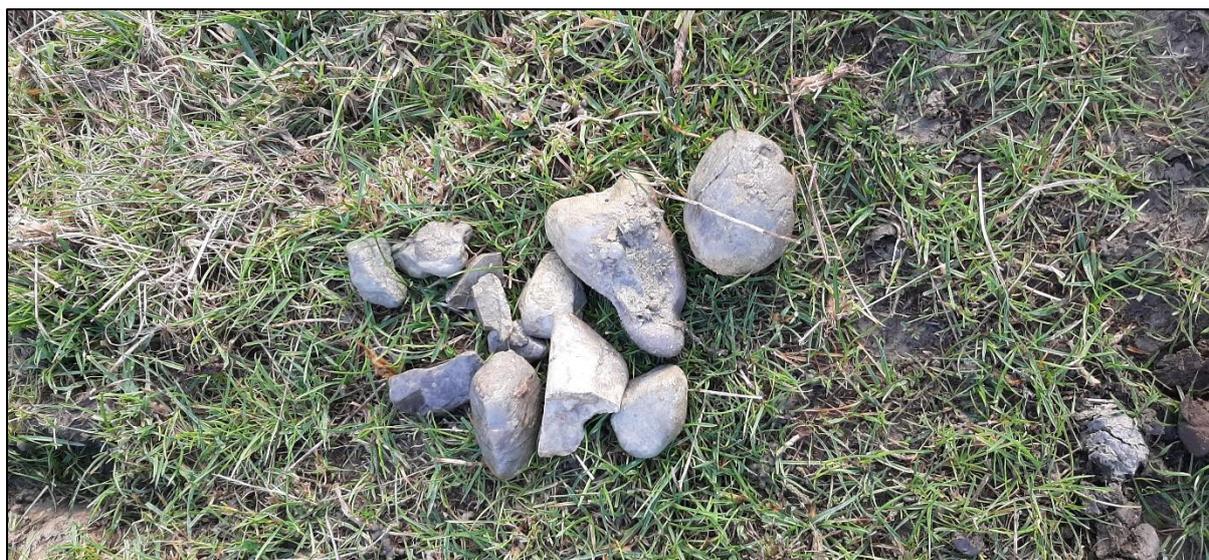
Figure 9: Exposed gravels on Crossing Drain wall (gravels 5-10 cm in size)
