MEMORANDUM

Job 10684

Subject: P:B.14d – Initial Piezometer Water Quality & Field Data

This memo provides feedback on the findings of slug tests performed and water sampling undertaken on 15 July 2021, at five recently installed monitoring piezometers at Porangahau.

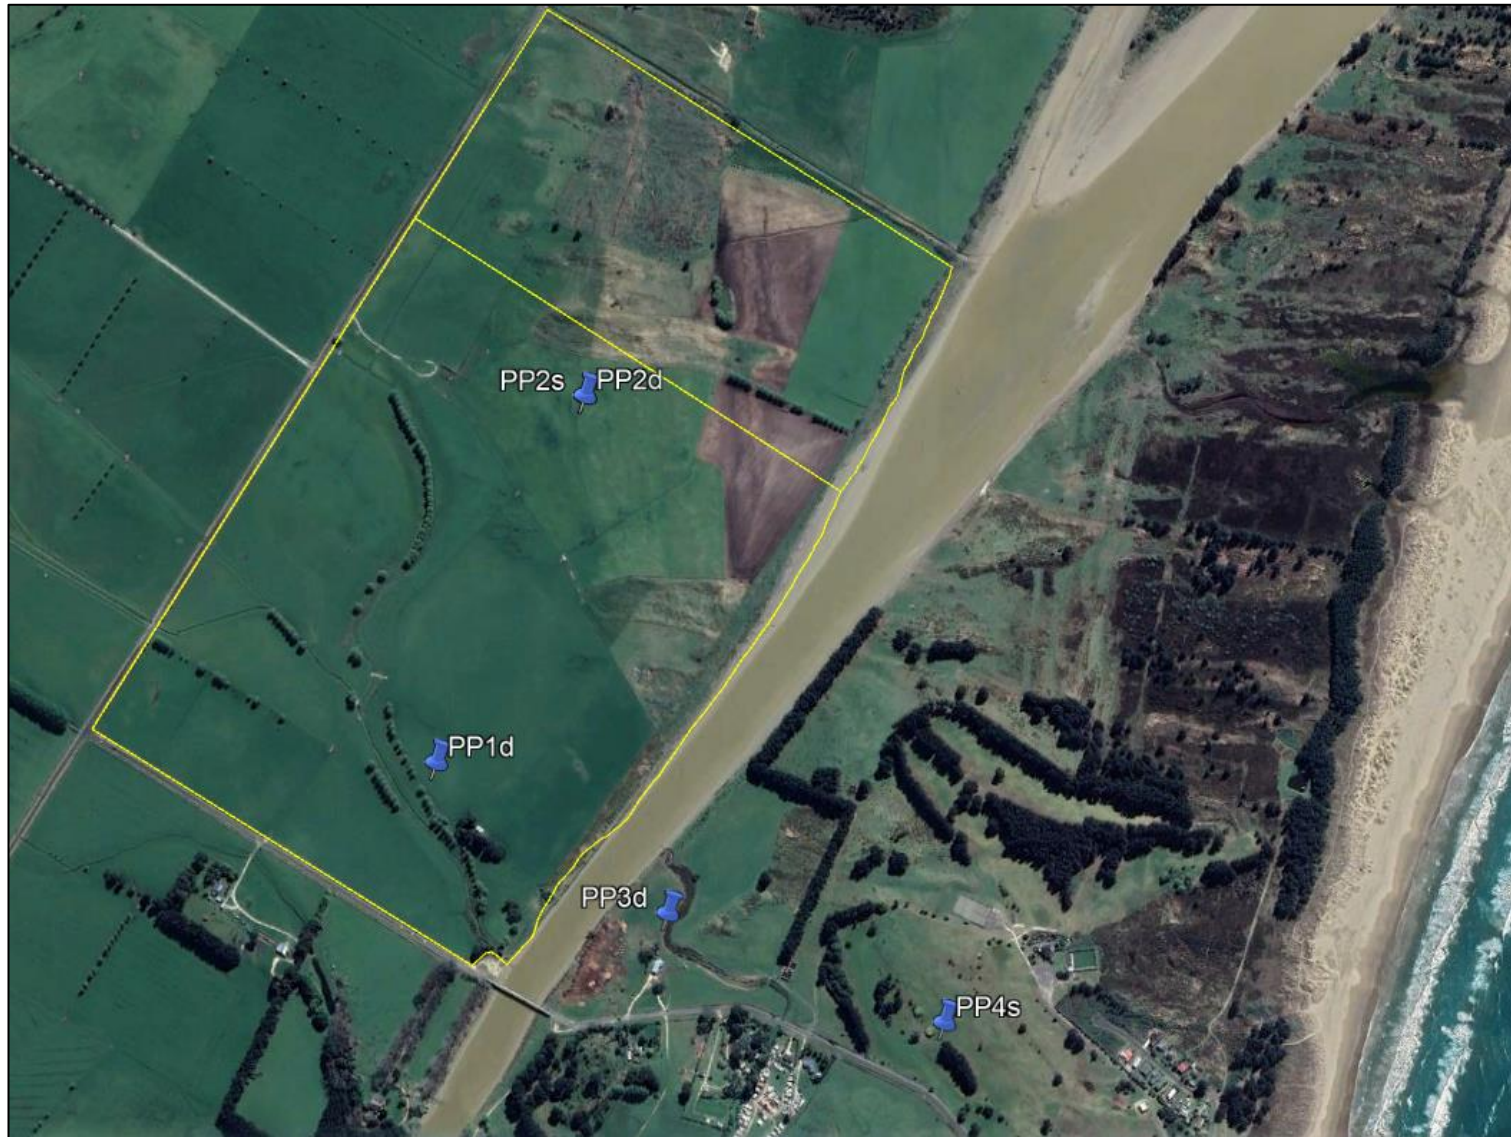
Figure 1: Monitoring Locations

The respective monitoring locations are described in Table 1 and illustrated in Figure 1.

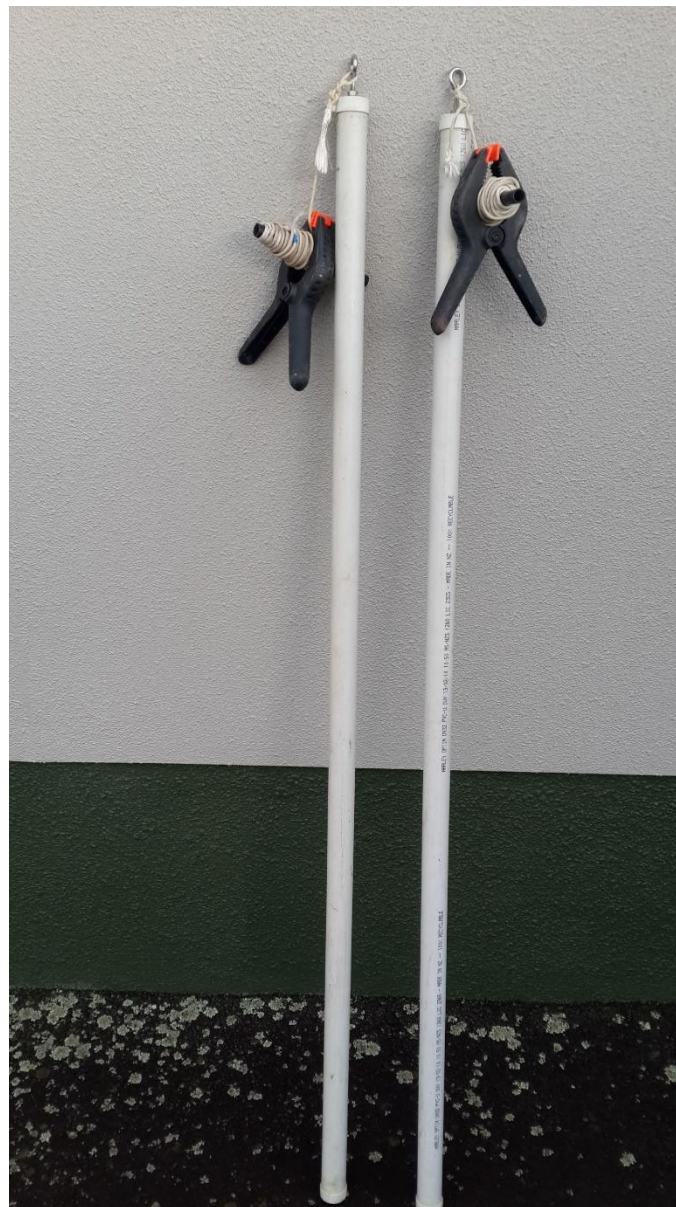
Figure 2: Slug Design

All five new piezometers were slug tested to get an understanding of hydraulic conductivity (K) across the site. A portable slug was sunk into each 50 mm PVC piezometer and retrieved to measure water level recovery. The slugs used measured 1,480 x 38 mm as is illustrated in Figure 2. Automated water level loggers set to record at 1 second intervals were installed in each piezometer prior to slug testing.
