Evaluation of Soils to Receive Porangahau and Te Paerahi's Wastewater

Central Hawke's Bay District Council

L E W E
Environmental
I m p a c t

December 2020

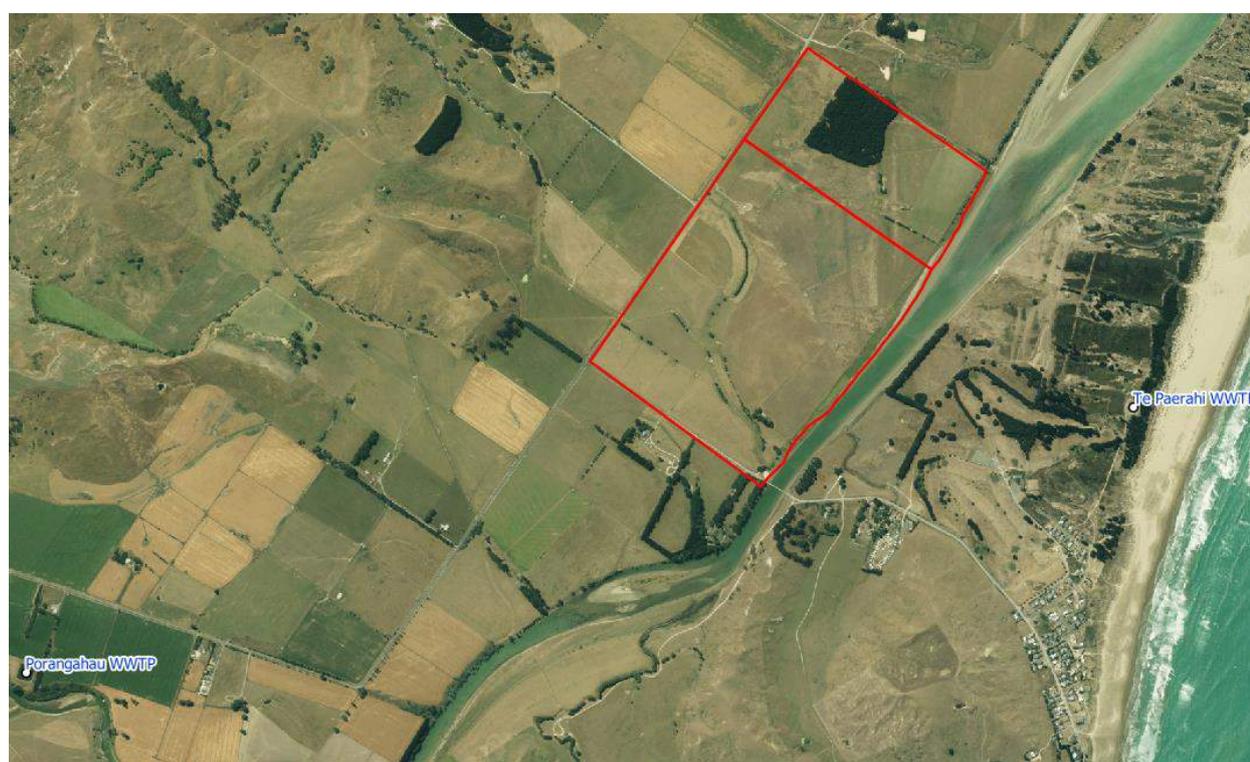
Figure 3.1: Stoddart Farm Site

Details of the property are provided within Table 3.1. Figure 3.1 represents the location of the property operated by the Stoddart's. The property is located directly between the two townships with Porangahau being to the west and Te Paerahi to the east. Distances recorded from the respective plants to the site are via roading networks.

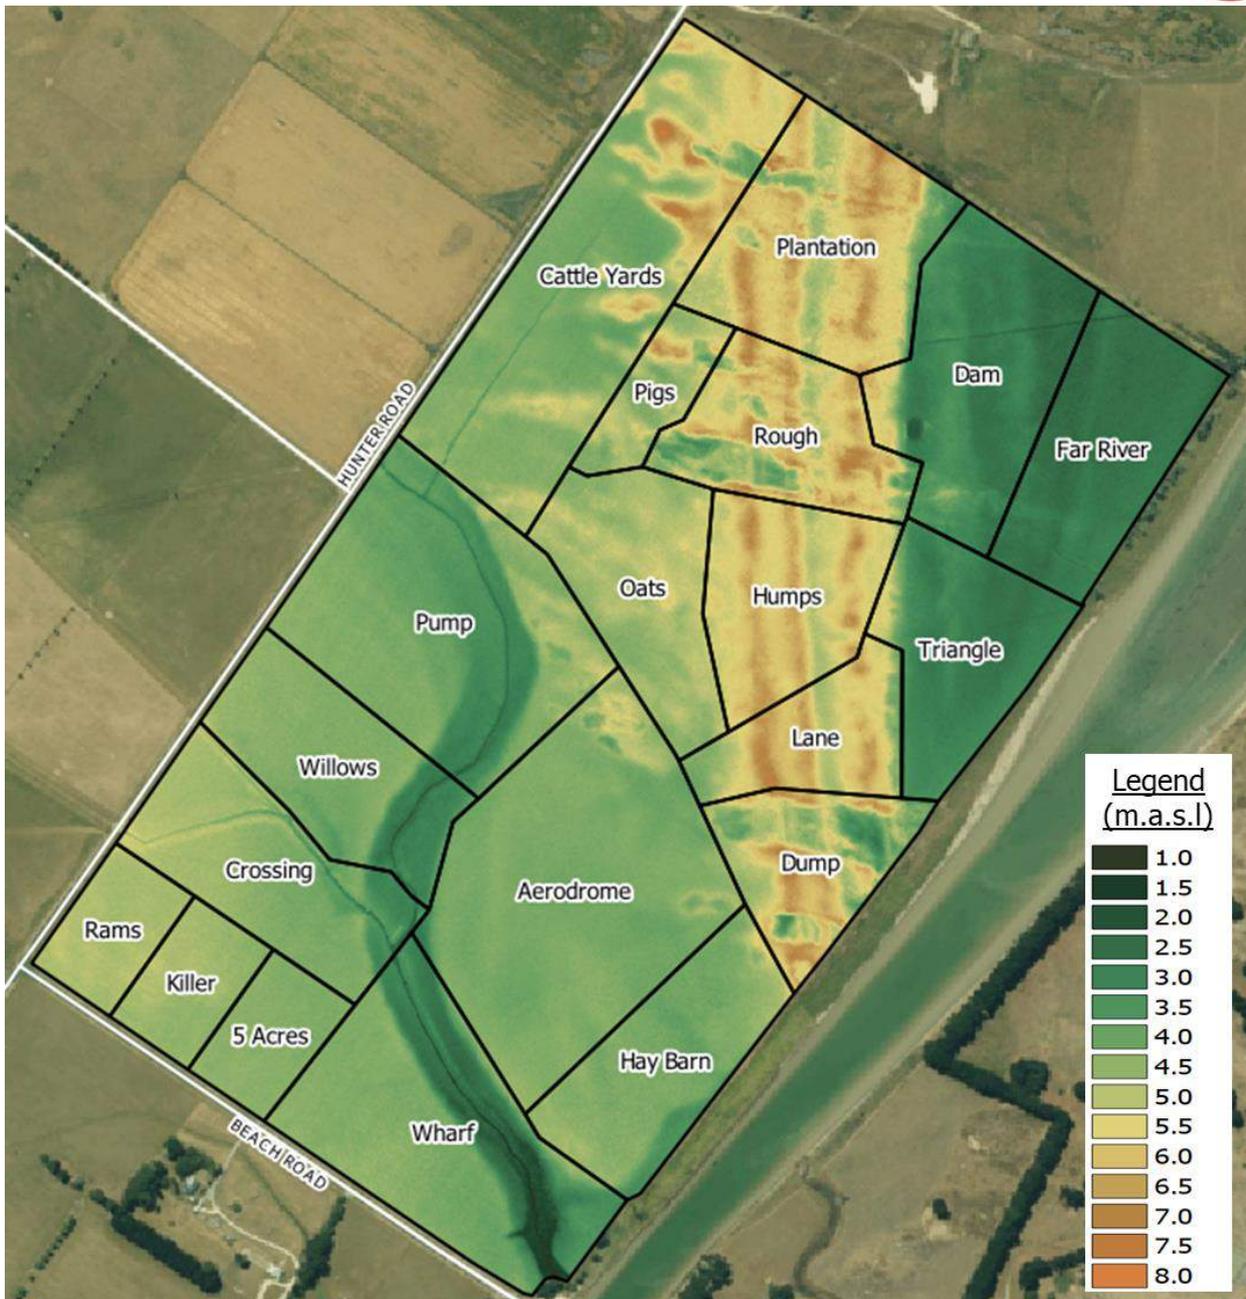
Figure 4.1: Elevation Map of the Stoddart Farm

Paddocks including and south of Pump, Aerodrome and Hay Barn, as well as Far River, Dam and Triangle to the north-east, all reside on the alluvial floodplain of the Porangahau River. These paddocks are all lower lying in comparison to those through the property's northern and central extent. The northern extent of Pump, Aerodrome and Hay Barn, as well as the western extent of the Dam and Triangle paddocks, all contain gentle slopes to the higher elevated sand dune paddocks. Figure 4.1 below represents the variation in elevation across the property with values shown in metres above sea level.

*Lidar imagery provided by HBRC contained a z value of +10 m which has been accounted for within elevation imagery and numbers supplied within this report.

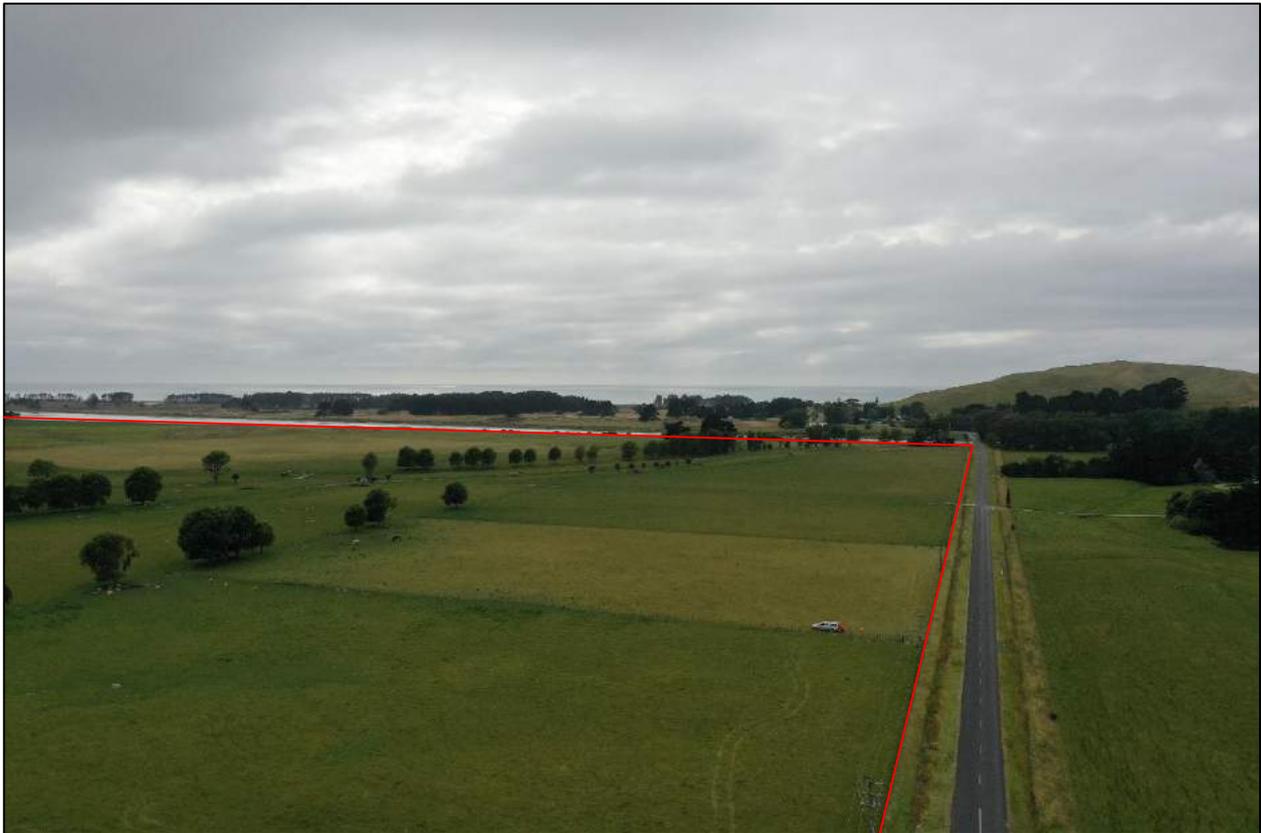
Figure 4.2: SW looking E

As part of field investigations, aerial imagery for the entire property was captured using a drone. Captured imagery included photos, videos and a whole site flyover. Photos and videos were taken across the site, providing a better perspective of the site to what can be experienced on the ground. Photos of the Site are shown within Figure 4.2 through Figure 4.6. The red line represents the property boundary for the Site.

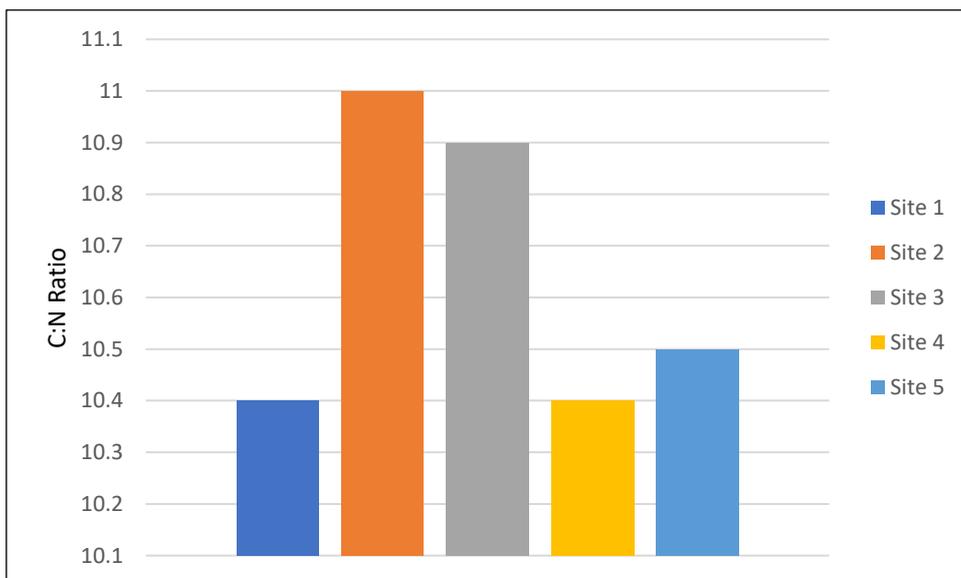
Figure 7.8: C:N Ratio Results

Figure 7.8 represents C:N ratios for each of the sites with these varying between 10.4 and 11. When comparing these values with those identified by Hill Laboratories, these are all classed as medium (10-15).

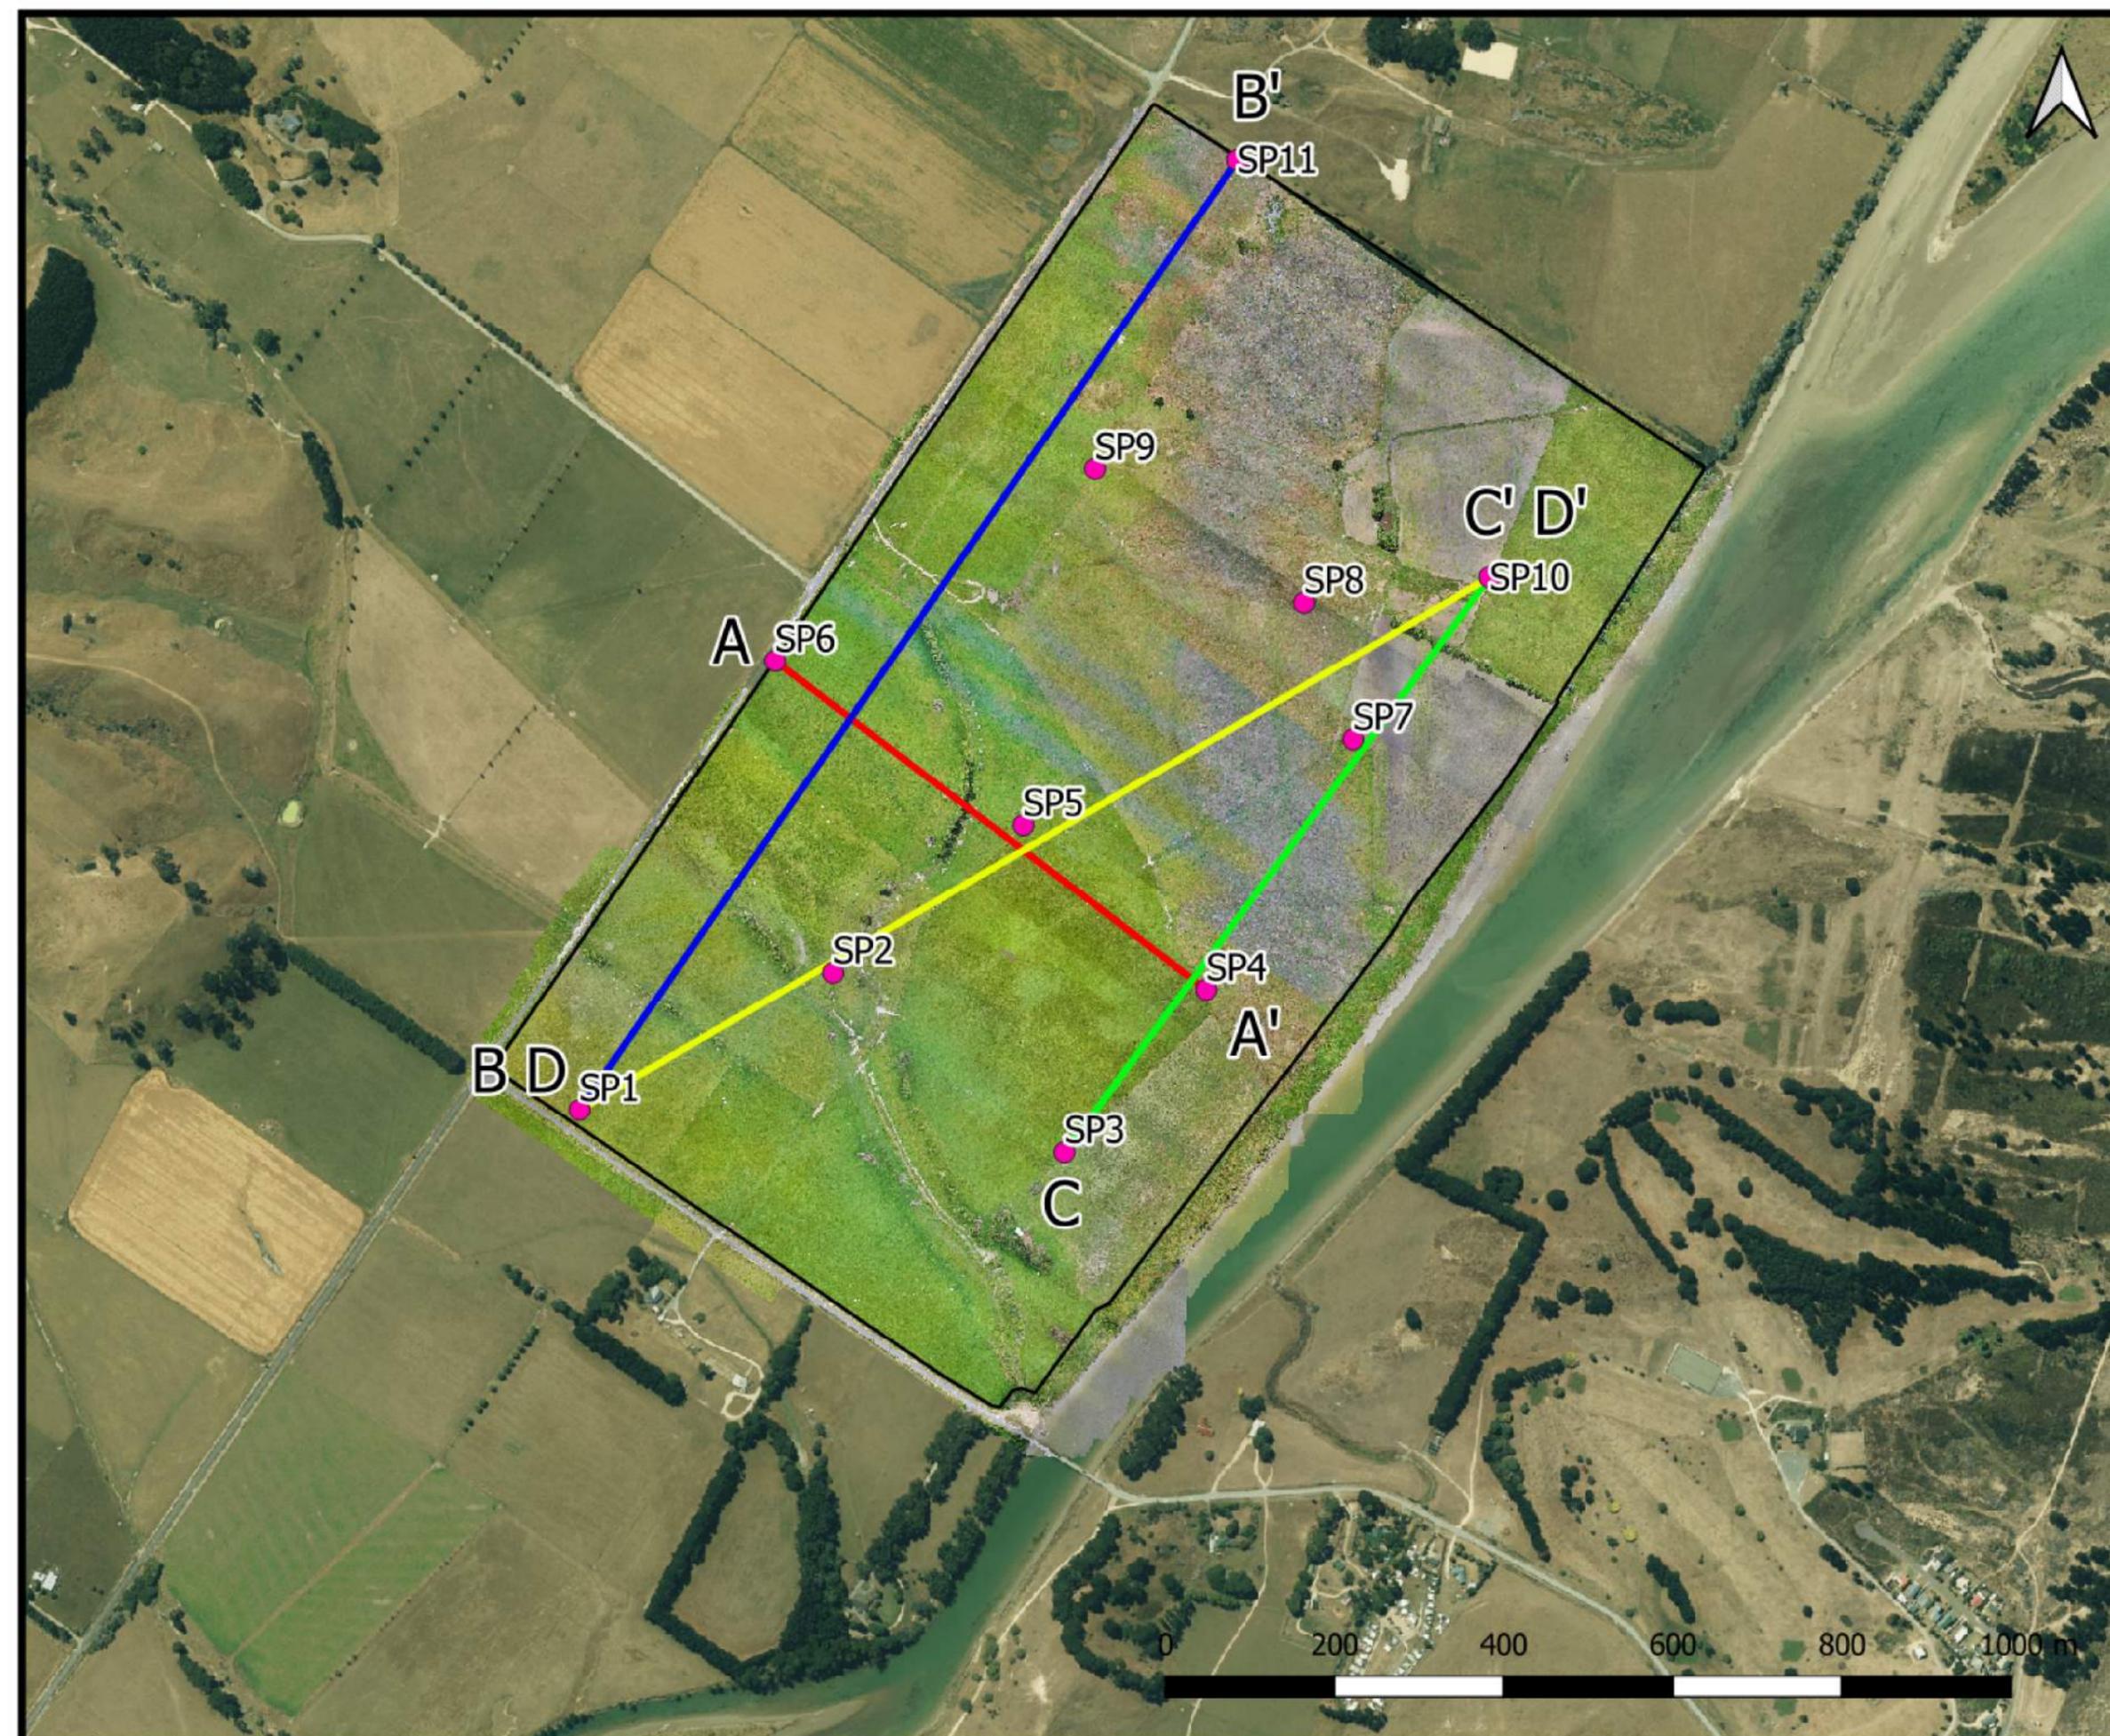
- Transect A
- Transect B
- Transect C
- Transect D
- Standpipes

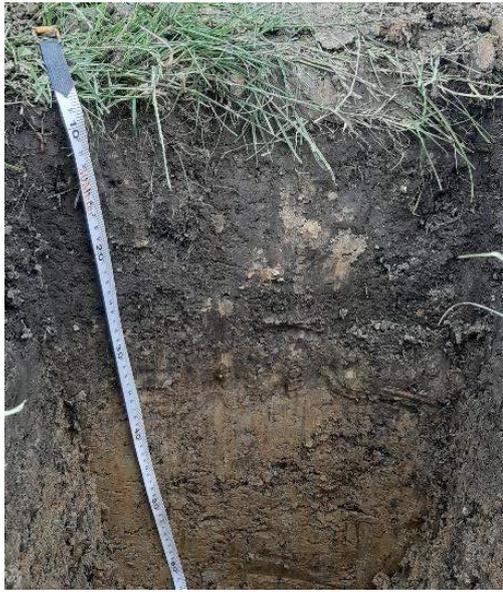
Soil	Kaiapo Silt Loam
Location	Site 1 - (5 Acres)
Drainage	Poorly drained (Smop, Landcare)
Topsoil depth (cm)	30 cm
Limiting horizon	None
Landform	Alluvial floodplain of the Porangahau River
Comments	Clay content appears to increase with depth within the subsoil layer.

Horizon	Depth (cm)	Description	Image
Topsoil	0-30	Brown (10YR 4/3) silty loam; no gravels; non sticky; slightly plastic; nut and crumb structure; fine roots to 40 cm; wavy, indistinct boundary (30-40 cm); cool; no mottles present

Subsoil	40-100	Strong brown (7.5 YR 5/6) & light gray (5YR 7/1) clay loam; no gravels; sticky; plastic; blocky structure; damp & cold; 20-30% mottles present (5YR 5/8)

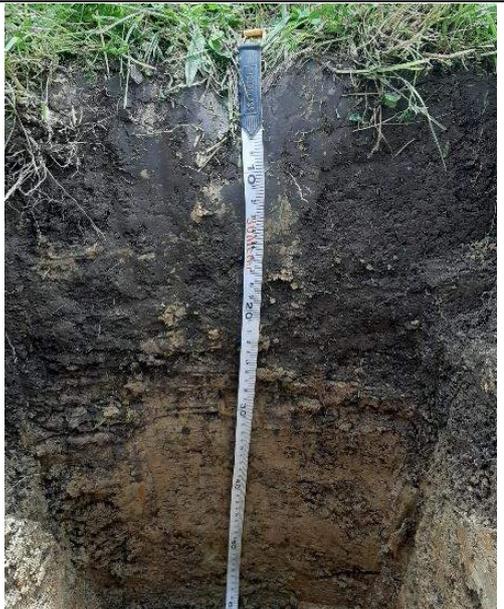
Soil	Kaiapo Silt Loam
Location	Site 2 – (Aerodrome)
Drainage	Poorly drained (Smap, Landcare)
Topsoil depth (cm)	20 cm
Limiting horizon	None
Landform	Alluvial floodplain of the Porangahau River
Comments	Clay content appears to increase with depth within the subsoil layer.

Horizon	Depth (cm)	Description	Image
Topsoil	0-20	Brown (10YR 4/3) silty loam; no gravels; non sticky; slightly plastic; nut and crumb structure; fine roots to 40 cm; wavy, indistinct boundary (20-35 cm); cool; no mottles present

Subsoil	35-100	Strong brown (7.5 YR 5/6) & light gray (5YR 7/1) clay loam; no gravels; sticky; plastic; blocky structure; damp & cold; 15% mottles present (5YR 5/8)

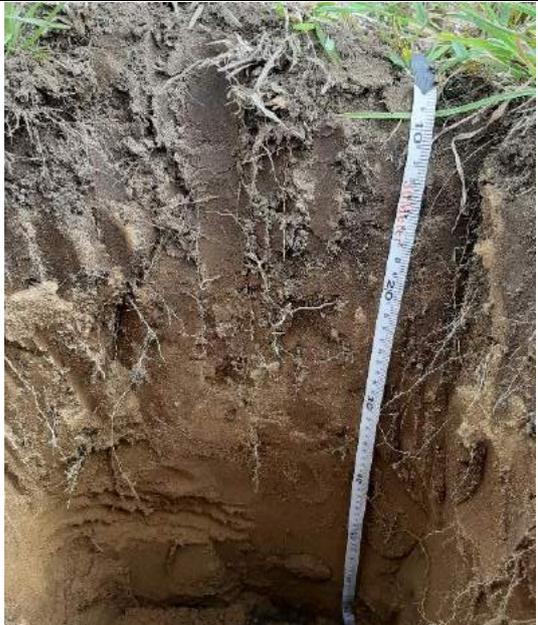
Soil	Kairaki Sandy Loam
Location	Site 3 – (Humps)
Drainage	Well drained (Smap, Landcare)
Topsoil depth (cm)	20 cm
Limiting horizon	None
Landform	Coastal sand dune overlying alluvial floodplain
Comments	No clay content noticed within upper 1 m of soil. Clay layer of the alluvial floodplain believed to be at equal elevation underlying this dune to Sites 1 & 2.

Horizon	Depth (cm)	Description	Image
Topsoil	0-20	Brown (7.5YR 4/2) sandy loam; no gravels; non sticky; non plastic; minimal structure, minor nut/crumb; fine roots to 45 cm; wavy, indistinct boundary (20-35 cm); cool; no mottles present

Subsoil	35-100	Brownish yellow (10YR 6/8) sand; no gravels; non sticky; non plastic; no structure; cool; no mottles present;

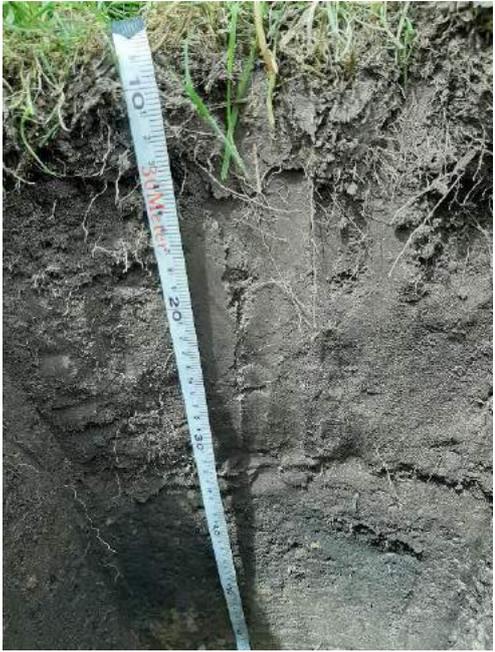
Soil	Kairaki Sandy Loam over clay
Location	Site 4 – (Far River)
Drainage	Well drained (Smap, Landcare)
Topsoil depth (cm)	35 cm
Limiting horizon	None
Landform	Alluvial floodplain of the Porangahau River containing wind blown sand.

Horizon	Depth (cm)	Description	Image
Topsoil	0-35	Dark brown (7.5YR 3/2) sandy loam; no gravels; non sticky; non plastic; minimal structure, minor nut/crumb; fine roots to 50 cm; wavy indistinct boundary (35-45 cm); cool; no mottles present

Subsoil	45-55	Black (10YR 2/1) silty loam; no gravels; non sticky; non plastic; nut/crumb structure; wavy distinct boundary (55-65 cm); cool; no mottles present	
Subsoil	65-100	Strong brown (7.5 YR 5/6) & light gray (5YR 7/1) clay loam; no gravels; sticky; plastic; blocky structure; damp & cold; 20-25% mottles present (5YR 5/8)

Located on the alluvial floodplain to the north-east, Site 4 contained the same clay layer as noticed for Sites 1, 2 and 5, however this was at greater depth. As with all other sites, the topsoil appeared to be relatively similar, with this closely reflecting that of Site 3. Variation for this location to other sites was the presence of a thin black layer between the topsoil and clay subsoil, representative of either a charcoal layer from a historic forest burn, or a former back dune peat swamp.

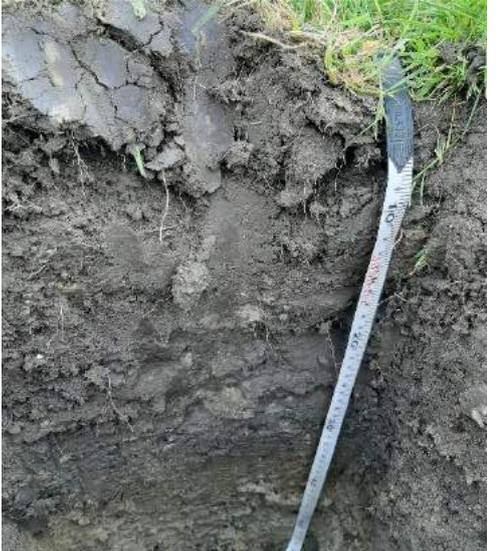
Soil	Kaiapo Silt Loam
Location	Site 5 – (Pump)
Drainage	Poorly Drained (Smap, Landcare)
Topsoil depth (cm)	30 cm
Limiting horizon	None
Landform	Alluvial floodplain of the Porangahau River
Comments	Clay content appears to increase with depth within the subsoil.

Horizon	Depth (cm)	Description	Image
Topsoil	0-30	Brown (10YR 4/3) silty loam; no gravels; non sticky; slightly plastic; nut and crumb structure; fine roots to 40 cm; wavy, indistinct boundary (30-40 cm); cool; no mottles present

Subsoil	40-100	Strong brown (7.5 YR 5/6) & light gray (5YR 7/1) clay loam; no gravels; sticky; plastic; blocky structure; damp & cold; 20% mottles present (5YR 5/8)

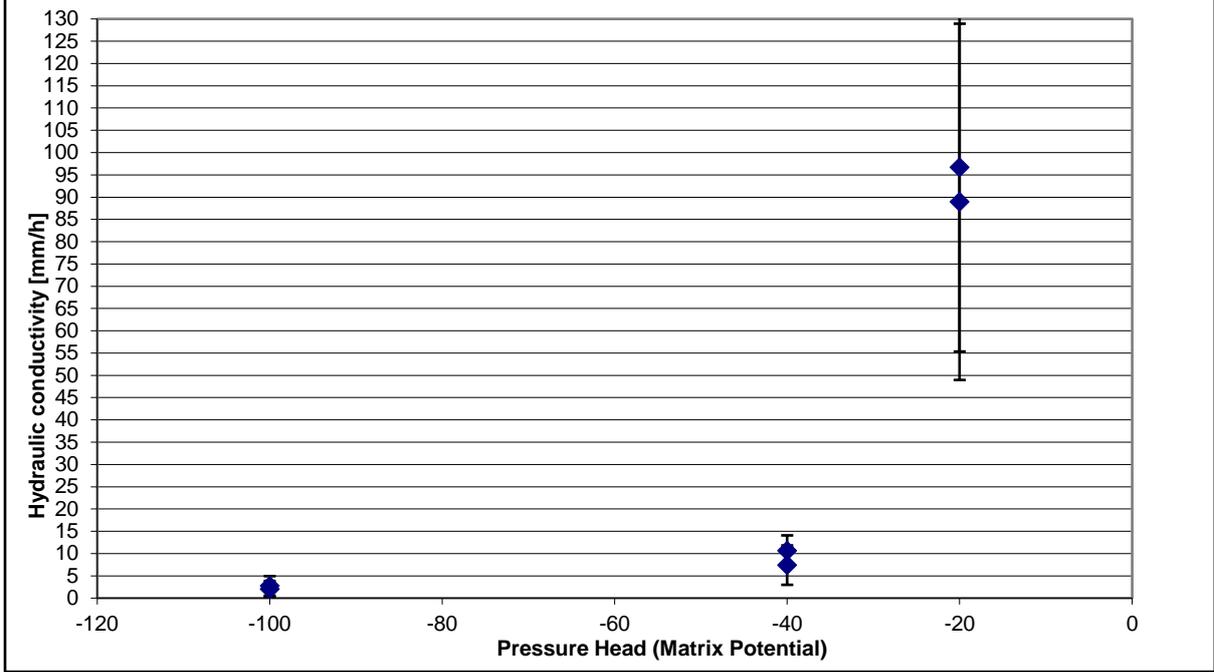
Unsaturated ($K_{-40 \text{ mm}}$) Hydraulic Conductivity Plots

For determination of the soils ability to receive wastewater to the soil surface at a low rate, soil unsaturated hydraulic conductivity ($K_{-40\text{ mm}}$) was measured using a CSIRO plate permeameter apparatus (Perroux and White, 1988). The permeameter method enables measurement of soil near-saturated hydraulic conductivity. Near-saturated soil conditions are favoured over saturated soil conditions in consideration of low rate application sites because:

The soil saturated hydraulic conductivity (K_{sat}) is 37 ± 28 mm/hr for clay sites and 106 ± 20 mm/hr for sandy sites. The unsaturated hydraulic conductivity ($K_{-40\text{ mm}}$) is 11 mm/hr for clay sites and 14 mm/hr for sandy sites. In order to avoid excessive loss of water, nutrients and other contaminants to adjacent surface water a rate more closely related to the $K_{-40\text{ mm}}$ is recommended. For long term discharge with a short irrigation return time a rate of up to 79 mm/d (for clay sites) and 101 mm/d (for sandy sites) is recommended for the Stoddart Farm Site.
