Pōrangahau Wastewater Discharge to Land - Ecology s92 Response (P:D.66a)

Further to the Hawkes Bay Regional Council (HBRC) letter dated 1 October 2021 in relation to resource consent application APP-126770, the following sets out our response to questions 41 – 47 raised under Section 92 of the Resource Management Act.

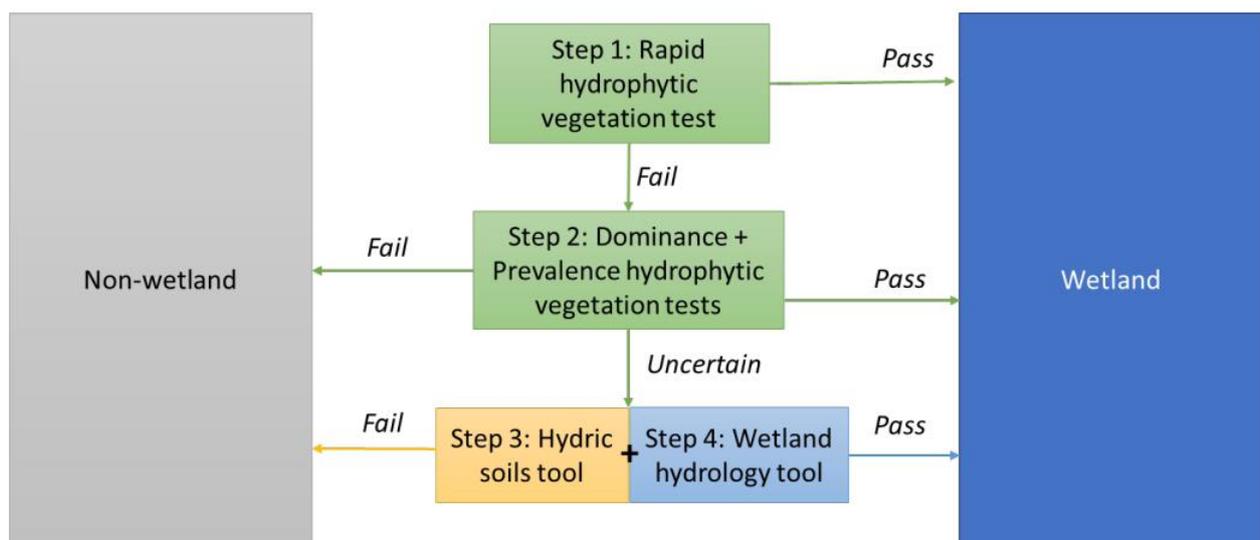
Figure 1. The sequence of steps for delineating wetlands using the hydrophytic vegetation, hydric soils and wetland hydrology tools (Ministry for the Environment, 2021)

Nevertheless, as the sites passed the dominance and prevalence vegetation tests, they would not require further clarification as they would be considered wetlands regardless (see Figure 1 below).

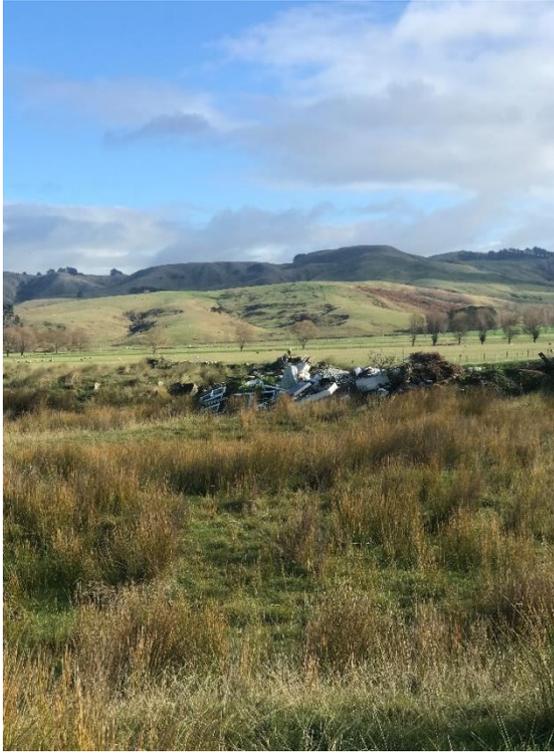
Site 3

Areas that had indications of visible soil saturation, or potential wetland vegetation (apparent low stature, grass, rushes and reed vegetation types) present in aerial imagery were mapped as potential wetlands. These potential wetlands were then investigated during the site visit in accordance with the Rapid Hydrophytic Vegetation Test. On inspection, sites 3-4 and 6- 11 were excluded on the basis of vegetation type (dune vegetation or dry pasture) and a lack inherent wetland characteristics (e.g. hydrology). Site 5 was also excluded on this basis having found to consist of planted riparian edge along a watercourse (See photos below).
