# **T:B.15 Evaluation of Soils Receiving Takapau Wastewater**

**Central Hawke's Bay District Council**

**L E W E**  
Environmental  
I m p a c t

December 2020

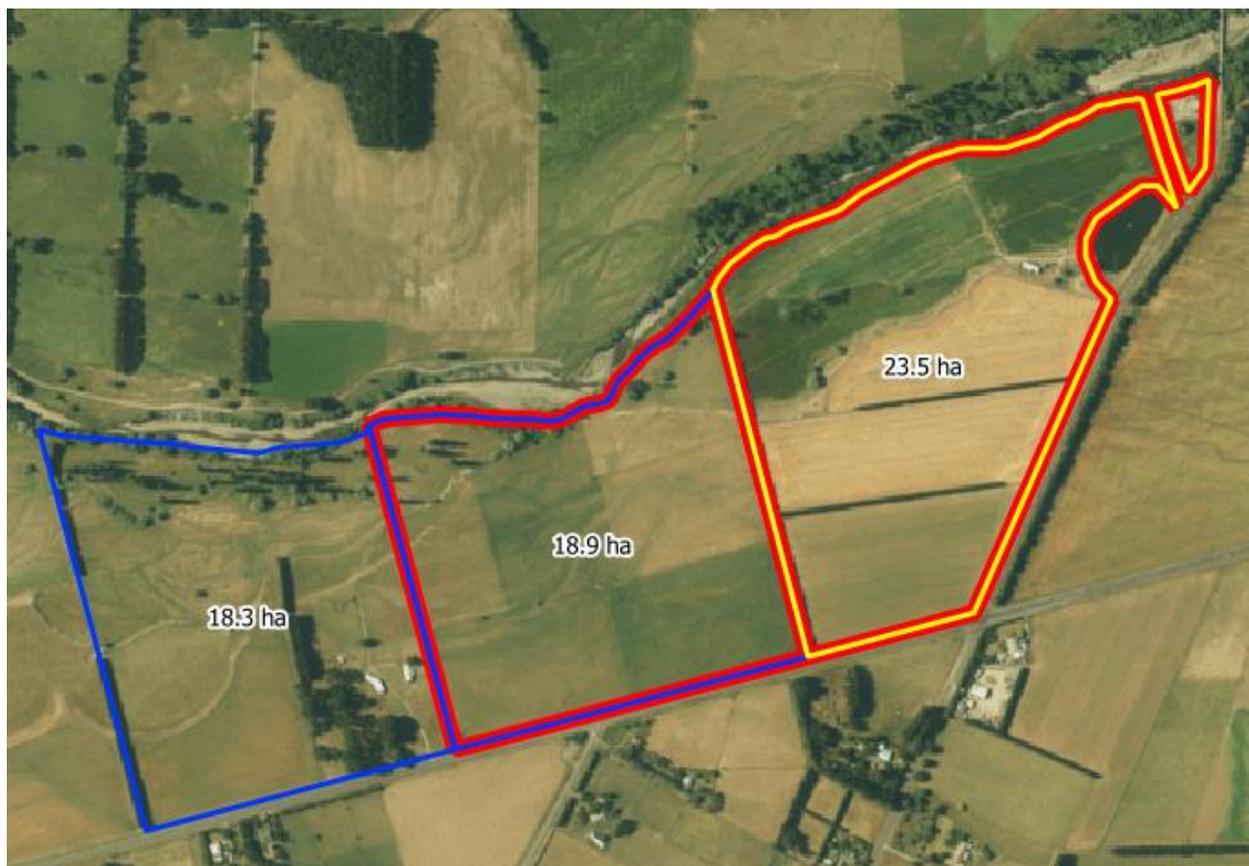
**Figure 3.1: Drummond Farm Site – Blue = Leased, Yellow = Owned, Red = Proposed Application Site**

Details of the owned and eastern leased parcel are provided in Table 3.1. Figure 3.1 represents the location of the three parcels operated by the Drummond's. The township of Takapau is located directly to the south. The yellow parcel outline represents the owned parcel, with blue parcel outlines representing the two leased parcels.

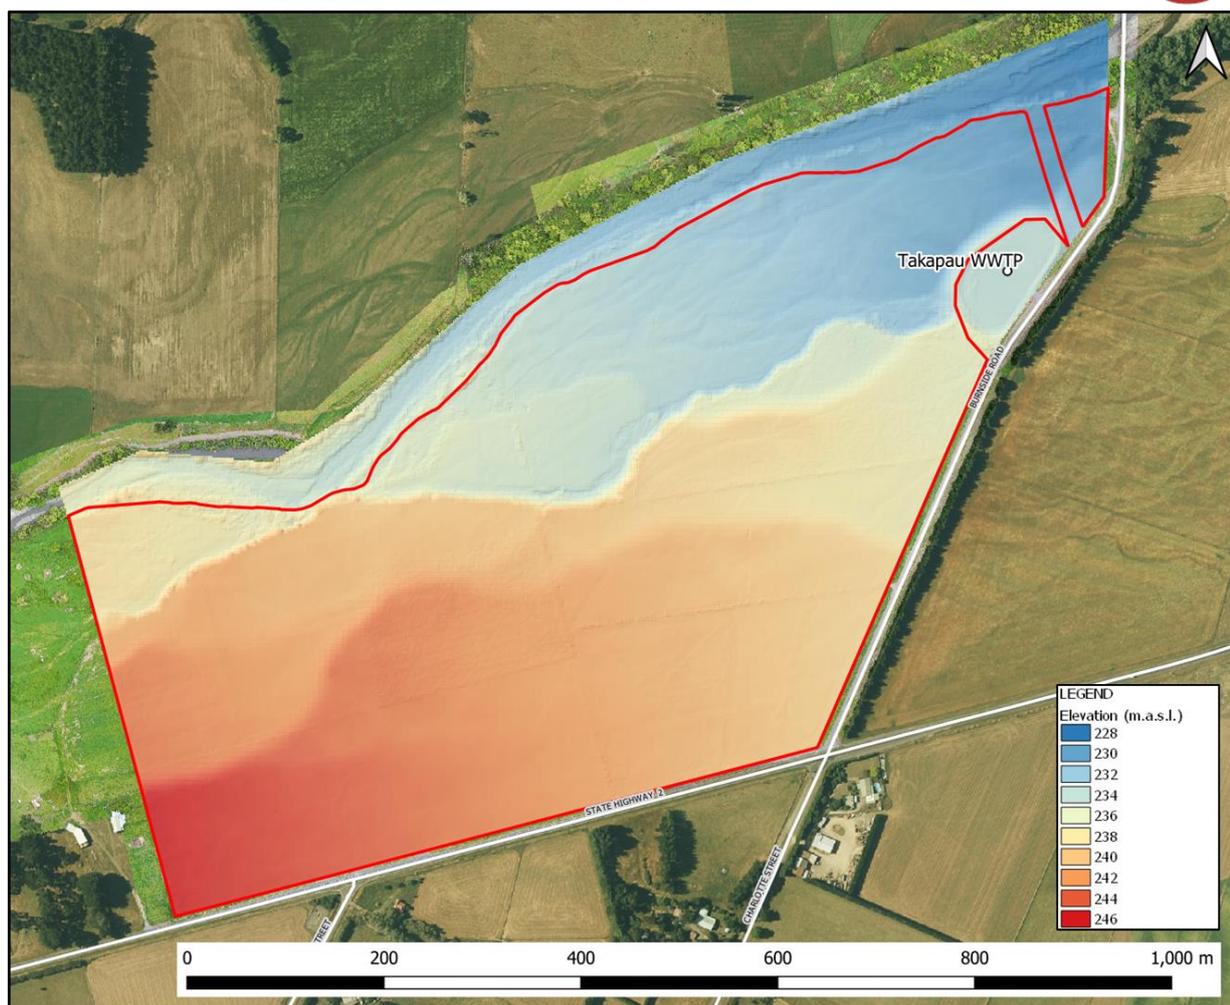
**Figure 4.1: Elevation Map of the Drummond Farm**

Across the property there appear to be the presence of four river terraces with two clear terraces distinguishable from elevation imagery (Figure 4.1). The lower terrace adjacent to the Makaretu River is clearly represented with this being elevated ~2 m above the river, with an elevation of between 230-236 m depending on location.

In Figure 4.1, blue regions represent lower lying elevations, with red/orange representing higher elevations.

The higher river terrace is located at an elevation of 238-246 m.a.s.l depending on location. When viewing through an elevation map, there appear to be two smaller, less noticeable river terraces that form this larger higher terrace. These terraces are difficult to notice from both aerial imagery and site investigations and are <2 m above the main higher terrace. It is likely that these older terraces may have undergone erosion and subsequently seem to blend into the landscape of this higher terrace.

The difference between the main upper and lower terraces is in the order of 4-6 m, with this difference represented through a steep slope that acts as a paddock boundary.

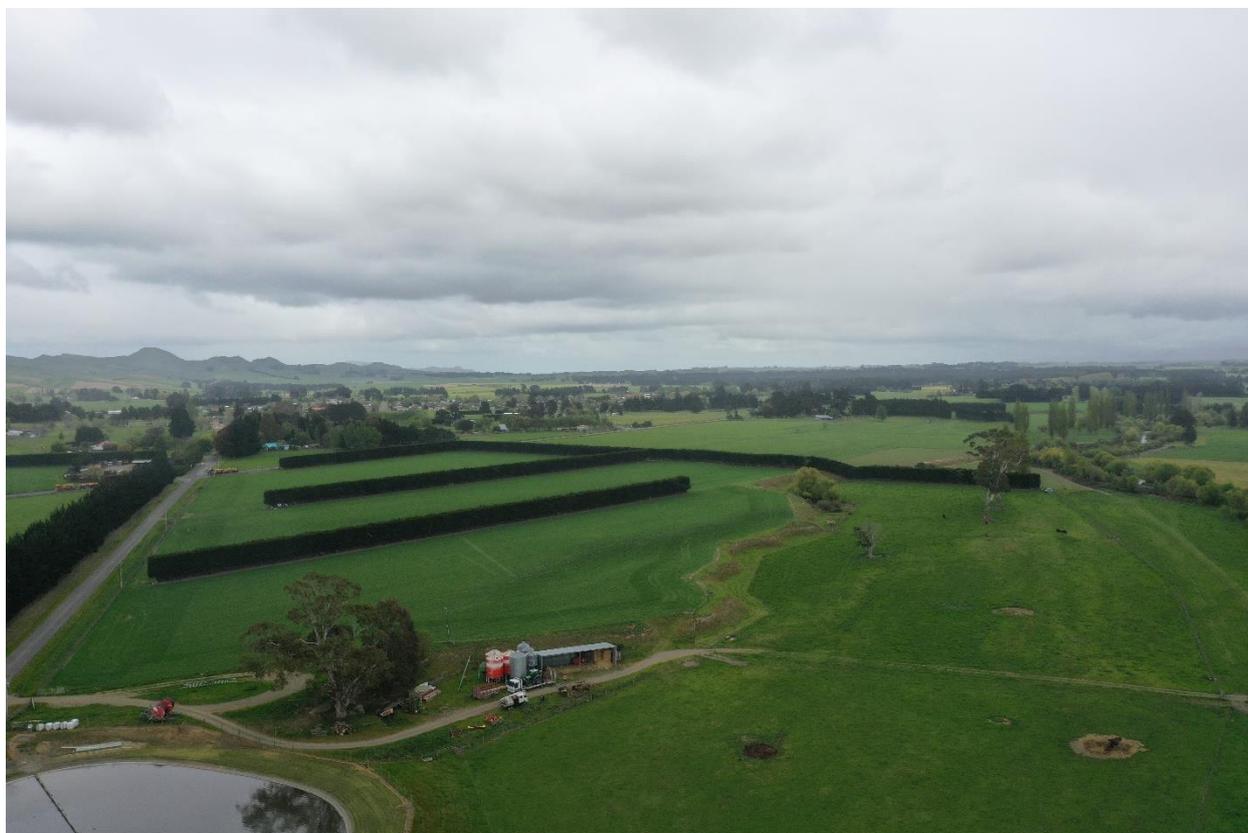
**Figure 4.2: Drummond Farm - NE looking SW**

As part of field investigations, aerial imagery for the owned and eastern leased parcels were captured using a drone. Captured imagery included photos, videos and a whole site flyover. Photos and videos were taken across the site to provide a better perspective of the site to what can be experienced on the ground. These photos and videos were also used to capture key features and supply visual resources to CHBDC. Figure 4.2 to Figure 4.5 shows the site from 80 m.

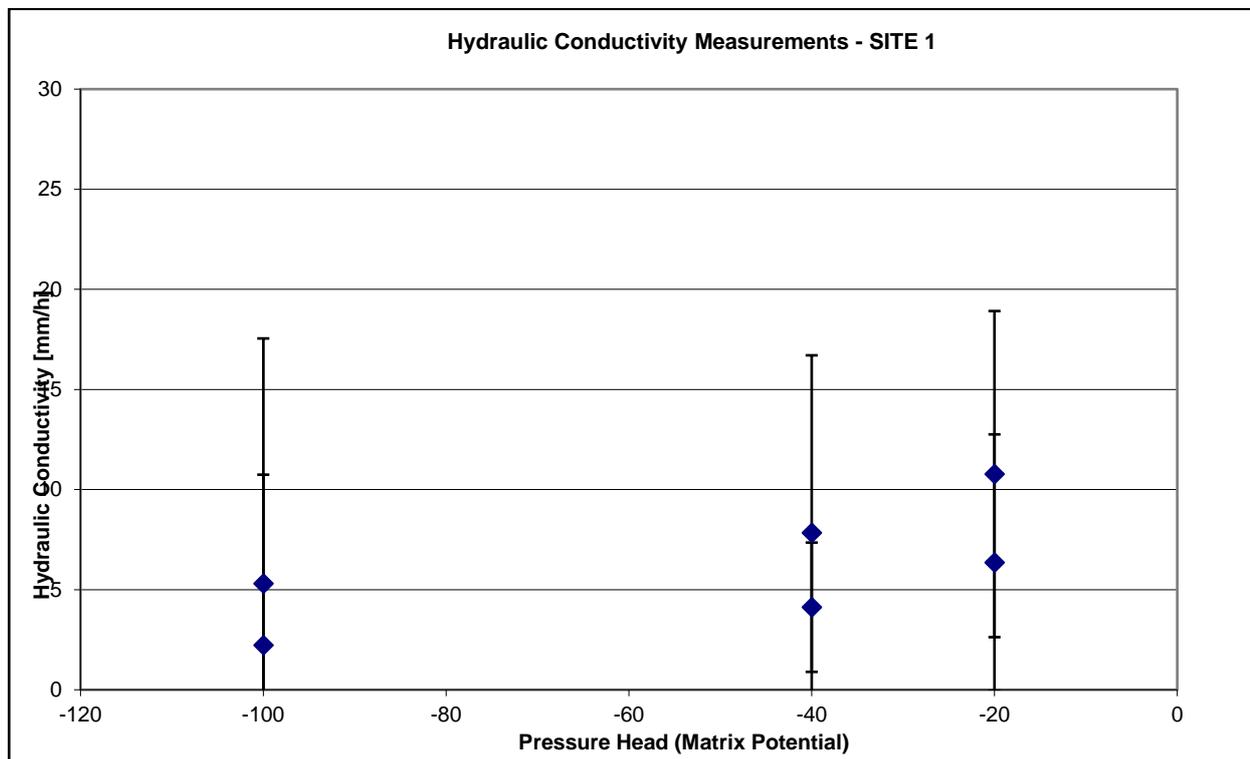
**Figure 5.1: Unsaturated Hydraulic Conductivity - Drummond Farm Site 1**

The plate permeameter tests were conducted in triplicate. Plots of the  $K_{-40\text{ mm}}$  results for each of the four locations on the Drummond Farm Site are given below in Figure 5.1 through to Figure 5.4. The plot shows the soil hydraulic conductivity at the three matrix potentials as mentioned in Section 5.3.2 above.

Based on both on-site, alongside desktop observations, it is considered that the  $K_{-40\text{mm}}$  value that should be adopted for the areas currently under pasture or that have not been cultivated within the current growing season should be 4 mm. For areas that have been cultivated within the current growing season (Site 2), a  $K_{-40\text{mm}}$  of 9 mm should be adopted. Any irrigation applied to the site should be at a rate that does not exceed these respective volumes depending on the cultivation history.

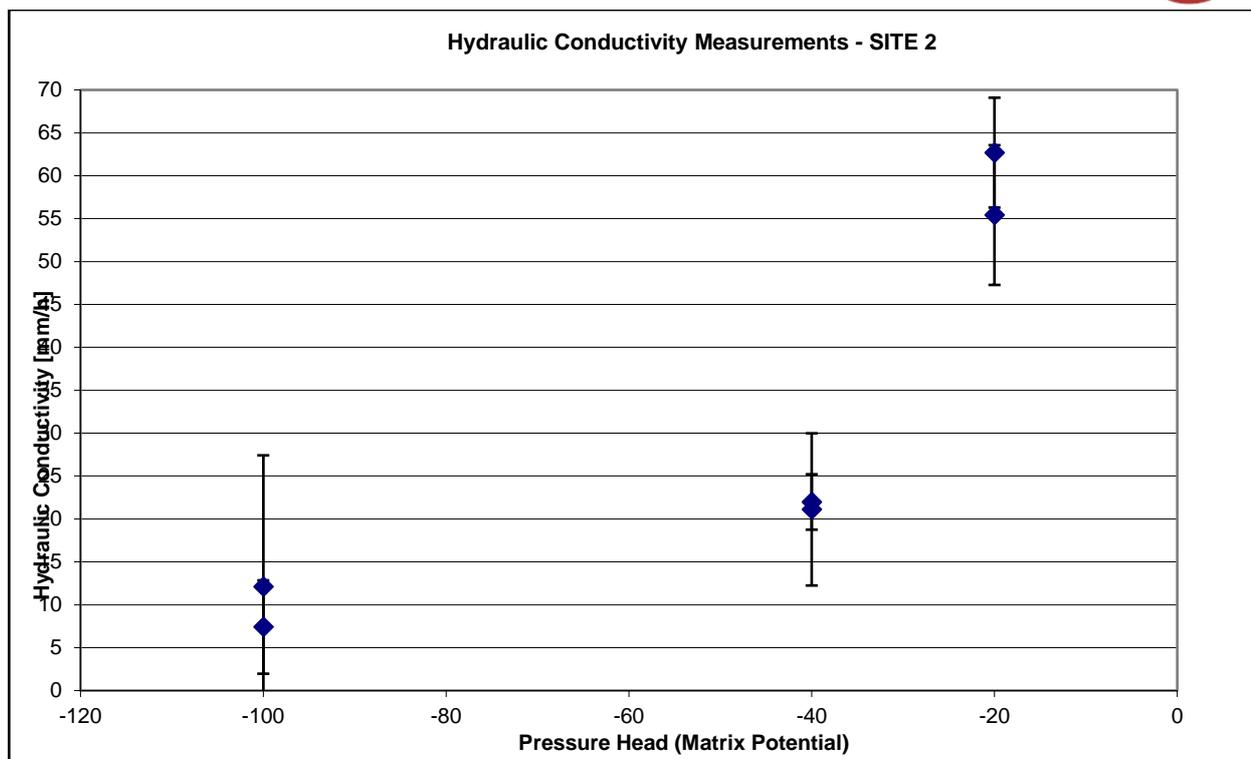
**Figure 5.2: Unsaturated Hydraulic Conductivity - Drummond Farm Site 2**

Site 2 below recorded the highest unsaturated hydraulic conductivity results due to the recent cultivation and sowing of the barley crop. This increase is to be expected and simply reflects the disturbance of the soil during cultivation, thus increasing the quantity of larger sized pores, thus increasing the conductivity shown below in comparison with other sites. It is likely that this value will reduce over time in no further cultivation occurs.

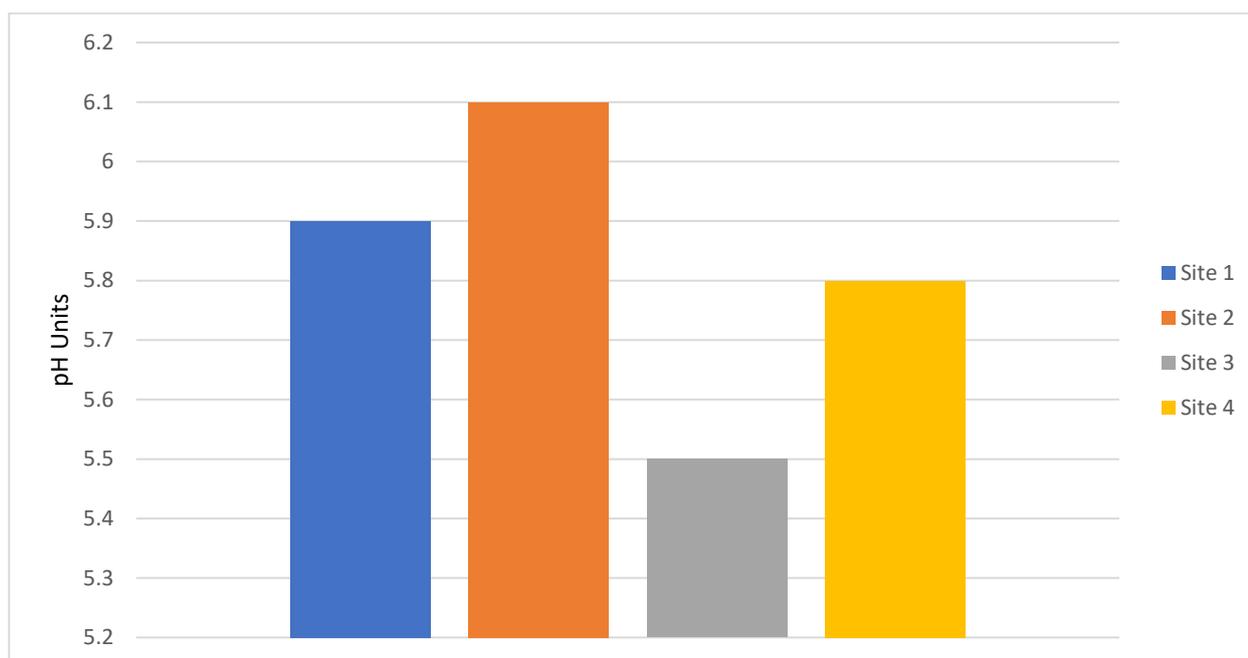
Figure 6.1: Soil pH Results

A plot of soil pH results is represented within Figure 6.1. From this, it is evident that all four sites contain slightly acidic topsoils ranging between 5.5 to 6.1 pH units. Site 3 contains the most acidic topsoil at 5.5 pH units, with Site 2 (currently in barley) containing the least acidic topsoil at 6.1 pH units. The medium pH range for a sedimentary soil underlined by Hills Laboratories is between 5.8 and 6.2 pH units. As evident, Site 2 falls outside this range with the remaining three soils all being within this range.

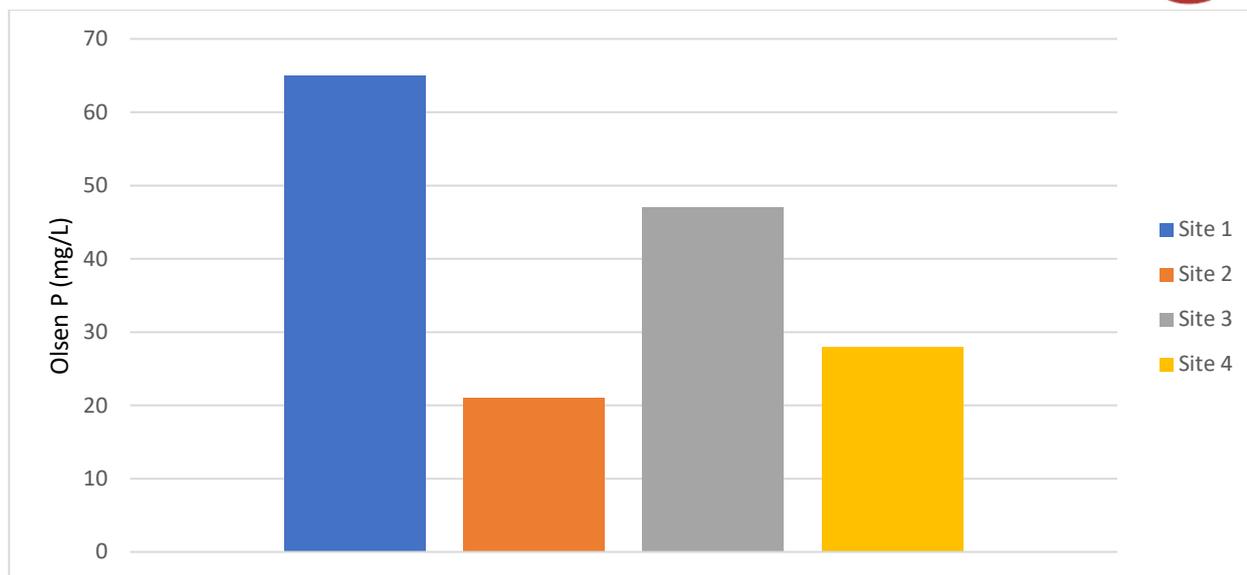
**Figure 6.2: Soil Olsen P Results**

A plot of Olsen P and Anion Storage Capacity ("ASC") results are represented within Figure 6.2 and Figure 6.3 respectively. For a sedimentary soil, the medium range for Olsen P is between 20-30 mg/L. From this figure, the lower terrace of Site 1 contains elevated concentrations of phosphorus at 65 mg/L, alongside Site 3 at 47 mg/L. Sites 2 and 4 are both within the medium range.

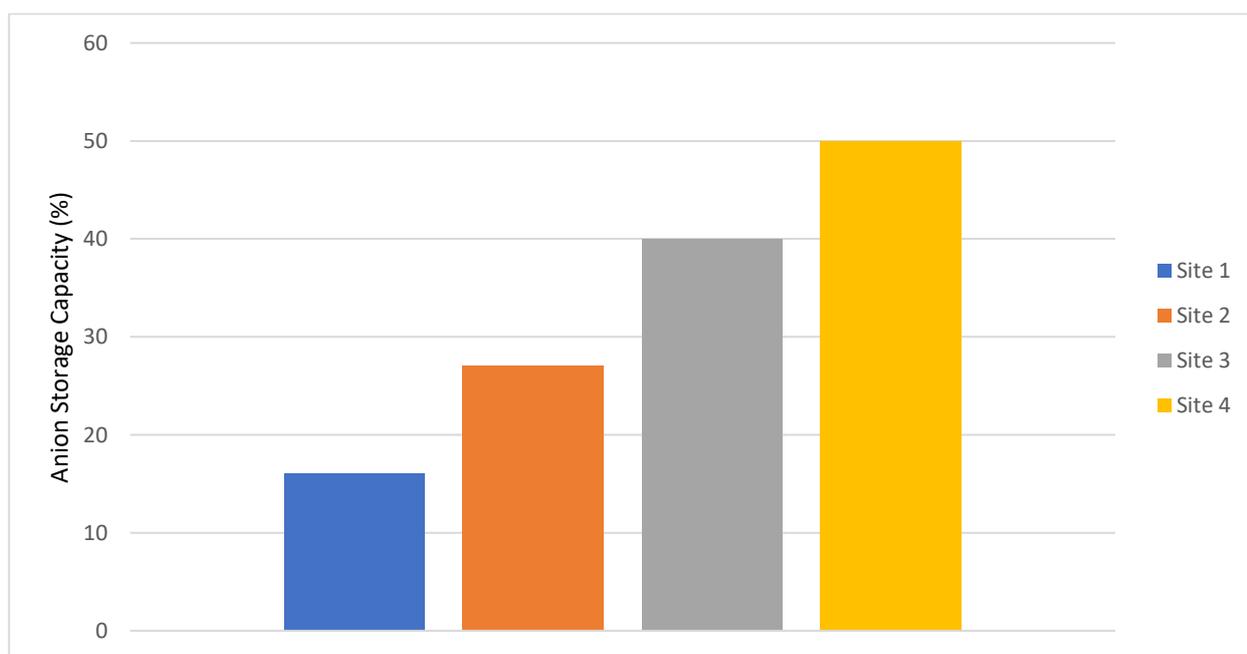
**Figure 6.3: Anion Storage Capacity Results**

From Figure 6.3, there is clear evidence that Sites 3 and 4 located on the leased Drummond property, contain higher ASC values than those on the owned Drummond parcel. For Sites 1 and 2, ASC values are classed as being low, with Sites 3 and 4 described as having medium ASC values according to Hill Laboratories typical levels (Hills Laboratories). Between these two figures, there does not appear to be a clear relationship between Olsen P and ASC. This can be represented through Site 1 for example where the site has an elevated Olsen P value, however it also has a low anion storage capacity of 16%. This is not unexpected since Olsen P is impacted by the fertiliser history of the site whereas the ASC is largely related to the soils mineralogy. The presence of allophane in the subsoil of the Takapau soils may result in higher ASC in the subsurface environment.

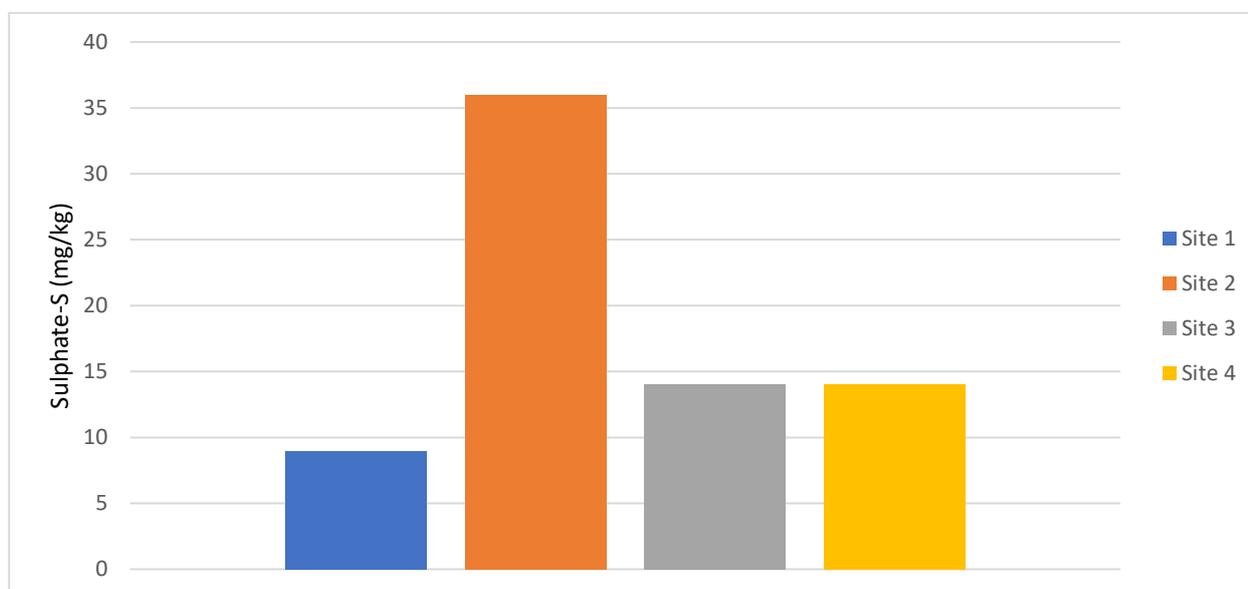
**Figure 6.4: Sulphate-S Results**

Sulphate-S results are represented within Figure 6.4 below. For all four sites, sulphate-S samples all fall outside of the medium range of 10-12 mg/kg for pastured sites and 10-15 mg/kg for cropped sites. From this, it is evident that Site 1 is below and Sites 3 and 4 are both slightly over the medium range for pasture. Site 2 contains elevated sulphate-S concentrations.

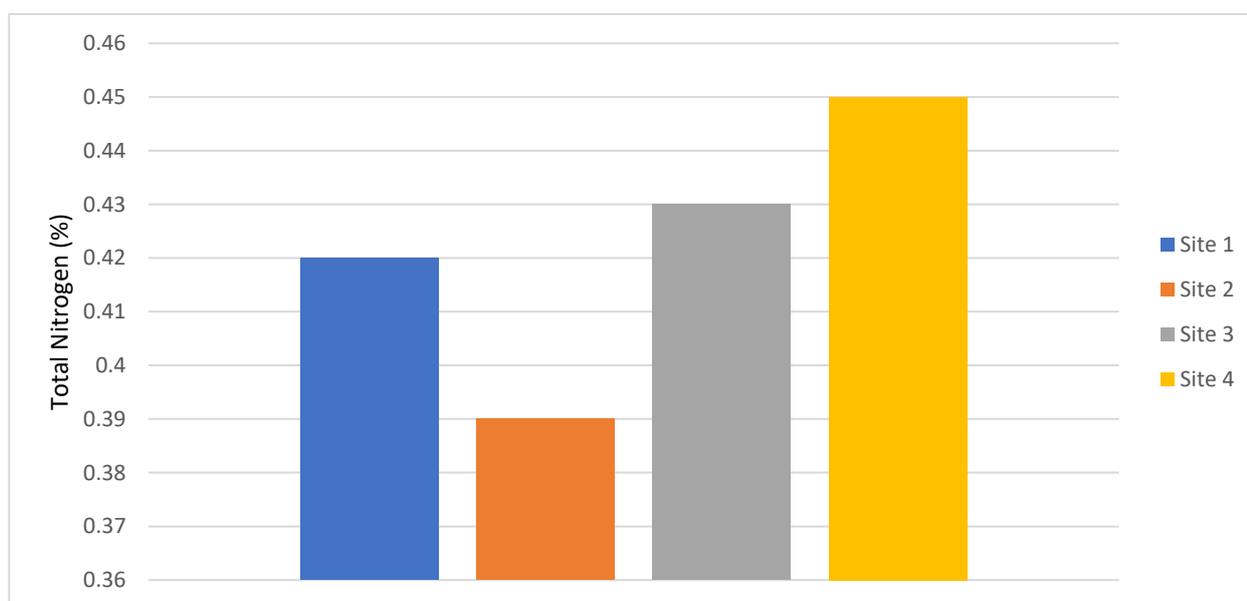
**Figure 6.6: Total Nitrogen Results**

From Figure 6.6, soil nitrogen concentrations are all relatively similar throughout the site. These concentrations vary between 0.39% at Site 2, to 0.45% at Site 4. When comparing these values to those underlined by Hill Laboratories, these soil nitrogen concentrations are representative of a medium value within soil (0.2 - 0.5% Total Nitrogen) (Hills Laboratories, n.d.).

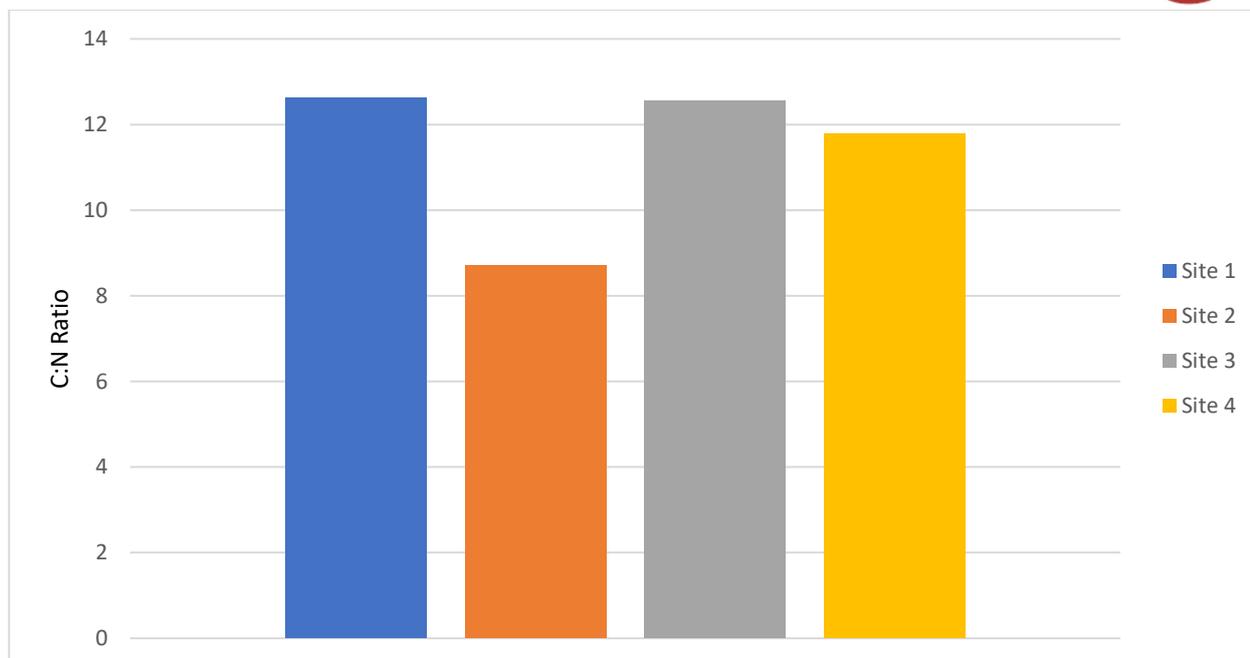
**Figure 6.7: C:N Ratio Results**

Figure 6.7 represents the C:N ratios for each of the sites. These values vary between 8.7 and Site 2, and 12.6 at both Sites 1 and 3. When comparing these values with those underlined by Hill Laboratories, it is evident that for Site 2, the C:N ratio is classed as low (8-10), and for Site 1, 3 and 4, this is classed as medium (10-15).

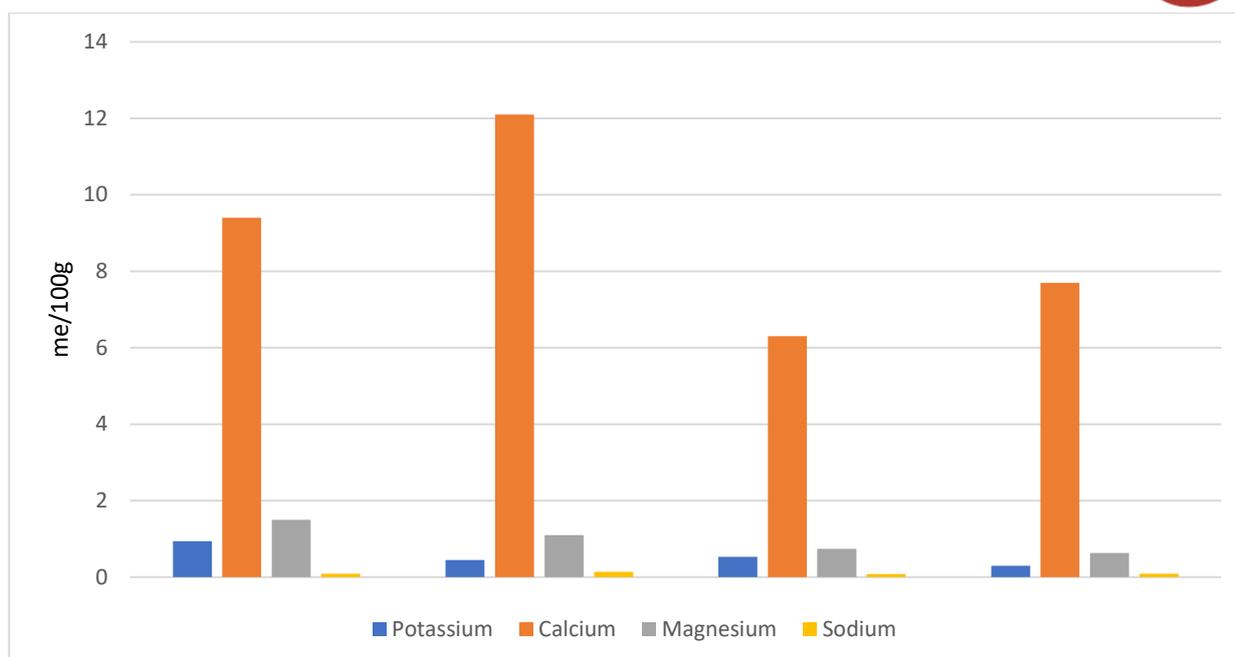
**Figure 6.8: Exchangeable Cation Results**

Magnesium concentrations range between 0.63 me/100 g (Site 4) and 1.5 me/100 g (Site 1). For medium ranges, these are between 0.4-0.6 me/100 g for pasture and between 0.6-1.2 me/100 g for cropping. For pastured sites, each of these three are above the Hills Laboratories range. Site 2 for cropping is between the designated medium range.

Sodium concentrations range between 0.08 me/100 g (Site 3) and 0.14 me/100 g (Site 2). There are no designated medium ranges for exchangeable sodium by Hill Laboratories however the current level are not considered to be an issue for plant growth and do not indicate any risk from irrigation of clean or enriched water.
