APPENDIX F Archaeological Memorandum

Transport Rebuild East Coast

Historic Heritage Management Advice

To: Nick Beattie
From: Andy Brown
Cc: Rebecca Benham
Date: 25/09/2025
Project Area: BR217 River Berm Works
Fault ID: BR217

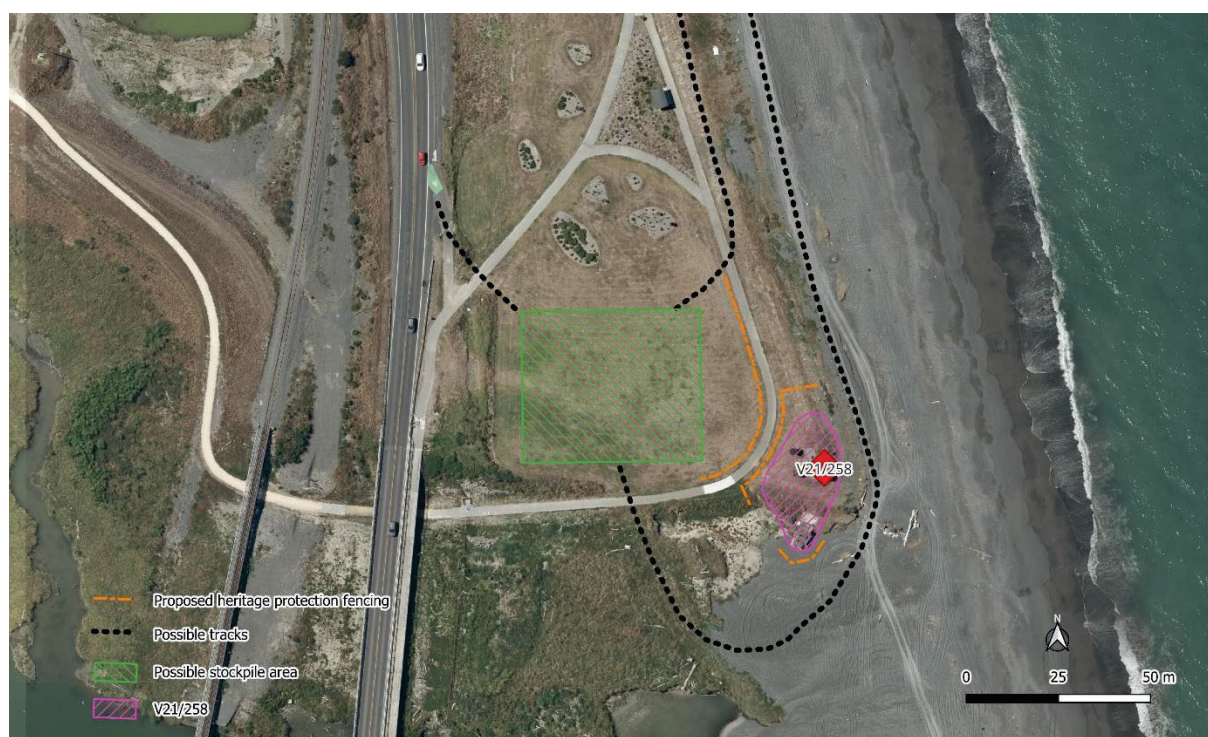
Figure 1 – Location of proposed access (black dotted lines) near V21/258 (LINZ, ArchSite).

No recorded historic heritage places or memorials are recorded within 50m of silt/slash removal works. However, the eastern access track and potential stockpile area are located within 50m of V21/258 (Figure 1, 2), a buried pill box associated with WWII coastal defence. Due to its post-1900 date the structure is not protected by the Heritage New Zealand Pouhere Taonga Act (2014) but has considerable heritage value, particularly in the context of the wider network of coastal defence sites. Therefore, every effort should be made to ensure the site is not adversely affected by works.

The proposed eastern access route will make use of informal beach tracks, which are approximately 10m removed from the recorded pillbox site (Figure 1 and 4). The possible laydown area is proposed to the north and west of the cycle/walkway running just to the west of the pillbox. This ensures a minimum 10m offset from the site.

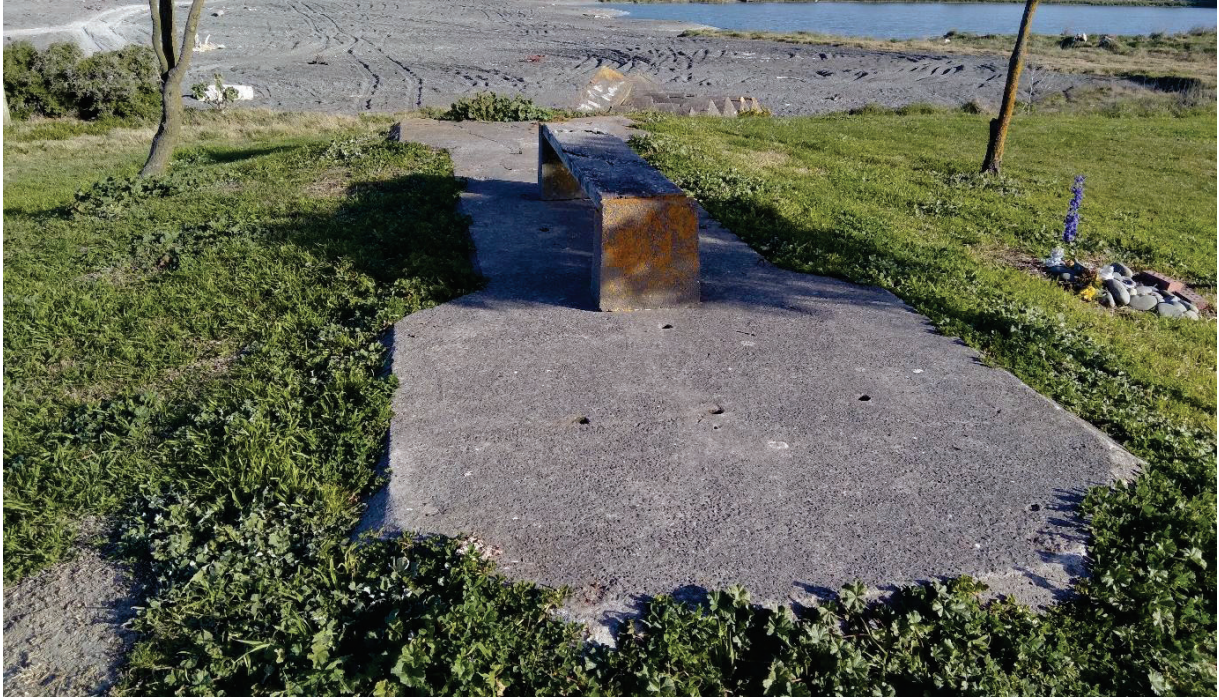
Figure 2 – The top of the pillbox.

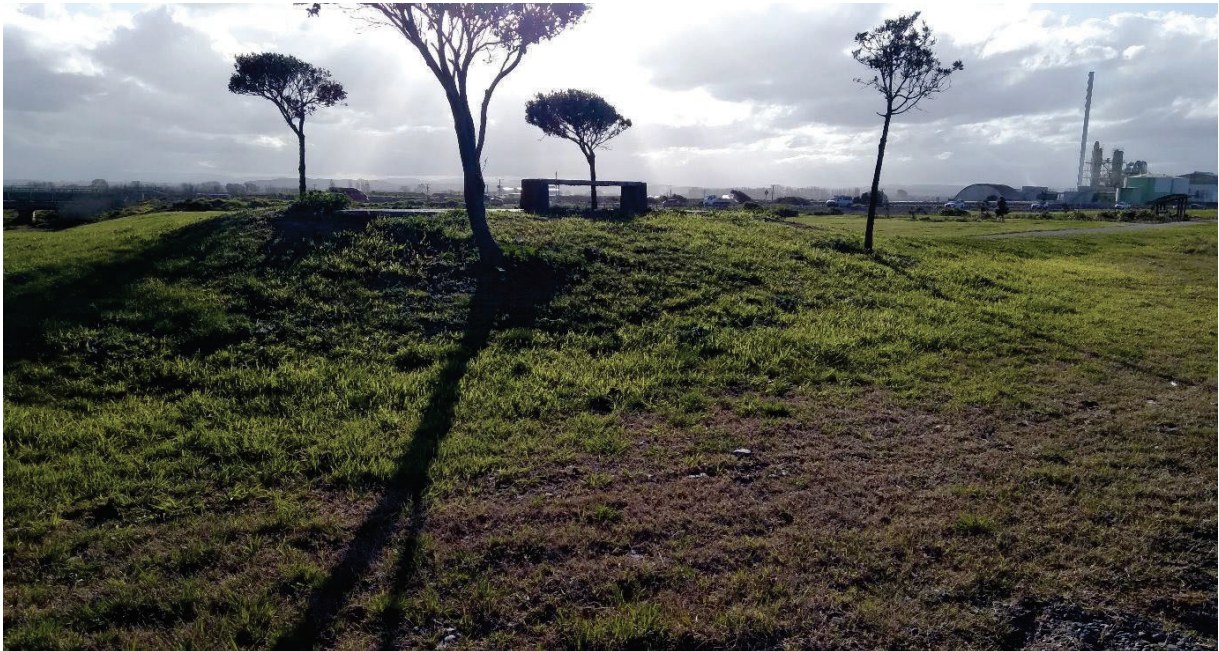
Figure 3 – West-facing image looking inland toward the pillbox (buried). The seat on the top of the pillbox is visible at the top of the mound.

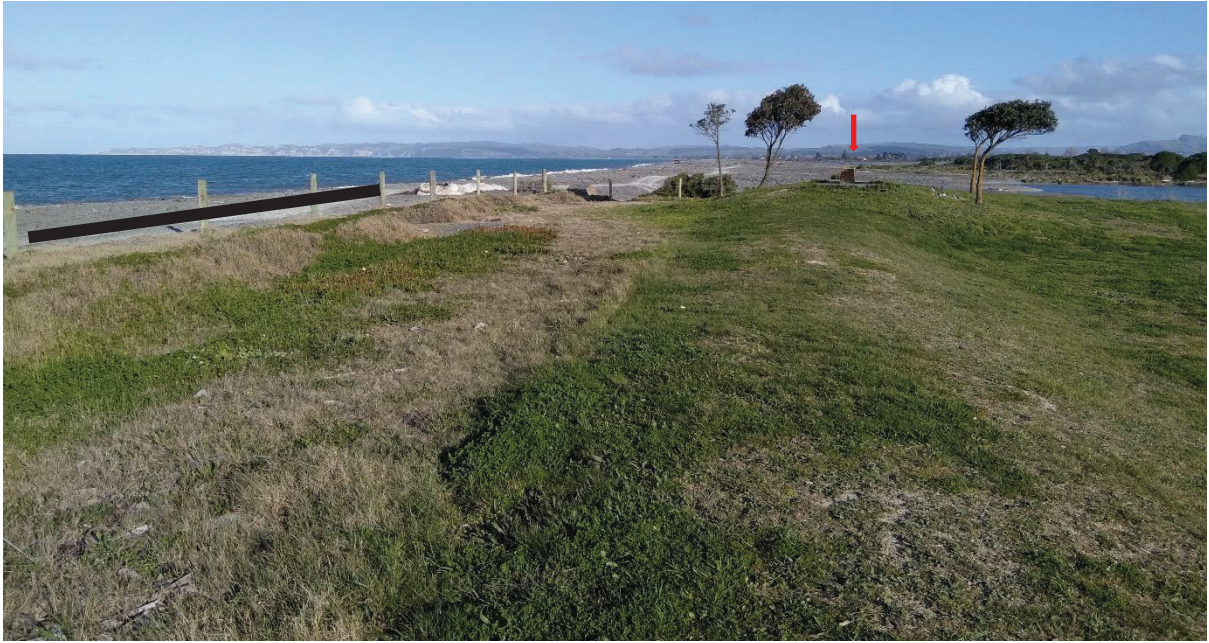
Figure 4 – The proposed access track (black line) and the location of the pillbox (red arrow).

The post-1900 pillbox (V21/258) is not subject to the provisions of the Heritage New Zealand Pouhere Taonga Act¹ and planned works will not affect the site. However, machine movements and activity in the area have the potential to affect the site if not properly managed. Therefore, it is recommended that fencing systems are used to exclude vehicles from the pillbox area. It is proposed that a small length of fence be placed south of the pillbox on the beach. It is also proposed that a length of fence be placed along the outside of the cycle path (including small lengths to cut off the headland area) and on the inside of the path. This arrangement would result in a clear barrier and the establishment of a minimum 10m buffer from the pillbox.
