# Awatoto Bridge 217

## Ecological Report Summary

Document Number [C5001-02-577-12000-EW-PP-TREC-000001] **(REQUEST VIA DOCUMENT CONTROL)**

### Transport Rebuild East Coast

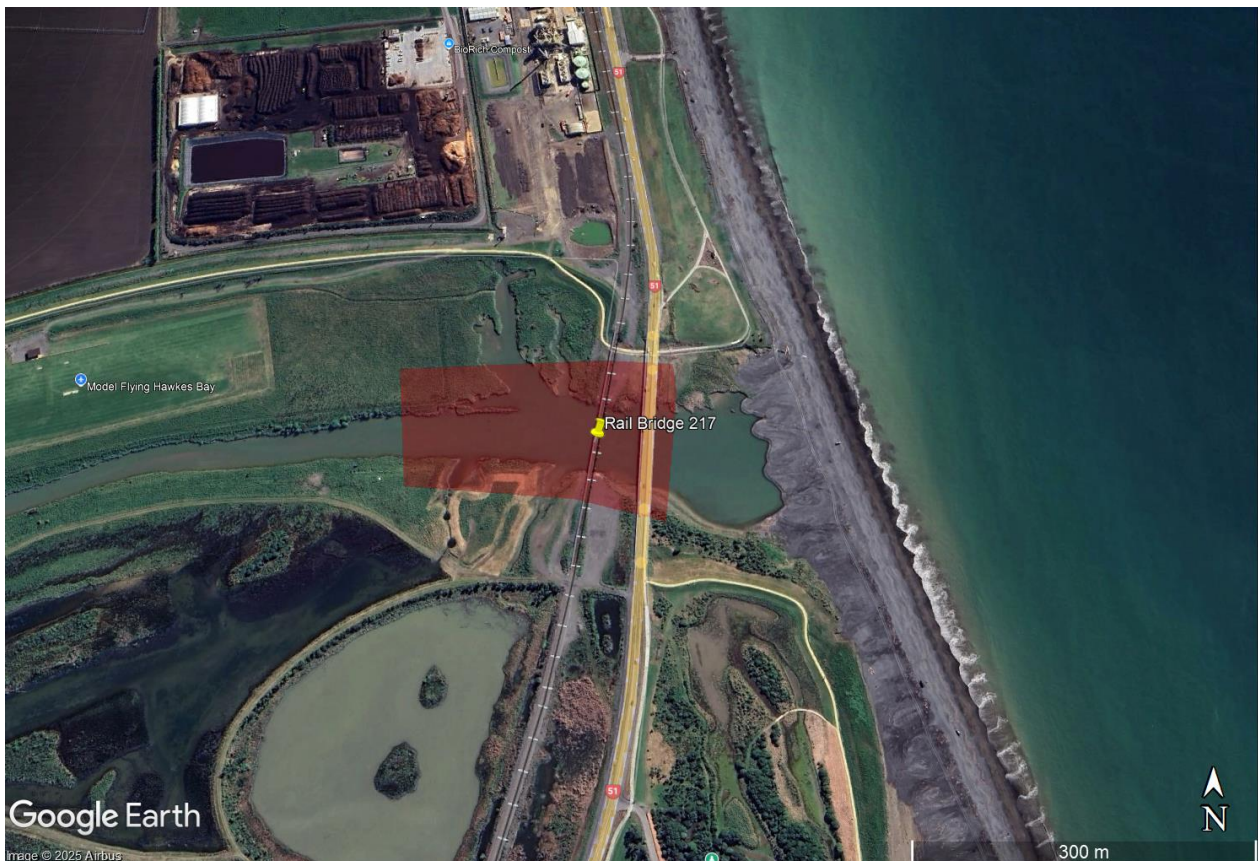
Figure 1. An image of the potential site, in red, with the rail bridge 217 pinned.

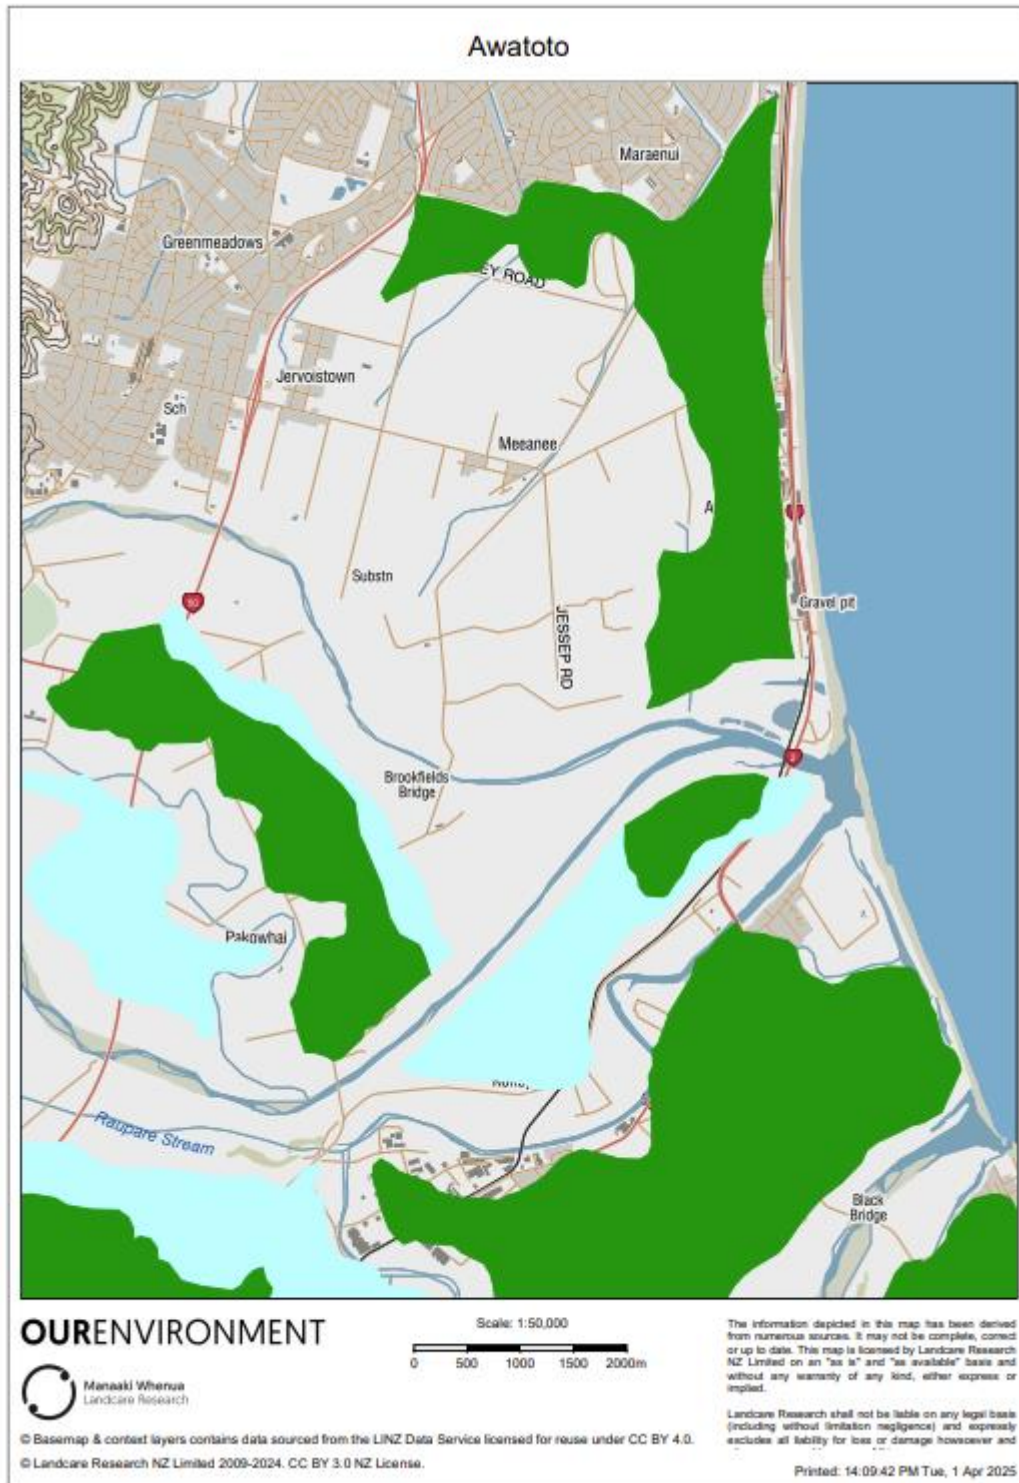
Figure 2. Pre-human wetlands. Areas overlayed in blue signify marshland, areas in green signify swamp.

The search of MfE's Pre-human wetland layer found the wider area to contain multiple wetlands (Figure 2), however none within the area of interest. The MfE wetland extent layer also identified no wetlands within the proposed impact area.

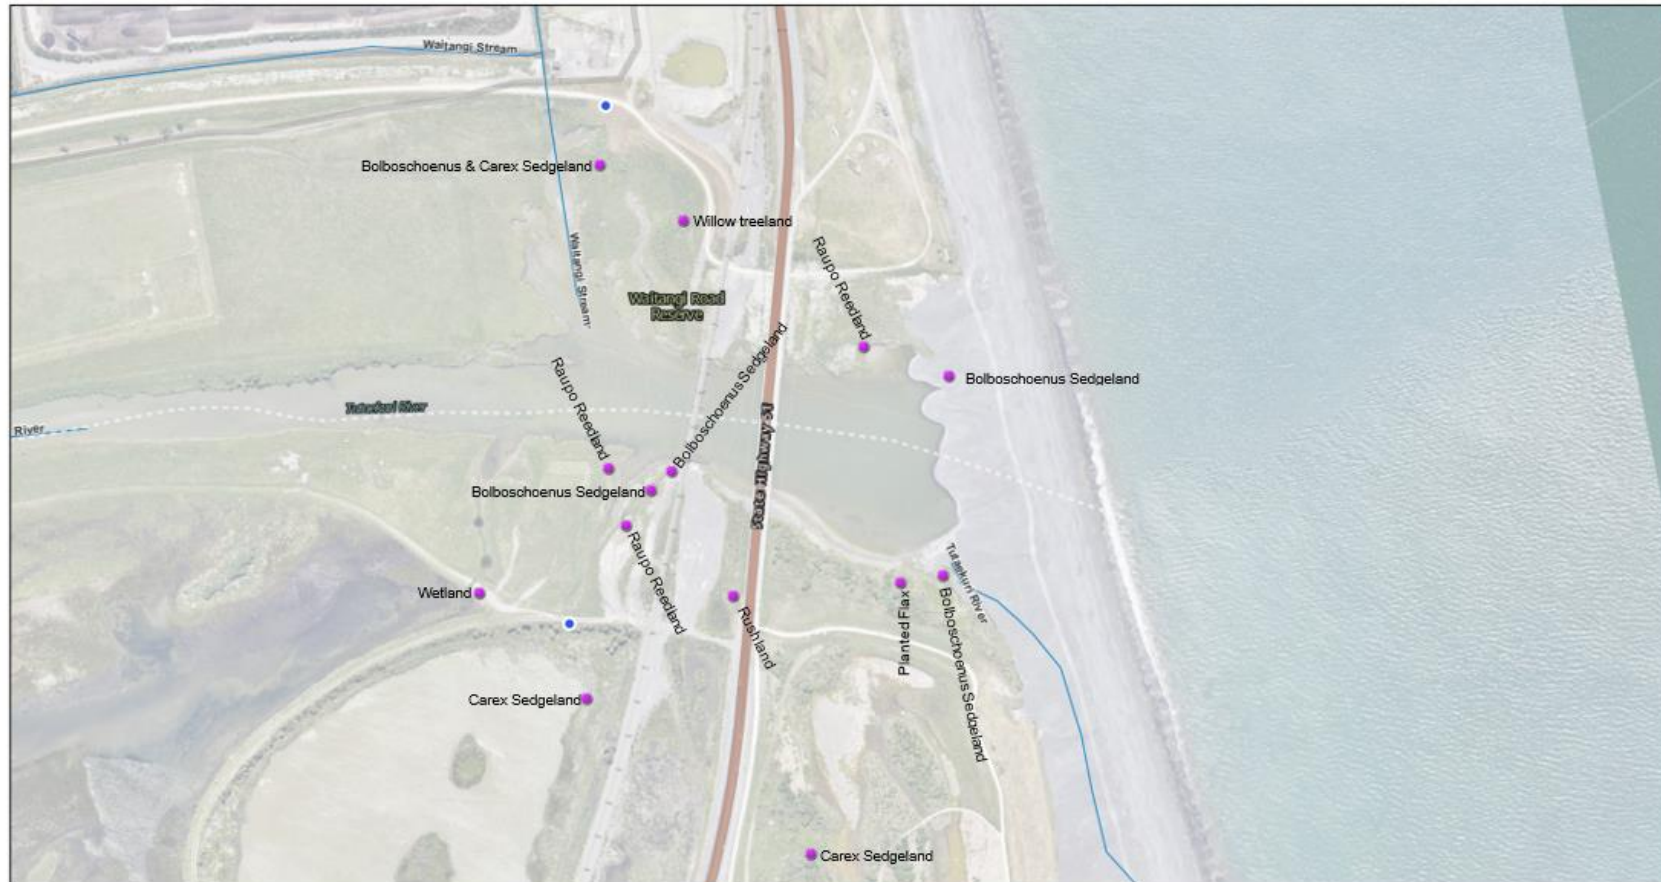
Ecology Region Field Maps

Figure 3. Ecology Region Field map

During the site visit the fourteen wetland areas were noted within the works area or its 100m buffer (Figure 3). These wetlands were all dominated by common native or exotic species. The different wetland types found are described in Table 1 below. Representative photos are provided in Figure 4 showing examples of each of the wetland types.

The wetlands shown in Figure 3 met the criteria outlined in the rapid tests for Natural inland wetlands. The wider area was a mixture of common and exotic species and included many areas of recent restoration plantings.

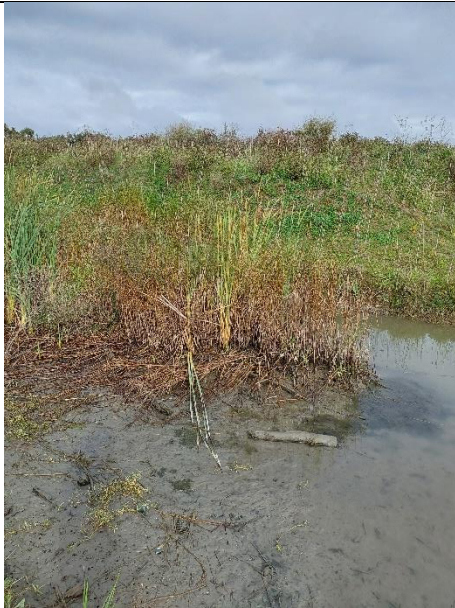
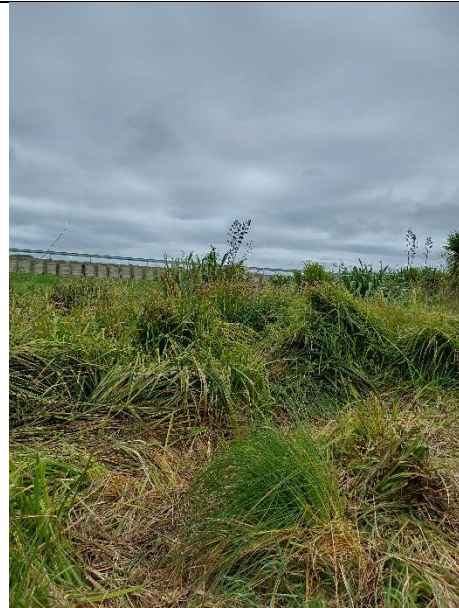
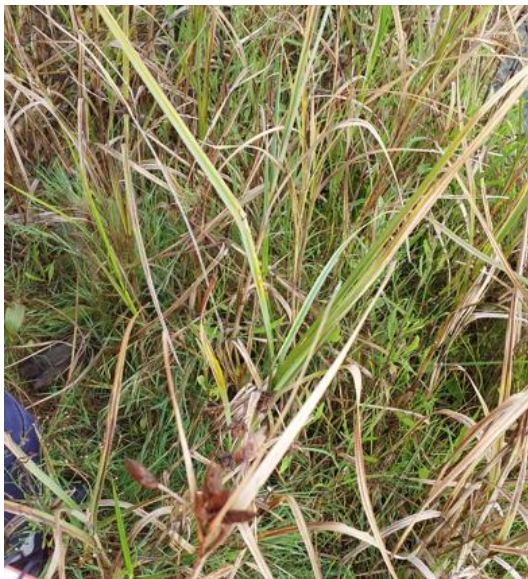
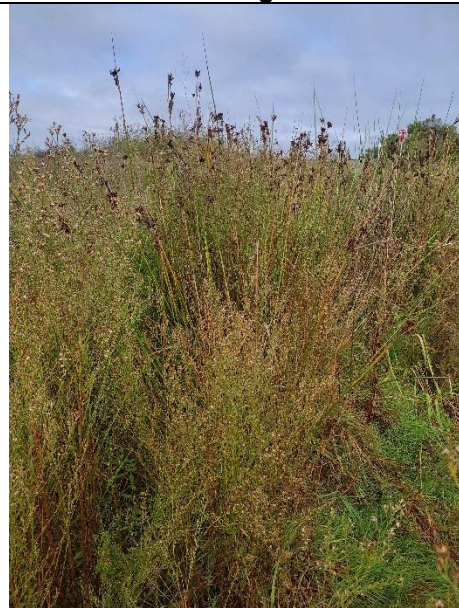
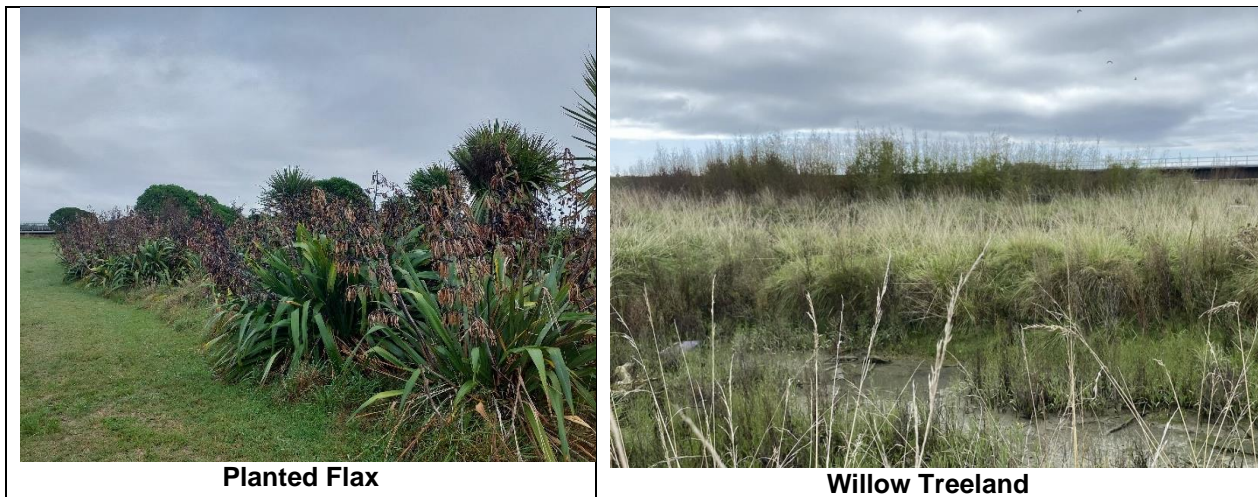
**Raupo Reedland**

**Carex Sedgeland**

**Bolboschoenus Sedgeland**

**Rushland**

Figure 4 Representative photos of Wetlands on site.

To assign value to these wetland areas, four matters were considered, as per the EIANZ guidelines. The wetlands onsite were found to be dominated by common native and exotic species and were small in size located in wetter areas along the river margins. Wetlands are a national priority for protection, due to their reduced extent. These wetlands are likely providing some habitat for fauna and provide ecosystem functions to the wider area. As a result, the wetlands within the impact area or its 100m buffer are valued from **Low-Moderate**.

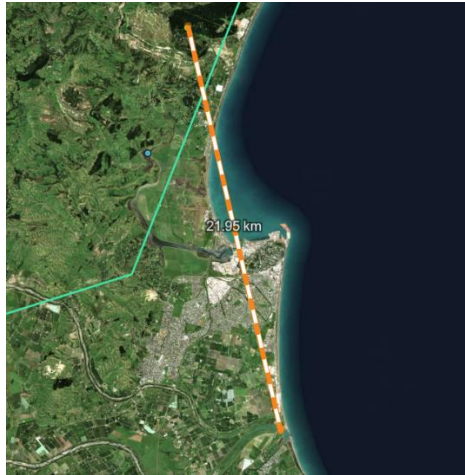
Figure 5. Image showing the distance to the closest recorded location of native bats.

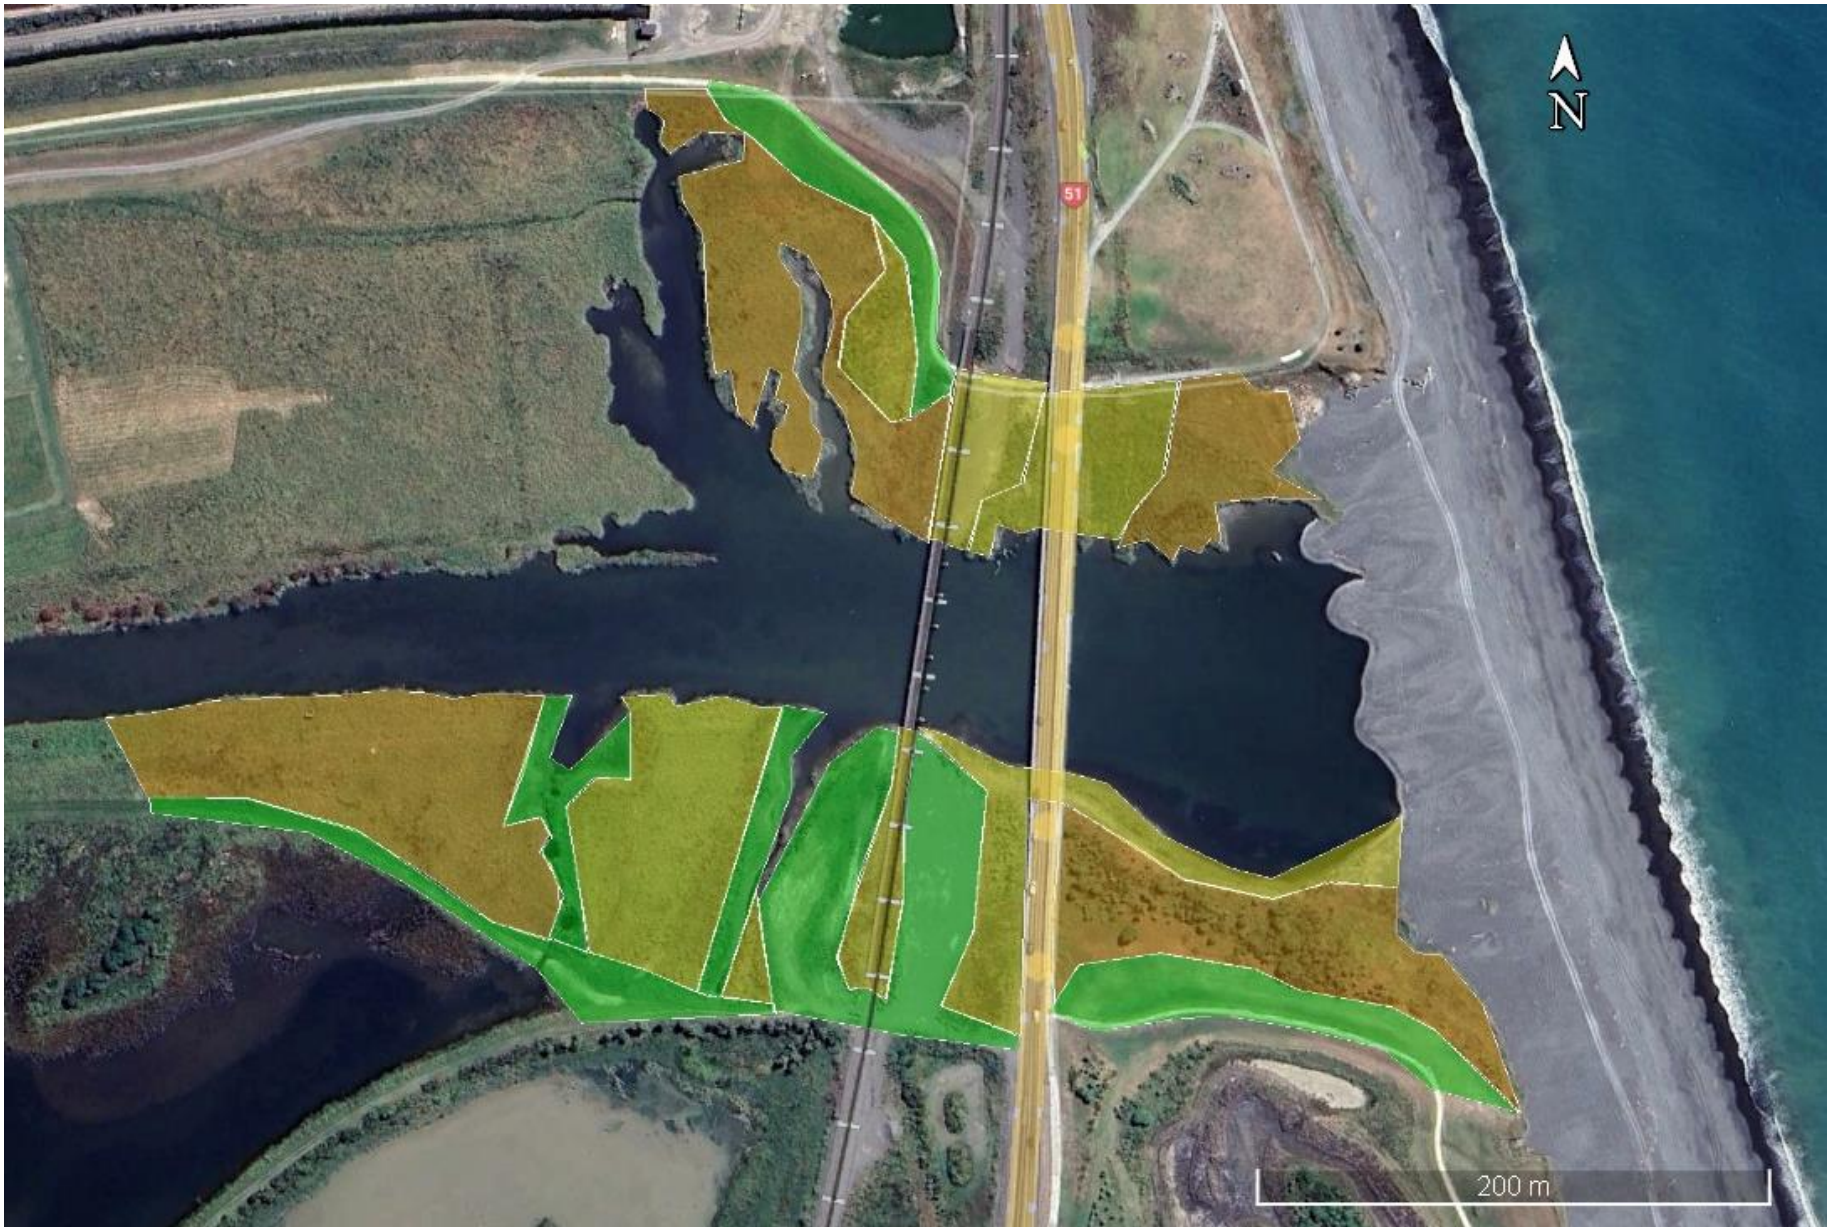
Figure 6 Site location of the Tutaekuri River mouth and different habitat quality present within the extent of works. Green = unsuitable to low quality; Yellow = low to moderate quality; Orange = moderate to high quality.

Overall, the habitats on the Northern and South banks were similar, largely dominated by dense rank grass with scattered cover objects such as wood located, and disturbed areas of largely gravel and weeds (see Figure 3-1, Appendix A). Further detail on habitats which are described below.
