To	Ben Ryder
CC	Sean Crocker, Dathan Proudlove, Melissa Pendley
From	Emily Frost
Date	24/06/2025
Subject	Bridge 217 Soil Chemistry Results
Reference	[C5001-02-577-12000-EW-PP-TREC-000001]
Revision	1

Background

Following the devastation of Cyclone Gabrielle, a temporary rail bridge was constructed in 2023 to allow for the restoration of the KiwiRail line South of Napier. However, circumstances have necessitated the life span of the bridge be extended to fifty years. This will require significant works to strengthen the existing structure, and reduce the potential impacts caused by weathering and flood events.

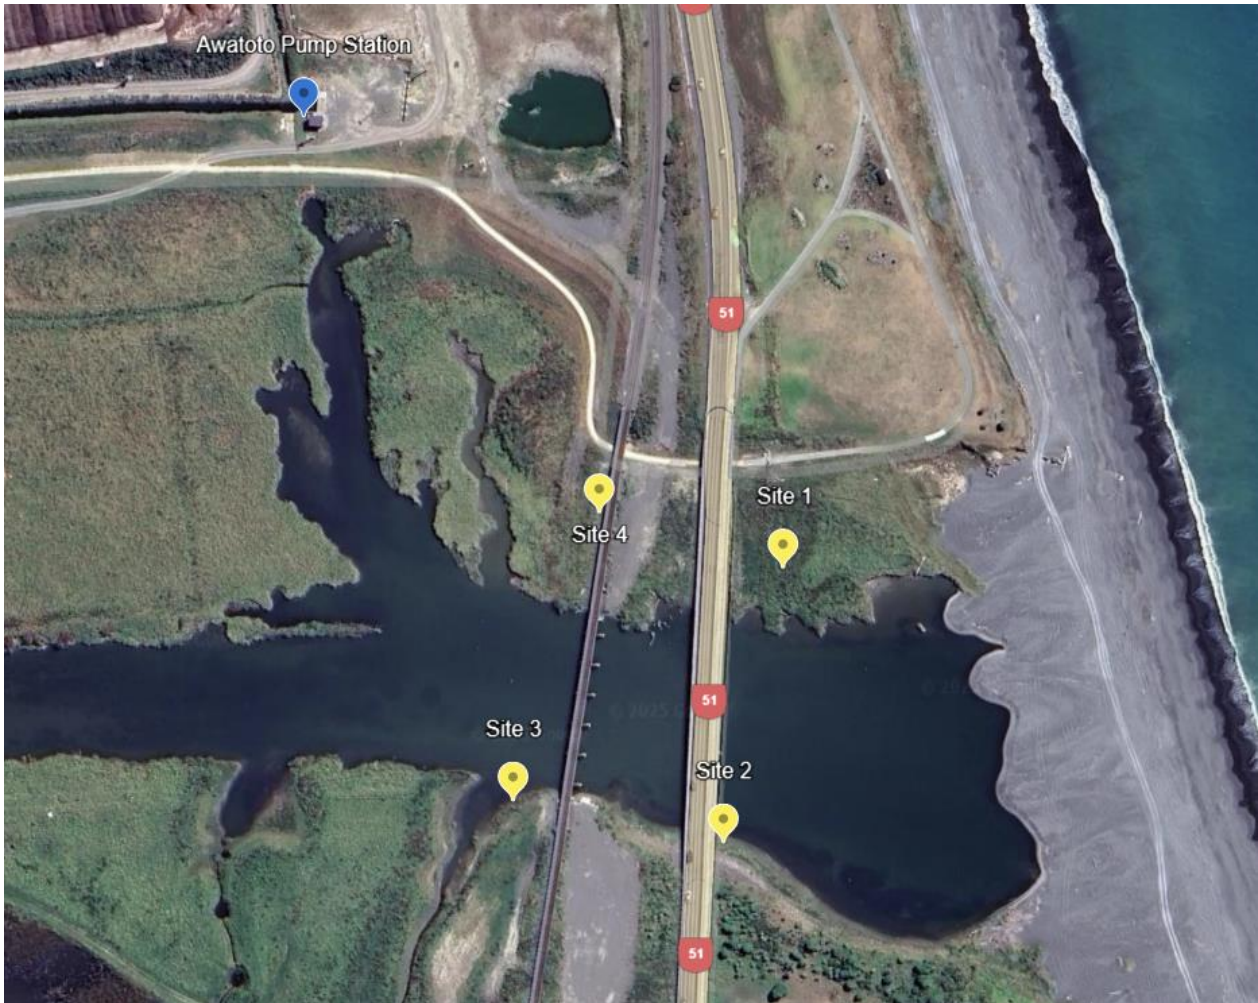
On the 28th of May, TREC SQEP went to site to dig a series of test pits to collect composite samples for processing. A series for 4 test pits of 30cm diameter and 1m depth were dug, with samples taken in composite (Figure 1). Approximately 1000cm³ composite soil samples were collected per test pit and shipped to Hills laboratory for processing for a suite of analytes, including:

Figure 1. Test pit locations in association with the Awatoto Pump station (formerly Mission Pump station).
