## Ohiti Road Stopbanks

### Preliminary and Detailed Site Investigation

Prepared for  
Hawke's Bay Regional Council

Prepared by  
Tonkin & Taylor Ltd

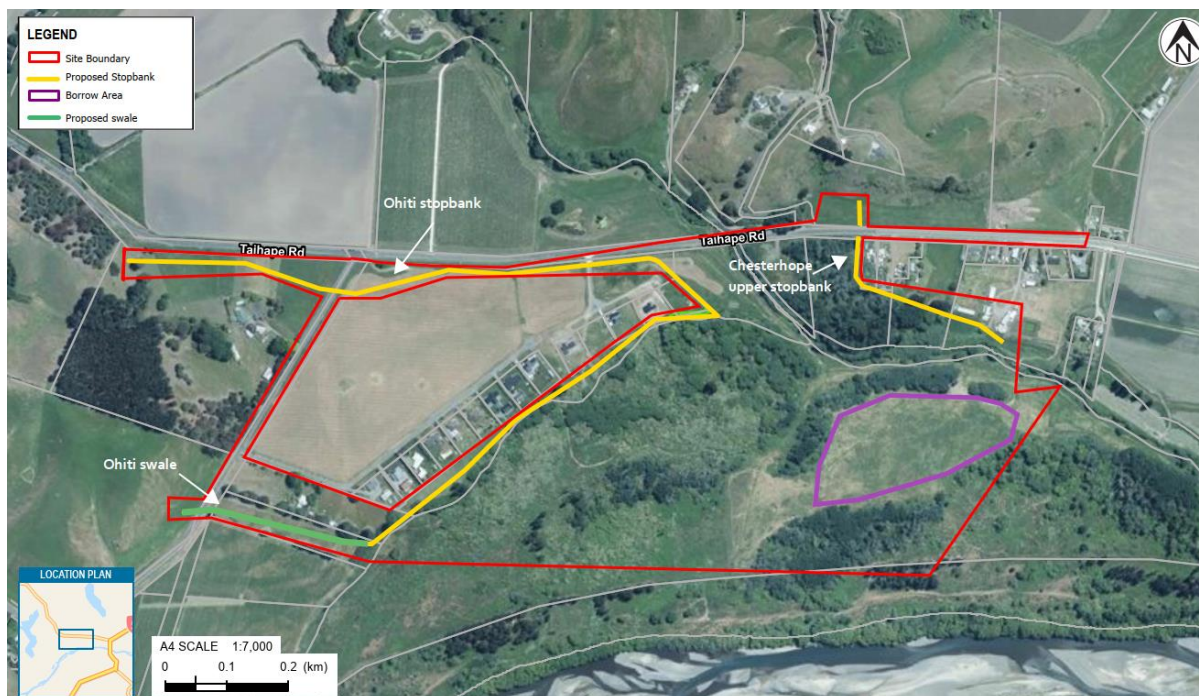
Figure 1.2: Current plan for the Ohiti/Chesterhope upper stopbanks and borrow area.

We understand HBRC proposes to construct two stopbanks, and borrow area, as part of post Cyclone Gabrielle flood mitigation works. Proposed locations of works are shown in Figure 1.2 below. Proposed soil disturbance work will include removal of vegetation and topsoil, excavation to approximately 0.5 m to key in the toe of the stopbank and cut to fill to form the stopbank.

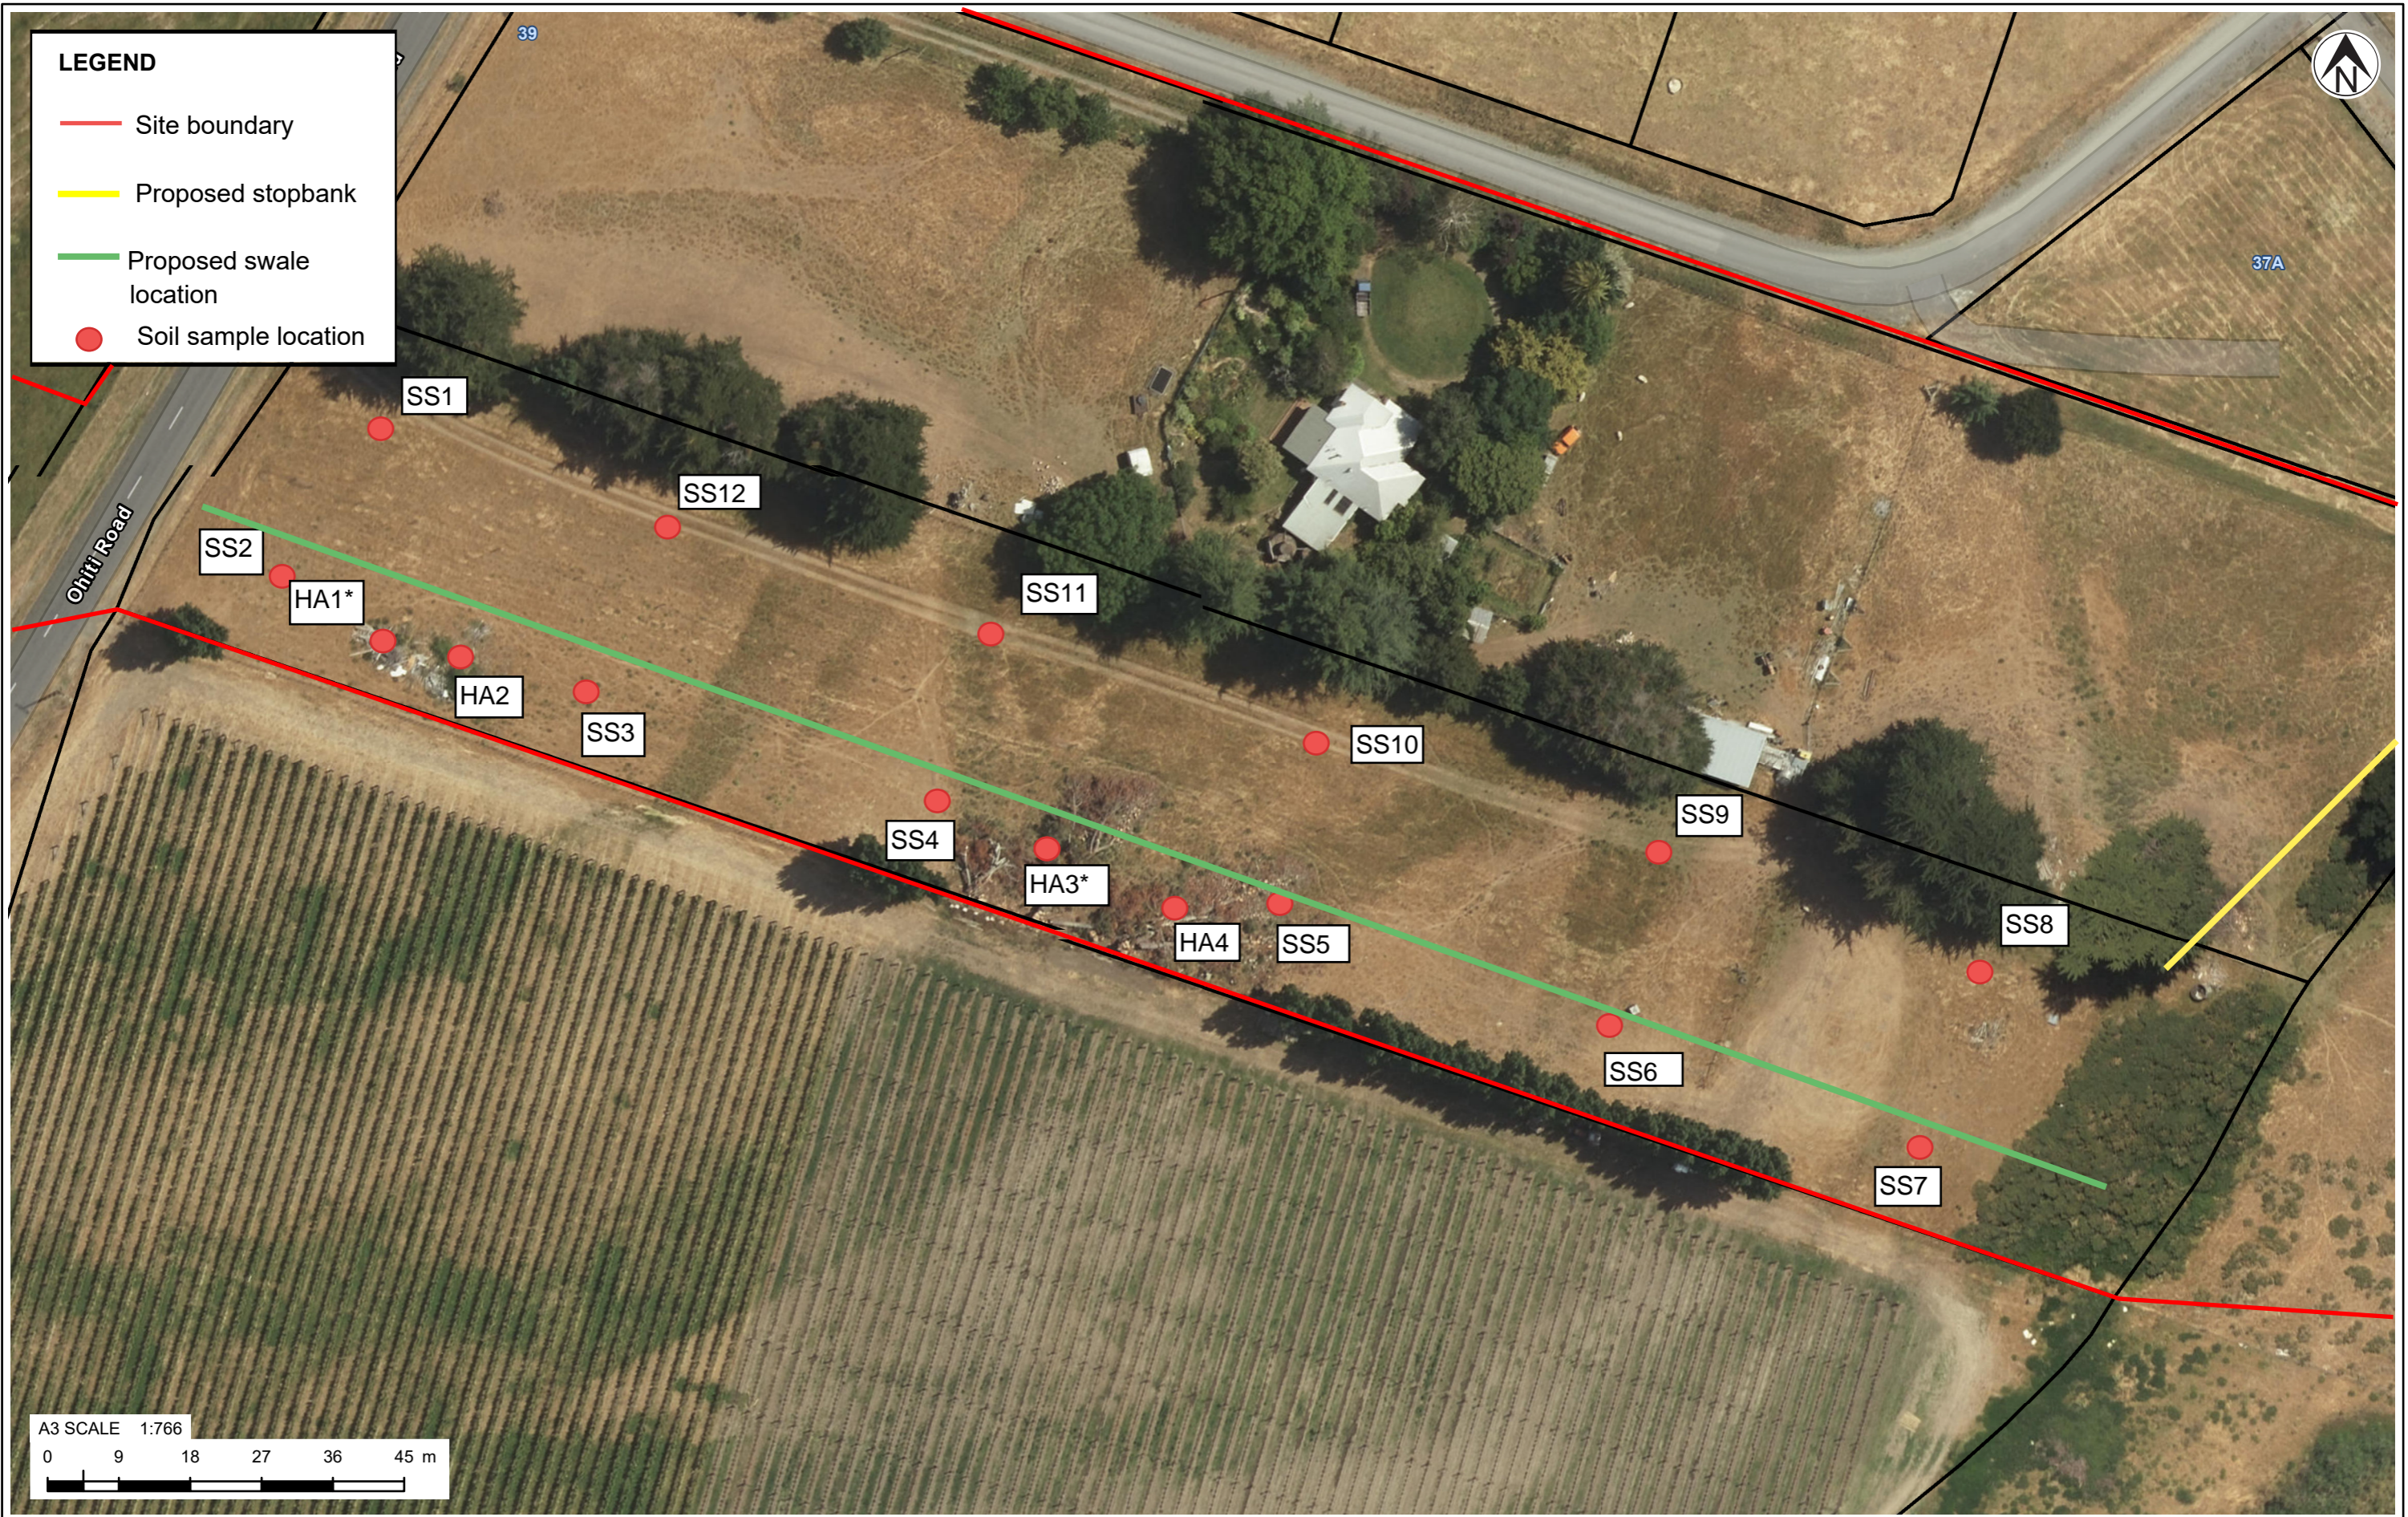
FIG No. FIGURE A.2

- Two surface soil samples and two deeper samples (0.1-0.4 m bgl) were positioned to target the presence of buried waste in burning areas identified in the former orchard (Figure Appendix A.2). Four samples were analysed for TPH. The two surface samples were also analysed for heavy metals, PAH and semi-quantitative asbestos.

- Gravelly silt within the stockpiles at the rear of 203 Ohiti Road.
- Charcoal fragments were encountered at HA02 to HA04 within the burning areas of the former orchard. The charcoal fragments were encountered in topsoil (0-0.1 m bgl) and not deeper within natural soils.

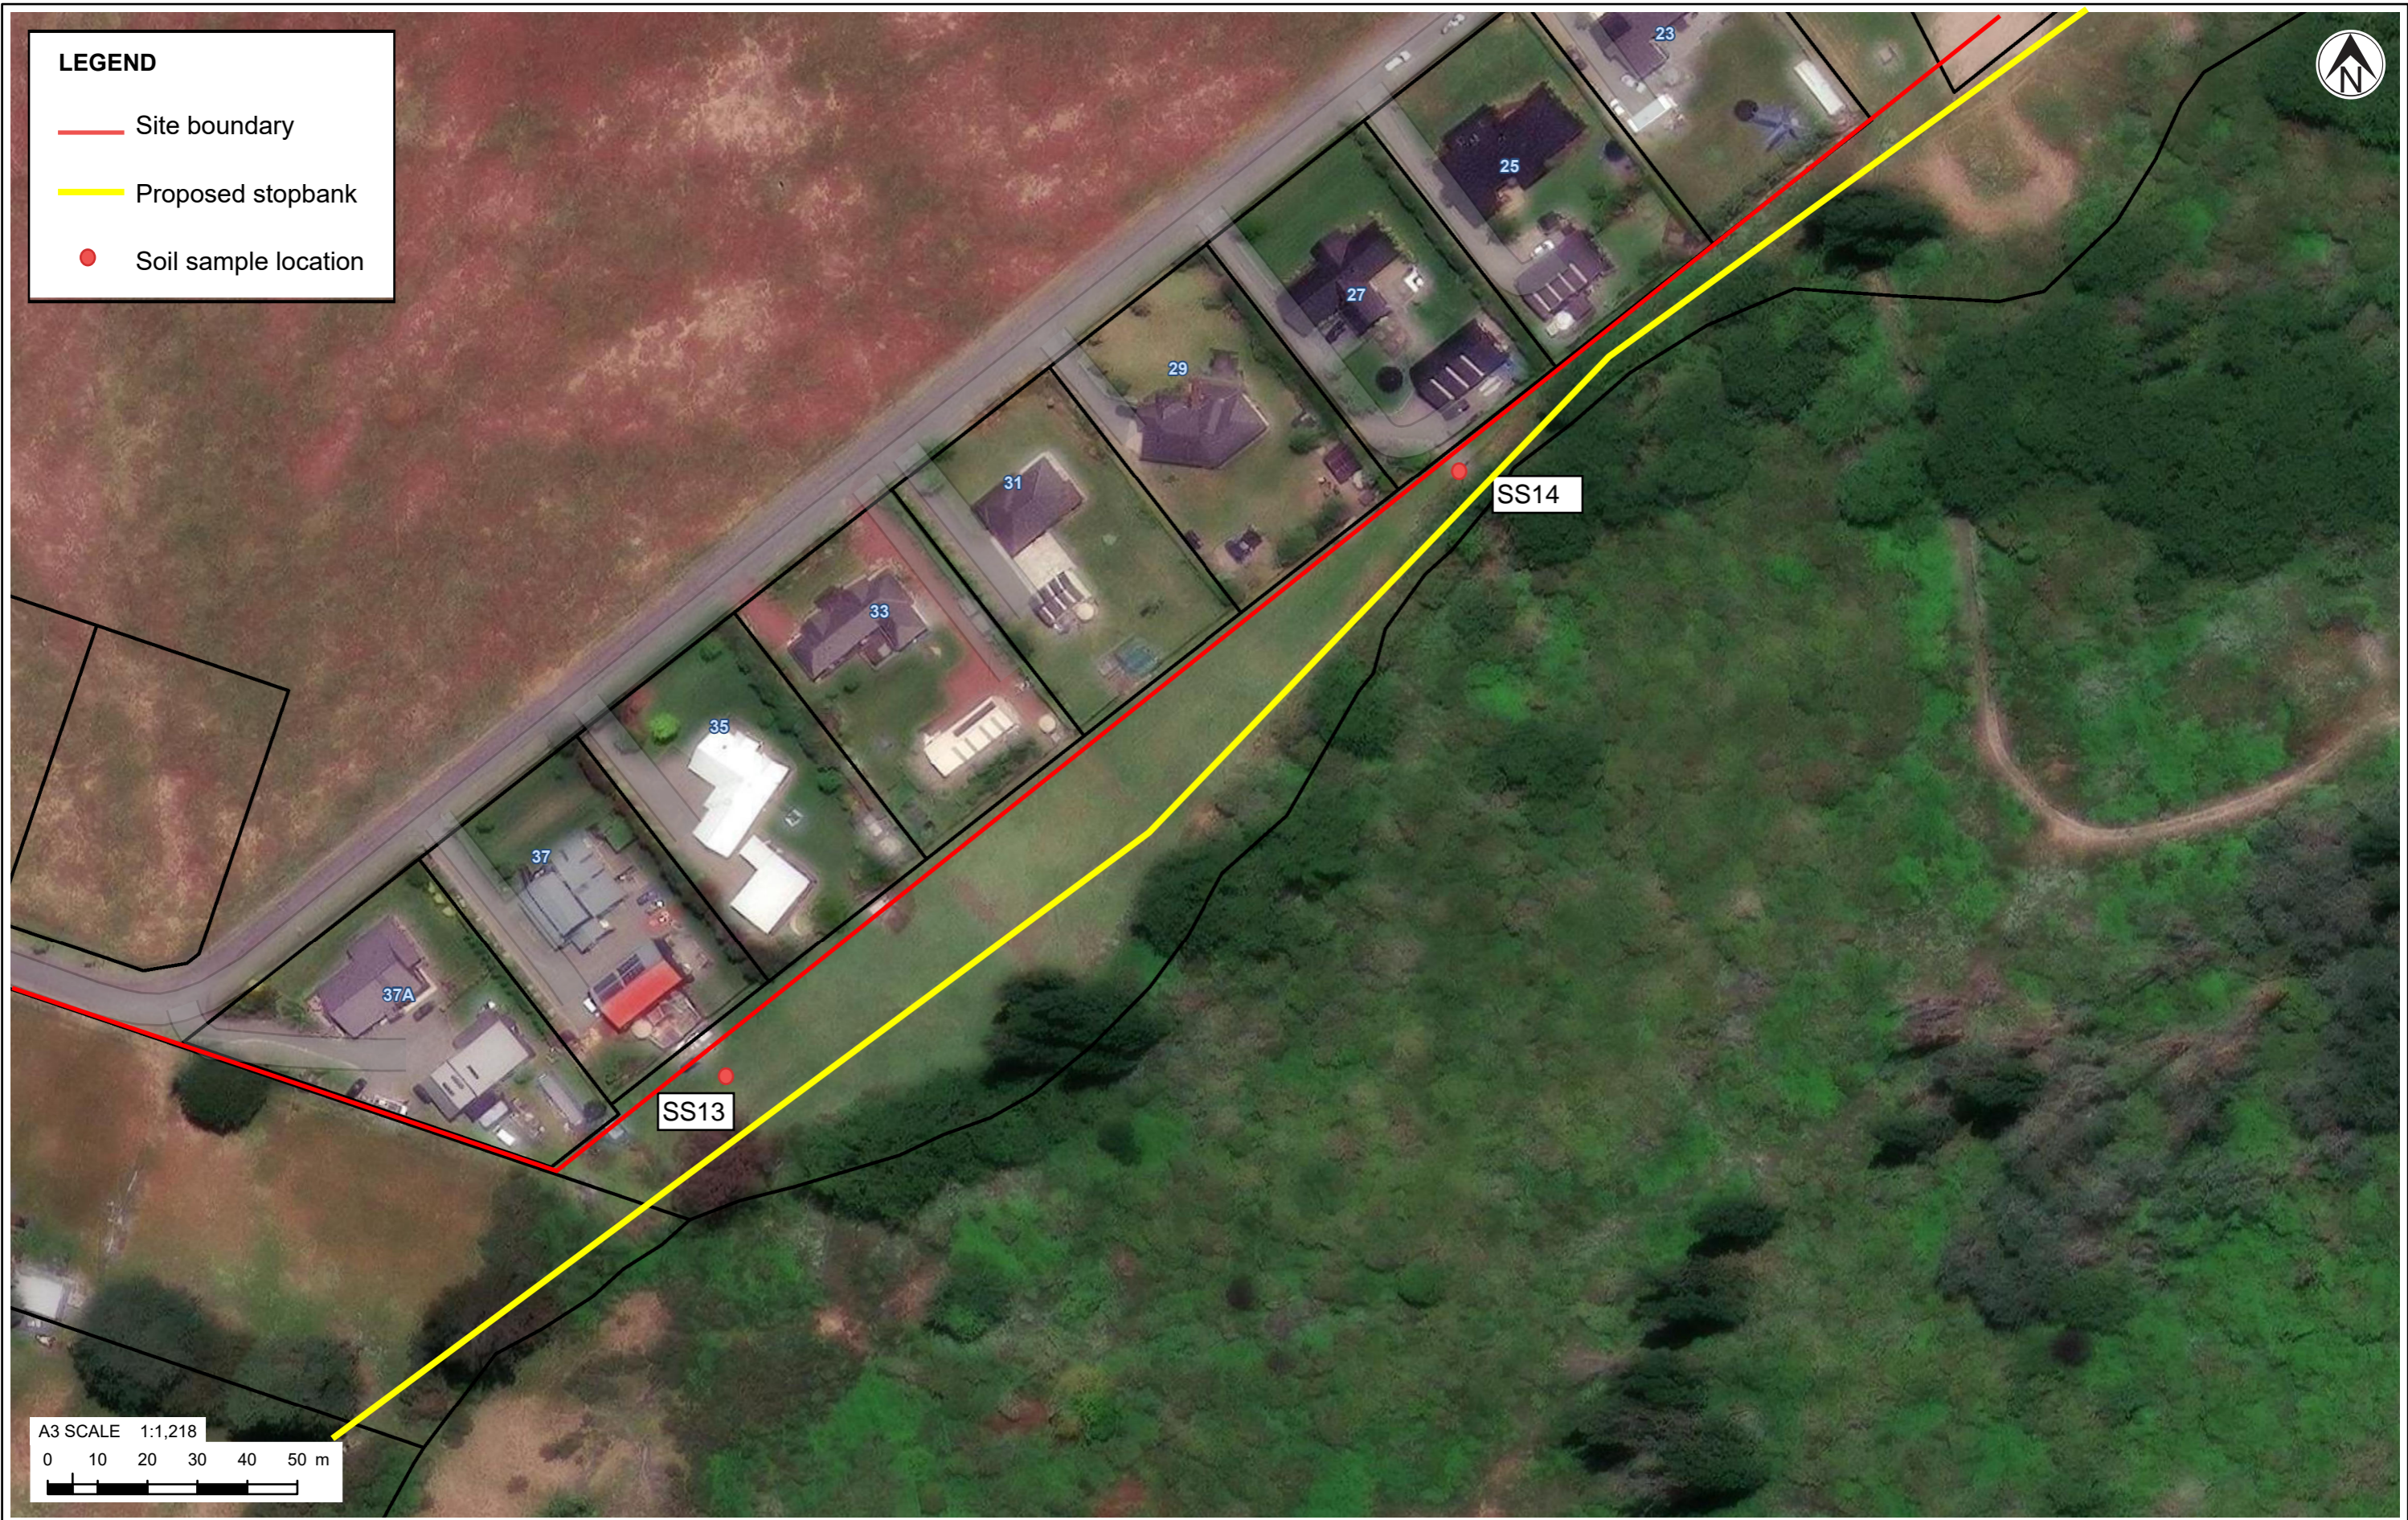
- Two targeted surface soil samples were collected beneath the burn barrels behind 203-209 Ohiti Road (Figure Appendix A.3). The two samples were analysed for heavy metals, PAH and TPH.

- Surface soil sample SS13, collected from the burn barrel adjacent to 37 Ohiti Road reported concentrations below human health and environmental criteria.

- Surface soil sample SS14 collected from the burn barrel adjacent to 27 Ohiti Road reported concentrations of heavy metals above human health and environmental criteria, including:

- Burn barrel adjacent to 27 Ohiti Road hotspot with copper and zinc concentrations which could present a risk to the environment. This contamination is likely directly from the burning of waste materials within the burn barrel. The extent of the hotspot is likely restricted to the surface soils (up to 0.2 m) beneath and with a 1 m radius of the burn barrels.

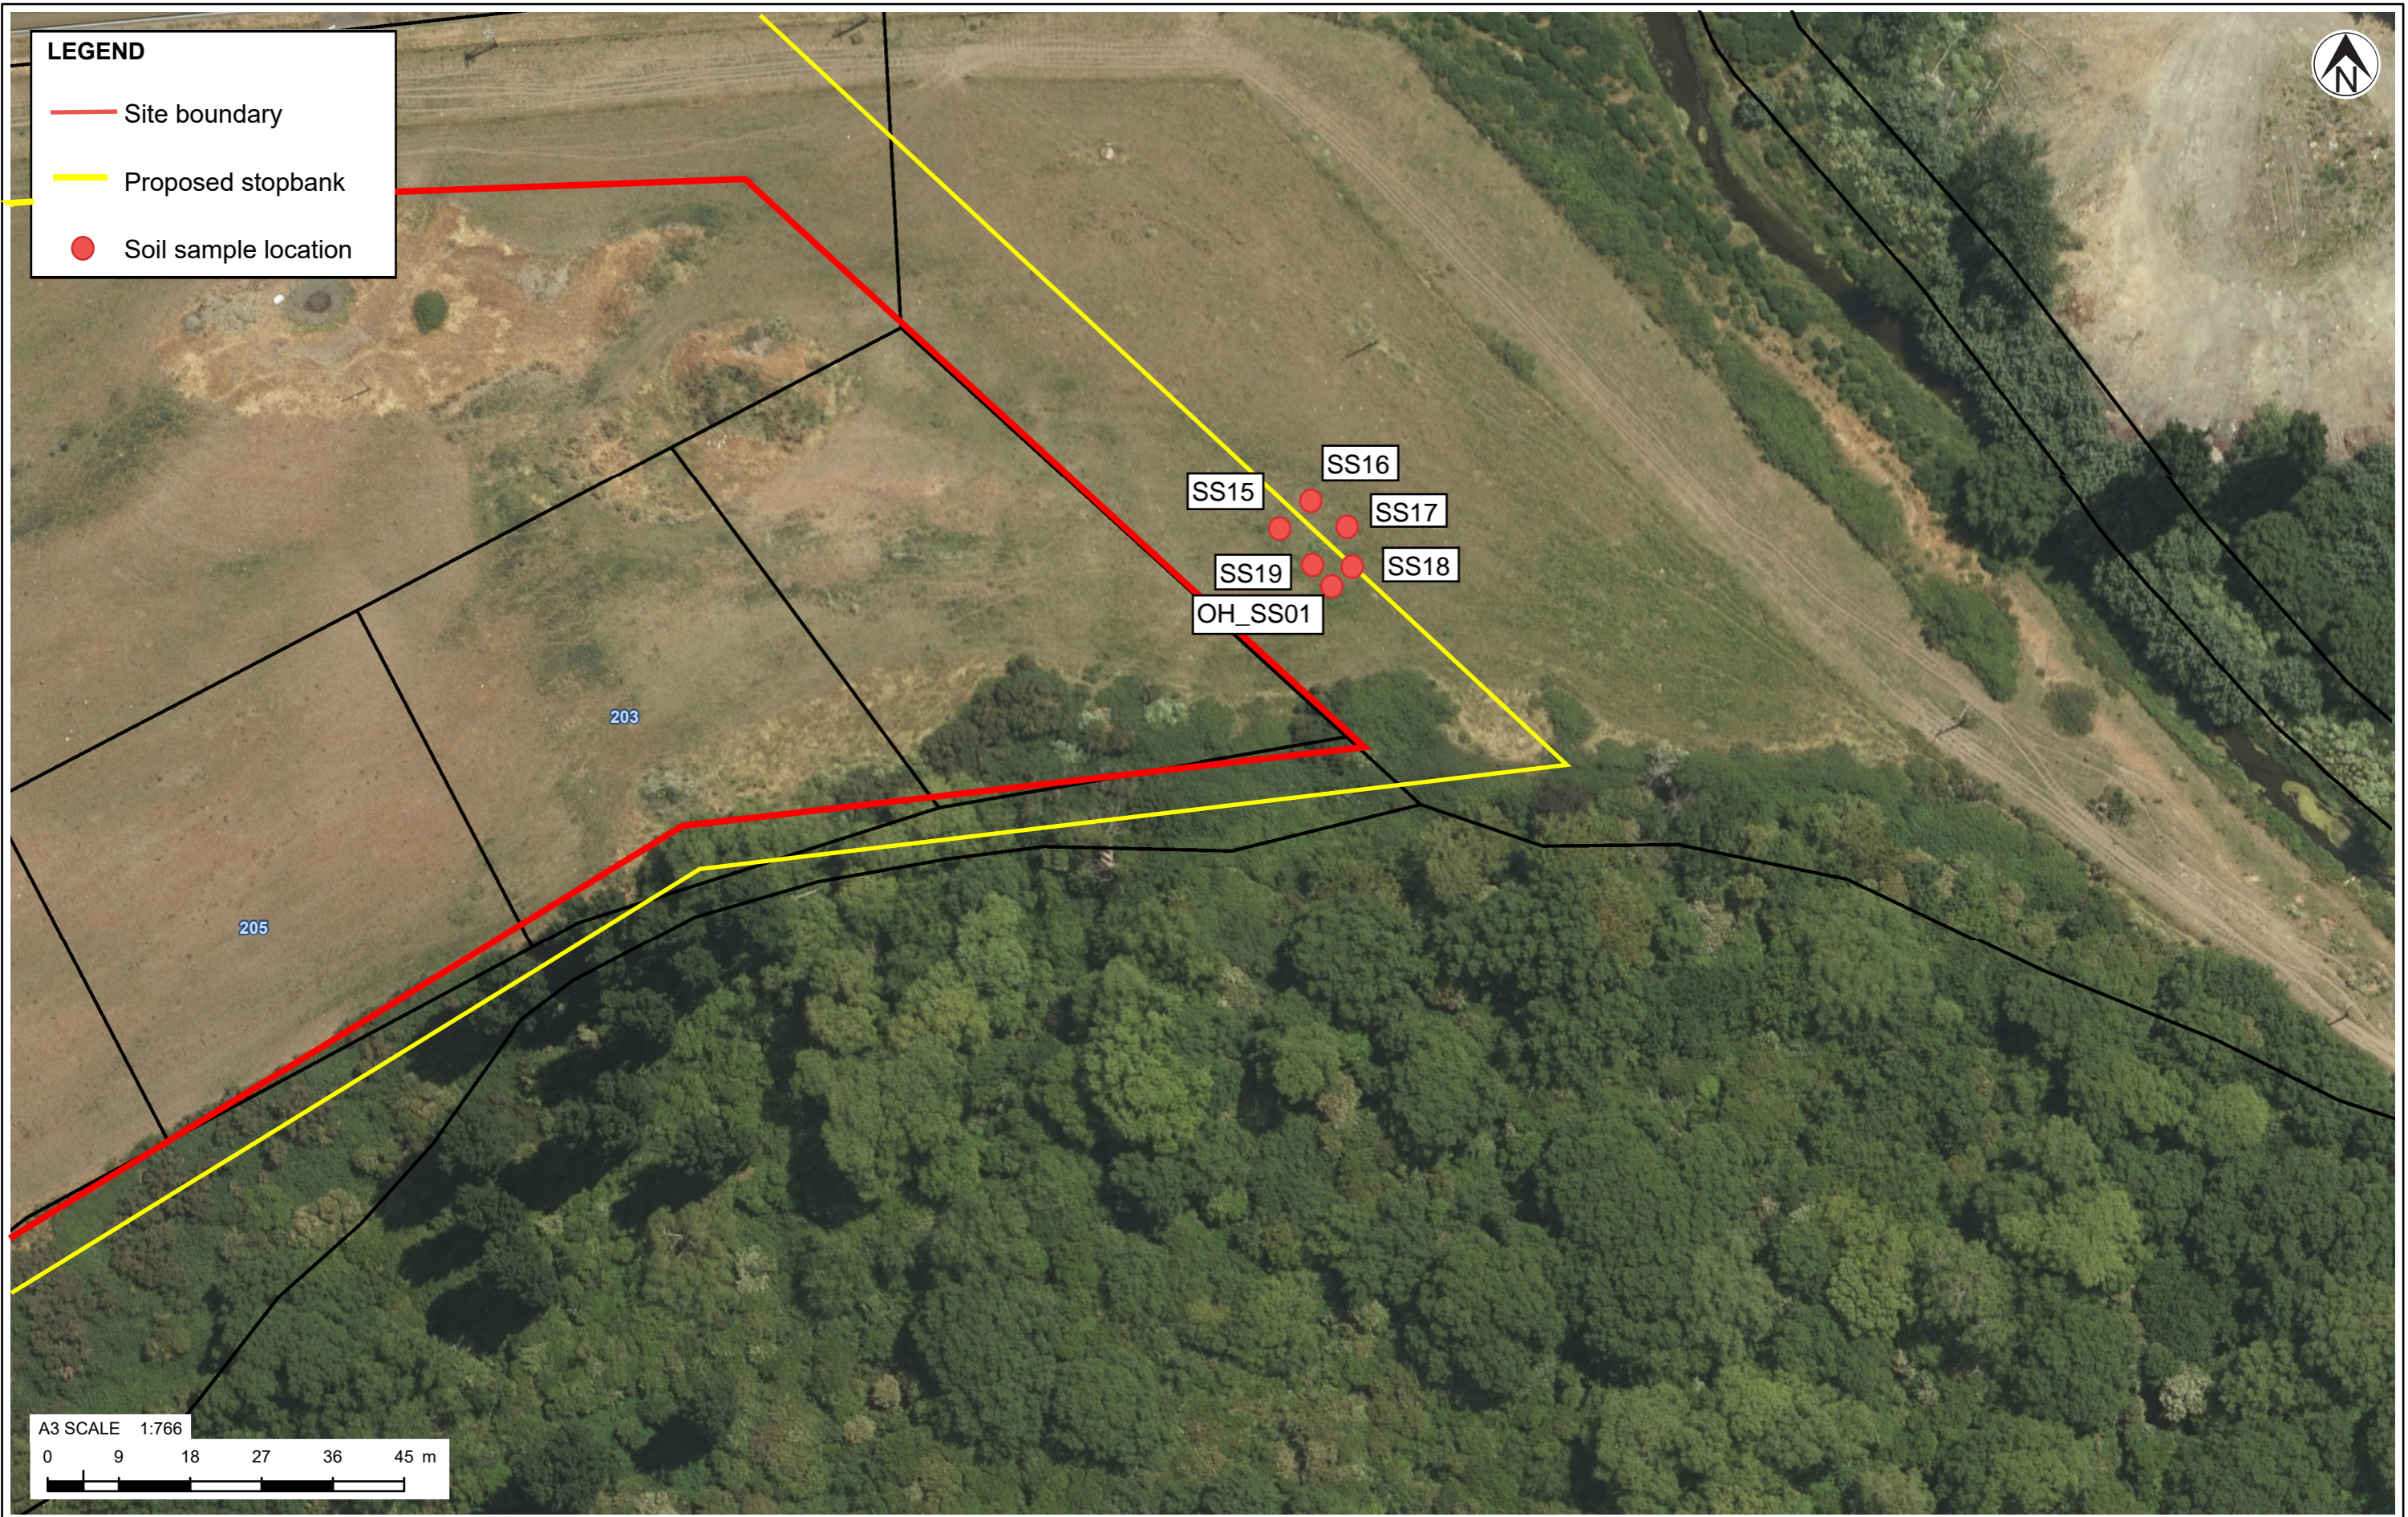
- Five sample locations were collected from the stockpiled material to the rear of 203 Ohiti Road (Figure Appendix A.4). The sampling density was collected above the recommended density for stockpiled material specified in the NZ Asbestos in Soil Guidelines<sup>12</sup> (14 samples per 1,000 m<sup>3</sup> of stockpiled material). The samples were analysed for semi quantitative asbestos and heavy metals.

- Ash and charcoal fragments were encountered at soil sample location SS14 within the burn barrel adjacent to 27 Ohiti Road.
- 11 small stockpiles were observed behind 203 Ohiti Road with each stockpile being approximately 3 m in length by 1 m in width and approximately 1 m high. The stockpiles comprised of sandy silt (inferred reworked natural material) with traces of general rubbish including glass, plastic and concrete. The estimated total volume of the stockpiles is 15 to 20 m<sup>3</sup>.

- The tested samples reported contaminant concentrations below human health.
- Asbestos in soil was detected in one soil sample OH\_SS01 with a concentration of loose fibres < 0.001 % w/w (weight by weight) in May 2025. Asbestos was not detected in the fibre cement sample.

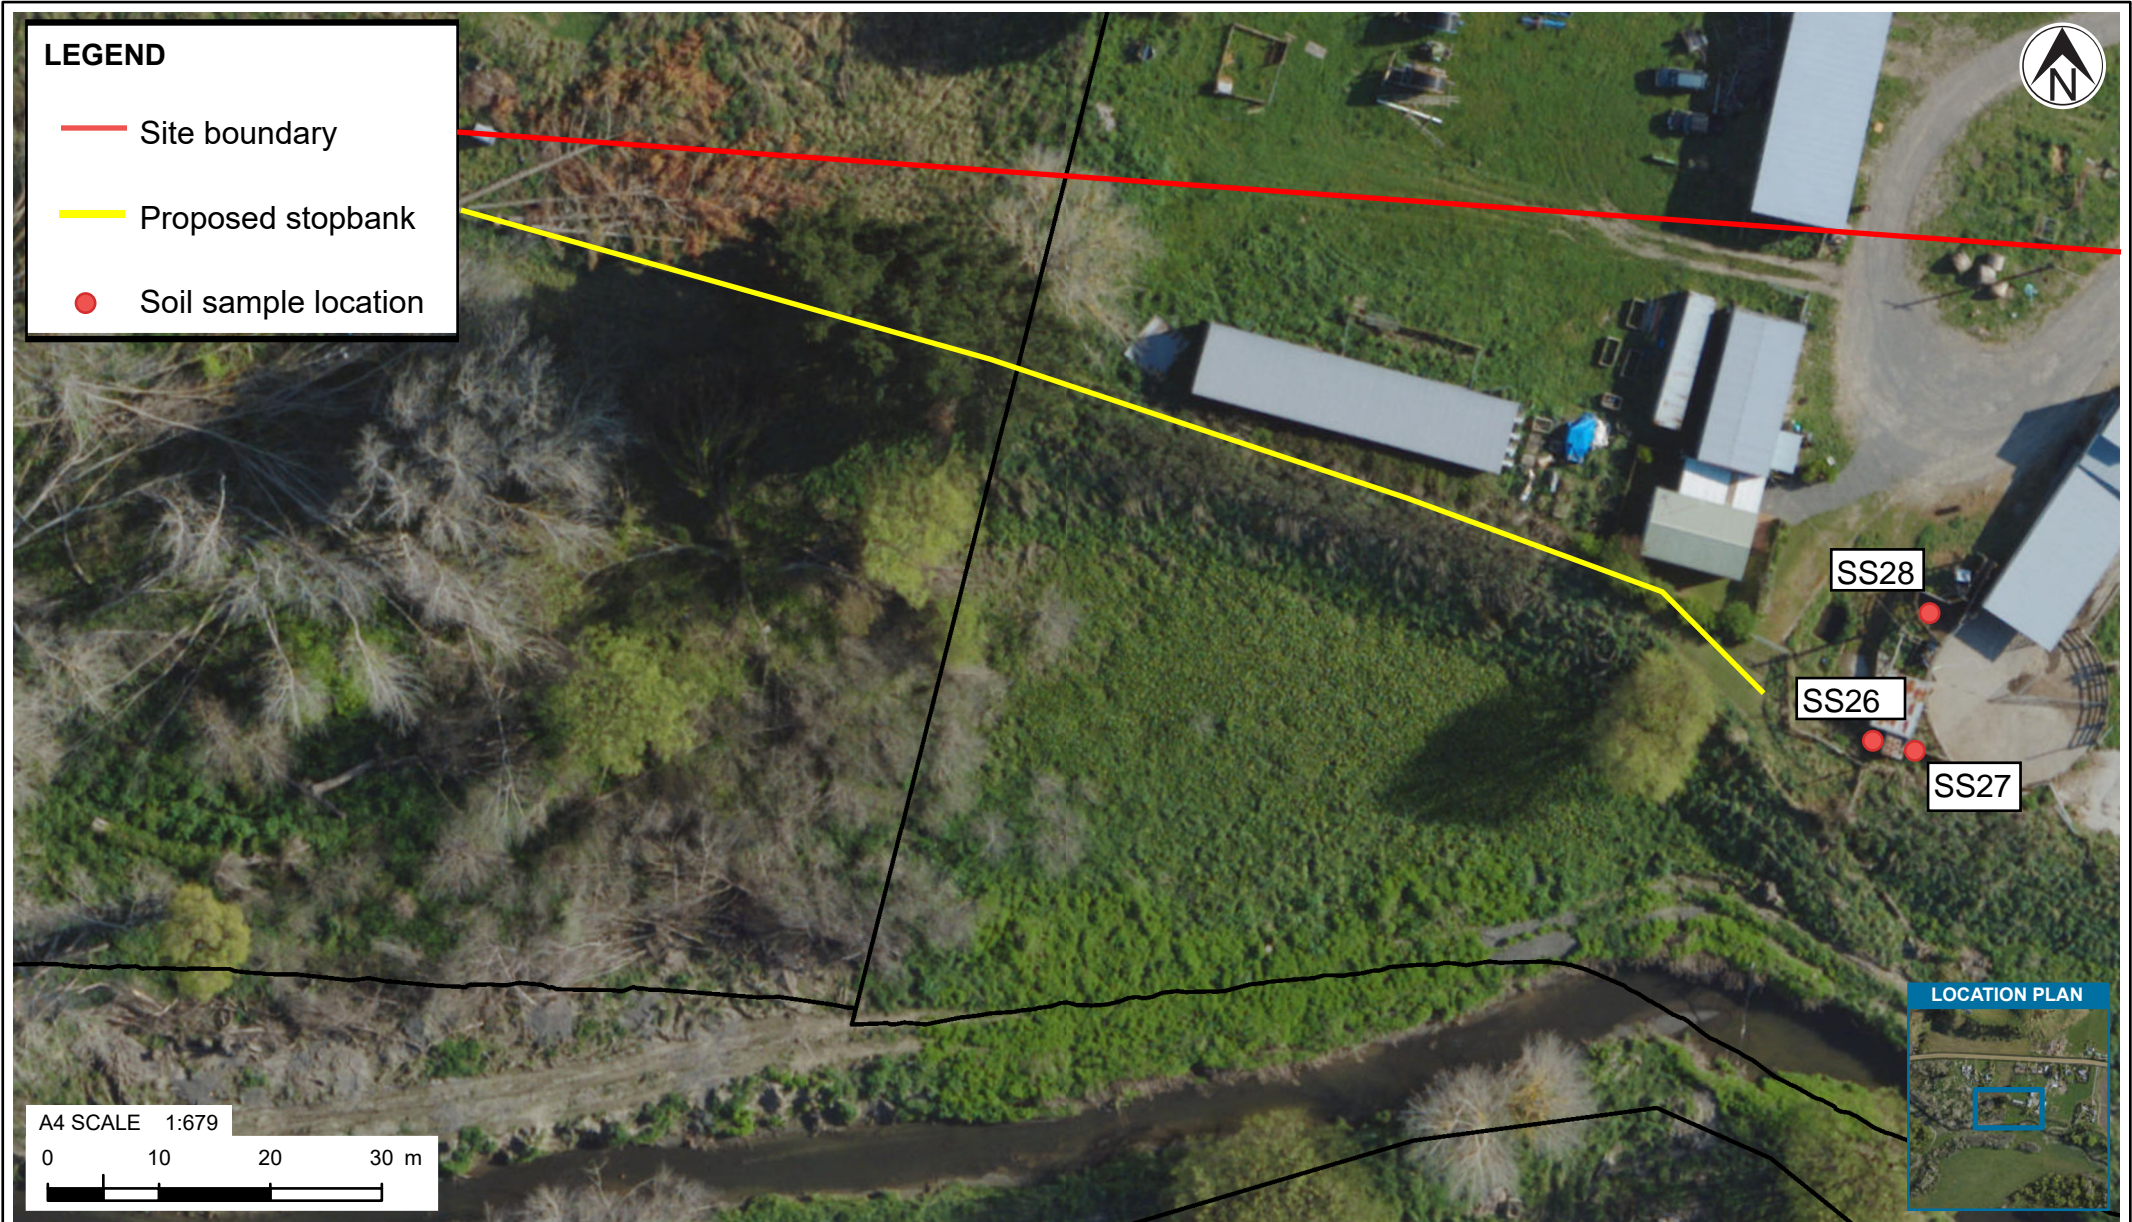
**FIG No.** FIGURE A.5

- Site boundary
- Proposed stopbank
- Soil sample location

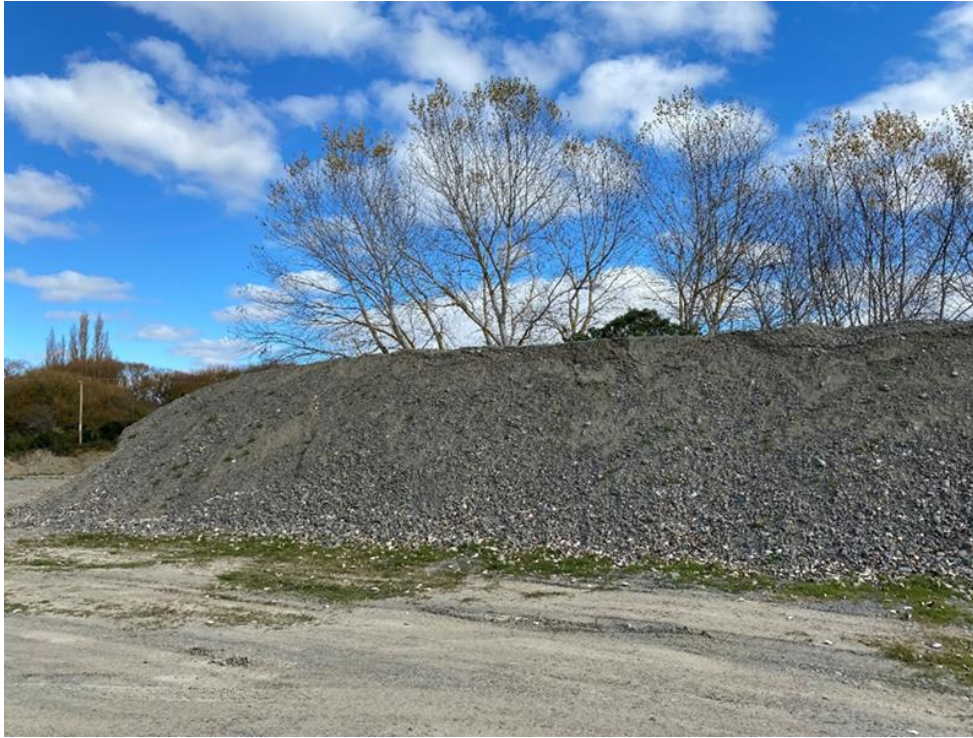
- The area on the east side of Ohiwa Stream is currently being used as a laydown area with large stockpiles (approximately 900 m<sup>3</sup>) of gravels adjacent to the proposed stopbank alignment. There are also several stockpiles around the perimeter of the laydown area that contain silt material, gravels and miscellaneous building debris (including concrete, brick and timber). This is assumed to have originated from the Cyclone Gabrielle flood response. Separate small piles of both scrap metal and old tyres were also observed in this area. These stockpiles were observed to be overgrown in February 2025 (Photograph Appendix B.1 to Photograph Appendix B.5).

*Photograph Appendix B.1: Stockpile of gravel on the eastern banks of the Ohiwa Stream, looking west on 8 May 2024.*

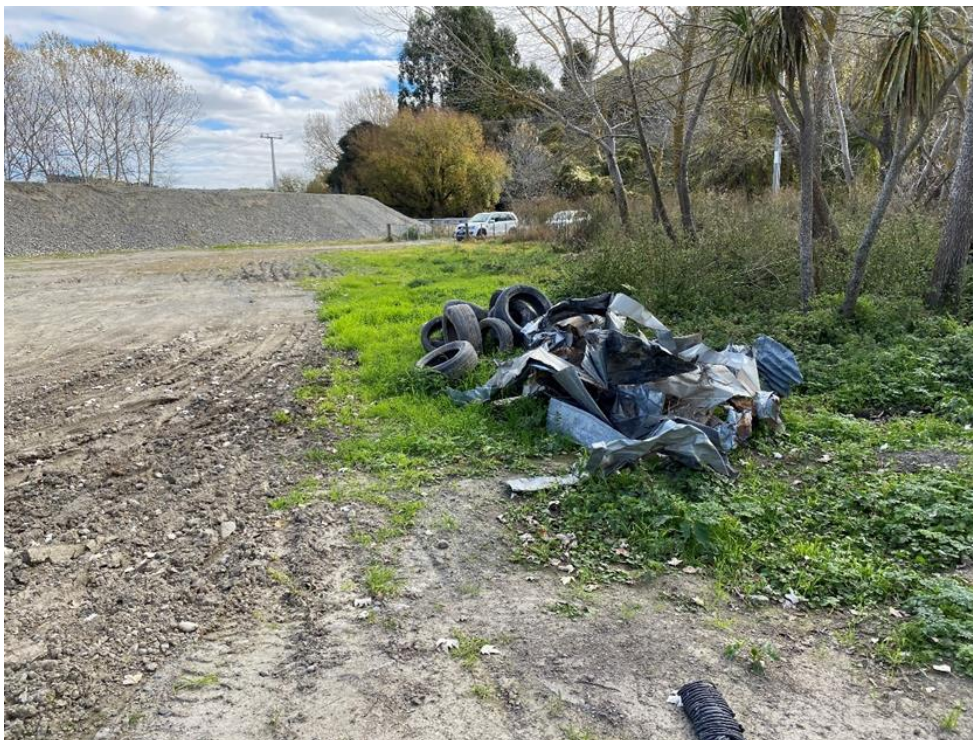
*Photograph Appendix B.2: Stockpile of tyres and scrap metal, located on the eastern portion of the site on 8 May 2024.*

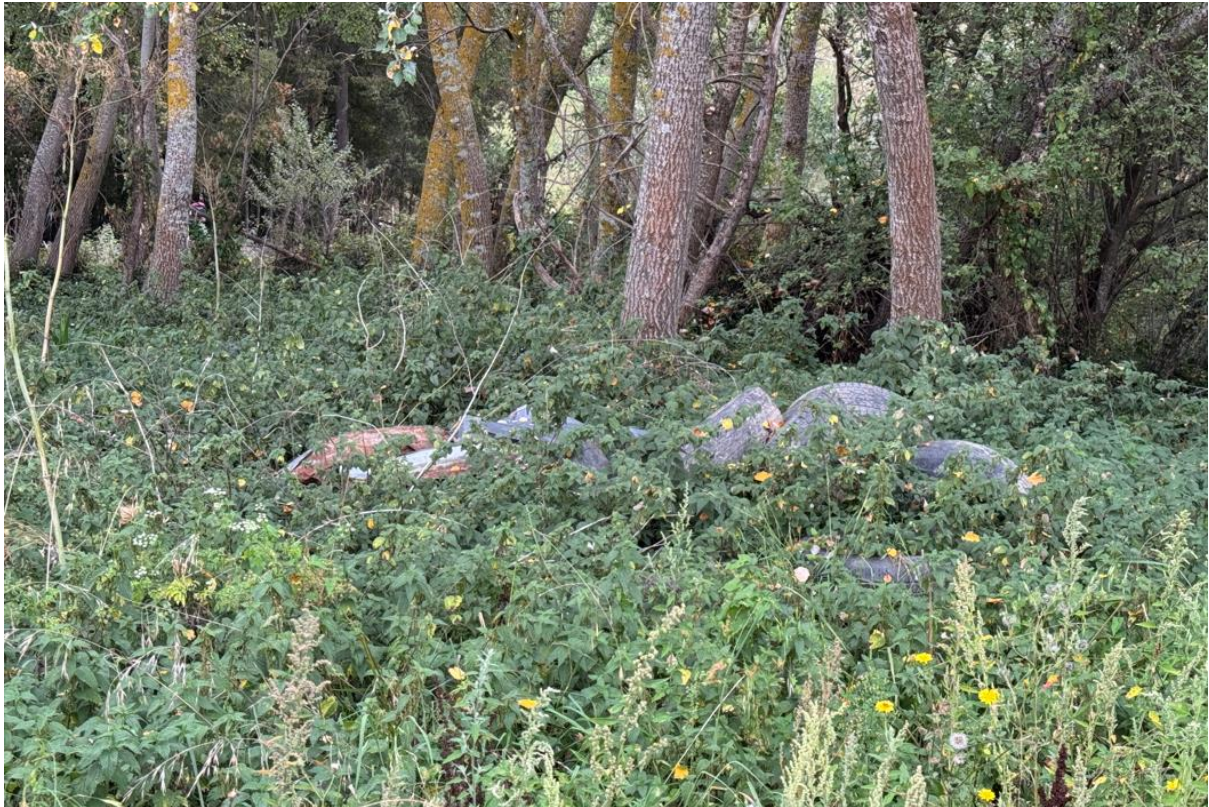
*Photograph Appendix B.3: Stockpile of tyres and scrap metal, located on the eastern portion of the site on 28 February 2025.*

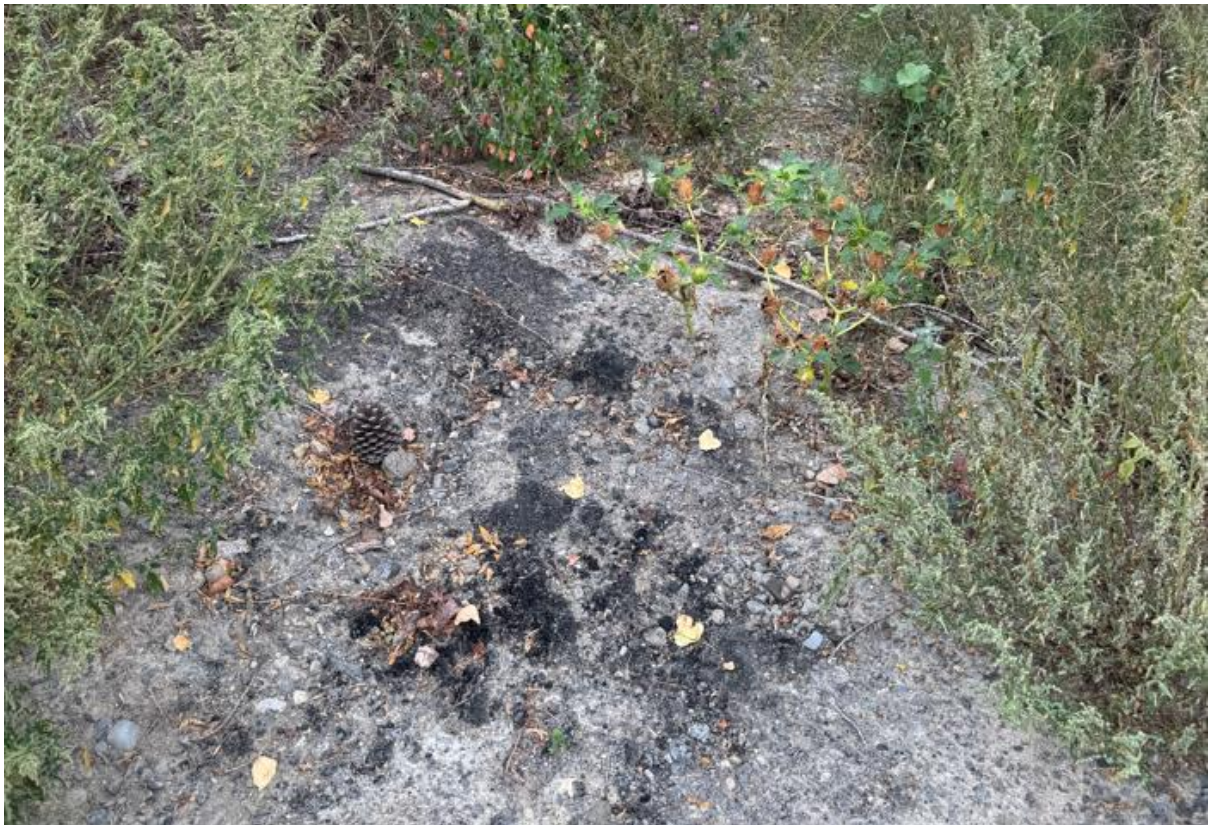
*Photograph Appendix B.4: Stockpile of asphalt/bitumen located on the eastern portion of the site on 28 February 2025.*

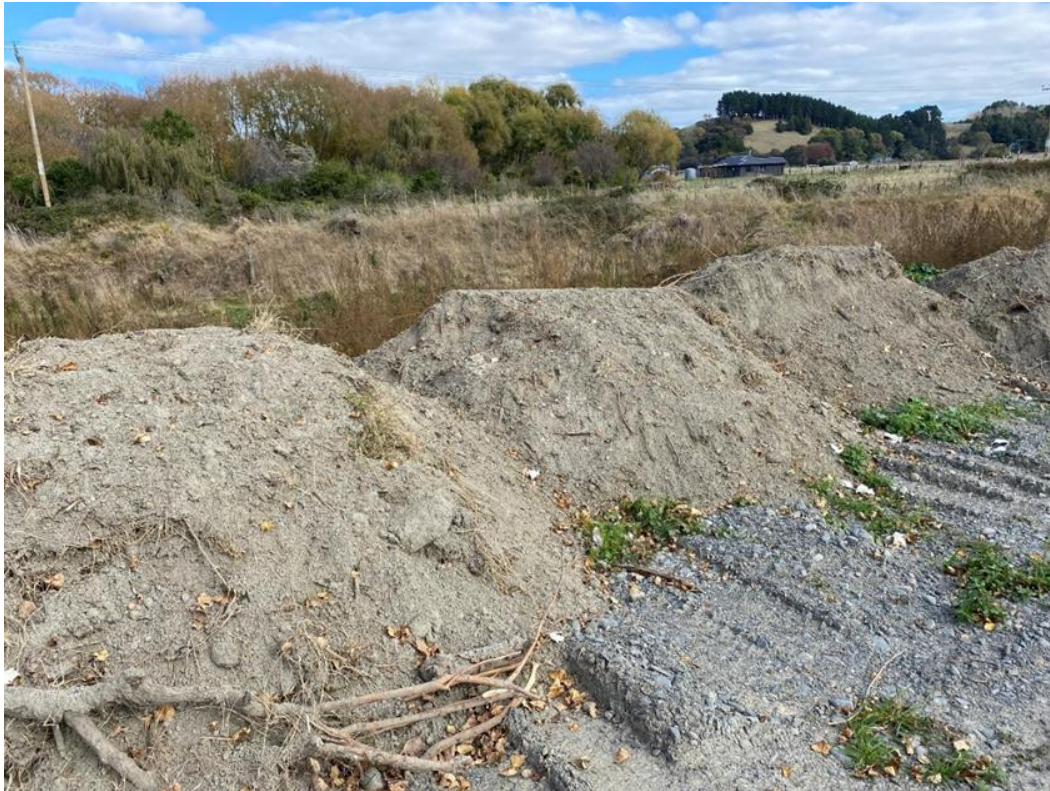
Photograph Appendix B.5: Stockpiles of silt around the perimeter of the laydown area, located at the eastern portion of the site, looking southwest on 8 May 2024.

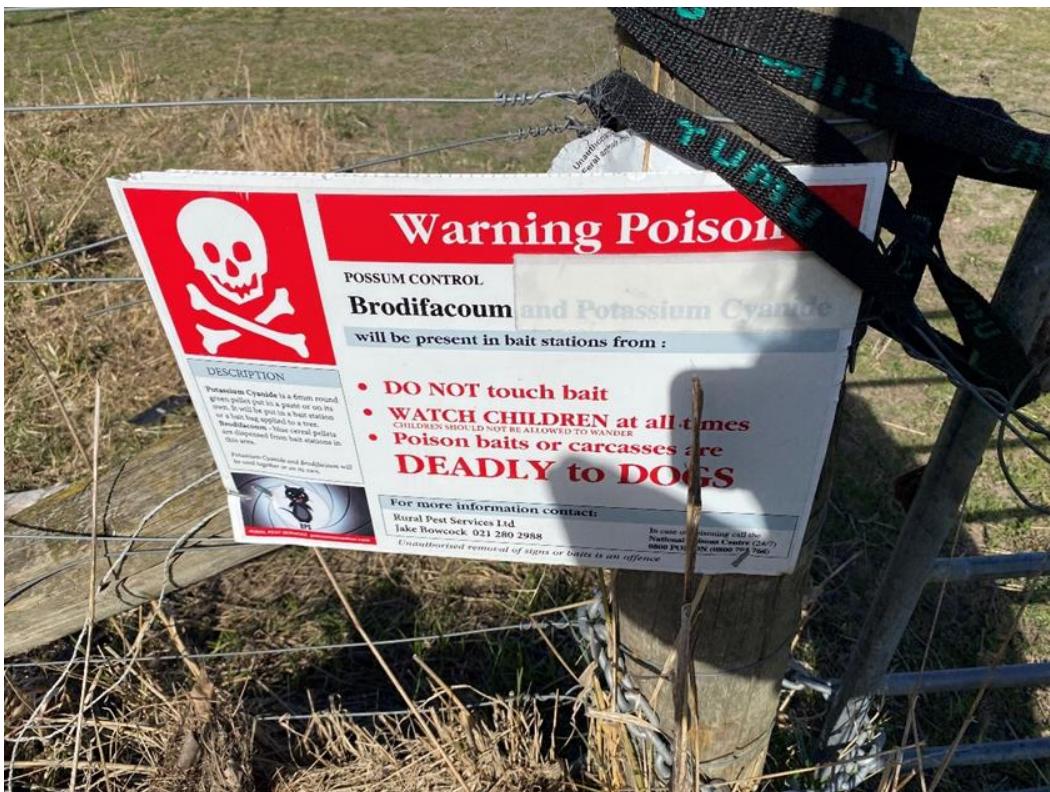
- A sign noting the use of pest (possum) control poison was observed on the eastern most paddock of the site (Photograph Appendix B.6). The sign was outside the proposed stopbank alignment.

Photograph Appendix B.6: Hazard sign that outlines the pest control on site. Located on the west side of Ohiwa Stream, looking south on 8 May 2024.

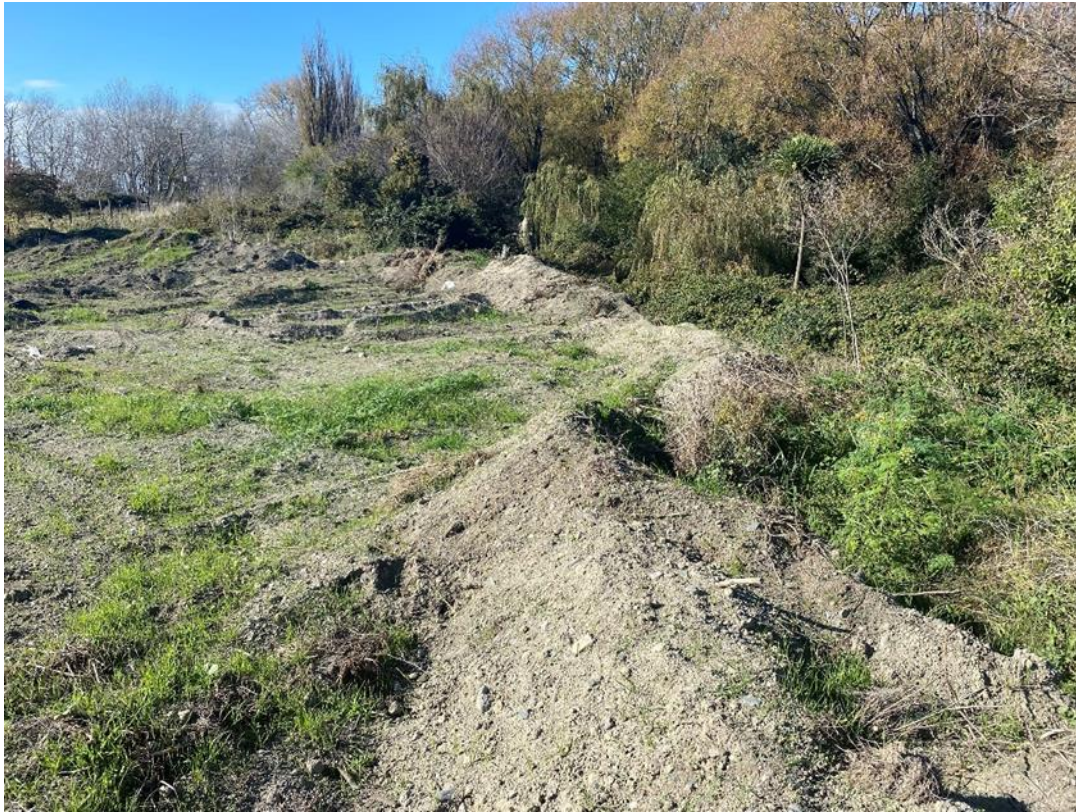
- A large stockpile of silt material containing miscellaneous building debris was observed behind the property at 203 Taihape Road within a gully on the proposed stopbank alignment. The pile also extended along the adjoining paddock and covered an area of approximately 350 m<sup>2</sup> (the total volume of the stockpile is unclear as the gully was inaccessible at the time of the site walkover and therefore, the depth is unconfirmed). The stockpile contained concrete, brick, timber, tiles, plastic, wire and two visible fragments of fibreboard (suspected ACM). A bulk sample of this was collected (OH Bulk 01). Refer to Photograph Appendix B.7 to Photograph Appendix B.10 within Appendix B.

*Photograph Appendix B.7: Stockpile of silt located at the back of 203 Taihape Road, looking east on 8 May 2024.*

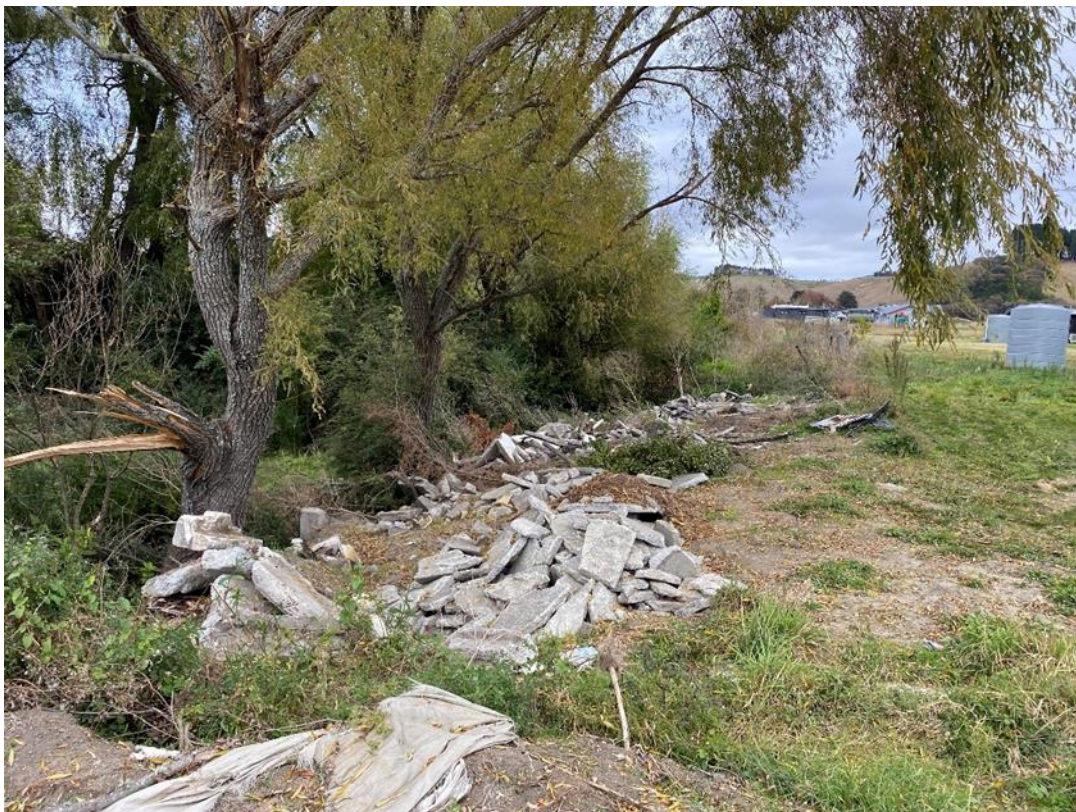
*Photograph Appendix B.8: Stockpile of silt and building debris located at at the back of 203 Taihape Road, looking west on 8 May 2024.*
