## Ohiti Road Stopbanks

### Preliminary and Detailed Site Investigation

Prepared for  
Hawke's Bay Regional Council

Prepared by  
Tonkin & Taylor Ltd

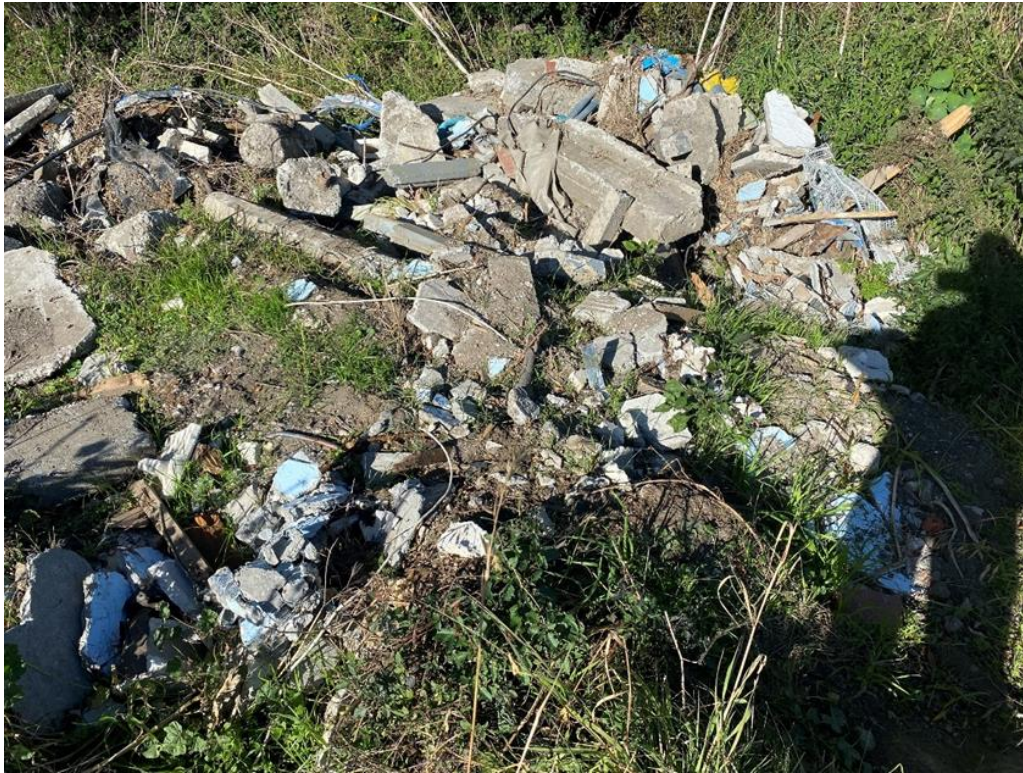
*Photograph Appendix B.9: Stockpile of silt and building debris located at the rear of 203 Taihape Road, looking south on 8 May 2024.*

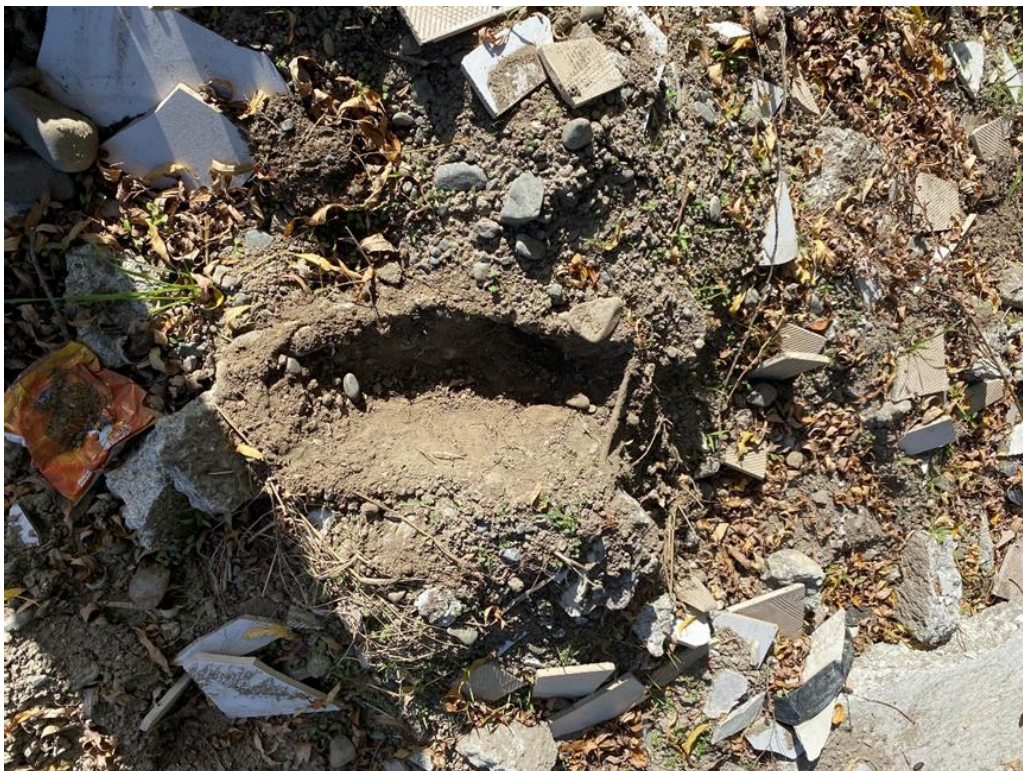
- The tested samples reported contaminant concentrations below human health.
- Asbestos in soil was detected in one soil sample OH\_SS01 with a concentration of loose fibres < 0.001 % w/w (weight by weight) in May 2025. Asbestos was not detected in the fibre cement sample.

*Photograph Appendix B.10: Location of OH\_SS\_01. Pieces of tile are visible around the sampling location and the fibre cement material sampled is visible in the top left corner of the image on 8 May 2024.*

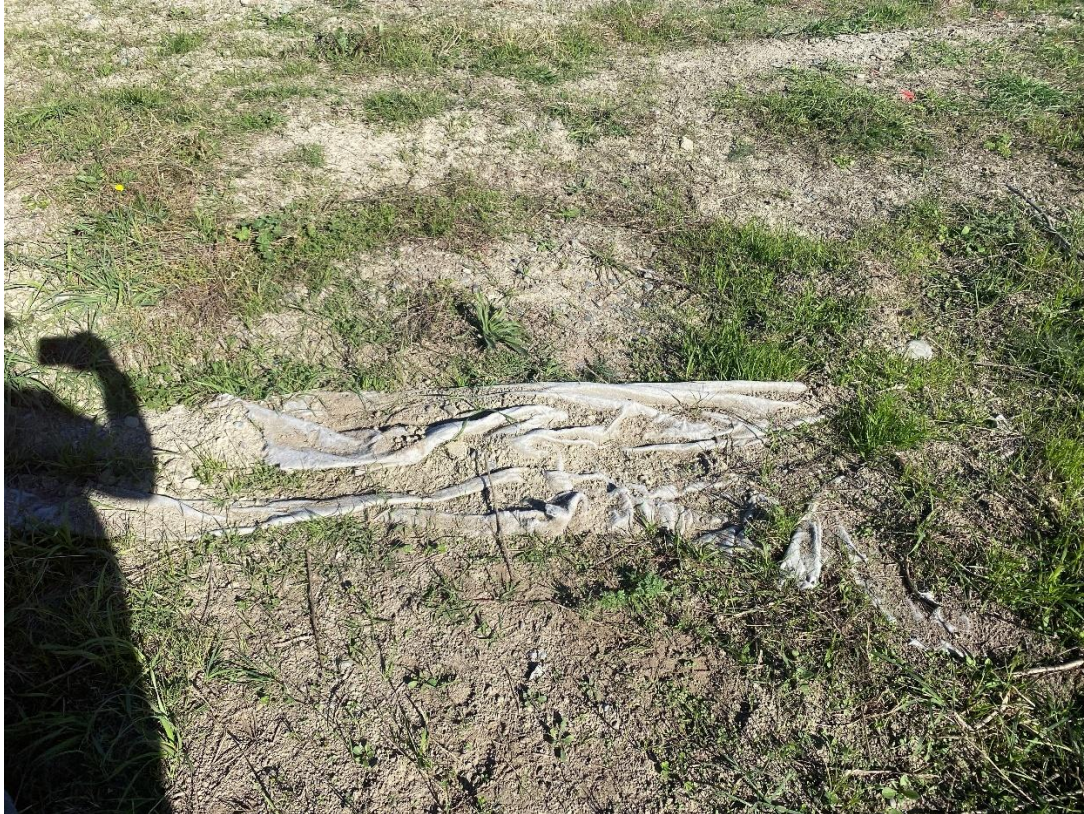
- Evidence of soil disturbance due to vehicle tracking to the stockpiling area, was observed in the paddock next to 203 Taihape Road, several pieces of exposed geofabric were seen across the area (Photograph Appendix B.11).

*Photograph Appendix B.11: Exposed geofabric present in the paddock next to 203 Taihape Road on 8 May 2024.*

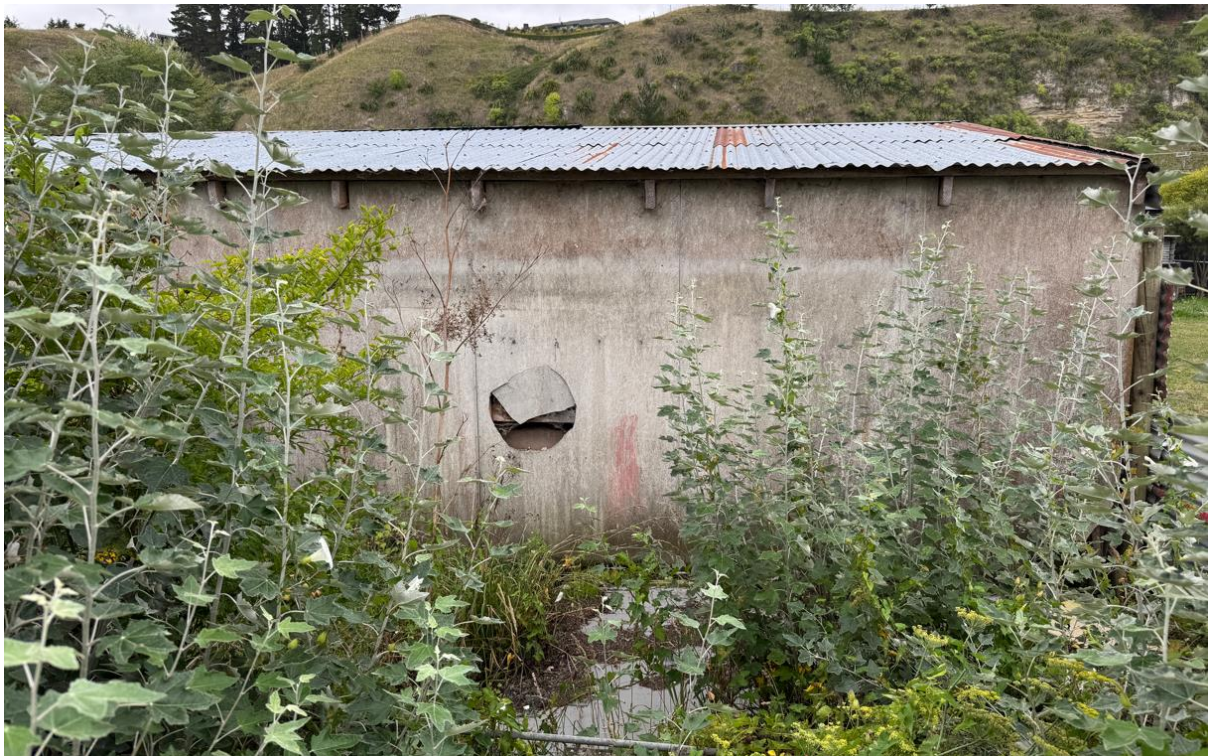
- Miscellaneous storage on unsealed ground was observed at 157 Taihape Road, along the stopbank alignment. Miscellaneous storage included timber, car bodies, temporary buildings, glass doors, a poor condition caravan, a steel drum and apparently empty intermediate bulk containers (IBC) (Photograph Appendix B.15). A suspected ACM clad shed is present at the rear of the property (Figure Appendix B.16). The suspected asbestos was observed to be in poor condition.

*Figure Appendix B.16: Suspected asbestos board on shed at rear of 157 Taihape Road on 28 February 2025. The suspected asbestos was observed to be in poor condition.*

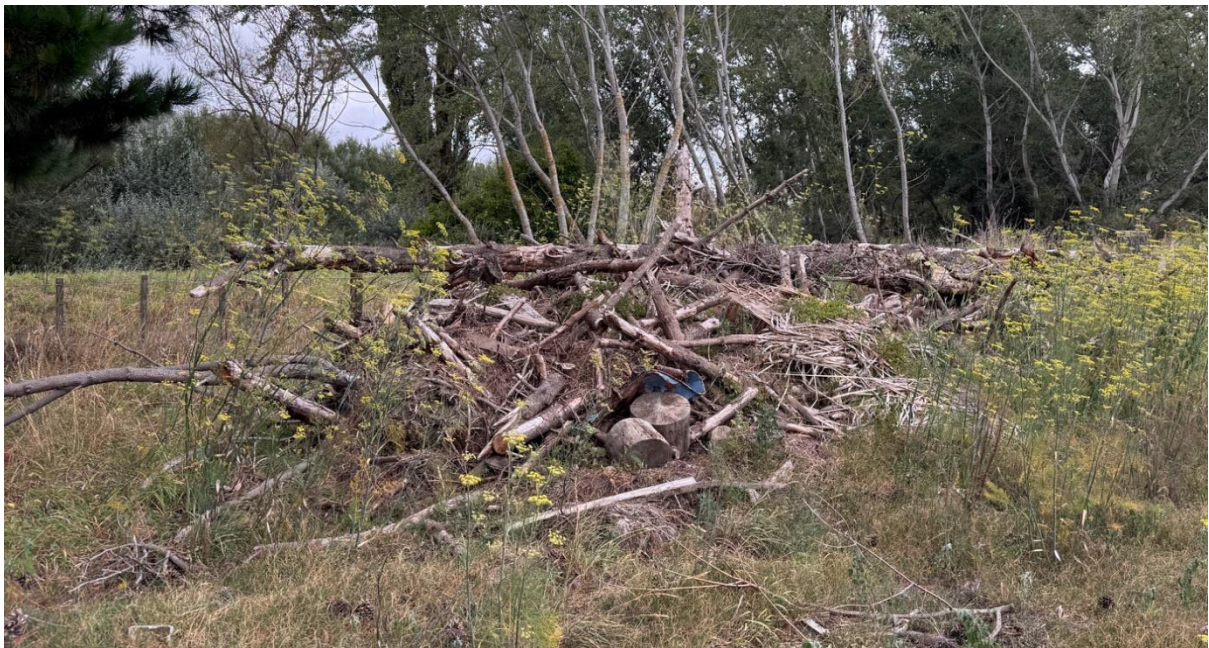
*Photograph Appendix B.18: Wood and branch stockpile with some metal at the western parcel boundary of 151 Taihape Road on 28 February 2025.*

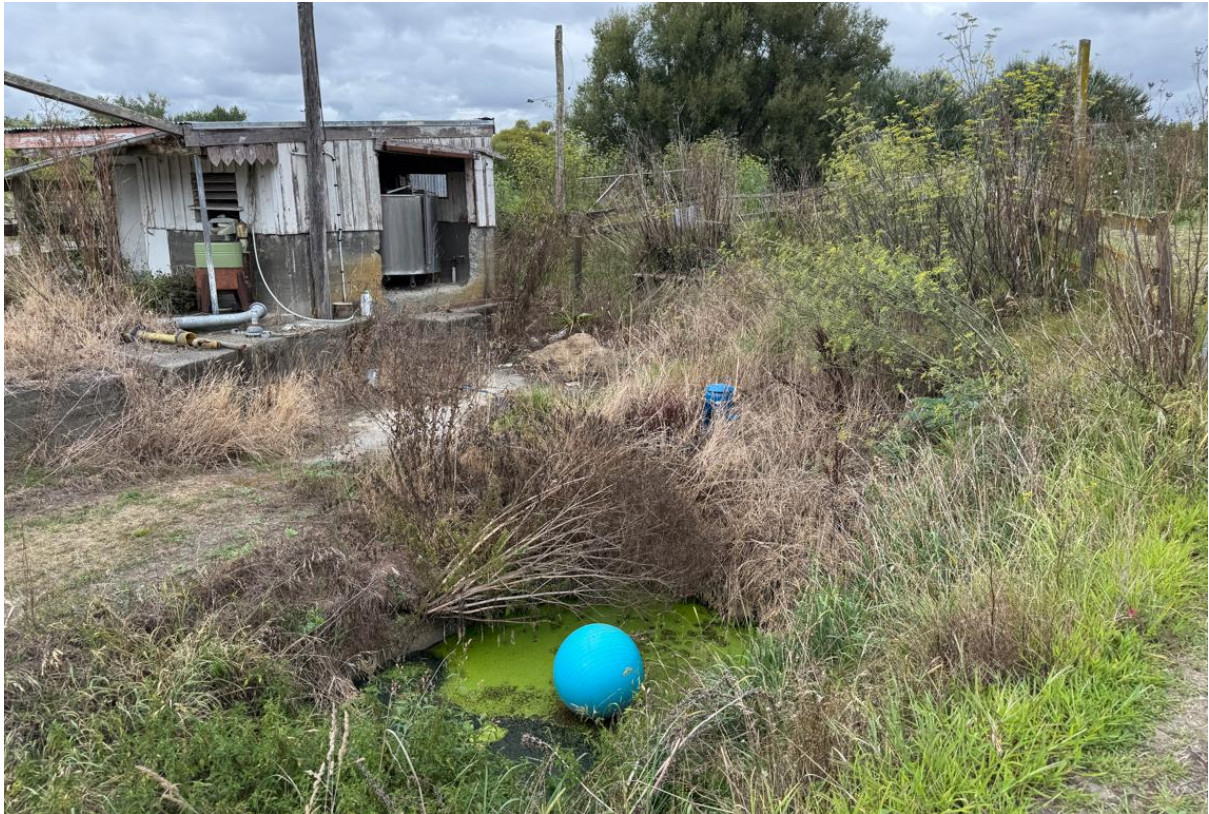
- The rear of the property at 131 Taihape Road appears to have been used for dairy milking with a milking shed and other farm buildings. Suspected asbestos cladding was identified on two buildings adjacent to the proposed stopbank alignment. The suspected asbestos was observed to be in poor condition. A water pump and surface water body were present south of the milking shed. Several small (< 10 L) containers of what appeared to be argi-chemicals and rodent poison were stored on the concrete floor of the shed, and an IBC with unidentified dark coloured liquid at 131 Taihape Road. A potential dairy effluent storage pond was present in the eastern portion of 131 Taihape Road, outside of site boundary. Refer to Photograph Appendix B.19 to Photograph Appendix B.23 in Appendix B.

*Photograph Appendix B.19: Suspected asbestos cladding on shed at the rear of 131 Taihape Road on 28 February 2025. The suspected asbestos was observed to be in poor condition. An assumed water pump and surface water body is present near the gate in the left of the photograph.*

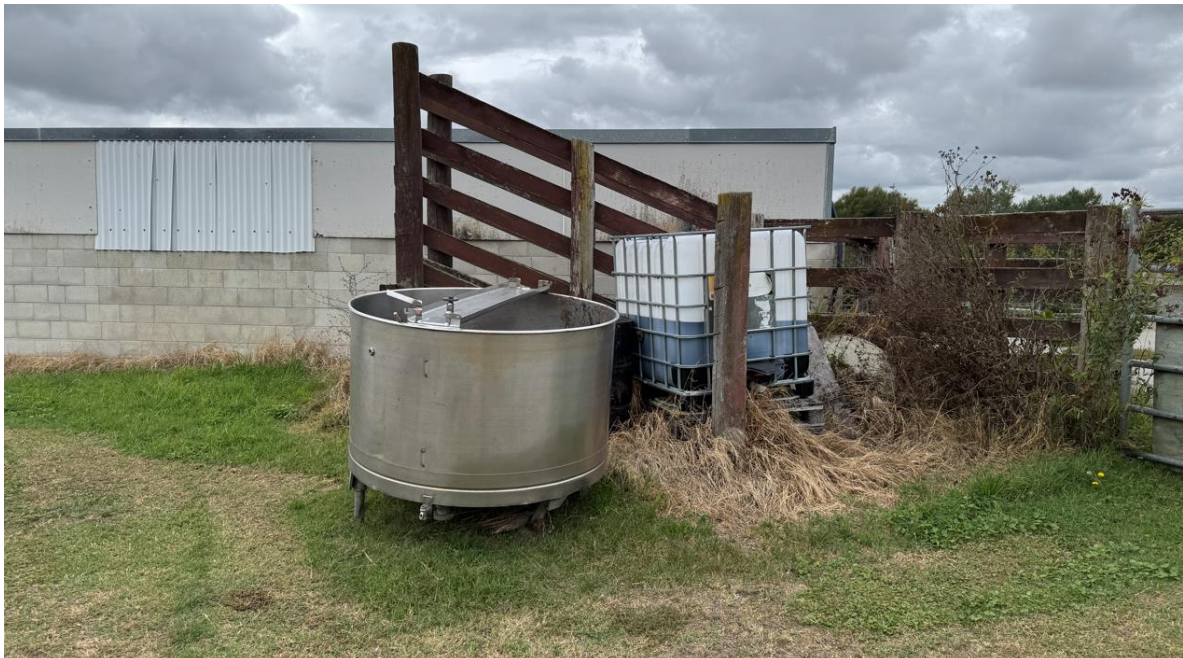
*Photograph Appendix B.20: Suspected asbestos cladding on the milking shed at the rear of 131 Taihape Road on 28 February 2025. The suspected asbestos was observed to be in poor condition. An IBC with unknown dark coloured liquid is present near the gate in the left of the photograph.*

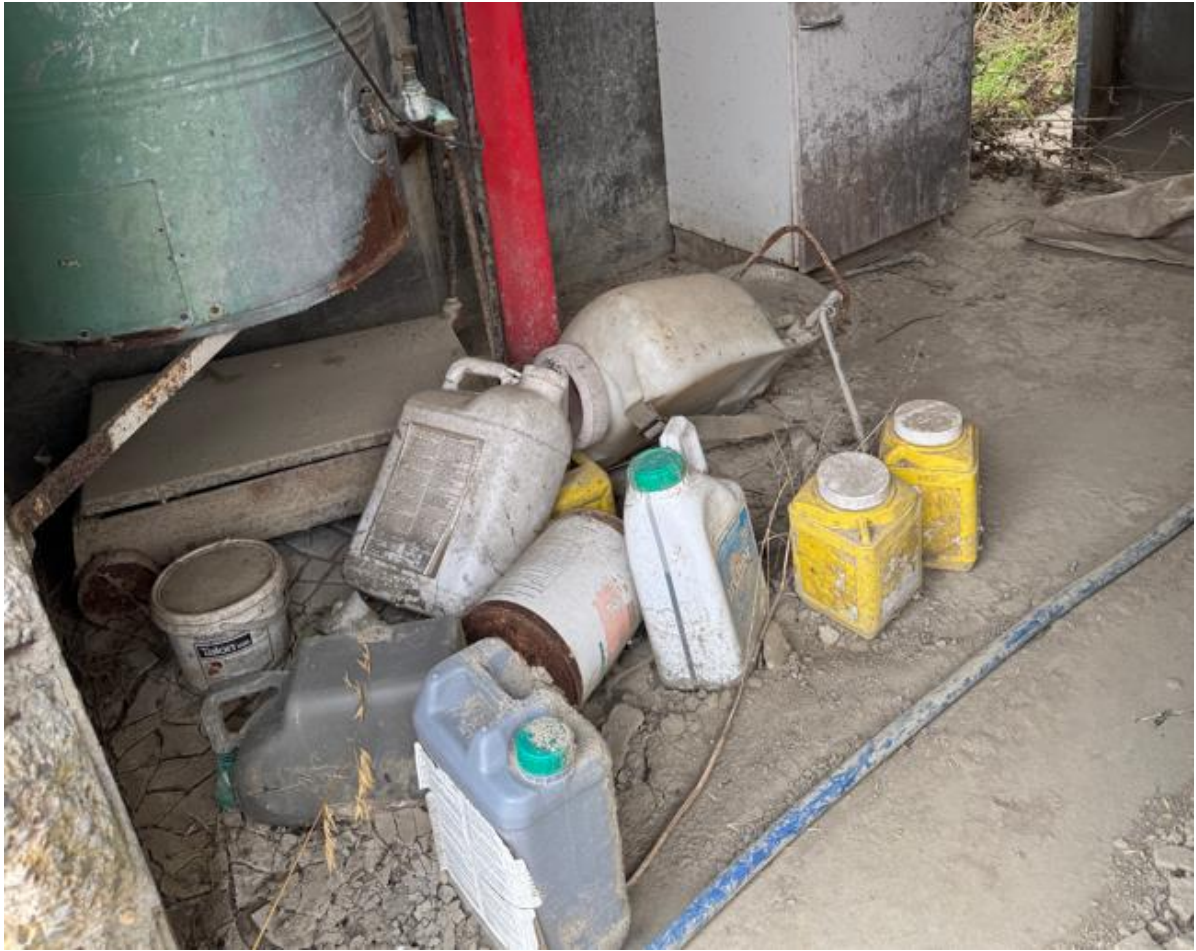
- No other visual or olfactory evidence of ground contamination was noted during sampling, including no surface staining beneath the IBC dispenser at 131 Taihape Road.

*Photograph Appendix B.21: Chemical storage within the shed at the rear of 131 Taihape Road on 28 February 2025.*

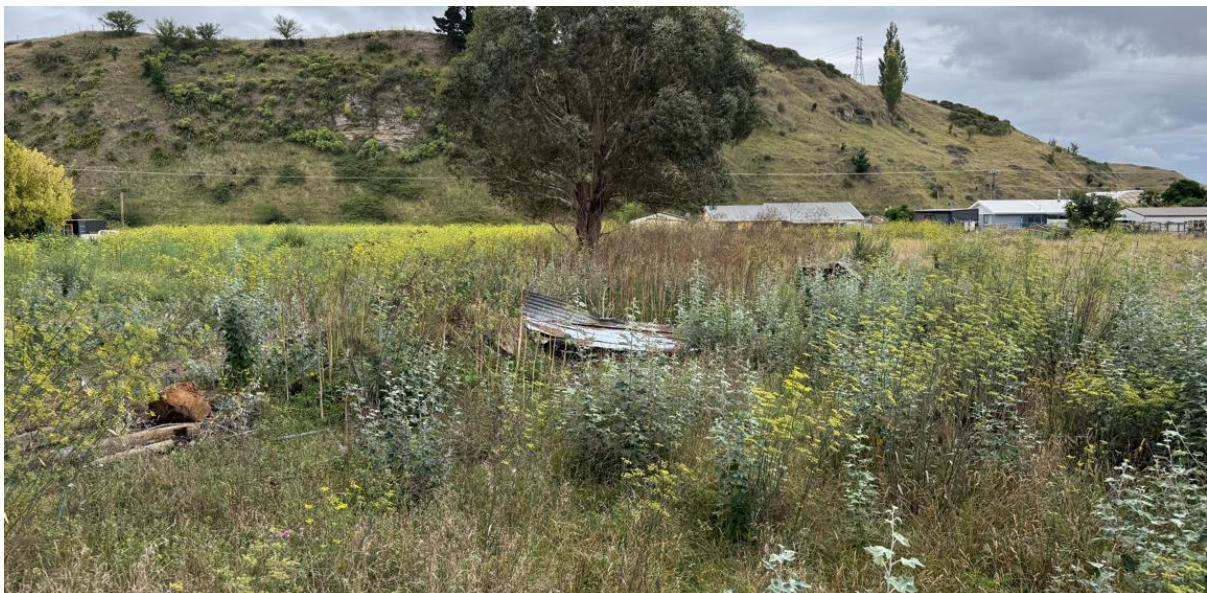
*Photograph Appendix B.22: Roofing iron stored on the ground at 131 Taihape Road on 28 February 2025.*

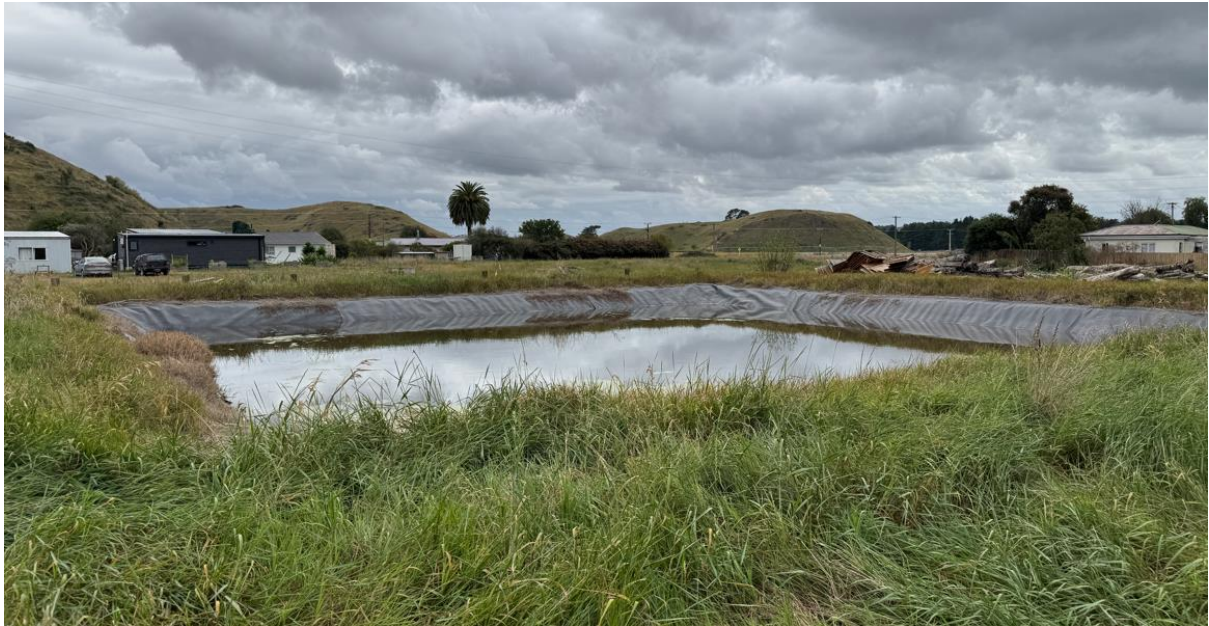
*Photograph Appendix B.23: Potential effluent pond east of the site boundary at 131 Taihape Road.*

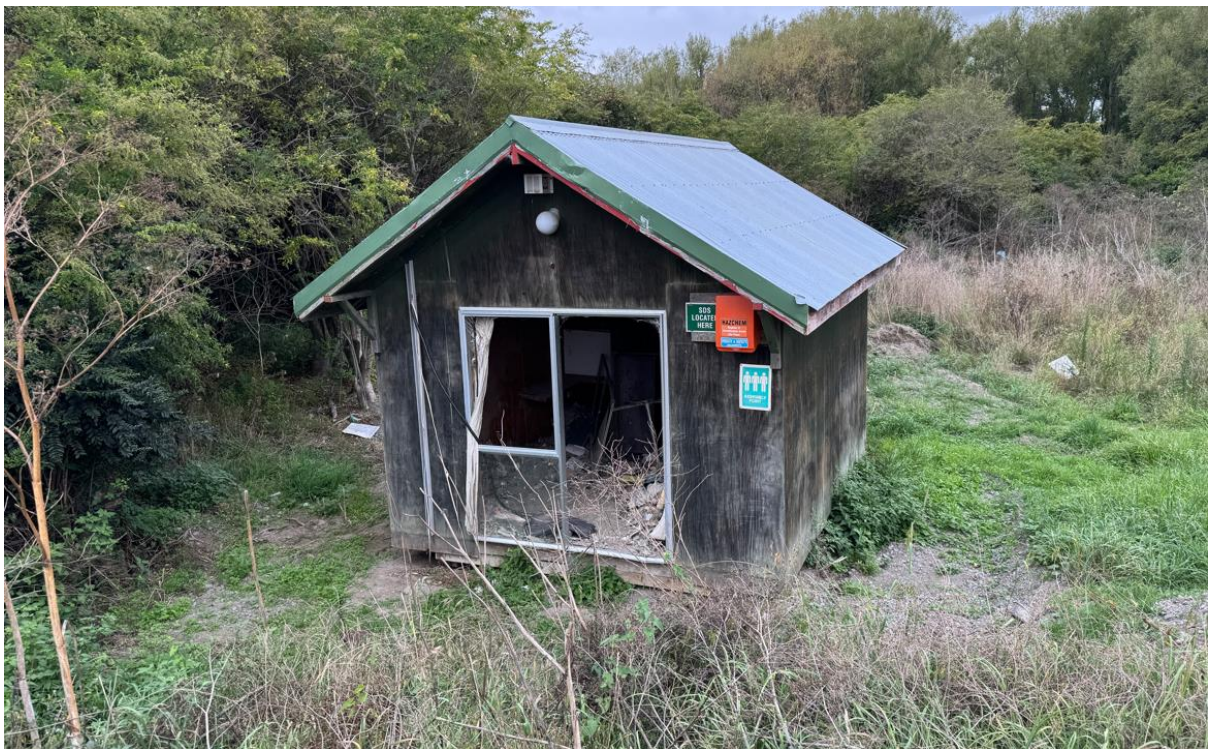
- A flood damaged shed constructed from wood cladding with an iron roof is present behind 109 Taihape Road (Photograph Appendix B.24). The shed is along the stopbank alignment.

*Photograph Appendix B.24: Flood damaged shed at 209 Taihape Road on 28 February 2025.*

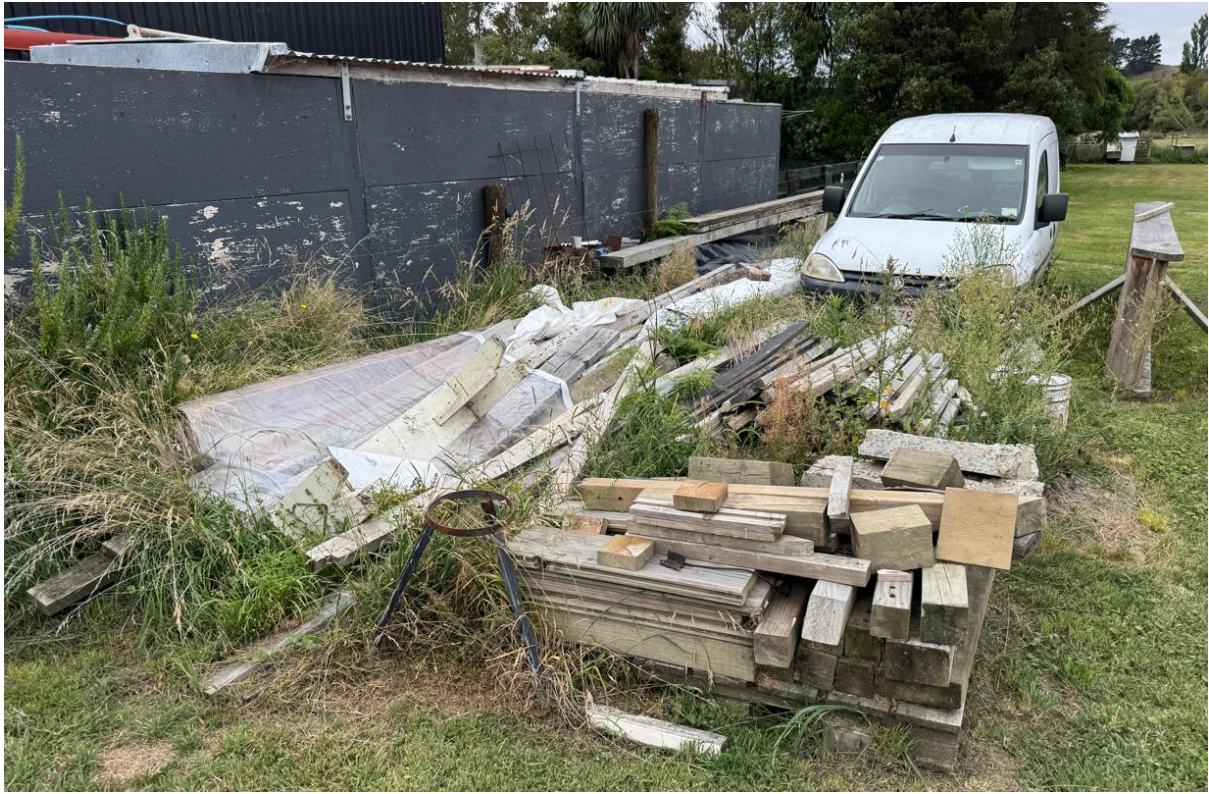
- A portion of property parcel Lot 1 DP 7904 south of 203 and 209 Ohiti Road, and 23 and 37 Ohiti Road is used for a variety of uses including a chicken enclosure, vegetable gardens and storage of building materials and vehicles. Two burn barrels were observed on 28 February 2025. Refer to Photograph Appendix B.25 to Photograph Appendix B.28. The proposed stopbank alignment is through this area.

*Photograph Appendix B.25: Building supplies and vehicles stored on the south of 209 Taihape Road on 28 February 2025.*

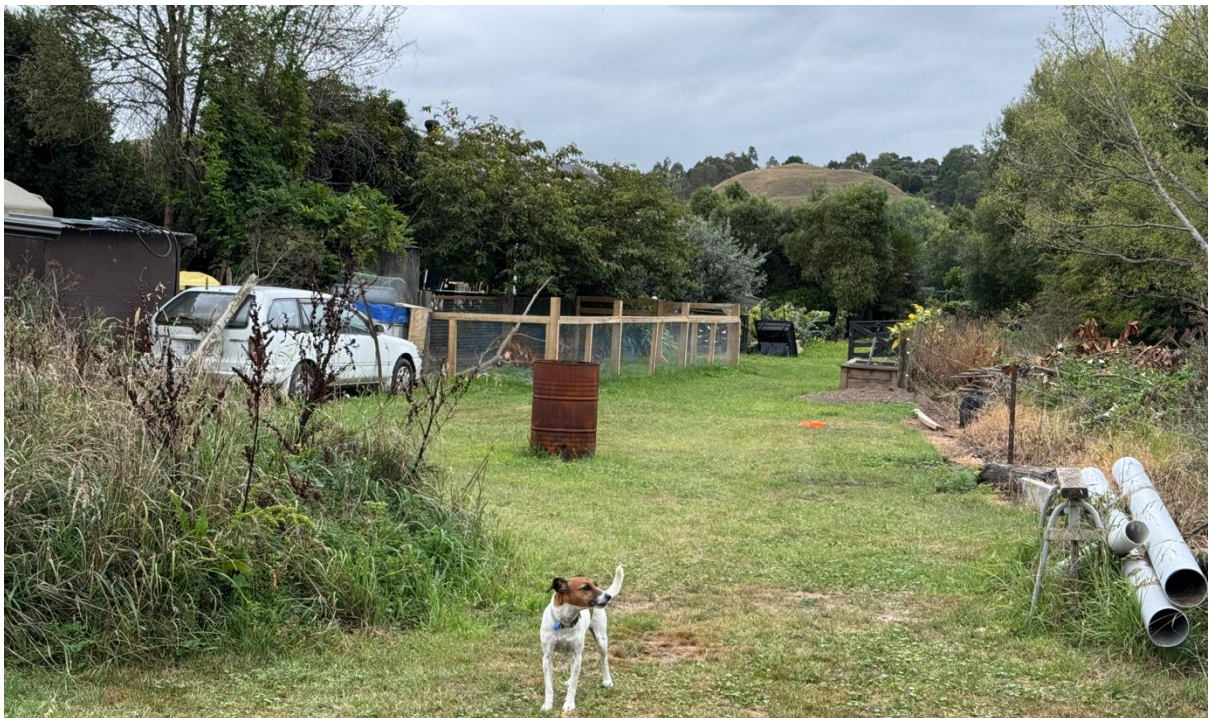
- Ash and charcoal fragments were encountered at soil sample location SS14 within the burn barrel adjacent to 27 Ohiti Road.
- 11 small stockpiles were observed behind 203 Ohiti Road with each stockpile being approximately 3 m in length by 1 m in width and approximately 1 m high. The stockpiles comprised of sandy silt (inferred reworked natural material) with traces of general rubbish including glass, plastic and concrete. The estimated total volume of the stockpiles is 15 to 20 m<sup>3</sup>.

*Photograph Appendix B.26: Vehicles and burn barrel located on the land south of 27 Ohiti Road on 28 February 2025.*

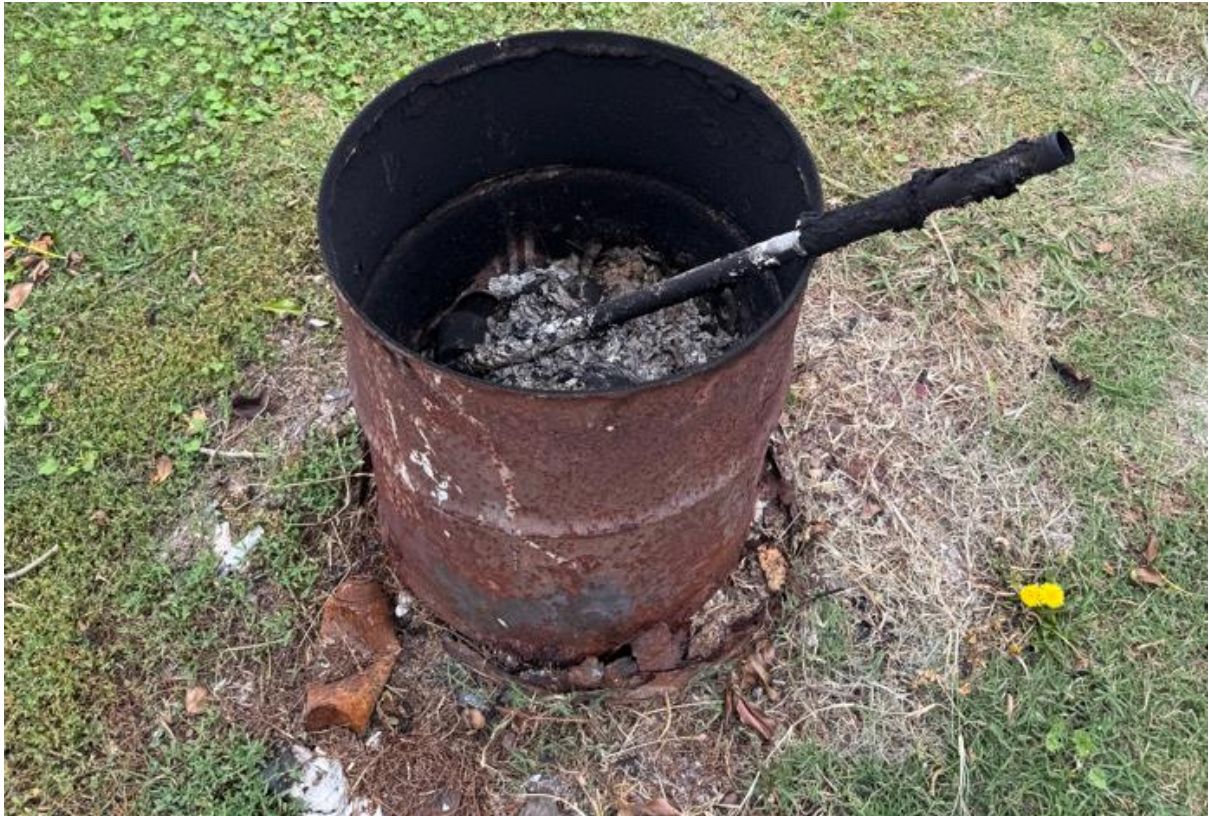
*Photograph Appendix B.27: Burn barrel located on the land south of 209 Taihape Road on 28 February 2025.*

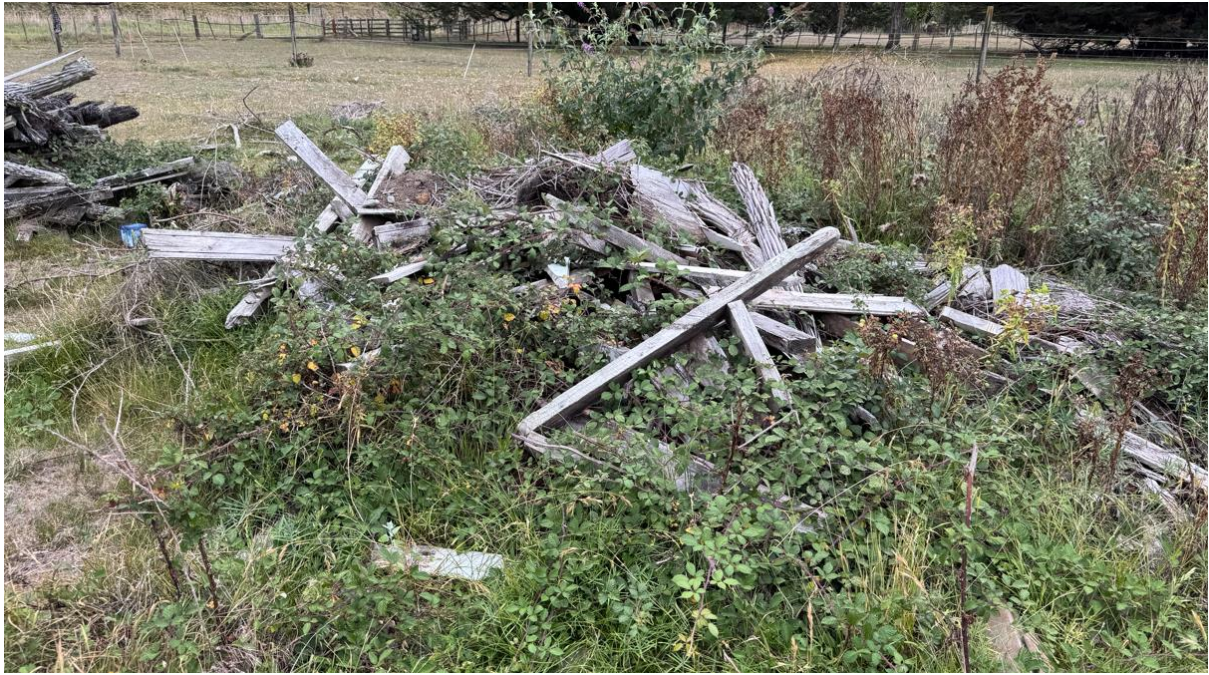
- The property parcel south of 39 Ohiti Road has large burn stockpiles at the front of the property near Ohiti Road. This property parcel is on the proposed stopbank alignment. The stockpiles comprise of wood/trees, old doors and suspected asbestos containing materials (Photograph Appendix B.29 and Photograph Appendix B.30). Charcoal fragments from previous burn piles were observed (Photograph Appendix B.31). Beehives occupied the southern portion of the property parcel (Photograph Appendix B.32).

*Photograph Appendix B.29: Property south of 39 Ohiti Road on 28 February 2025. Apparent burn piles of timber and trees with some building materials.*

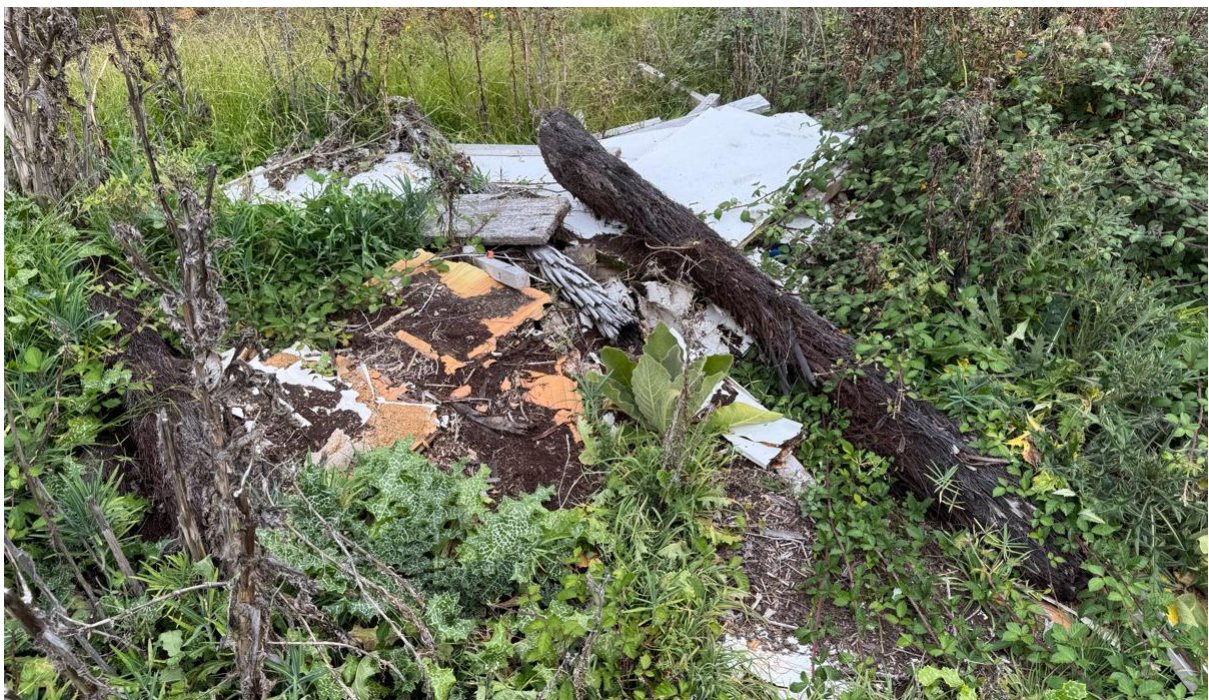
*Photograph Appendix B.30: Property south of 39 Ohiti Road. Large piles of timber and trees.*

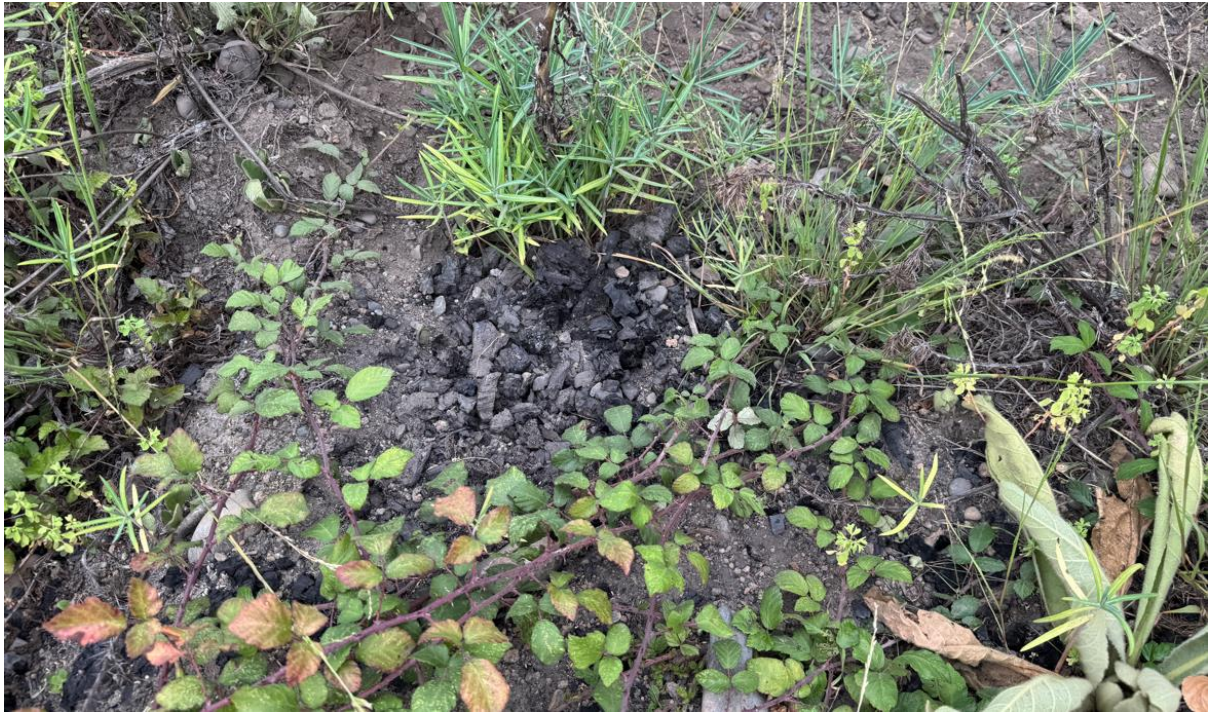
*Photograph Appendix B.31: Charcoal observed on the ground on the property south of 39 Ohiti Road indicating location of a previous burn pile.*
