# **Ecological Assessment for Pākōwhai Pump Station Upgrade**

Andy Hicks

16 July 2026

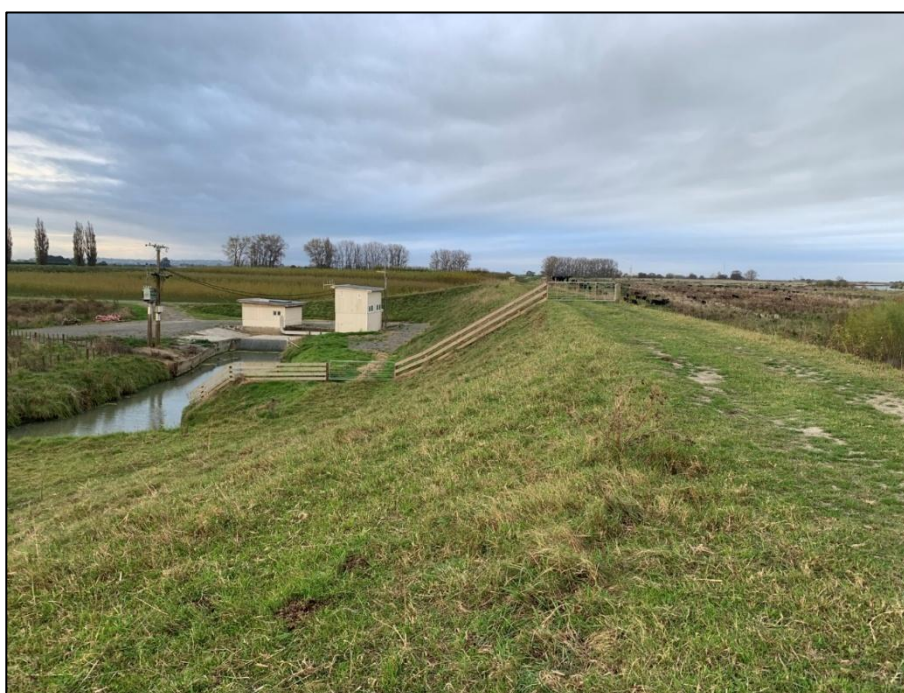
**Figure 3.** Stopbank habitat unit

The stopbank corridor comprises an engineered bund, with compacted fill, access tracks, and maintained grass cover (**Figure 3**). Vegetation is dominated by exotic species (see **Table 5**), is often sparse and low-growing and subject to regular disturbance and maintenance. This habitat unit has negligible ecological value (see **Table 5**) other than for transient use by common fauna.

This habitat unit has a current ecological value of Negligible. The proposed activity will involve construction works within an already highly modified stopbank environment dominated by maintained exotic grasses and associated infrastructure. While construction will temporarily disturb or remove existing vegetation within the immediate footprint, the affected habitat is of very low complexity, is routinely maintained, and will be reinstated to a similar low-value condition following completion of the works. In that context, the expected magnitude of effect is Low. Based on the current ecological value of Negligible, the resulting level of effect is Very Low.

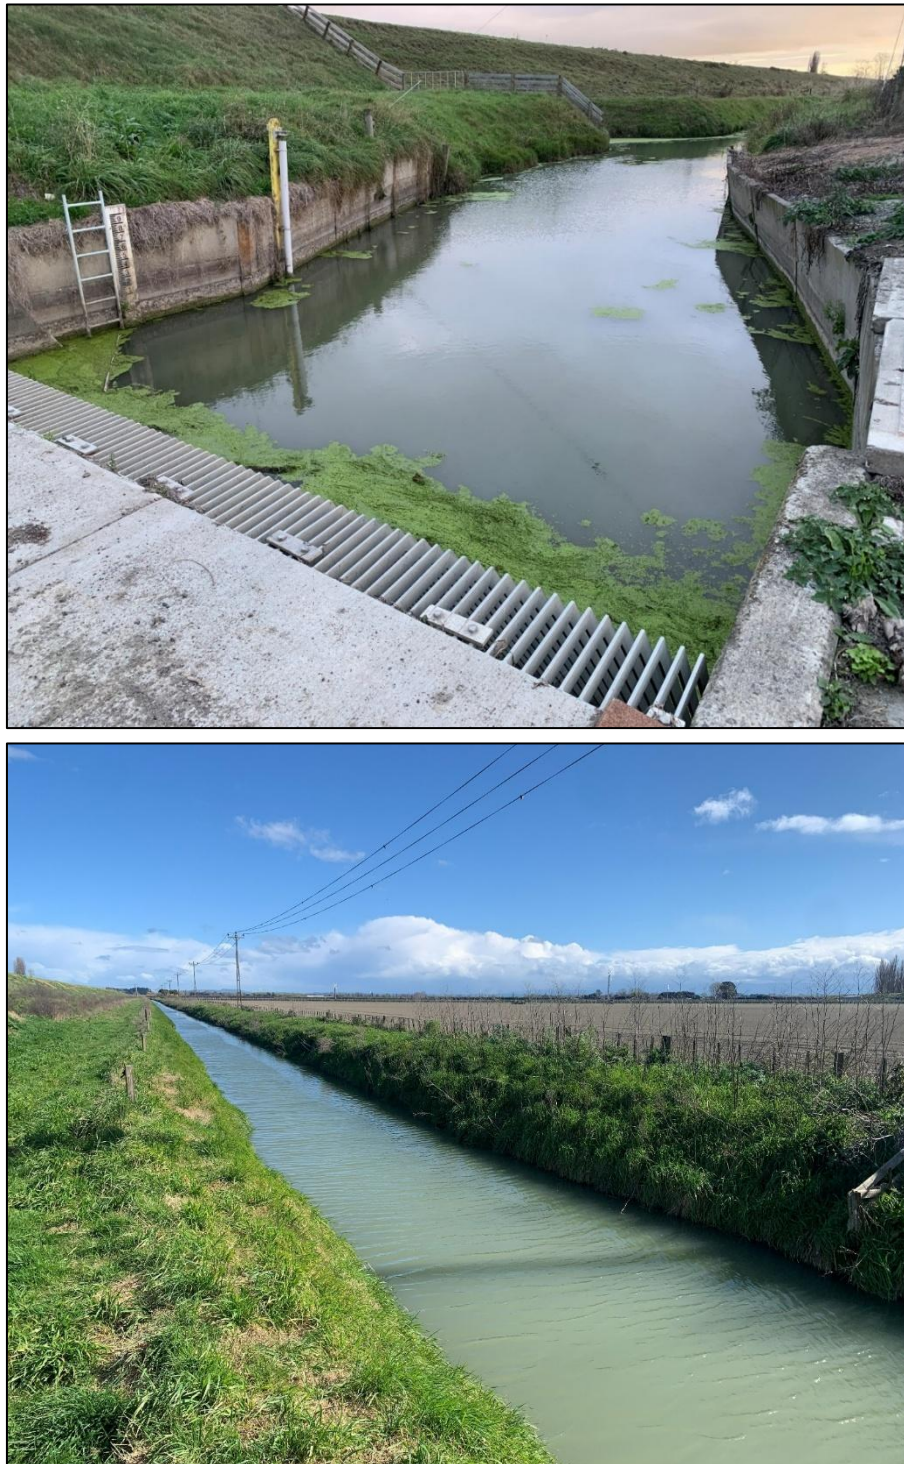
**Figure 4.** Stream and riparian margin habitat unit. Top, looking up the main inflow. Bottom, looking across the riparian margins.

This habitat unit consists of a modified stream channel with associated riparian margin adjacent to the pump station infrastructure (**Figure 4**). The channel is highly engineered with incised banks. Riparian corridor is narrow and largely composed of exotic and opportunistic species that are frequently mown (**Table 7**). While habitat quality is degraded, this unit provides connectivity within the wider drainage system and receiving environment and is relevant for being a key node for fish passage to the upstream catchment which leads to an ecological value of moderate due to the aquatic values supported (**Table 8**).

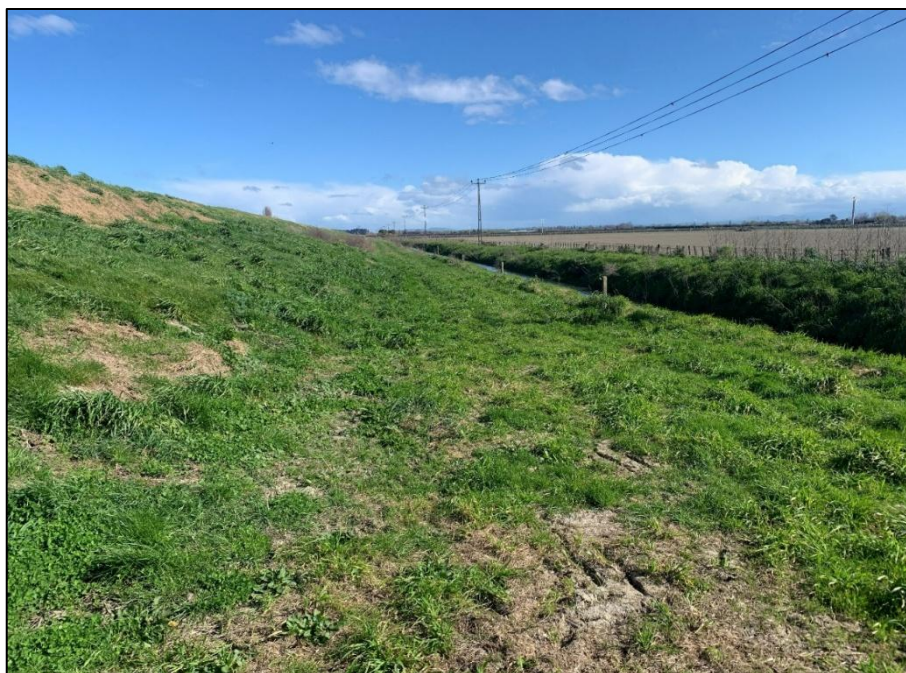
**Figure 5** Stream berm habitat unit

A narrow berm-like feature between the stream margin and stopbank toe (Figure 5). The area looked to have been disturbed recently with as much pasture associated weed species as grass (Table 9). This habitat has negligible ecological value (Table 10) but may provide transitional habitat for common wetland-associated fauna, especially during wetter periods.

The stream berm habitat unit has a current ecological value of Negligible. It is a repeatedly disturbed pasture environment with high prevalence of weeds and very low habitat complexity with negligible ecological function. Construction effects within this unit will be confined to further temporary disturbance of an already artificial and recently modified habitat type. The expected magnitude of effect is therefore Low, noting that the habitat can be readily reinstated to an equivalent condition. When compared with a current ecological value of Negligible, the resulting level of effect is Very Low.

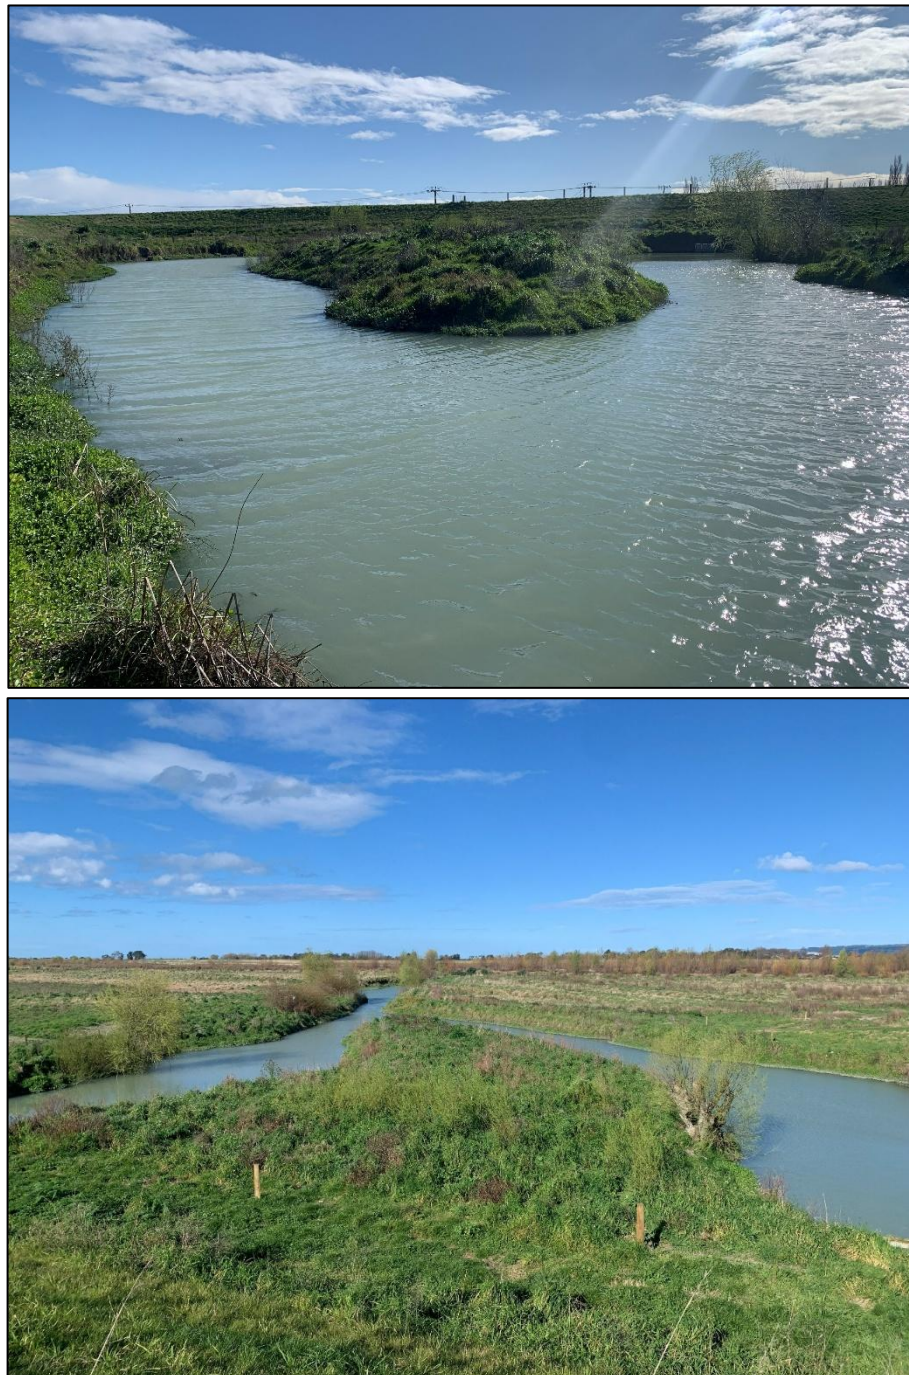
**Figure 6.** River and Riparian habitat unit

While two indigenous wetland species were recorded along the water's edge, riparian and berm vegetation is dominated by exotic grasses and herbs (**Table 11**). Consequently, the ecological significance of this habitat unit is derived primarily from its role as aquatic habitat and a fish passage corridor, rather than from its current vegetation values.

Overall, while the terrestrial riparian margins are highly modified and support relatively limited indigenous biodiversity values, the combined river and riparian habitat unit is assessed as having High ecological value due to its connection to the highly significant Ngaruroro River itself, the channel's role in supporting indigenous fish communities, and its importance in maintaining freshwater connectivity to the upstream catchment (**Table 12**)

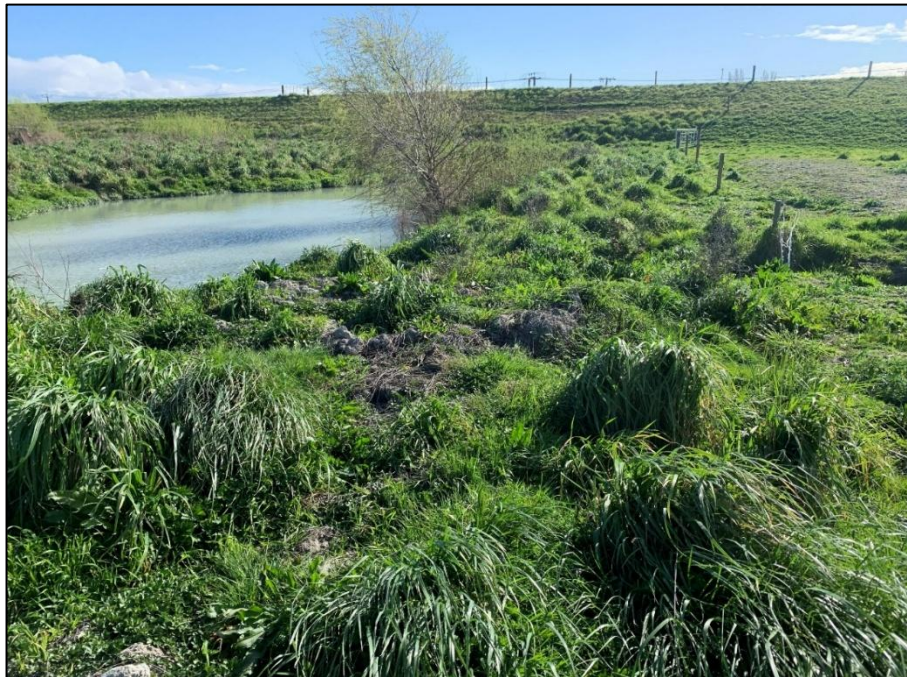
**Figure 8.** River Berm habitat unit

The habitat unit comprises flat to gently sloping, low-lying land associated with the river berm areas around the Pump Station discharge point and associated channels (**Figure 8**). Vegetation within the lowland unit is dominated by rank grass and associated exotic pasture species with some crack willow (**Table 15**). No indigenous plant species were observed, and the structural diversity is primarily rank grassland. The area is subject to periodic inundation during high river flows. This habitat unit has been assessed as having low ecological value (**Table 16**).

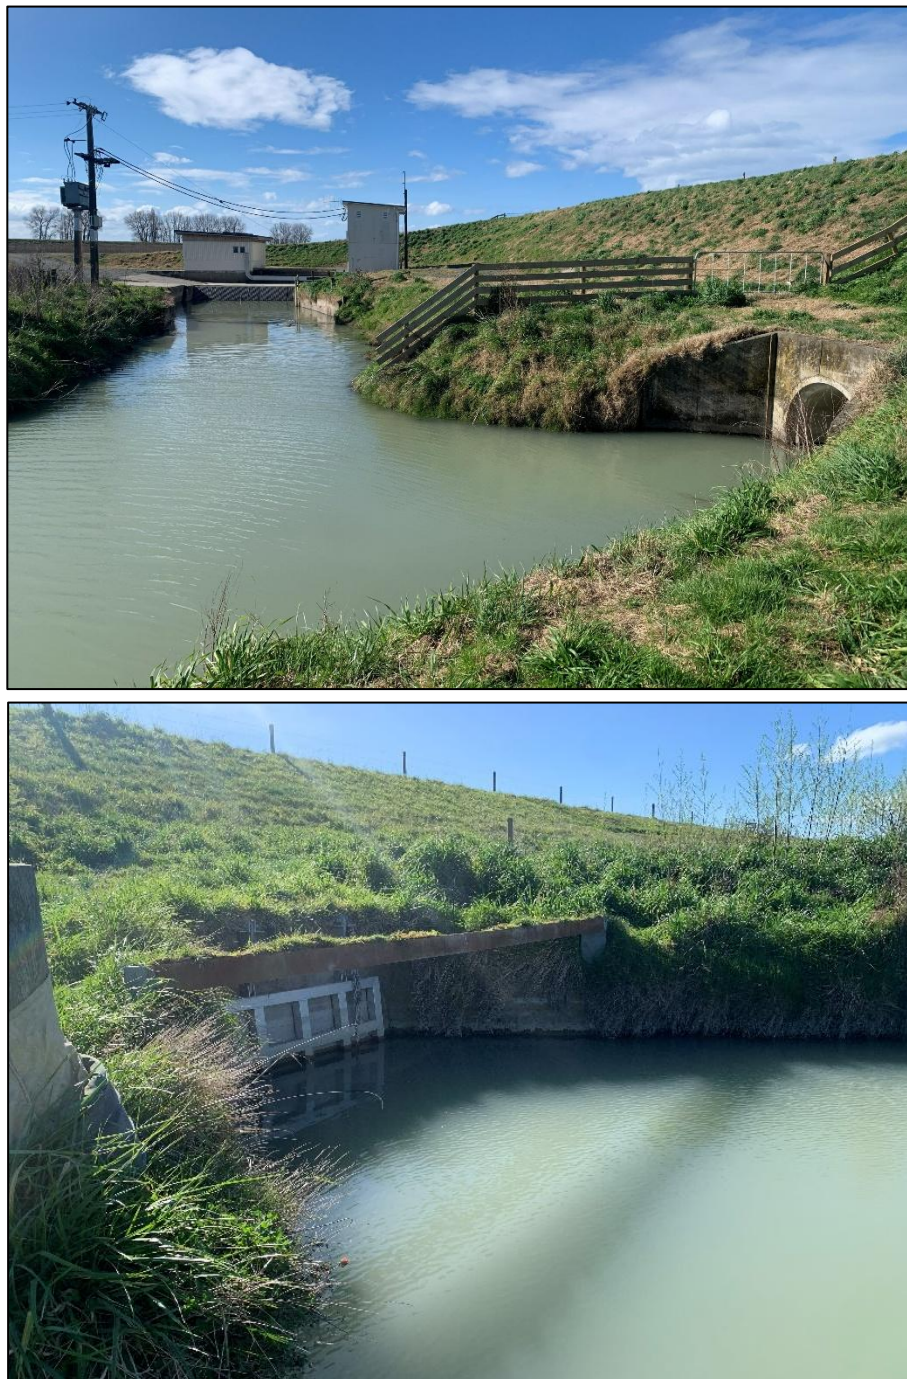
**Figure 9.** Gravity outflow upstream of Pākōwhai Pump Station. Top, the inlet side of the gravity flow bypass flowing to the right of image, with the existing Pump Station in background. Bottom, outlet side of gravity bypass, with conventional flap gate shut due to ambient river level.

In addition to improving downstream passage conditions, the proposal also provides for upstream fish passage. The existing gravity outlet through the stopbank will be retained and modified to facilitate fish movement between the Ngaruroro River and the upstream drainage network. Detailed design of the proposed fish passage provisions has not yet been completed, and the final configuration will be confirmed during subsequent design phases. For the purposes of this assessment, it has been assumed that the fish passage design will function as intended, resulting in an improvement in upstream fish passage and aquatic connectivity relative to the current situation. This will maintain and enhance aquatic
