## **PRELIMINARY SITE INVESTIGATION: PAKOWHAI PUMP STATION, FARNDON ROAD, HASTINGS DISTRICT**

### **1.0 Introduction**

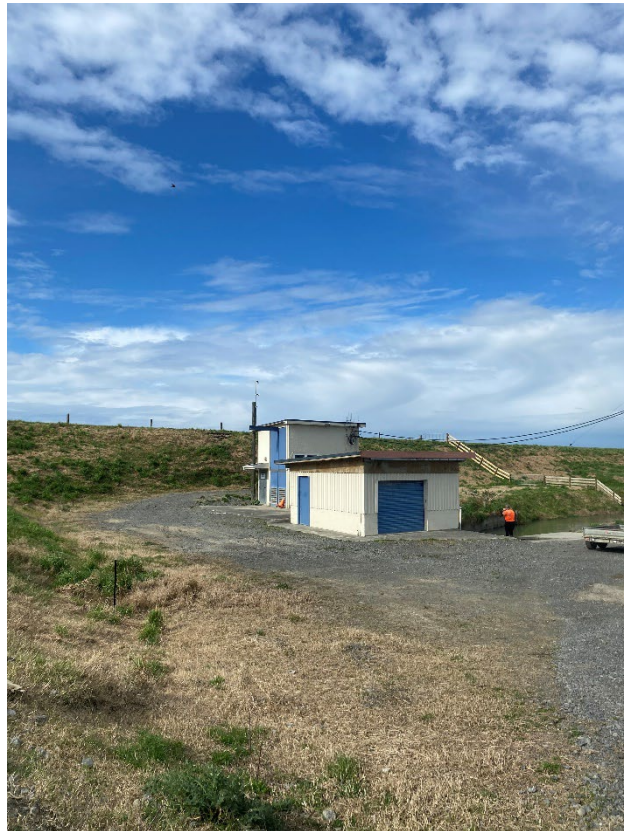
**Photograph 1: View from the western section of the site, looking south-west towards the two buildings that make up the pump station.**

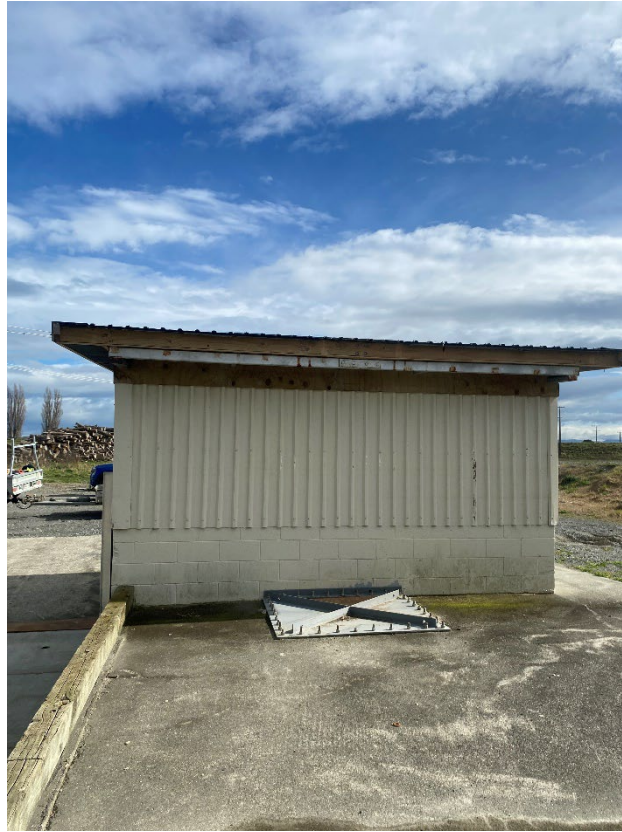
**Photograph 3: View facing the western pump station building.**

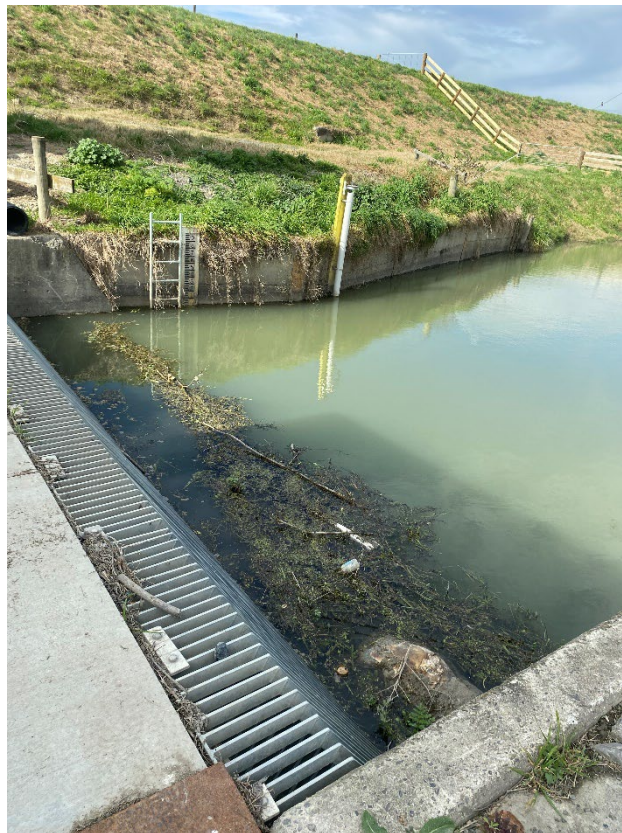
**Photograph 4: View from the edge of the pump station's concrete slab, looking south-west along the main drain channel adjacent to the pump station.**

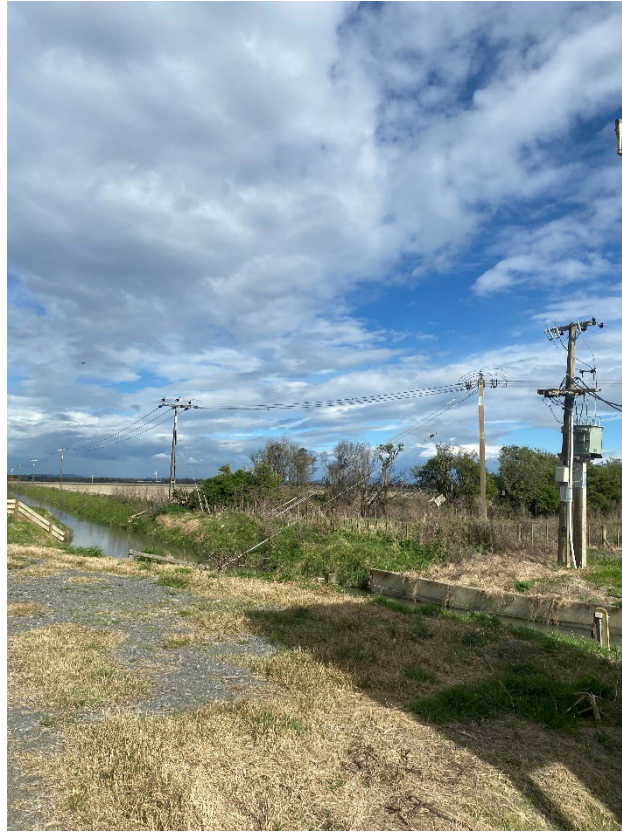
**Photograph 5: View of the overhead power lines running south-west along the edge of the main drain channel, supplying power to the pump station.**

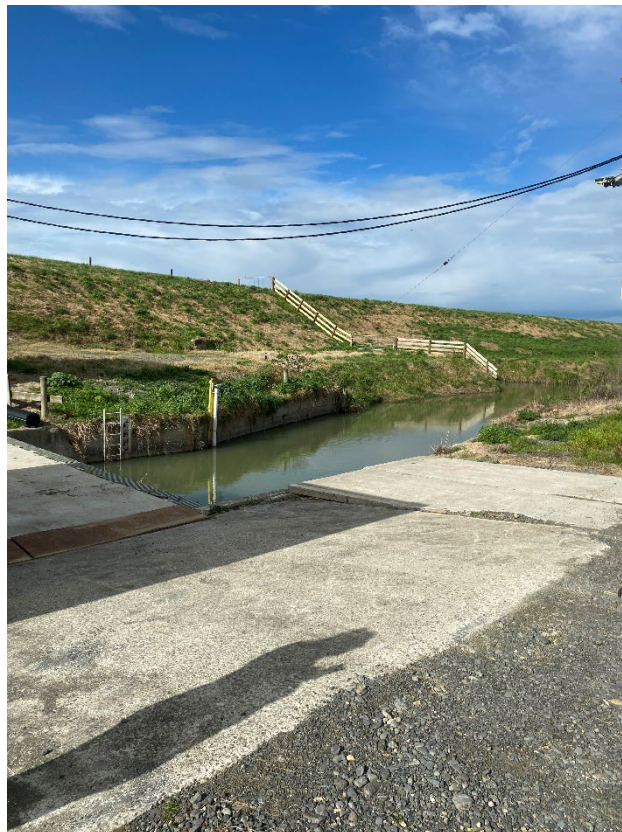
**Photograph 6: Overhead cables connected to the taller pump station building.**

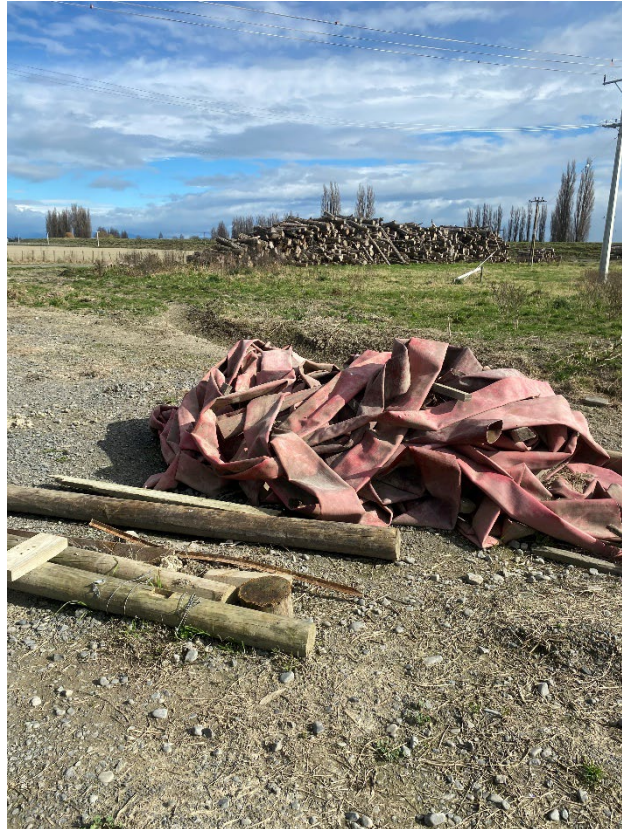
**Photograph 7: The area has been largely cleared of Cyclone Gabrielle silt, with some stockpiled logs adjacent to the site, along with small stockpiles of an old red hose and remnants of old fencing.**

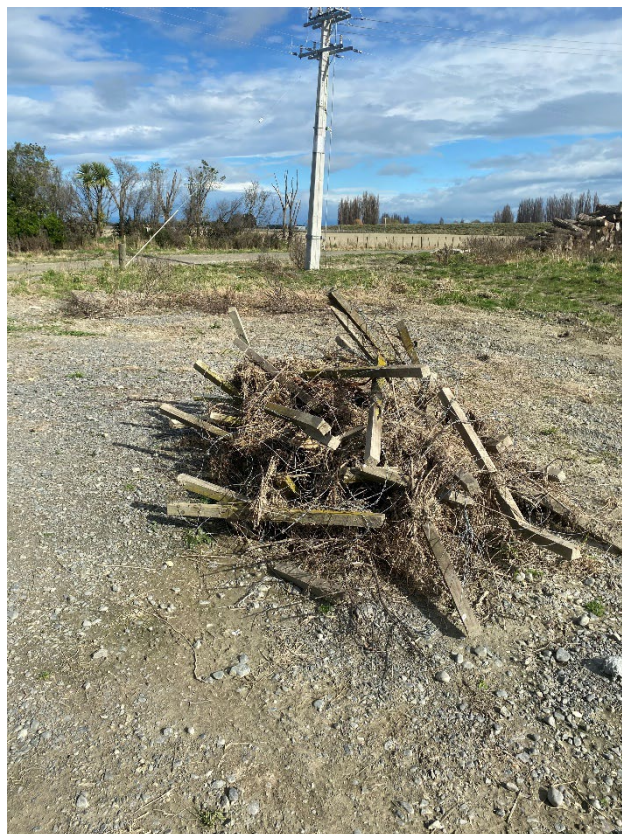
**Photograph 8: Pile of old fencing remaining from Cyclone Gabrielle nearby the site.**

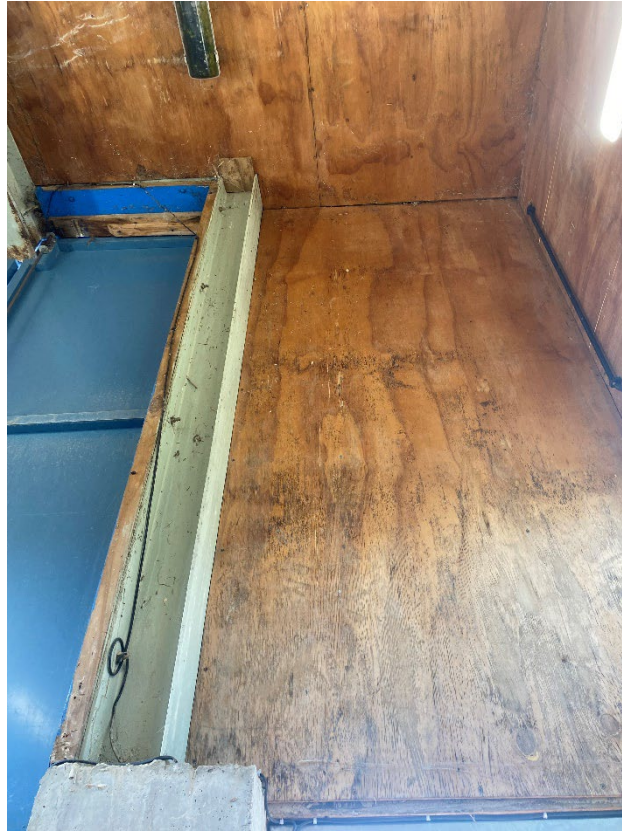
Cyclone Gabrielle in February 2023 inundated the site, submerging both pump station buildings and leaving the area covered in a layer of silt. The northern building required roof repairs due to the extent of the flooding.

**Photograph 9: Interior of the taller pump station building, showing remaining wetness on the ceiling from the flood.**

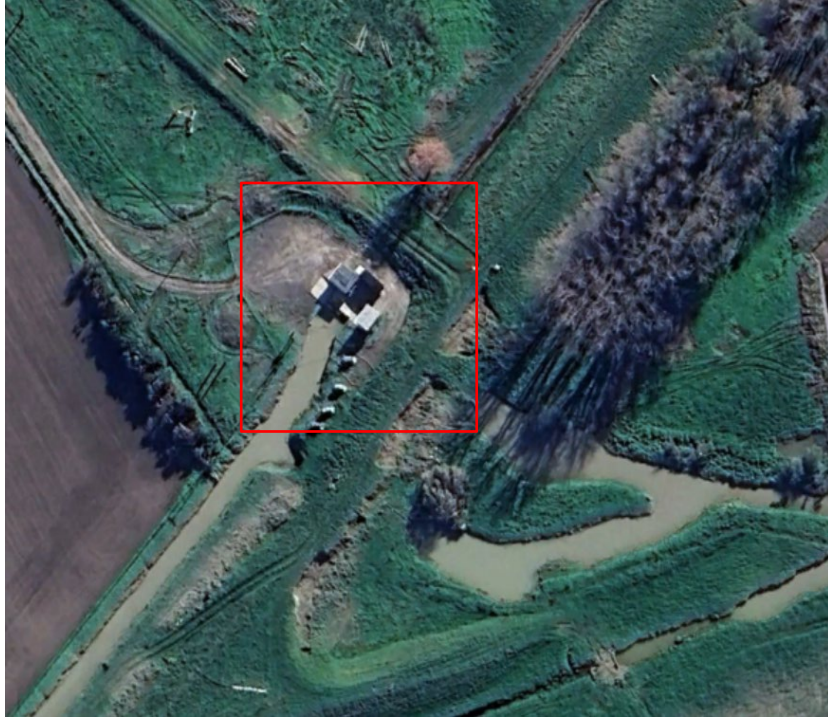
| <b>2023<br/>(February)</b> | Evidence of damage from Cyclone Gabrielle is visible, including objects resembling earth-moving equipment and land covered in mud and silt. The water in the drains and rivers is heavily sedimented. The northern building appears to be missing its roof or undergoing repairs. |

**Historical Aerial Image – 19-20 February 2023** (Source – LINZ). The site is highlighted in red.
