Geotechnical Assessment Report

Pakowhai Secondary Stopbank

Prepared for
Hawkes Bay Regional Council

Prepared by
Tonkin & Taylor Ltd

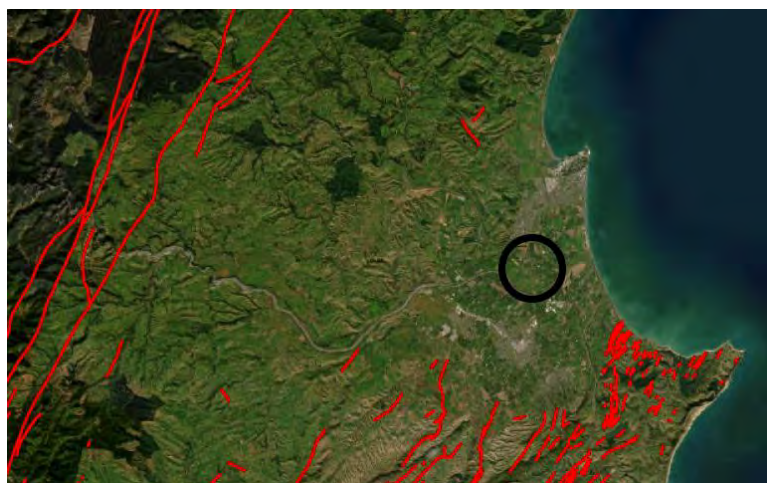
Figure 2.2: Active faults (faults indicated in red, general site location circled in black)¹¹.

The GNS active faults database¹¹ identifies numerous southwest to northeast trending active faults across the western ranges and southern Hawkes Bay region, approximately 10+ km south of the site. The Hikurangi subduction zone, offshore of Hawkes Bay, presents a more significant seismic hazard

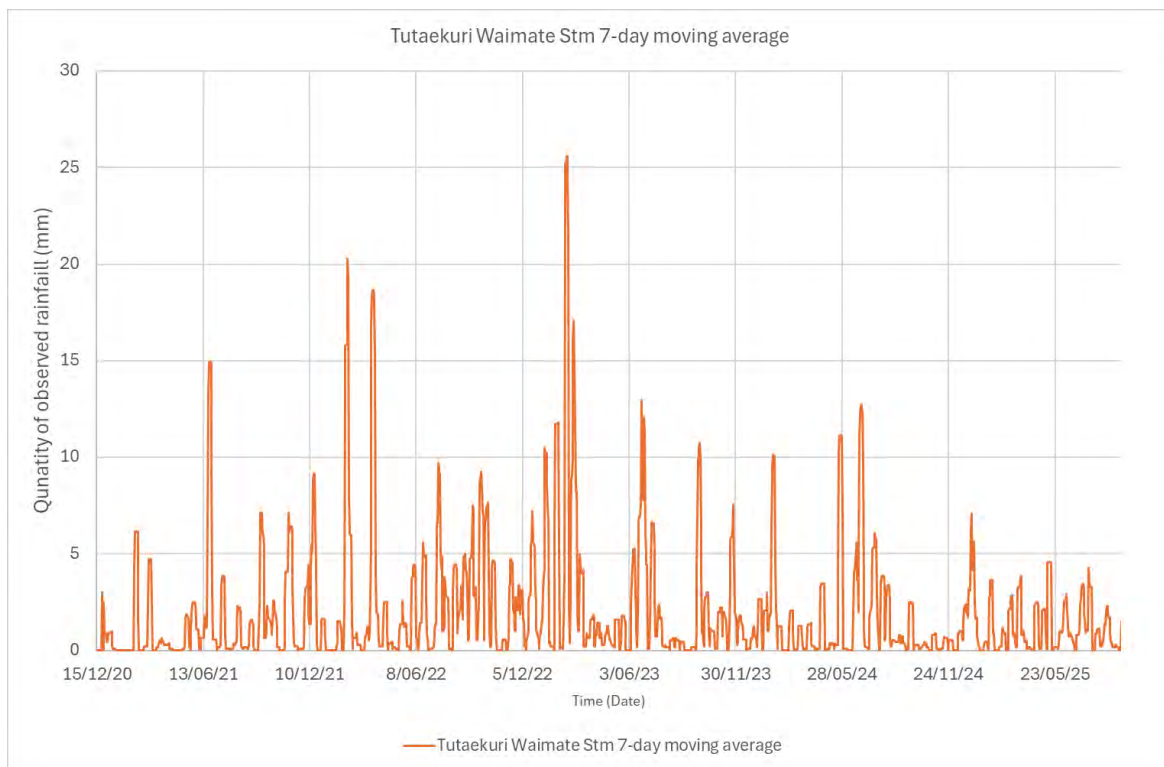
Figure 3.2: The observed rainfall at the Tutaekuri Waimate Stream at Chesterhope weather station.¹⁵

We note this period (August 2024) was not necessarily a wet period of year. Therefore, during times of excessive rainfall, the groundwater may be high than what we have measured. The observed rainfall at the Tutaekuri-Waimate stream is shown in Figure 3.2.

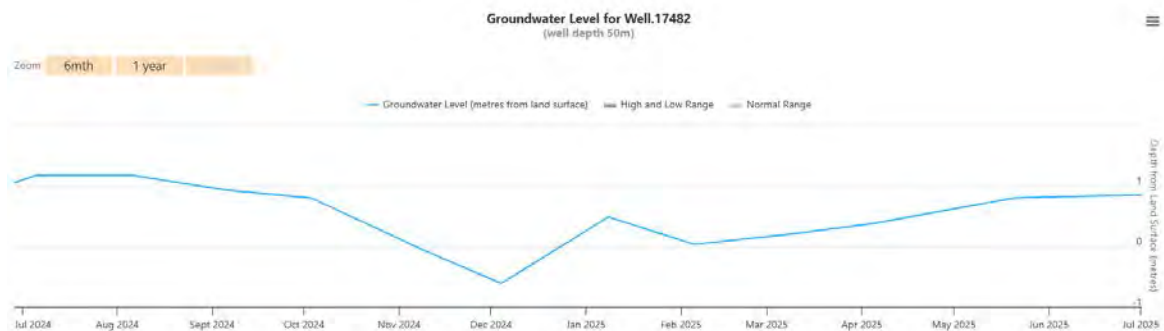
Figure 4.1. One year groundwater monitoring data at Well 17482.

Figure 4.1 presents the groundwater monitoring data from Well 17482, illustrating groundwater level fluctuations over the past year.

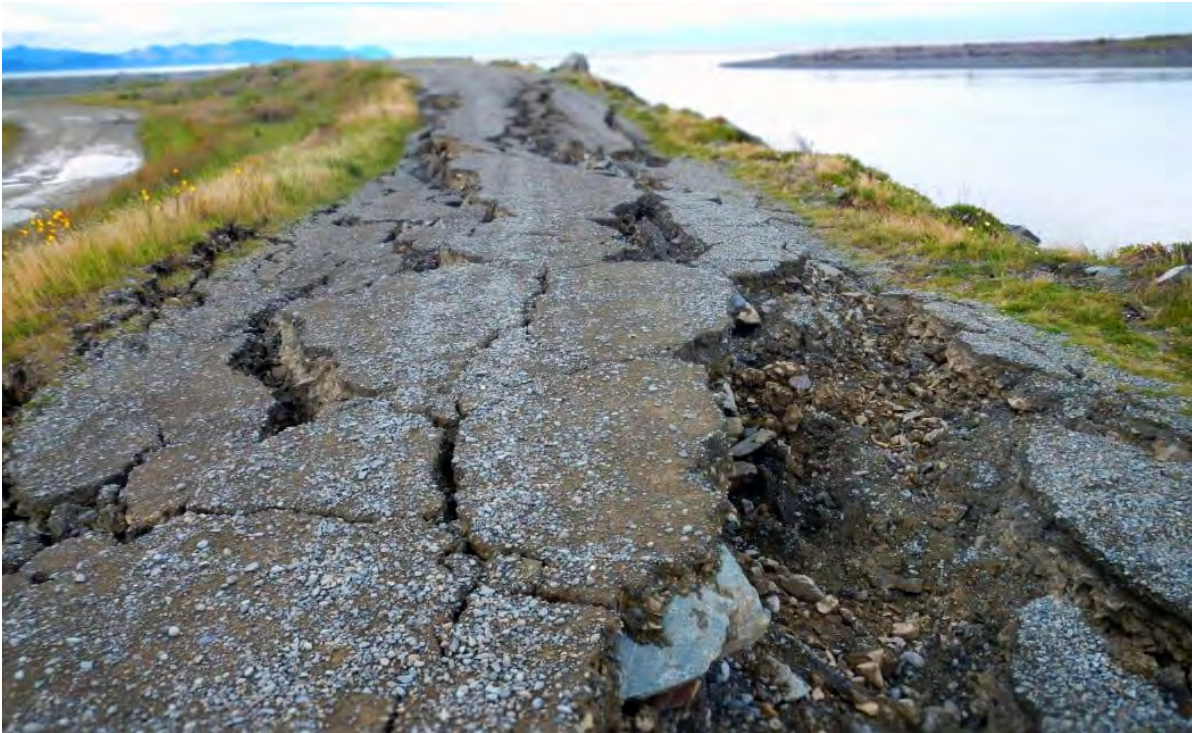
Figure 5.1: A photo showing lateral spreading along a flood protection system²⁰.

Given the stopbank itself can have additional fill placed to bring the flood protection back to the design level following free-field settlements during a seismic event, the primary concern are areas susceptible to near-surface liquefaction with a free-face (e.g. river bank), which could result in lateral spreading into the adjacent stream. This may require a complete rebuild of the damaged stopbanks following a seismic event. An example of this damage is shown in Figure 5.1.

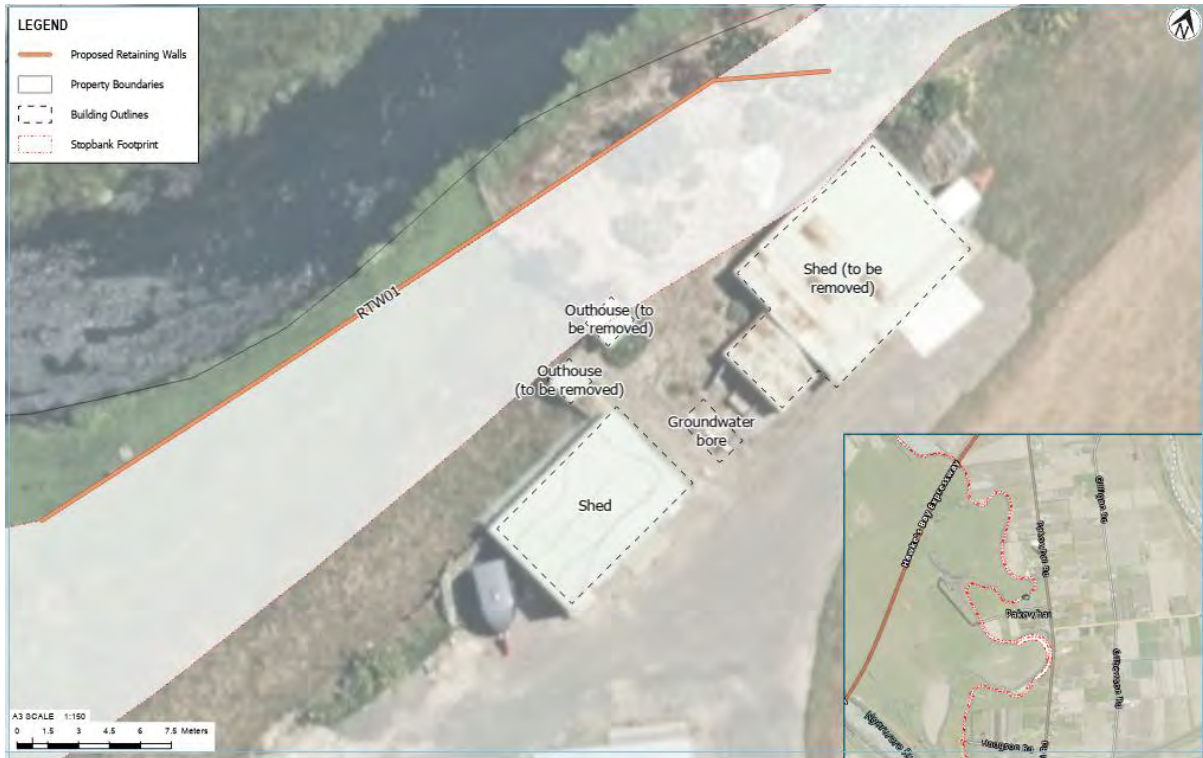
Figure 6.3: The layout of the property at 24 Chesterhope Road with one of the retaining wall options assessed.

The stopbank alignment within the property at 24 Chesterhope Road is constrained due to several nearby structures. Figure 6.3 shows the site layout with one of the proposed retaining options.

This site area has limited ground investigations, but is understood to have significant soft ground at shallow depths. This soft ground is positioned where the maximum resisting forces are applied for typical retaining solutions. Therefore, a significant retaining structure will be required to meet the flood protection level of service.

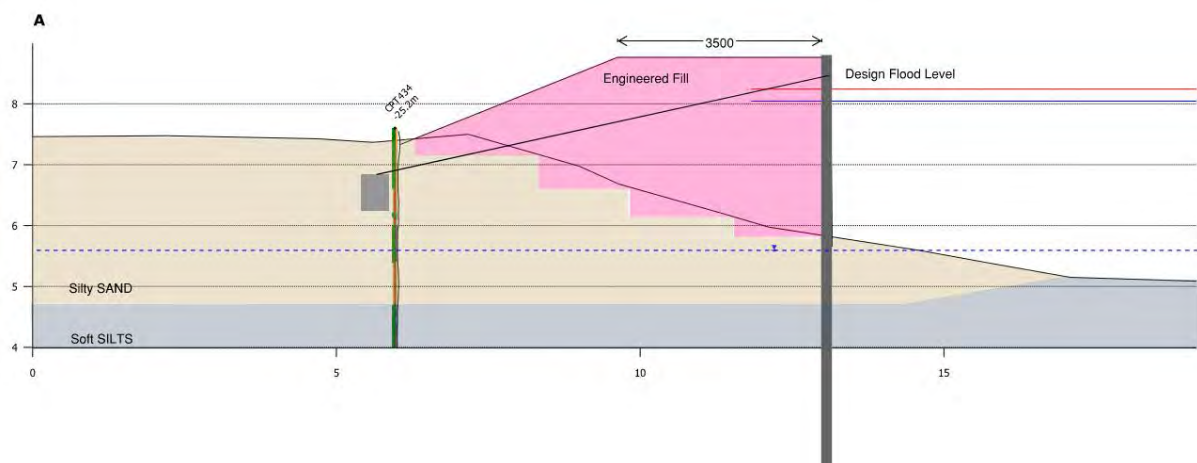
Figure 6.4: A typical cross section of the kingpost with an anchored solution of the proposed retaining option.

We have undertaken a preliminary WALLAP²² analysis using geotechnical design parameters derived from the nearby CPT434. We have updated soil properties for this retaining wall alignment to reflect a very soft near surface material (the softest amongst GZ-03). A typical cross section of the assessed wall is shown in Figure 6.4.

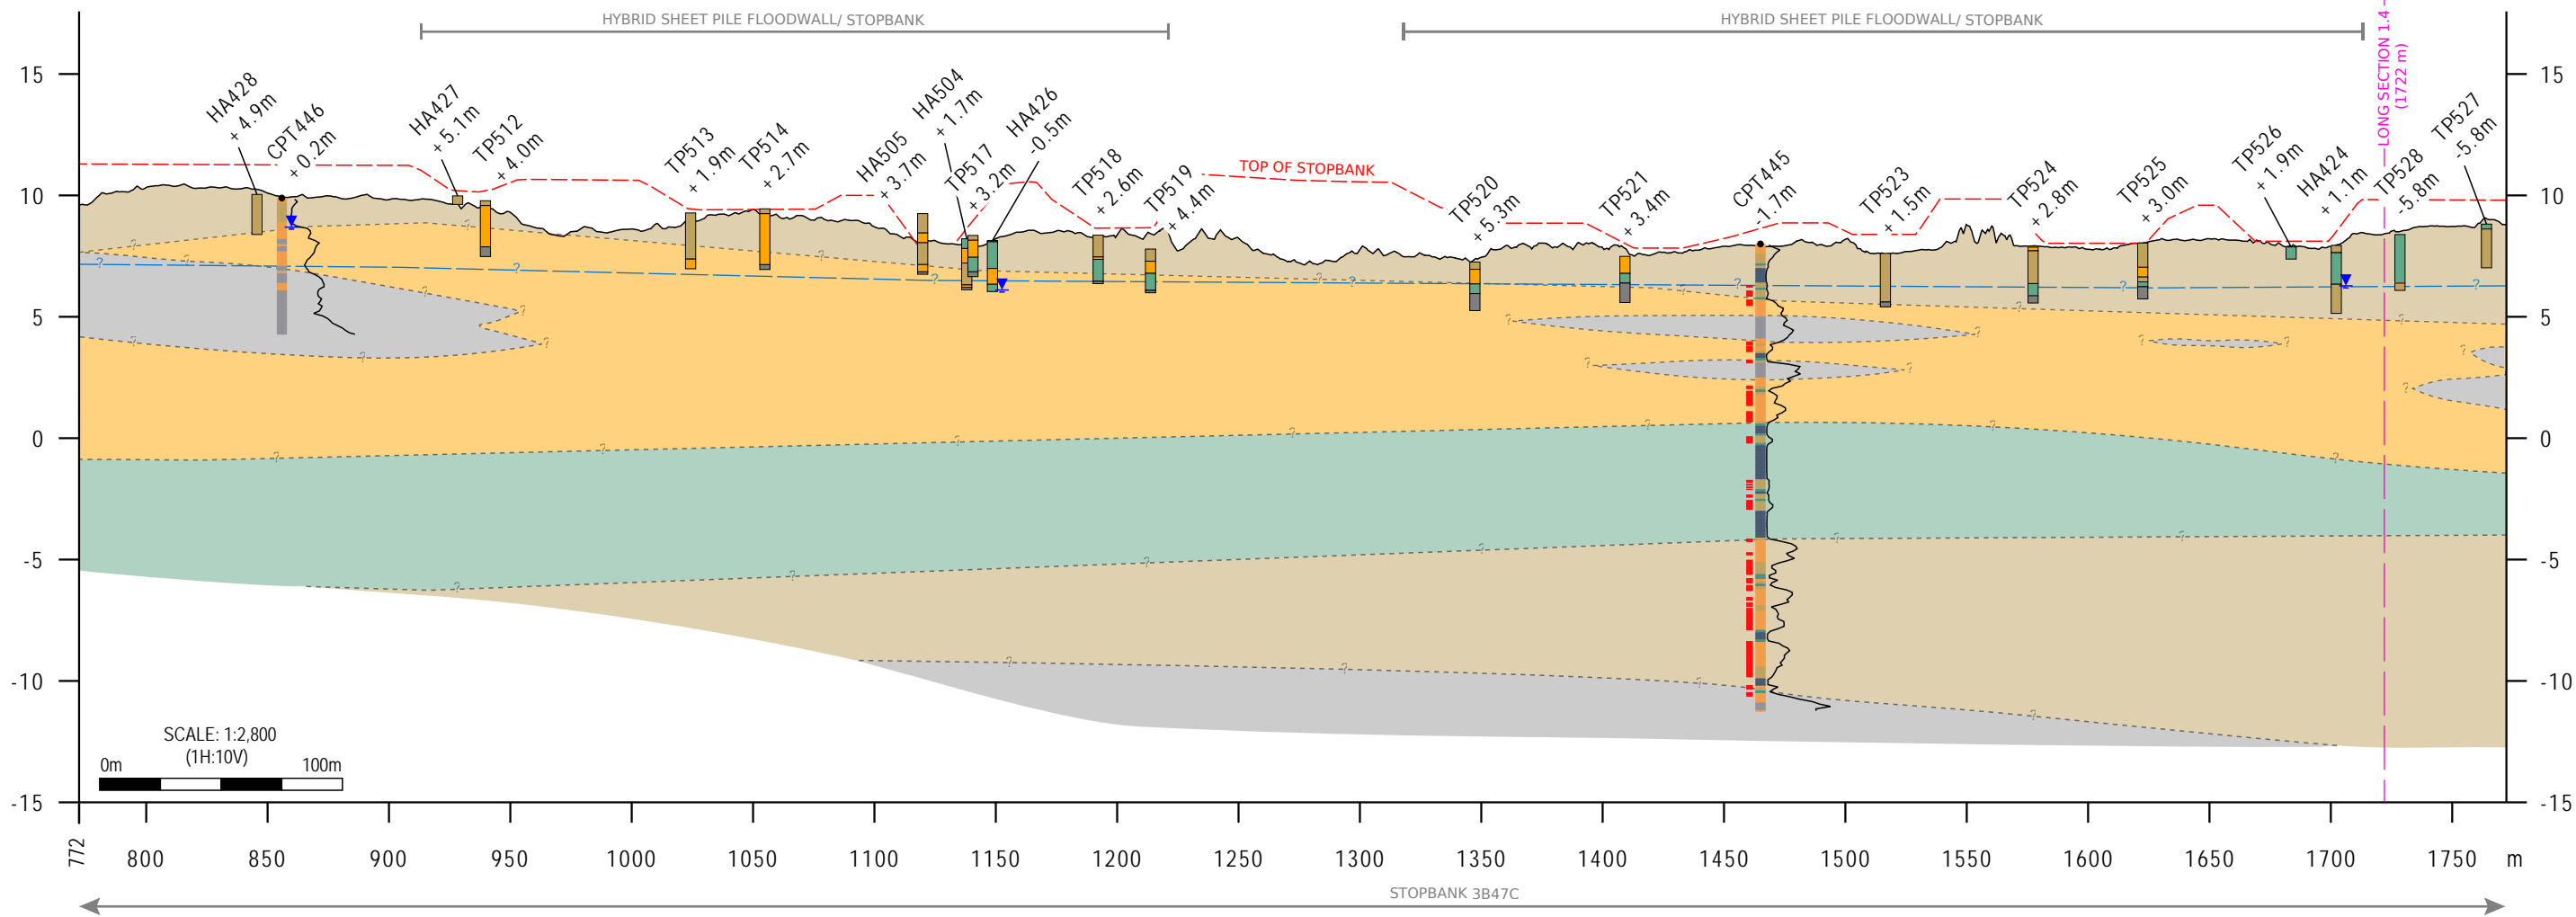
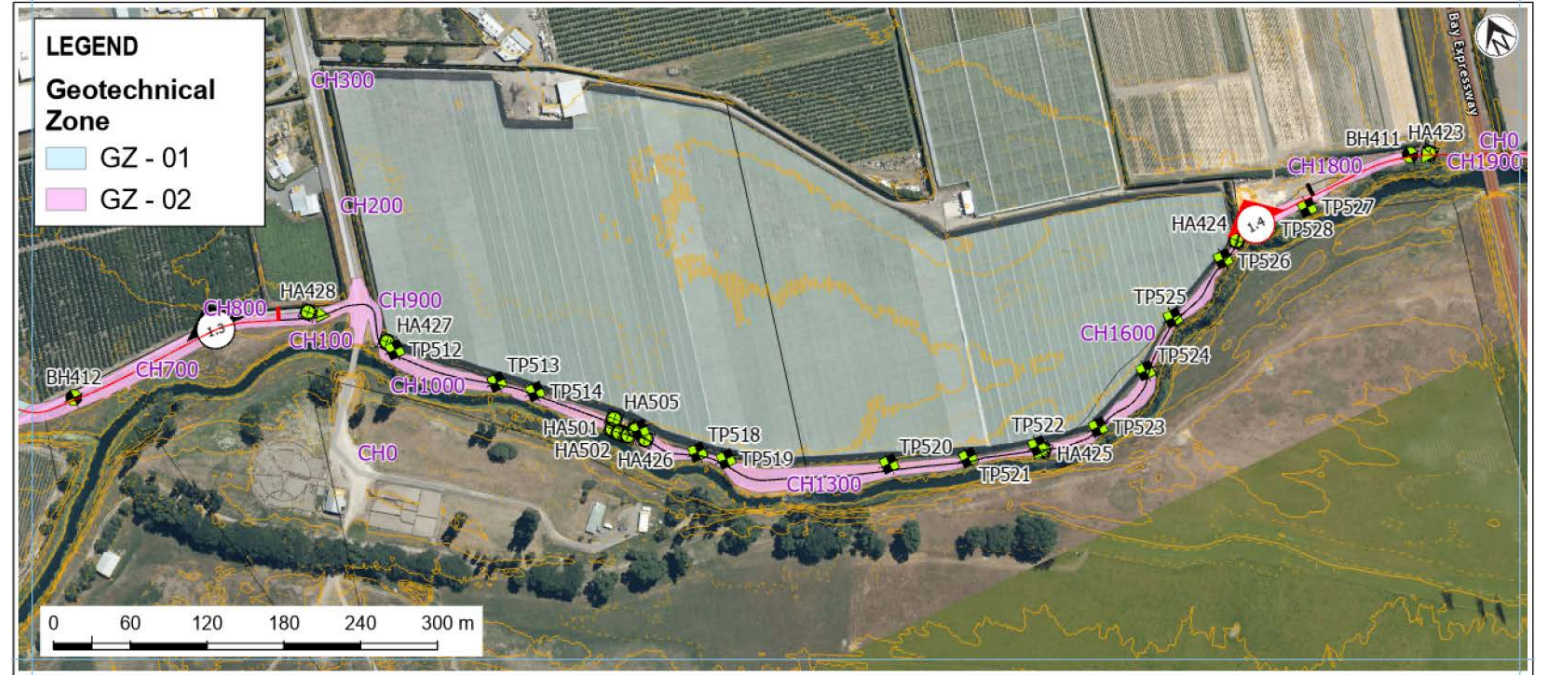
CLIENT	HAWKES BAY REGIONAL COUNCIL	
PROJECT	PAKOWHAI SECONDARY STOPBANK	
TITLE	GEOLOGICAL LONG SECTION 1.3	
SCALE (A3)	AS SHOWN	FIG No. 1.3
REV	1

1. THE CONE PENETRATION TEST SOIL BEHAVIOUR INDEX (IC) HAS BEEN DERIVED USING THE METHODOLOGY DESCRIBED IN ROBERTSON AND WRIDE, 1998.
2. INVESTIGATIONS OVER 40M OFFSET FROM THE SECTION ALIGNMENT HAVE BEEN COLOUR GREY
3. ELEVATION LEVELS ARE WITHIN NZVD16 VERTICAL DATUM
4. WE HAVE GROUPED THE UNITS BASED ON THE DOMINANT GEOLOGICAL UNIT AND WHAT IS LIKELY TO LEAD TO MORE CONSERVATIVE CONDITIONS IN OUR MODELLING

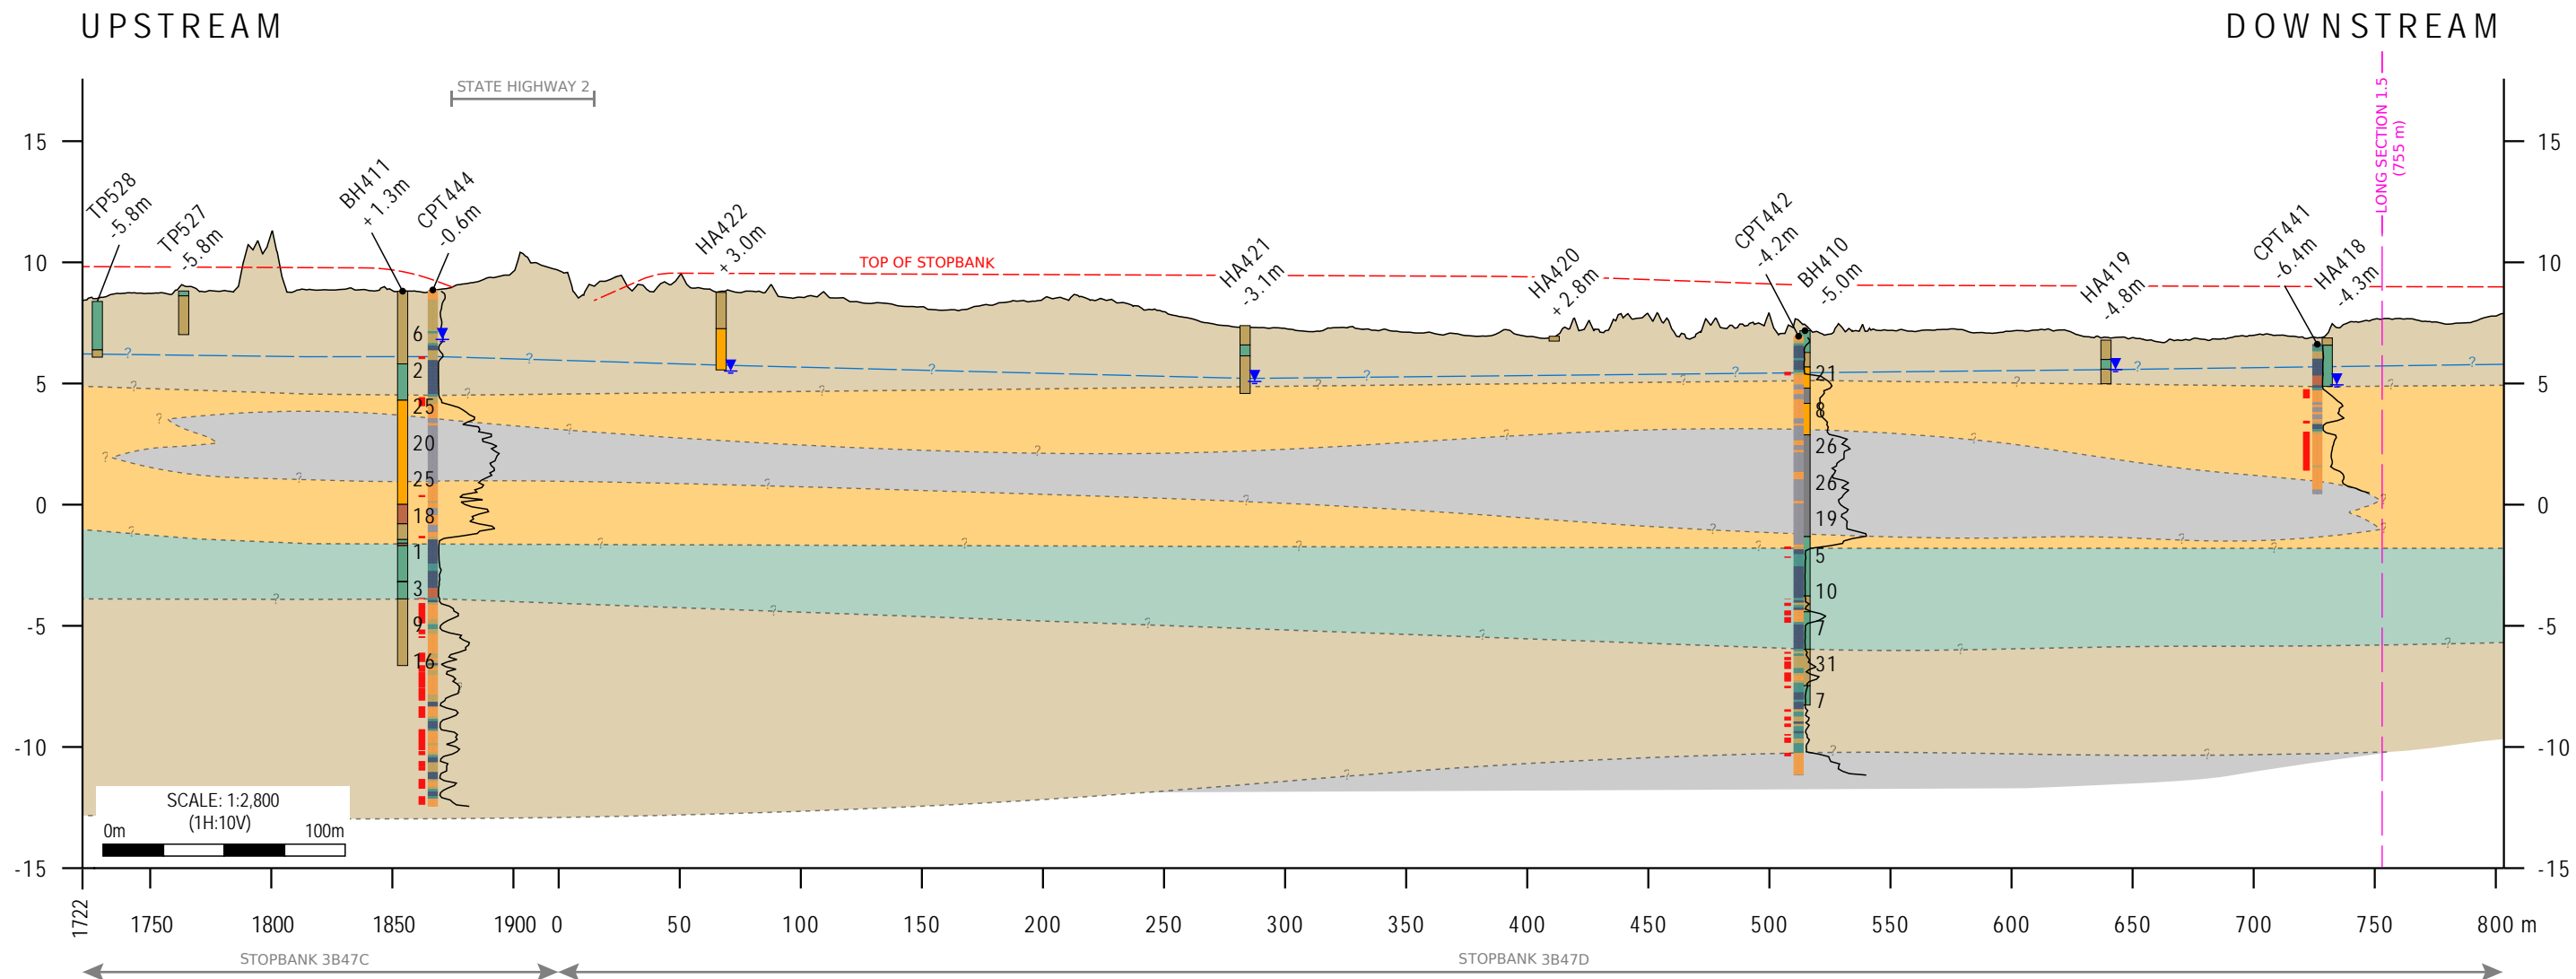
CLIENT	HAWKES BAY REGIONAL COUNCIL	
PROJECT	PAKOWHAI SECONDARY STOPBANK	
TITLE	GEOLOGICAL LONG SECTION 1.4	
SCALE (A3)	AS SHOWN	FIG No. 1.4
REV	1

1. THE CONE PENETRATION TEST SOIL BEHAVIOUR INDEX (IC) HAS BEEN DERIVED USING THE METHODOLOGY DESCRIBED IN ROBERTSON AND WRIDE, 1998.
2. INVESTIGATIONS OVER 40M OFFSET FROM THE SECTION ALIGNMENT HAVE BEEN COLOUR GREY
3. ELEVATION LEVELS ARE WITHIN NZVD16 VERTICAL DATUM
4. WE HAVE GROUPED THE UNITS BASED ON THE DOMINANT GEOLOGICAL UNIT AND WHAT IS LIKELY TO LEAD TO MORE CONSERVATIVE CONDITIONS IN OUR MODELLING

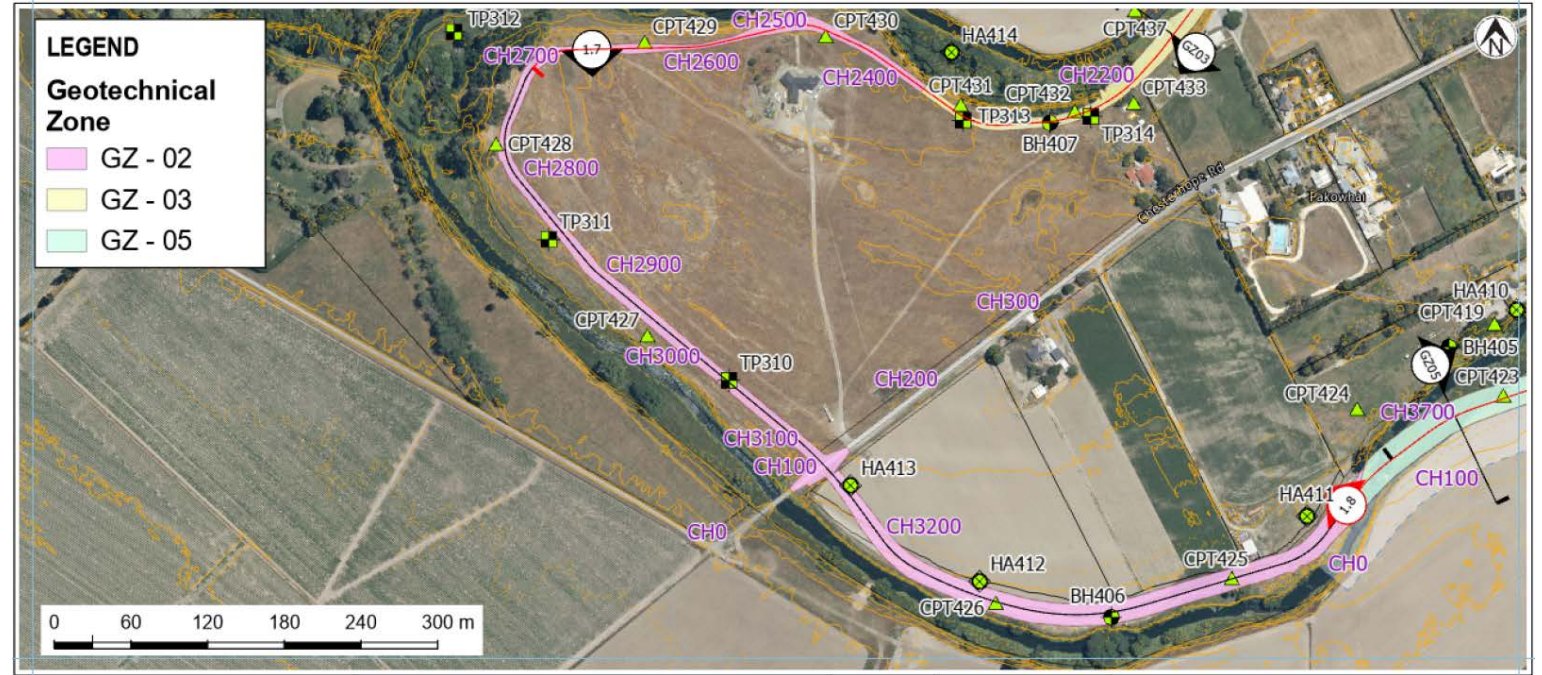
1. THE CONE PENETRATION TEST SOIL BEHAVIOUR INDEX (IC) HAS BEEN DERIVED USING THE METHODOLOGY DESCRIBED IN ROBERTSON AND WRIDE, 1998.		PROJECT No.	1017353.2403	CLIENT	HAWKES BAY REGIONAL COUNCIL
2. INVESTIGATIONS OVER 40M OFFSET FROM THE SECTION ALIGNMENT HAVE BEEN COLOUR GREY		DESIGNED	BRTA	Aug.25	PROJECT
3. ELEVATION LEVELS ARE WITHIN NZVD16 VERTICAL DATUM		DRAWN	BRTA	Aug.25	
4. WE HAVE GROUPED THE UNITS BASED ON THE DOMINANT GEOLOGICAL UNIT AND WHAT IS LIKELY TO LEAD TO MORE CONSERVATIVE CONDITIONS IN OUR MODELLING		CHECKED	DAMI	Sep.25	TITLE
		APPROVED			DATE
		SCALE (A3)			AS SHOWN
		FIG No.			1.7
		REV			1

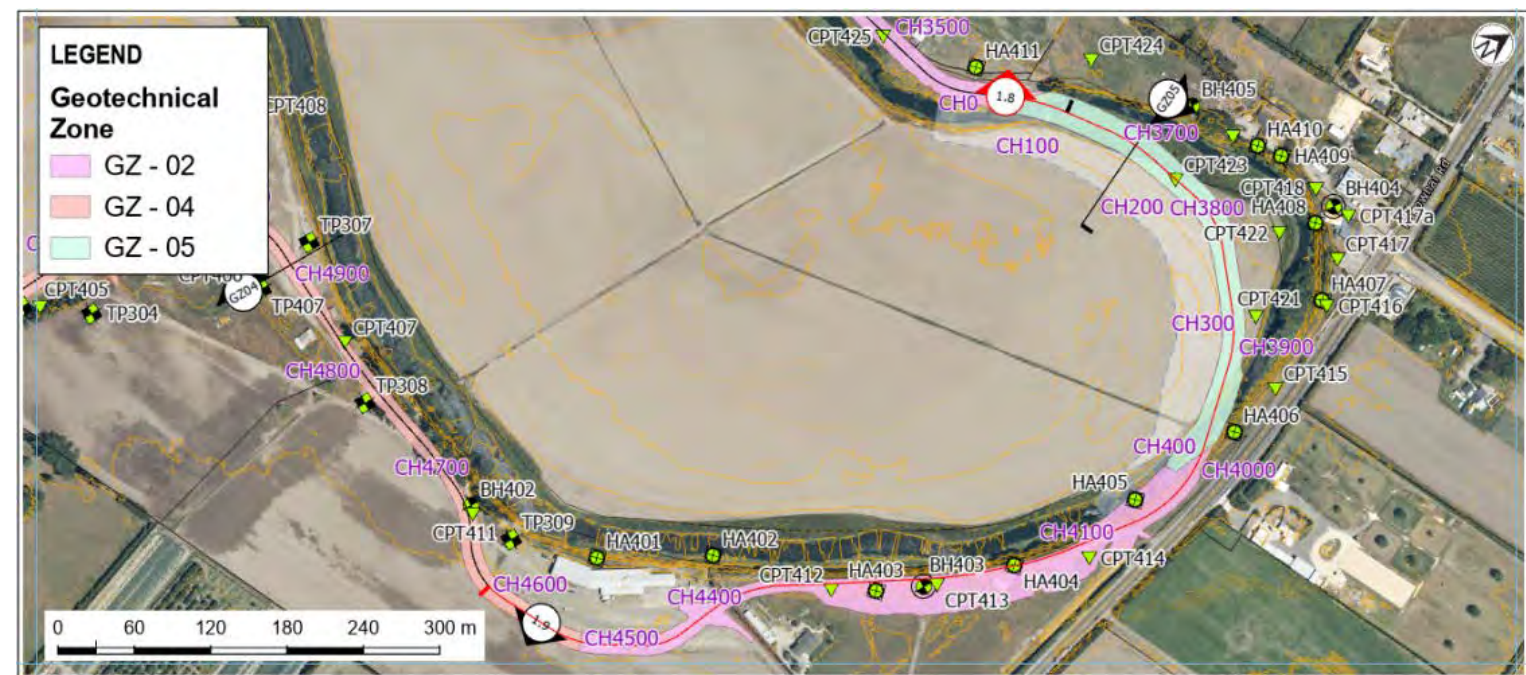
<p>1. THE CONE PENETRATION TEST SOIL BEHAVIOUR INDEX (IC) HAS BEEN DERIVED USING THE METHODOLOGY DESCRIBED IN ROBERTSON AND WRIDE, 1998.</p> <p>2. INVESTIGATIONS OVER 40M OFFSET FROM THE SECTION ALIGNMENT HAVE BEEN COLOUR GREY</p> <p>3. ELEVATION LEVELS ARE WITHIN NZVD16 VERTICAL DATUM</p> <p>4. WE HAVE GROUPED THE UNITS BASED ON THE DOMINANT GEOLOGICAL UNIT AND WHAT IS LIKELY TO LEAD TO MORE CONSERVATIVE CONDITIONS IN OUR MODELLING</p>	<p>PROJECT No. 1017353.2403</p>	<p>CLIENT HAWKES BAY REGIONAL COUNCIL</p>
	<p>DESIGNED BRTA Aug.25</p> <p>DRAWN BRTA Aug.25</p> <p>CHECKED DAMI Sep.25</p>	<p>PROJECT PAKOWHAI SECONDARY STOPBANK</p>
	<p>APPROVED _____ DATE _____</p>	<p>TITLE GEOLOGICAL LONG SECTION 1.8</p>
	<p>SCALE (A3) AS SHOWN FIG No. 1.8</p>	<p>REV 1</p>
