**Pakowhai Secondary
Stopbank**

Preliminary Site Investigation

Prepared for
Hawkes Bay Regional Council

Prepared by
Tonkin & Taylor Ltd

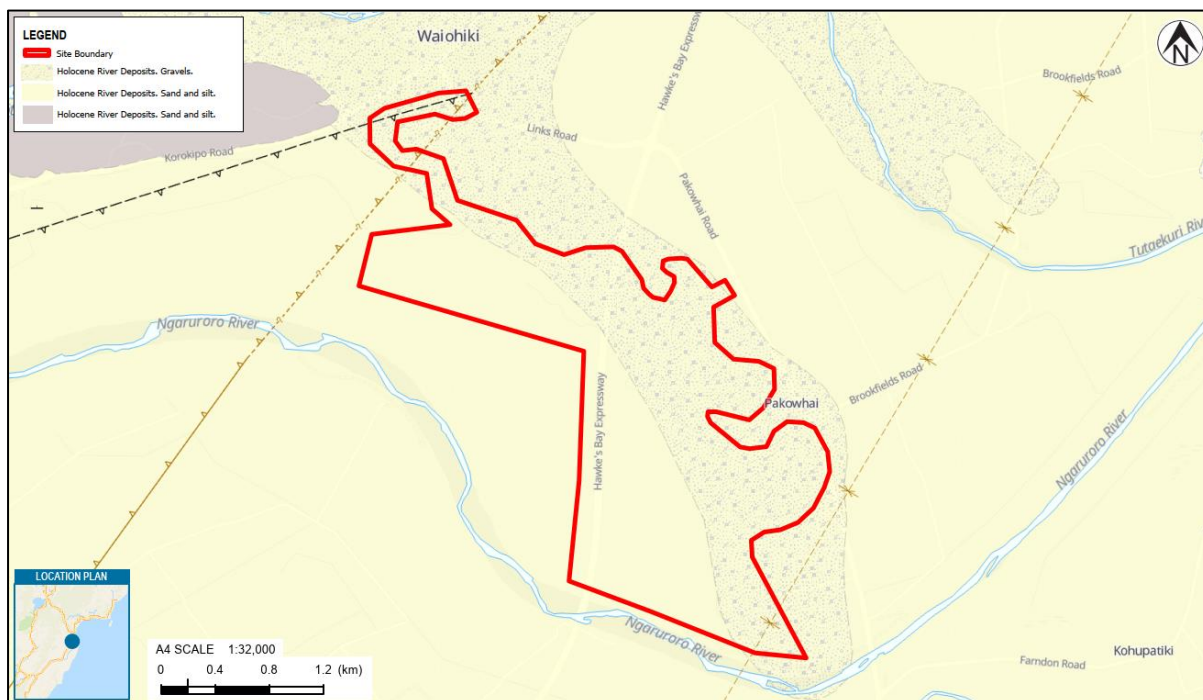
The published geology beneath the site is described by Lee, Begg and Bland⁴ as Holocene River Deposits including silts, sands and gravels from the Heretaunga Formation, as shown below in Figure 3.1.

Figure 3.1 Published geology of the Pakowhai Area (source: Lee J.M., et al) as per footnote.

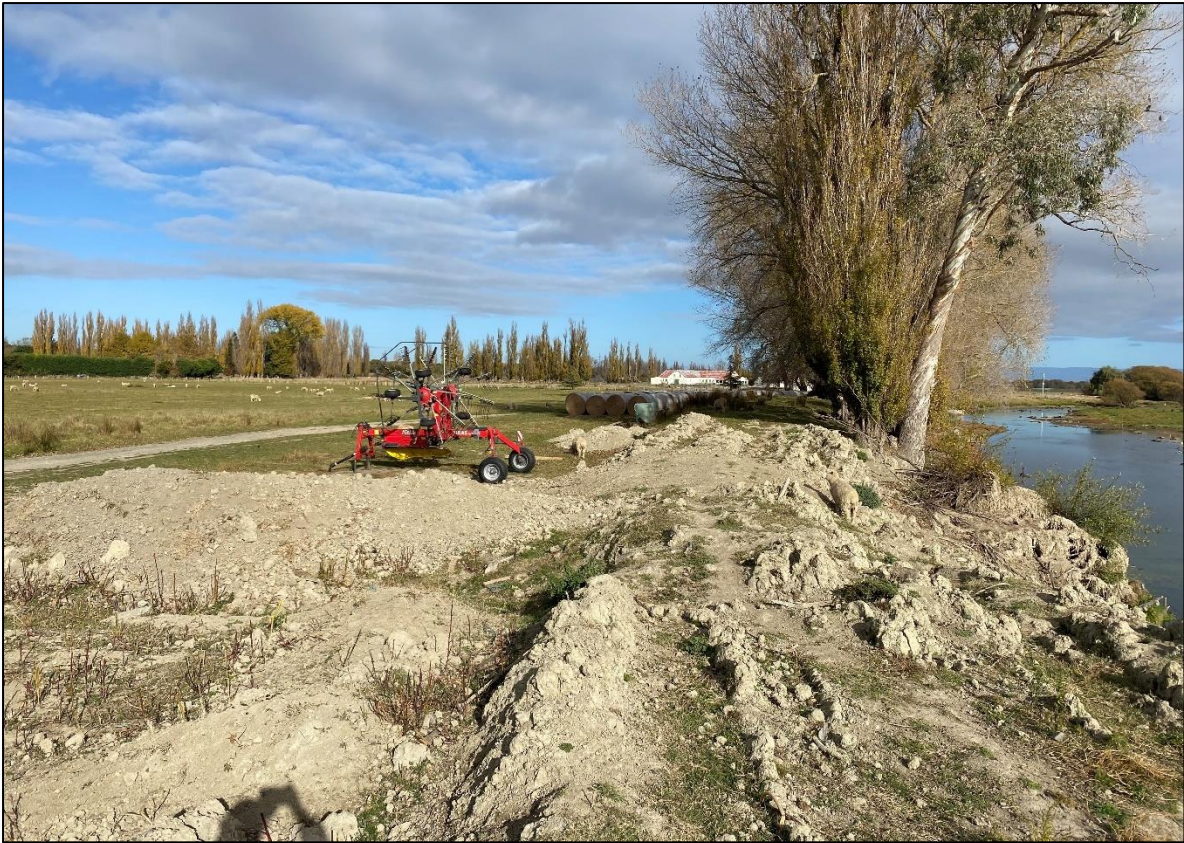
- The Pakowhai area has been significantly affected by the Cyclone Gabrielle storm event in early 2023. Evidence of the storm/flood damage in the form of stockpiled silt materials and building debris, was present in areas within the site. See Photograph Appendix B.1.

Photograph Appendix B.1: Silt stockpiles present along the Tūtaekurī Waimate Stream.

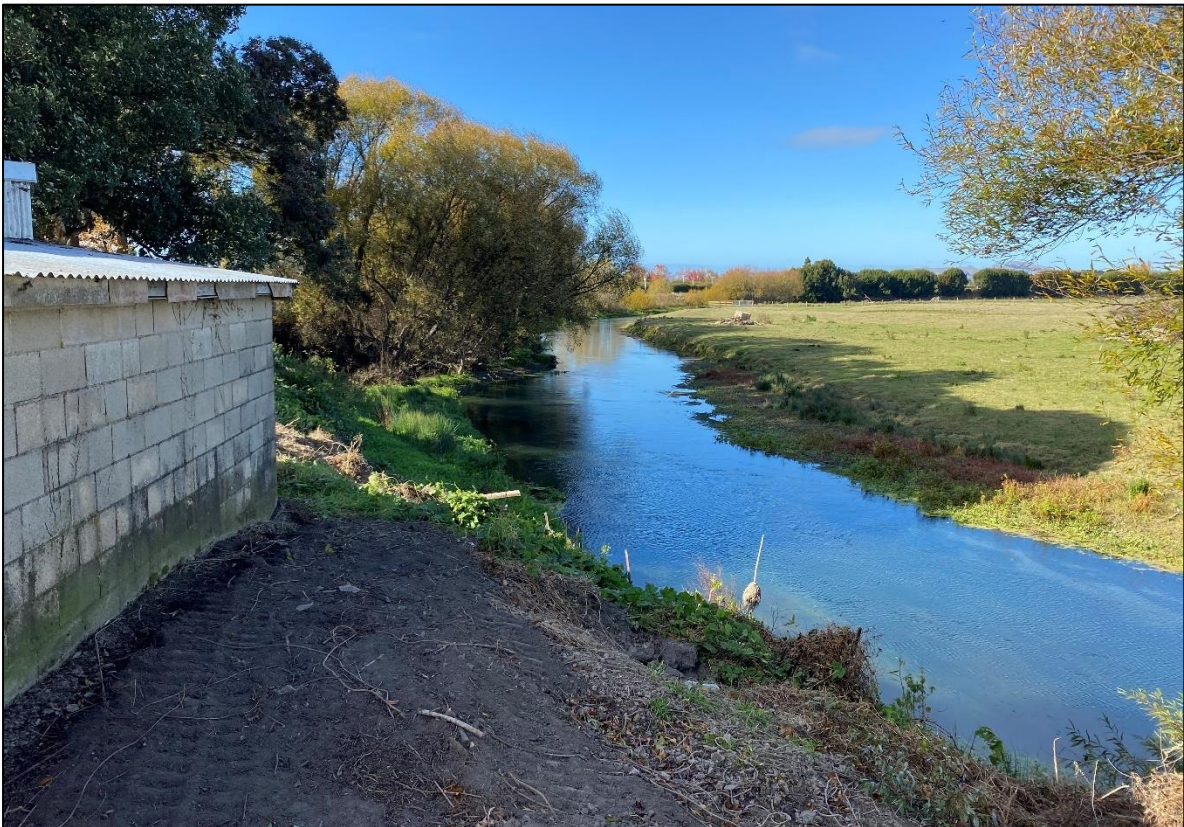
- The Pakowhai Memorial Hall is located adjacent to the Tūtaekurī-Waimate Stream, at the intersection of Pakowhai Road and Brookfields Road. The hall building is constructed of a combination of; concrete block, timber weatherboard, fibreboard, and plaster coated cladding. Fibre cement fragments were observed on the ground surface at the rear of the building, likely to have been from the broken fascia board on the rear portion of the building. See Photograph Appendix B.2 and Photograph Appendix B.3. Testing of fragments confirmed

Photograph Appendix B.2: Rear of Pakowhai Hall building beside Tūtaekurī Waimate Stream. Broken fibre cement fascia along rear of building and three fragments visible on ground surface.

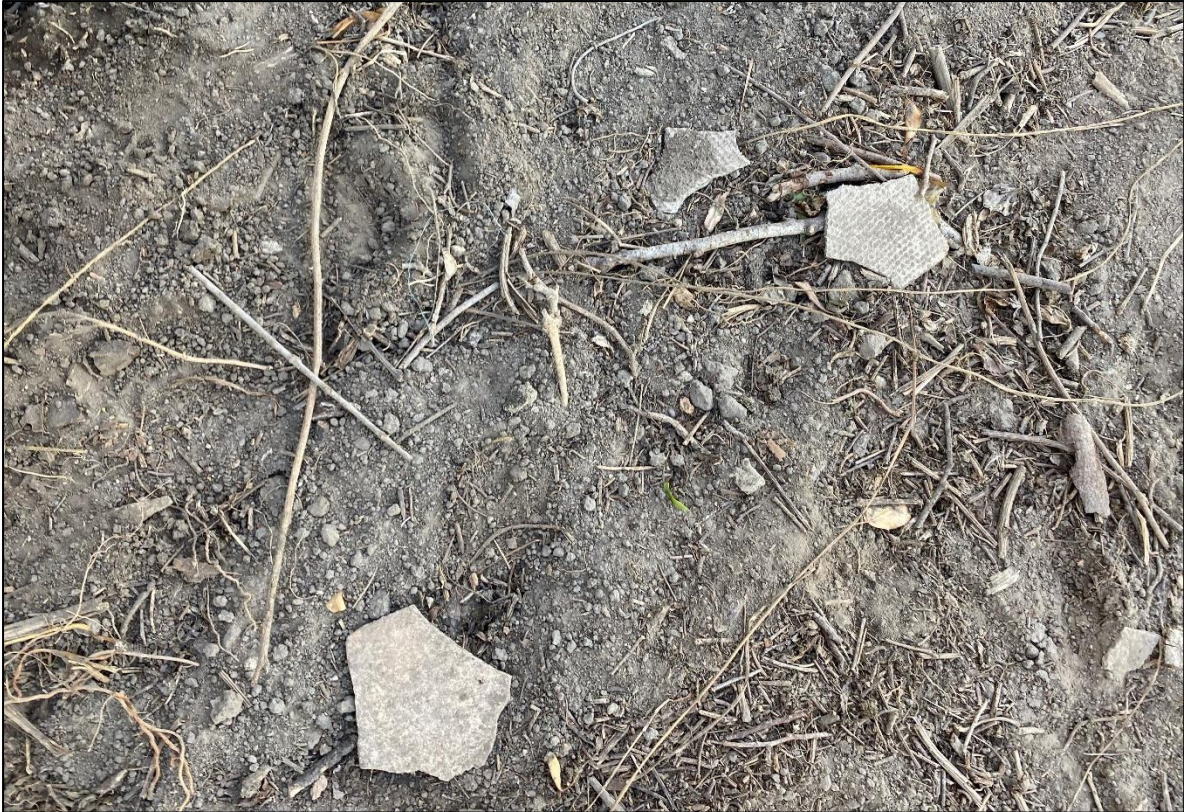
Photograph Appendix B.3: Fibre cement fragments (ACM) on ground surface to the rear of the Pakowhai Memorial Hall.

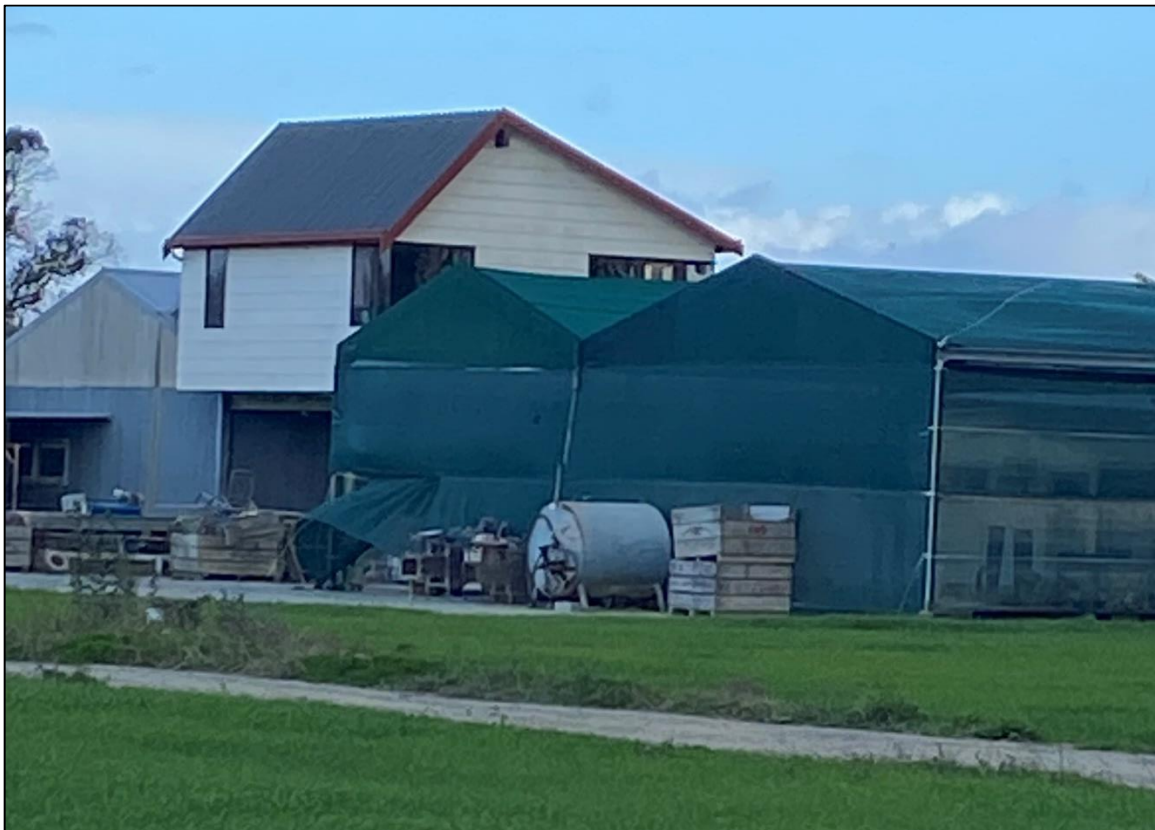
- An aboveground storage tank (AST) was observed near the packing sheds at the orchard property located at 43 Hodgson Road, the property adjacent to the site, approximately 220 m from the site. See Photograph Appendix B.4. The exact use of this tank is unknown, but it appears to collect rainwater from the roof of the packing sheds.

Photograph Appendix B.4: Aboveground storage tank (AST) at 43 Hodgson Road.

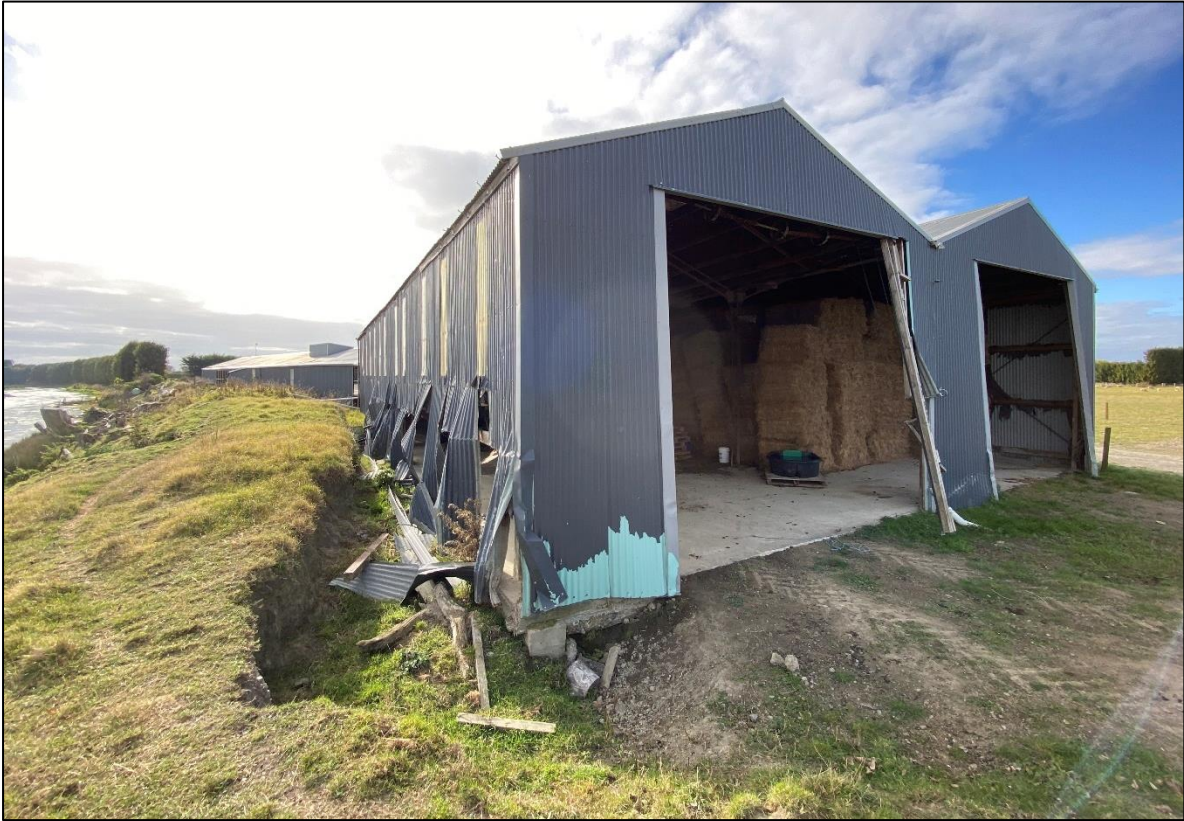
- A damaged shed containing farm machinery, timber pallets, and hay bales was observed at the property at 1854 Pakowhai Road, adjacent to the stream. The shed was constructed of corrugated iron and clearlite sheets. One 200 L drum, labelled 'Caltex', and five 'jerry cans' (~30 L each), all in good condition, were temporarily stored along the fence line near to the farm shed. A slight hydrocarbon odour was detected near the containers, but no staining was observed on the ground surface. See Photograph Appendix B.5 and Photograph Appendix B.6.

Photograph Appendix B.5: Damaged farm shed at 1854 Pakowhai Road.

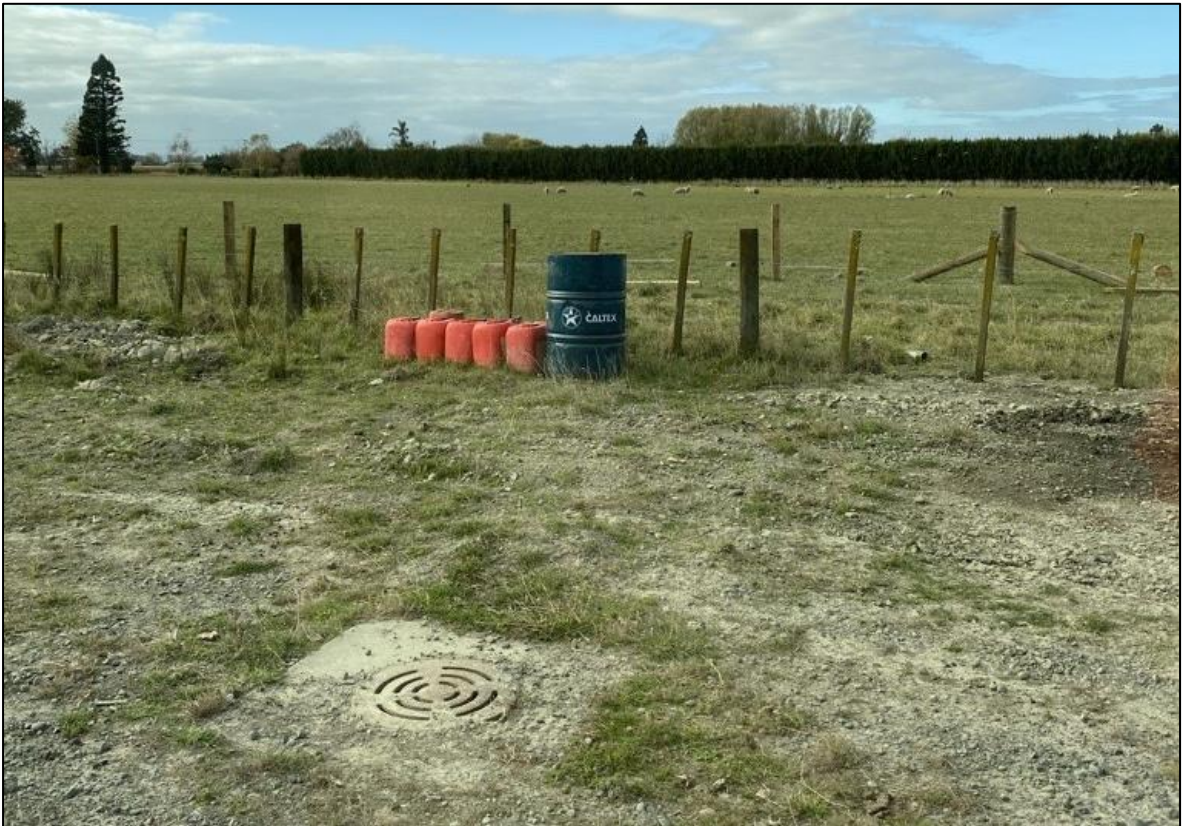
Photograph Appendix B.6: Drum and jerry cans (potential low-volume fuel storage) near to the damaged farm shed at 1854 Pakowhai Road.

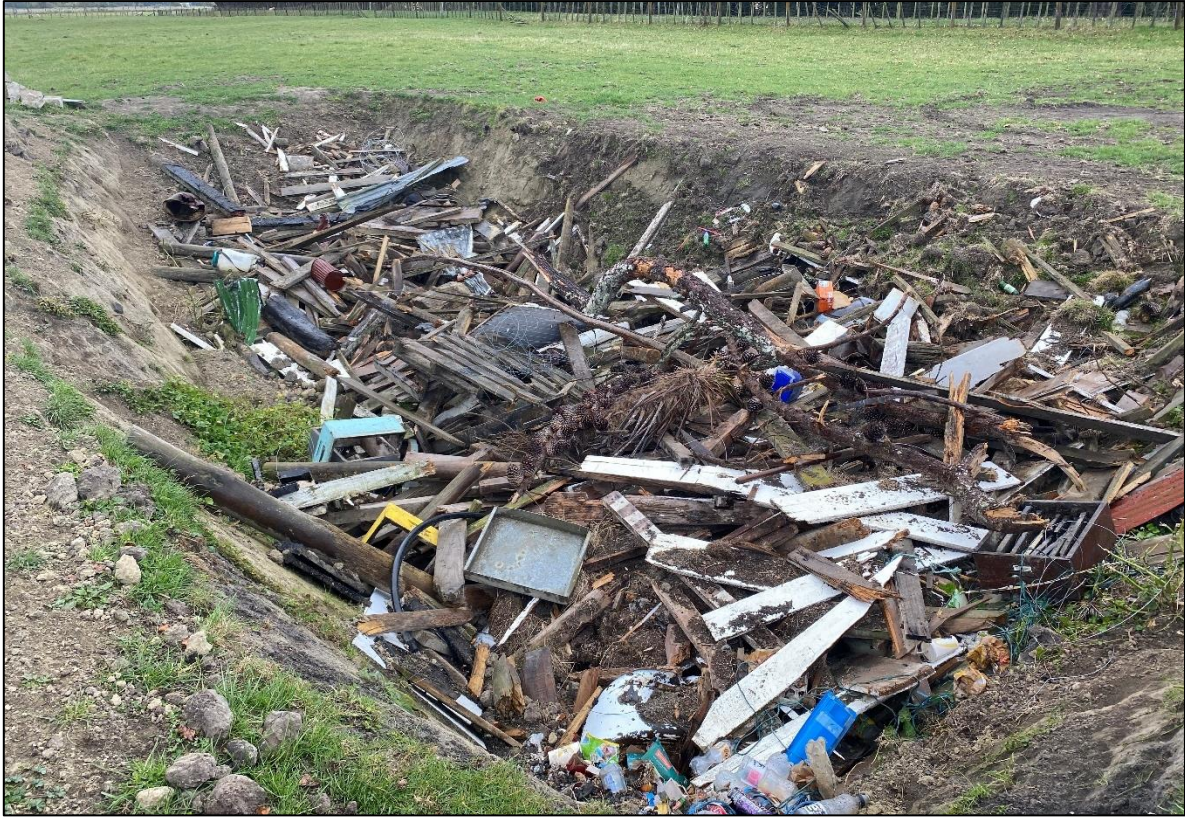
- A farm waste pit measuring approximately 11 m by 3.5 m was observed within the property at 76 Chesterhope Road, to the rear of the farm sheds at the centre of the property. The material observed within the pit includes, building debris (wood and treated timber, cladding corrugated iron sheets), wire, timber pallets, scrap metal pieces, a metal barrel, a plastic container backpack weed sprayer, and general domestic rubbish. A stockpile of concrete blocks (around 5 to 10 m³) was adjacent to the pit together with a slightly larger soil stockpile, which appeared to have been excavated to form the pit. See Photograph Appendix B.7 and Photograph Appendix B.8.

Photograph Appendix B.7: Farm waste pit at 76 Chesterhope Road.

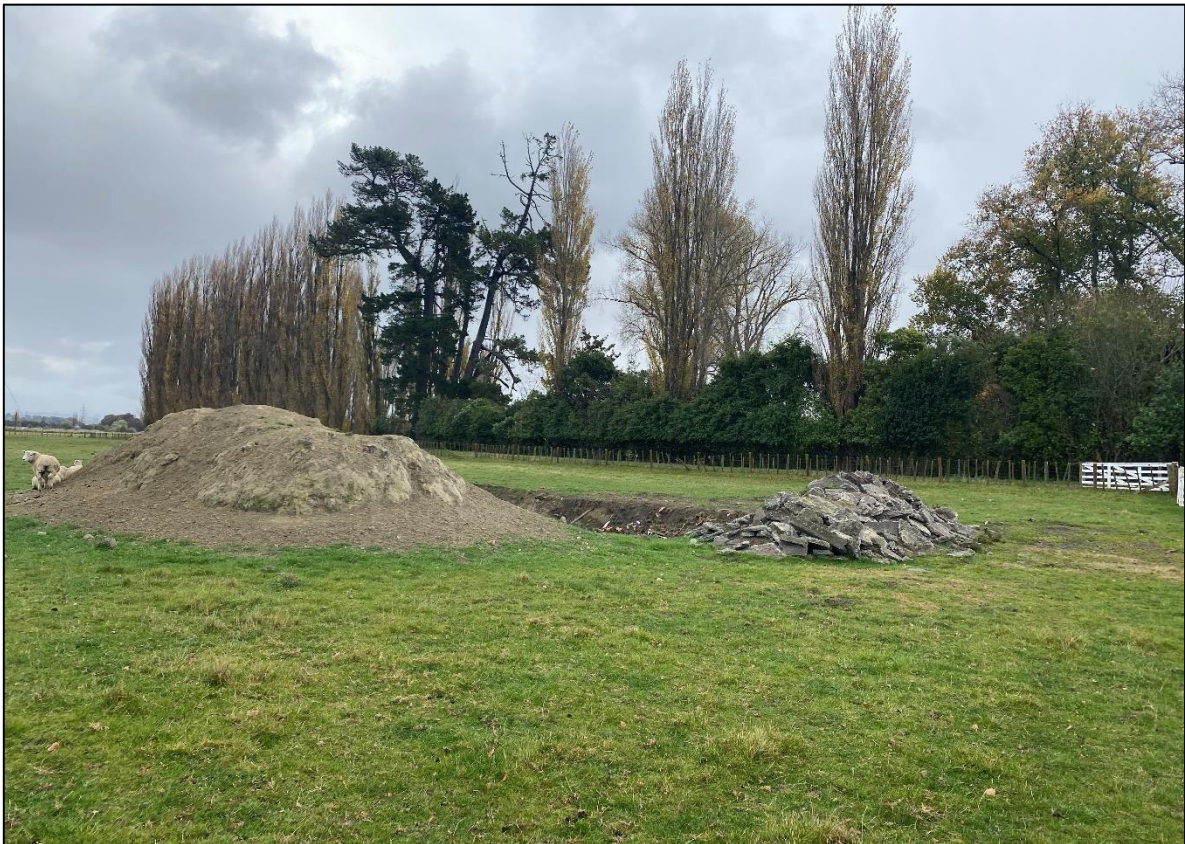
Photograph Appendix B.8: Area surrounding the farm waste pit at 76 Chesterhope Road, showing stockpiled concrete and soil.

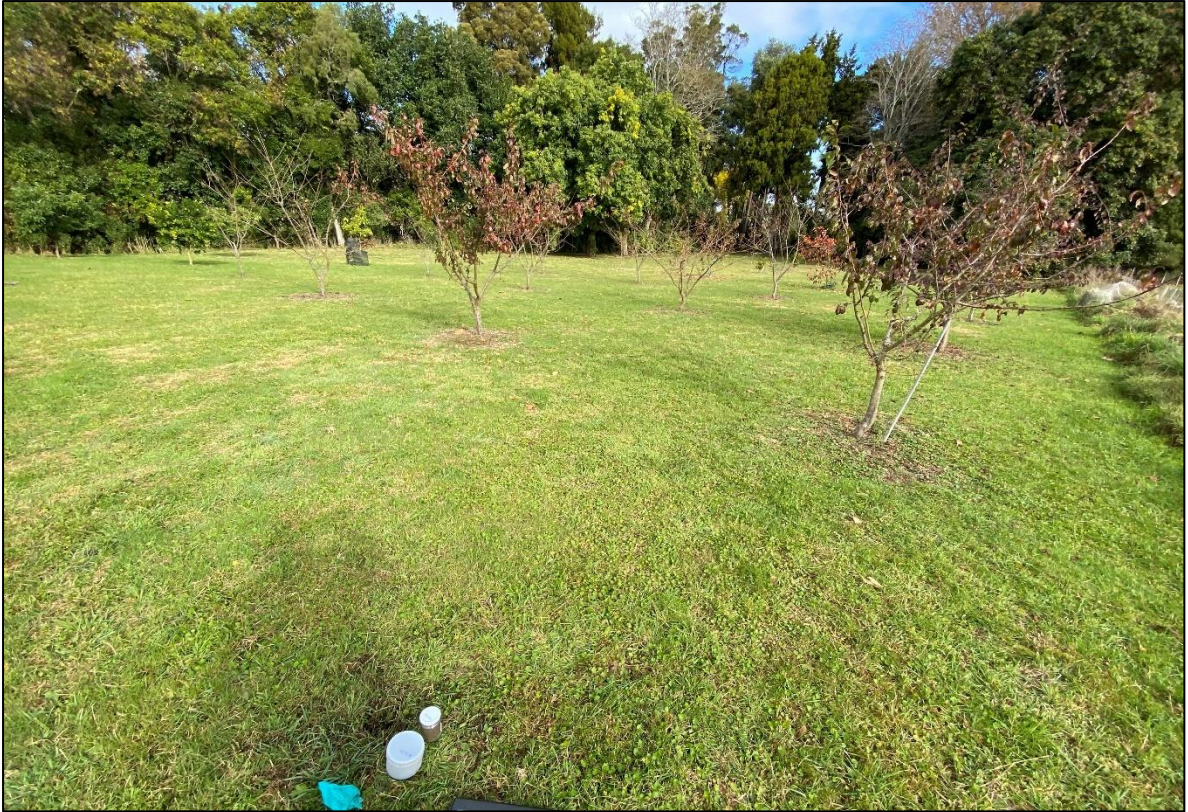
- A former vegetable and fruit garden, associated with the homestead, is present on the eastern side of 76 Chesterhope Road, near the northern-most proposed borrow area. At the time of the site visit the garden was overgrown with weeds. Only the concrete foundation of a former glasshouse remains; all glass and timber panels have been removed. See Photograph Appendix B.9 and Photograph Appendix B.10.

Photograph Appendix B.9: Fruit trees within the former gardens at 76 Chesterhope Road.

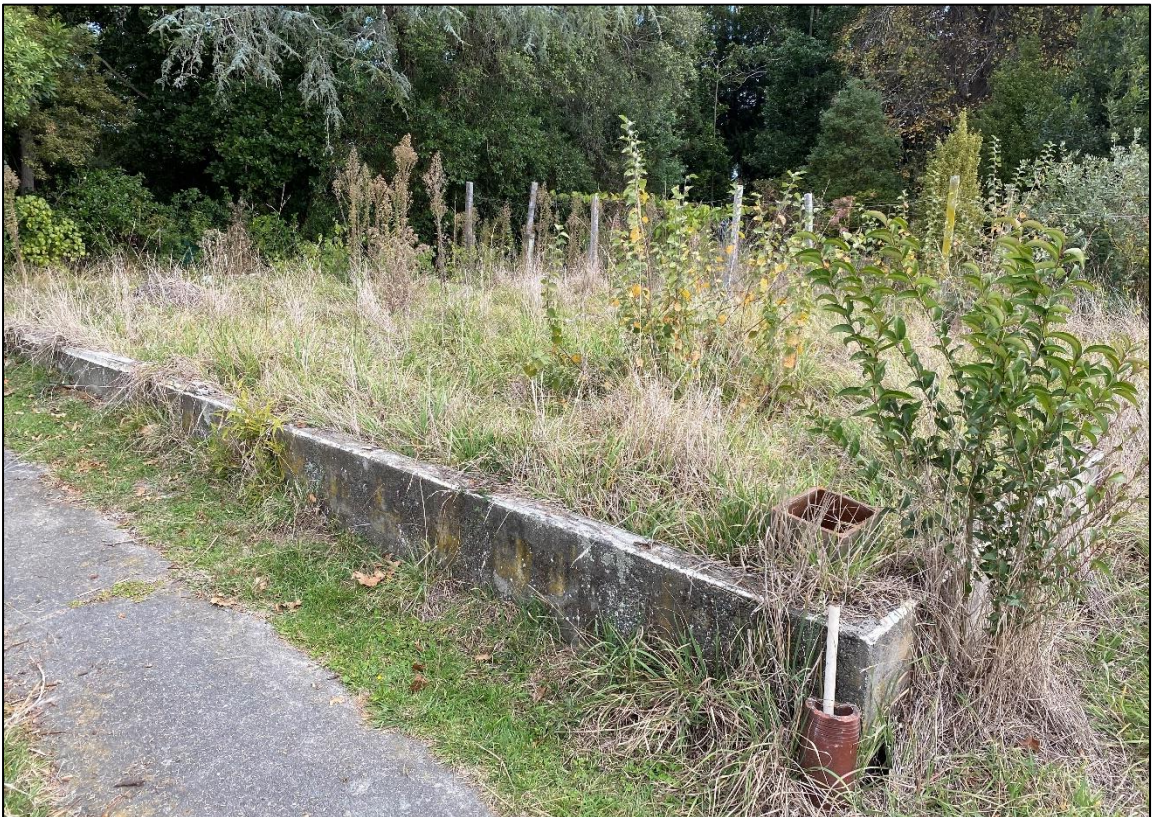
Photograph Appendix B.10: Concrete foundation of the former glasshouse at 76 Chesterhope Road.

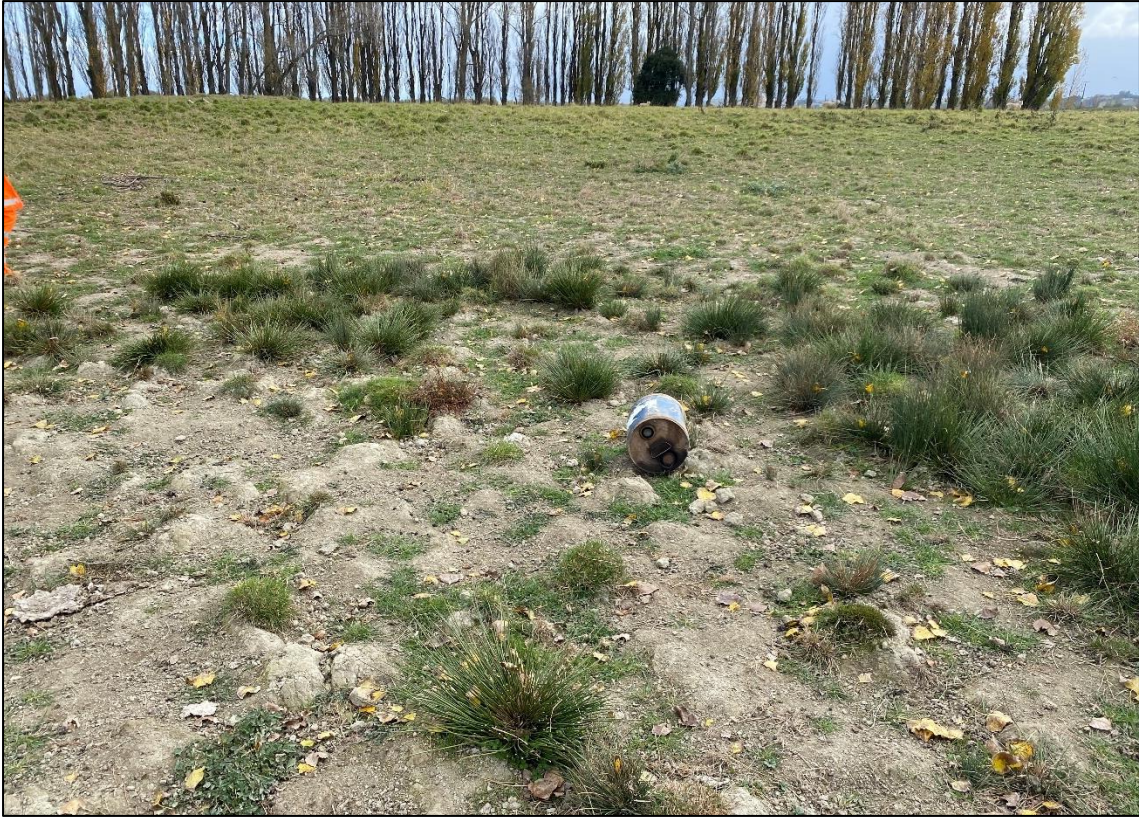
- A blue 20 L metal drum was observed in a sparse area of vegetation near to the vegetable and fruit garden. Hydrocarbon staining was observed the top of the drum, but not on the surrounding ground. See Photograph Appendix B.11.

- An existing stopbank along the Tūtaekurī-Waimate Stream was observed to the west of the area containing the 20 L metal drum. See Photograph Appendix B.11.

Photograph Appendix B.11: 20L metal drum in sparsely vegetated area. Existing stopbank in the rear of image.

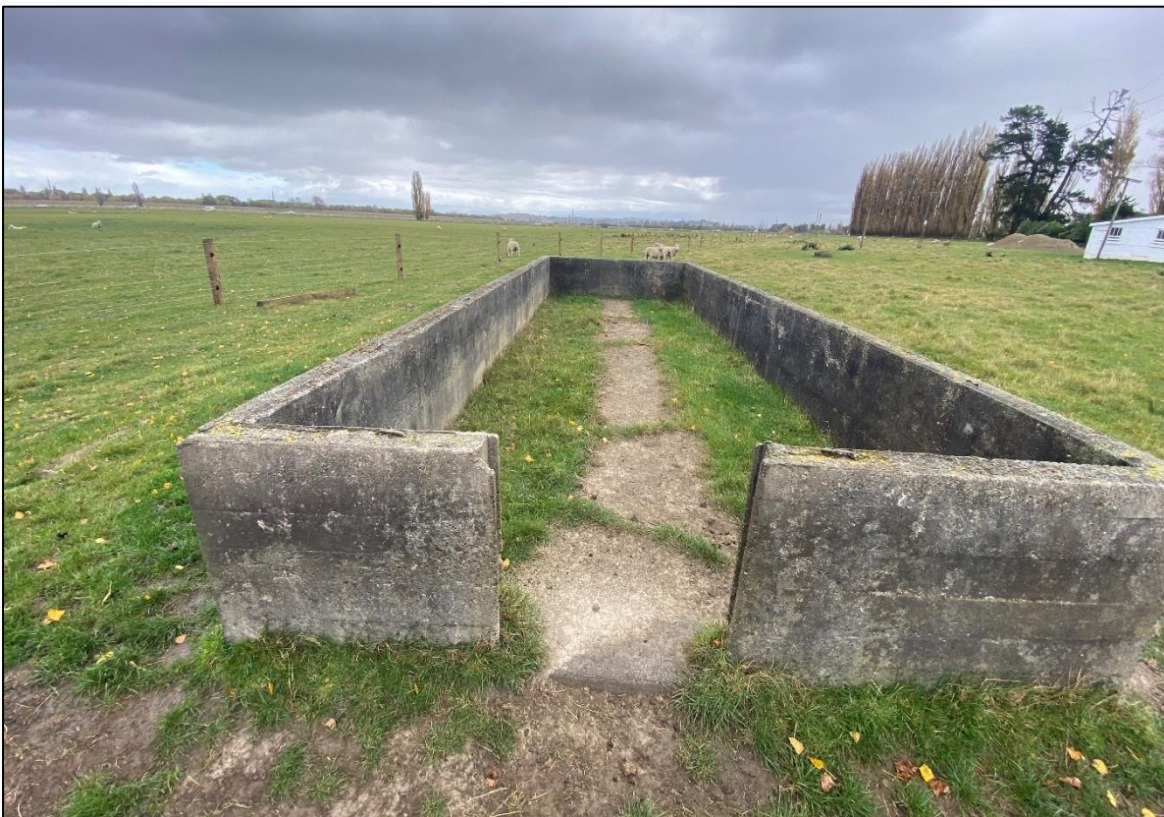
- A rectangular concrete structure, potentially the base of a former shed, was observed near to the sheds on the property at 76 Chesterhope Road, along the main accessway. See Photograph Appendix B.12.

Photograph Appendix B.12: Rectangular concrete structure near sheds at 76 Chesterhope Road. Stockpiled topsoil adjacent to farm waste pit visible to the right of image.

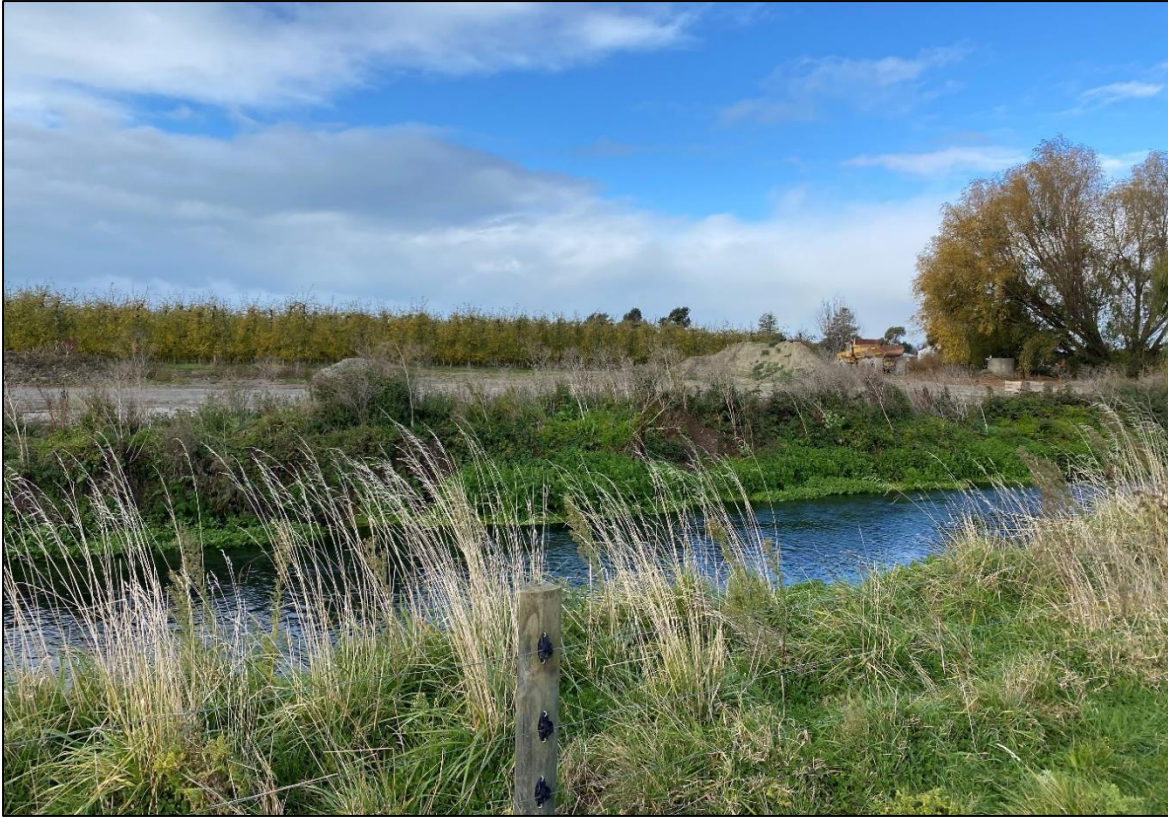
- An AST (most likely containing diesel for farm vehicles) is present at 76 Chesterhope Road, near to the farm sheds and access track.
- An area of earthworks was observed to the rear of the property at 2026 Pakowhai Road, adjacent to the Tūtaekurī-Waimate Stream. At the time of the site visit stockpiles of soil and gravels, with grass growth, could be seen on site, as well as a large articulated dump truck. See Photograph Appendix B.13.

Photograph Appendix B.13: Earthworks occurring to the rear of 2026 Pakowhai Road, adjacent to the Tūtaekuri Waimate Stream, viewed from across the stream at 76 Chesterhope Road.

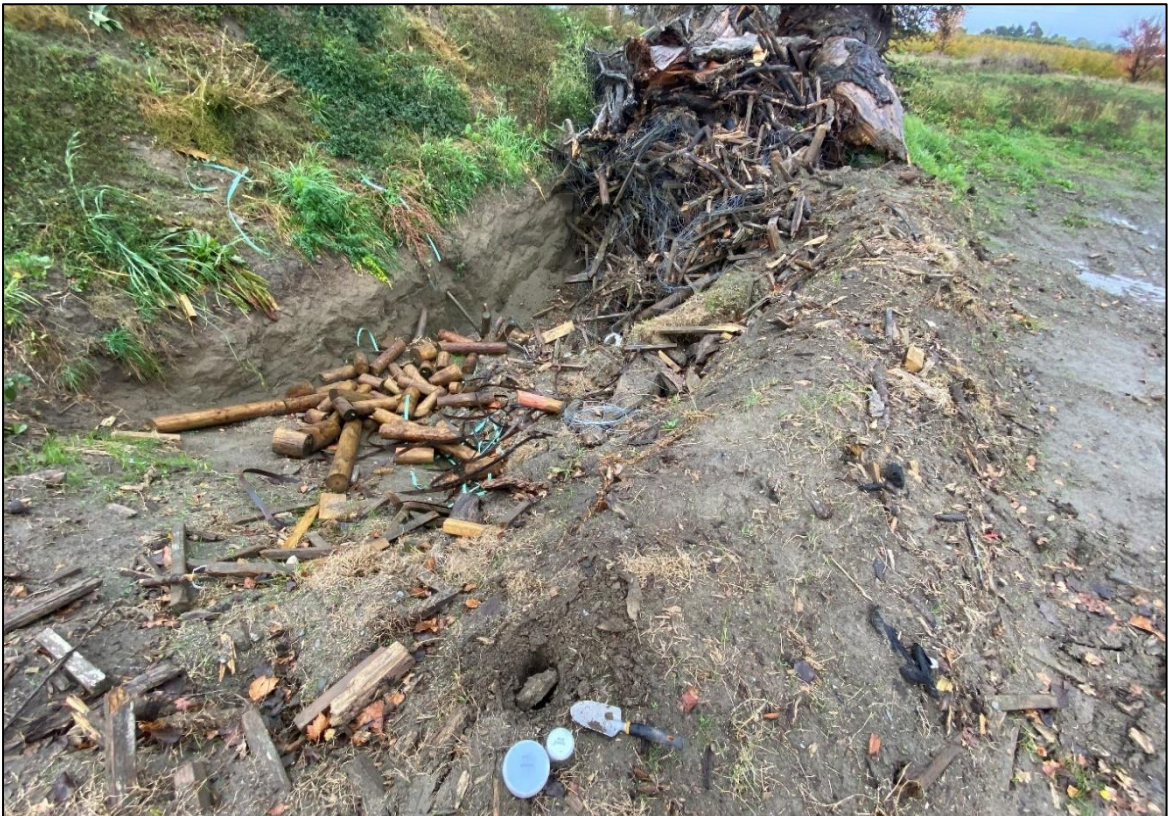
- A woolshed and sheep yards are present at the end of Franklin Road. A farm waste pit was observed in a paddock adjacent to the sheep yards. Waste contained within the pit included; wood and treated timber, fencing wire, paint cans and plastic. See Photograph Appendix B.14 and Photograph Appendix B.15.

Photograph Appendix B.14: Waste pit in paddock near sheep yards at end of Franklin Road, sample location SS15.

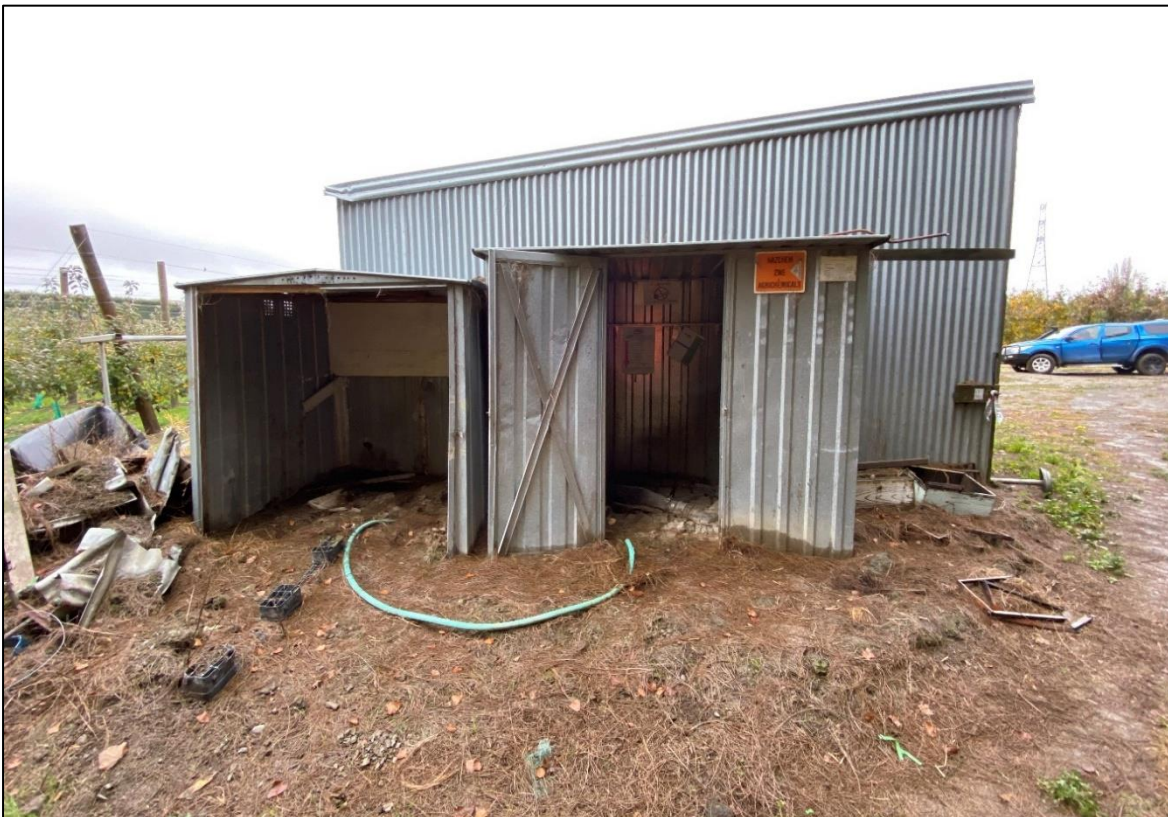
- Corrugated iron agrichemical storage sheds were observed at the woolshed at the end of Franklin Road and also on the south-west portion of 70 Franklin Road (adjacent to the Tūtaekurī-Waimate Stream). The storage shed at 70 Franklin Road had been inundated with silt by Cyclone Gabrielle and was no longer in use. See Photograph Appendix B.15 and Photograph Appendix B.16.

Photograph Appendix B.16: Agrichemical storage shed at 70 Franklin Road, inundated with silt during the cyclone and no longer in use.

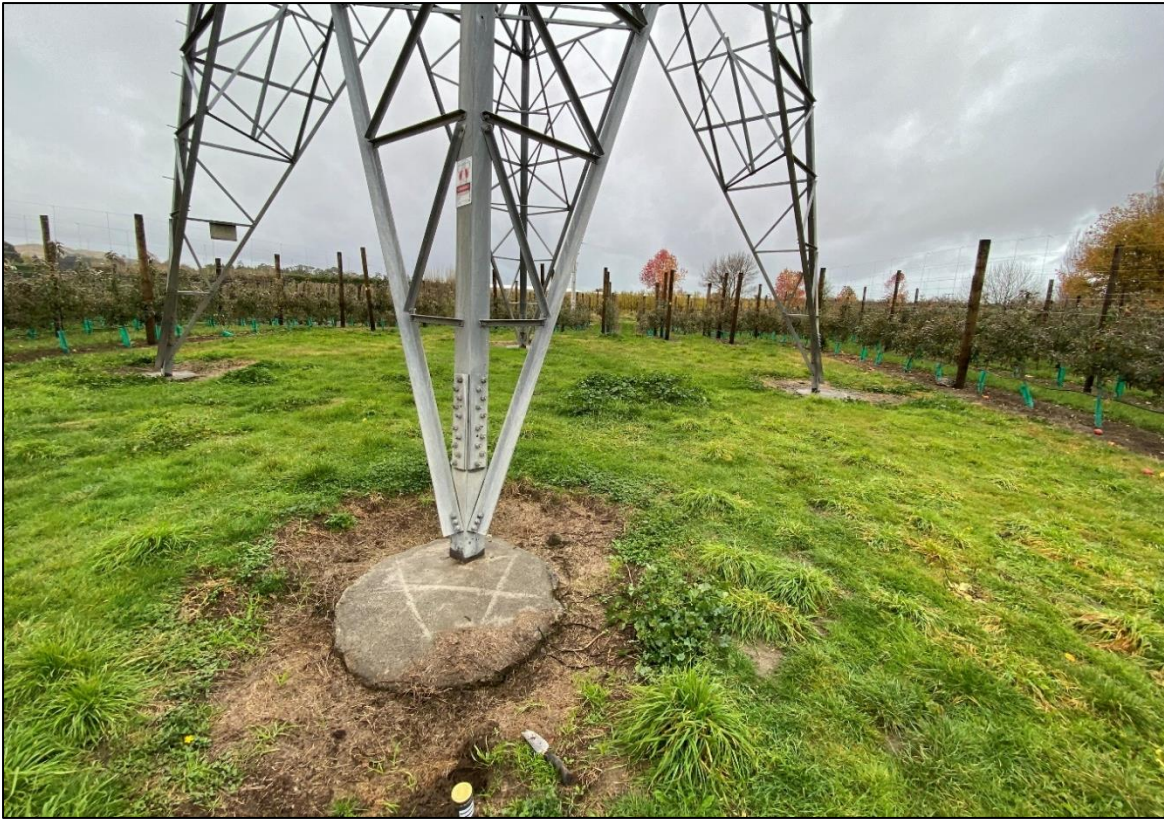
Photograph Appendix B.17: Pylon within orchard at 70 Franklin Road. Sample location SS19.

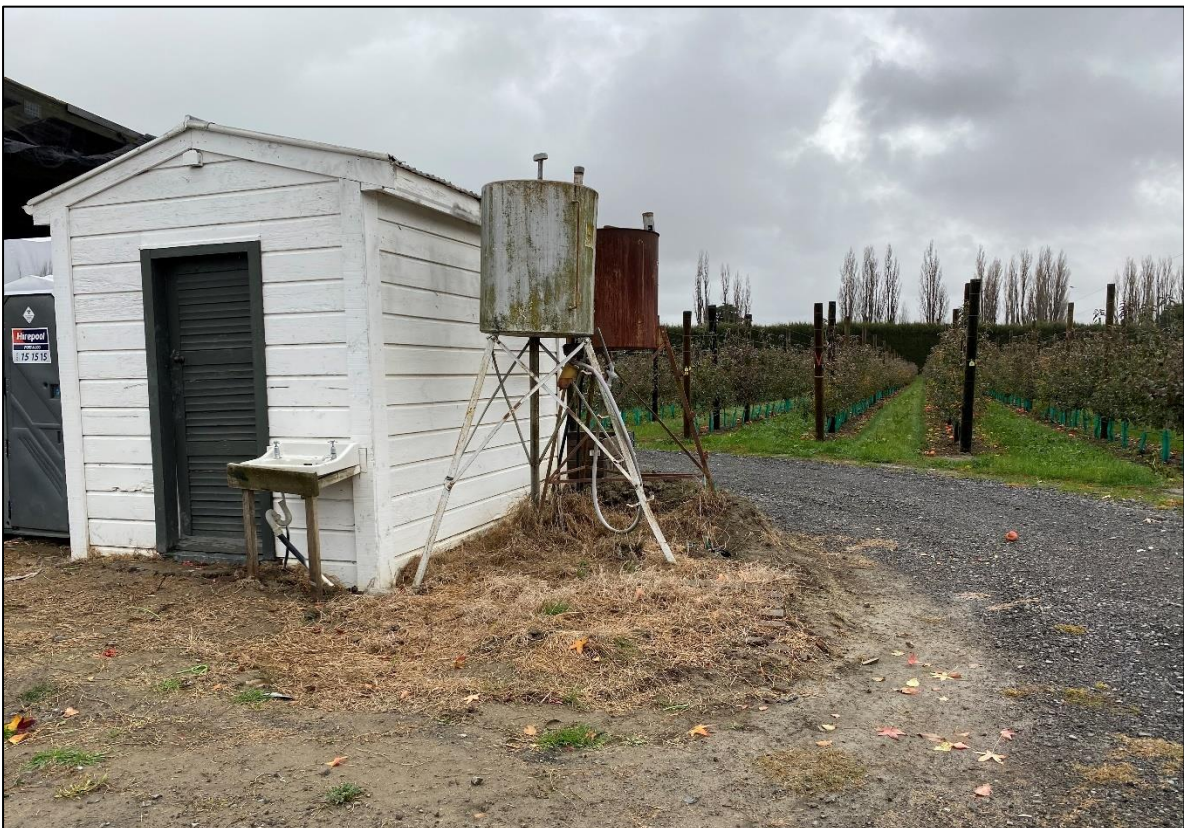
- Two small ASTs were adjacent to the sheds and portable toilet, beyond a demolished house, at 70 Franklin Road. Only one appeared to contain diesel, while the other appeared to be empty. The surface of the empty tank rusted, and it appeared older than the tank that was full. While staining of the surrounding ground was not observed, vegetation beneath the ASTs appeared in poor condition, possibly as a result of recent weed spraying. See Photograph Appendix B.18.

Photograph Appendix B.18: Two small AST's at 70 Franklin Road.

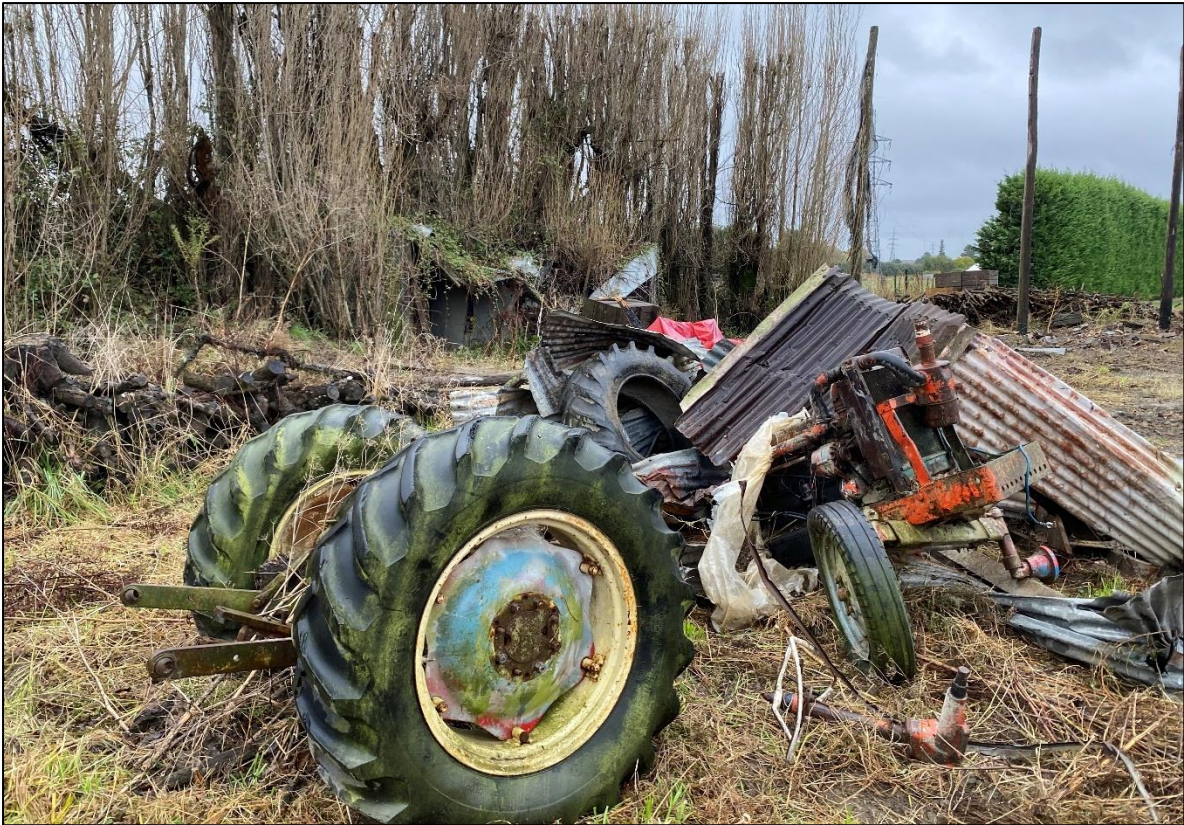
- An area at the rear of 56 Franklin Road, adjacent to the access of 70 Franklin Road, contained piles of discarded tractors, tyres, timber pallets, corrugated iron, plastic, and green waste (some appeared to have been burnt prior to putting on pile). A circuit board (potential piece of computer or laptop) was on top of the green waste material. Further materials had been discarded along the hedge line (outside of the project site). See Photograph Appendix B.19 and Photograph Appendix B.20.

Photograph Appendix B.19: Discarded tractor and waste materials at 56 Franklin Road.

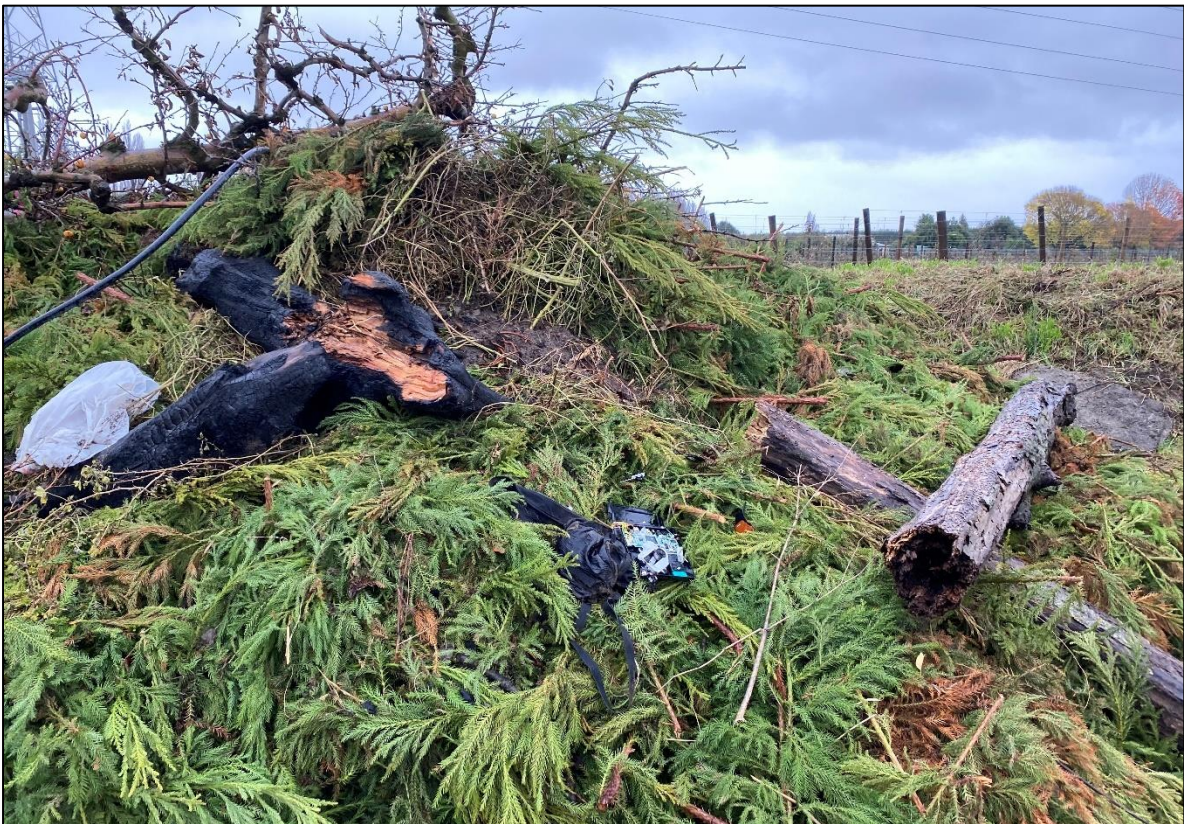
Photograph Appendix B.20: Greenwaste pile at 56 Franklin Road, burnt log to left of time and circuit board at centre.

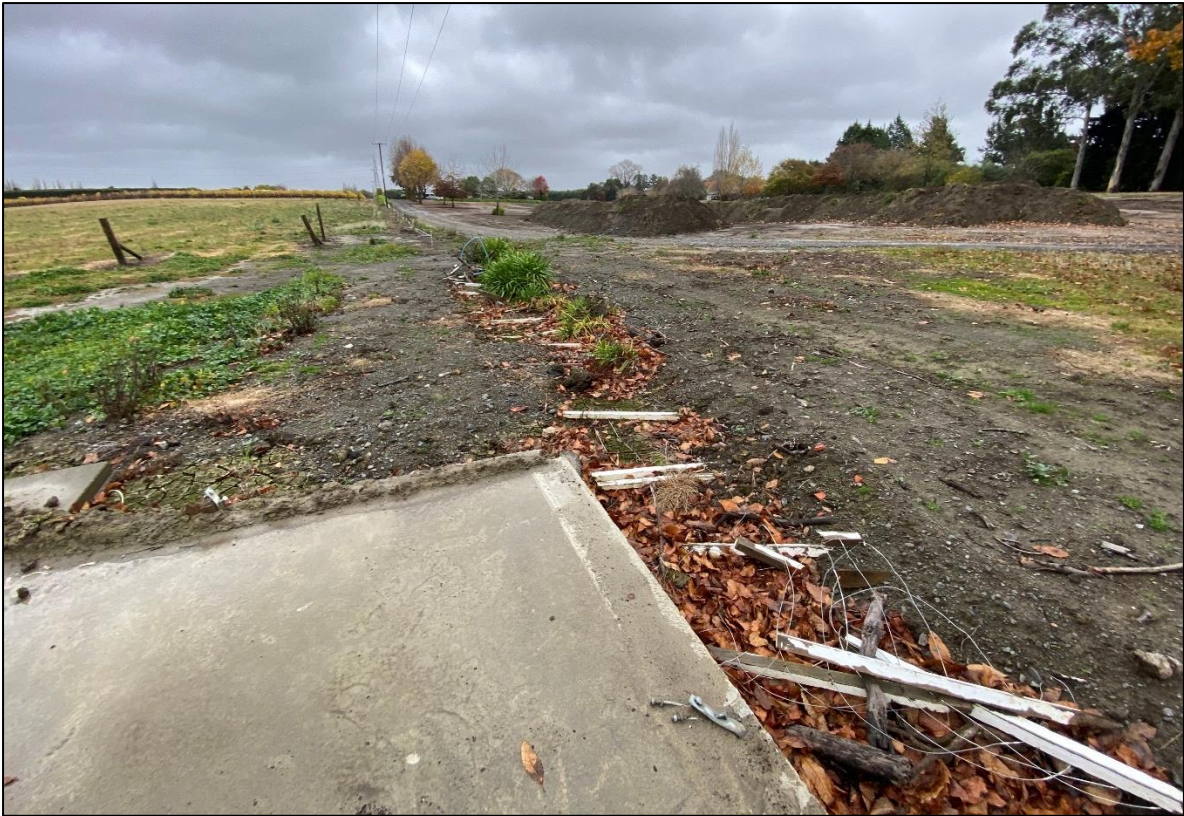
- Earthworks were being undertaken by an excavator on the boundary of 1153 Links Road and the golf course property. Large stockpiles (total volume unconfirmed) of what appears to be topsoil were observed on the golf course property, adjacent to the site. See Photograph Appendix B.21.

Photograph Appendix B.21: Stockpiles of topsoil in area of earthworks occurring on golf course property, adjacent to 1153 Links Road.
