**Pakowhai Secondary
Stopbank**

Preliminary Site Investigation

Prepared for
Hawkes Bay Regional Council

Prepared by
Tonkin & Taylor Ltd

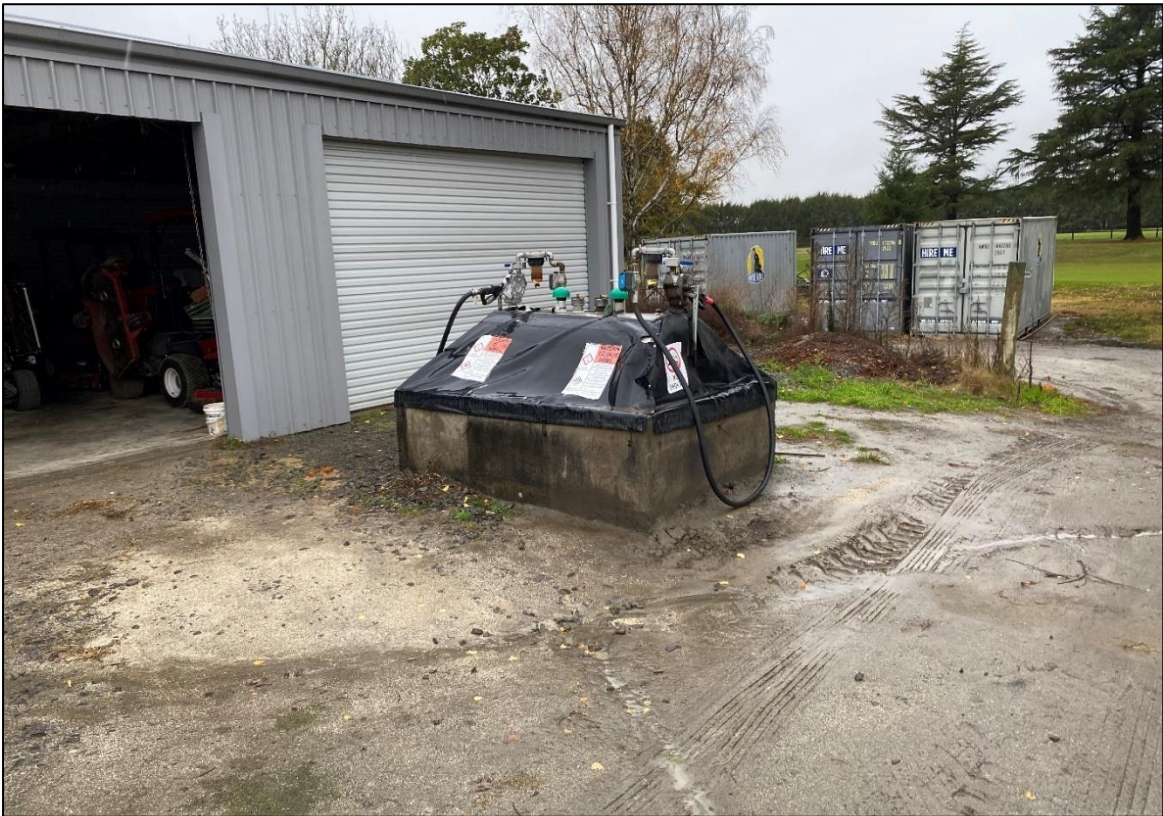
- A split petrol and diesel AST is present on the golf course property, by the maintenance sheds, outside of the project site area by approximately 75 m. The AST was within a concrete bund and had a cover, the ground beneath was unable to be observed at the time of the site visit. From discussions with the Turf Manager of the Napier Golf Club, we understand the AST was installed following Cyclone Gabrielle, where a former AST was inundated and displaced. See Photograph Appendix B.22.

Photograph Appendix B.22: AST by maintenance sheds at golf club (offsite), looking south towards the site.
