# Pōrangahau Flood Mitigation Ecological Impact Assessment

Hawke's Bay Regional Council

✦ October 2025

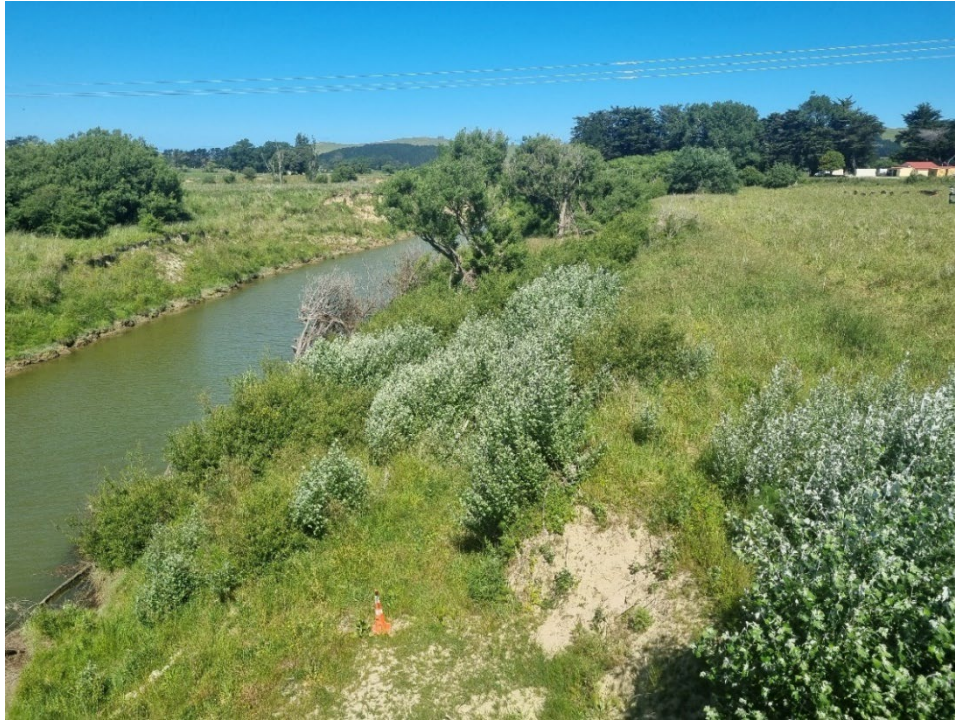
**Photograph 1: Extensive rank grass, trees, and shrubs in full sun**

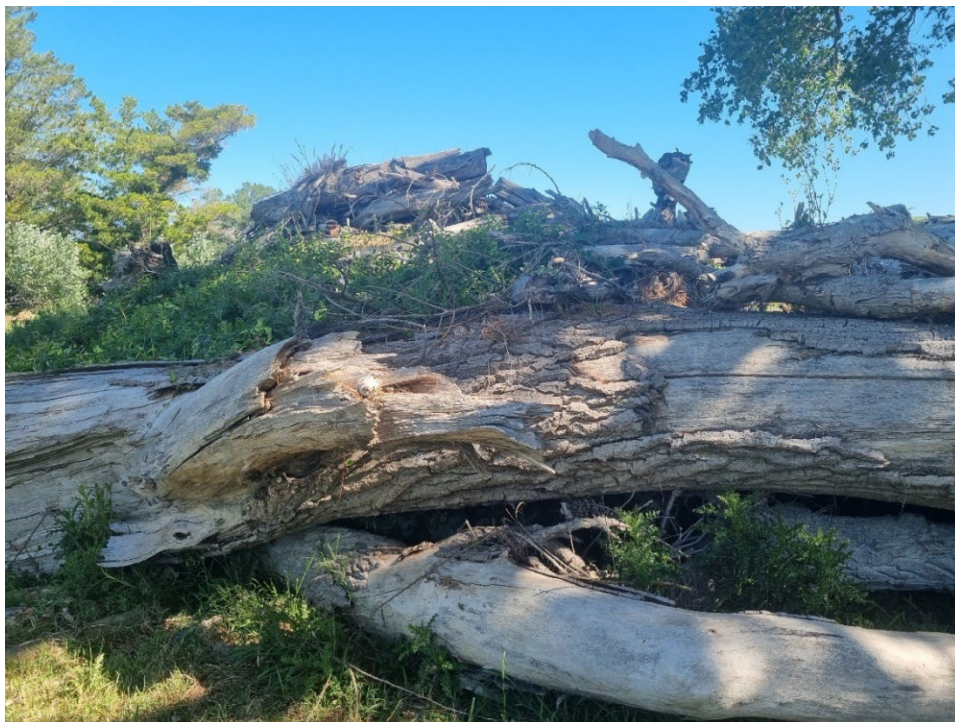
**Photograph 2: Several piles of woody debris are present along the proposed Pōrangahau stopbank footprint**

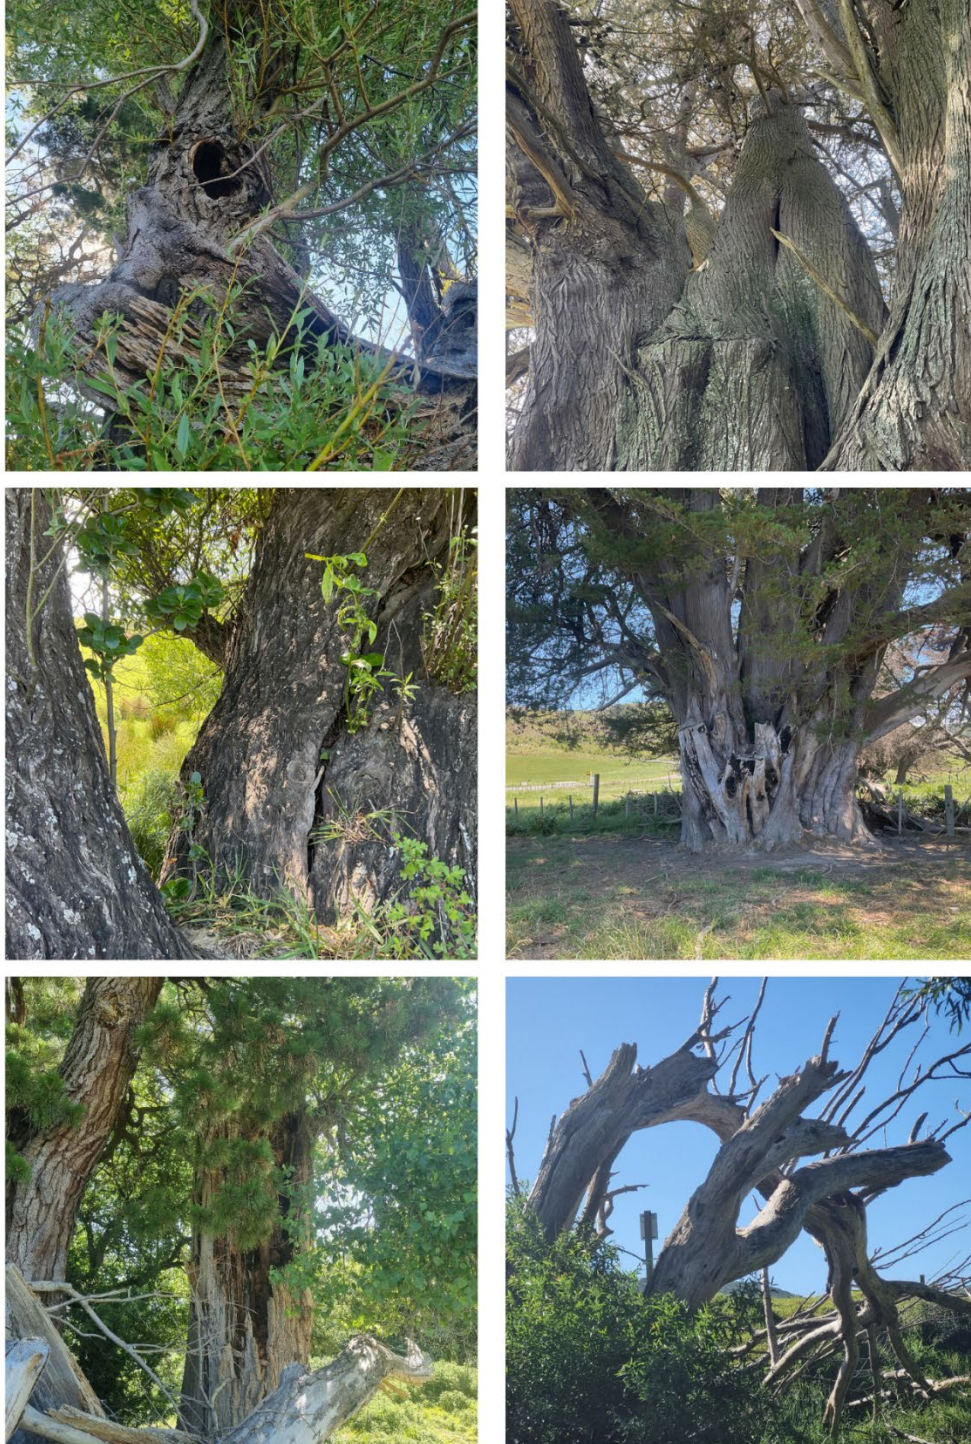
**Photograph 3: Trees with features suitable for pekapeka roosting within the stopbank corridor**

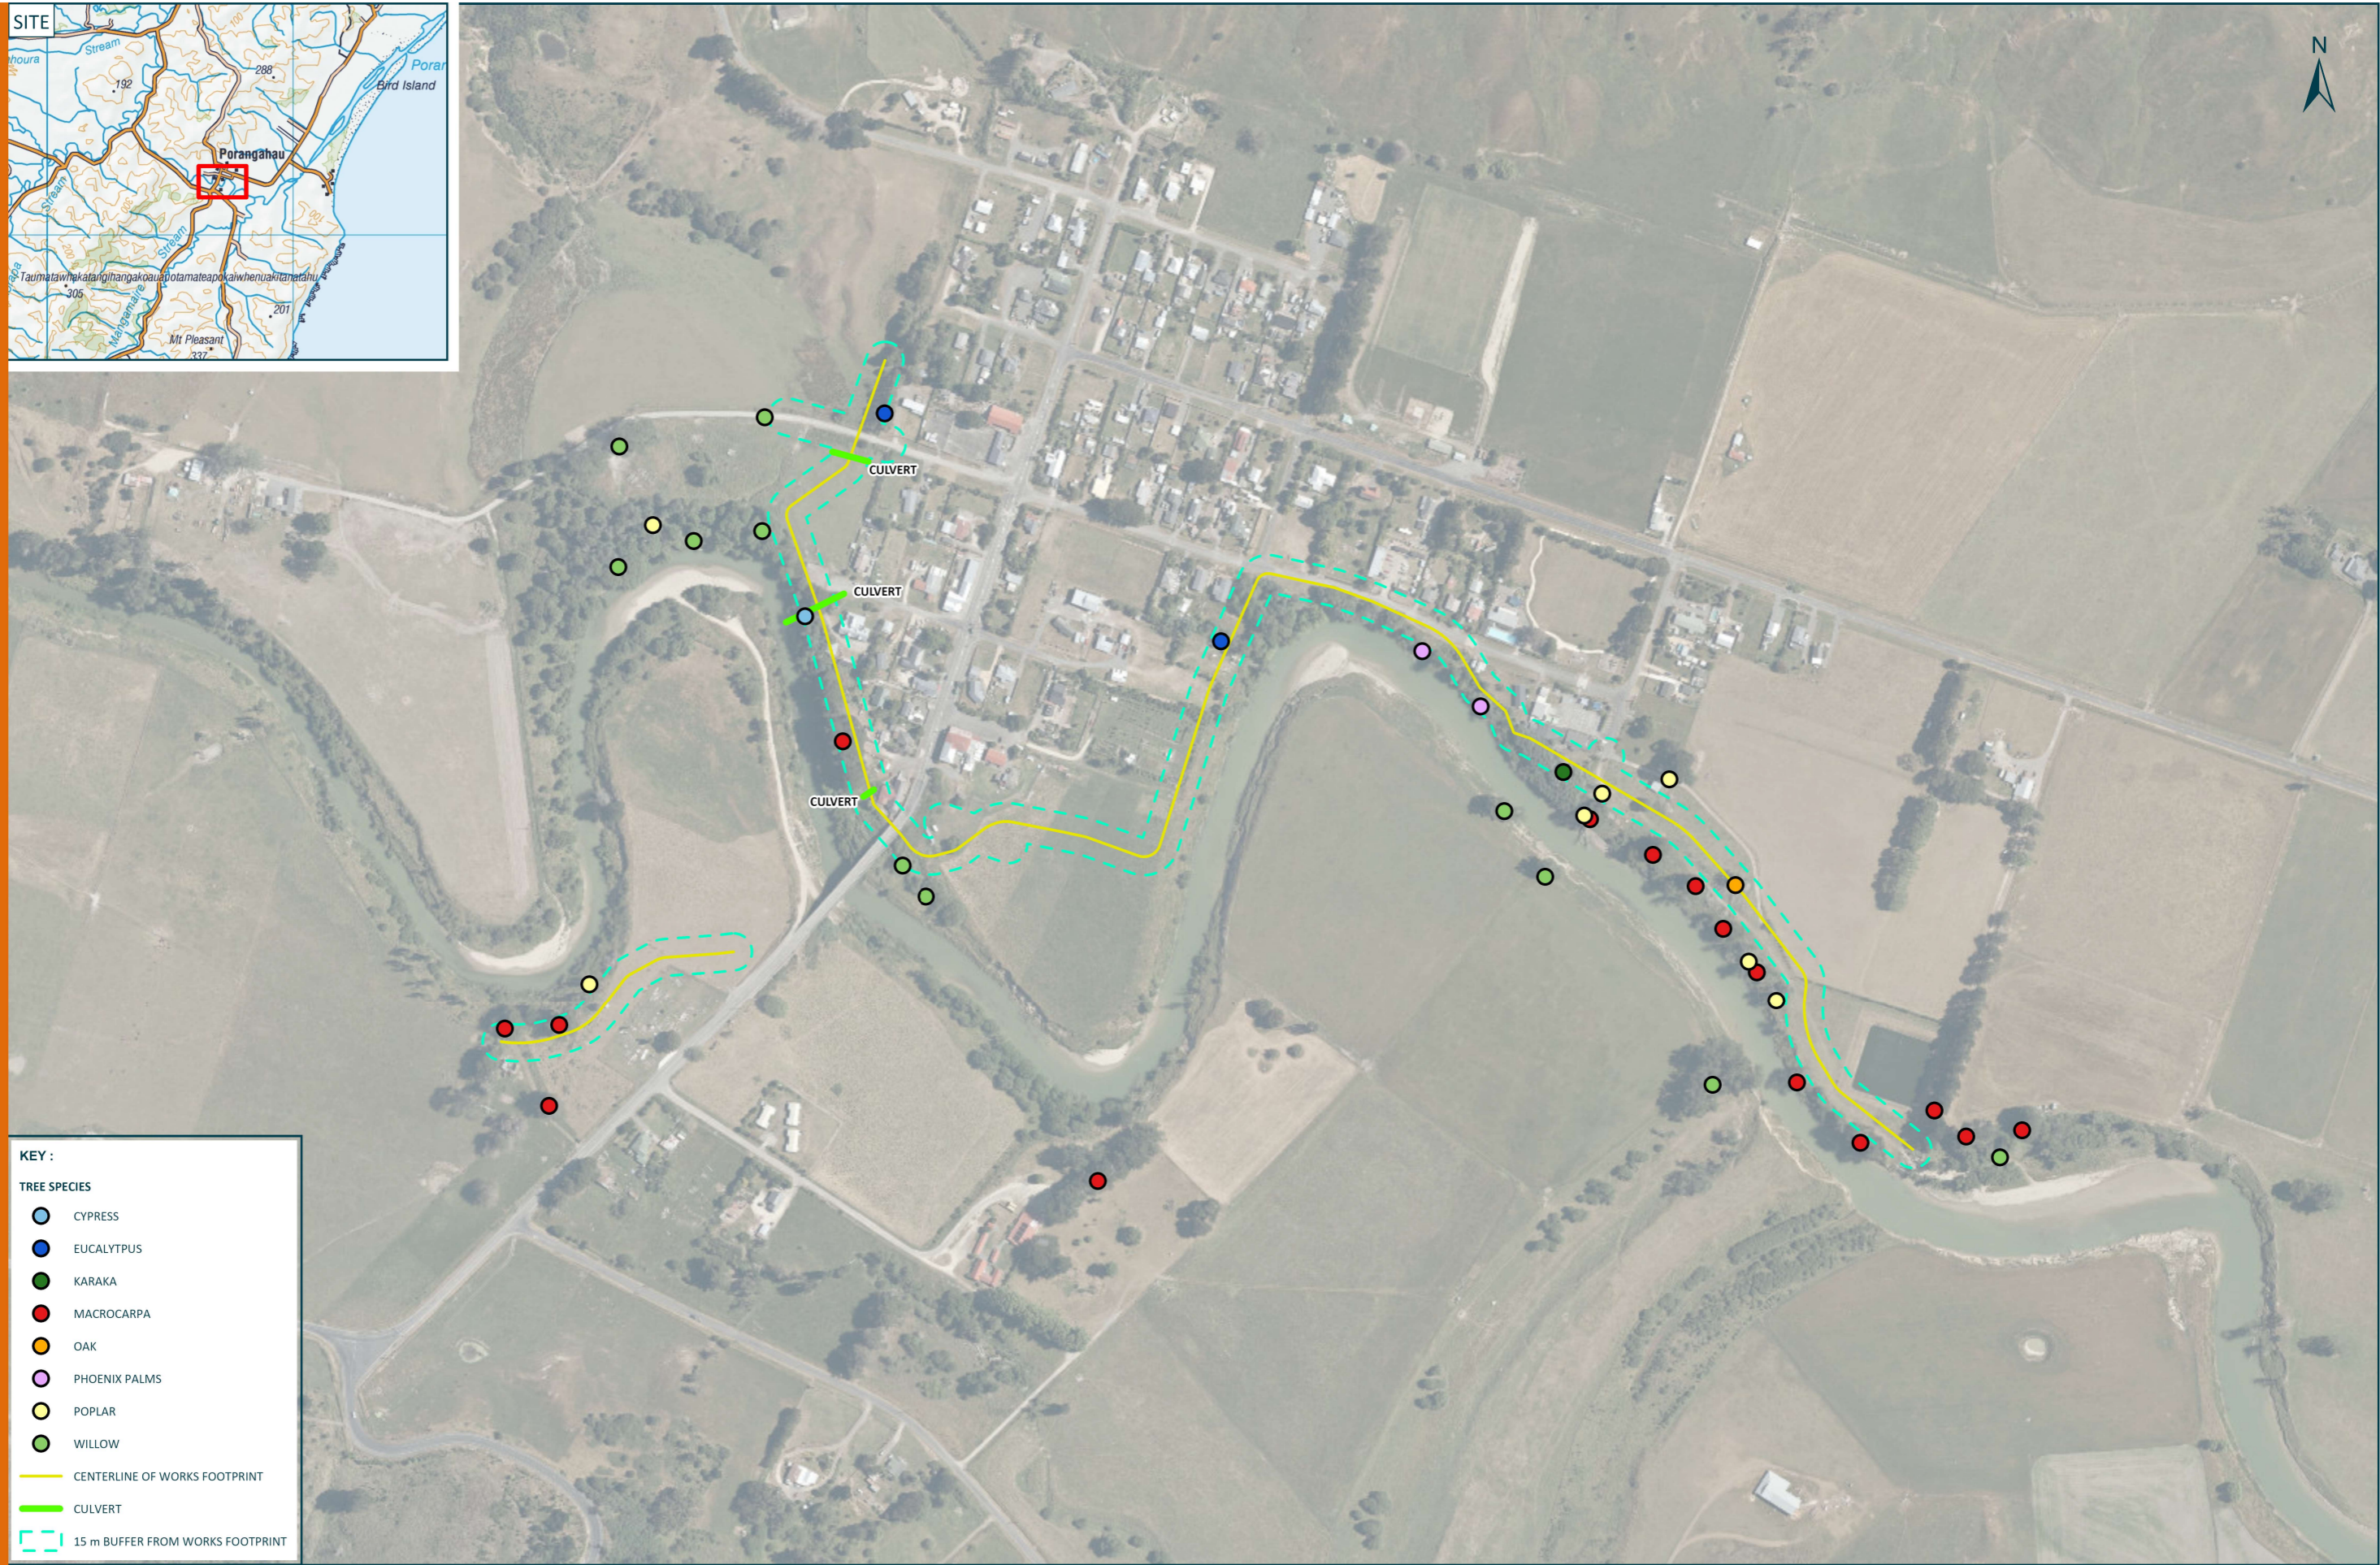
**KEY :**

**TREE SPECIES**

At the project site, many mature trees with potential bat roosting features (e.g., hollows, broken or twisted boughs, flaking bark, etc) were observed and recorded (Photograph 3, locations shown in Figure 4). Tree species were predominately exotic and included species such as macrocarpa (*Hesperocyparis macrocarpa*), poplar (*Populus nigra*, *P. deltoides*, *P. alba*), willow (*Salix x fragilis*, *S. cinerea*), tī kōuka (*Cordyline australis*), and karaka (*Corynocarpus laevigatus*). Several large, dead trees were also observed within the corridor.

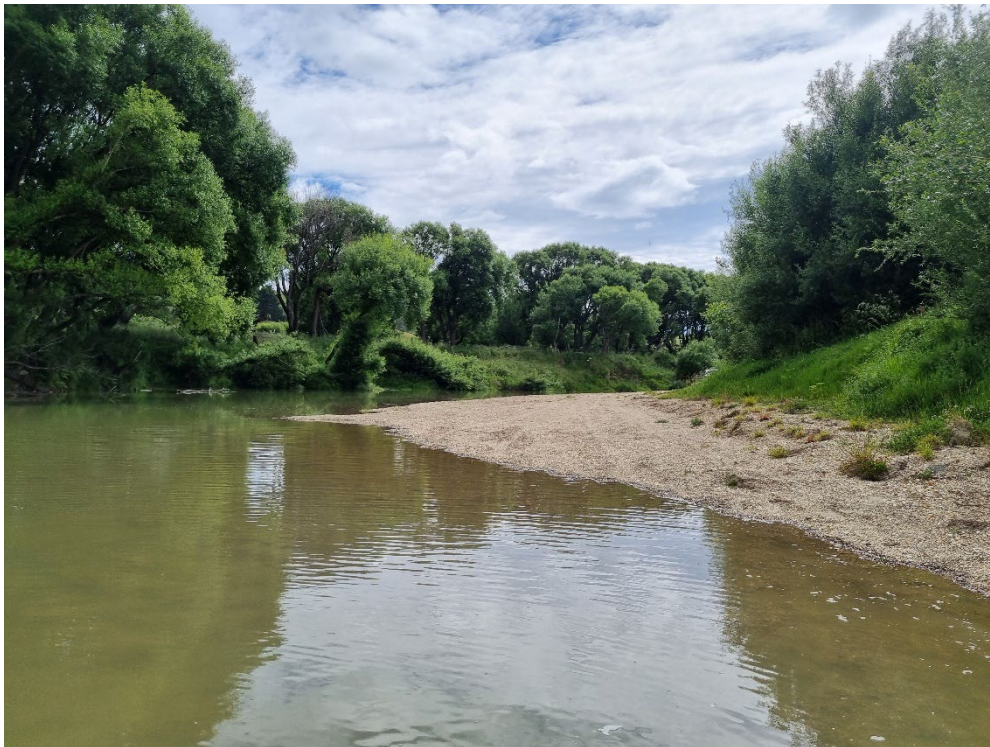
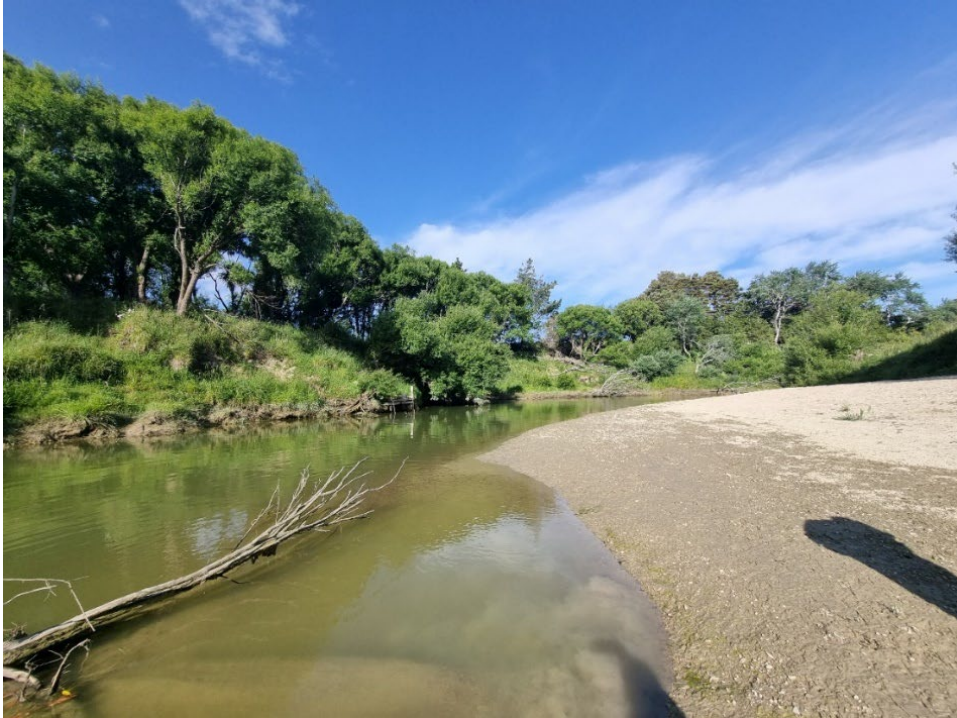
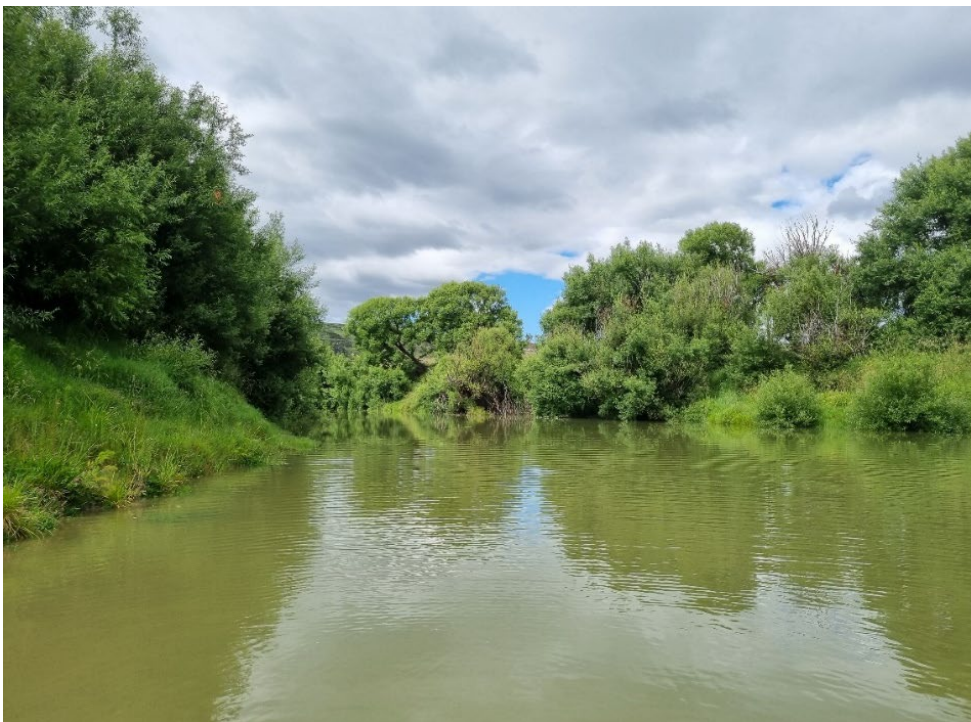
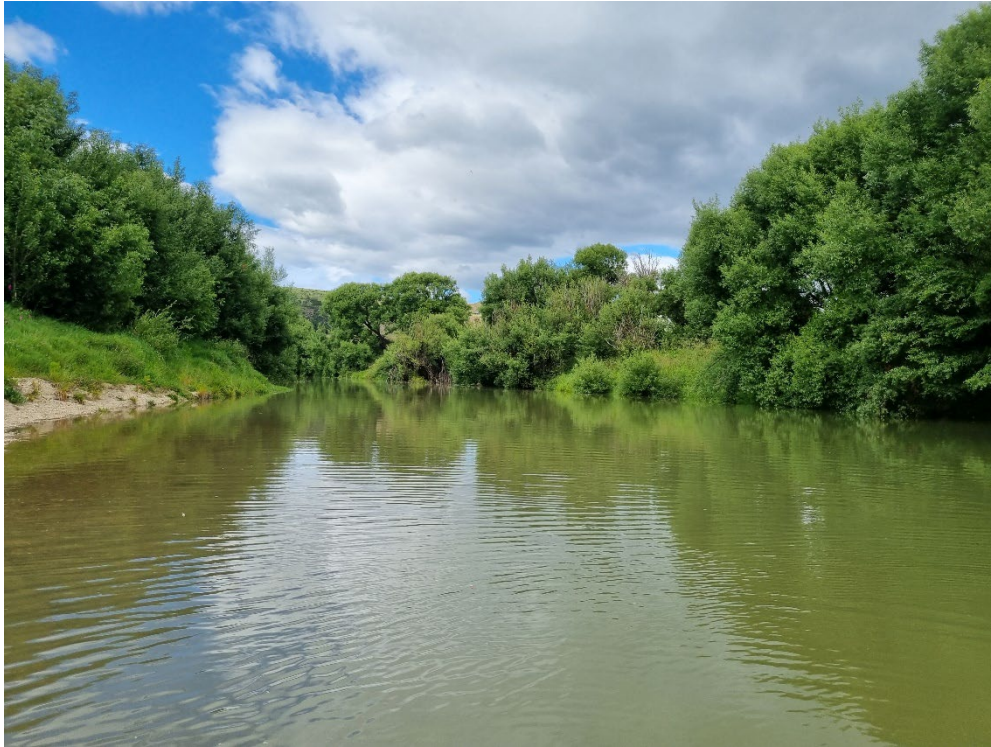
In the upstream reach, the riparian zone was dominated by rank grass and crack willow. On the TLB, mature, over-hanging crack willow were observed, while younger willow dominated the TRB. The channel was approximately 15 m wide with a stream bed consisted of gravels overlain by deposited fine sediment. High amounts of woody debris were present in the reach, as shown in photograph 5. This reach is tidally influenced based on field observations and water quality results.

**Photograph 4: Reach 1 looking downstream at high tide**

**Photograph 5: Reach 1 looking downstream at low tide**

**Photograph 6: Reach 1 looking upstream at high tide**

**Photograph 7: Reach 1 looking upstream at low tide**

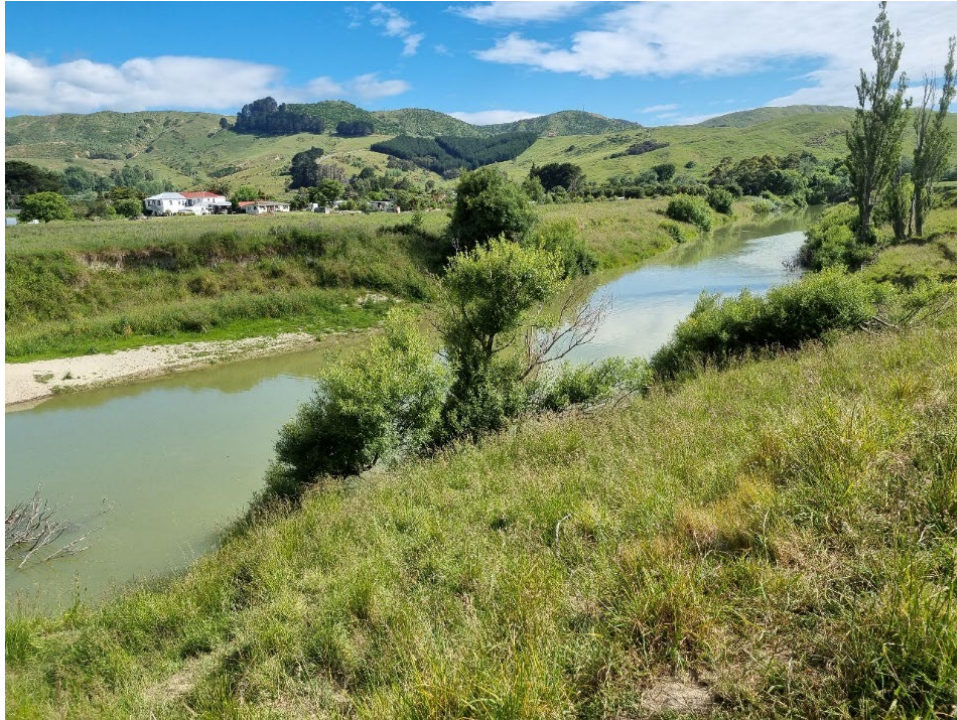
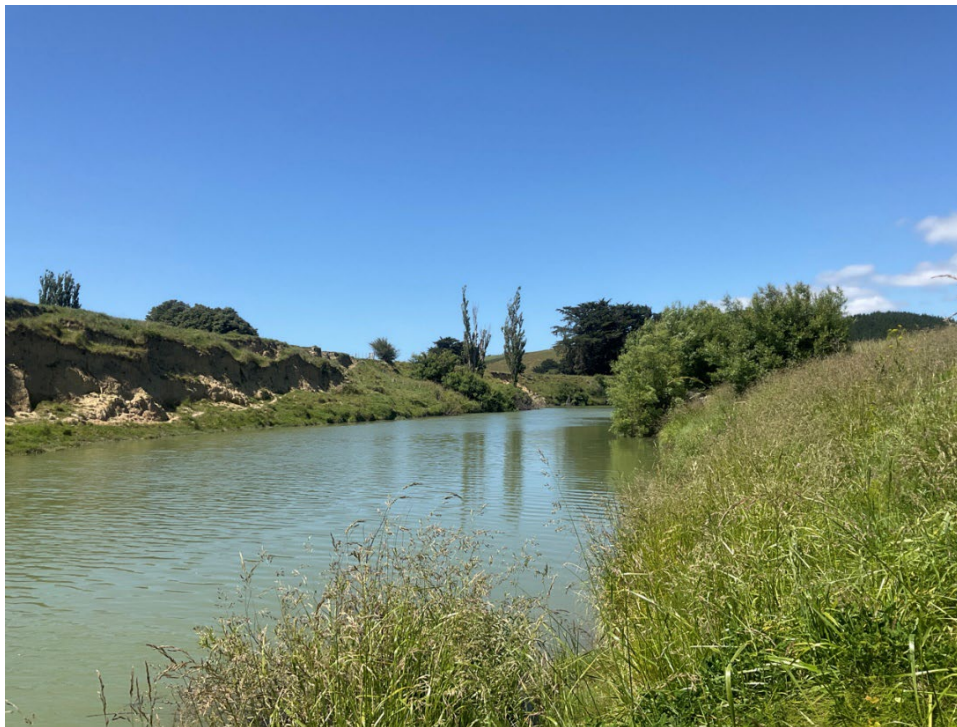
Reach 2 was approximately 30 m wide and characterised by minimal riparian vegetation, and high bank erosion (Photographs 8 - 9). The TLB had a 30 m wide, fenced riparian margin. Vegetation consisted of shoulder height rank grass and the occasional crack willow. Undercut banks were also present at the water's edge. The TRB was steep, with low rank grass, bare earth, and scattered willow and poplar.

**Photograph 8: Reach 2 looking downstream from the TRB**

**Photograph 9: Reach 2 looking upstream from the TLB**

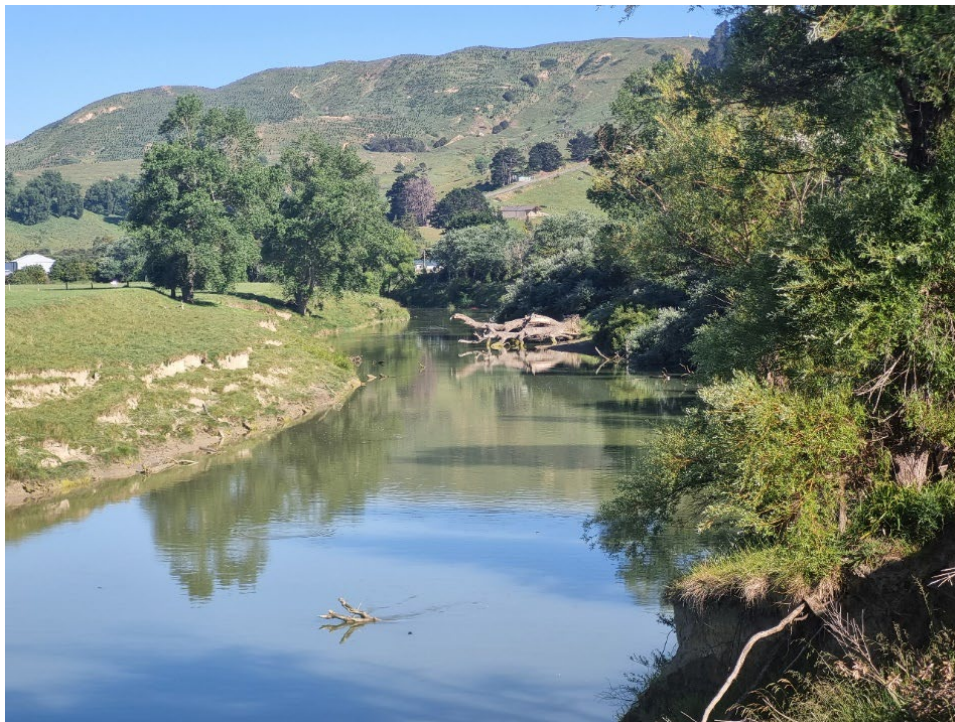
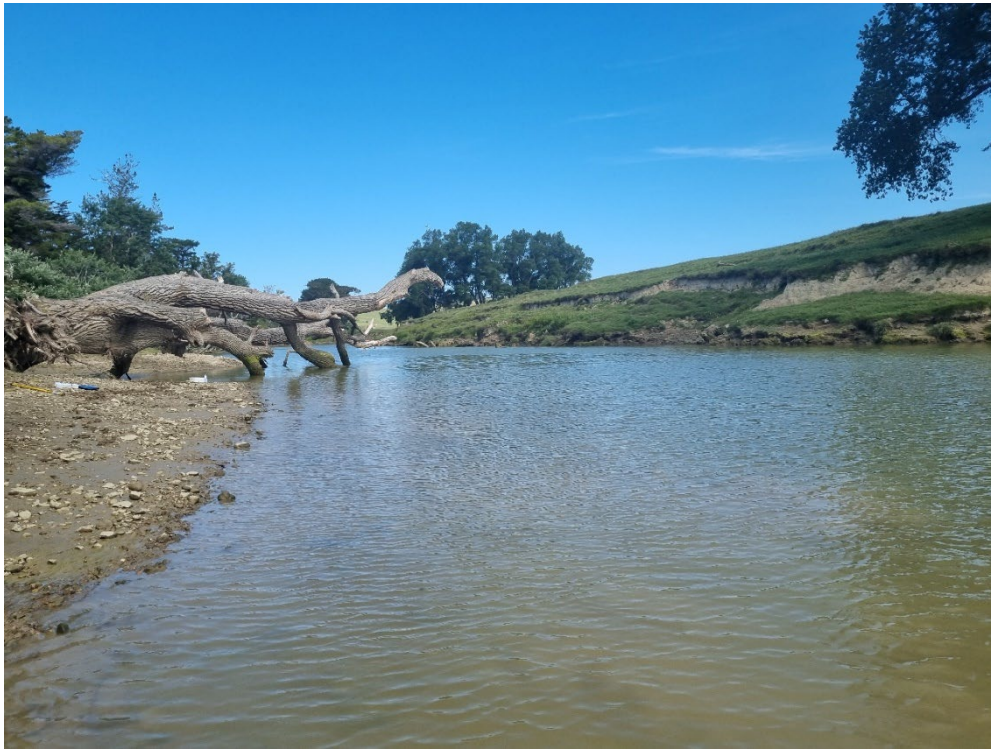
The downstream reach was approximately 30 m wide and characterised on the TRB by minimal riparian vegetation and high bank erosion. The TLB was characterised by mature willow, poplar and macrocarpa, with minor pockets of bank erosion. Both banks lacked fencing, however stock access to the majority of the TLB was prevented by large piles of woody debris and vegetation. The stream bed comprised gravel and cobbles overlain by deposited sediment. Woody debris was abundant in the stream, as shown in photographs 10 - 11 below.

**Photograph 10: Reach 3 looking upstream from the TLB**

**Photograph 11: Reach 3 looking downstream from the TLB**

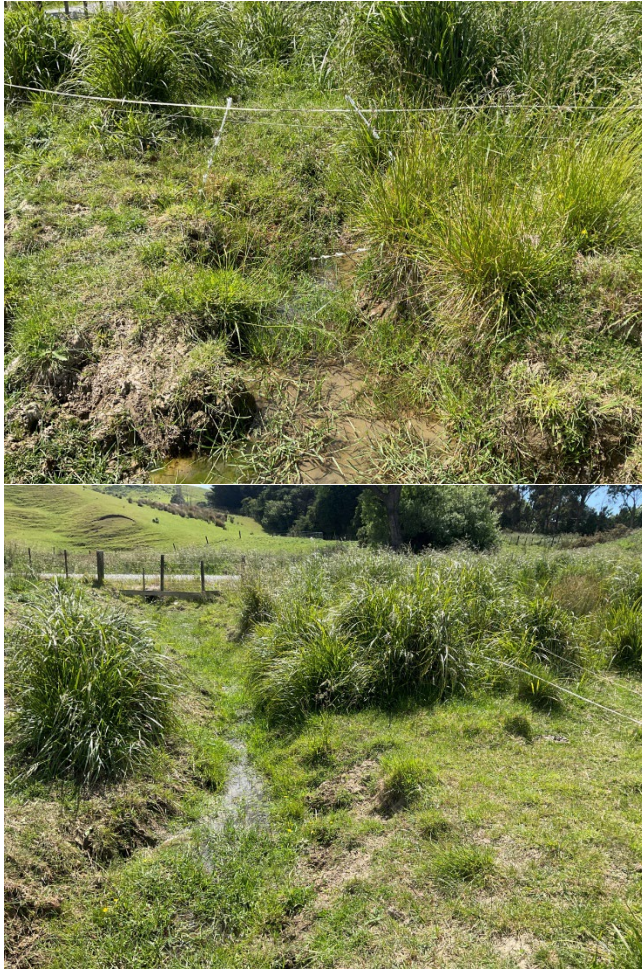
A small unnamed intermittent stream flows from the township through rautahi sedgeland wetland south of Keppel Street, before continuing along margins dominated by creeping bent (*Agrostis stolonifera*). The channel is primarily stormwater-fed, with inputs from the township providing the majority of baseflow, and it passes through pastoral land before converging with the Pōrangahau River. At the time of the site visit, the stream was not flowing, with shallow pooling (up to 5 cm) in its deepest sections. The streambed supported dense vegetation growth, with little evidence of high-velocity bed turnover or scouring that would be expected from regular baseflows or frequent high-flow events. No formal assessments were undertaken for this stream.

**Photograph 12: Intermittent stream flows through the Rauntahi sedgeland (top) and joins the creeping bent stream margin (bottom).**

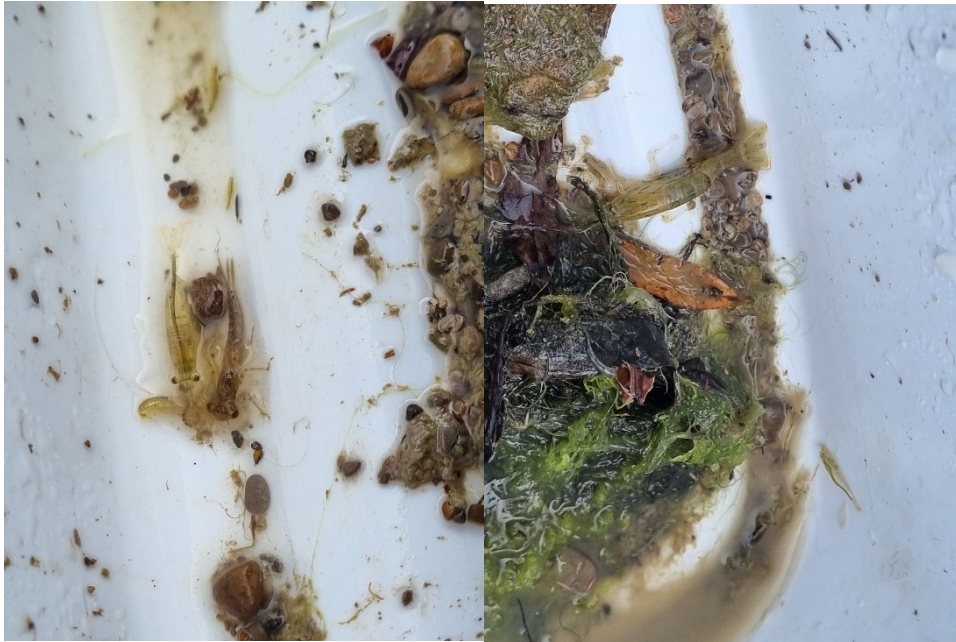
While macroinvertebrate samples have not been processed in the laboratory (as agreed by the standardised scope provided by HBRC), field observations identified freshwater shrimp (*Paratya curvirostris*), kōura (*Paranephrops planifrons*) and damselfly larvae (Photograph 12). Kākahi, freshwater mussels, were also observed.

**Photograph 13: Field observations of shrimp and damselfly larva**

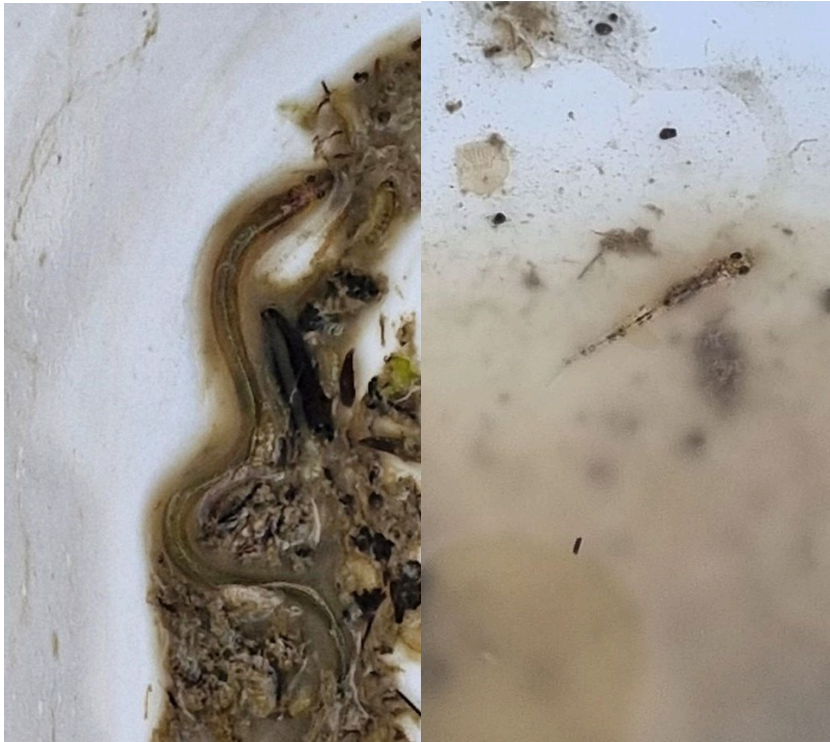
No targeted fish sampling occurred, but incidental observations were made during the field assessments. Within the assessment reaches, small shoaling fish were observed jumping out of the water. Based on their behaviour and size, these were likely to be smelt (*Retropinna retropinna*). Incidental observations of īnanga were also made. While collecting macroinvertebrate kicknet samples, post-glass eels and juvenile bullies were also caught (Photograph 13).

**Photograph 14: Observations of juvenile eels and bullies**

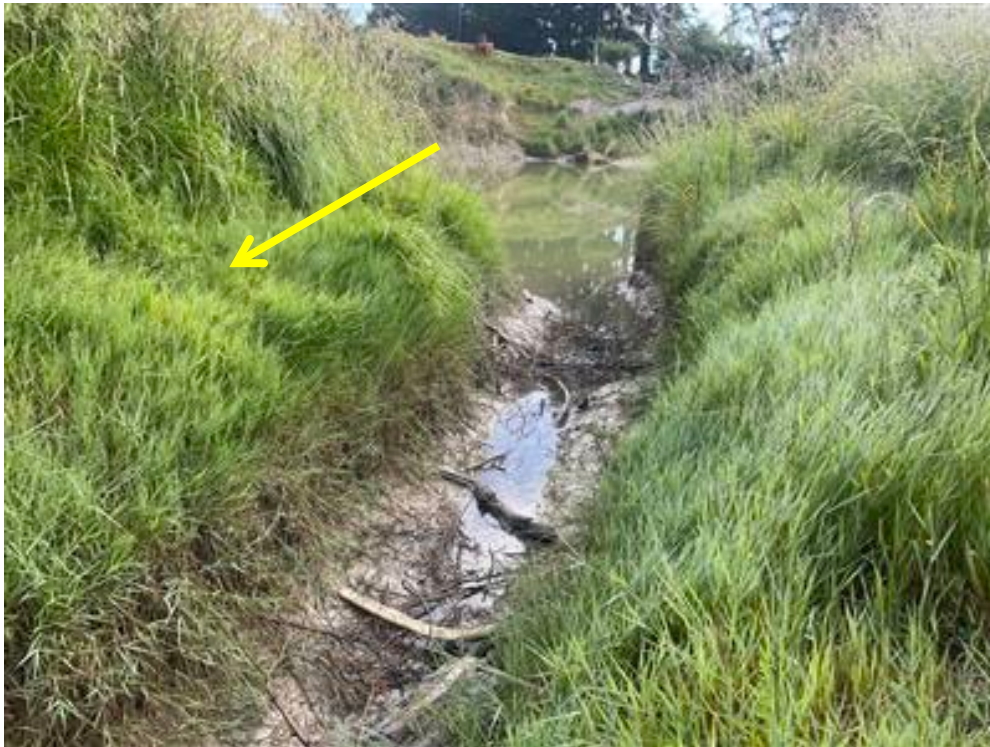
However, downstream of the project site (and thus Site 4), is an old river oxbow which has been dug out and planted with native riparian vegetation (pers comm). Locals have reported seeing inanga swimming up the channel during high tide. Because the bed is set higher than the bed of the Pōrangahau River more buoyant fresh water could flow into the channel while the heavier saline-brackish water flows along the deepest part of the channel. Such conditions might be conducive to inanga spawning. The observed riparian vegetation supports this possibility and appears indicative of vegetation that is regularly inundated with fresh and/or brackish water (Photograph 14). However, it is uncertain whether vegetation growth is lush enough to provide the dense, humid microclimate required for successful spawning. Likely causes of unsuitable conditions could be lack of sun exposure, sandy soils, brackish water that is too saline, grazing or other control of vegetation or vegetation that is inundated by water for too long.

**Photograph 15. Looking downstream at the old river oxbow, showing lush riparian grass growth. Yellow arrow indicates where grass growth may be lush enough to support inanga spawning.**

Below are photos of vegetation taken in the old oxbow opposite the WWTP (Photographs 15 and 16) between water quality sample sites 9 and 10 (Figure 1), 1 hour prior to high tide. The exact location is shown by the pin on the google earth images below (Figure 5). Crab holes observed in this location indicate that it is tidally influenced (Photograph 16).

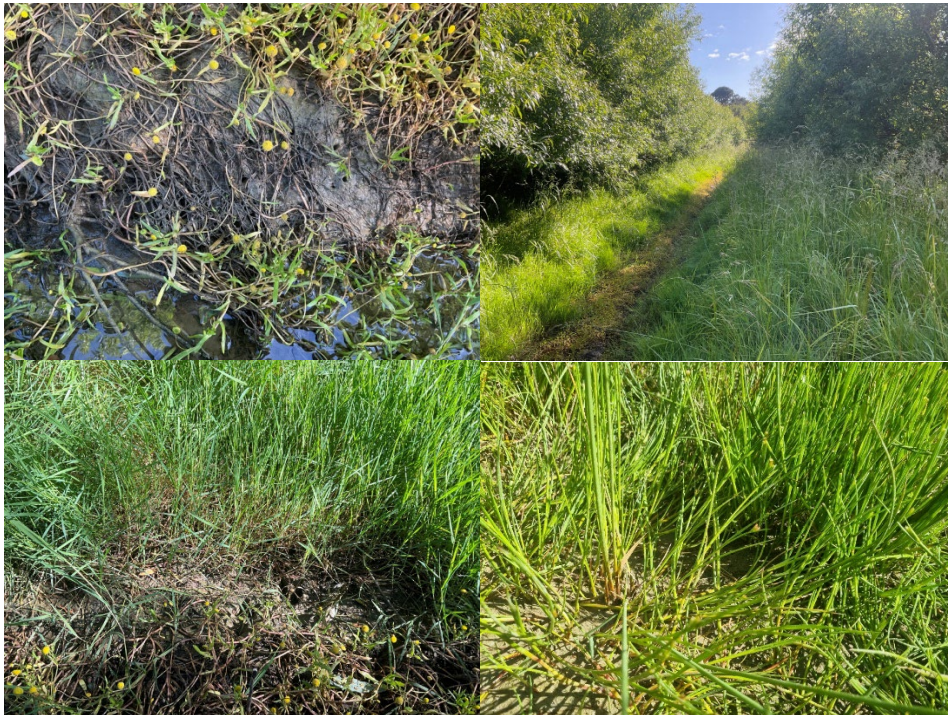
**Photograph 16: Vegetation present within the old oxbow**

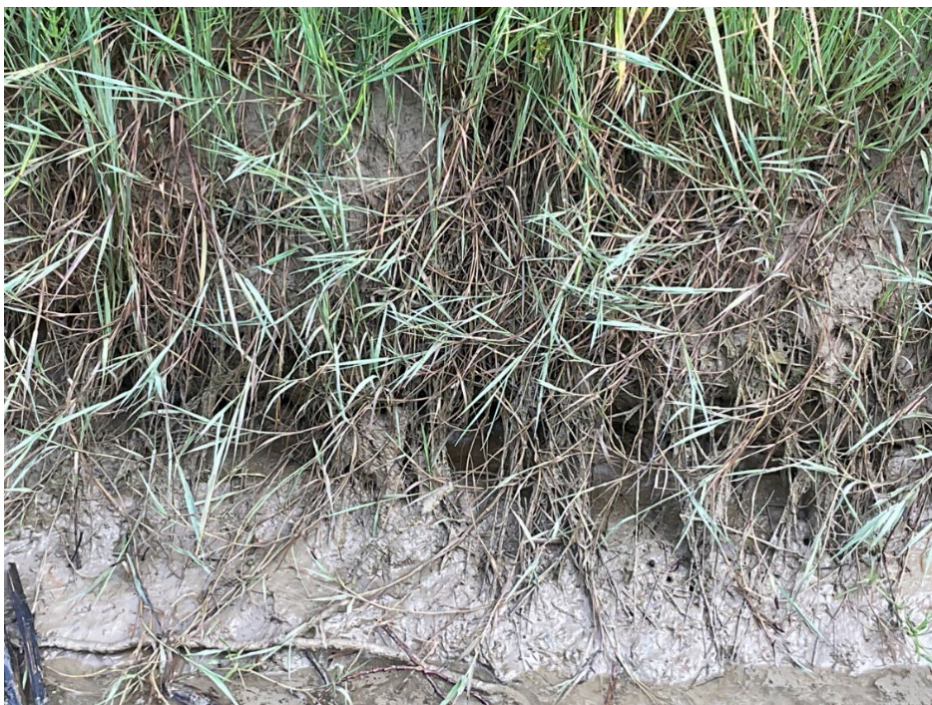
**Photograph 17: Example of crab holes at this location, demonstrating that it is tidally influenced**

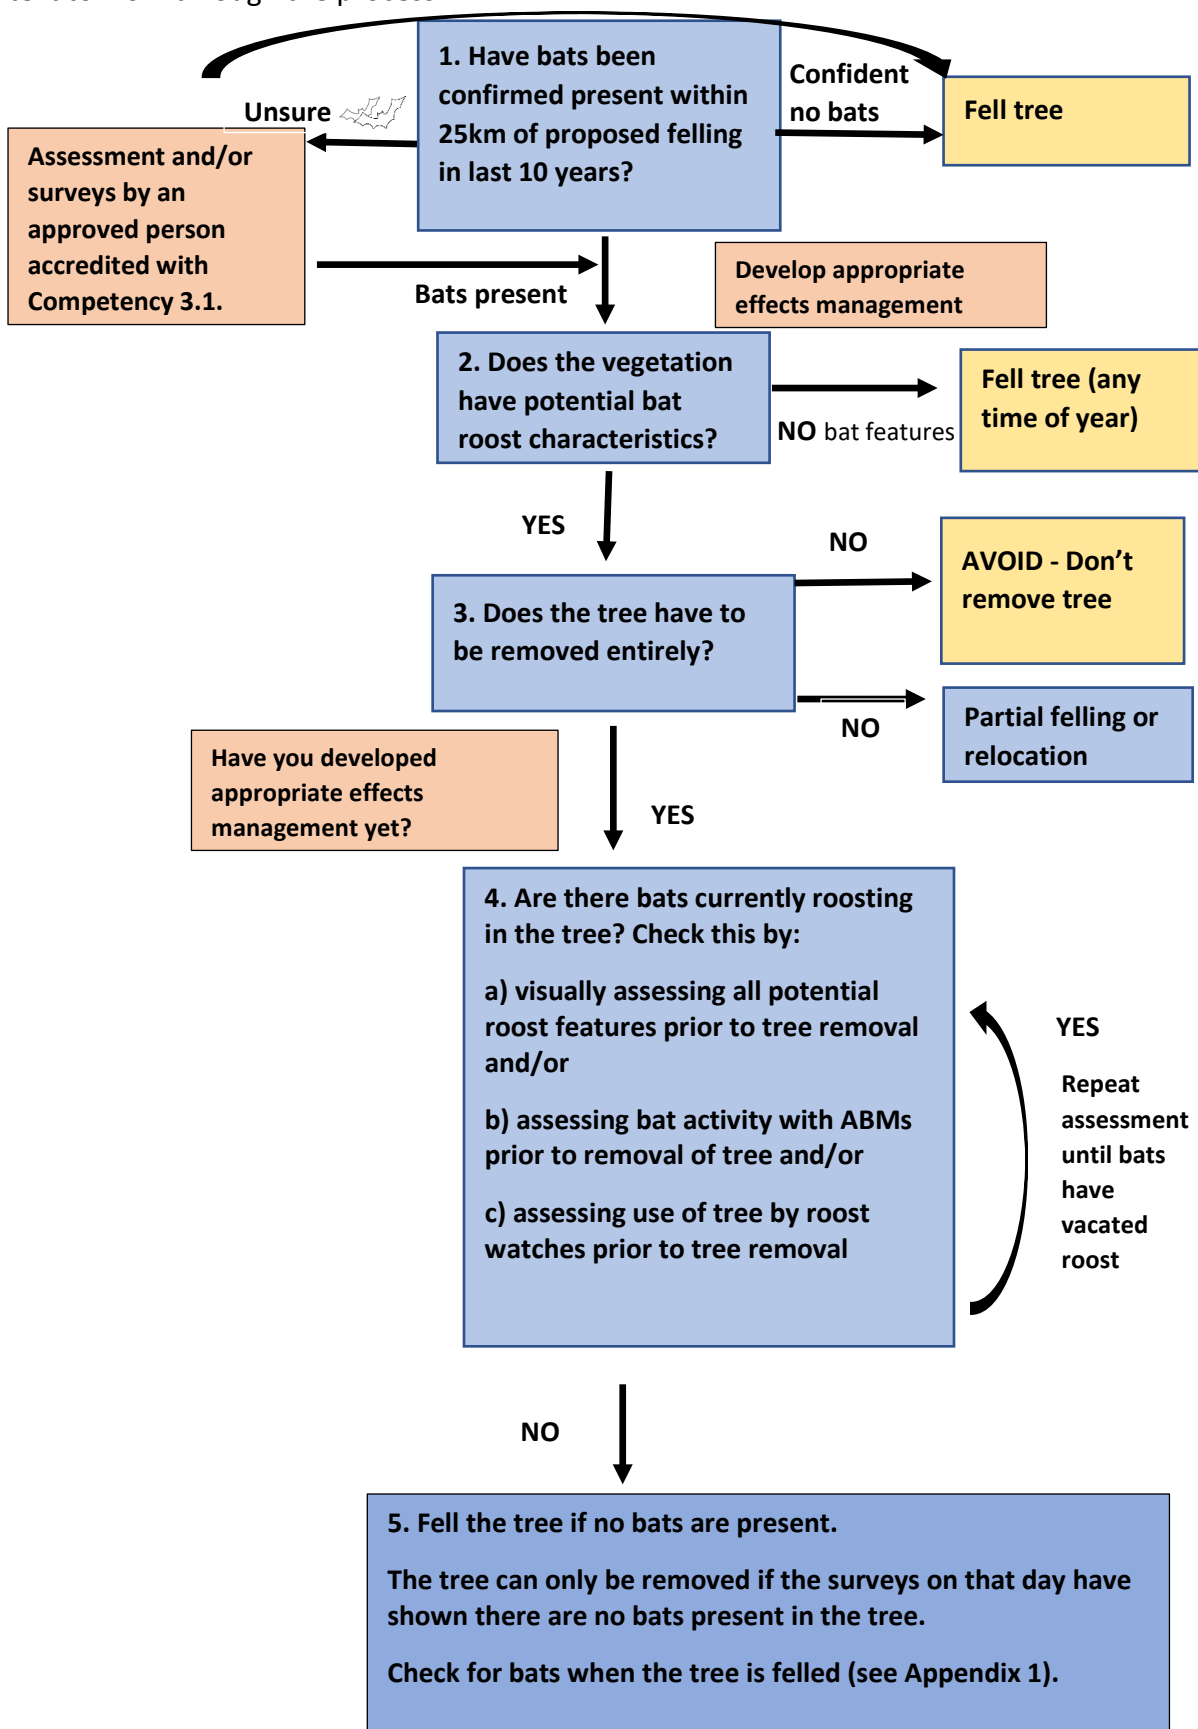
**Figure 1. Tree removal in bat areas flow chart**

Each numbered step relates to a step in the Decision Tool for Tree Removal. Follow each step fully in the text to work through the process.
