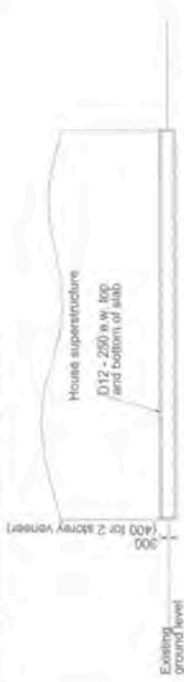
Figure 5.6: Enhanced foundation slab – Option 2

Option 2 – Construct a thick slab foundation over the existing soil

Note: NZS ground clearances adjacent to house foundation must be complied with, DPC omitted for clarity.

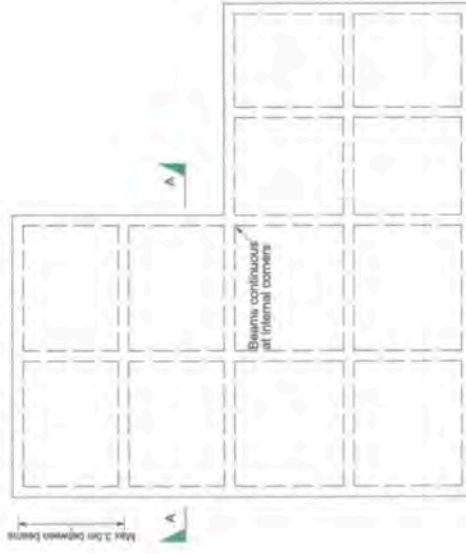
Figure 5.7: Enhanced foundation slab – Option 3 plan

Option 3 – Construct a generic beam grid and slab foundation

Note: Reinforcing details are not sufficient for two-storey heavy-weight slabbing (brick veneer) with a heavy roof but can be used for a two-storey heavy-weight slabbing with a light-weight roof.

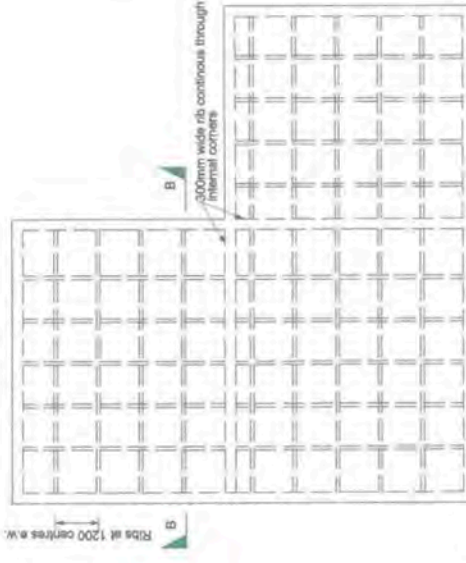
Figure 5.10: Enhanced foundation slab – Option 4 plan

Option 4 – Construct a waffle slab over the existing soil

Note: Reinforcing details are not sufficient for two-storey heavy-weight slabbing (brick veneer) with either a heavy or light roof.

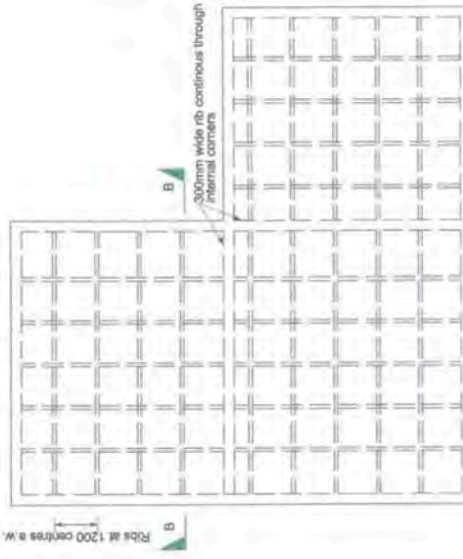
Figure 5.10: Enhanced foundation slab – Option 4 plan

Option 4 – Construct a waffle slab over the existing soil.

Note: Reinforcing details are not sufficient for two-storey heavy weight cladding (brick veneer) with either a heavy or light roof.
