**PŌRANGAHAU STOPBANK BORROW AREA 3 MATERIAL INVESTIGATION ADDENDUM TO
PORANGAHAU STOPBANK BORROW AREA MATERIAL INVESTIGATION REF
HB01041700R007**

Hawke's Bay Regional Council (HBRC) appointed Pattle Delamore Partners Limited (PDP) to carry out the geotechnical investigation and design of a stopbank protecting Pōrangahau Town from future significant flood events.

This letter reports the assessment of the material of the site "Borrow Area 3", situated north of Beach Road, as shown in Figure 1.

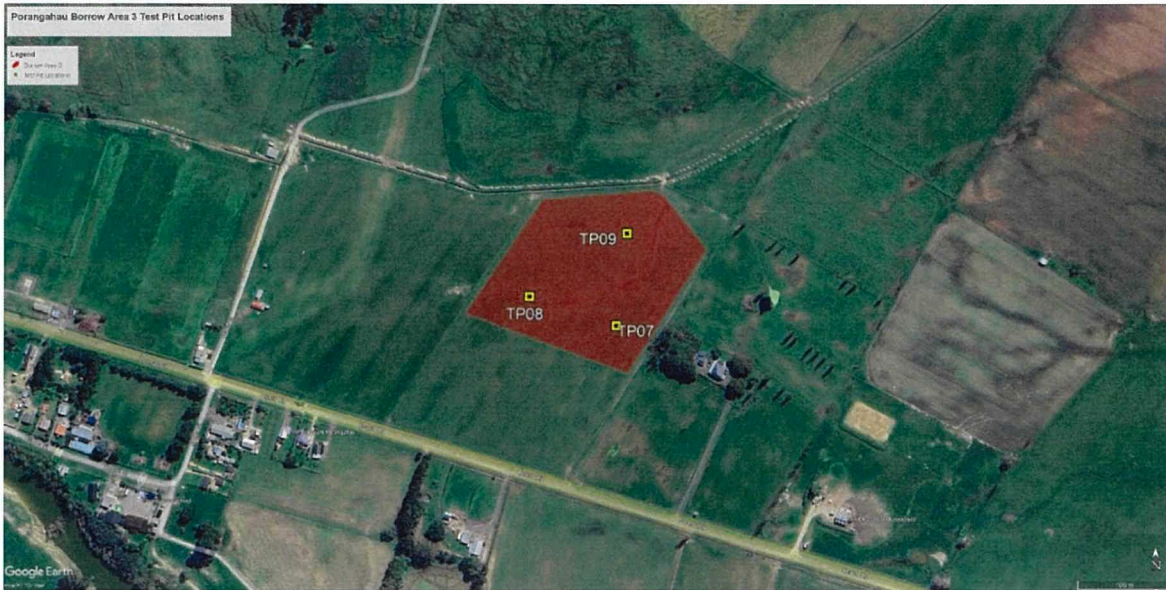
Figure 1: Site Layout, Borrow Area 3 Investigation Test Locations

Test pitting was carried out in the Borrow Area 3, as identified by HBRC, north of Beach Road in Pōrangahau (Figure 1 above). Three test pits were excavated using a Volvo 16T excavator with a straight-edged bucket. The test pits were inspected, profiled and selectively sampled by an engineering geologist according to NZGS (2005). The details of the sampling and results are summarised in Table 1 below, and the test pit soil profile logs are included in Appendix A.

The Borrow Area 3 and test pit locations are shown in Figure 1. The materials in the test pits were generally consistent across the borrow area and comprised recent topsoil overlying Holocene-aged alluvial deposits, occurring in bedded layers and are not uniform in vertical or horizontal distribution across the site. Test pits were excavated down to 3m below ground level or to where groundwater was encountered. The test pits had the following general horizons:

Borrow Area 3 was identified as a potential source for stop bank construction material (as shown in Figure 1) and measures approximately 3.4 ha in area. The topsoil thickness is consistent at 0.3 m thick. This topsoil material will need to be removed and stockpiled to expose the underlying borrow material, to be used for stopbank construction, then placed back into the reshaped borrow pits once the construction material has been removed to reinstate the areas.

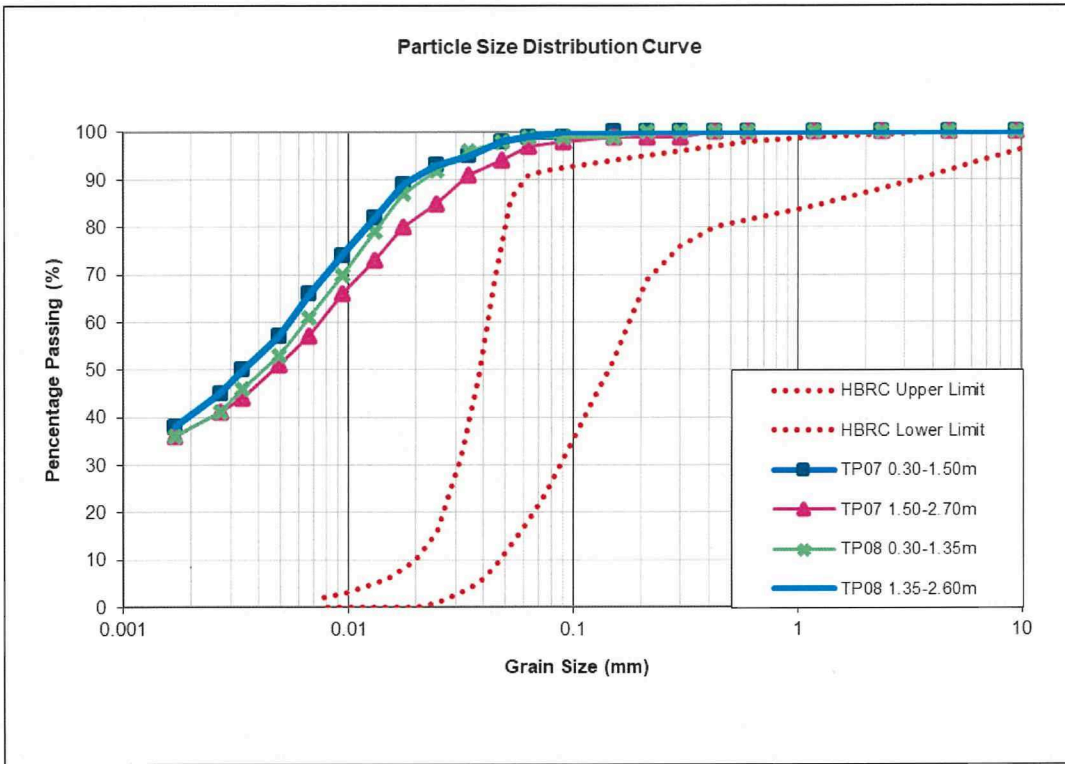
Figure 2: HBRC Stopbank Borrow Material Grading Curves vs. Site Test Pit Material from Proposed Borrow Area 3

Indicative samples were taken from TP07 and TP08. Material particle size distribution testing showed that the material from the proposed Borrow Area 3 falls outside the HBRC grading envelope (Figure 2), with the bulk of the material being silt or clay. Additionally, California Bearing Ratio (CBR) testing was carried out on all the samples from TP07 and TP08 with results ranging from 1 to 2.5 % (with NZ standard compaction). Maximum Dry Densities ranged from 1.39 t/m³ and 1.57 t/m³.

- ∴ Material Properties: The target material at this site does not comply with HBRC's (2021) particle size distribution grading specification. Other stop banks in the Hawke's Bay region appear to have been constructed using similar materials and these have performed acceptably during Cyclone Gabrielle.

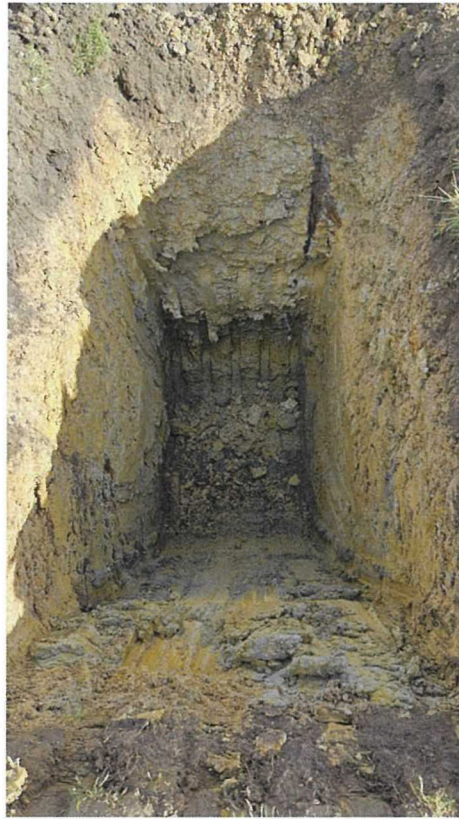
TP07: 0.0-3.2 m bgl

- ∴ Unit 1 – Topsoil – Silt/sandy silt: The six test pits contained a shallow horizon of silt or sandy silt with a dark brown colour. Vertical thicknesses of this horizon were consistent in the three test pits at 0.3 m. This material was not sampled, as it is considered topsoil and was not targeted for use as a construction material.

- ∴ Unit 2 - Clayey silt: The three test pits contained a shallow horizon of silty clay or clayey silt with a light grey mottled orange-brown colour and an inferred soft to firm consistency. The horizon also contained wood debris fragments. Vertical thicknesses of this horizon ranges from 1.05 to 1.35 m. This material was sampled in TP07 and TP08.

- ∴ Unit 3 – Silty clay: This unit occurs in all test pits and has a light grey mottled light yellowish orange to orange, streaked light grey. Inferred material consistencies were soft to firm with high plasticity. The vertical thickness of this horizon ranges from 1.1 m to 1.25 m. This horizon was sampled in TP07 and TP08.

- ∴ Unit 4 – Silty Sand. This horizon was present in all test pits and is bluish grey in colour. The inferred material consistency was loose with low plasticity. The vertical thickness of this horizon ranges from 0.50 m to 0.60 m. This horizon was not sampled.

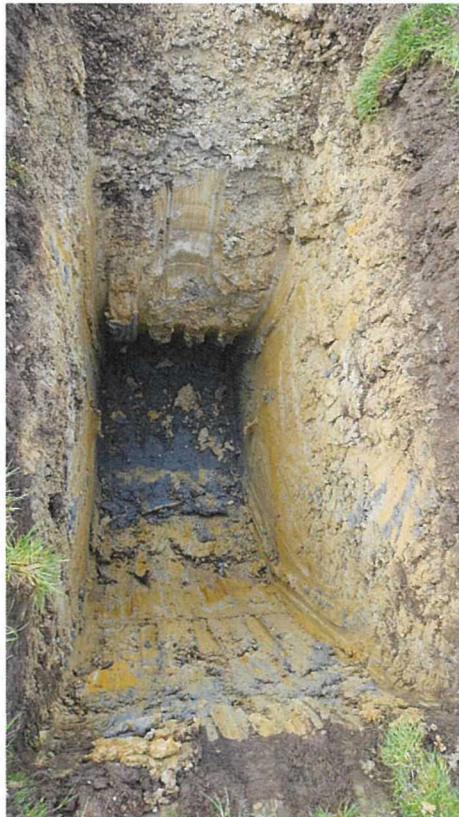
TP08: 0.0-3.2 m bgl

Groundwater was encountered in two of the test pits at depths of 2.4 m to 3.15 m below ground level (mbgl). The groundwater seepage from the test pit sidewalls was slow.

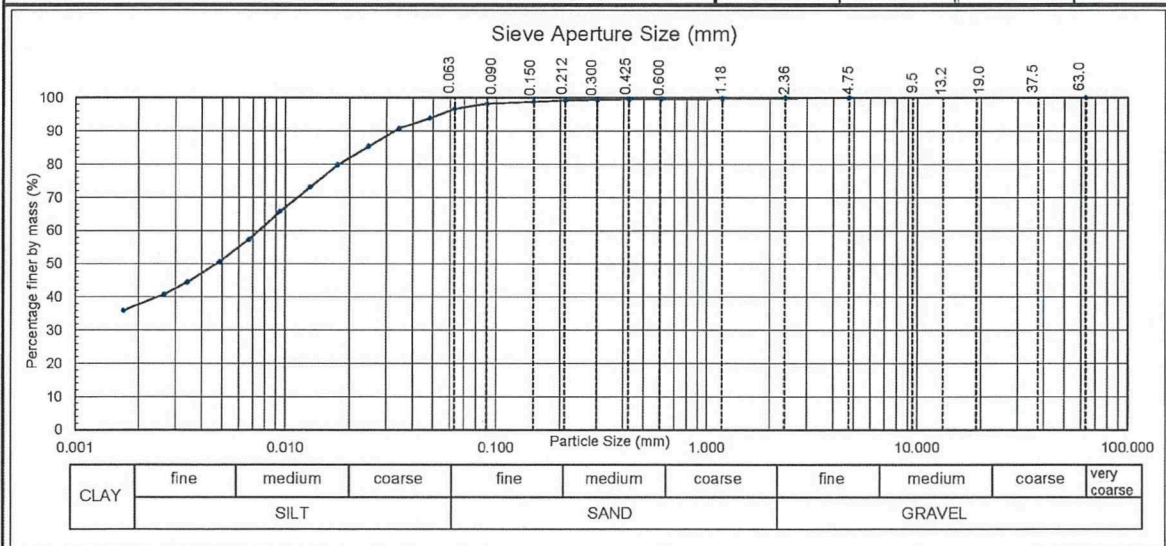
Project No: 2-L072825
 Lab Ref No: NA9670_WA2
 Client Ref: 3,4-TP07/1.5-2.7 m

Sieve Analysis					Hydrometer Analysis				
Sieve Size (mm)	Passing (%)	Sieve Size (mm)	Passing (%)	Sieve Size (mm)	Passing (%)	Particle Size (mm)	Passing (%)	Particle Size (mm)	Passing (%)
63.0	--	4.75	100	0.300	99	0.0483	94	0.0067	57
37.5	--	2.36	100	0.212	99	0.0344	91	0.0049	51
19.0	--	1.18	100	0.150	99	0.0246	85	0.0034	44
13.2	--	0.600	100	0.090	98	0.0176	80	0.0027	41
9.5	--	0.425	100	0.063	97	0.0131	73	0.0017	36
Note: "--" denotes sieve not used and/or hydrometer analysis not tested						0.0094	66

Test Methods	Notes
Particle Size Analysis: NZS 4402:1986: Test 2.8.4 (Washed Grading & Hydrometer Method)	pH of suspension : 9.5 (Macherey Nagel 0-14 pH Indicator strip) All information supplied by Client

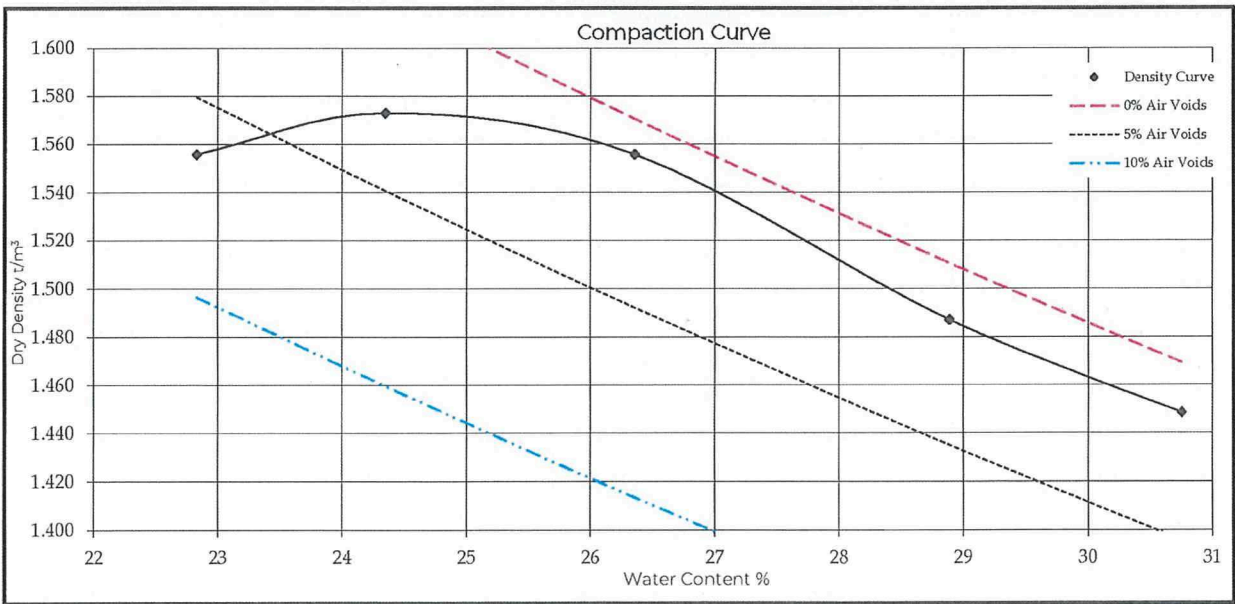
Project : Porangahau Laboratory Testing
 Location : Porangahau
 Client : P. Lombard
 Contractor : Pattle Delamore Partners Ltd
 Sampled by : Client
 Date sampled : 29/08/25
 Sampling method : Unknown
 Sample description : Clayey SILT, trace of sand. grey, mottled orange
 Sample condition : As Received
 Solid density : 2.68 t/m³ (Assumed)
 Source : TP07 (1.5m - 2.7m)

Test Results							
Maximum dry density	1.57	t/m ³		Natural water content	28.9	%	
Optimum water content	24.4	%		Fraction tested	Whole		
Sample ID	-3	-2	-1	Nat	1		
Bulk density t/m ³	1.911	1.956	1.966	1.917	1.894		
Water content %	22.8	24.3	26.4	28.9	30.8		
Dry density t/m ³	1.556	1.573	1.556	1.487	1.449		
Sample condition	Moist	Moist	Moist	Wet	Wet

Test Methods	Notes
Compaction NZS 4402 : 1986 Test 4.1.2 (Heavy)

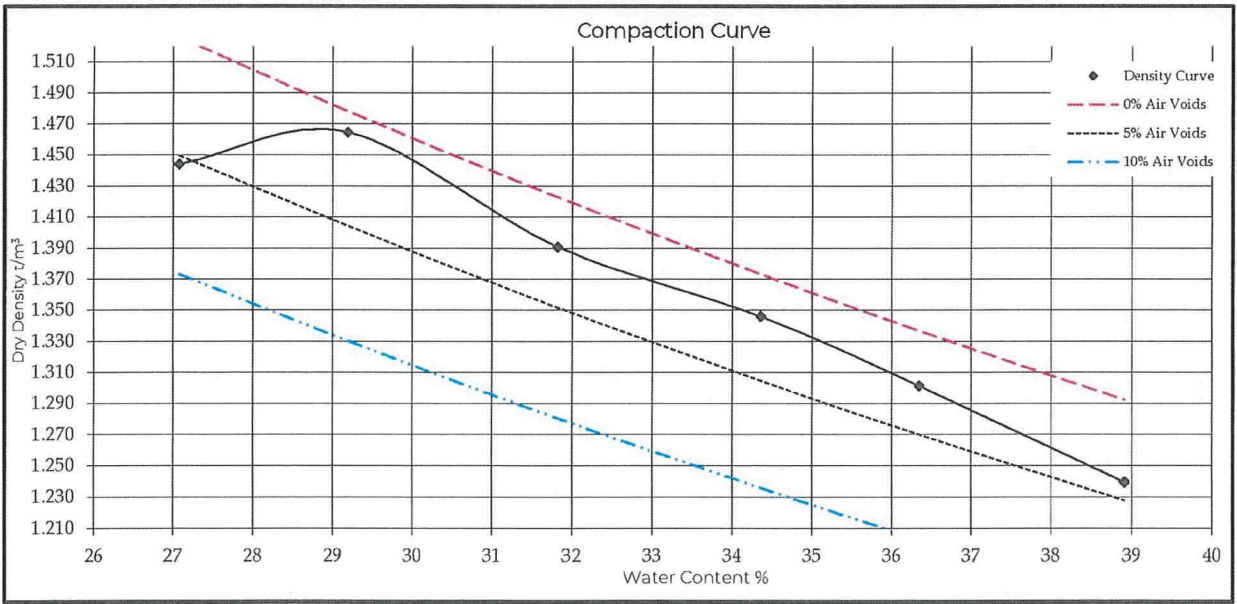
Project : Porangahau Laboratory Testing
 Location : Porangahau
 Client : P. Lombard
 Contractor : Pattle Delamore Partners Ltd
 Sampled by : Client
 Date sampled : 29/08/25
 Sampling method : Unknown
 Sample description : Clayey SILT, trace of sand. grey, mottled orange
 Sample condition : As Received
 Solid density : 2.60 t/m³ (Assumed)
 Source : TP08 (1.35m - 2.60m)

Test Results							
Maximum dry density	1.46	t/m ³	Natural water content	38.9	%		
Optimum water content	29.2	%	Fraction tested	Whole			
Sample ID	-10	-8	-6	-4	-2	Nat	
Bulk density t/m ³	1.835	1.892	1.833	1.808	1.774	1.722	
Water content %	27.1	29.2	31.8	34.4	36.3	38.9	
Dry density t/m ³	1.444	1.465	1.391	1.346	1.301	1.239	
Sample condition	Moist	Moist	Moist	Wet	Wet	Wet

Test Methods	Notes
Compaction NZS 4402:1986 Test 4.1.2 (Heavy)
