DESK-BASED ARCHAEOLOGICAL ASSESSMENT OF
THE PROPOSED WAIROA FLOODWAY, WAIROA

Desk-based Archaeological Assessment of Proposed Wairoa Floodway, Wairoa

19th August 2025

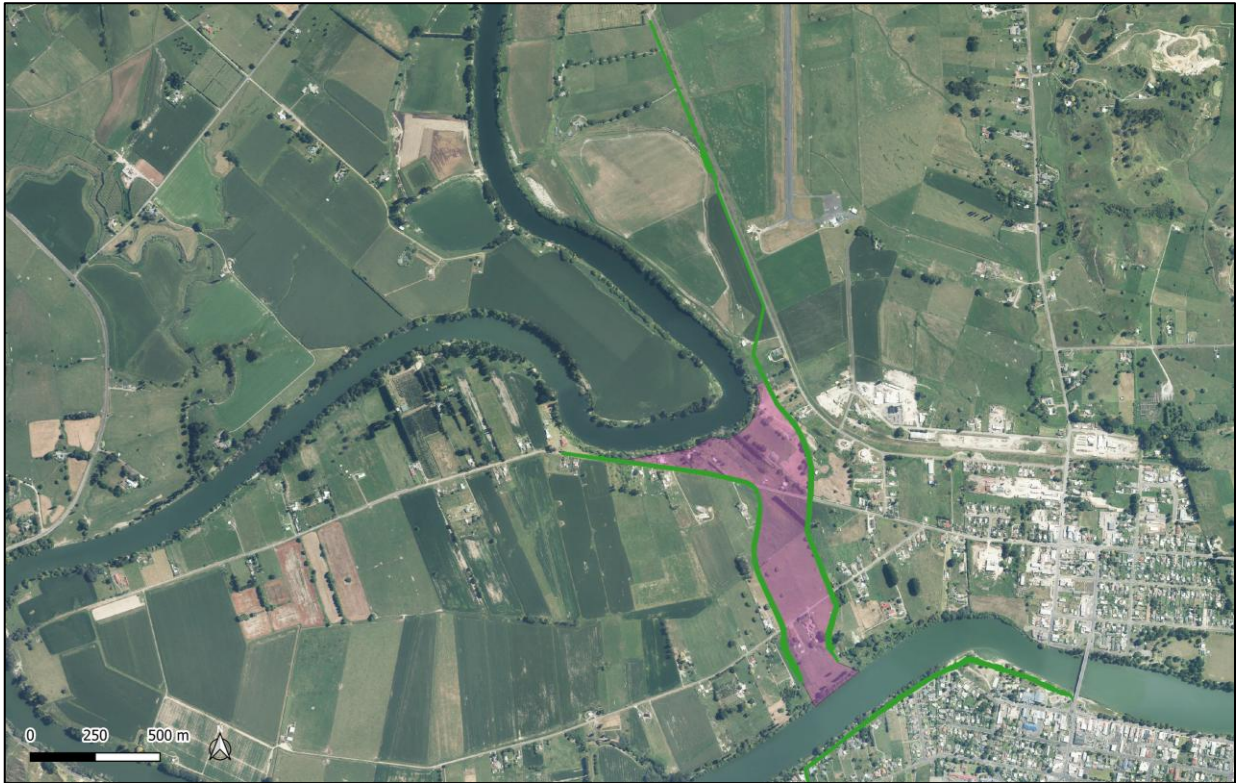
Figure 2 – Overall plan of the proposed Wairoa Floodway project. Green lines are the stopbanks, pink polygon is the proposed floodway (adapted from plan supplied by WSP).

WSP is leading the design phase of the project. The current design will involve the construction of a floodway consisting of two stopbanks to control overflow. The floodway between the two stopbanks will be formed by excavating the current ground surface between approximately 0.3 and 1.5m. The design also includes a townside stopbank, which runs for approximately 1.1km upstream of the State Highway 2 Bridge on the true right of the Wairoa River (Figure 2).

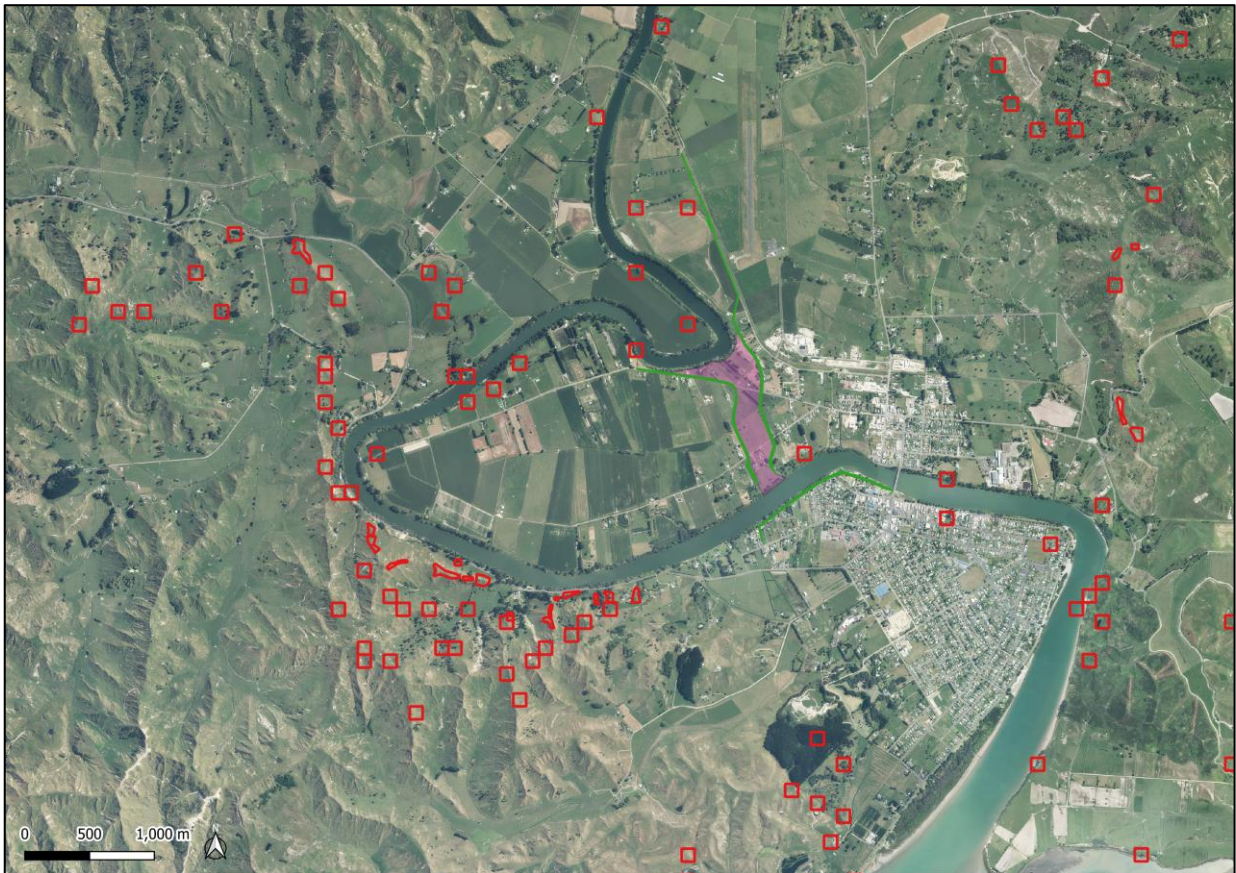
Figure 3 – Distribution of recorded archaeological sites (red polygon) in the Wairoa area. Source: LINZ & ArchSite.

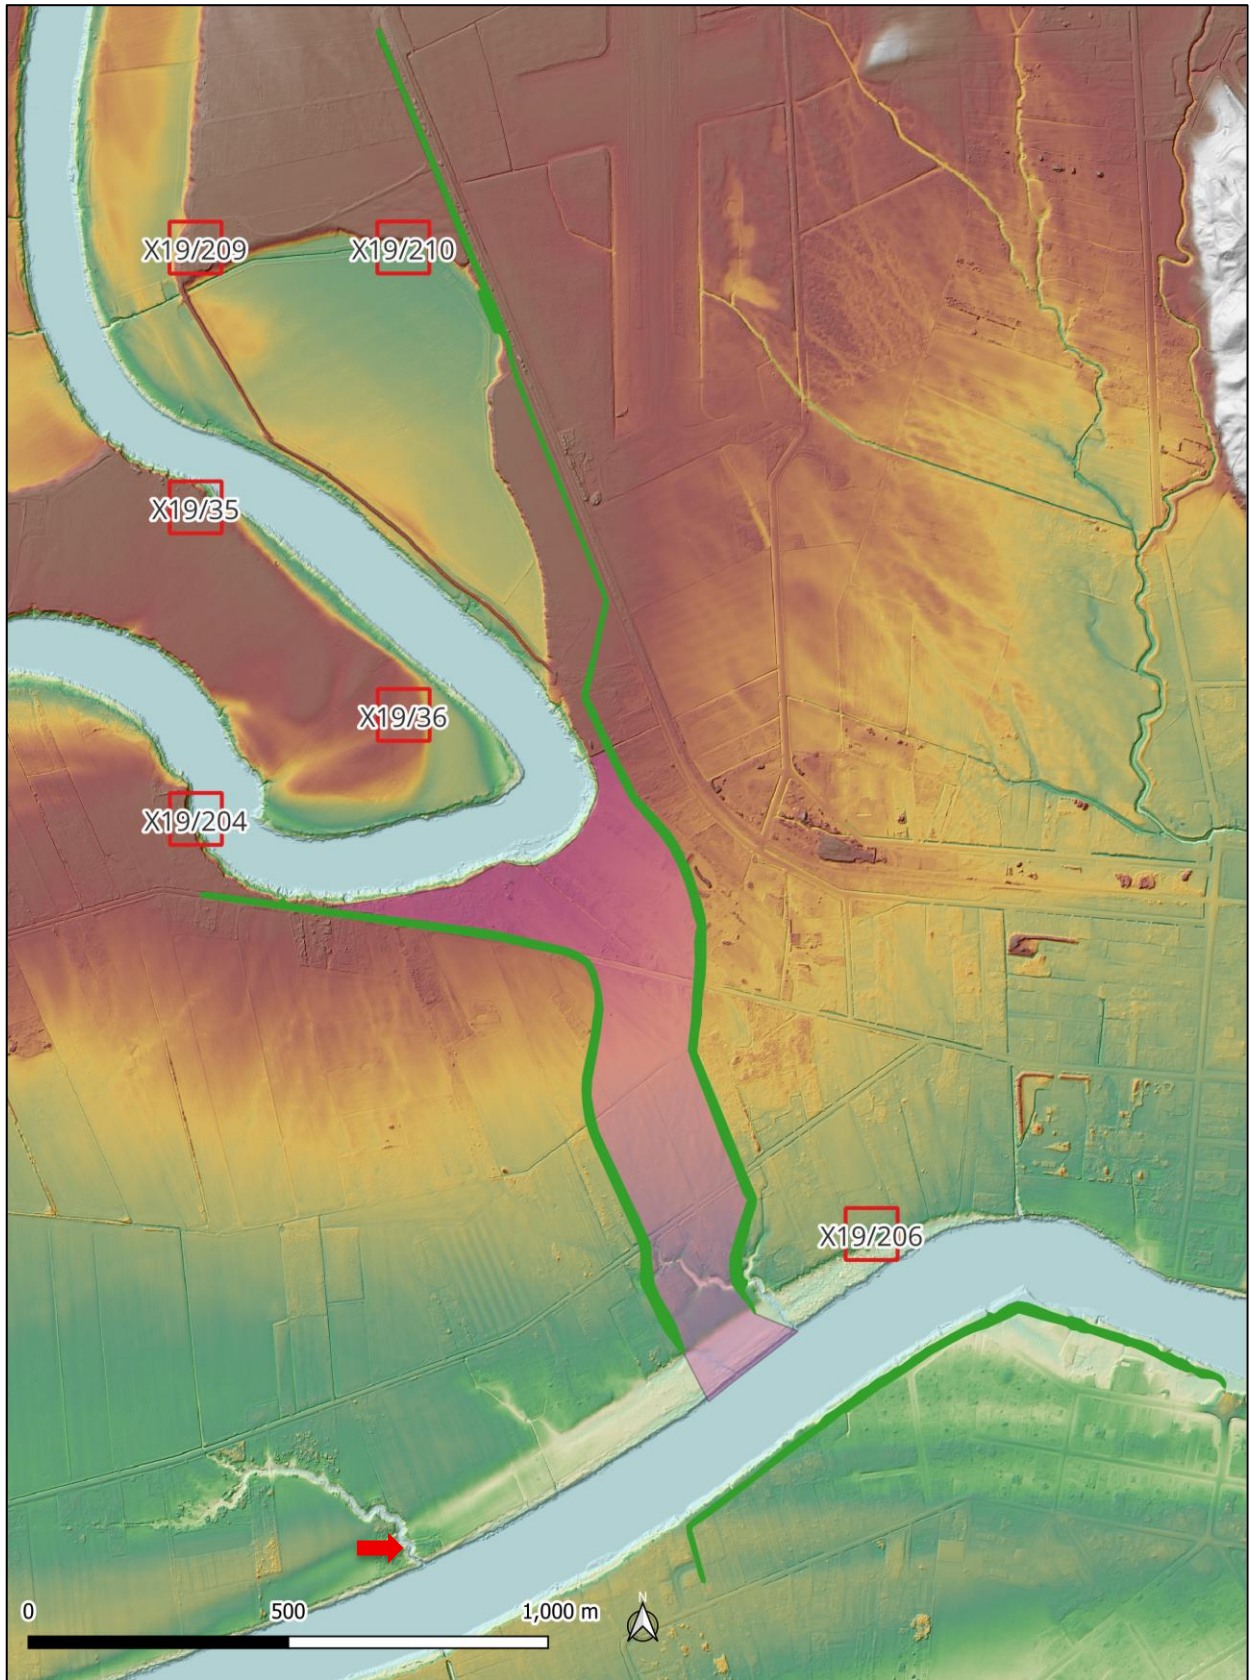
Figure 4 – Digital elevation model with the project area overlaid. Recorded archaeological sites near the project areas are shown (red polygons) and a potential unrecorded site is indicated by the red arrow. Source: LINZ & ArchSite.

There are no recorded archaeological sites in the planned footprint of the floodway, although six are in close proximity to planned works (Figure 4).

LiDAR data was analysed to identify the presence of visible surface archaeological features within the project area and assess the landscape for suitability in terms of historic settlement / activity. Figure 4 is a LiDAR-derived digital elevation model (DEM) of the project area showing the general topography. A single unrecorded archaeological site was identified adjacent to an urupā to the west of the project area. No unrecorded sites were identified in the project area.
