# Hawke's Bay Regional Council

## **Wairoa Floodway Design Phase**

Preliminary Site Investigation and Limited Detailed  
Site Investigation

2-T4441.03

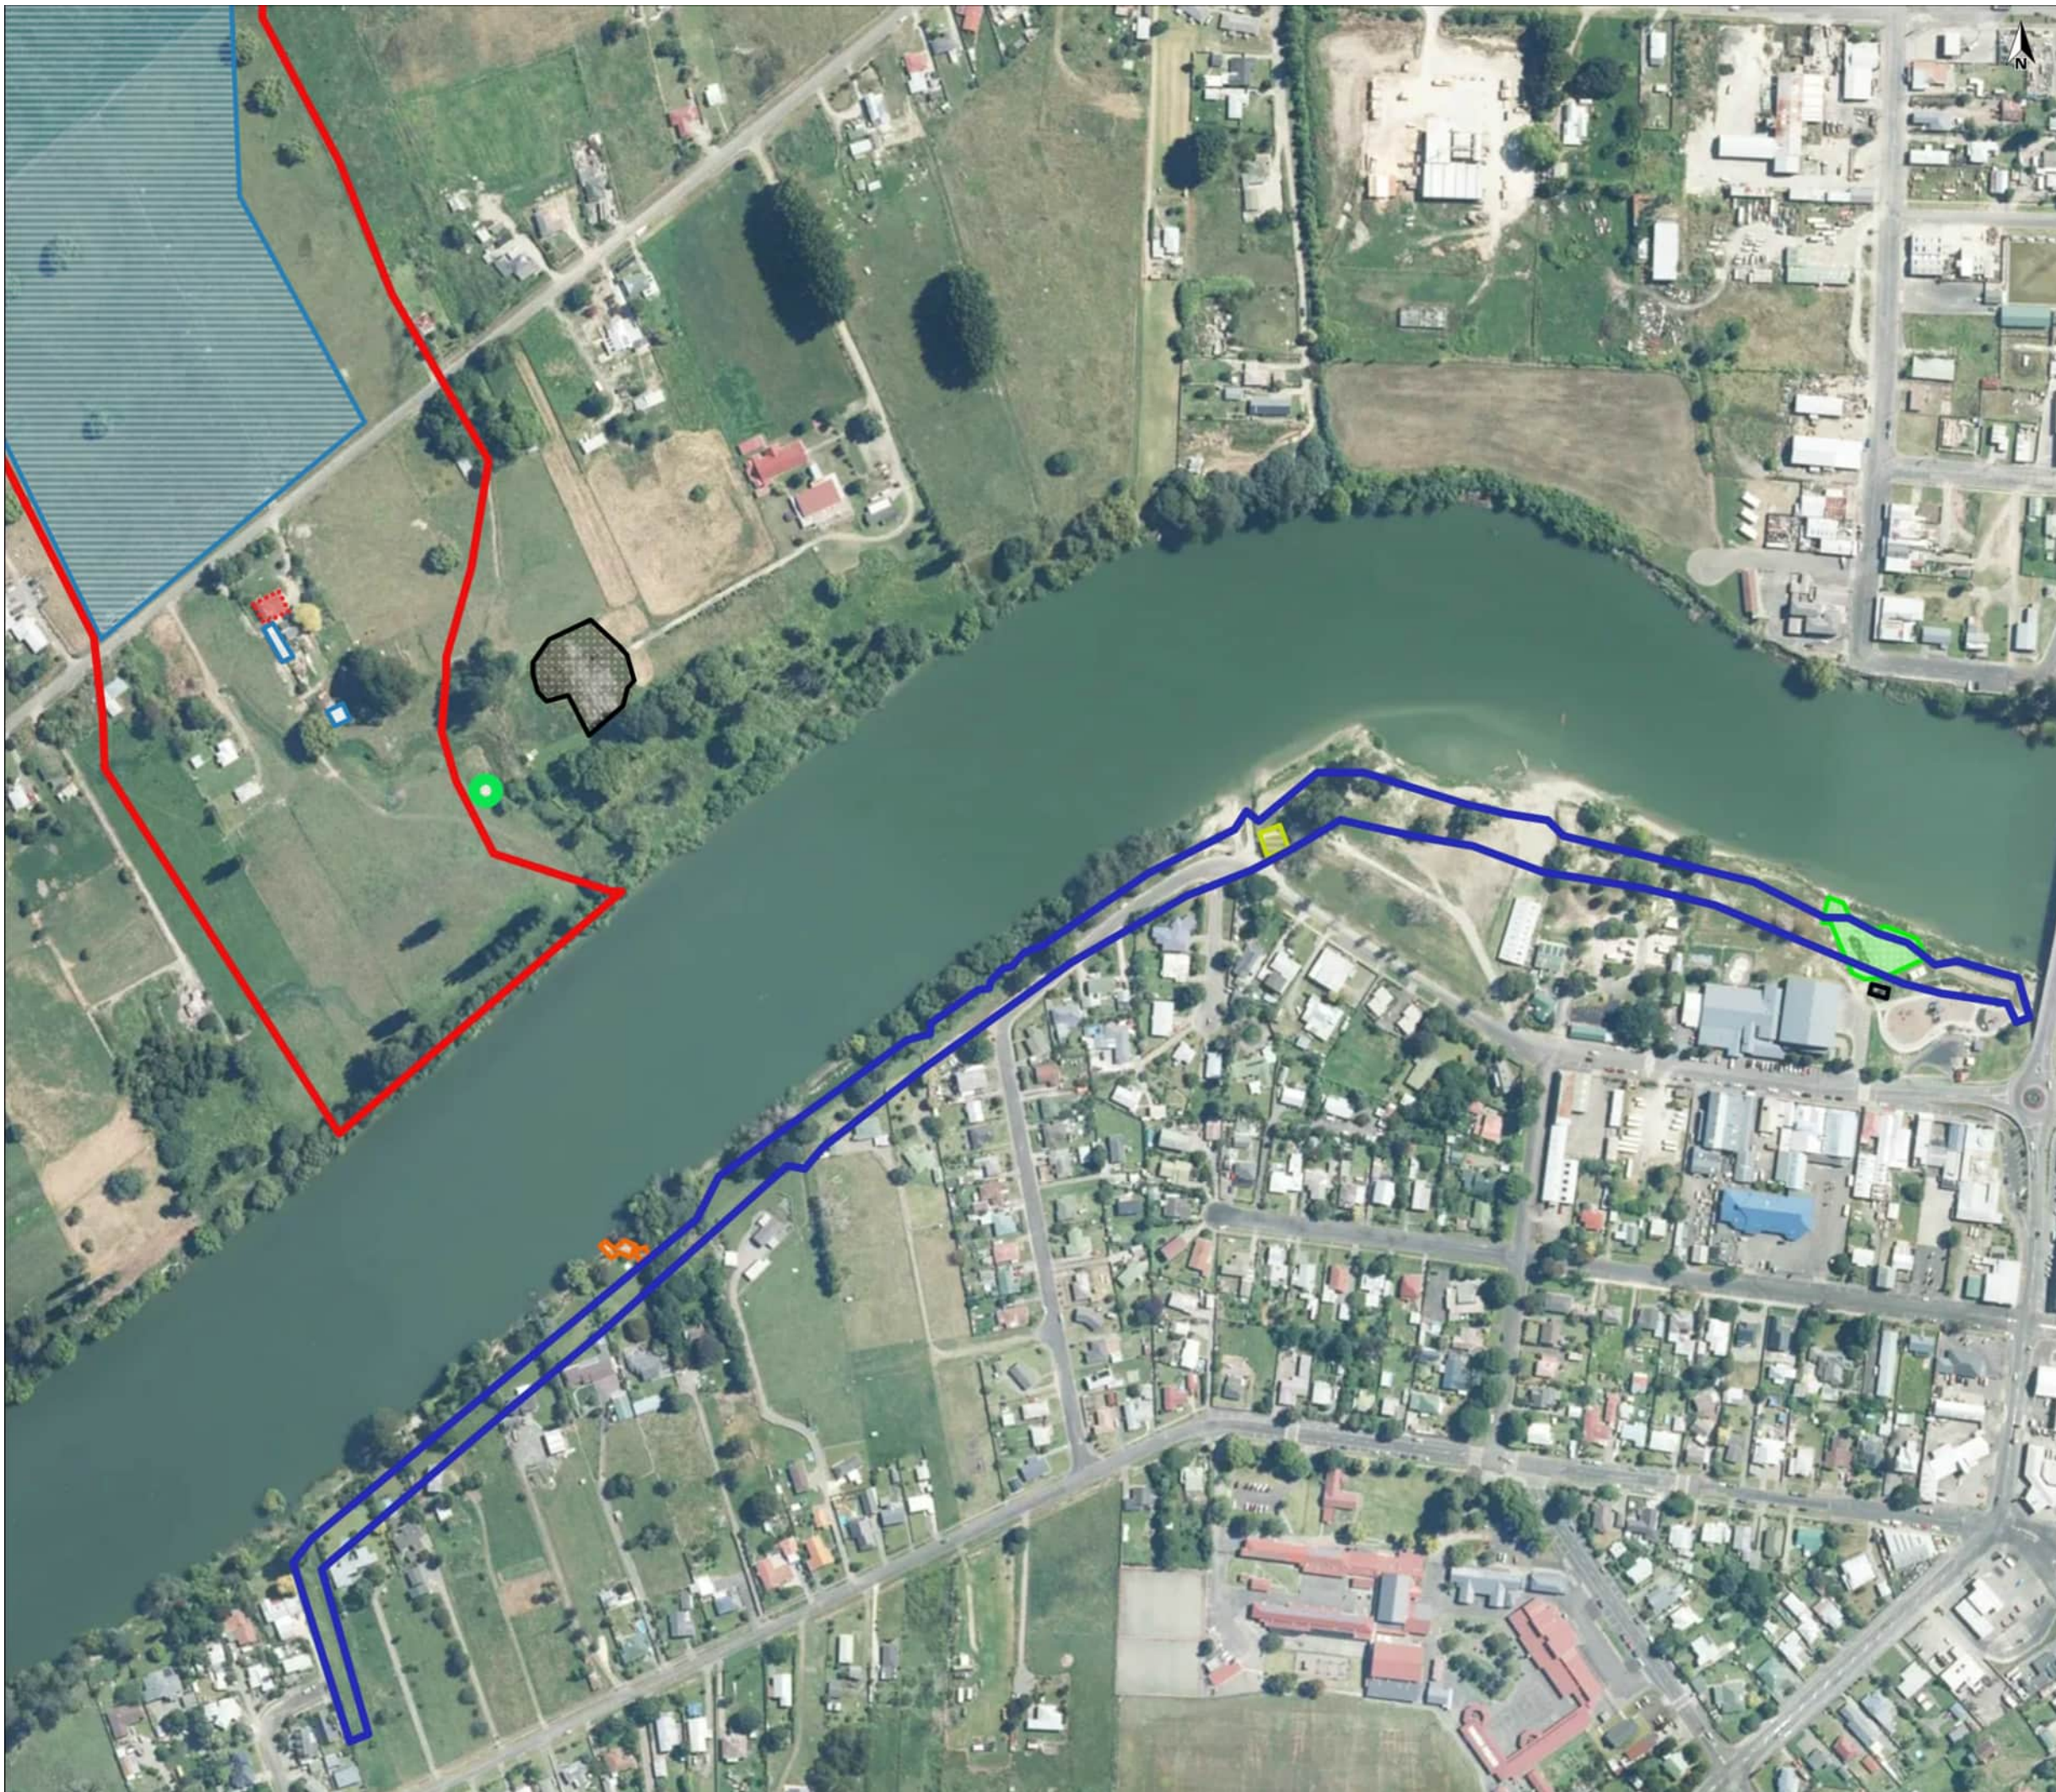
| Project:<br>Wairoa<br>Floodway Design<br>Phase | Drawn: RF | Figure: 2B |

The Site was visited by a WSP Contaminated Land Specialist (CLS) on 3 and 4 July 2025. WSP was accompanied on Site to most locations by Sue Wilson, the landowner engagement specialist from HBRC. In some instances where Ms Wilson was not able to accompany WSP, she called ahead to the relevant landowners to inform them of our presence and confirm access was permitted. Not all locations were made available to WSP for the Site walkover. A summary of the observations made are given in Table 4-1 and Table 4-2 Site walkover Observations – Stopbank., points of interest are shown on Figure 2 and Site Photographs are provided in Appendix C.

- Site Boundary - Floodway
- Site Boundary - Townside
- ★ Demolished House
- 🏠 Boat house/Boat ramp
- 🏠 Ski Club
- 🏠 Pump Station
- ★ Skate Park
- ⊗ Urupa
- 🏠 Shed/Barn
- Waste Pile
- 🏠 Harvested Maize

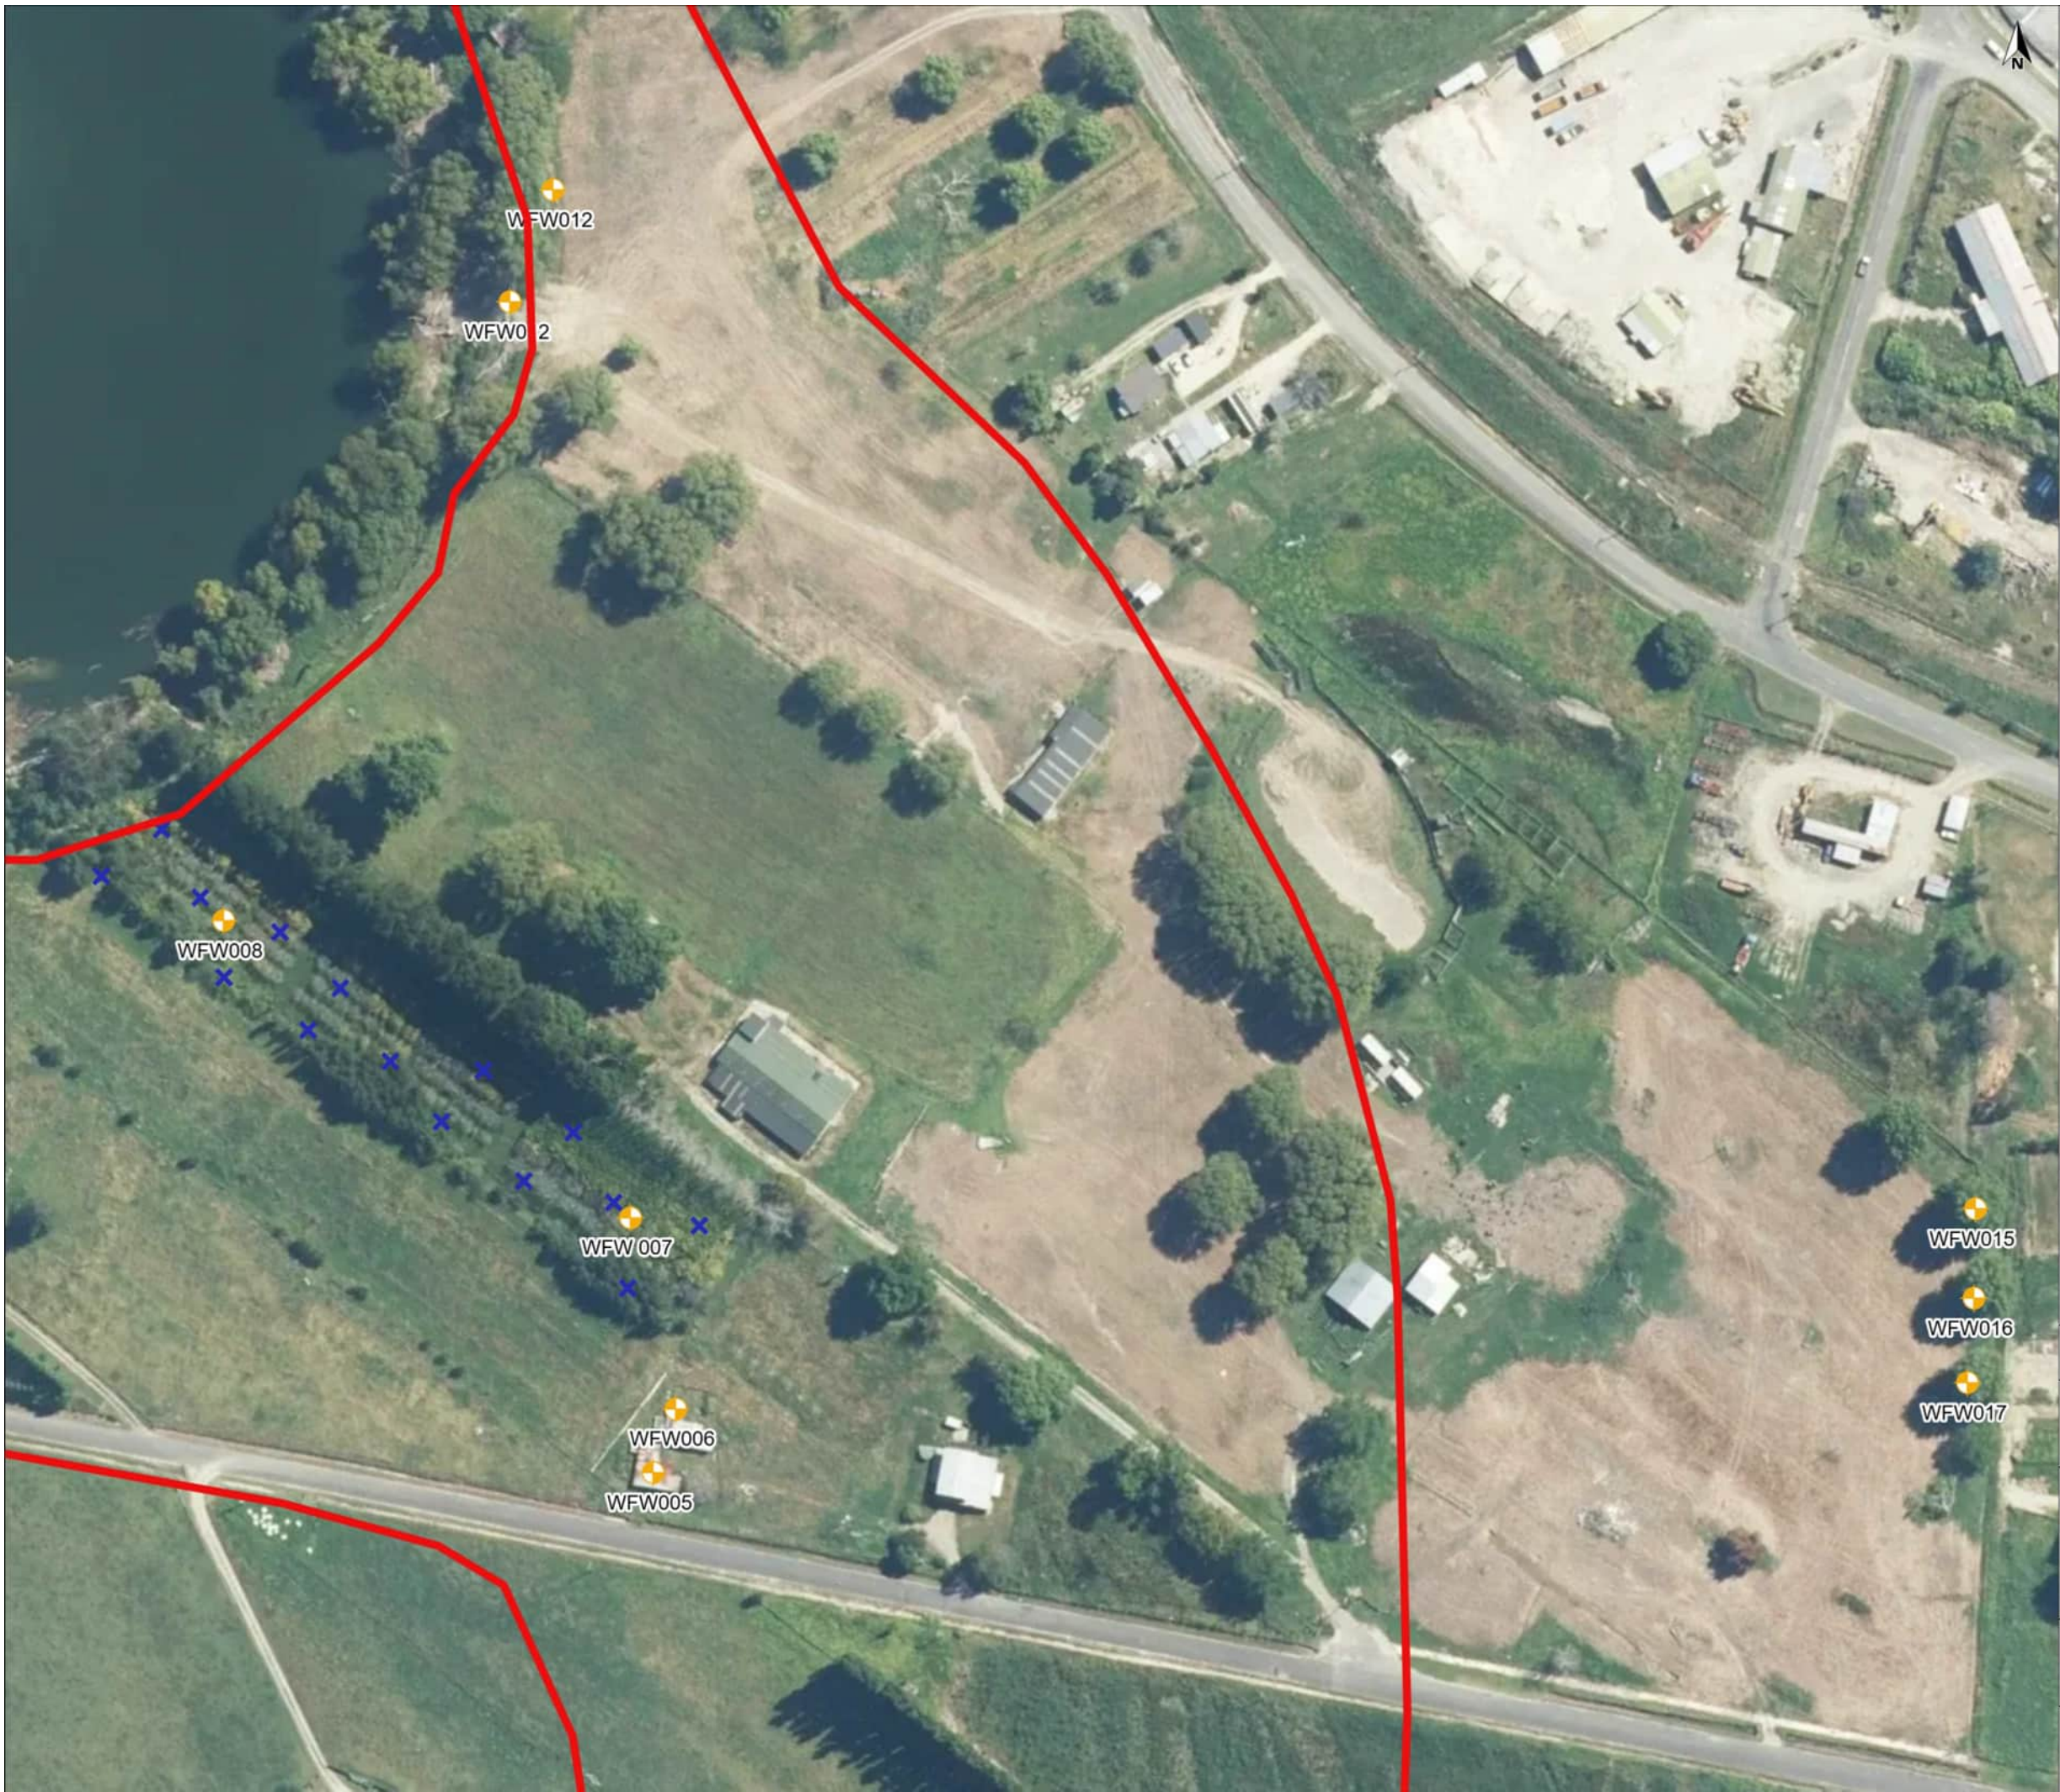
- Site Boundary - Floodway
- Site Boundary - Townside
- ✕ WSP Samples December 2024
- ⬮ Soil Samples July 2025

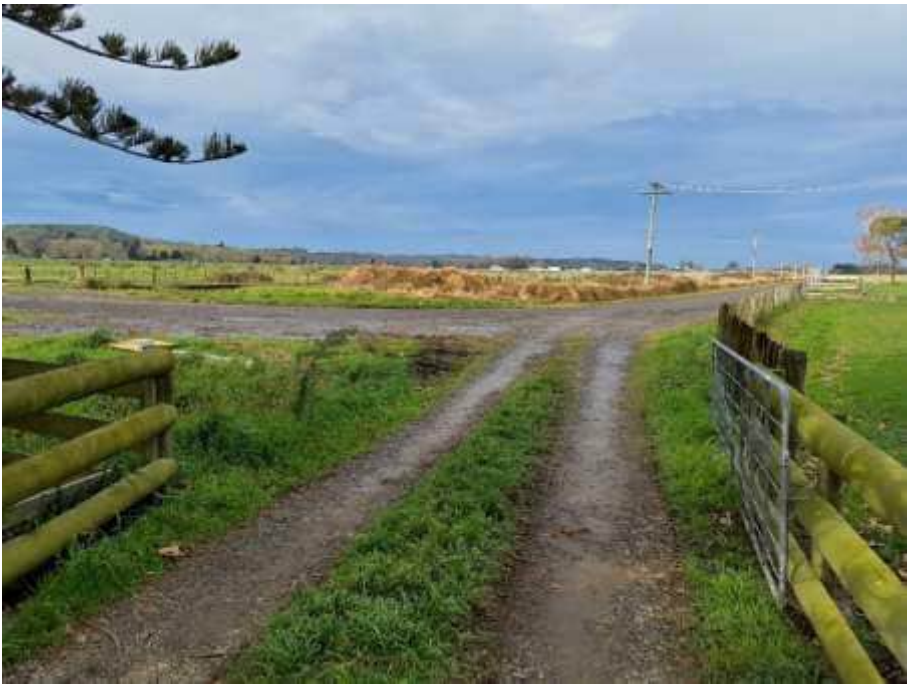
| <b>Photo No. 1</b> | <b>Date:</b><br>03/07/2025 | |

| Location | Observations | Photo Reference |
|---|---|---|
| <b>177 Railway Road</b> | Property is agricultural with a recent citrus orchard planted adjacent to the proposed stopbank location. | Photo 1 |

| <b>Description:</b><br>177 Railway Road looking towards the southeast. | | |

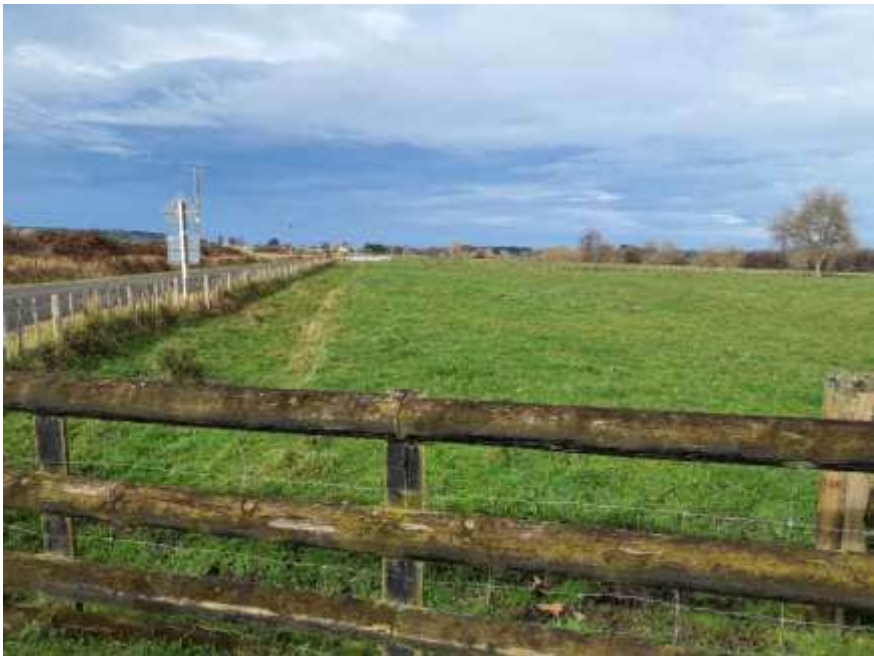
| <b>Photo No. 2</b> | <b>Date:</b><br>03/07/2025 | |

| Location | Observations | Photo Reference |
|---|---|---|
| <b>165 Railway Road</b> | Property is agricultural, observed adjacent to the proposed stopbank location was fenced pasture and Railway Road. The southern end of the Site had a shed or workshop present which was accessed from a farm track off Railway Road adjacent to 41 Railway Road. The workshop was observed to be a steel and timber construction. No access to the inside of the shed was possible. Waste oil drums were observed outside the shed with soil staining on the ground. Looking towards the north alongside the Wairoa River, an existing stopbank was observed. The proposed stopbank is located in the location of this shed and extends north adjacent to Te Kopua Urupa (cemetery). | Photo 2, 3, 4, 5 |

| <b>Description:</b><br>165 Railway Road looking towards the southeast. | | |

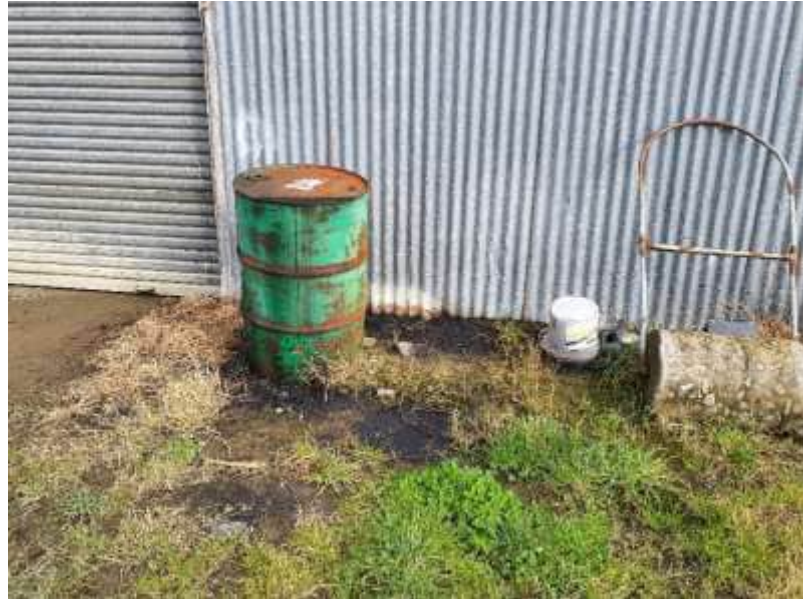
**Description:**

165 Railway Road southeast at south end by 45 Railway Road showing oil staining on soil.

The TPH sample was collected from soils on the east side of the Railway Road workshop building located to the south of Te Kopua Urupa. The visibly stained soils in this area should be disposed of at a suitable Class 3 managed landfill. This location is shown in Figure 3. The samples exceeding the WAC are summarised in Table 9-2.

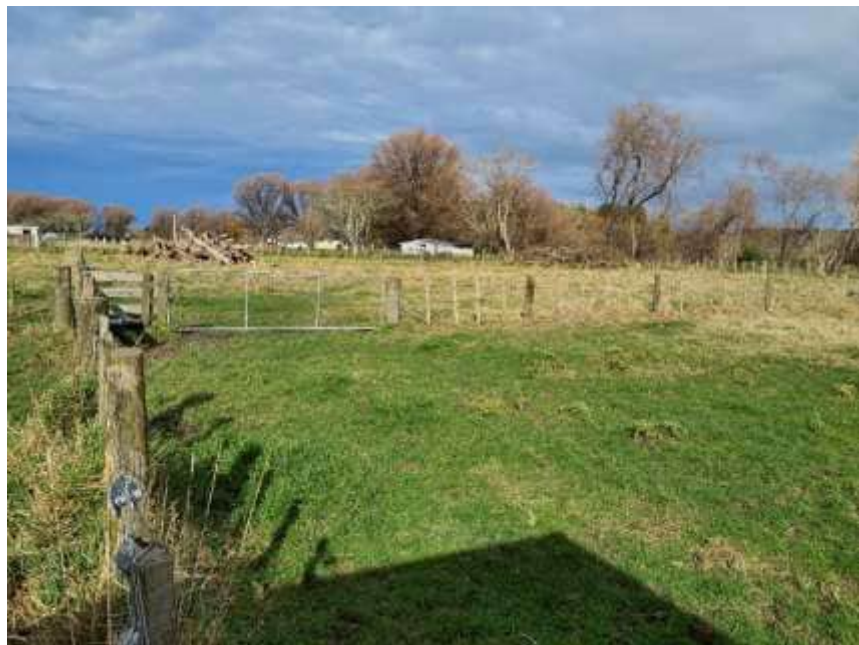
**Photo  
No. 6**

| Location | Observations | Photo Reference |
|---|---|---|
| <b>45 Railway Road</b> | This property had a residential home and associated paddocks. Stock animals onsite included chickens and sheep. The proposed stopbank passes through the paddocks approximately 100m from the rear of the residential home. | Photo 6 |

45 Railway Road looking south towards the Wairoa Showgrounds.

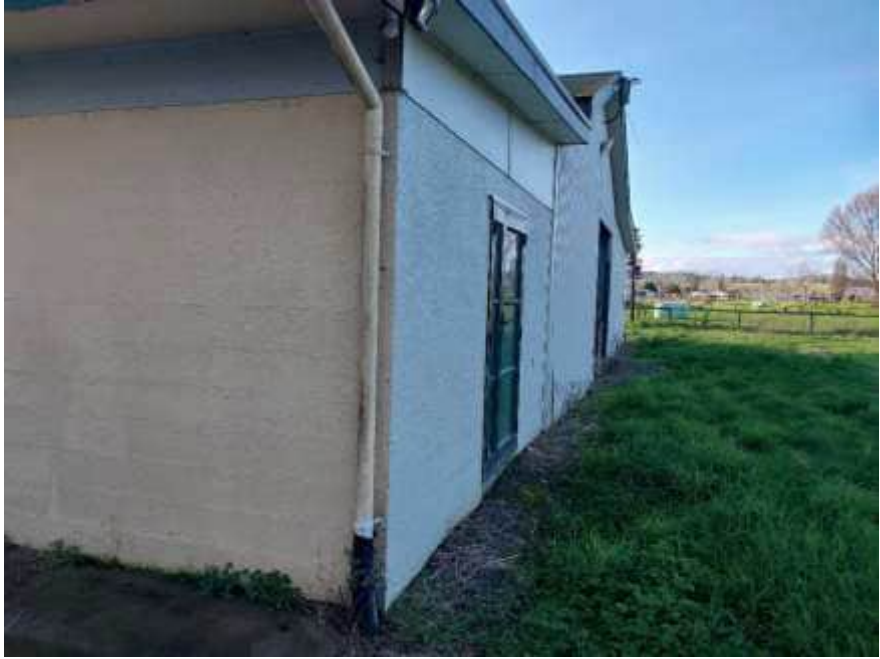
| <b>Photo No. 7</b> | <b>Date:</b><br>03/07/2025 | |

| Location | Observations | Photo Reference |
|---|---|---|
| <b>Wairoa A&amp;P Showgrounds</b> | The Wairoa A&P Showgrounds is a grassed areas with a range of buildings for use as sheds, function rooms, a shearing shed, animal pens and toilets. Observed on Site were also stacked piles of treated timber that had been used for fencing in the old horse arena area. Timber stacks were stored off the ground on separate timber runners. Signs of clean up from flooding events were seen in stockpiles of coarse vegetation and silt. Evidence of recent subsidence along the riverbank was also seen with the fence line on the northern end having dropped down the edge of the riverbank edge. | Photo 7, 8, 9, 10, 11, 12 |

| <b>Description:</b><br>Wairoa Showgrounds main building. | | |

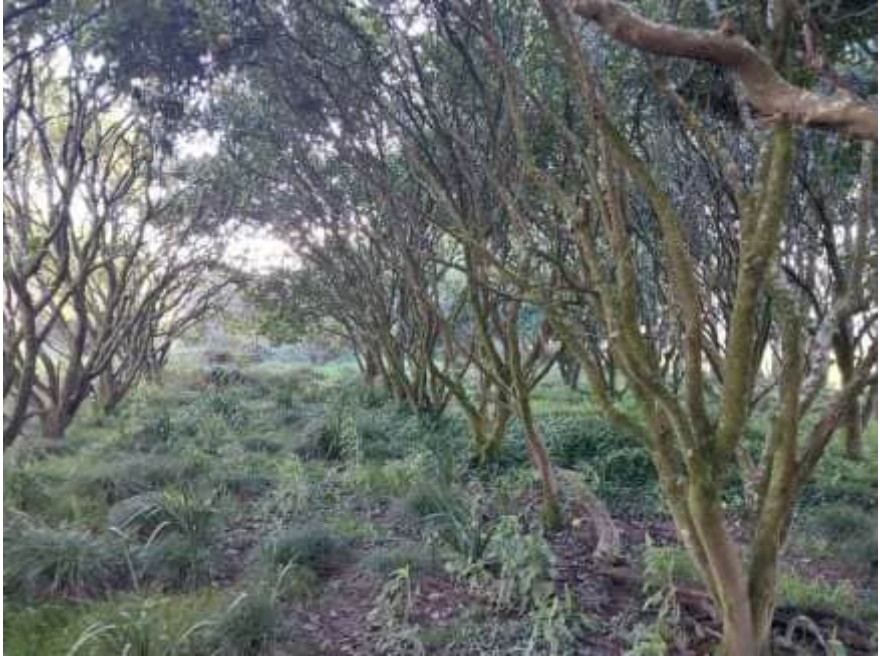
| <b>Photo No. 15</b> | <b>Date:</b><br>03/07/2025 | |

| <b>Description:</b><br>56 Ruataniwha Road<br>Citrus Orchard | | |

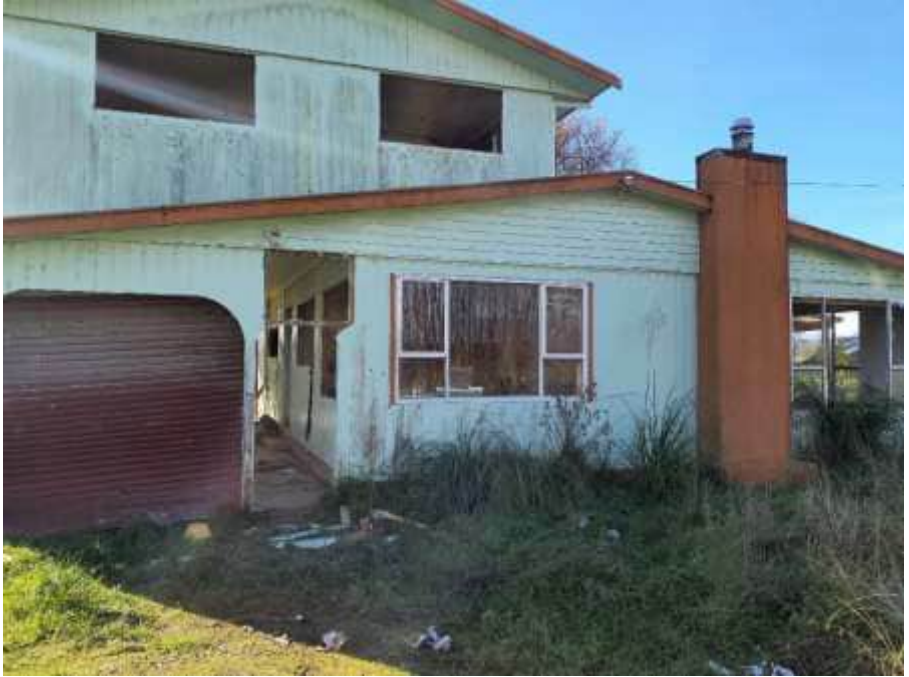
| <b>Photo No. 16</b> | <b>Date:</b><br>03/07/2025 | |

| <b>Description:</b><br>56 Ruataniwha Road<br>abandoned house with potential ACM cladding, | | |

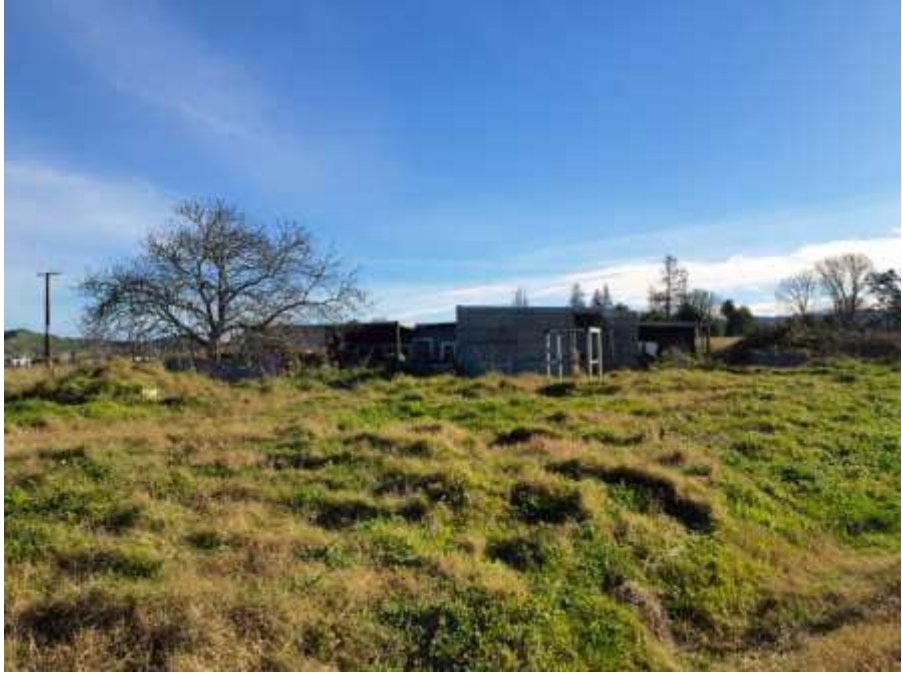
| <b>Photo No. 7</b> | <b>Date:</b><br>03/07/2025 | |

| <b>Description:</b><br>56 Ruataniwha Raod pig sty and implement shed on west side of property. | | |

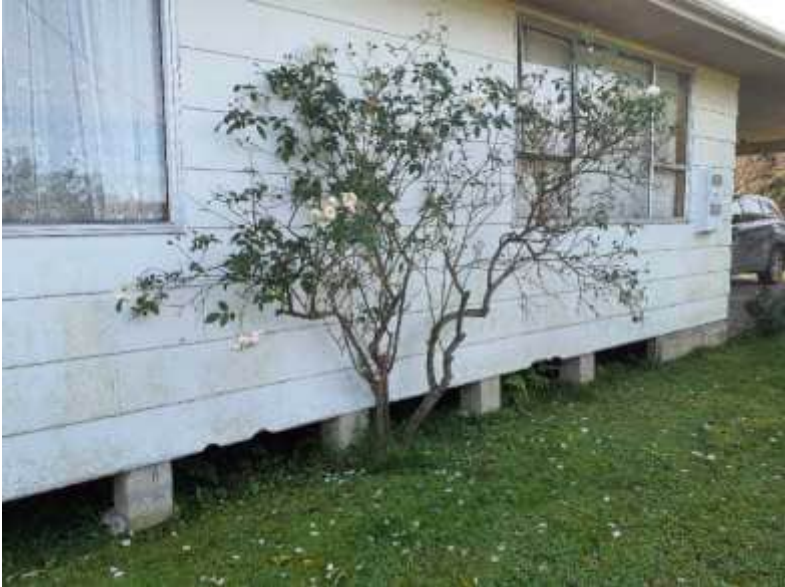
| <b>Photo No. 18</b> | <b>Date:</b><br>03/07/2025 | |

| <b>Description:</b><br>102 Ruataniwha Road, showing minor deterioration to exterior cladding, potential ACM. | | |

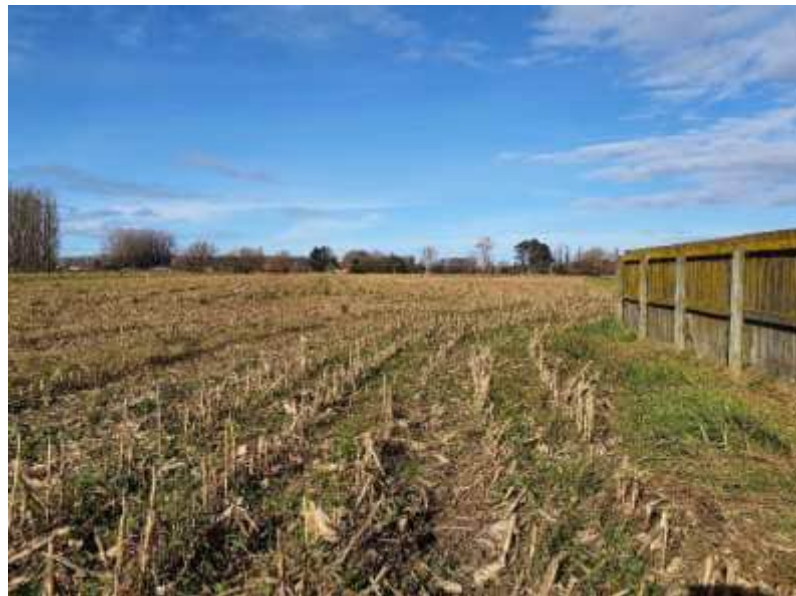
**Photo No. 20**

| <b>75 Ruataniwha Road</b> | The proposed floodway encompasses the existing pasture on this property. The paddocks were observed to be recently harvested maize crops. | Photo 20 |

75 Ruataniwha Road, looking towards the south.

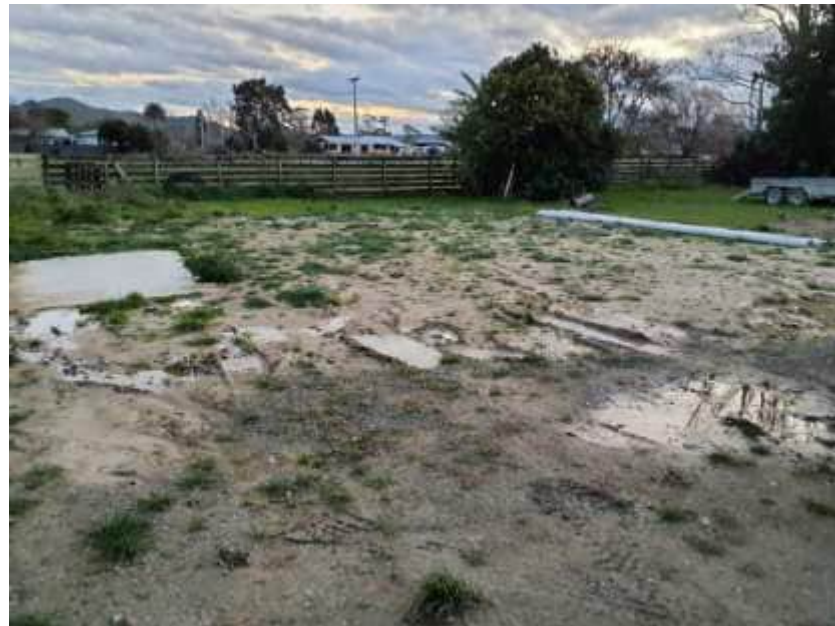
**Description:**

55 Waihirere Road footprint of former residence damaged during cyclone Gabriel.

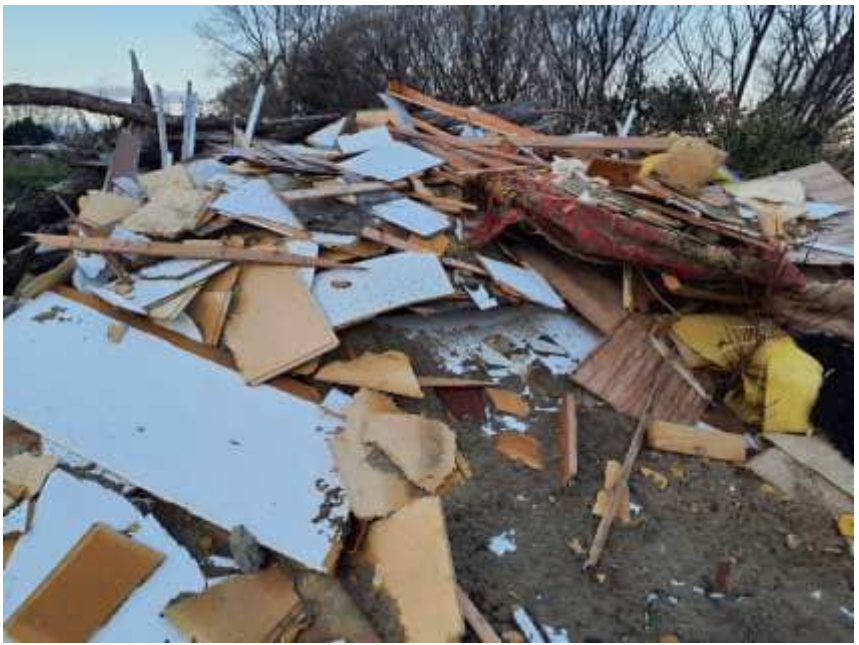
| <b>Photo No. 23</b> | <b>Date:</b><br>03/07/2025 | |

| <b>Description:</b><br>Stockpiled waste material from demolished house at 55 Waihirere Road. | | |

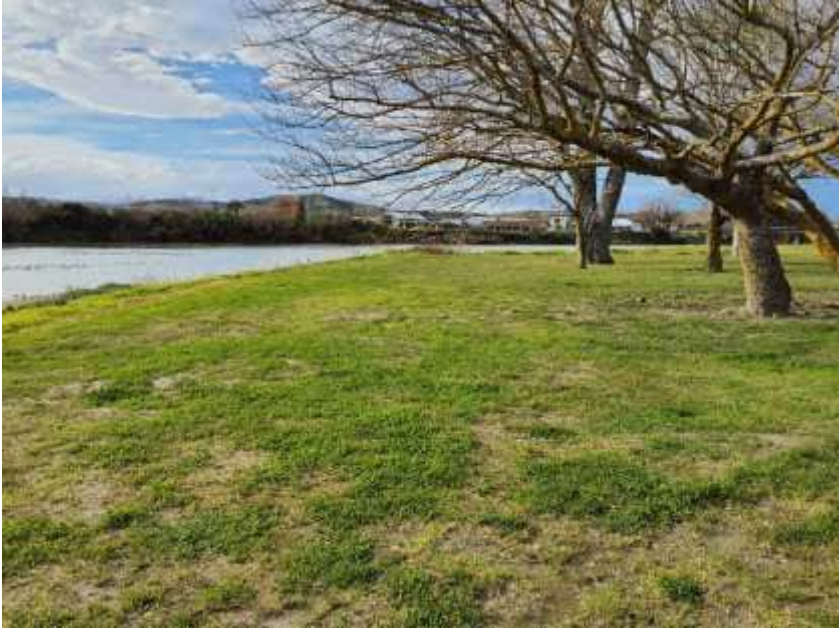
| <b>Photo No. 29</b> | <b>Date:</b><br>04/07/2025 | |

| <b>Location</b> | <b>Observations</b> | <b>Photo Reference</b> |
|---|--|---|
| <b>Wairoa Ski Club</b> | The ski club building and the boat ramp were observed during the walkover. No evidence of contaminating activities was observed however access was not available for the building, it is unknown if fuel is stored on Site. | Photo 29, 30 |

| <b>Description:</b><br>Recreational area between Ski Club and Park. | | |

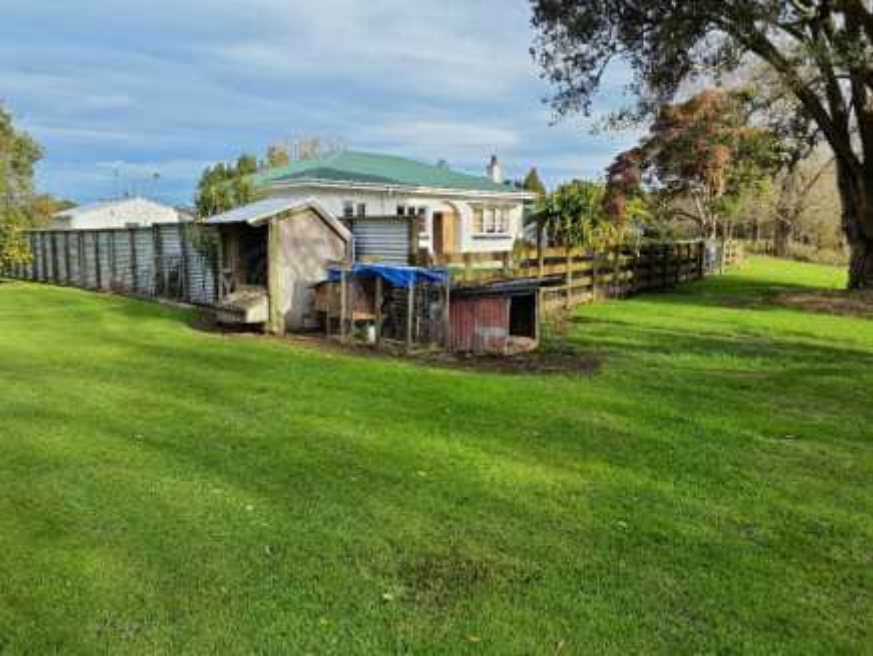
| <b>Photo No. 31</b> | <b>Date:</b><br>04/07/2025 | |

| <b>Location</b> | <b>Observations</b> | <b>Photo Reference</b> |
|---|--|---|
| <b>25 Churchill Street, 14 to 52 Mitchell Street.</b> | The riverbank area adjacent to the properties on Mitchell Street and Churchill Street was observed and photographs collected. This part of the Site is council owned land but the residential properties adjacent to this area maintaining the land that adjoins their properties. The property located at 30 Mitchell Street had constructed a boat house and were in the process of building a small dock. Some of the riverbank was used for green waste disposal, piles of lawn clippings and tree trimmings were observed near 48 and 52 Mitchell Road. | Photos 30 to 37 |

| <b>Description:</b><br>25 Churchill Street, looking southwest. | | |

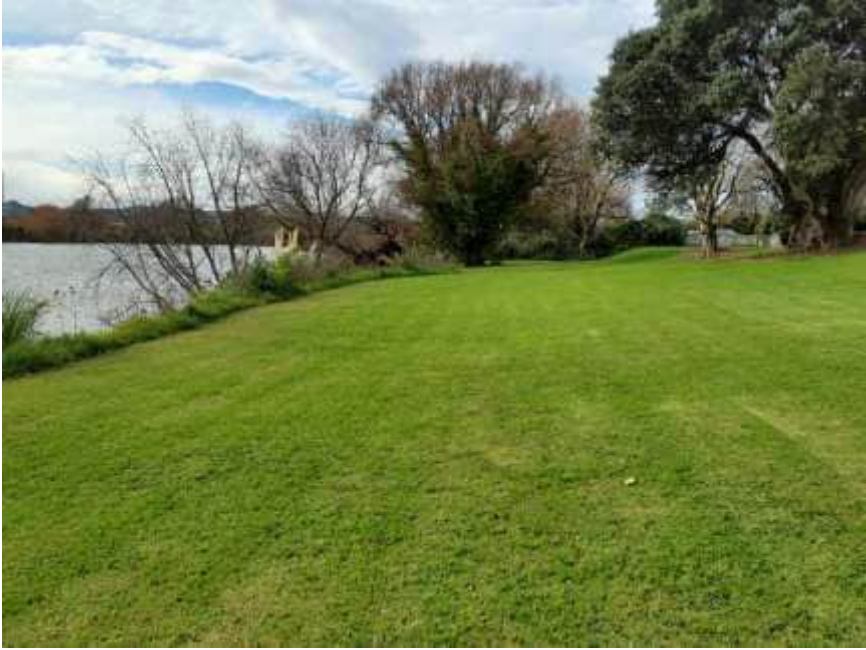
| <b>Photo No. 32</b> | <b>Date:</b><br>04/07/2025 | |

| <b>Description:</b><br>14 Mitchell Street looking east. | | |

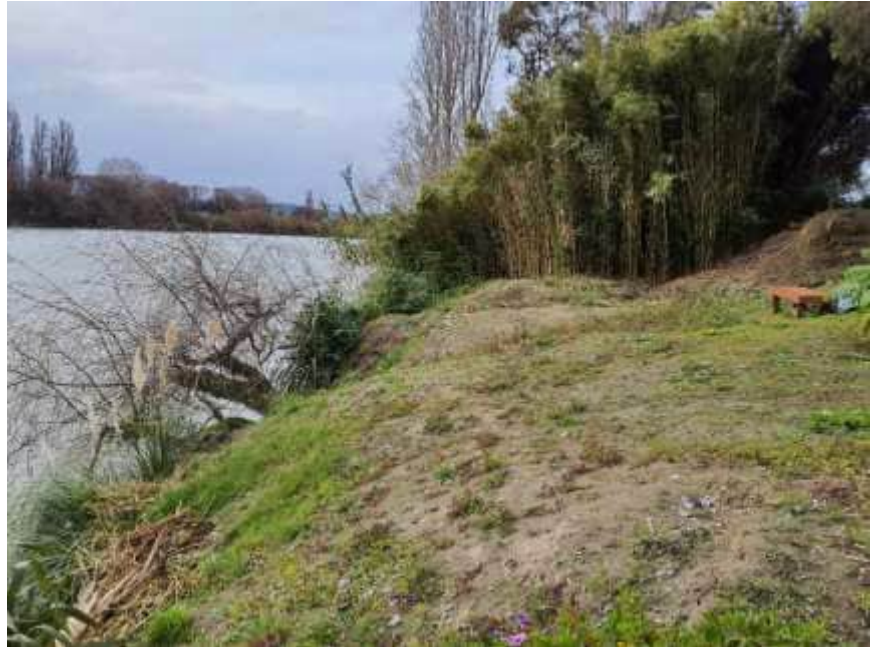
48 Mitchell Street Looking  
East

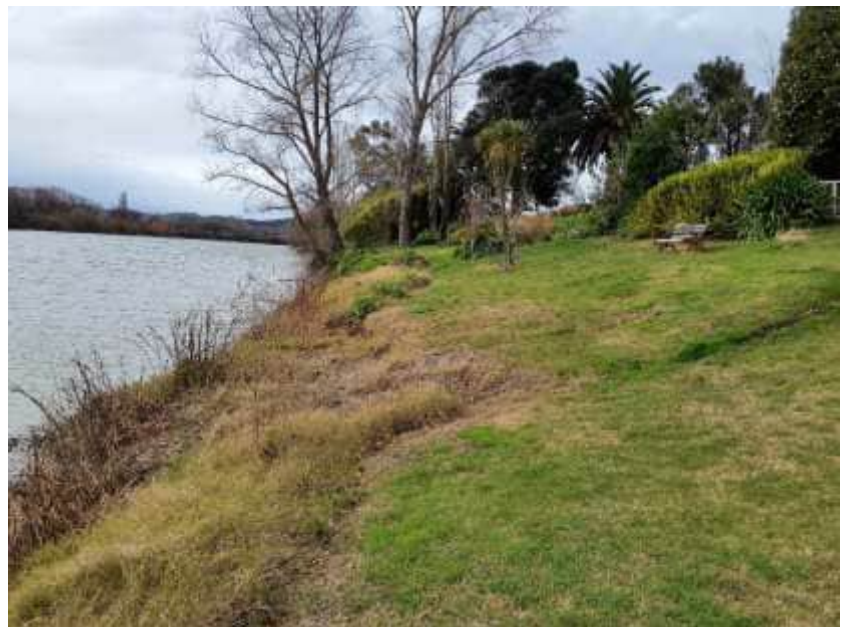
**Photo  
No. 36**

52 Mitchell Street looking  
east.
