**BEFORE THE ENVIRONMENT COURT
AT AUCKLAND**

**EVIDENCE IN CHIEF OF THOMAS JAMES KAY
ON BEHALF OF ROYAL FOREST AND BIRD PROTECTION SOCIETY**

Geomorphology / Natural Character

1 September 2023

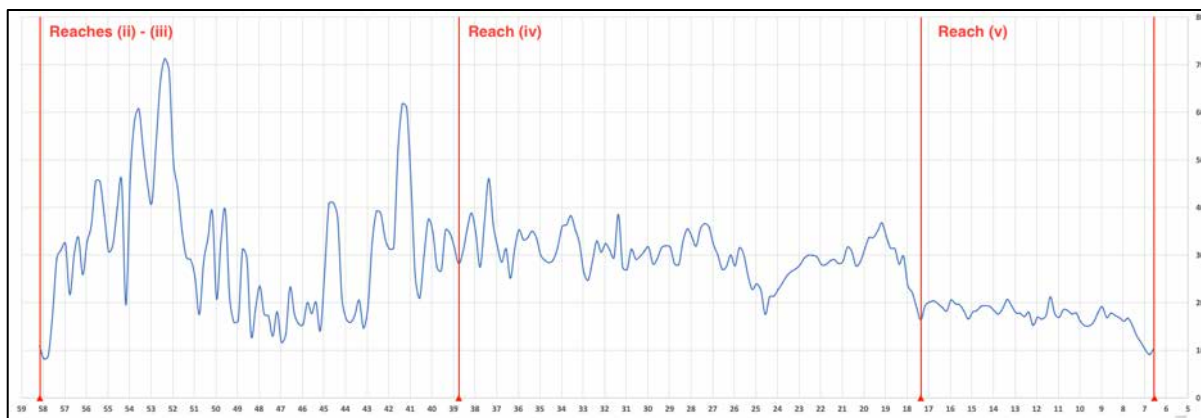
Figure 4: Graph showing the variation in the active channel width of the Ngaruroro River from the Whanawhana Cableway (left of the graph) downstream to within 6km the coast (right of the graph). The y-axis shows the channel width in metres (higher = wider) and the x-axis shows distance from the sea in metres (flowing from the left (upstream) to the right (downstream)). Substantial variation can be seen in the active channel width of the river upstream of the HBRC Flood Management Scheme area (Reaches (ii)-(iii)). The river narrows and becomes more consistent in width when it enters the HBRC Flood Management Scheme Area (Reach (iv)) and narrows again where it is lined on both sides with stopbanks (Reach (v)). Measurements taken in QGIS at 200m intervals using 2019/2020 aerial imagery. Smoothed line connects points. Larger graph provided as an appendix.

41. This variation in confinement (and the degree of impact from the HBRC Flood Management Scheme and stopbanks) can also be seen in variation in the active channel width²¹ of the Ngaruroro River from Whanawhana down to the coast, as illustrated in Figure 4. This graph shows there is substantial variation in the active channel width of the river upstream of the HBRC Flood Management Scheme area (from around 100m wide to over 700m wide), which is characteristic of the river operating within the space naturally available to it (rather than being actively confined by human intervention). After exiting the gorge and flowing through an extremely wide braided section (Reaches (ii) – (iii) as identified by Prof. Fuller), the river narrows and becomes more consistent in width when it enters the HBRC Flood Management Scheme Area (Reach (iv)) and narrows further where it is lined on both sides with stopbanks (Reach (v)). Compare Figures 2-4.

42. Figures 2-4 illustrate the lower Ngaruroro River (below the Whanawhana Cableway) is not simply one homogenous reach – it is better considered as a number of reaches with varying degrees of modification, which traverse a continuum of highly natural to highly modified. Some of these reaches are naturally confined (e.g., by terraces) while others have been constrained by human intervention such as edge protection planting and stopbanks. In particular, the reach from the Whanawhana Cableway to the top of the HBRC Flood Management Scheme is largely unimpacted by human confinement and reflects a natural braided and semi-braided/wandering form (discussed further below). While the reach from the top of the HBRC Flood Management Scheme to Fernhill Bridge/Omahu has been confined by human activity and is not as natural as the section upstream, it generally still has a wider active channel than other Hawke’s Bay rivers and exhibits a relatively high degree of braiding too (see Braiding Index in Table 1 and comparison to other rivers later in this evidence).

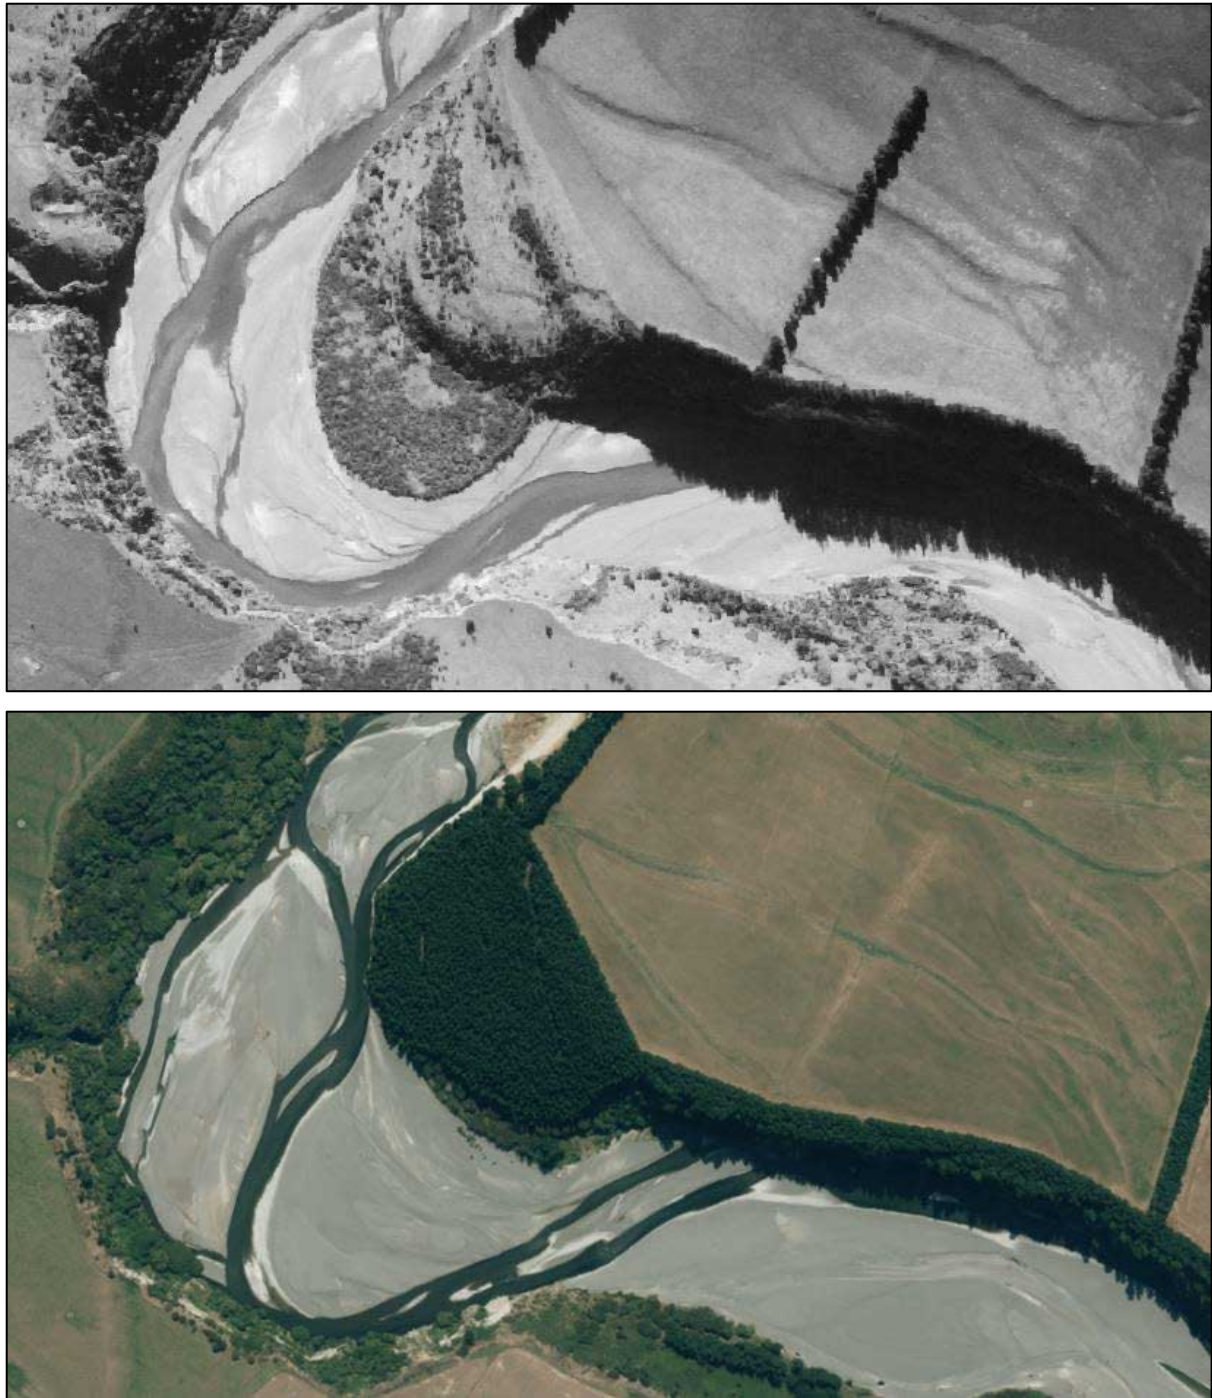
Figure 7: Aerial imagery²⁵ of the Ngaruroro River about 5km downstream from the Whanawhana Cableway in 1950 (top) and 2019/2020 (bottom). The width of the active channel remains similar (as per Figure 5).

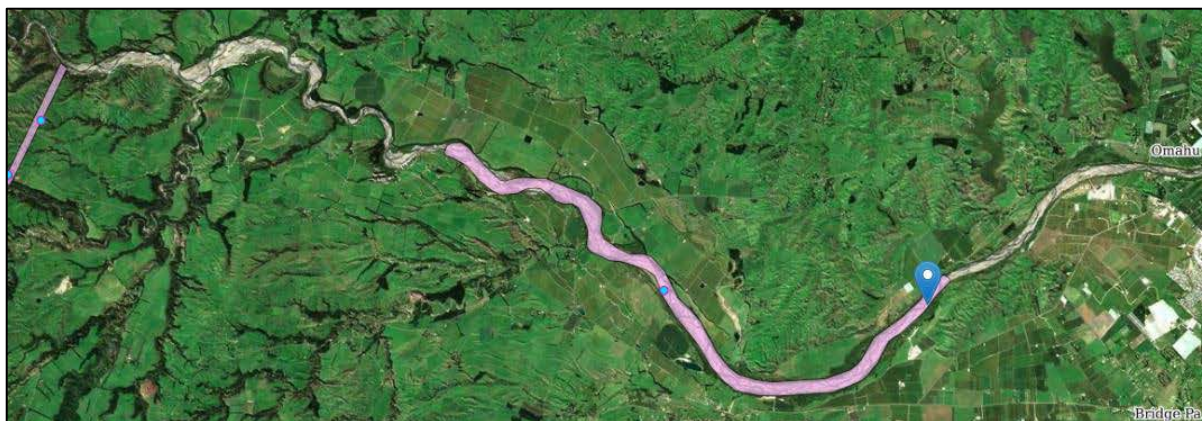
Figure 9: Lower Ngaruroro River as mapped in the online New Zealand Geopreservation Inventory.

57. Interestingly, the mapped area in the Inventory does not include the widest section of the channel (compare Figures 2-5 with Figure 9 below). It is unclear to me why this is the case.

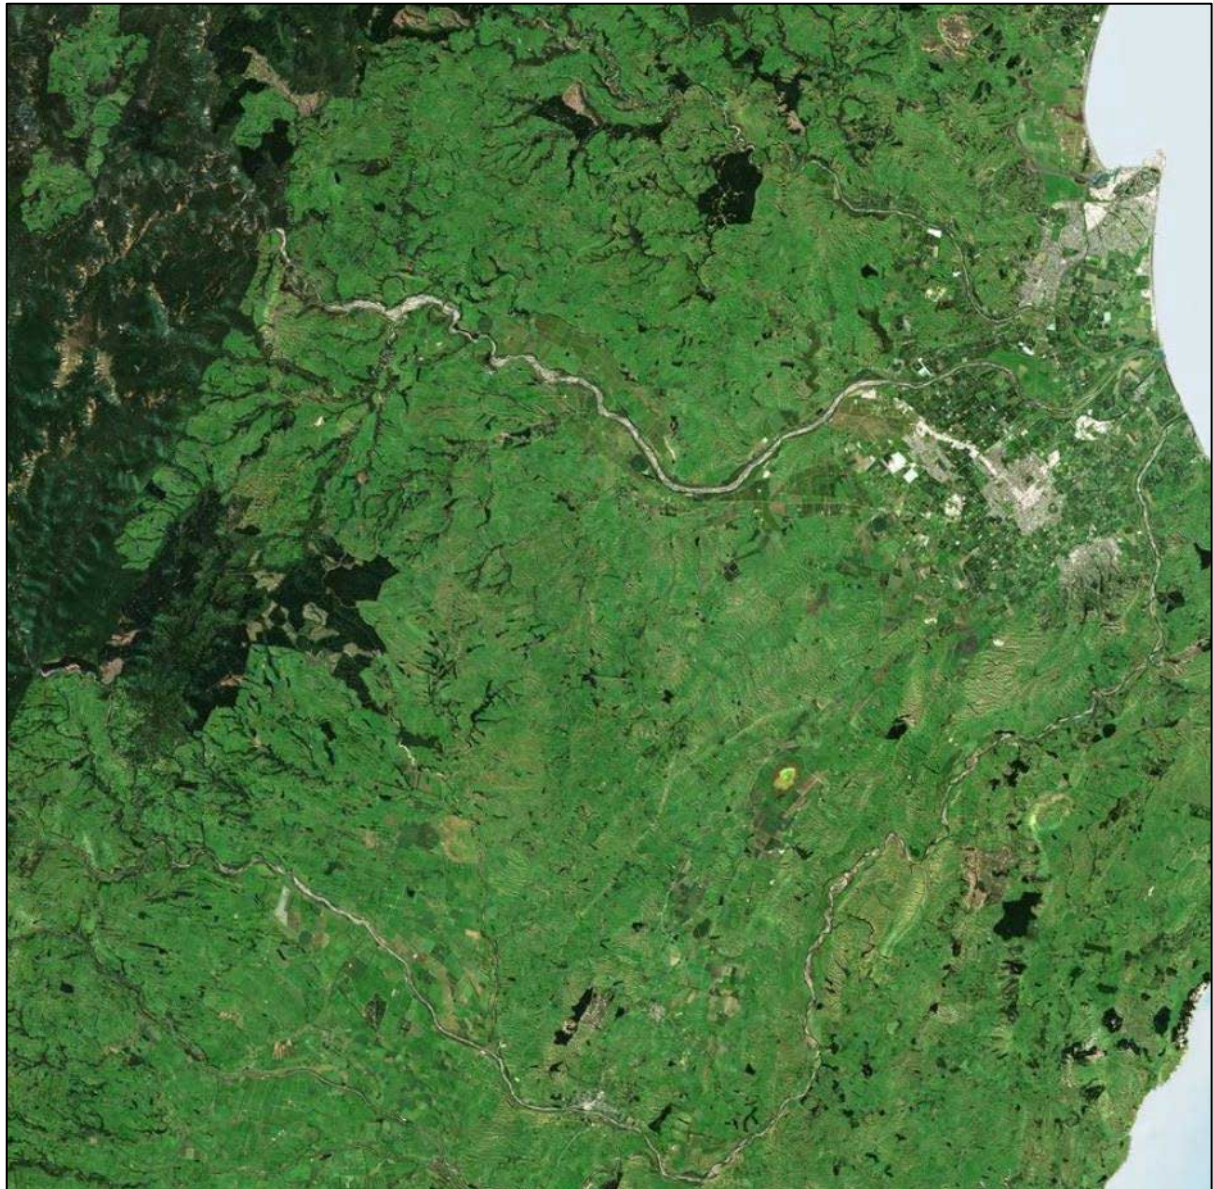
Figure 10: Aerial imagery³⁹ of Hawke’s Bay covering the Tūtaekurī (top of image), Ngaruroro (upper-middle of image), Tukituki (right and bottom of image), and Waipawa (bottom left of image) Rivers. The active gravel (braided) area of the Ngaruroro River (seen as white/grey colour in the image) stands out against the landscape and is noticeably more obvious than the braided/semi-braided/wandering areas of the other rivers. Only at Fernhill Bridge/Omahu does the river become significantly less conspicuous.

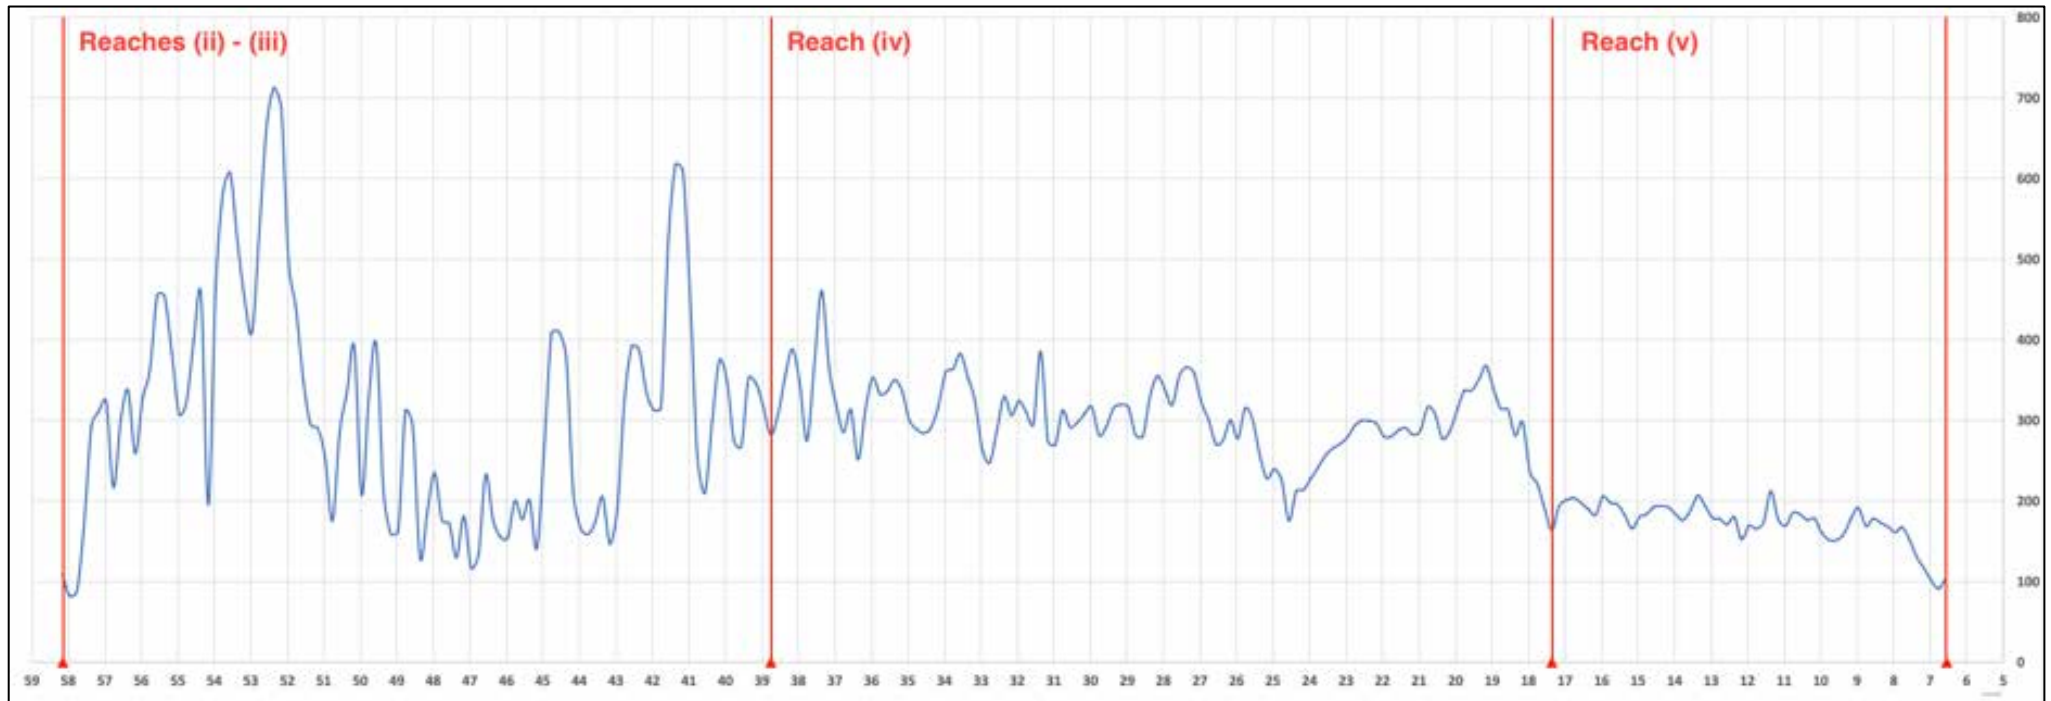
LARGER VERSION OF FIGURE 4

Figure 4: Graph showing the variation in the active channel width of the Ngaruroro River from the Whanawhana Cableway (left of the graph) downstream to within 6km the coast (right of the graph). The y-axis shows the channel width in metres (higher = wider) and the x-axis shows distance from the sea in metres (flowing from the left (upstream) to the right (downstream)). Substantial variation can be seen in the active channel width of the river upstream of the HBRC Flood Management Scheme area (Reaches (ii)-(iii)). The river narrows and becomes more consistent in width when it enters the HBRC Flood Management Scheme Area (Reach (iv)) and narrows again where it is lined on both sides with stopbanks (Reach (v)). Measurements taken in QGIS at 200m intervals using 2019/2020 aerial imagery. Smoothed line connects points.
