Ahuriri Estuary: Contact Recreation and Food Gathering Review

July 2014
HBRC Report No. EMT 13/10 – 4483

Environmental Science - Water Quality and Ecology

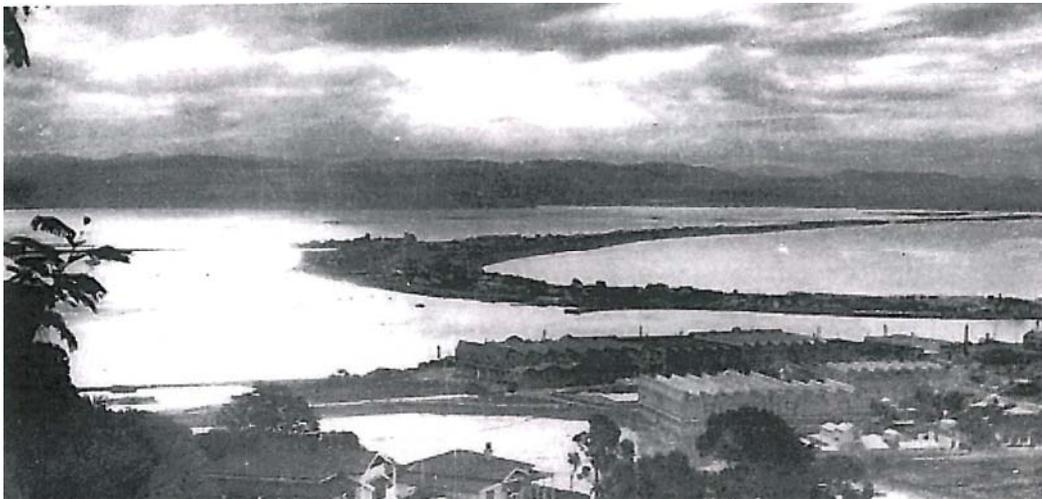
Figure 1-1: Ahuriri Lagoon pre-1931 earthquake.Source: Hawke's Bay Museum.

In a region dominated by alluvial flood plain river mouths, the Ahuriri Estuary (Te Whanganui-a-Orotu) represents one of the few tidal lagoon estuaries in Hawke’s Bay. Formed in the wake of the 1931 earthquake, the Ahuriri Estuary is the remnants of the former Ahuriri Lagoon (Figure 1-1). The earthquake resulted in an uplift of between 1 - 2 metres, exposing approximately 1300 ha (Figure 1-2) (Chague-Goff et al., 2000). Drainage and reclamation following the earthquake has reduced the area to its current size of approximately 470 ha of true estuary, and around 175 ha of associated wetlands (Figure 1-3; (Comerty, 1996).

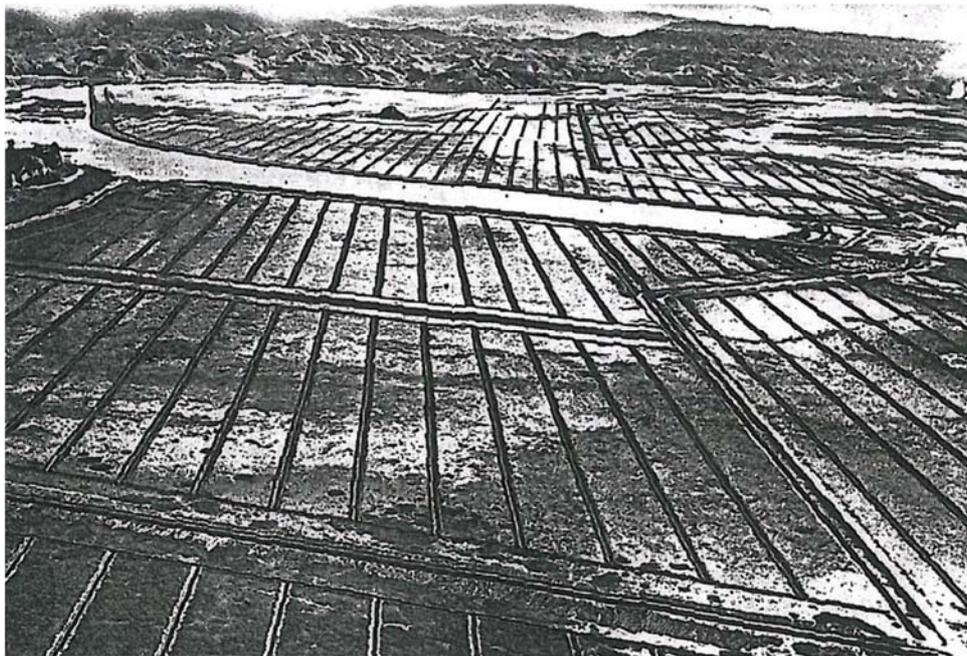
Figure 1-3: Drainage channels constructed to the north and south of the main estuary outfall channel to develop agricultural land. Source: Hawke's Bay Museum.
