Stream Ecological Valuations

Selected sites within the
Napier and Heretaunga
Catchments

May 2010
EMT 10/19
HBRC Plan Number 4201

Stream Ecological Valuations From Selected Reaches Within the Napier and Heretaunga Catchments

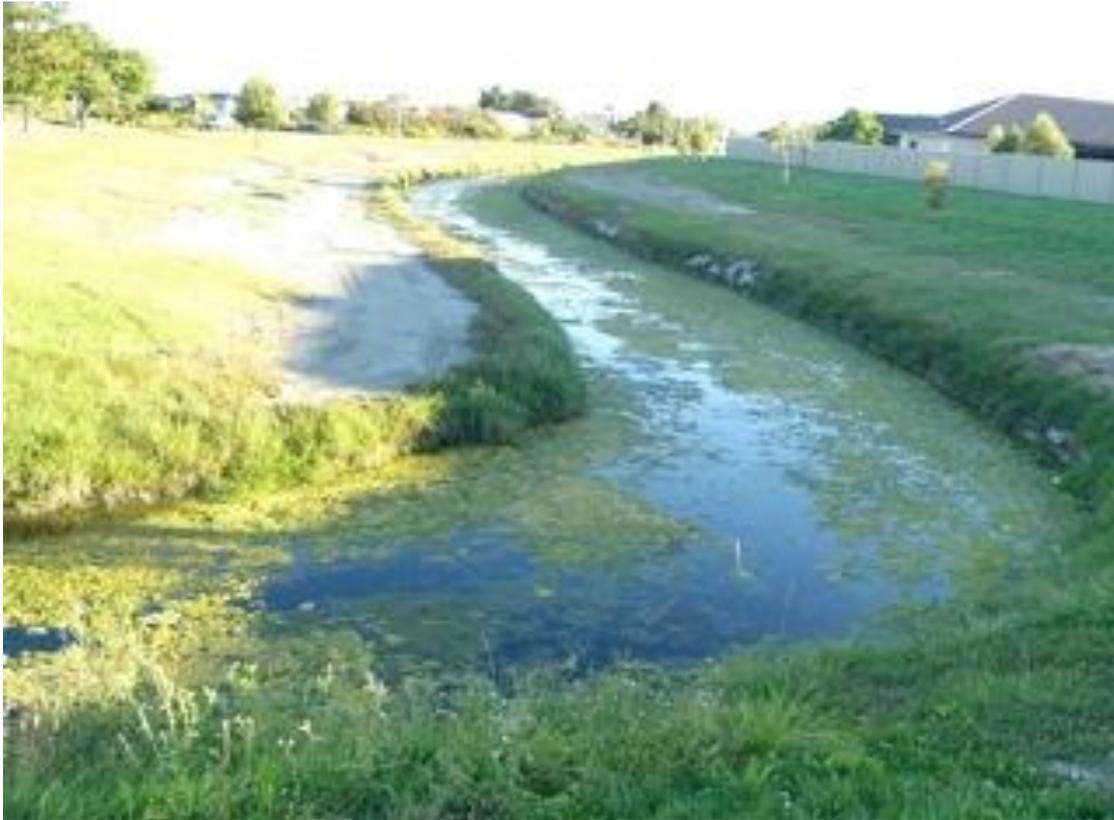
Figure 1: Typical character of Saltwater Creek @ Tamatea Drive study reach, December 2009

The stream channel is entrenched within the surrounding plain to a depth of 2-3 meters. Bank slumping is occasional.

Saltwater Creek has an average wetted width of 7.5 metres at Tamatea Drive and 4.5 m at Lancaster Street, and an average depth of 0.33m and 0.27m respectively.

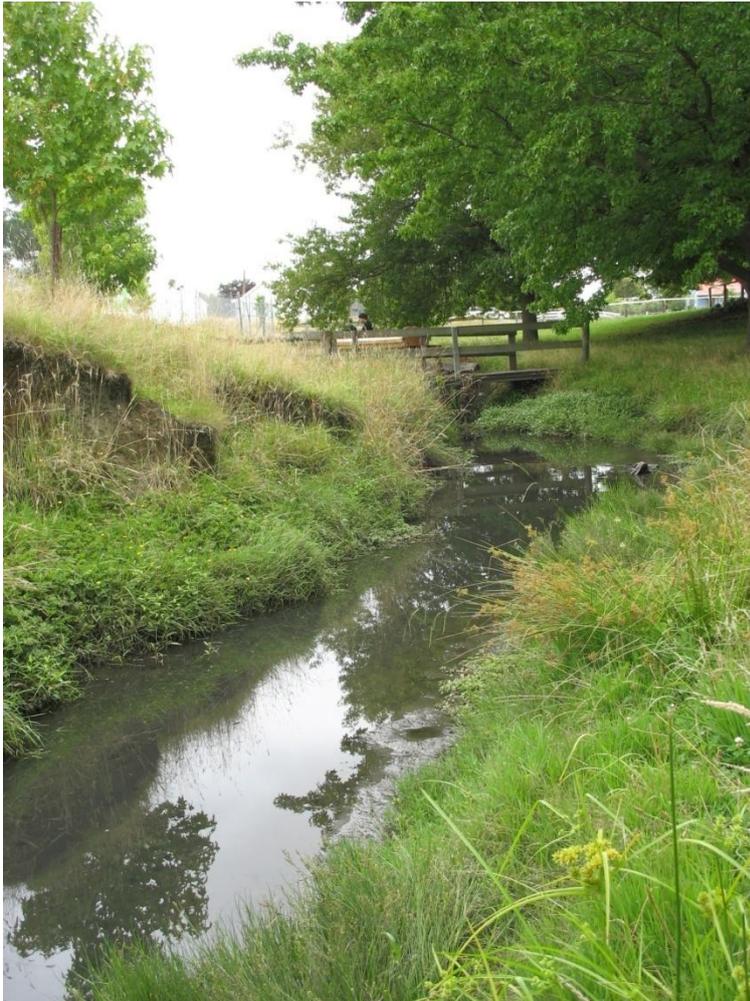
Figure 3: Typical character of the Ruahapia SEV study reach, January 2010

The land surrounding the Ruahapia study reach is rural on the true right bank and park on the true left bank. Riparian vegetation is predominantly rank pasture with occasional exotic trees. Emergent macrophytes and sedges are common along the stream margins and occasional submerged macrophytes are also evident. The substrate is predominantly muds and silts with occasional large and small woody debris. Stock have free access to the stream. The stream channel is entrenched within the surrounding plain to a depth of 2-3 metres. Bank slumping is common.

The Ruahapia study reach has an average wetted width of 2.4 m and an average depth of 0.08 m.

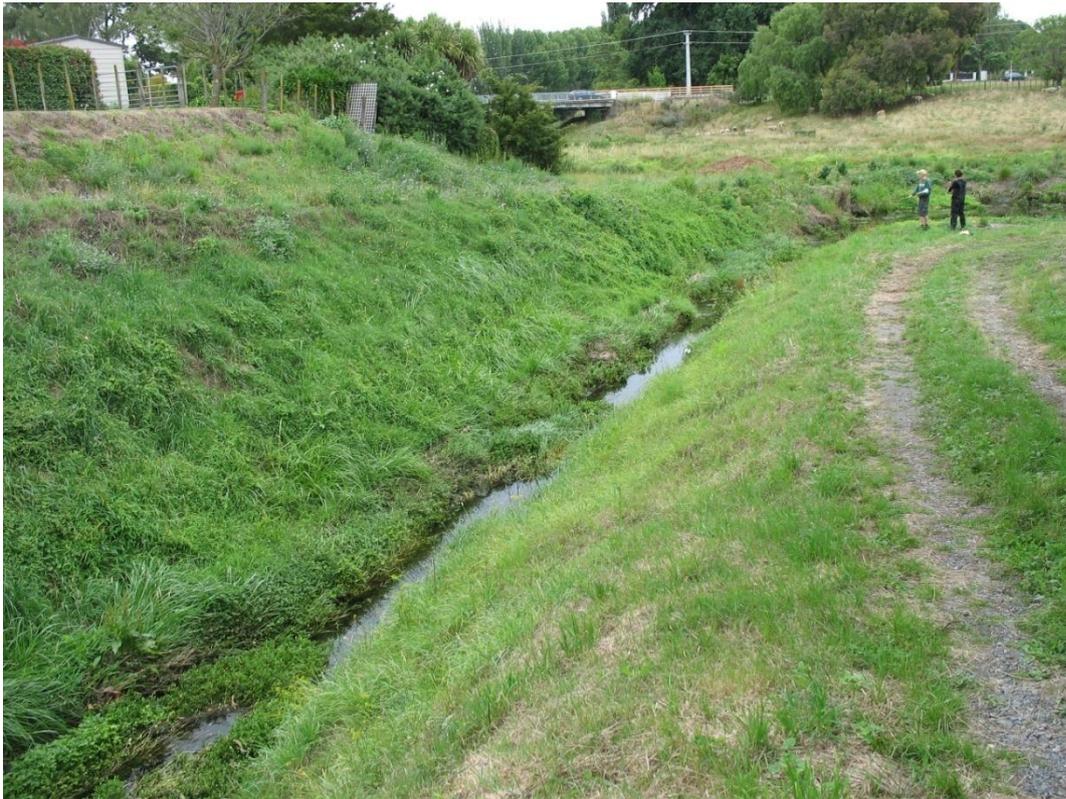
Figure 4: Typical character of the Karitewhenua Stream SEV study reach at Napier Rd, January 2010

The land surrounding the Karitewhenua Stream is predominantly pastoral however the study reaches fall within an urban landscape. The upper reaches of the stream (Te Mata Rd) are ephemeral and it was noted that stream flow ceased somewhere between 10th December 2009 and 22nd December 2009 and remained dry through to the present (April 8th 2010). The substrate within the stream is predominantly small to large gravels. The Napier Rd site has a mean wetted width of 4.8 m and mean depth of 0.15m while the Te Mata Rd site has a mean width of 0.58m and mean depth of 0.04m.

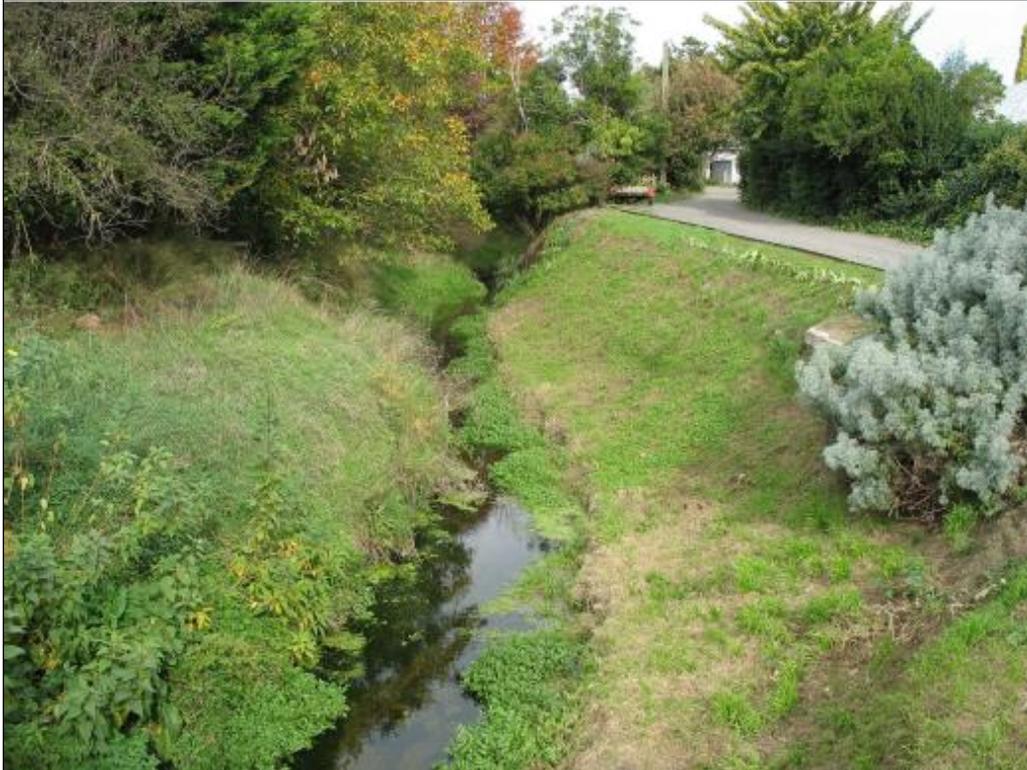
Figure 6: Typical character of the Mangarau Stream SEV study reach at Te Aute Rd, January 2010

The land surrounding the Mangarau Stream is predominantly pastoral however the study reaches fall within an urban landscape. Like the Karitewhenua and Herehere streams, the Mangarau Stream is a cobble / gravel stream system with occasional occurrence of runs, riffles and pools. The stream is well entrenched within a flood plain of between 3 – 5 metres in height. The Te Aute Rd site has a mean wetted width of 2.6m and a mean depth of 0.23 m while the Kierunga Rd site has a mean wetted width of 2.0m and a mean depth of 0.20 m.

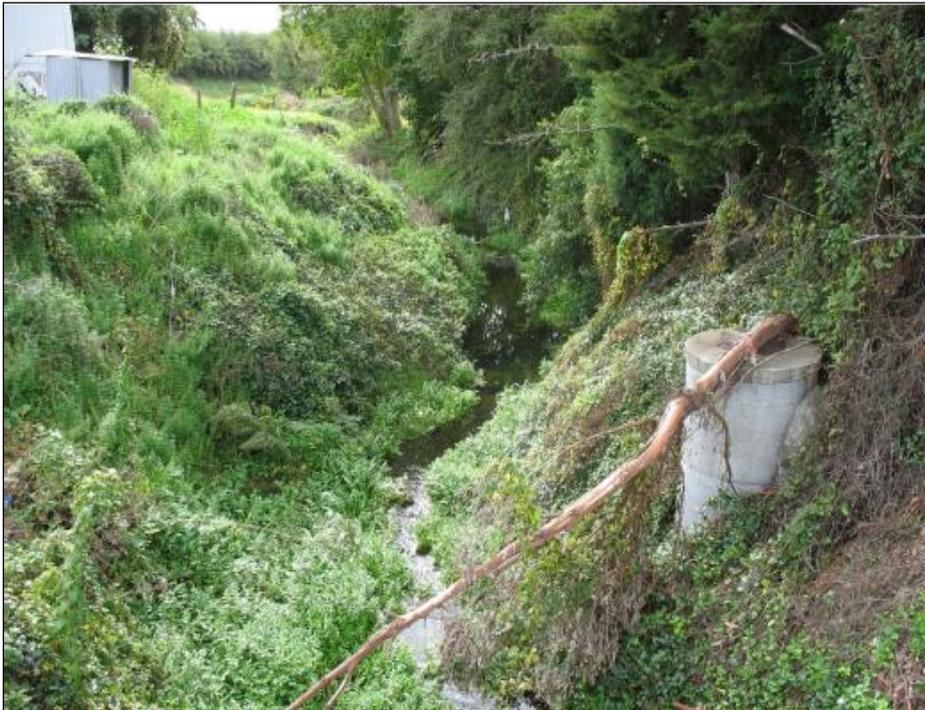
Figure 8: Typical character of the Herehere Stream SEV study reach at Te Aute Rd, January 2010

The land surrounding the Herehere Stream is predominantly pastoral or horticultural. The true left bank of the stream is within the influence of an orchard while the true right bank adjoins an urban landscape. Like the Karitewhenua and Herehere streams, the Herehere Stream is a cobble / gravel stream. While areas of sediment deposition are evident, the stream bank is very firm to walk on. The stream is well entrenched within the flood plain with stream sides of 3-5m height. The stream has a mean wetted width of 2.2 m and a mean depth of 0.16 m.

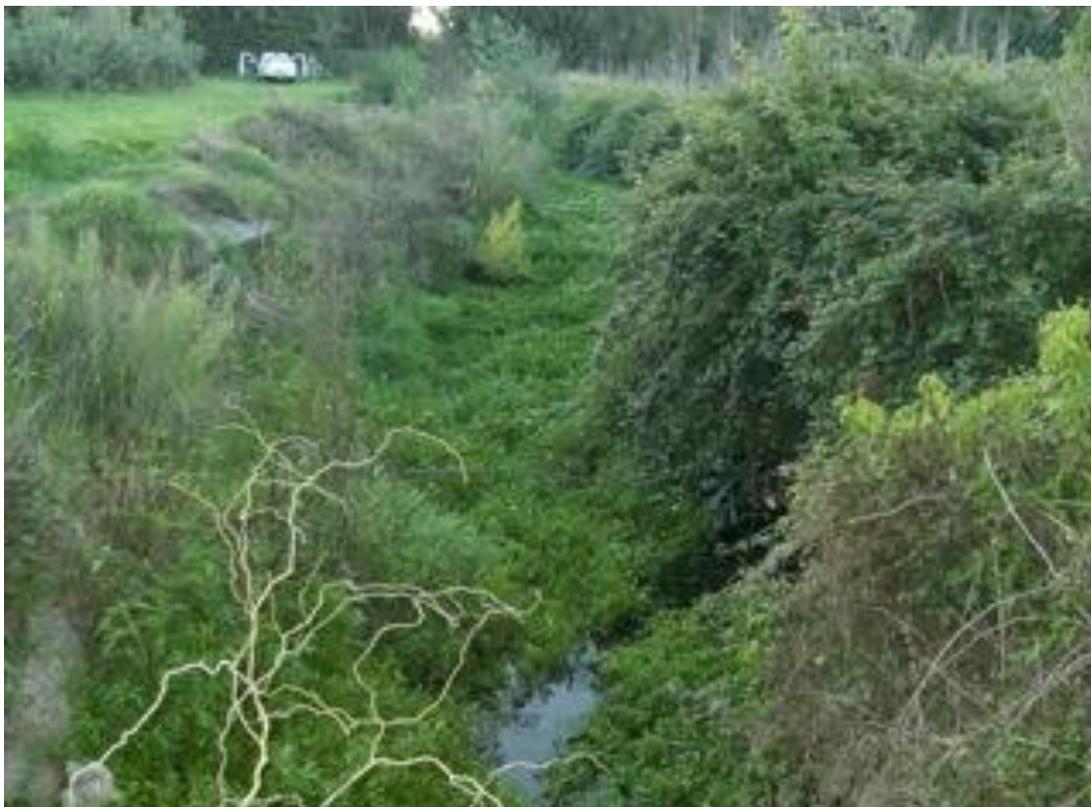
Figure 9: Typical character of the Irongate Stream SEV study reach at Te Aute Rd January 2010

The land surrounding the Irongate Stream is predominantly pastoral or horticultural however the true left of the stream is within the urban influence of the suburb of Flaxmere. Like the Karitewhenua and Herehere streams, the Irongate Stream is a cobble / gravel stream however years of sediment inputs from surrounding land uses and stream bank erosion have resulted in the stream bed being blanketed with a layer of sediment resulting in a boggy nature to the streambed. The stream is well entrenched within the flood plain with stream sides of 2-3 m height. The stream has a mean wetted width of 3.9m and a mean depth of 0.24 m.

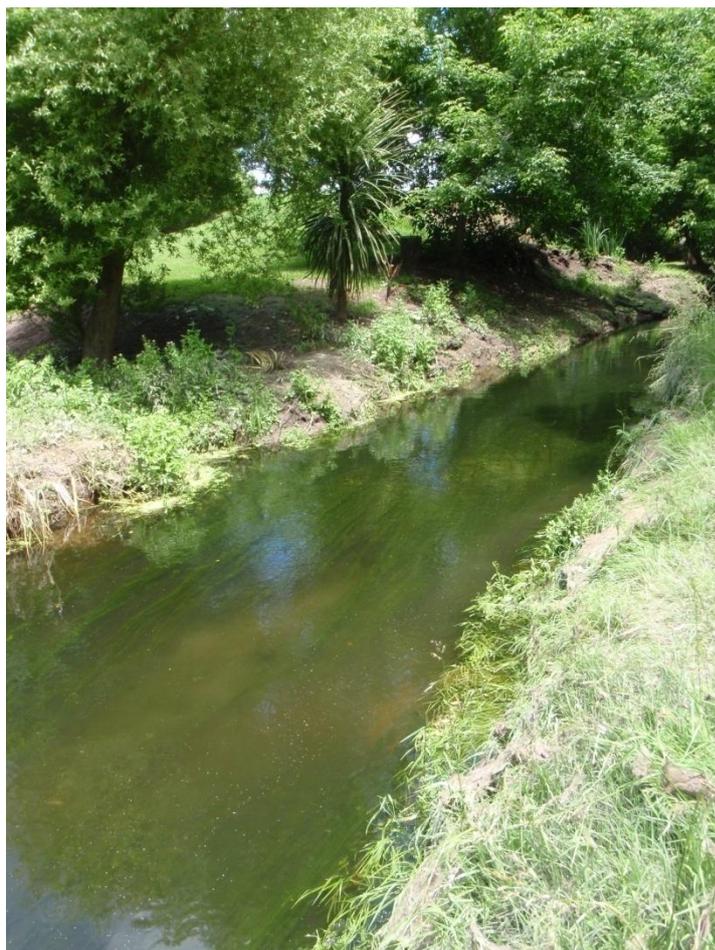
Figure 10: Typical character of the Louisa Stream SEV study reach at Te Aute Rd, January 2010

The land surrounding the Louisa Stream is predominantly pastoral or horticultural. Like the Karitewhenua and Herehere streams, the Irongate Stream is a cobble / gravel stream however years of sediment inputs from surrounding land uses and stream bank erosion have resulted in the streambed being blanketed with a thick layer of sediment resulting in a boggy nature to the streambed. The stream is well entrenched within the flood plain with stream sides of 2-3 m height. The stream has a mean wetted width of 3.5m and a mean depth of 0.55 m. The stream is dominated by submerged aquatic macrophytes such as Lagrosiphon, Canadian pond weed and crinkly pond weed. The stream is fairly uniform in shape with no presence of riffles or pools. Areas of stream bank erosion are evident within the reach, particularly on the true right bank.

The Louisa Stream also scored low in terms of the roughness of the surrounding riparian vegetation. The thickness of vegetation on the floodplain will influence the amount of runoff material retained by it. Field observations found the true right bank of the Louisa Stream to be heavily eroded and the stream bank tops also lacked any vegetation in the lower section of the reach.

Table 26 shows that if the muddy substrate was replaced with gravels and cobbles, the dissolved oxygen demand of the substrate (Vdod) would reduce thereby improving the overall biogeochemical score. Furthermore water quality would improve as would habitat provision resulting in an improved SEV score.

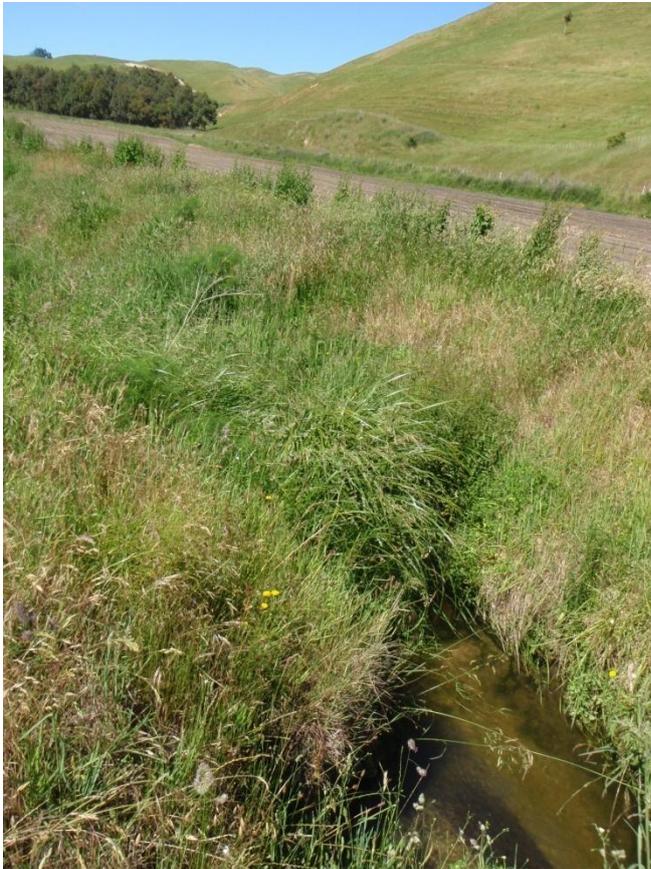
Figure 11: Typical character of the Te Waikaha Stream SEV study reach at Te Aute Rd, January 2010

within the flood plain with stream sides of 3-5m height. The stream has a mean wetted width of 1.8 m and a mean depth of 0.47 m.

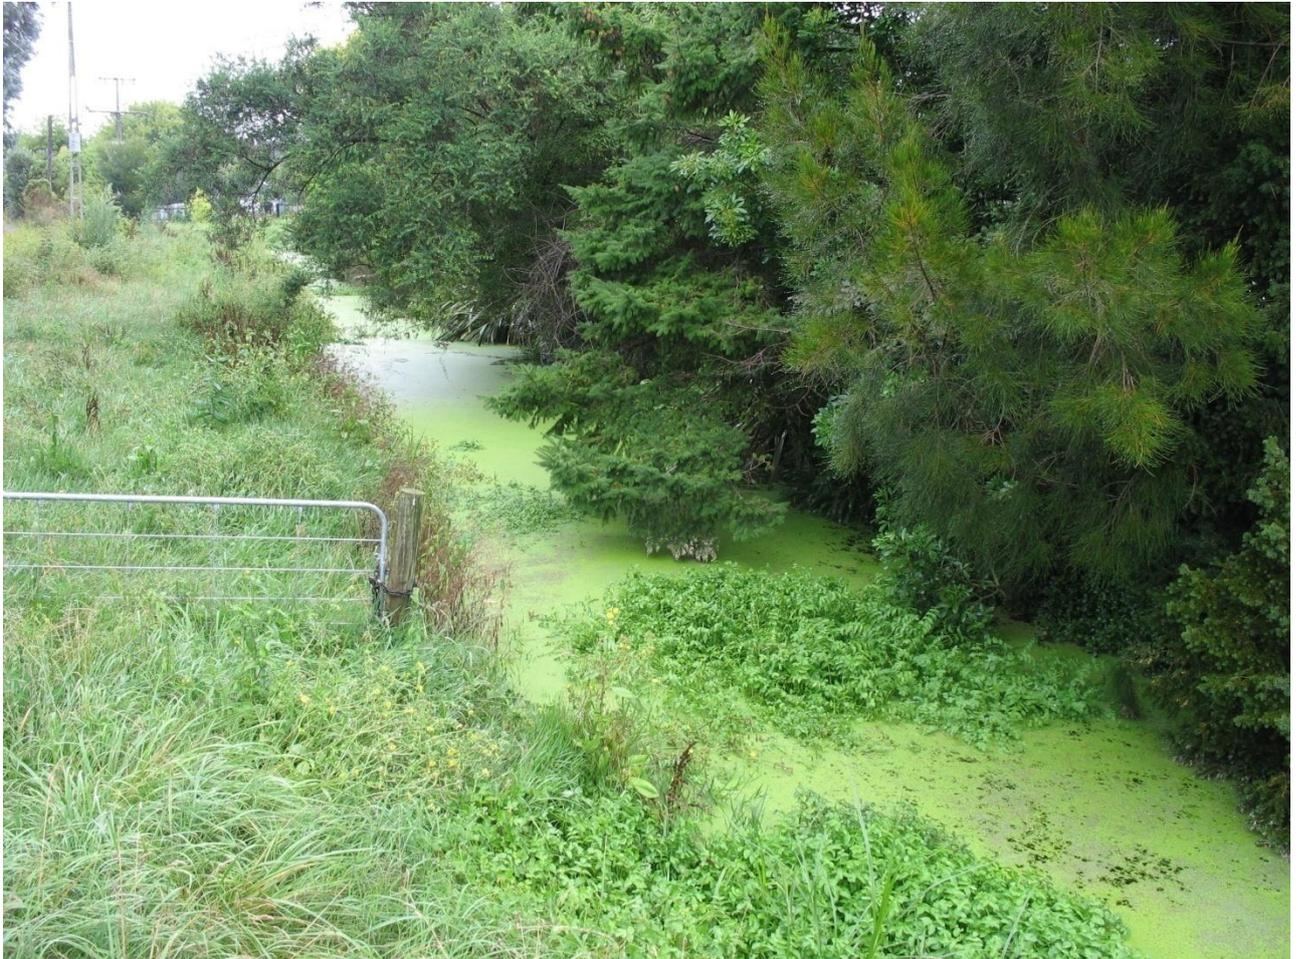
Figure 12: Typical character of the Muddy Creek SEV study reach at Mill Rd. January 2009

The land surrounding the Herehere Stream is predominantly pastoral or horticultural. The stream is well entrenched with stream banks between 1 – 2 m in height. The stream bottom is very muddy with silts and sand being the most predominant substrate. There is an absence of riffles or pools, with the stream being engineered as a run with few bends for flooding purposes. The stream has a mean wetted width of 5 m and a mean depth of 0.44 m.

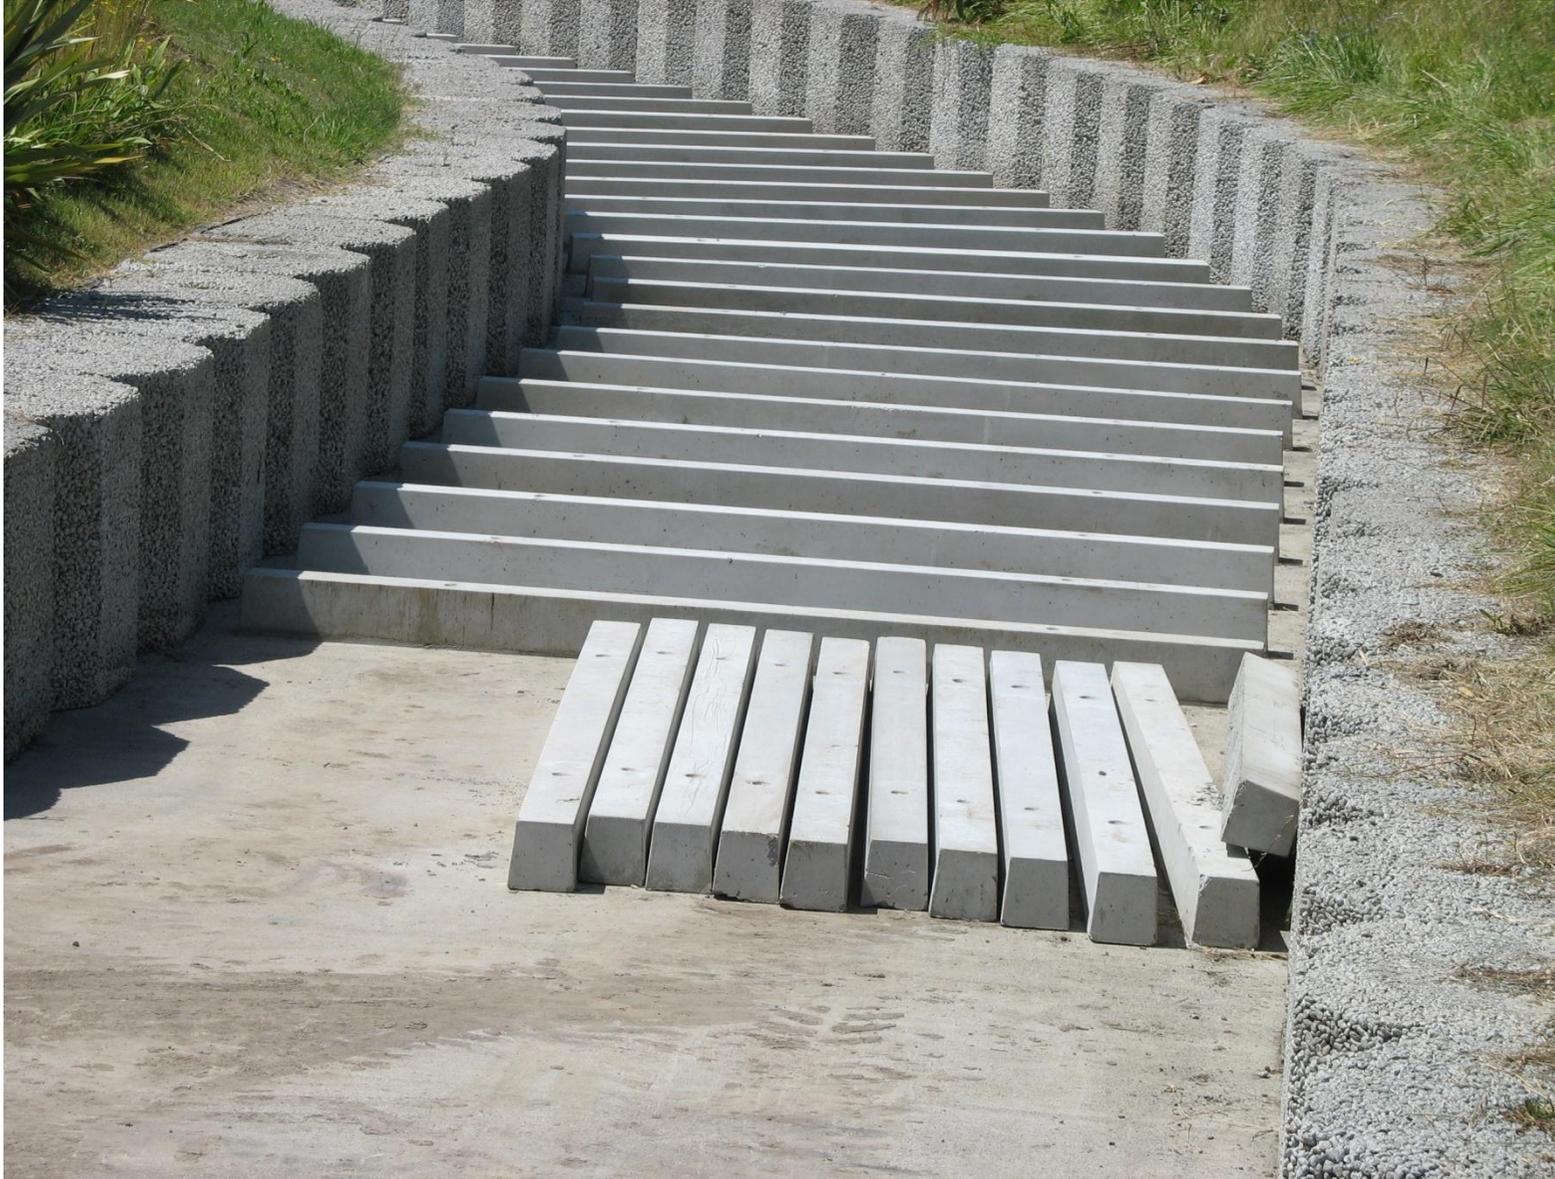
Figure 21: Fish barrier on the corner of Brookvale Rd and Woodlands Drive. The streams base flow has been piped and concreted over.

The Mangarau Stream @ Te Aute Rd has a low hydraulic function owing to it having a retaining wall immediately adjacent to the stream edge. This reduces the connectivity to the floodplain. Karitewhenua Stream at Napier Rd scores low in hydraulic function because a major fish barrier is located upstream of this point (located on the corner of Brookvale Rd and Woodlands Drive) which reduces the value of the variable associated with connectivity for species migrations. All other sites score moderately well on hydraulic function. (See Figure 21).
