Stream Ecological Valuation: Ruahapia and Raupare Streams

Prepared for Hawke's Bay Regional Council

March 2011

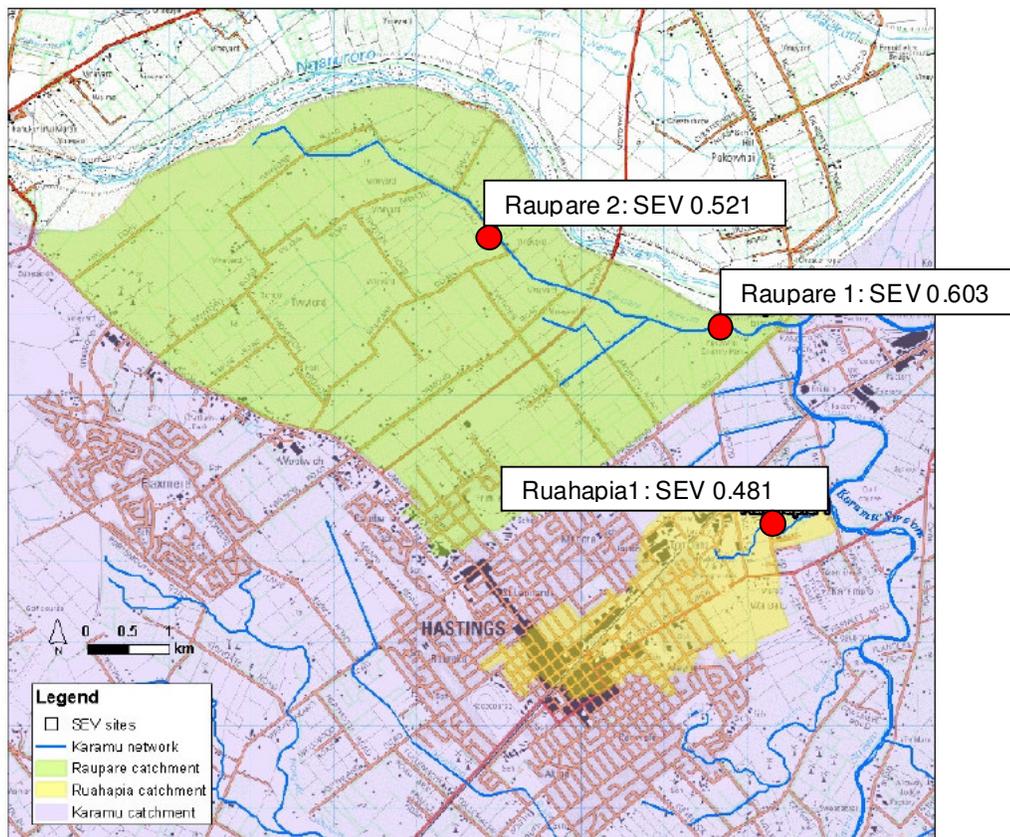
Ruahapia and Raupare Streams baseline SEV results summary:

A summary of the results of the SEV baseline survey are presented spatially, below. In summary, the baseline survey determined levels of ecological functional integrity were moderate to low in the Ruahapia Stream, moderate in the upper Raupare Stream, and moderate to high in the lower Raupare Stream at the Pakowhai Country Park. The SEV score at the lower Raupare Stream site was more than one whole SEV unit above any other site measured through the Hawke's Bay baseline assessment programme to date.

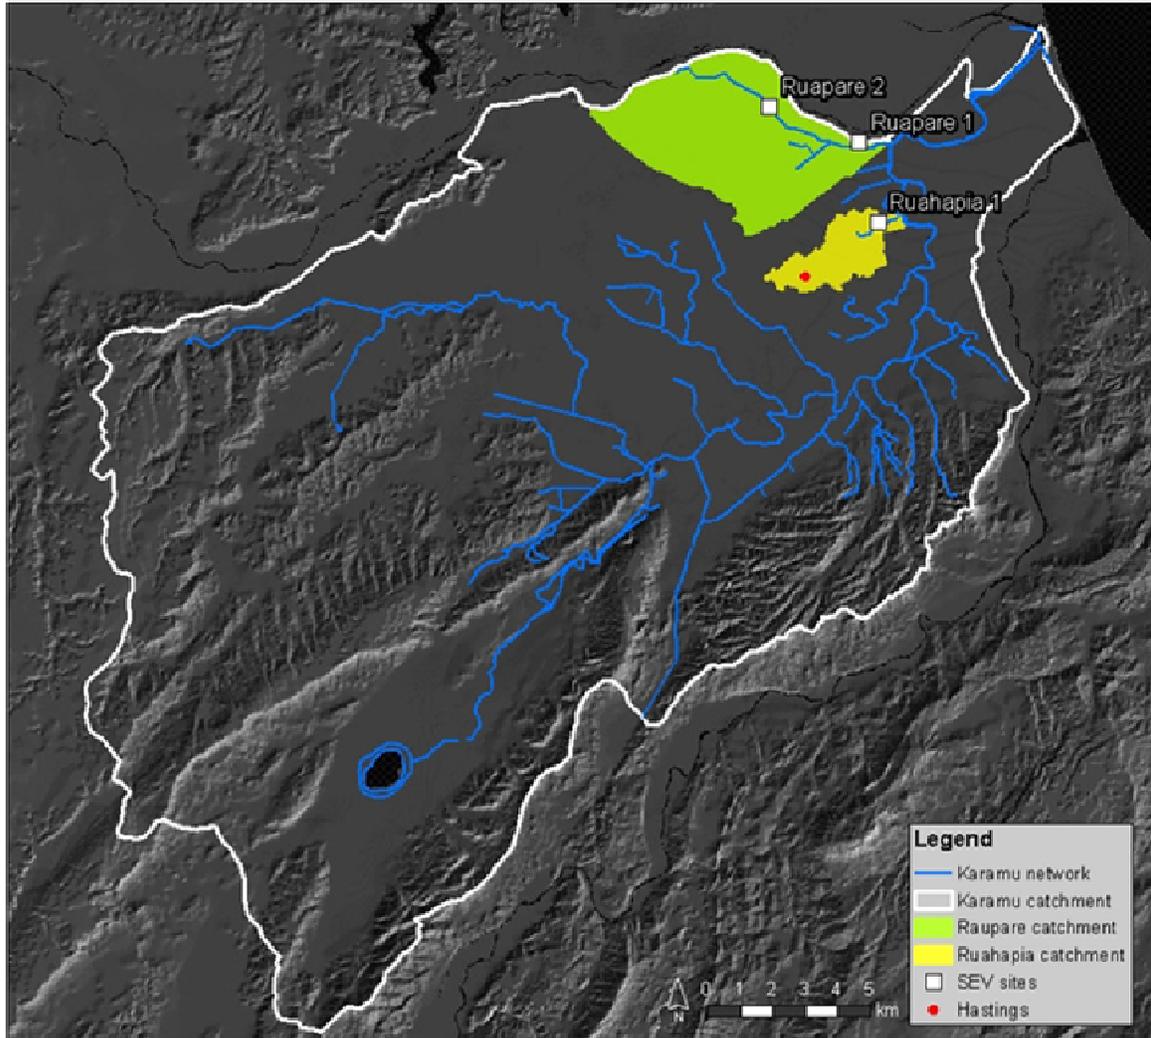
Figure 1-1 : Ruahapia and Raupare catchments, streams and study reaches in relation to the Karamu catchment

The location of subject streams and study reaches in relation to the wider Karamu catchment are presented in Figure 1-1 below.

The Ruahapia Stream is positioned in the lower reaches of the Karamu Catchment (See Figure 1-1). The Ruahapia Catchment has a total area of approximately 497 ha¹. Of that area, 38% is covered in industrial land use, 28 % is in residential land use. The remaining 33 % is in rural land use. Given the land use and catchment area, approximately 50 % of the catchment is covered in impervious surface.

The Raupare Stream is positioned in the lower reaches of the Karamu Catchment (See Figure 1-1). The Raupare Catchment has a total area of approximately 2566 ha². Of that area less than 5 % is covered in residential land use with the remainder in rural land use. On that basis less than 5 % of the catchment area features impervious cover. The upper reach of the Raupare Stream does not have significant area of impervious cover within its catchment.

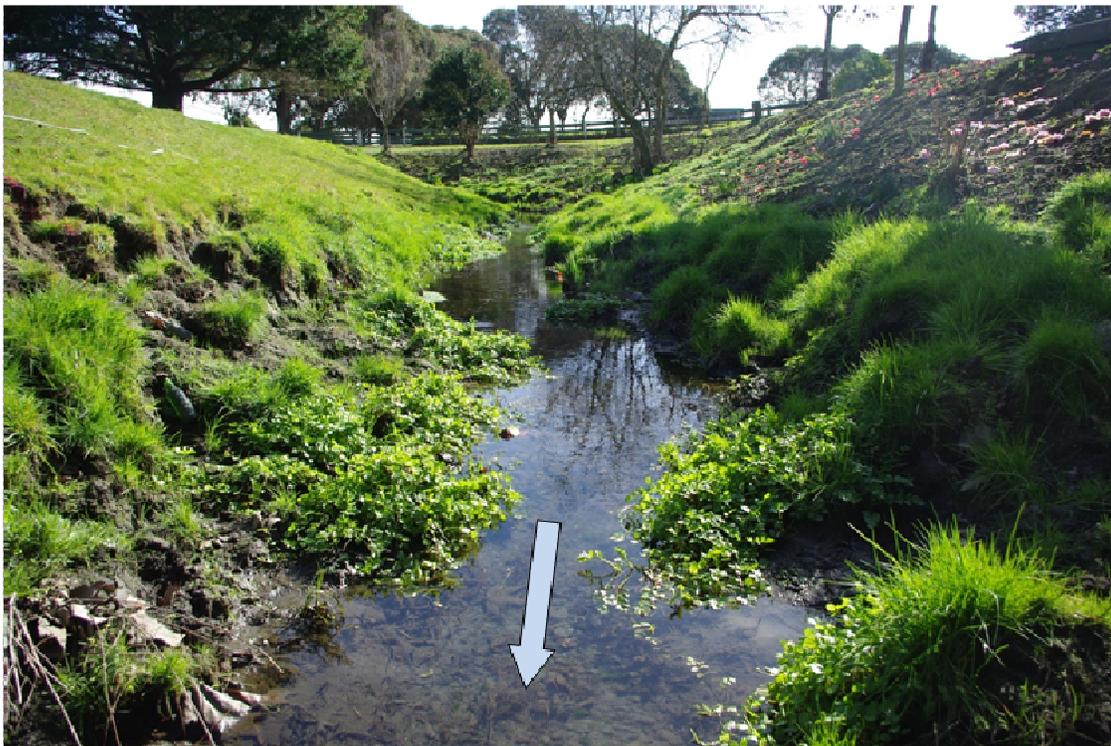
Figure 2-1 : Typical character of the Ruahapia 1 SEV study reach, August 2009

The land surrounding Ruahapia 1 is rural in character. Riparian vegetation is predominantly short pasture. Occasional exotic trees are present within the riparian zone. Stock has free access to the stream.

The stream channel is entrenched within the surrounding plain to a depth of several meters. Bank slumping is common.

The Ruahapia 1 study reach has an average wetted width of 1.78 metres, and an average depth of 0.11 metres.

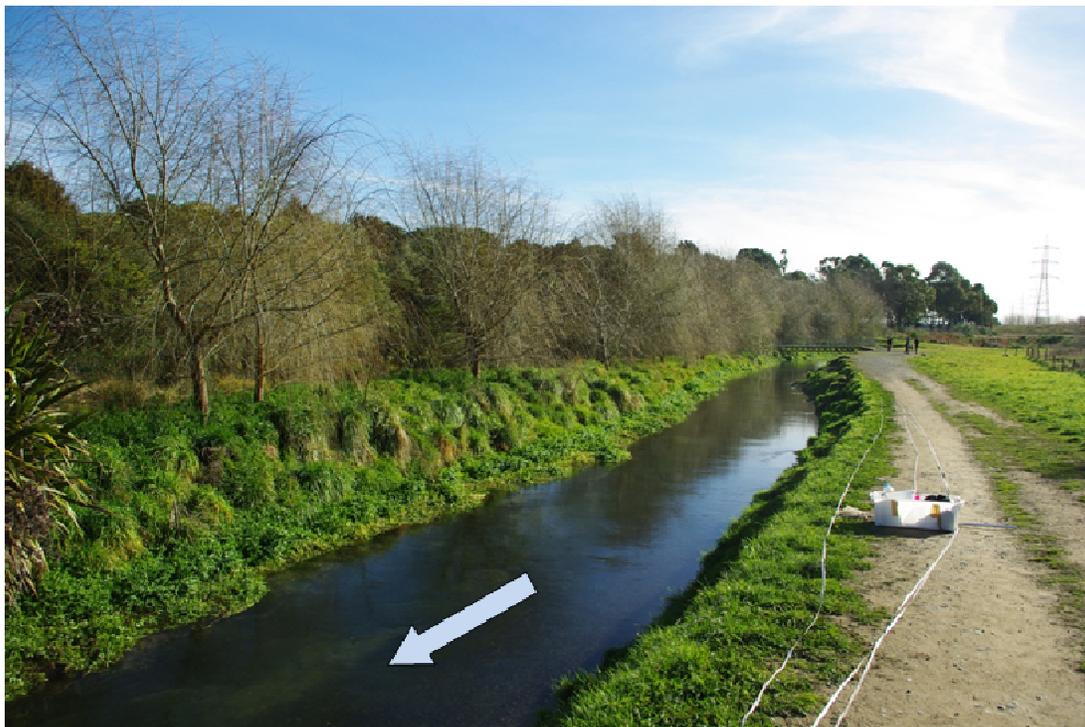
Figure 2-2 : Typical character of the Raupare 1 SEV study reach, September 2009

Land use in the vicinity of Raupare 1 is reserved parkland, with expansive areas of mown grass (particularly on the true left) and mixed native and exotic tree-land on the true right of the stream. To the true right of the stream is a relatively³ expansive floodplain.

The stream alignment is artificially channelised, although it retains natural substrate and earth banks. Bank erosion is common along the steeper true left bank.

The Raupare 1 study reach has an average wetted width of 7.1 metres, and an average depth of 0.3 metres.

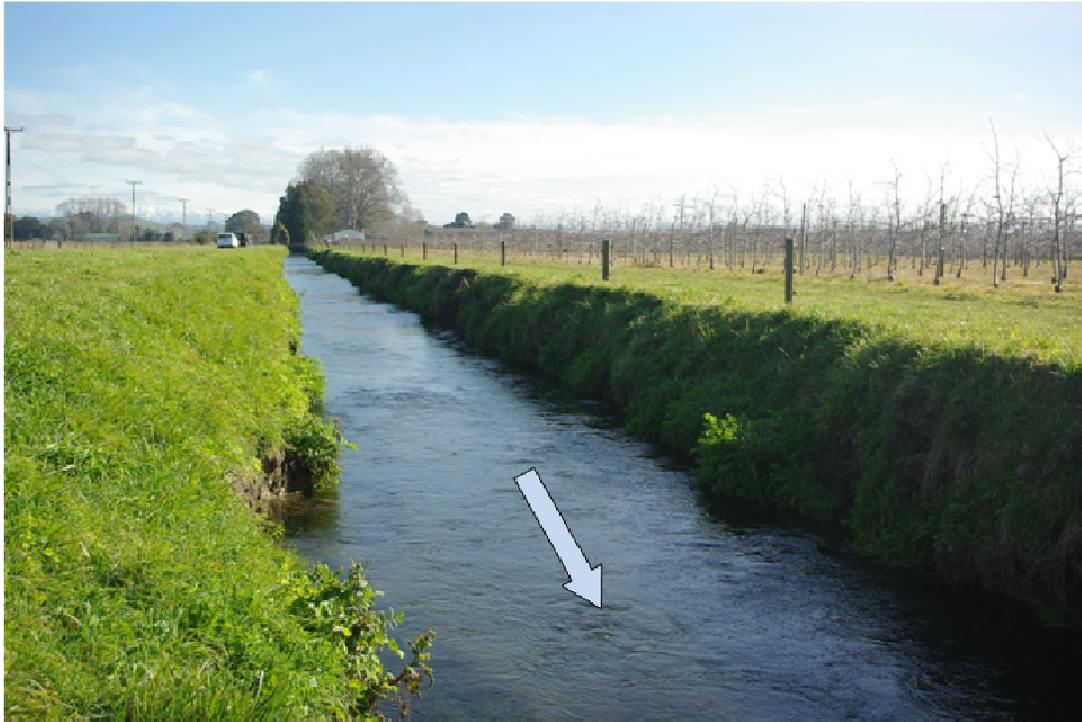
Figure 2-3 : Typical character of the Raupare 2 SEV study reach, August 2009

Land use in the vicinity of Raupare 2 is agricultural, in particular orchards and vineyards. The Raupare Stream is separated from Nicholl Road on the true right by a 7.5 metre grass verge.

The channel is straightened and incised. The stream is set within near vertical banks, which are vegetated with exotic grasses and periodically mown.

The Raupare 2 study reach has an average wetted width of 4.3 metres, and an average depth of 0.57 metres. Macrophyte growth is abundant. The stream substrate is predominantly silt and clay.

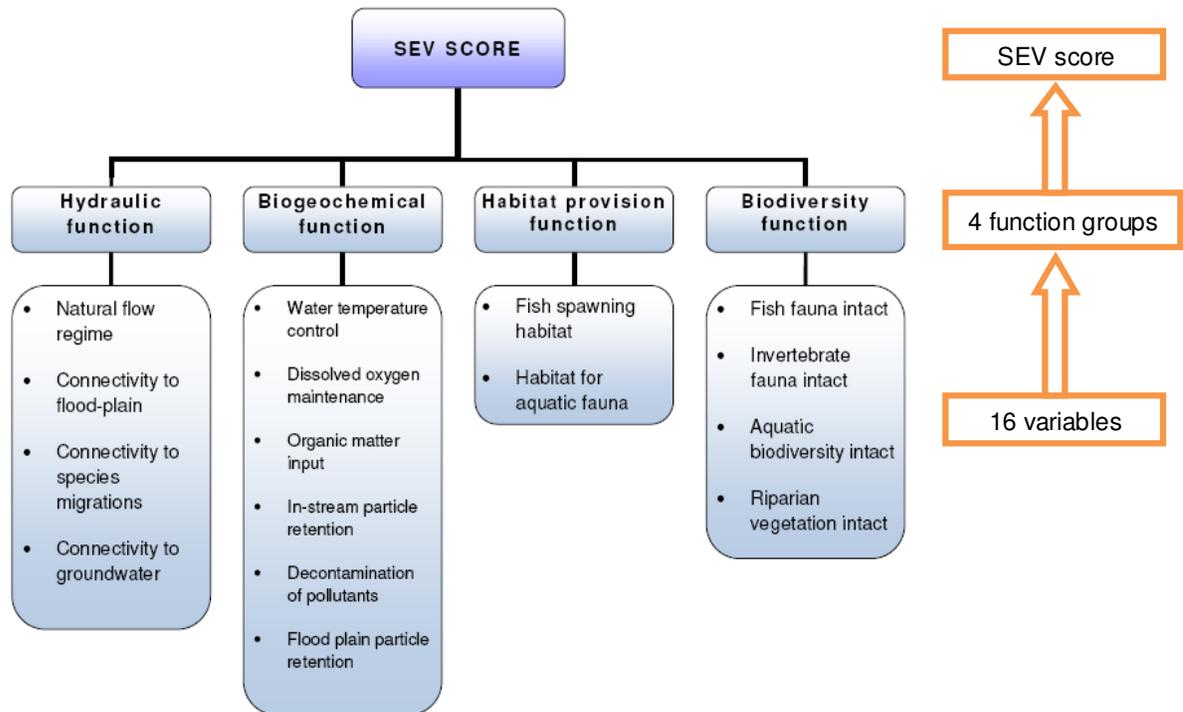
Figure 3-1 : SEV general structure

The SEV score is generated by collection of data relating to 16 variable scores. Those variable scores contribute to one or more function group scores. The SEV score is the average of those four function group scores.

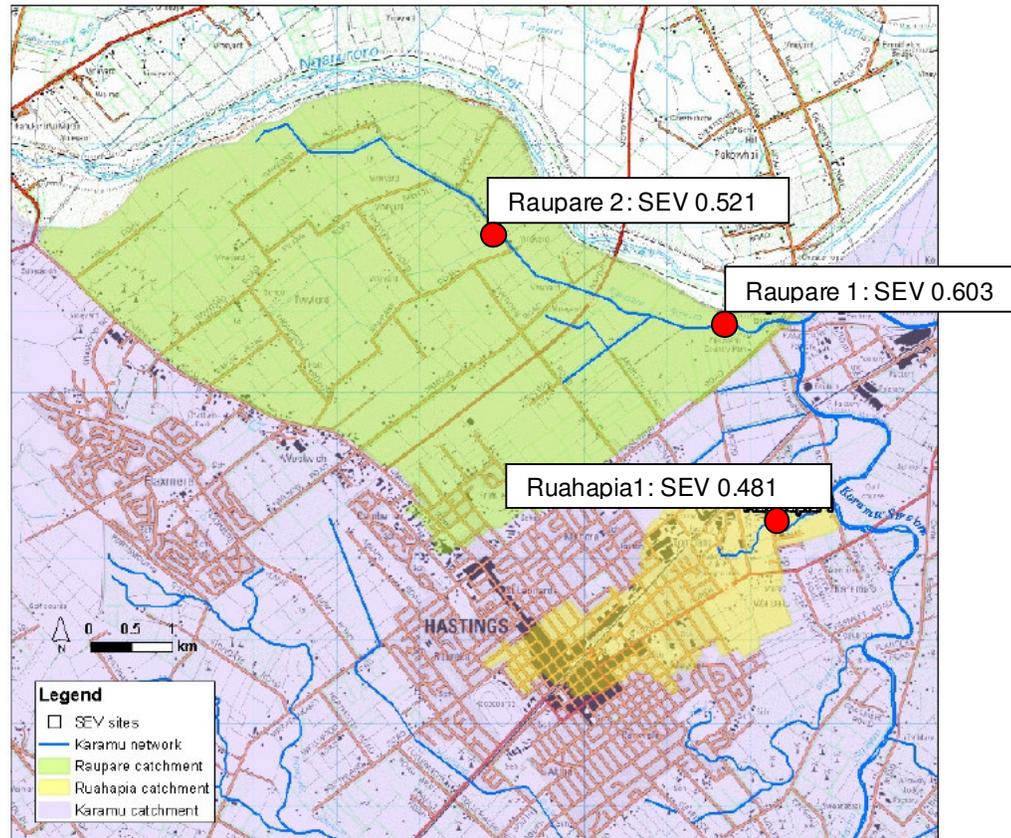
Figure 4-1 : SEV scores for the Raupare and Ruahapia Stream study reaches

Test scores returned from SEV analysis of the representative reaches of the Raupare and Ruahapia Streams are presented in Figure 4-1 below. Moderate SEV scores were returned from the Ruahapia 1 and Raupare 2 study reaches. A moderate to high score was returned from Raupare 1, at the Pakowhai Country Park.

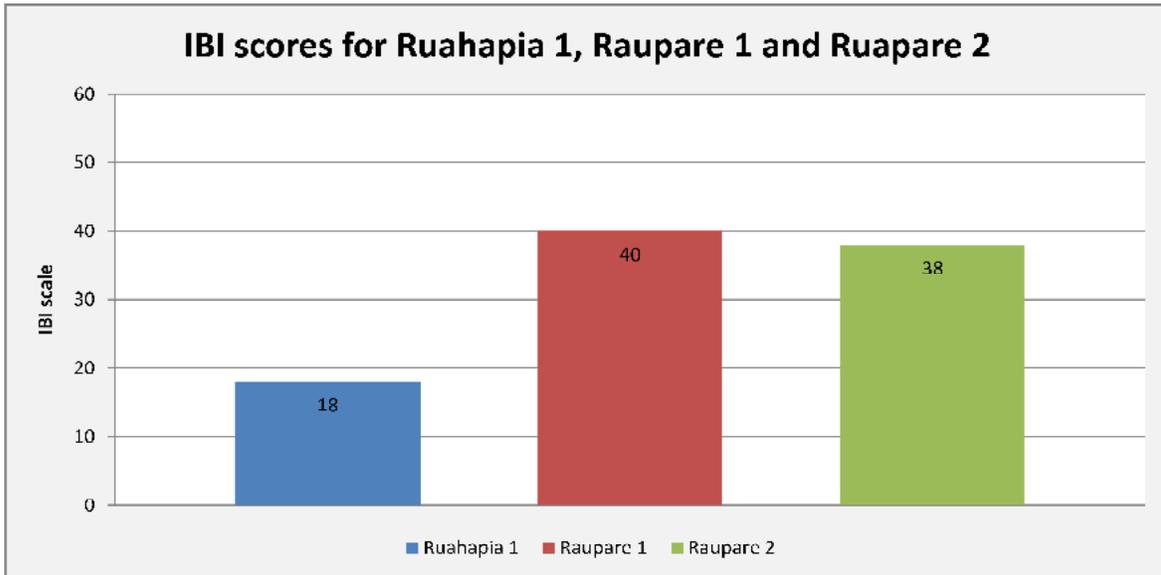
Figure 4-2 : IBI scores for the Raupare and Ruahapia Stream study reaches

Index of Biotic Integrity scores for the Ruahapia and Raupare Streams are presented in Figure 4-2 below.

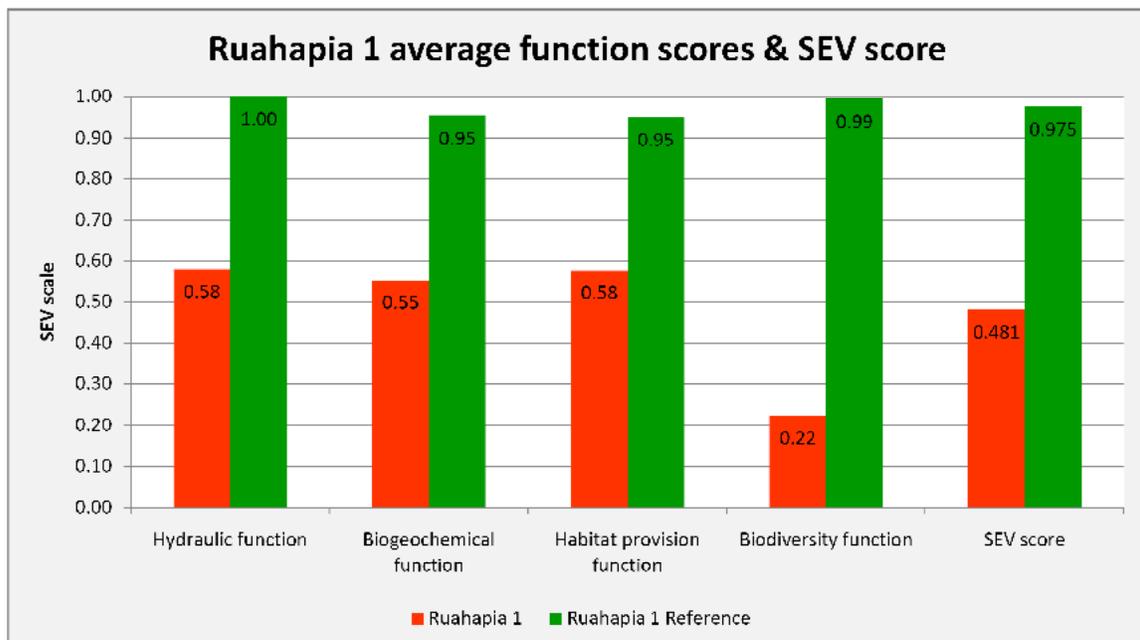
Figure 4-3 : Average function scores and overall SEV score for the Ruahapia 1 study reach

The Ruahapia 1 study reach returned moderate hydraulic, biogeochemical and habitat provision scores (0.58, 0.55 and 0.58 respectively). The overall SEV score was reduced by the poor biodiversity variable scores (biodiversity function score of 0.22). In particular the impaired fish and macroinvertebrate community structures, and highly degraded riparian condition contributed to the poor biodiversity function score.

The Ruahapia 1 study reach returned an SEV score of 0.481. This is a moderate score which suggests good potential for aquatic ecological enhancement. Three obvious key actions for enhancement of the Ruahapia Stream are (1) enhancement of the riparian zone; (2) remediation of the significant fish passage barrier at the confluence of the Ruahapia and Karamu Streams (where the Ruahapia Stream cascades from a perched and overhanging culvert); and (3) investigation into the cause(s) of the severely impaired macroinvertebrate community structure, with a focus on remedying those impacts.

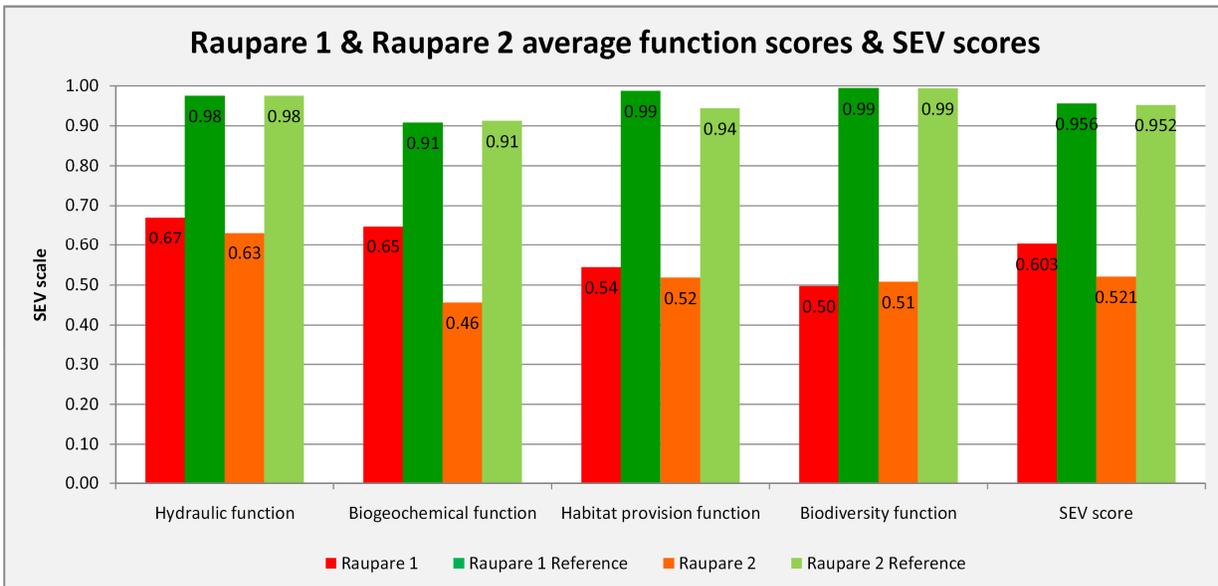
Figure 4-4 : Average function scores and overall SEV score for the Raupare 1 and 2 study reaches

The absence of significant areas of impervious surface upstream of the study reach was found to benefit the hydraulic function group score (0.63). The absence of floodplains at the Raupare 2 study reach restricted both the hydraulic and, in particular, the biogeochemical function group score 0.46.

Poor or absent habitat for native fish spawning and poor upstream shading moderated the habitat provision function score (0.52). Despite the excellent EPT variable score (1.0), the highly modified and degraded riparian conditions limited the biodiversity function score (0.51).

Two factors constraining the SEV score in the lower reaches of the Raupare Stream are poor riparian condition, contributing little to shading of organic matter inputs to the stream ecosystem, and poor riparian landforms suitable for galaxiid spawning.

The upper Raupare Stream features no floodplains, and a straightened alignment. Elevated water velocities and an impaired ability of the stream to retain organic matter inputs depressed the SEV score. As with the other sites of this study, the riparian conditions at the upper Raupare Stream are poor, which impairs a number of biogeochemical, habitat and biodiversity function variables.

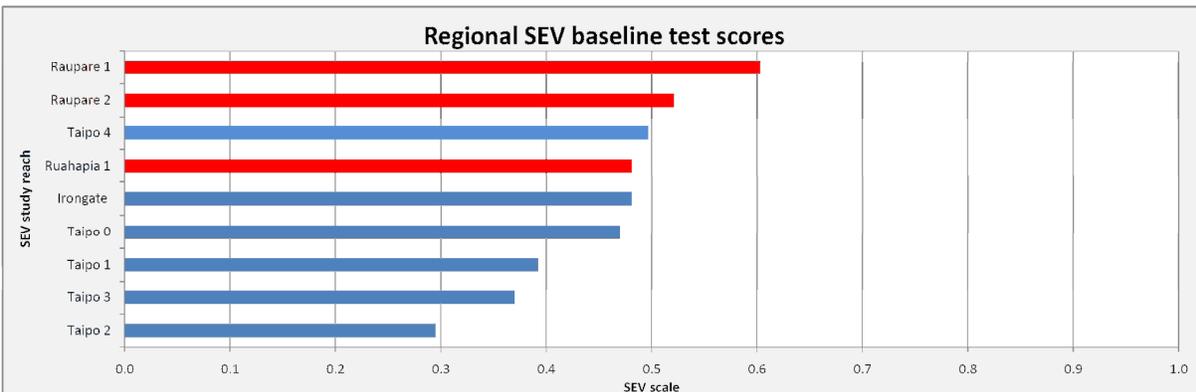
Figure 5-1 : Regional comparison of baseline SEV test scores

It should be noted that during 2009 the SEV was applied to a number of Napier's' urban waterways, and scores from those assessments ranged from 0.204 (Plantation 2) to 0.497 (OTRB1).

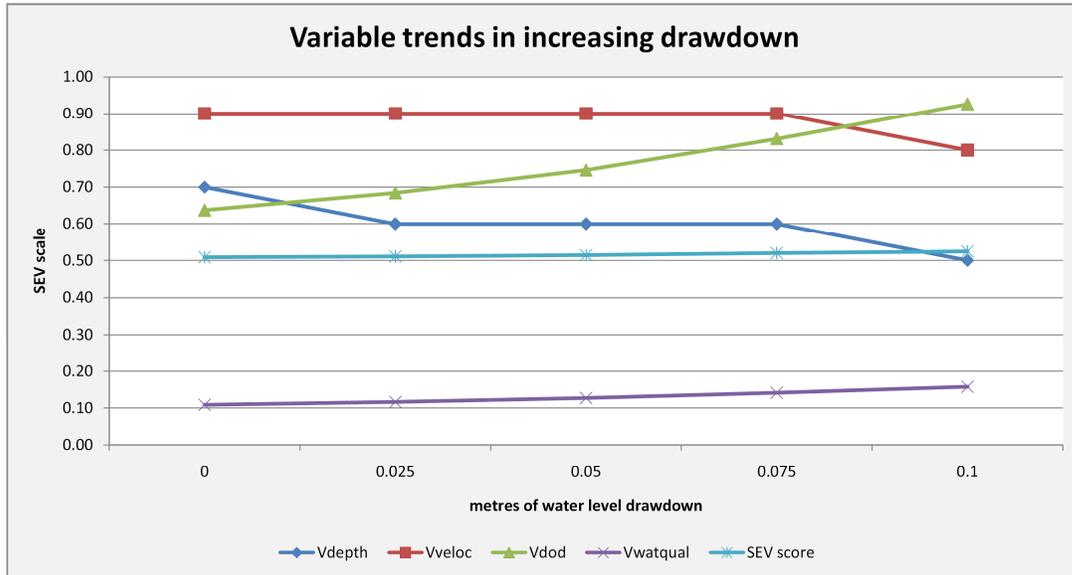
Figure 5-2 : Trends in SEV variable scores with reducing average water depth (Vdepth)

If only mean depth (i.e. Vdepth) is adjusted in the SEV calculator, incorrect results are returned. For example, when mean depth of the Ruahapia 1 study site was reduced by 0.025 metres, 0.05 metres, 0.075 metres and 0.1 metres the following trends in variable and SEV scores resulted (see Figure 5-2).

With the declining Vdepth variable score, Vdod increased. The increase in Vdod consequentially caused an increase in Vwaterqual. The aggregate of these variable changes effect a steady increase in SEV score with increasing stream flow depletion.

For the SEV to provide a prediction of the effects of stream flow depletion on ecological function, the results from a reasonably accurate velocity – depth prediction would be needed by the SEV calculator for each drawdown scenario. If that could be obtained, variables affected by stream flow depletion would be adjusted in a relative manner, and a more reasoned SEV result could be expected.

3. The SEV calculator provides broad categories for assessing changes in average depth. The winter water levels of the Raupare Stream fall within the 'deepest' category, and the Vdepth variable score remained unaffected by up to a 0.1 metre reduction in average depth. The shallower average depth of the Ruahapia Stream is more susceptible to reduction in average depth, and a reduction in Vdepth from 0.7 to 0.5 was observed.
4. For the SEV to provide a prediction of ecological function effects of stream flow depletion, the results from a reasonably accurate velocity – depth prediction would be needed by the SEV calculator for each drawdown scenario. If that could be obtained, SEV variables affected by stream flow depletion would be adjusted in a relative manner, and a more reasoned SEV result could be expected.
