Flood Resilience: Whirinaki Landscape Scoping Assessment

Hawke's Bay Regional Council (**HBRC**) are currently undertaking a number of flood resilience projects in response to recent weather events (e.g. Cyclone Gabrielle). Narrative Landscape have been engaged to provide landscape advice in relation to the proposed Whirinaki stopbank upgrade (the '**Project**').

HBRC FLOOD RESILIENCE - WHIRINAKI
Landscape Effects Scoping

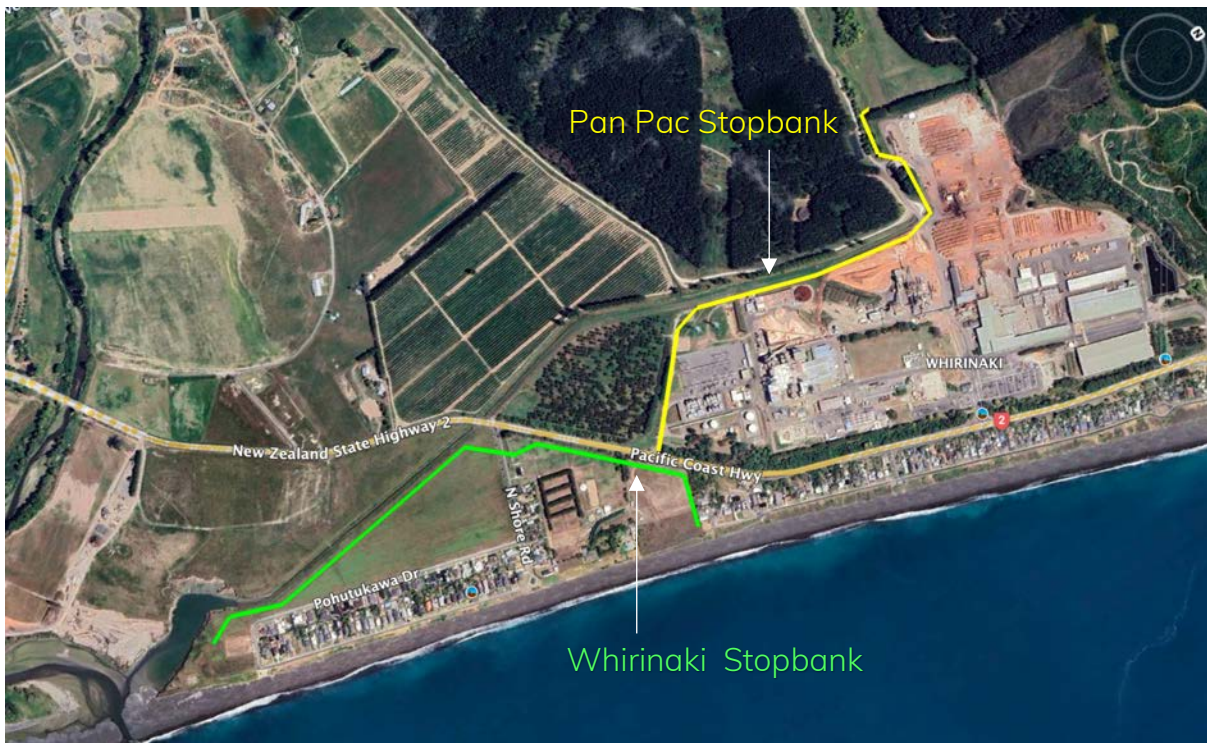
The project is described in the PDP Report² as having two portions (Figure 2). Portion 1 is 1.25km long and referred to as the Whirinaki Stopbank (a 100-year LOS) that connects from the Ararata Urupā through to SH2. Portion 2 is 1.4km long and referred to as the Pan Pac Stopbank (a 500-year LoS) which extends inland from SH2.

Figure 2: Proposed Stopbank Alignment.

The project is planning to extend an approximately 3m high stopbank along the eastern edge of the existing Whirinaki Drain. The revised alignment broadly maintains the stopbank footprint from earlier designs (east of Whirinaki Drain), with a key difference being that the raised portion of SH2 has been shifted further north.

- Stopbank / Road Raising
 - The proposal involves raising part of SH2 and North Shore Road to function as a combined road and stopbank structure.
 - The stopbank alignment has been slightly shifted in places compared to earlier options, particularly at the tie-ins near Pohutukawa Drive.
 - The stopbank crest height will be an RL of 3.5m. This results in in typical stopbank heights of 2.7m (500-year LOS) and 1.5m (100-year LOS) above existing ground.
- Scour Protection
 - Potential scour protection along parts of the Whirinaki Drain and coastal edge, using rock armouring or engineered revetment, to stabilise erosion-prone areas.
- Ancillary Works
 - Drainage culverts, scour outlets, and road tie-ins are included in the drawings.
 - There will also be temporary effects associated with stockpile locations, borrow areas, laydown area and the temporary bypass road during construction.

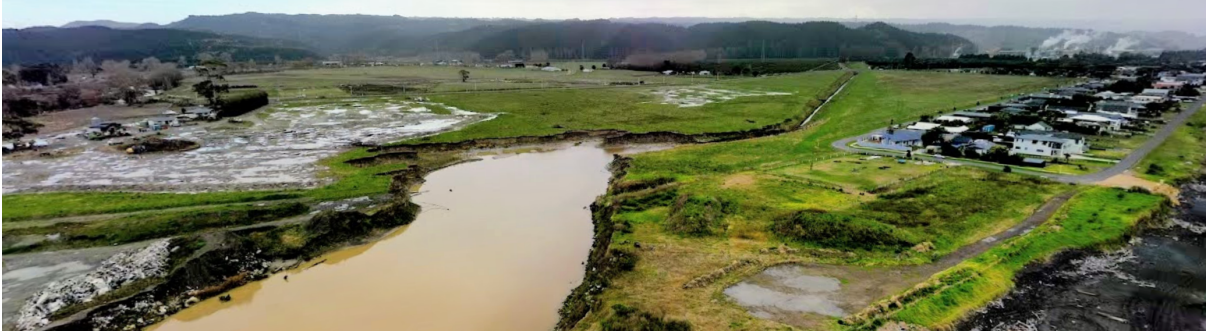
Figure 3: Aerial view of the southern end of the project area.

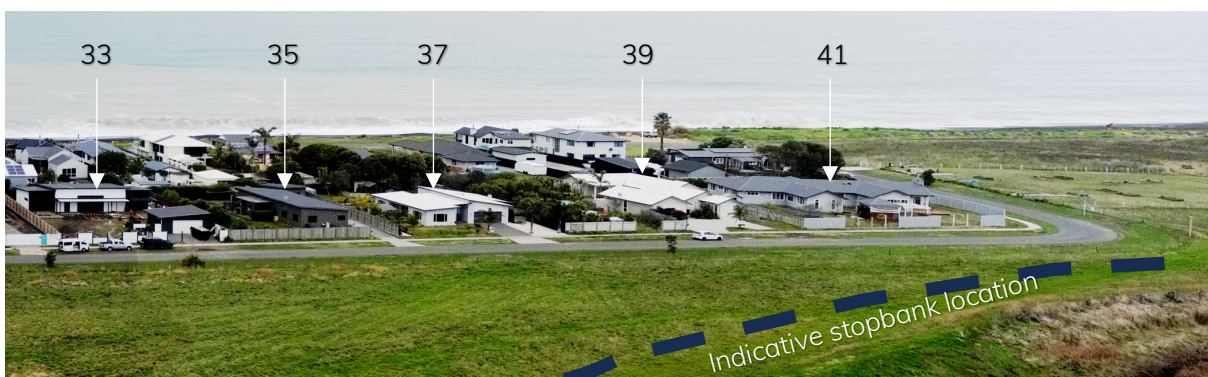
Those Pohutukawa Dr properties nearest the proposed stopbank (e.g. 33, 35, 37, 39 & 41 Pohutukawa Dr), have a slightly higher degree of visual effect due to the proximity, however upon review (Figure 4), it is observed that these properties are not orientated to take advantage of views to the west (e.g. toward the stopbank). Instead, the garaging and fencing⁴ reduce visibility toward the stopbank.

Figure 4: Pohutukawa Dr dwellings nearest the southern extent of the proposed stopbank

It is considered that the adverse visual effect on these 5 dwellings Pohutukawa Dr dwellings (33, 35, 37, 39 & 41) will be **Low** when views are obtained from their dwellings. The remaining properties along Pohutukawa Dr will experience no more than a **Very-Low** adverse effect.

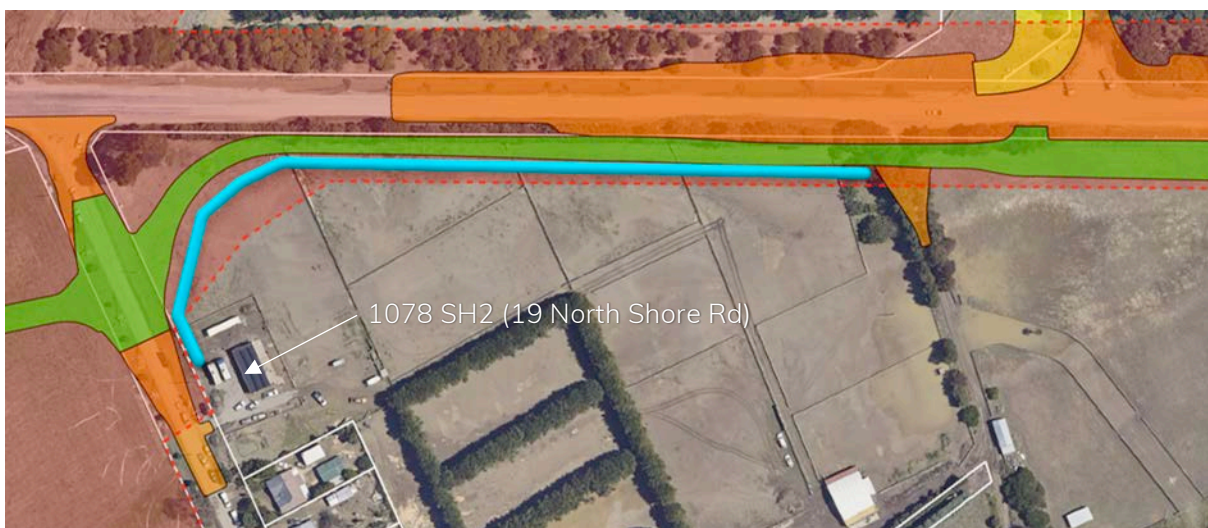
The proposed stopbank will be crossed by a newly raised North Shore Road carriageway directly in front of this dwelling (Attachment 1: Viewpoint H). As a result, 1078 SH2 (19 North Shore Rd) is likely to have a notable reduction in visual amenity from their dwelling due to having a direct line of sight to this elevated section of road. Additionally, it is understood that the existing roadside vegetation and earth bund providing a buffer to SH2 is required to be removed to accommodate the proposed roading/stopbank upgrades.

Figure 5: Potential mitigation planting for property at 1078 SH2 indicated by blue line

It is acknowledged that the dwelling is generally orientated to take advantage of an open view north across their landholding, and that the storage shed (shipping container) provides a degree of buffering from the SH2. However, it is considered that this single property may potentially have an adverse visual effect that is **High** (significant), and that mitigation options should be explored in consultation with the landowner to address the SH2/North Shore Rd interface (general location of landscape treatment indicated by blue line on Figure 5 below).

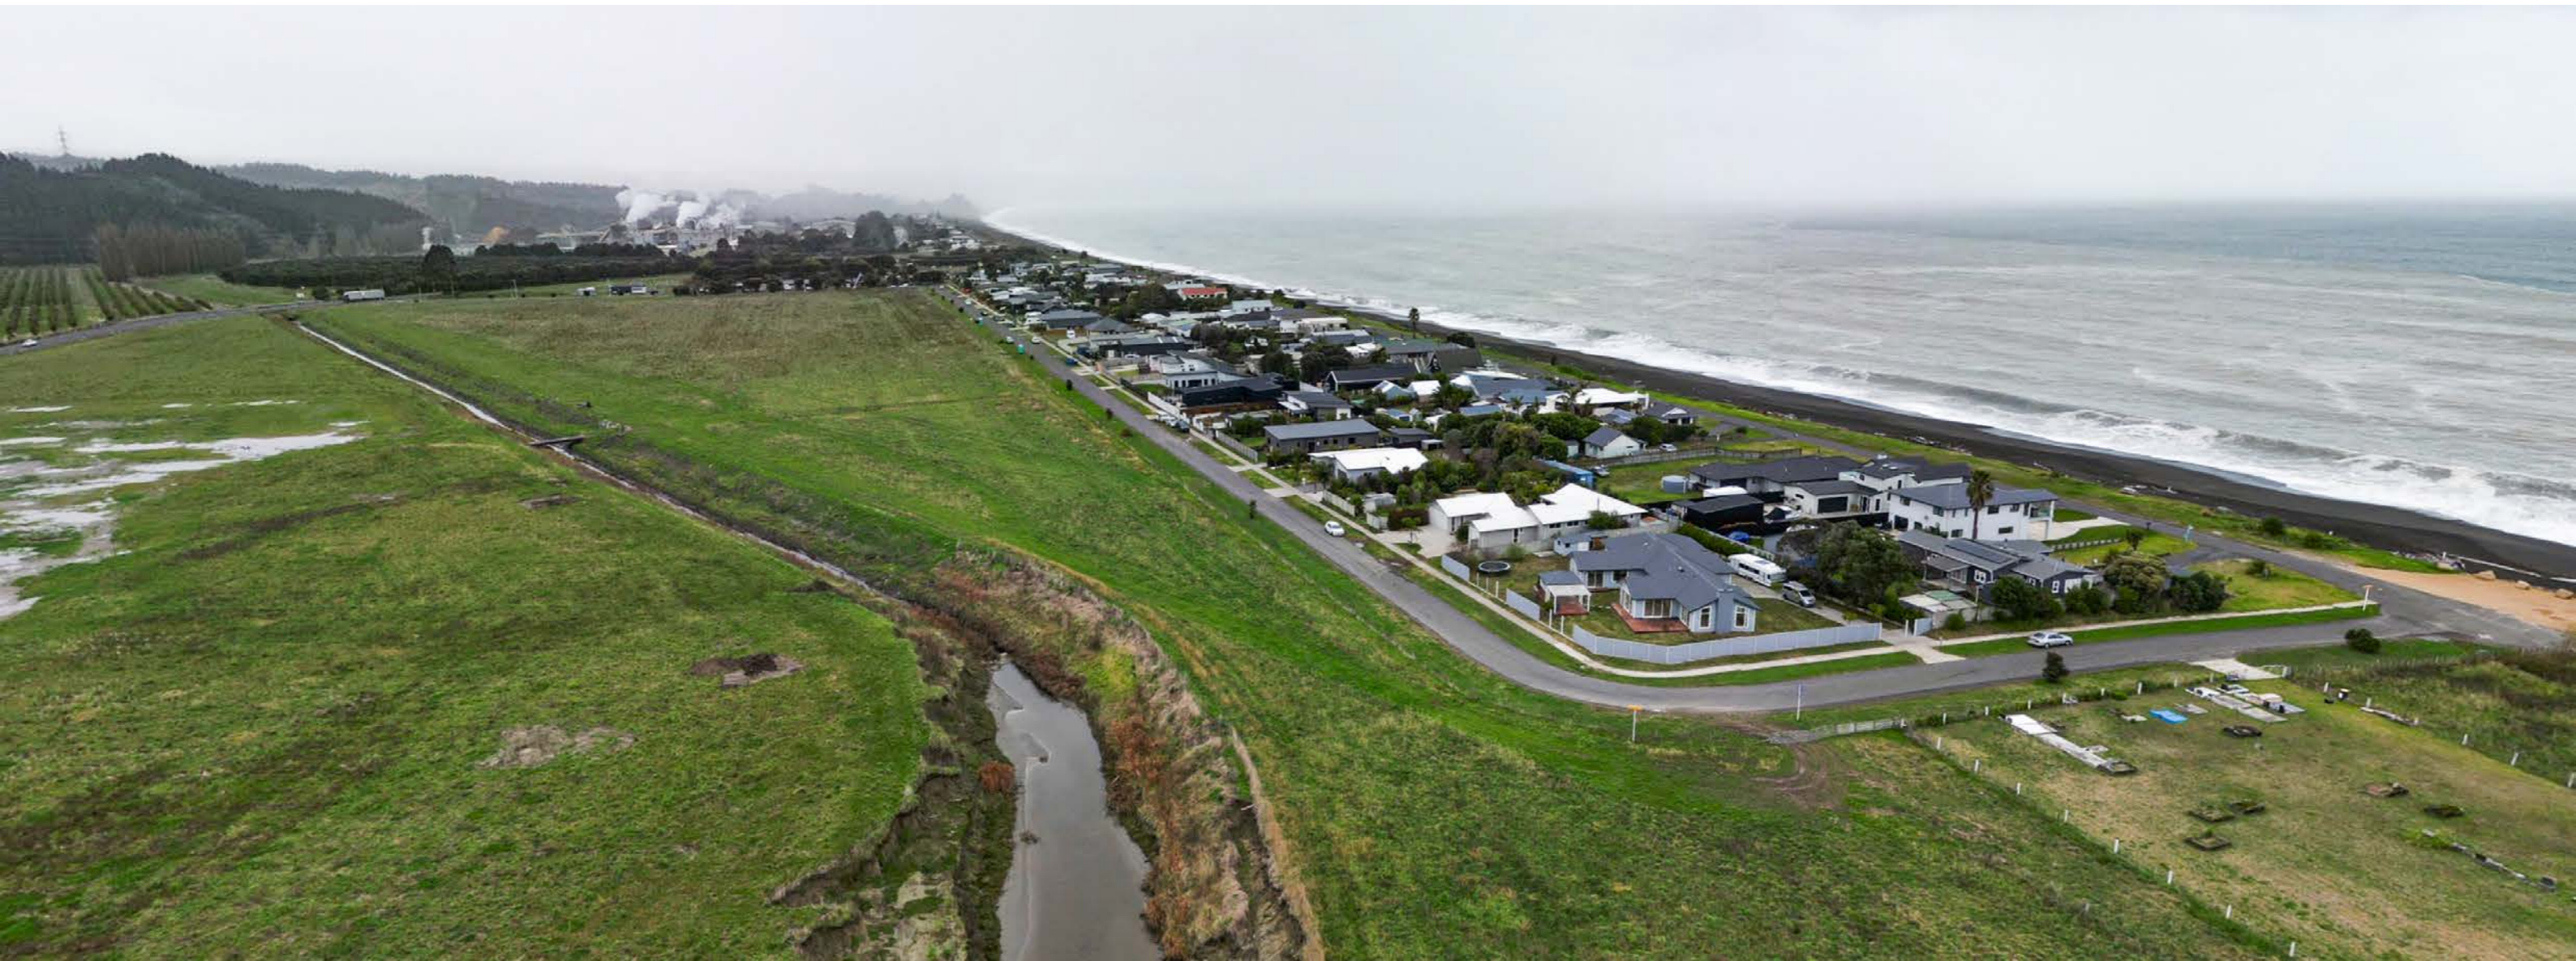
**Context Map
SHEET 01**

- Whirinaki Stopbank (Portion 1)
- Pan Pac Stopbank (Portion 2)
- Areas of Raised Road
- OiC Boundary

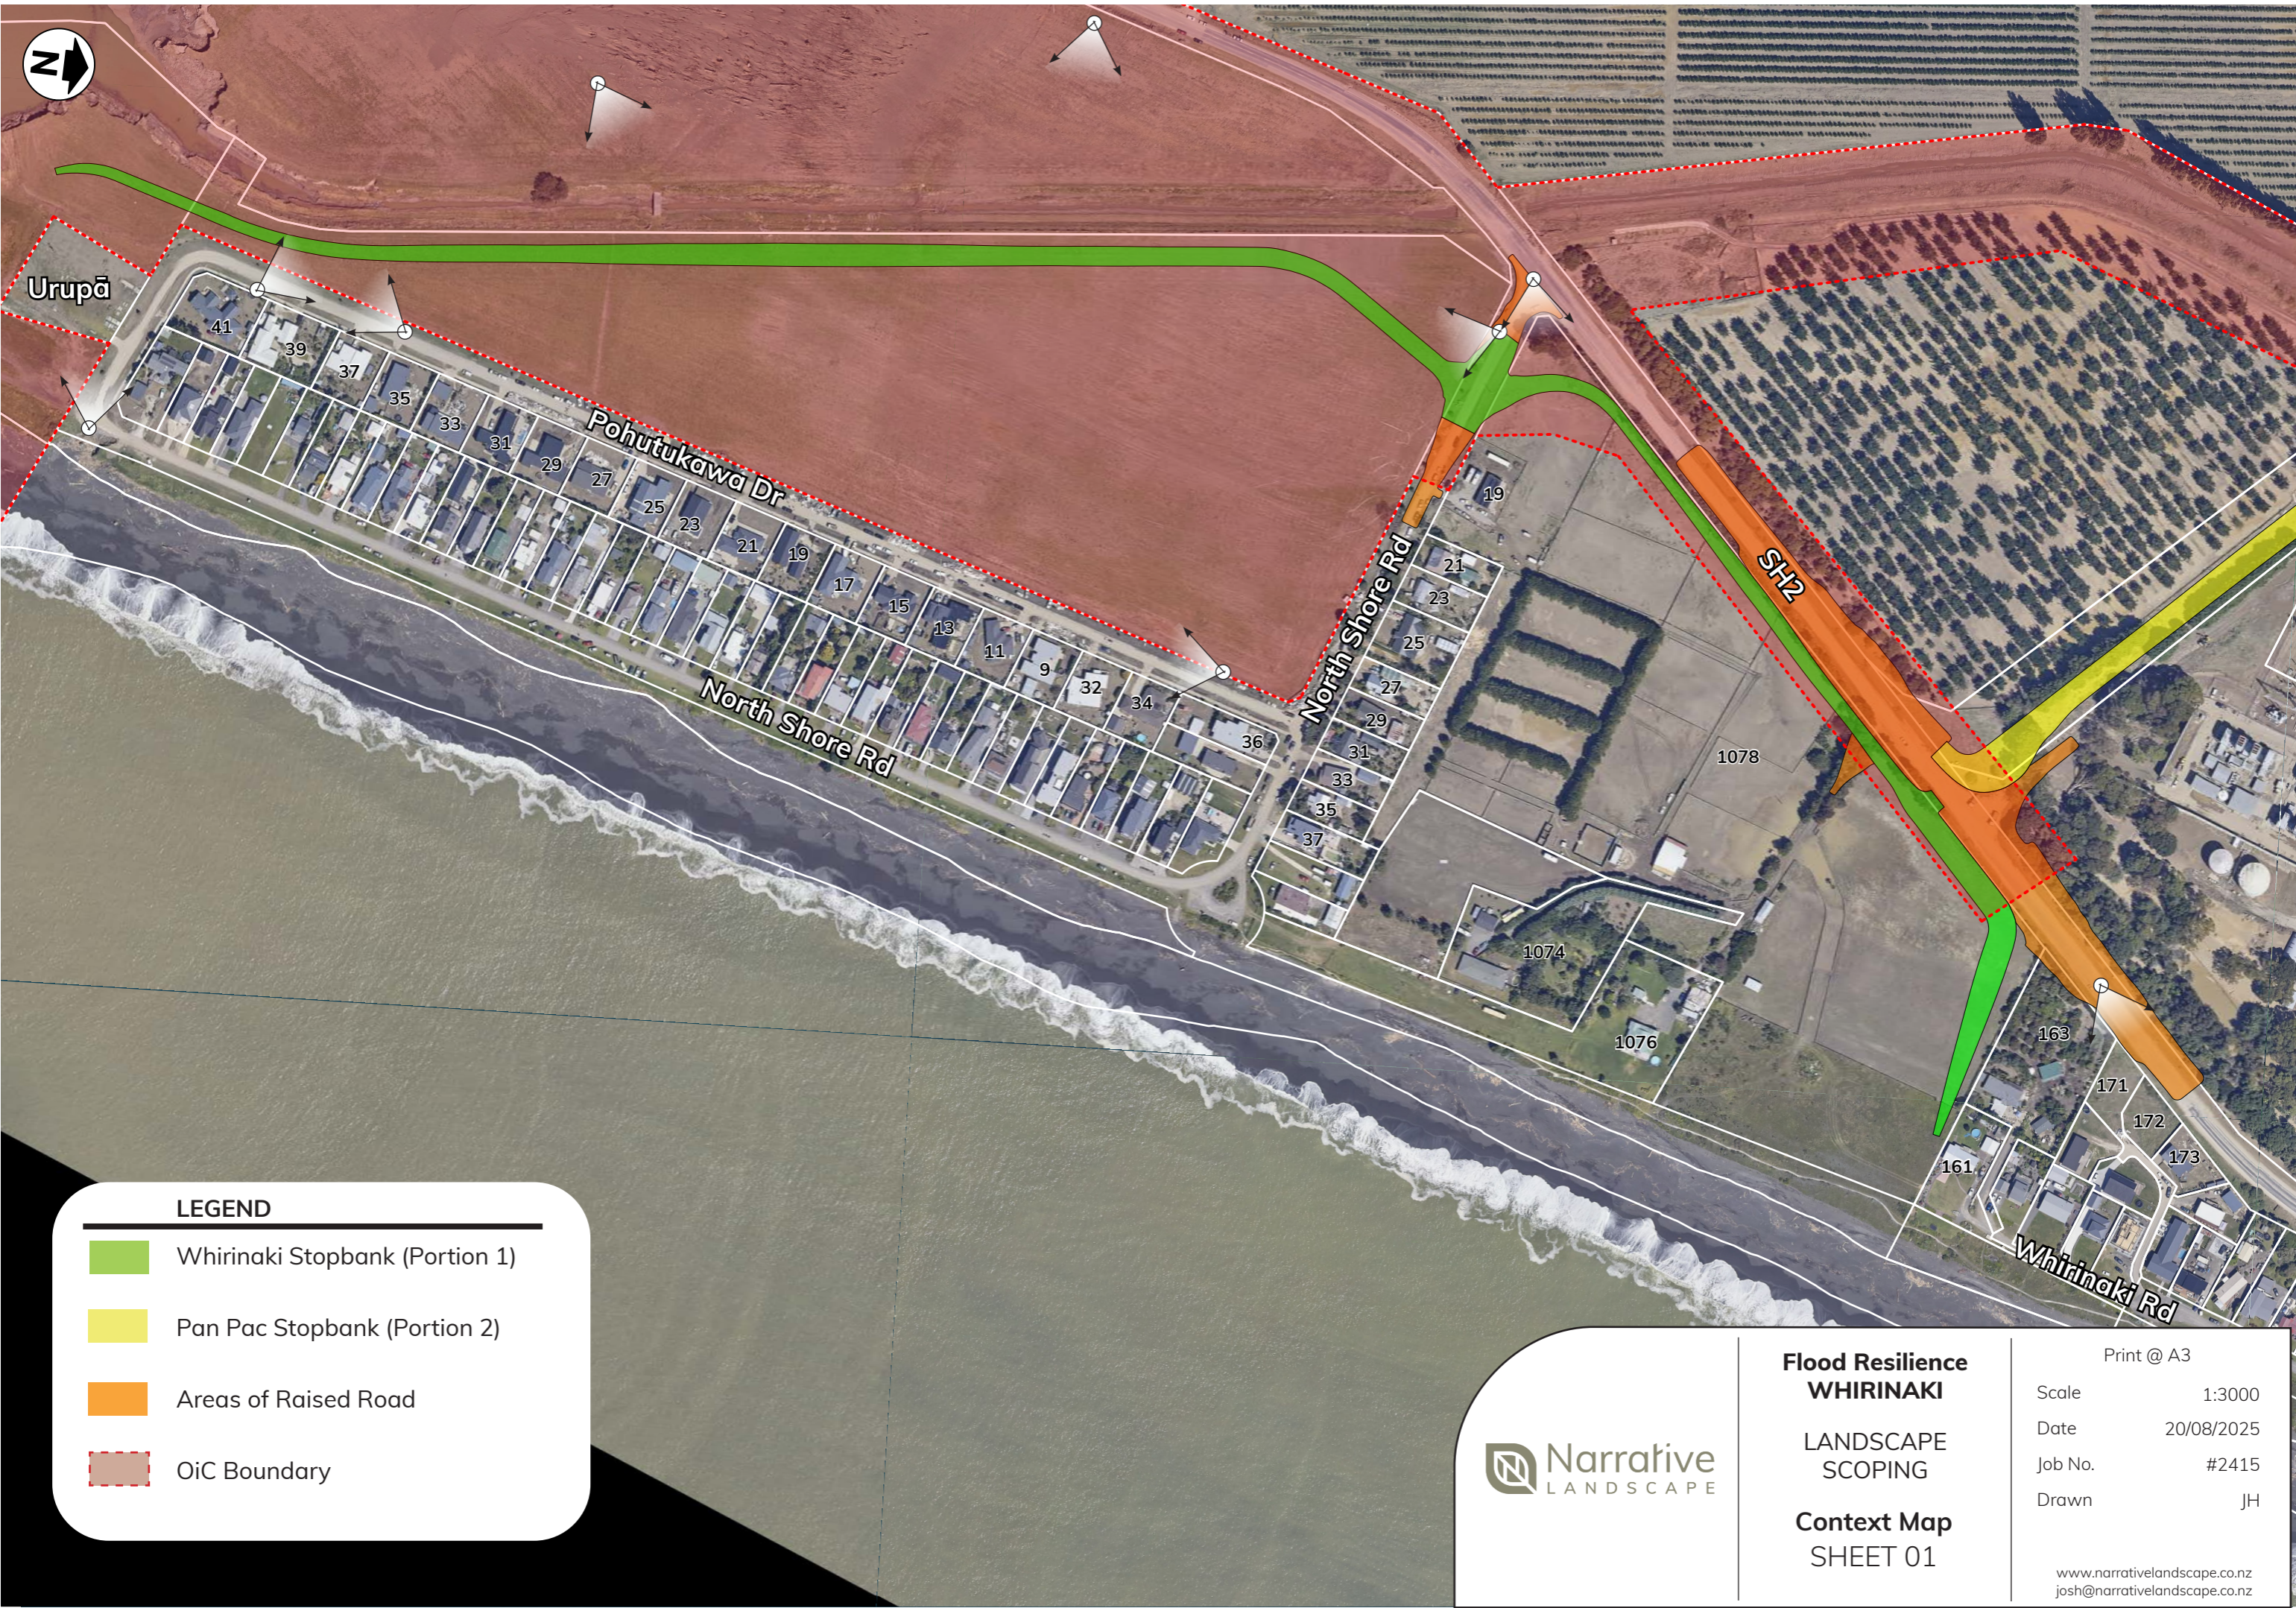
**HDC Planning Map
SHEET 02**

I am advised that stopbanks are a permitted activity under the Hastings District Plan, provided that they are located within the River Hazard overlay, which is displayed by the blue wave symbol overlay on HDC planning maps (Attachment 1: Sheet 02). The Pan Pac portion of stopbank (west of SH2) is outside of this hazard overlay, while approximately half of the Whirinaki stopbank is located within this overlay (the section south of North Shore Rd). Additionally, the work required to lift the road height is primarily addressed through the NZTA designation.

The Hawke’s Bay Regional Coastal Environment Plan identifies the extent of the ‘Coastal Environment’ in this area as the properties accessed along North Shore Rd and Whirinaki Rd (blue dotted line on Attachment 1: Sheet 02). The project is primarily situated outside of the mapped coastal environment. However, the southernmost section of the proposed stopbank (near the Ararata Urupā) is situated within the mapped coastal environment.

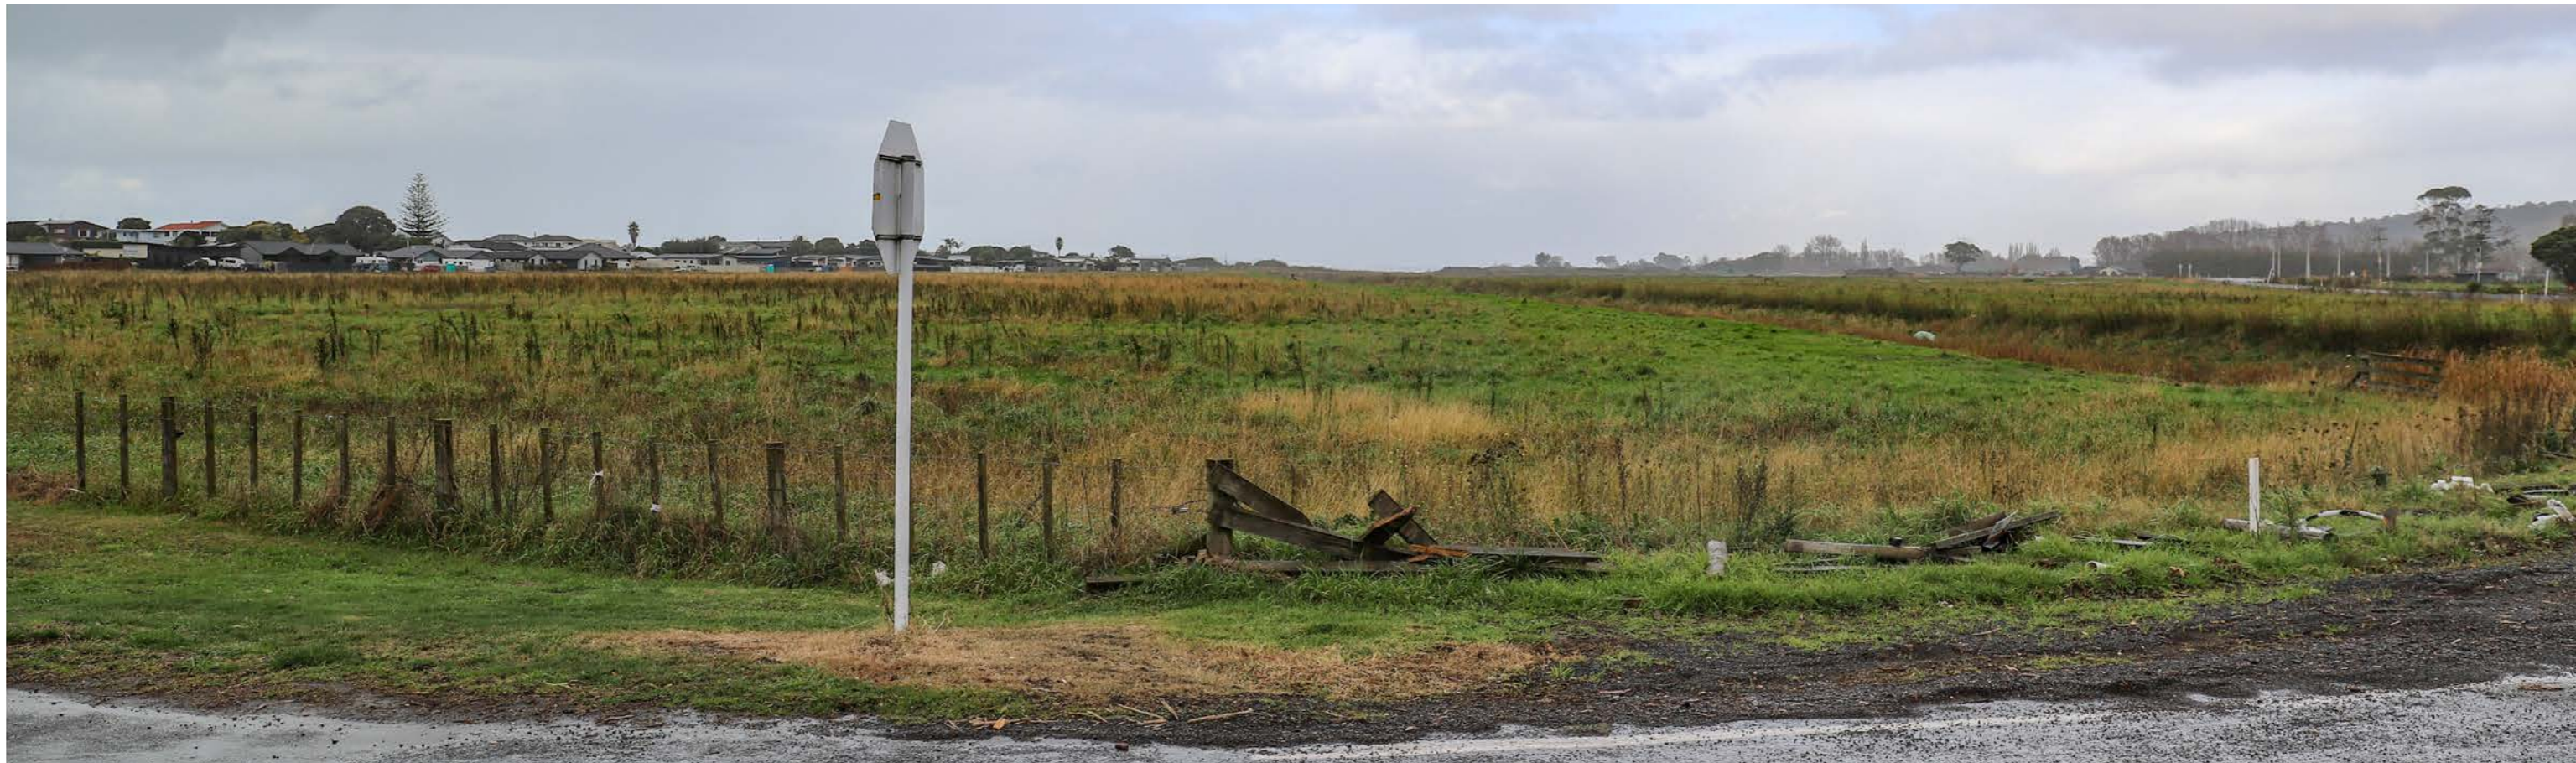
VIEWPOINT A - PHOTO DETAILS

Date: 19/06/2024
 Time: 10:32am
 Latitude: 39° 23' 12.378" S
 Longitude: 176° 53' 5.934" E
 Camera/Lens: Canon 6D mkii/24mm
 Field of View: 40°

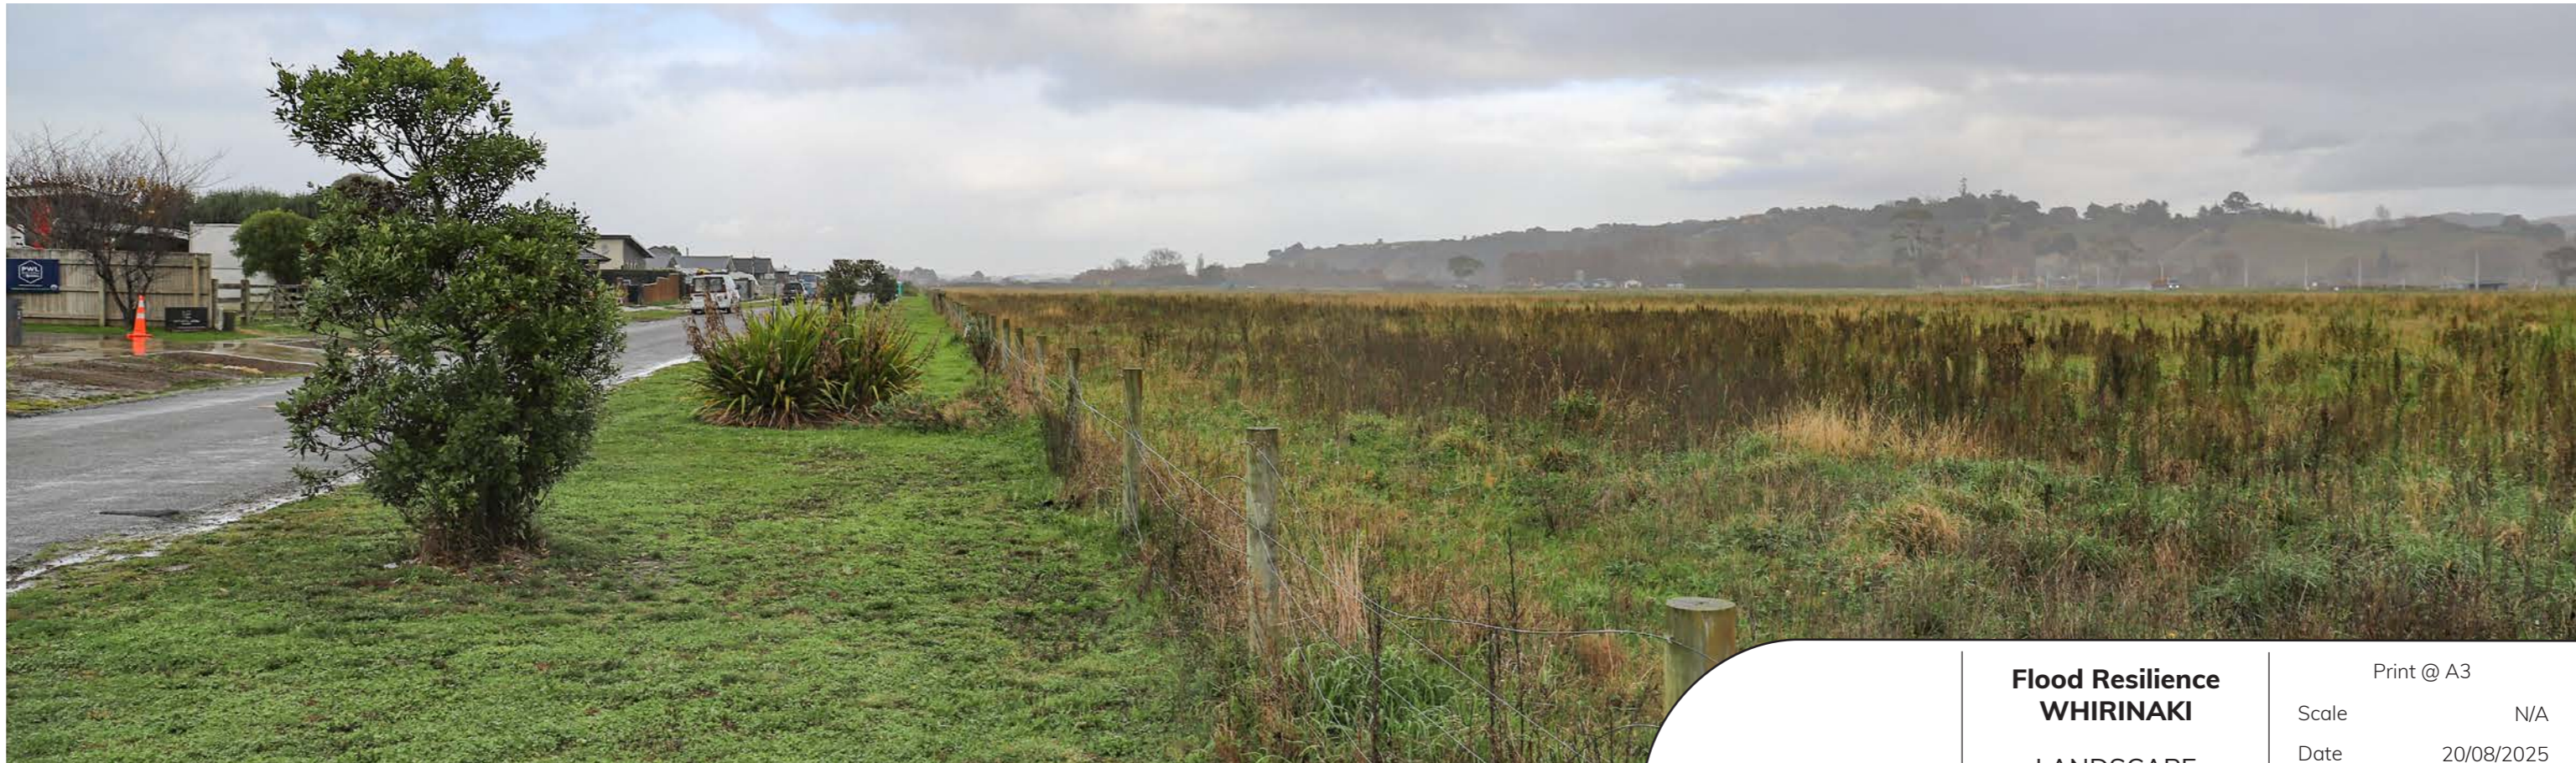
VIEWPOINT B - PHOTO DETAILS

Date: 19/06/2024
 Time: 10:28am
 Latitude: 39° 23' 16.566" S
 Longitude: 176° 53' 15.462" E
 Camera/Lens: Canon 6D mkii/24mm
 Field of View: 40°

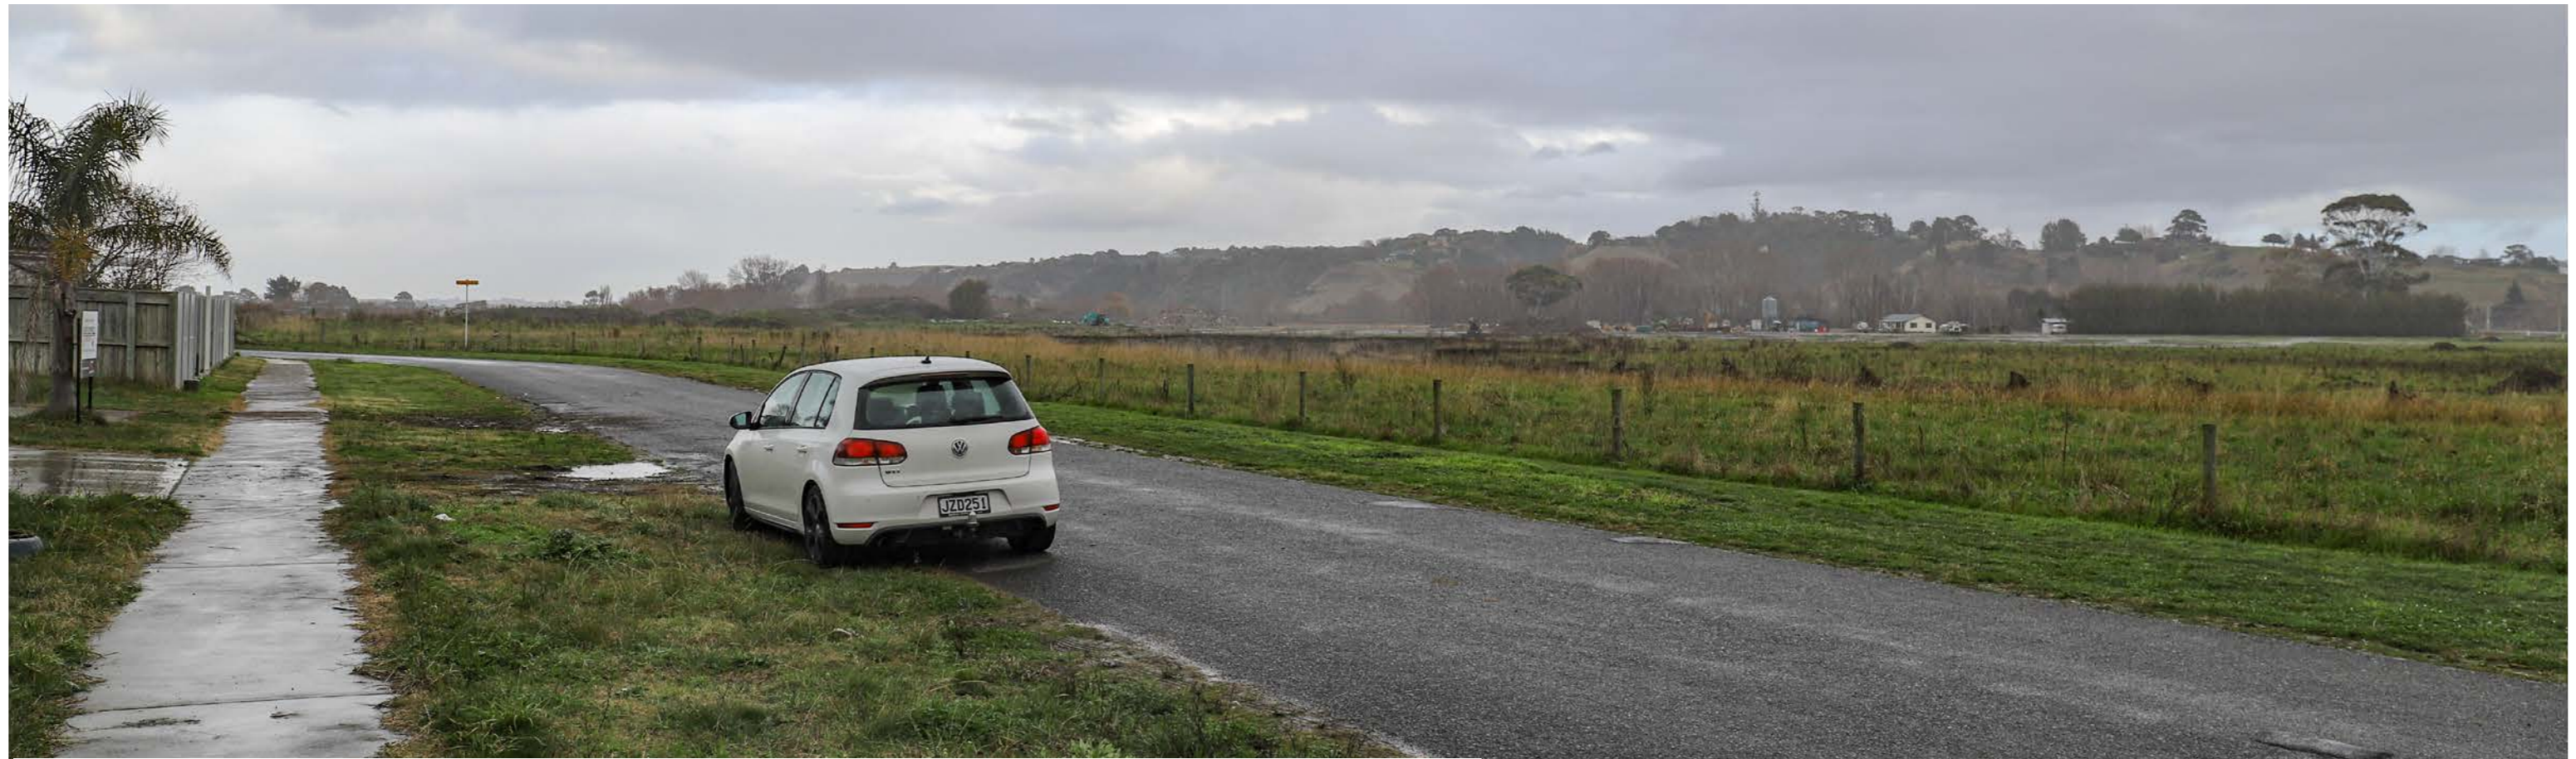
VIEWPOINT C- PHOTO DETAILS

Date: 19/06/2024
Time: 10:23am

Latitude: 39° 23' 32.7" S
Longitude: 176° 53' 9.438" E

Camera/Lens: Canon 6D mkii/24mm
Field of View: 40°

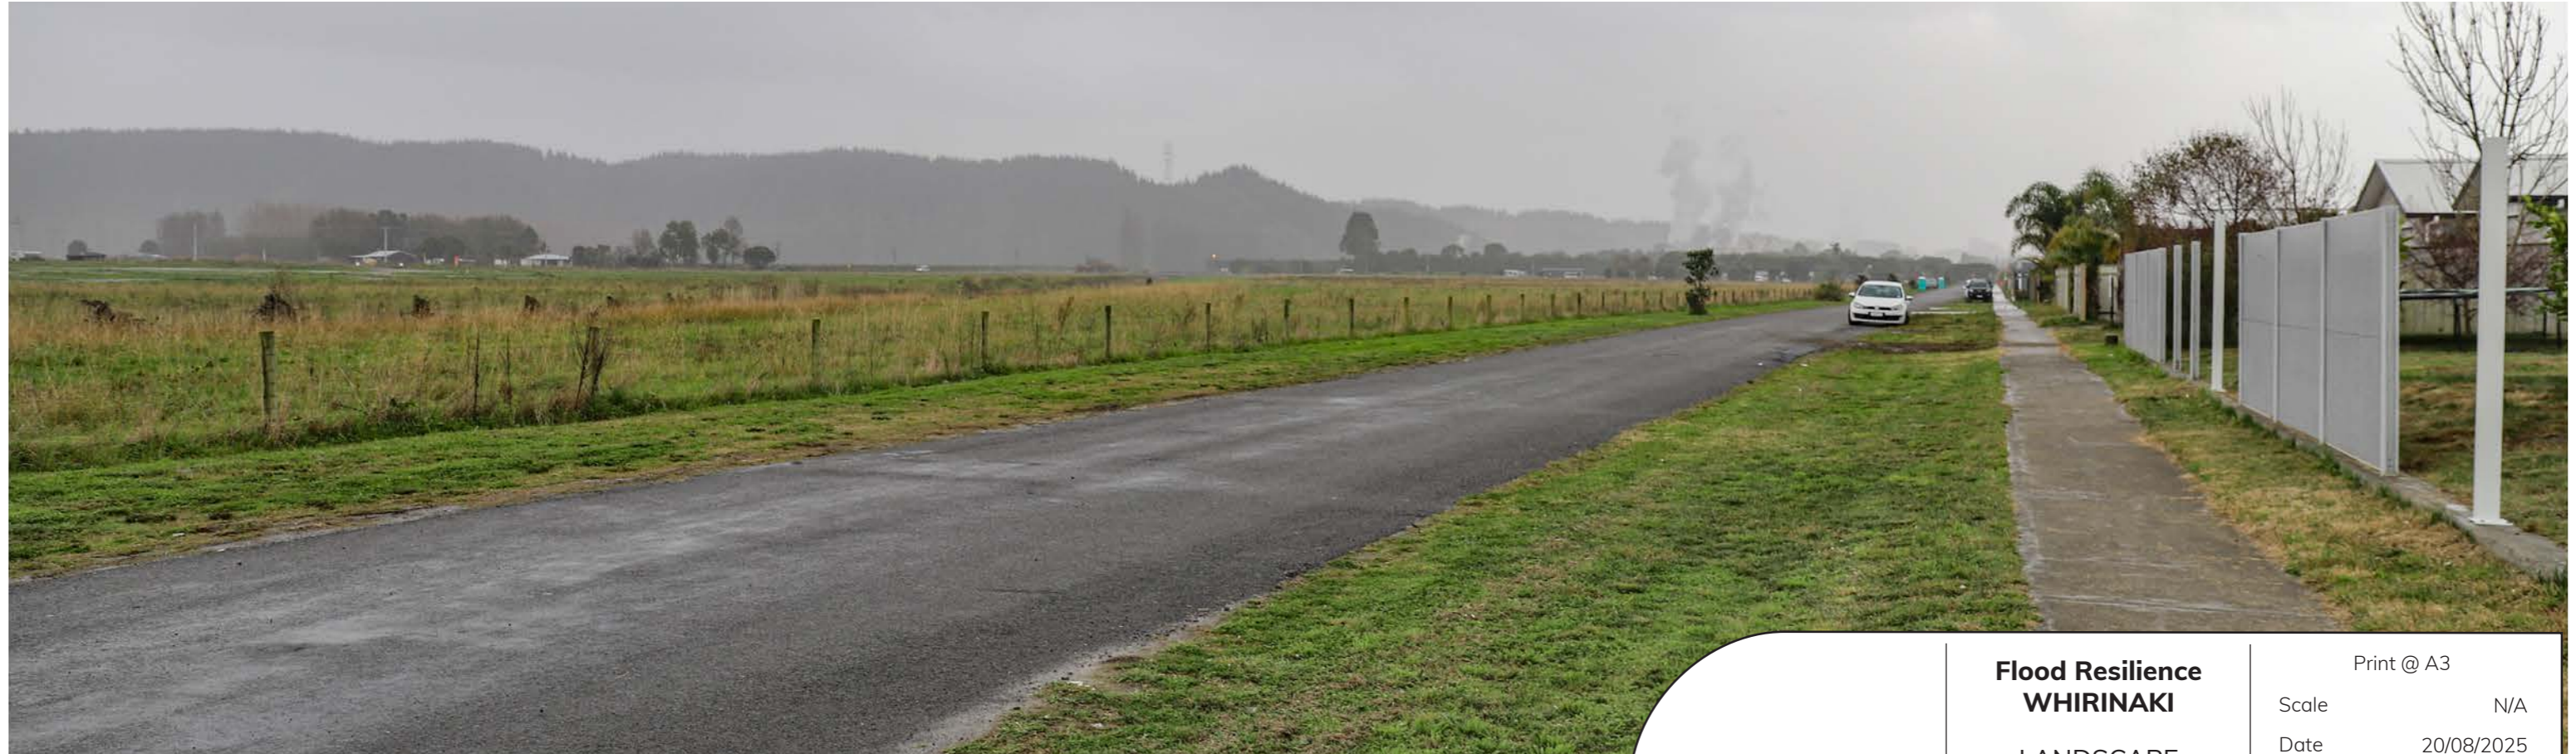
VIEWPOINT D - PHOTO DETAILS

Date: 19/06/2024
Time: 10:22am

Latitude: 39°23'34.96"S
Longitude: 176°53'8.65"E

Camera/Lens: Canon 6D mkii/24mm
Field of View: 40°

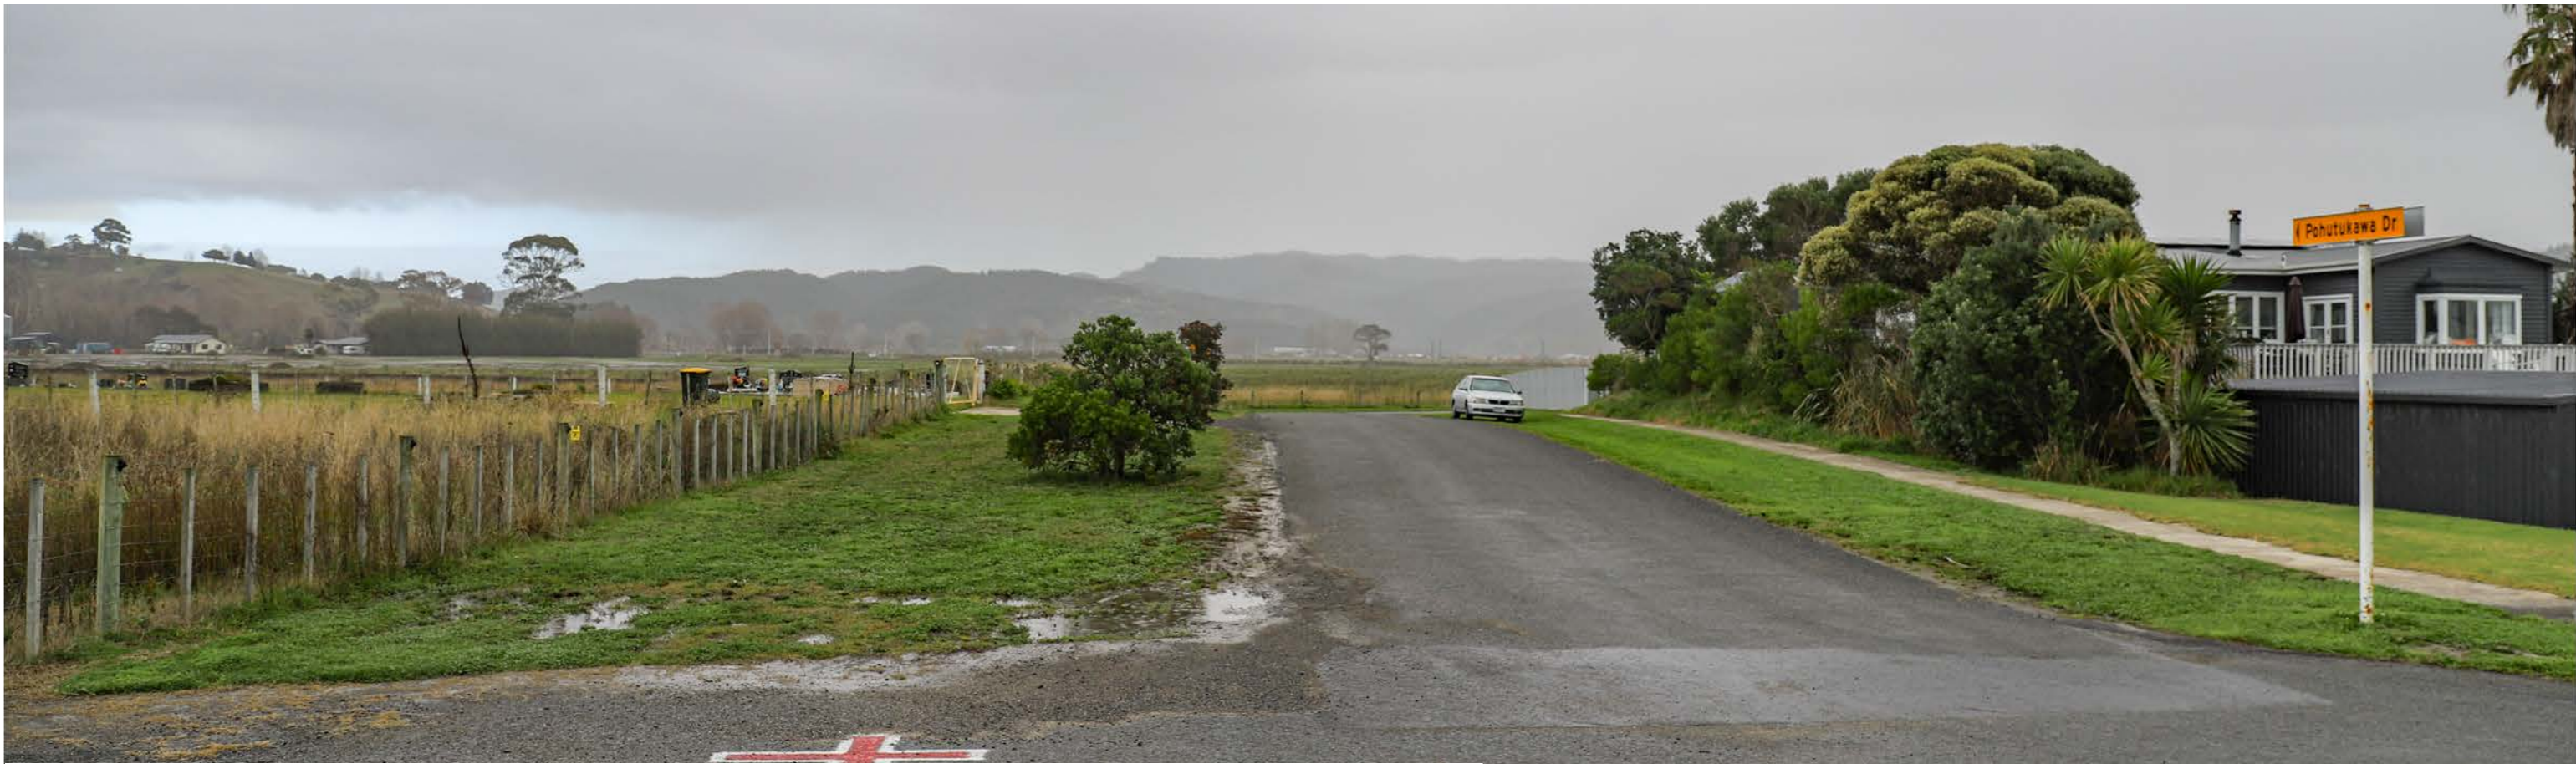
VIEWPOINT E - PHOTO DETAILS

Date: 19/06/2024
Time: 10:20am

Latitude: 39°23'36.83"S
Longitude: 176°53'12.30"E

Camera/Lens: Canon 6D mkii/24mm
Field of View: 40°

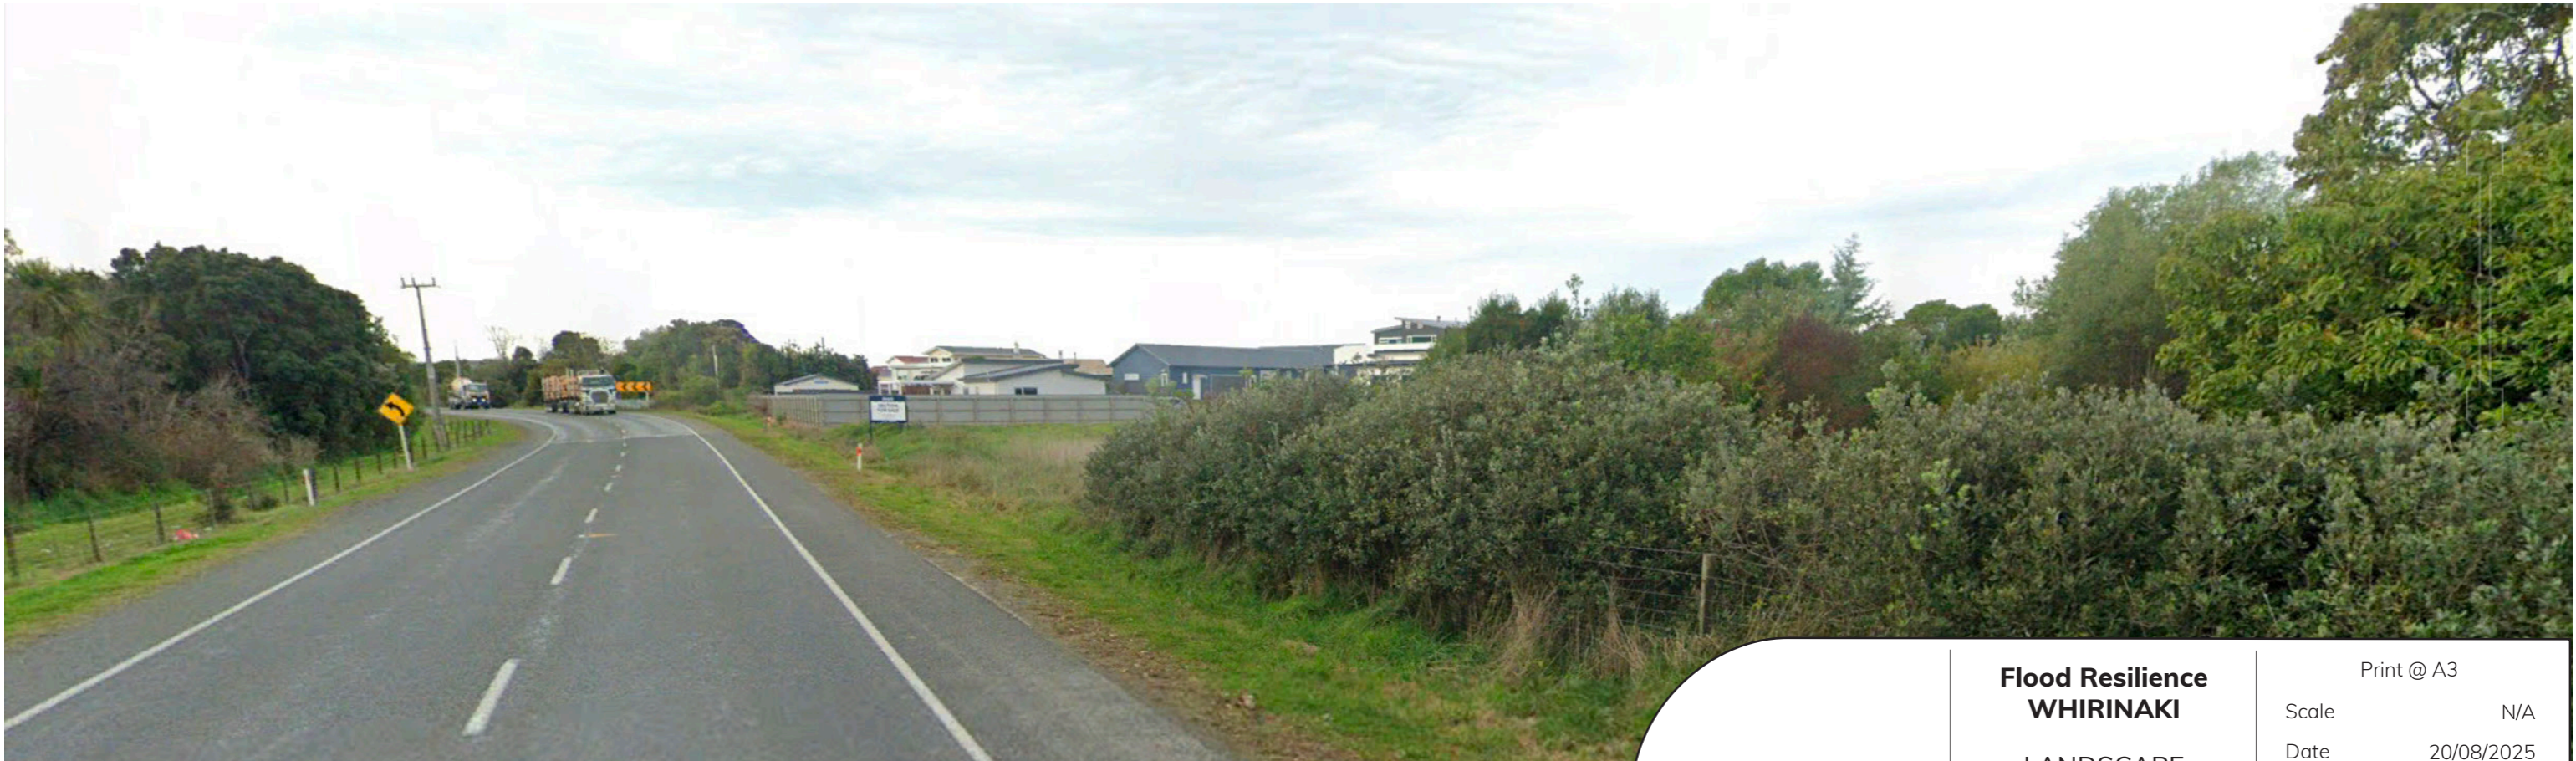
VIEWPOINT F - PHOTO DETAILS

Date: 09/2024

Latitude: 39°23'1.22"S
Longitude: 176°53'20.33"E
