Flood Resilience: Whirinaki Landscape Scoping Assessment

Hawke's Bay Regional Council (**HBRC**) are currently undertaking a number of flood resilience projects in response to recent weather events (e.g. Cyclone Gabrielle). Narrative Landscape have been engaged to provide landscape advice in relation to the proposed Whirinaki stopbank upgrade (the '**Project**').

HBRC FLOOD RESILIENCE - WHIRINAKI
Landscape Effects Scoping

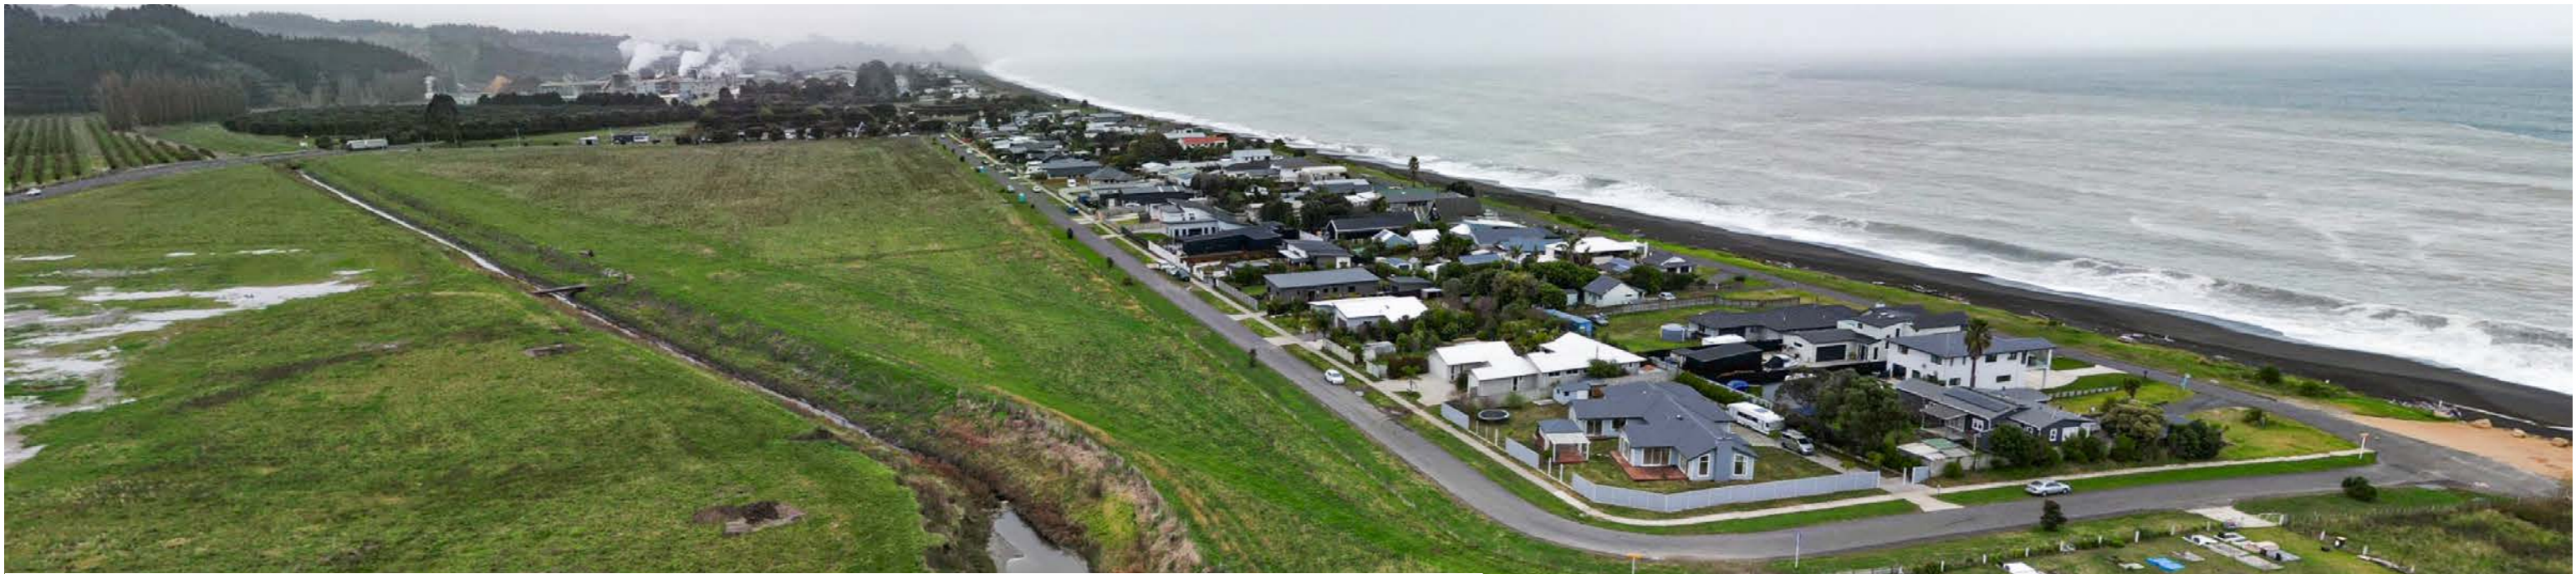
VIEWPOINT G - PHOTO DETAILS

Date: 19/06/2024
 Time: 9:46am
 Latitude: 39° 23' 37.608" S
 Longitude: 176° 53' 4.386" E
 Camera/Lens: DJI Mini3 Pro/24mm
 Field of View: 40°

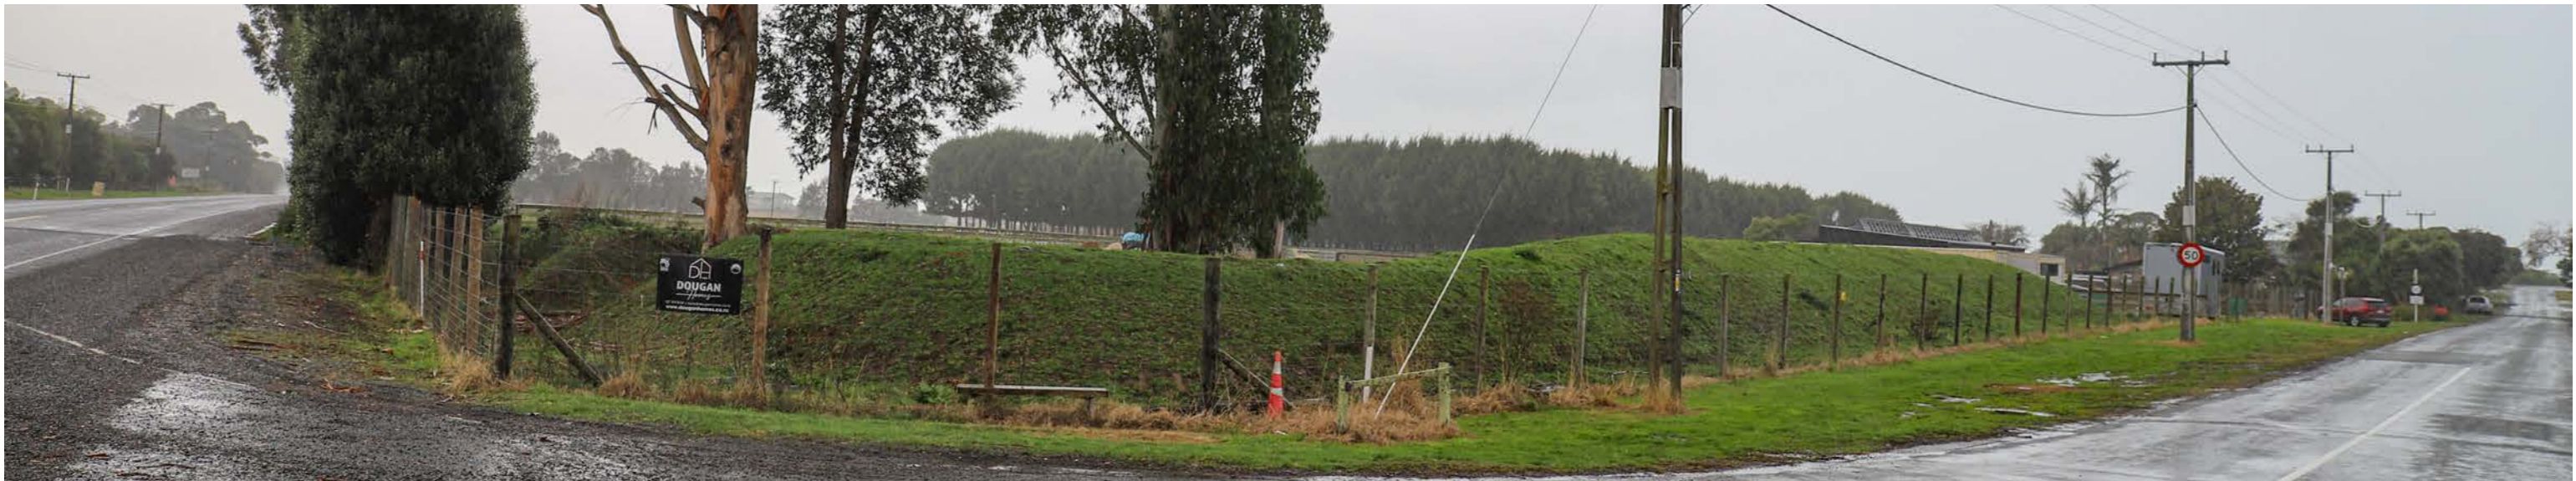
VIEWPOINT H - PHOTO DETAILS

The proposed stopbank will be crossed by a newly raised North Shore Road carriageway directly in front of this dwelling (Attachment 1: Viewpoint H). As a result, 1078 SH2 (19 North Shore Rd) is likely to have a notable reduction in visual amenity from their dwelling due to having a direct line of sight to this elevated section of road. Additionally, it is understood that the existing roadside vegetation and earth bund providing a buffer to SH2 is required to be removed to accommodate the proposed roading/stopbank upgrades.

It is acknowledged that the dwelling is generally orientated to take advantage of an open view north across their landholding, and that the storage shed (shipping container) provides a degree of buffering from the SH2. However, it is considered that this single property may potentially have an adverse visual effect that is **High** (significant), and that mitigation options should be explored in consultation with the landowner to address the SH2/North Shore Rd interface (general location of landscape treatment indicated by blue line on Figure 5 below).

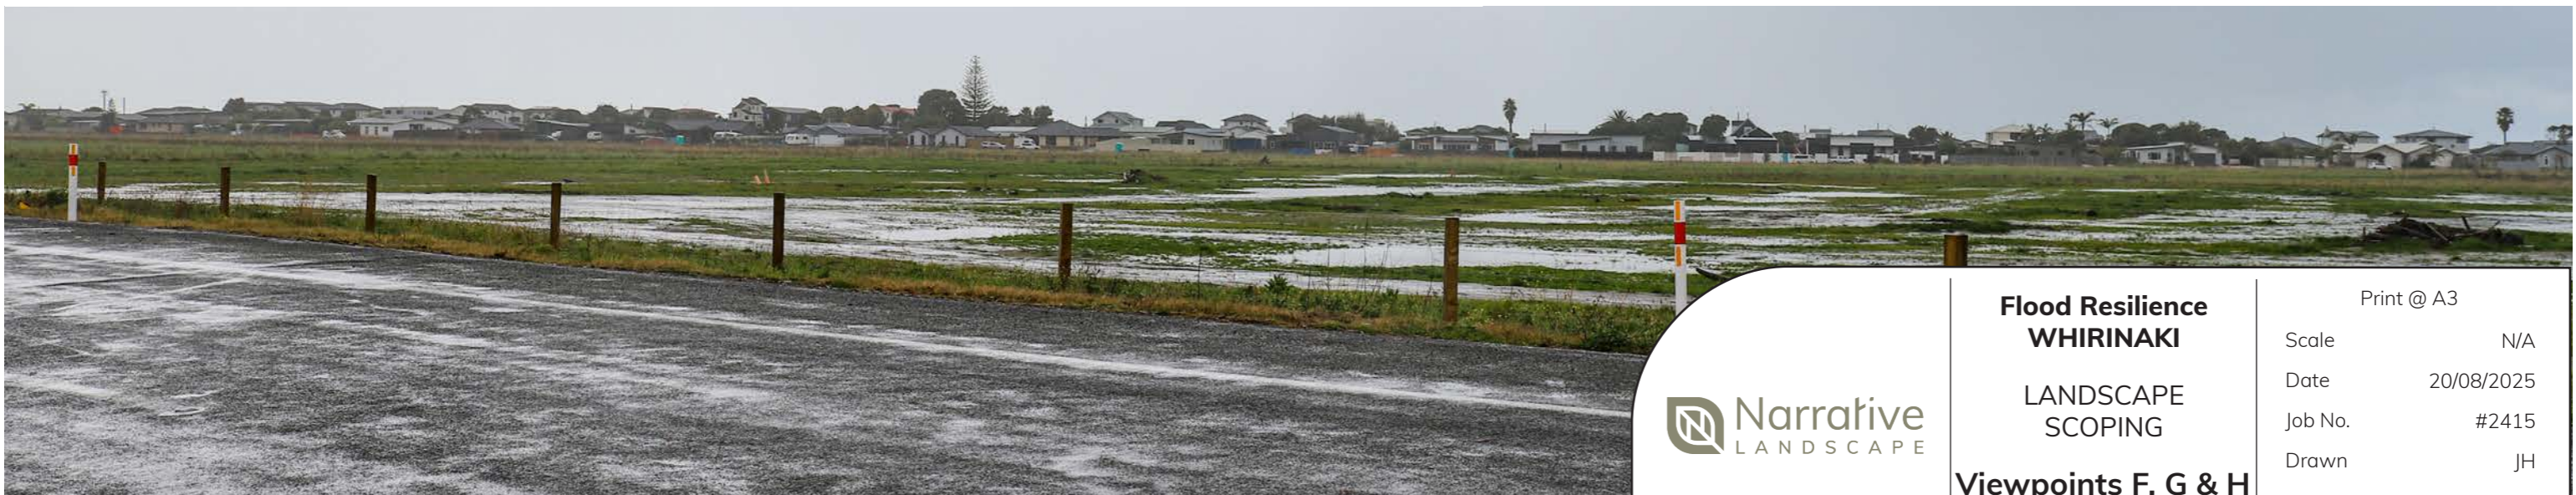
VIEWPOINT I - PHOTO DETAILS

Date: 19/06/2024
 Time: 10:34am
 Latitude: 39° 23' 25.122" S
 Longitude: 176° 52' 55.488" E
 Camera/Lens: Canon 6D mkii/24mm
 Field of View: 40°
