Lovett, A. and Cameron, S. 2013. Installation of rainfall recharge recording sites: Bridge Pa, Maraekakaho and Fernhill, Heretaunga Plains, Hawke's Bay, *GNS Science Consultancy Report CR 2013/05* 51p.

This report details the installation of three rainfall recharge lysimeters and instrument enclosures at the Bridge Pa, Maraekakaho and Fernhill sites. This network will provide rainfall recharge information useful for groundwater management in the Hawke's Bay region. In conjunction with installations in Canterbury and Bay of Plenty, the Hawkes Bay sites form a network currently consisting of ten rainfall recharge monitoring sites across New Zealand.

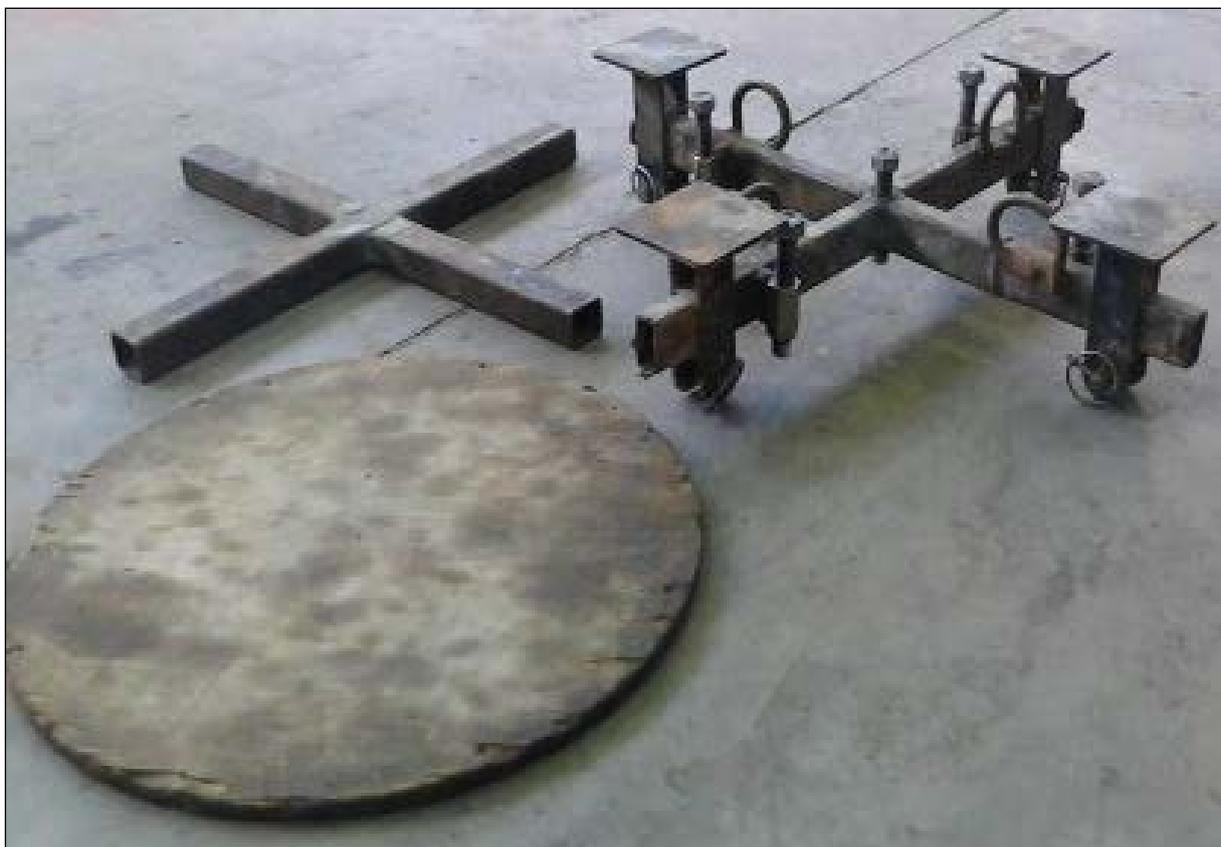
Figure 2: Head works and wooden plate.

GNS Science, Bay of Plenty Regional Council and HBRC jointly funded and purchased equipment required for installation of rainfall recharge lysimeters (Figures 2 – 6). HBRC contracted Lincoln Ventures Limited (LVL) to fabricate the lysimeters. GNS Science were contracted to oversee the field installation using materials and methods that were consistent with previous installations (Reeves *et al.*, 2005; Cameron *et al.*, 1992). This report was prepared for HBRC following project completion and details the installation of the three lysimeters and instrument enclosures at the three sites. HBRC have the responsibility of installing the remaining instrumentation required, including rain gauges and the telemetry system, to complete the monitoring sites.

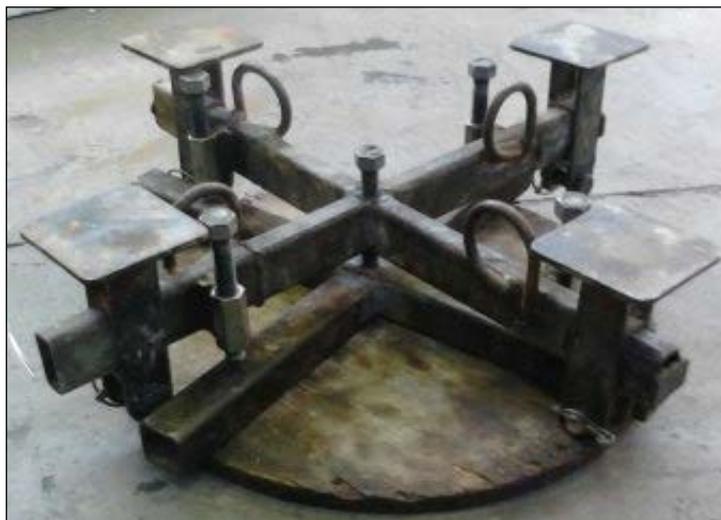
Figure 3: Head works assembled.

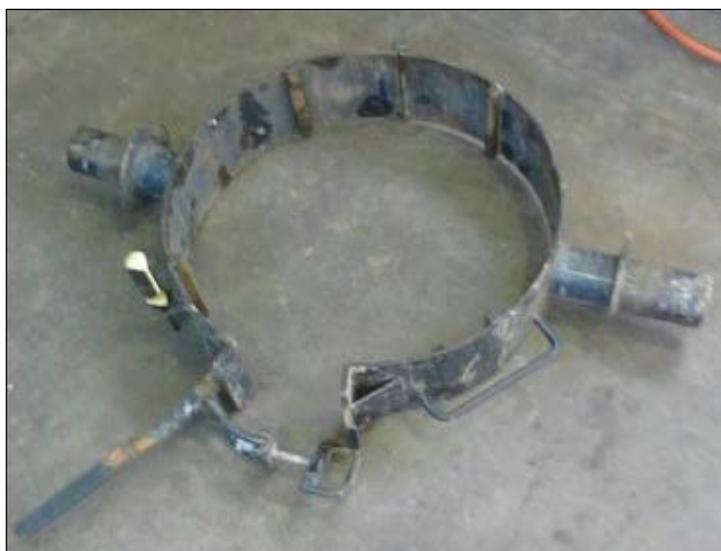
Figure 4: Swivel clamp.

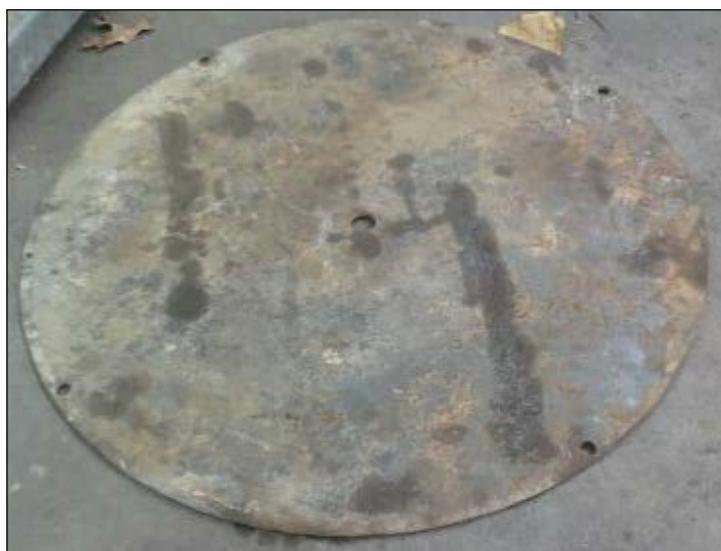
Figure 5: Base cutting plate.

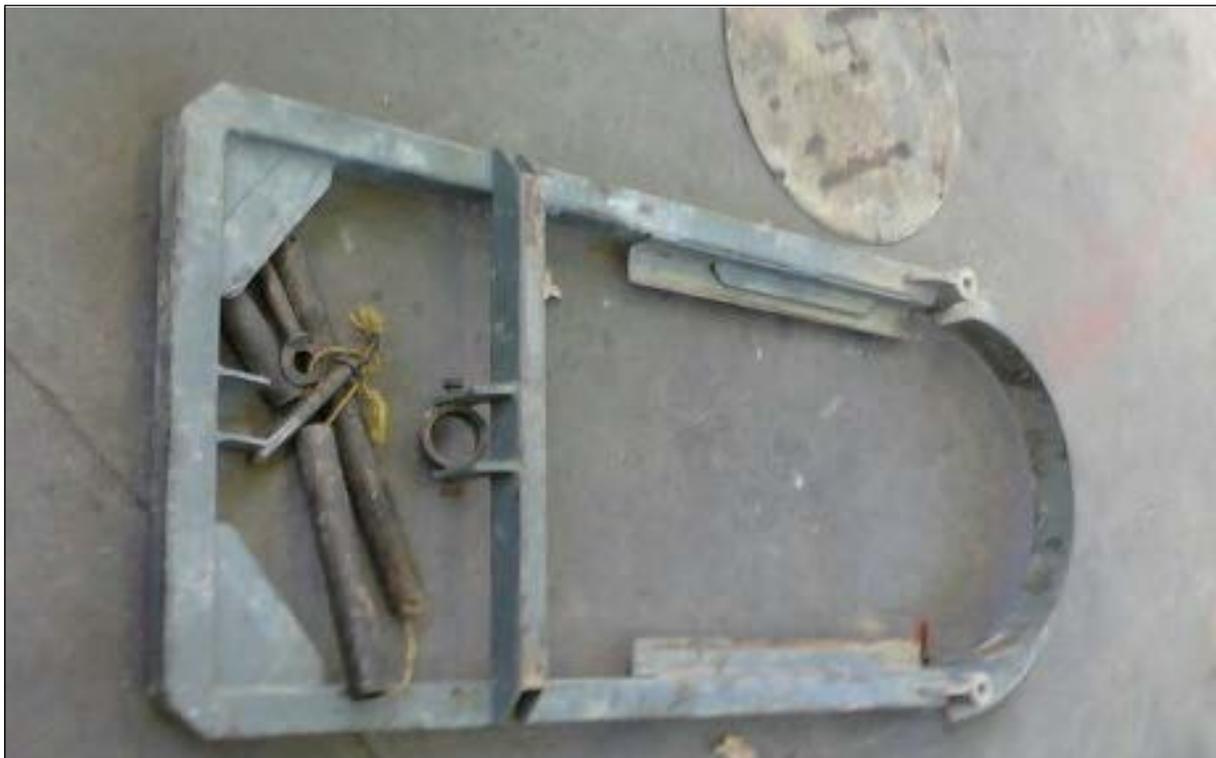
Figure 6: Base cutting plate and cutting plate enclosure.

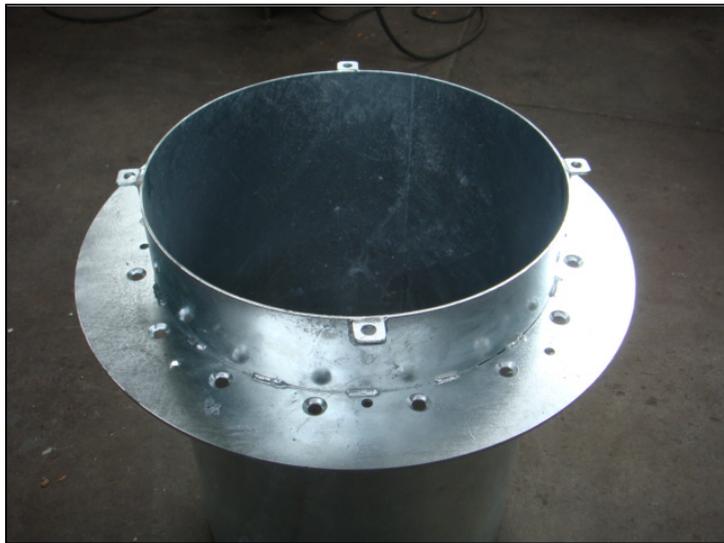
Figure 10: LVL lysimeter top.

HBRC contracted LVL to manufacture nine rainfall recharge lysimeters. Each lysimeter was formed from 3 mm thick steel, which was rolled and welded to produce a cylinder 700 mm high and 500 mm in diameter (Figure 10). A 95 mm wide circular plate was welded 100 mm below the top of the lysimeter to prevent soil consolidation around the outside of the lysimeter once installed. This plate was drilled with tapered holes to facilitate drainage through the plate (Figure 10). The lysimeter base plate was manufactured to be slightly concave (c. 10 mm) to promote drainage from the lysimeter. A 32 mm diameter female pipe fitting was welded to the centre of the base plate for attachment of external pipe fittings (Figure 11). An 8 mm thick by 50 mm wide gradually tapered steel ring was attached to the inside of the casing at the base of the lysimeter and was bevelled at a 45° angle to provide an internal cutting ring (Figure 12). The cutting ring provides a gap between the soil column and lysimeter casing, which is subsequently sealed with petroleum jelly during the preparation stage. Four 800 mm long steel rods with a 100 mm long threaded end were used to secure the base plate to the lysimeter casing (Figures 13 and 14). All components were hot galvanised prior to shipping.

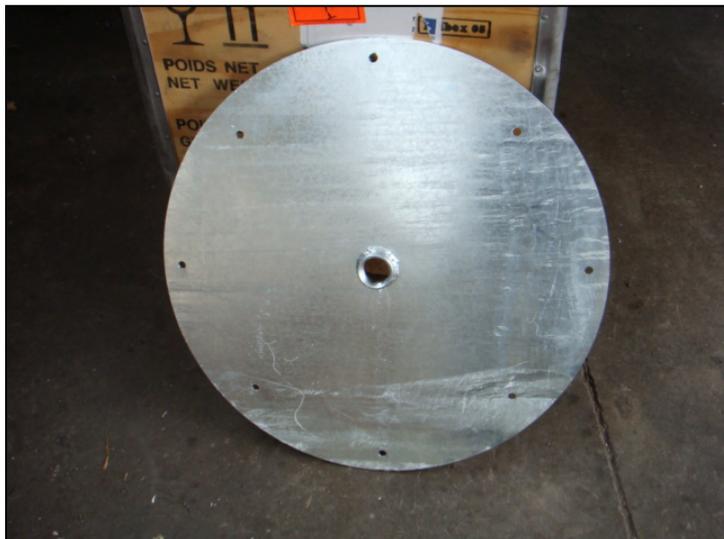
Figure 11: LVL lysimeter base plate.

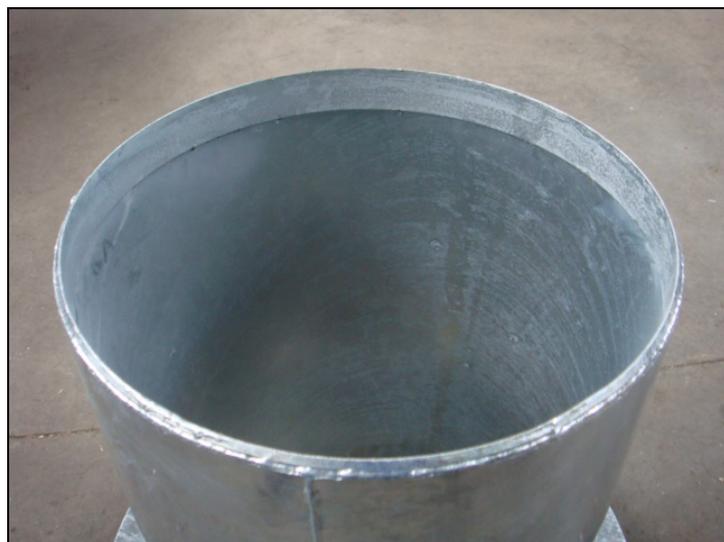
Figure 12: LVL lysimeter cutting ring.

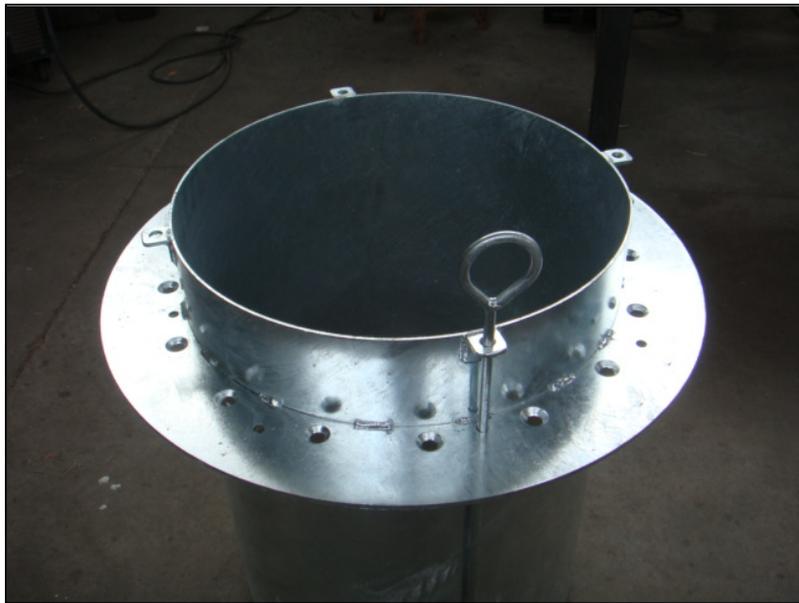
Figure 13: LVL lysimeter top, drill holes and rods.

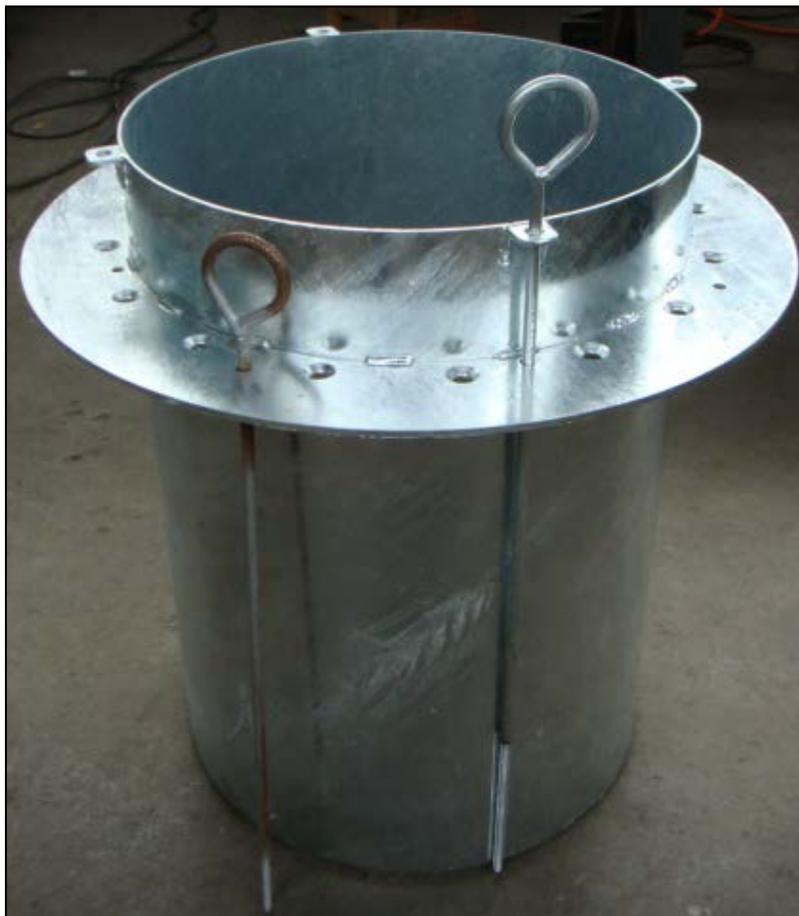
Figure 14: LVL lysimeter casing showing rods.

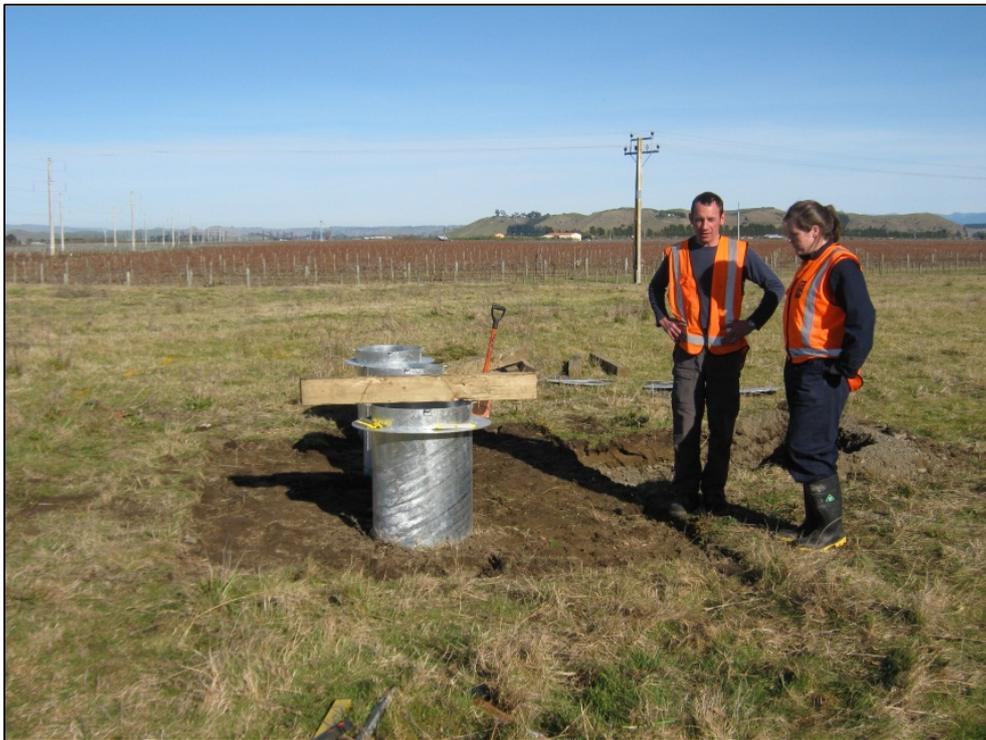
Figure 15: Site layout including test pit and grass sod removal, Fernhill Site.

The site plan was designed to ensure workable placement of the instrument enclosure, lysimeters and instrumentation equipment. Upon arrival at the site, an excavator was used to dig a test pit. Grass sod was then removed from a rectangular area surrounding the installation site in order to assist with site re-establishment (Figure 15).

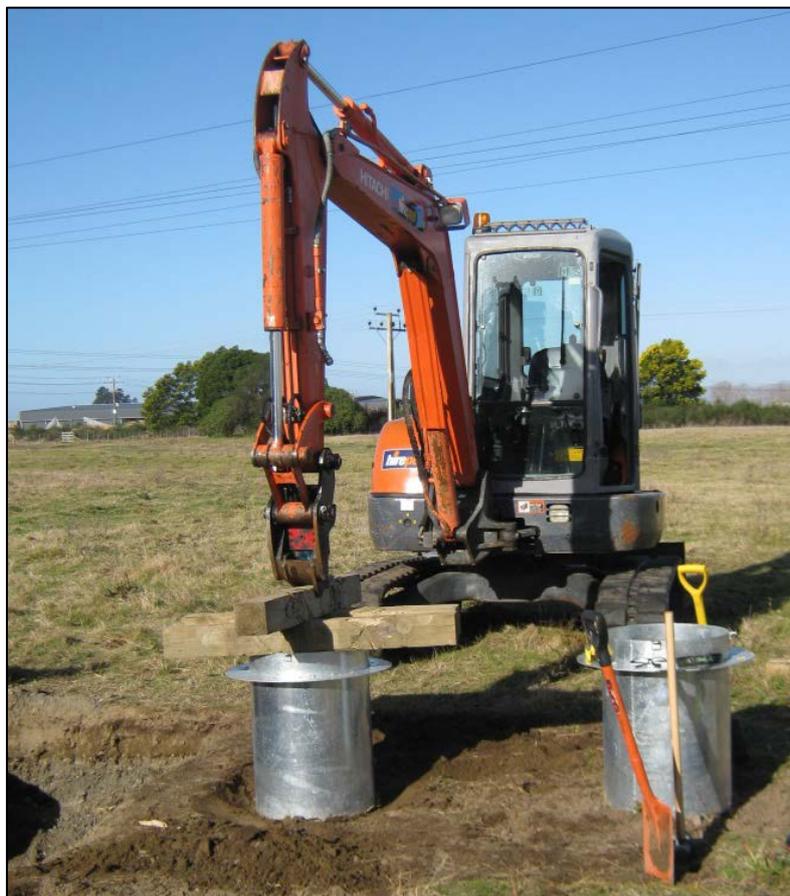
Figure 16: Driving the lysimeter casing into the ground using the excavator, Fernhill Site.

Each lysimeter casing was driven into the ground using a combination of weight from the hydraulic arm of the excavator and a sledge hammer (Figure 16). The steel casing was protected by 1.2 m long, 125 mm x 125 mm house piles and levels were used to ensure the lysimeter was driven down vertically (Figure 17). Soil from around the lysimeter base was excavated throughout the process to facilitate driving of the casing and to decrease the risk of damage to the internal soil column. After the lysimeter had been driven down to ground level, the cutting frame was installed and a 10 tonne Porta Power was used to drive the cutting plate under the lysimeter and isolate the soil column (Figure 18). Four threaded rods were inserted through the eyelets at the top of the lysimeter and through to the cutting plate where they were secured (Figure 19). The head works were fitted to the top of the lysimeter and a swivel clamp was fixed around the centre of the lysimeter (Figure 20). The lysimeter was then lifted from the pit using the excavator and lifting chains (Figure 21) and was inverted to allow for preparation of the soil base.

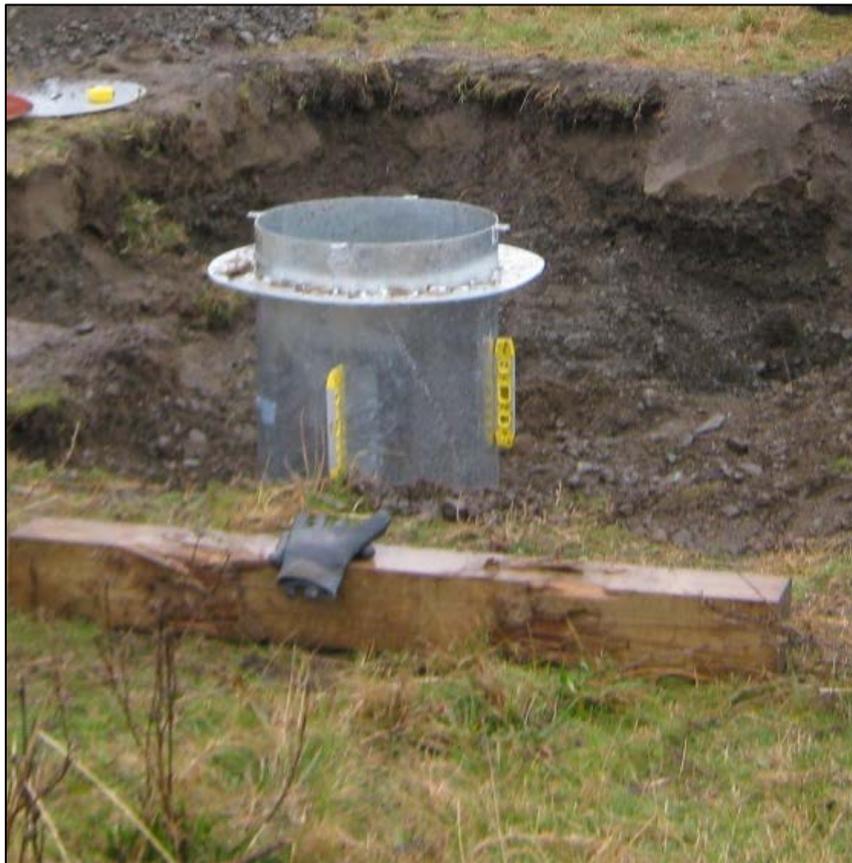
Figure 17: Lysimeter during driving to isolate of the soil column, Fernhill Site.

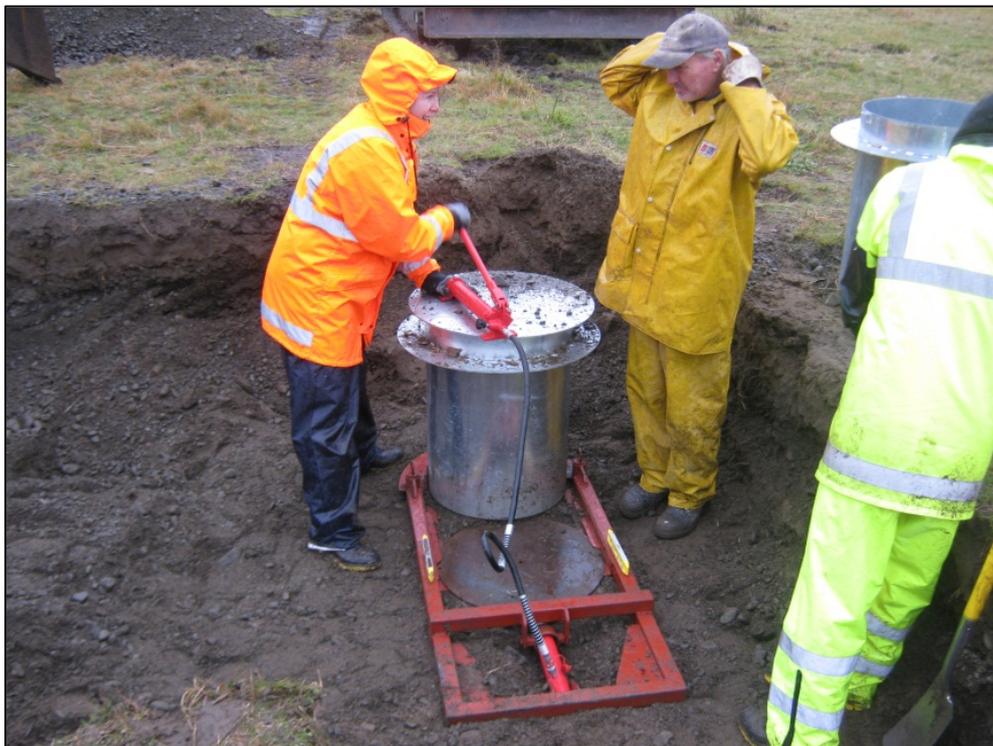
Figure 18: Using the Porta Power to insert base cutting plate beneath lysimeter, Fernhill Site.

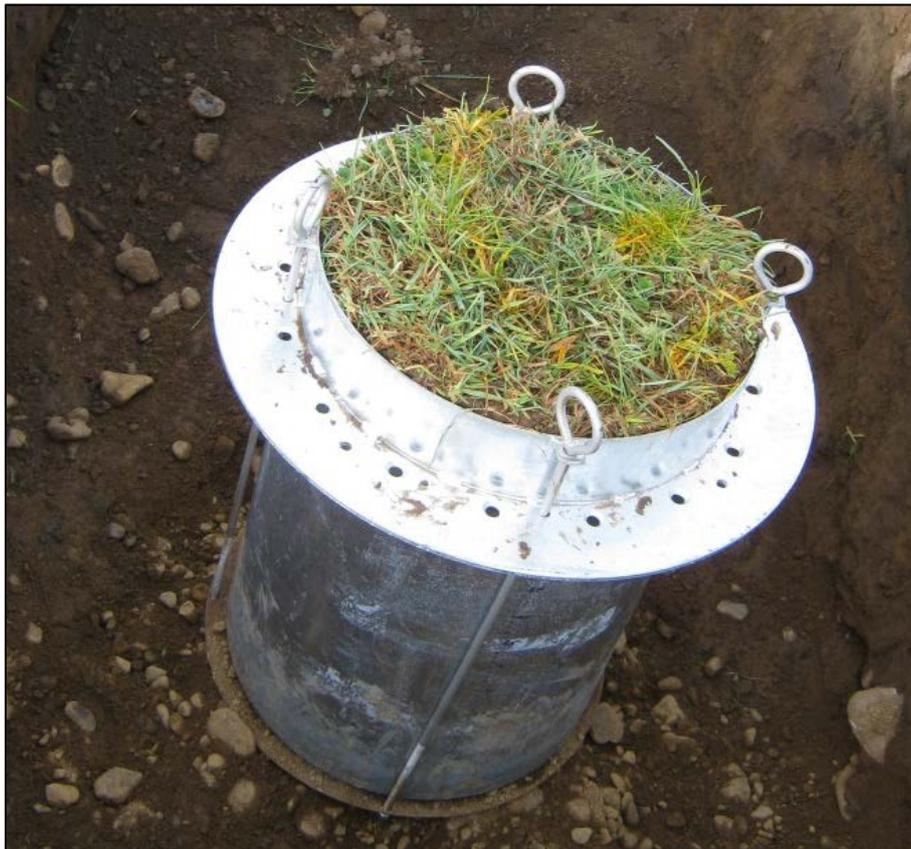
Figure 19: Threaded rods inserted through top and base plate, Maraekakaho Site.

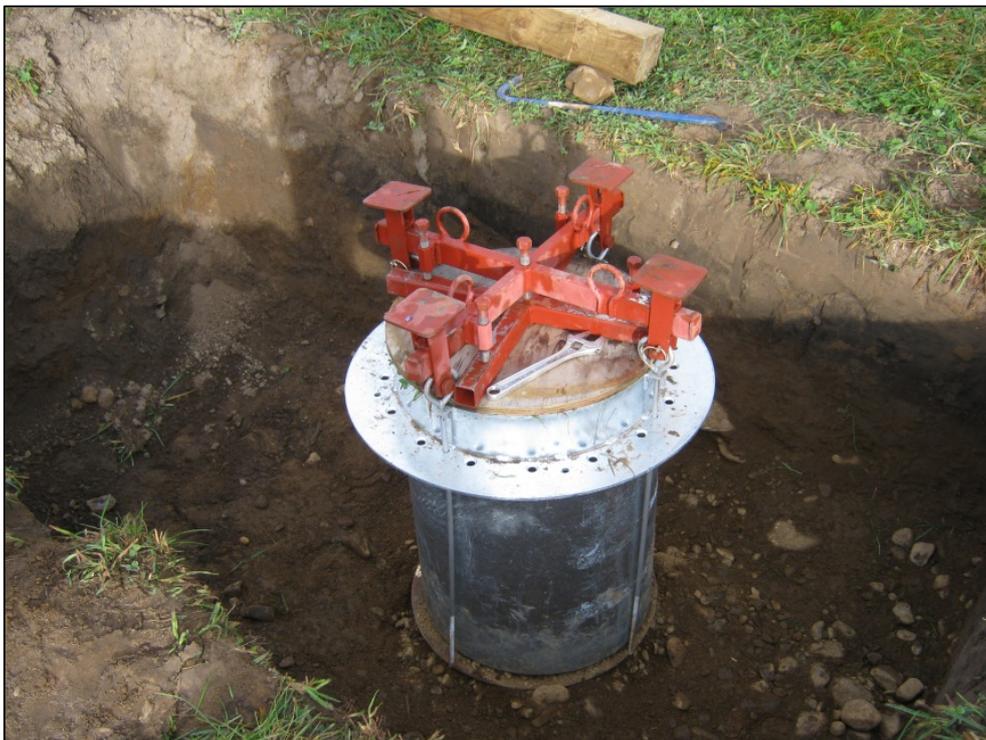
Figure 20: Head works secured onto the lysimeter ready for extraction, Maraekakaho Site.

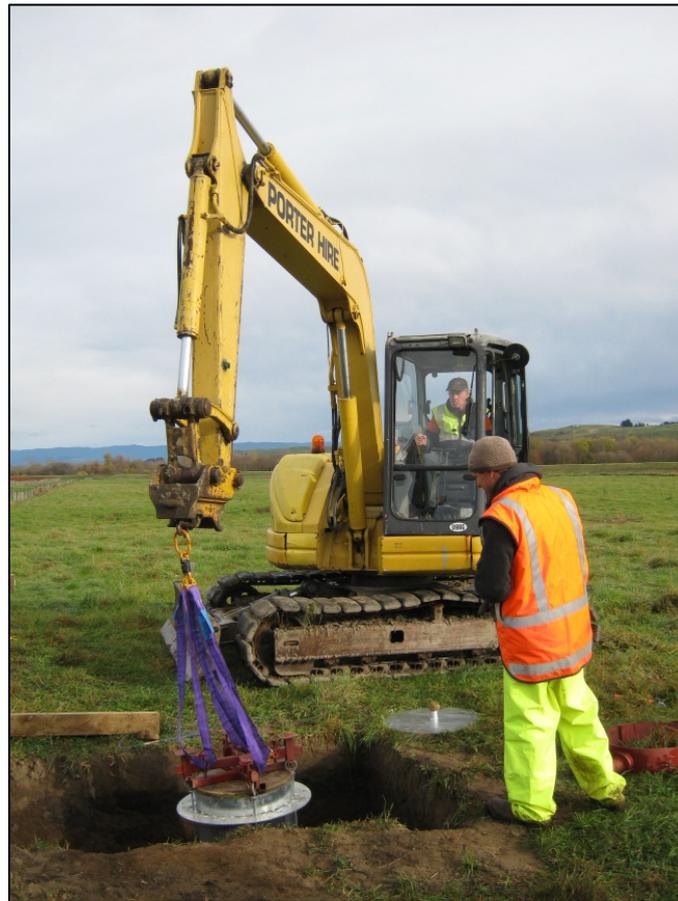
Figure 21: Lysimeter being lifted using an excavator and lifting ropes, Maraekakaho Site.

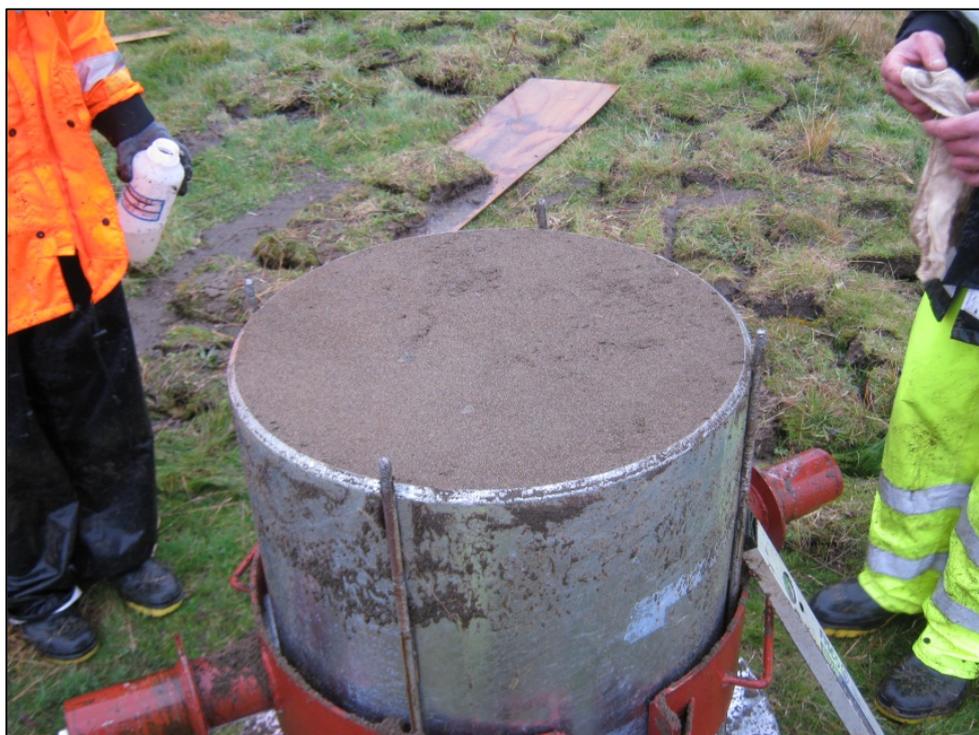
Figure 22: Base of lysimeter prepared so that it is level, Fernhill Site.

Firstly, the cutting plate was removed. The sediment was prepared so that the base of the lysimeter was level, which allowed the base plate to be secured without any gaps (Figure 22). A circular layer of shade cloth was cut and placed on the soil base to stop fine material flowing from the lysimeter following installation (Figure 23).

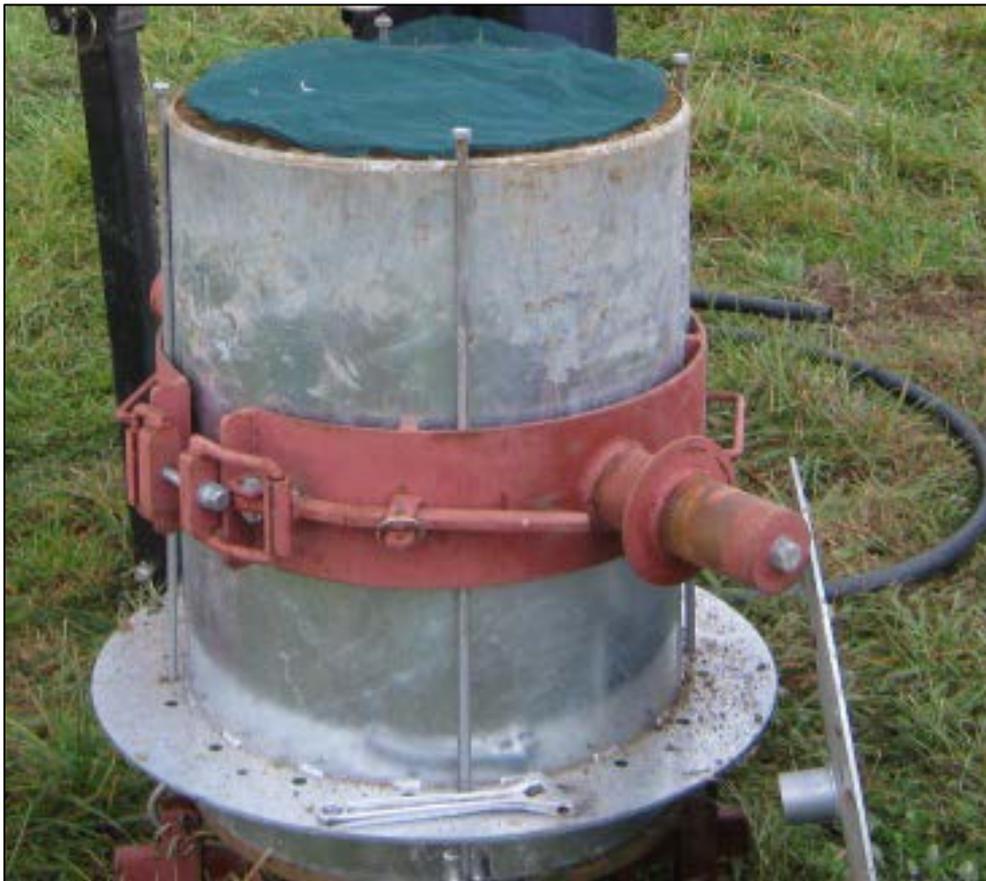
Figure 23: Shade cloth placed on the prepared lysimeter base, Maraekakaho Site.

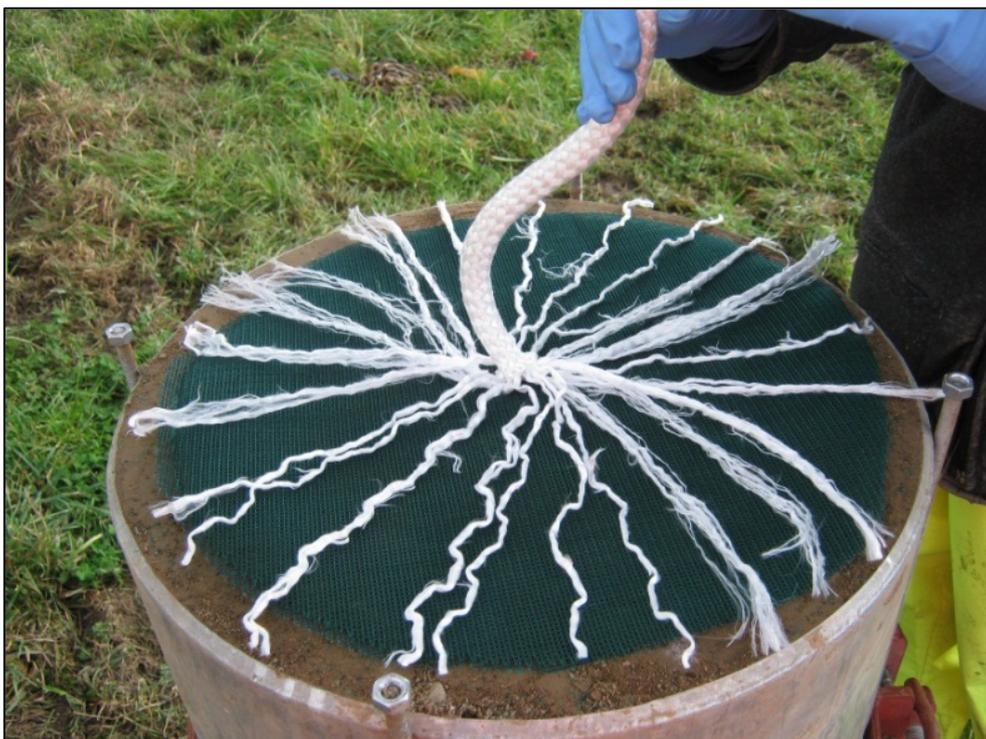
Figure 24: Splayed fibreglass wick and shade cloth, Maraekakaho Site.

A fibreglass wick can be used to reduce the surface water tension in the soil column and facilitate drainage from the lysimeter in finer grained soil conditions. Due to the fine-grained soil base at the Bridge Pa site, the intention was to use fibreglass wicks. However, a shallow perched water table was encountered at 1.2 m BGL, and prevented the use of wicks at this site (see Section 2.3.5). At the Maraekakaho Site, a fibreglass wick was splayed out from the centre of the mesh (Figure 24). Fibreglass wicks were not required at the Fernhill site as the sediment at the base of the lysimeter column was dominated by free-draining gravel clasts.

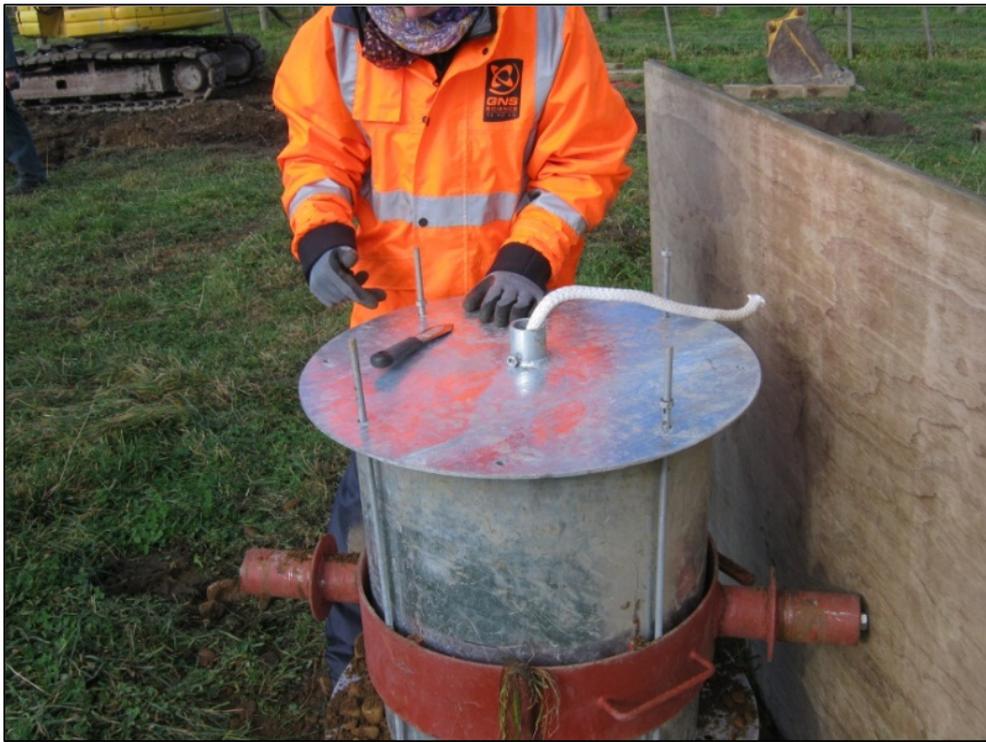
Figure 25: Securing the base plate after insertion over the fibreglass wick, Maraekakaho Site.

The base plate was inserted onto the rods and, where wicks were used, the wick was carefully pulled through the base pipe with care taken to ensure the shade cloth and splayed wick were not disturbed. The base plate was bolted securely against the column (Figure 25). The lysimeter was then inverted and placed on a timber platform and the casing was cleaned of all sediment and solvents to prepare for sealing (Figure 26). Sika 291 marine sealant was applied to the lysimeter base plate and casing and left to set overnight (Figure 27). A 20 L bucket of Waxrex Petroleum Jelly was heated on a gas burner. Once hot, a hand pump and copper nozzle was used to pump the petroleum jelly into the gaps between the steel casing and soil column.

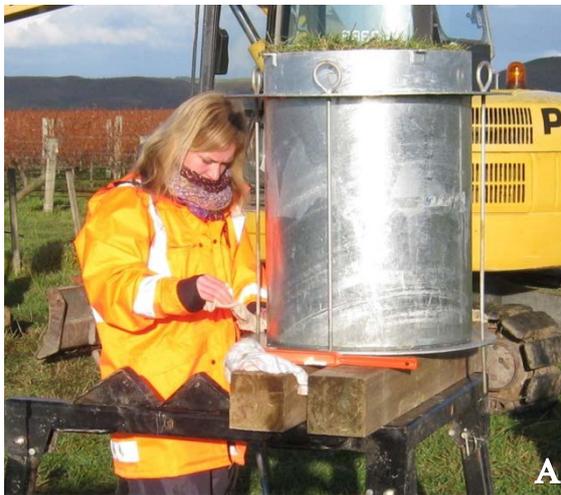
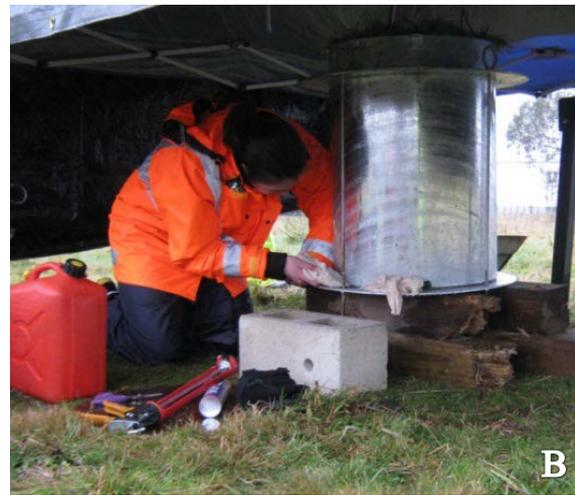
Figure 26: Lysimeters on wooden platforms being prepared for sealing, Maraekakaho Site (A) and Fernhill Site (B).

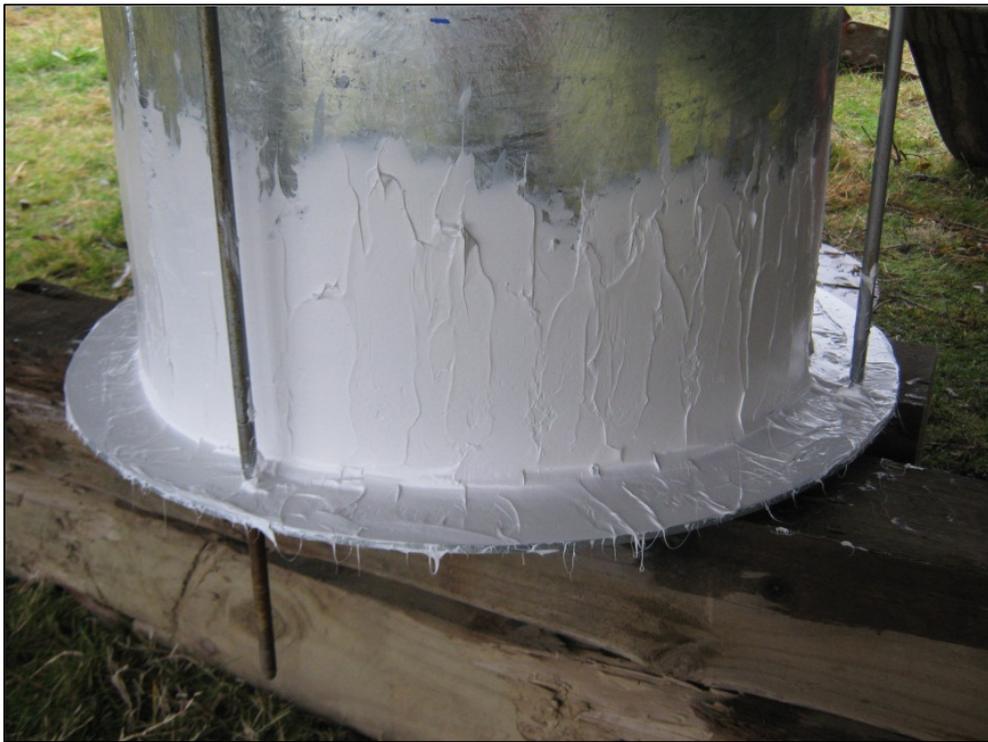
Figure 27: Lysimeter following application of Sika 291 marine sealant, Fernhill Site.

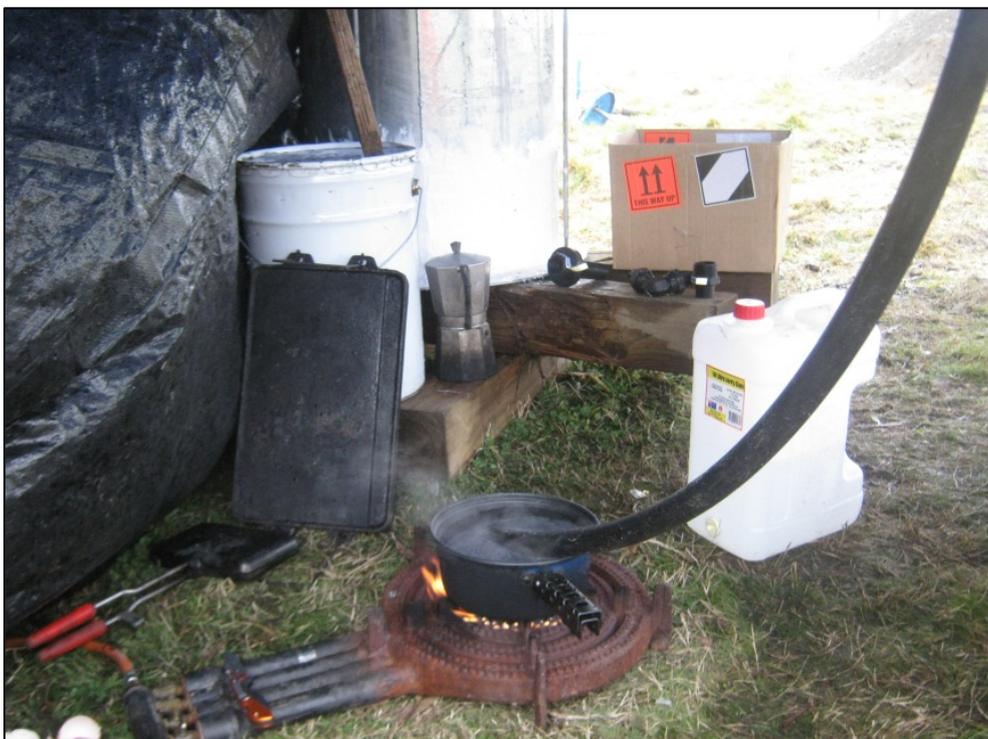
Figure 28: Warming of alkathene pipe ends in hot water prior to attachment, Fernhill Site.

At each site, the timing for attachment of pipe fittings was slightly different and was often conducted simultaneously with installation of lysimeters into the excavated pit. All alkathene pipe ends were placed in boiling water and fittings were wrapped with thread tape prior to attachment (Figure 28). Pipe fittings were attached to the outflow at the base of each lysimeter. At the Maraekakaho site, a coupler and alkathene pipe was inserted over the fibreglass wicks and fixed onto the lysimeter outflow. The pipe and wick was then cut 500 mm from the lysimeter base (Figure 29) and a right-angle fitting was attached to this pipe (Figure 30). Alternatively, at Bridge Pa and Fernhill sites a right-angle connector was directly

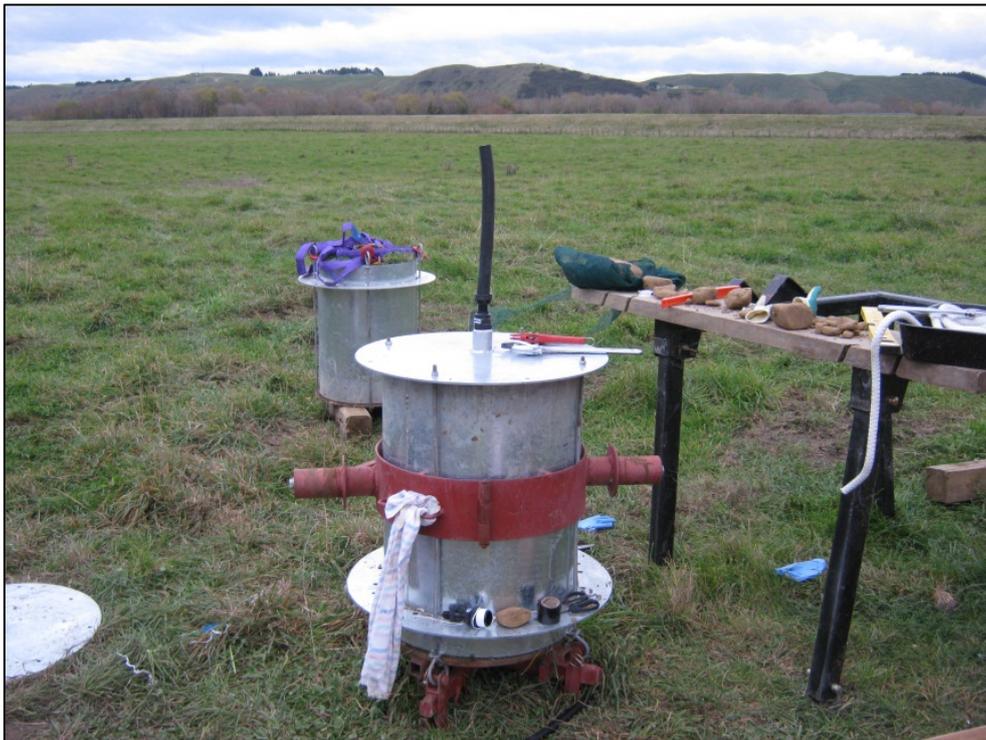
Figure 29: Lysimeter with base fitting and c. 500 mm alkathene pipe, Maraekakaho Site.

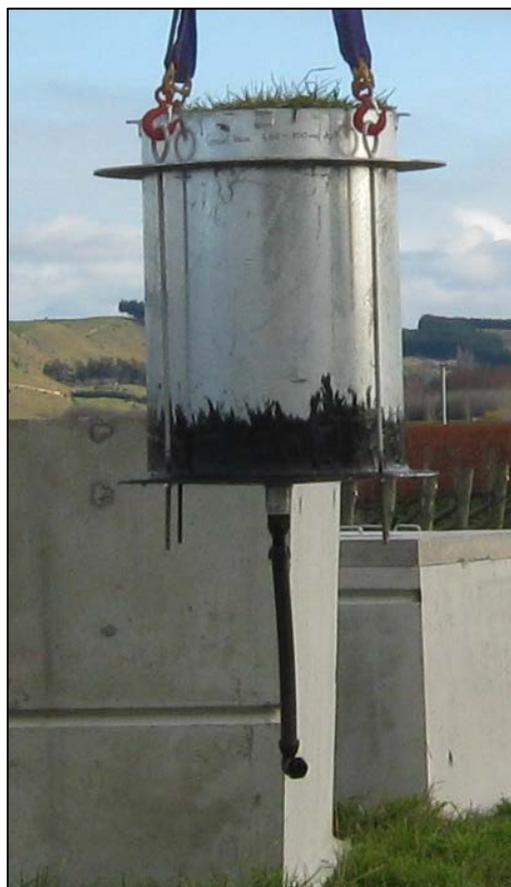
Figure 30: Lysimeter with enclosed fibreglass wick and right angle fitting, Maraekakaho Site.

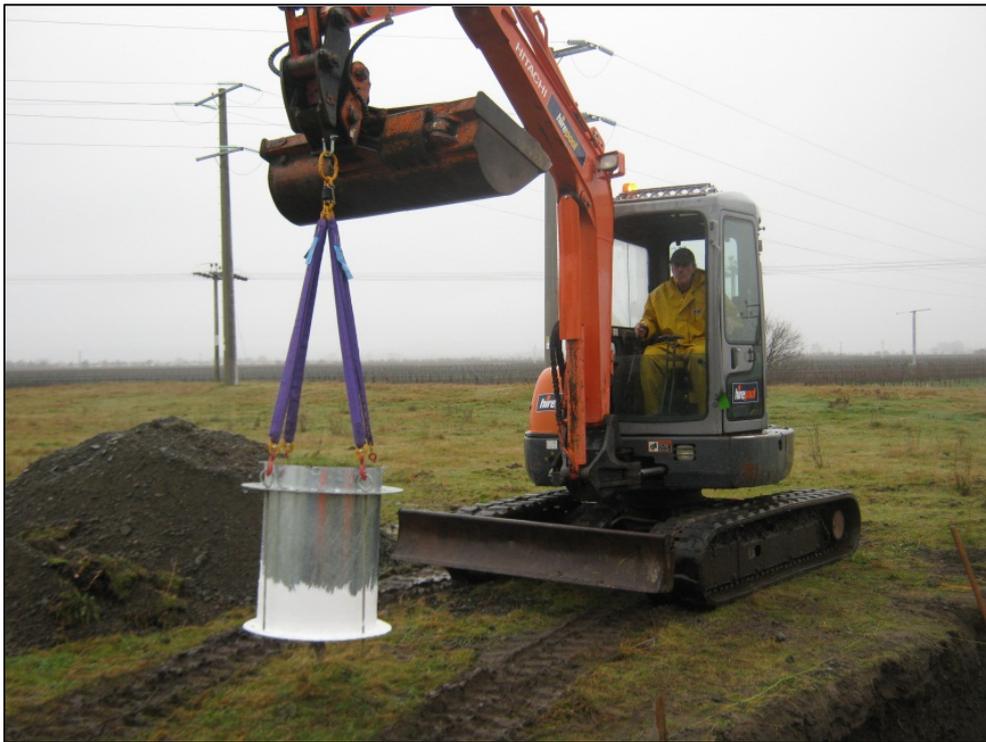
Figure 31: Lysimeter with right angle fitting only attached to the base plate, Fernhill Site.

attached to the base of the lysimeter (Figure 31). An approximately 3 m length of alkathene pipe was then attached to the right angle fittings at the base of each lysimeter (Figure 32). Alkathene pipe was laid to ensure a gradient (approximately 200 mm fall) sufficient to facilitate water flow from the lysimeter to the instrument enclosure. A length of 65 mm diameter flexi-pipe was placed over the alkathene pipe for protection (Figure 33).

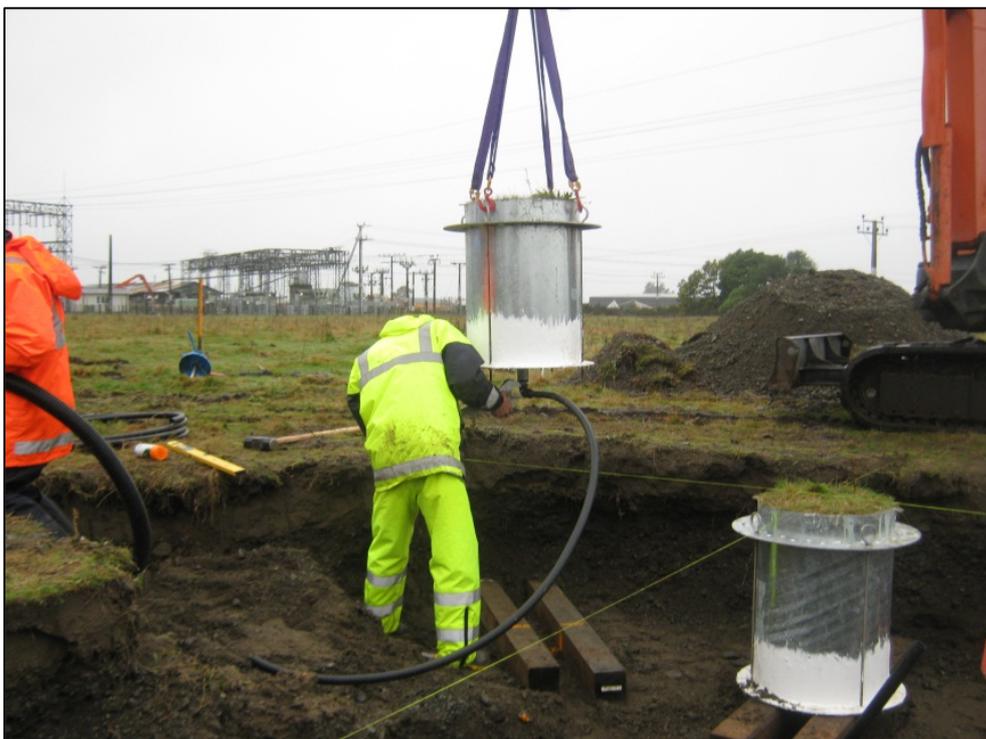
Figure 32: Attaching the outflow alkathene pipe to right angle base fitting, Fernhill Site.

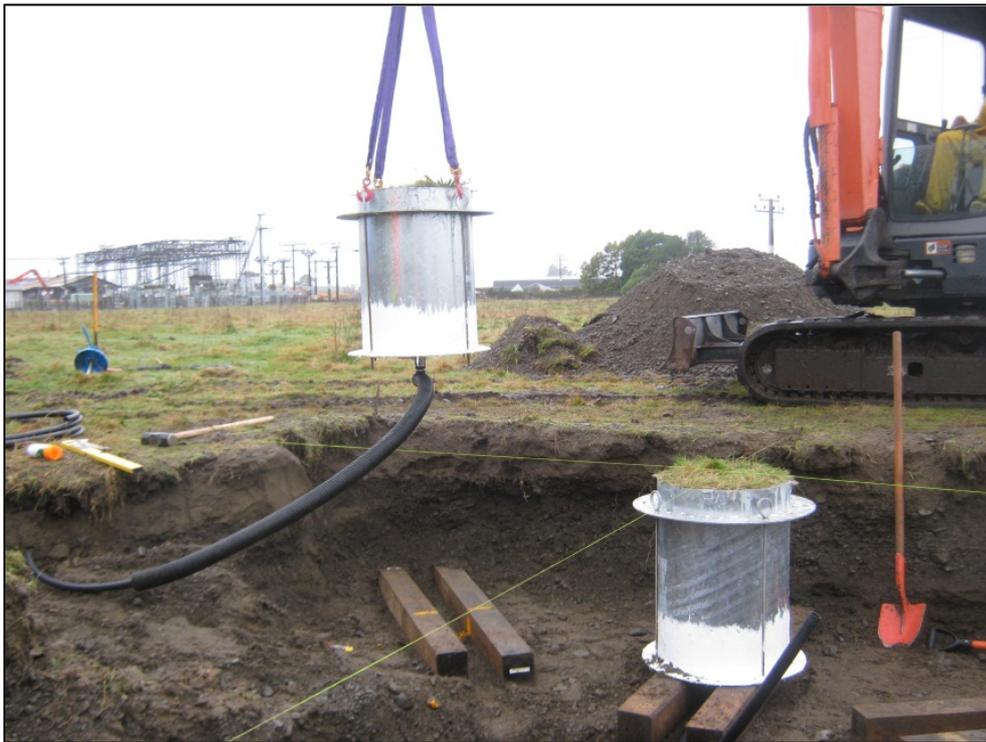
Figure 33: Alkathene pipe and flexi-pipe attached to the base of the lysimeter, Fernhill Site.

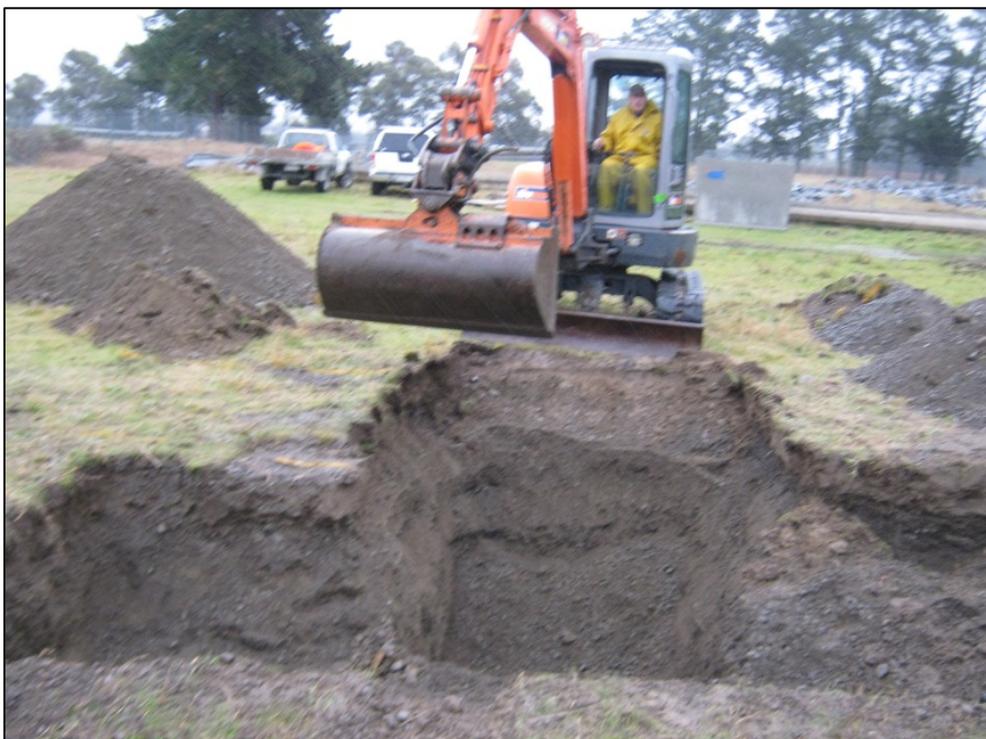
Figure 34: Excavating the pit for lysimeter and enclosure installation, Fernhill Site.

The pit was excavated and prepared for installation of the lysimeters and the instrument enclosure (Figure 34). String lines were set at ground level to assist with reinstallation of the lysimeters at the same height as the ground level surrounding the pit (Figure 35). An excavator was used to lift and position the lysimeters into the excavated pit, and a hi-ab crane was used to position the instrument enclosure in the pit. At the Bridge Pa site, four 150 mm x 150 mm paving stones were installed to form each lysimeter platform (Figure 36). At the Maraekakaho and Fernhill sites, 1.5 m long 125 mm x 125 mm treated house piles were installed to form the base platform for each lysimeter (Figure 37). At the Maraekakaho Site, an approximately 500 mm length of 310 mm diameter PVC was placed on top of the timber platforms in order to protect the fibreglass wicks and alkathene pipe (Figure 38). The PVC pipe was at a length suitable to ensure the top of the lysimeter was at ground level. At Bridge Pa and Fernhill sites, lysimeters were placed directly on the paving stone and timber platforms, respectively. Lysimeters were installed onto the respective platforms and levelled using the string lines.
