Lovett, A. and Cameron, S. 2013. Installation of rainfall recharge recording sites: Bridge Pa, Maraekakaho and Fernhill, Heretaunga Plains, Hawke's Bay, *GNS Science Consultancy Report CR 2013/05* 51p.

This report details the installation of three rainfall recharge lysimeters and instrument enclosures at the Bridge Pa, Maraekakaho and Fernhill sites. This network will provide rainfall recharge information useful for groundwater management in the Hawke's Bay region. In conjunction with installations in Canterbury and Bay of Plenty, the Hawkes Bay sites form a network currently consisting of ten rainfall recharge monitoring sites across New Zealand.

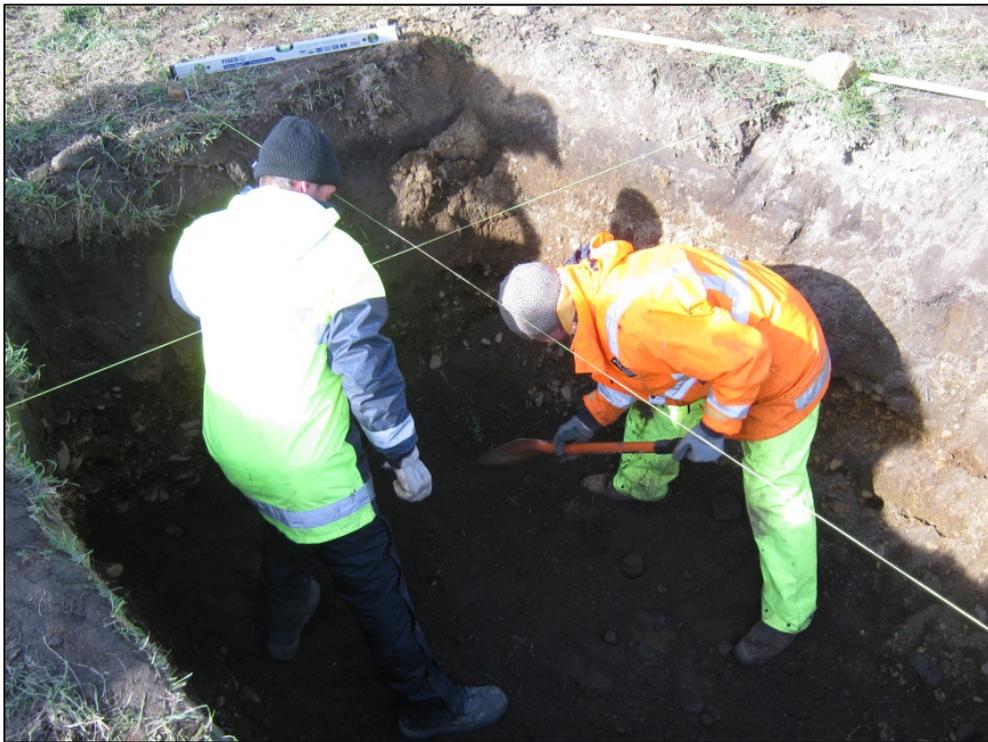
Figure 35: Completing pit excavation and installed string lines, Maraekakaho Site.

The pit was excavated and prepared for installation of the lysimeters and the instrument enclosure (Figure 34). String lines were set at ground level to assist with reinstallation of the lysimeters at the same height as the ground level surrounding the pit (Figure 35). An excavator was used to lift and position the lysimeters into the excavated pit, and a hi-ab crane was used to position the instrument enclosure in the pit. At the Bridge Pa site, four 150 mm x 150 mm paving stones were installed to form each lysimeter platform (Figure 36). At the Maraekakaho and Fernhill sites, 1.5 m long 125 mm x 125 mm treated house piles were installed to form the base platform for each lysimeter (Figure 37). At the Maraekakaho Site, an approximately 500 mm length of 310 mm diameter PVC was placed on top of the timber platforms in order to protect the fibreglass wicks and alkathene pipe (Figure 38). The PVC pipe was at a length suitable to ensure the top of the lysimeter was at ground level. At Bridge Pa and Fernhill sites, lysimeters were placed directly on the paving stone and timber platforms, respectively. Lysimeters were installed onto the respective platforms and levelled using the string lines.

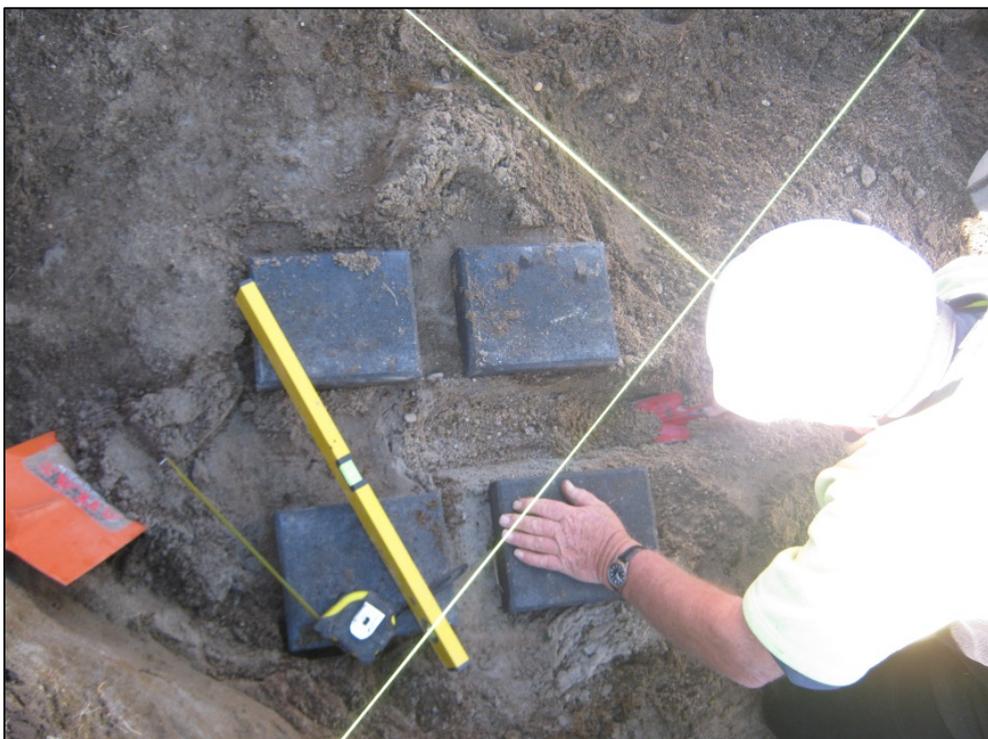
Figure 36: Levelling of paving stones for the lysimeter base, Bridge Pa Site.

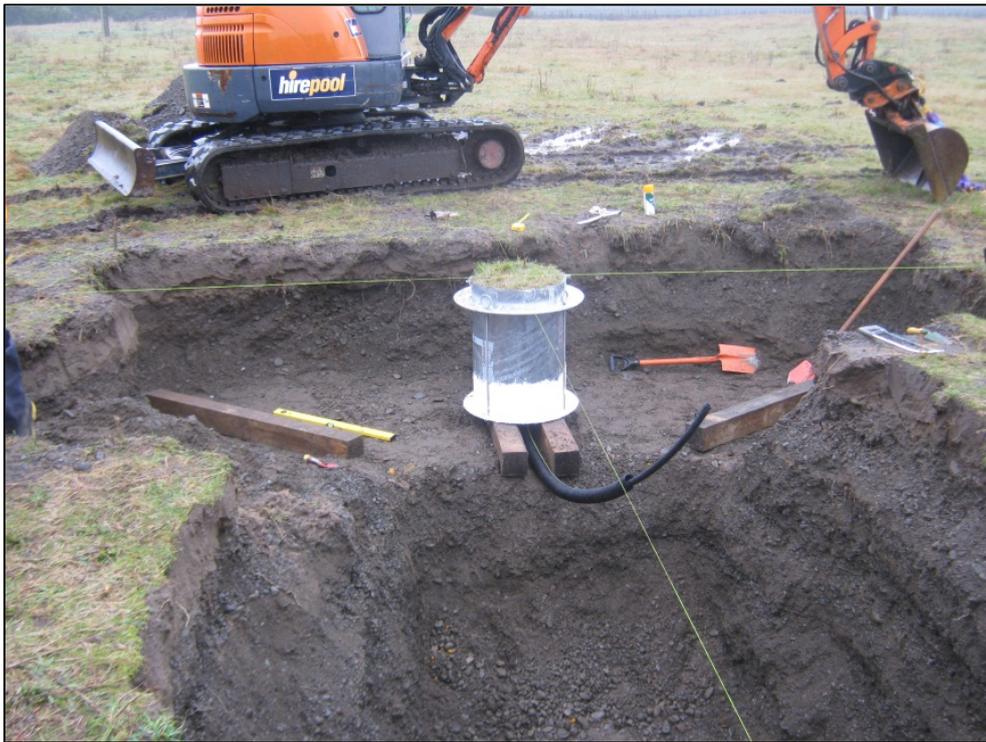
Figure 37: Timber platforms for lysimeter base, Fernhill Site.

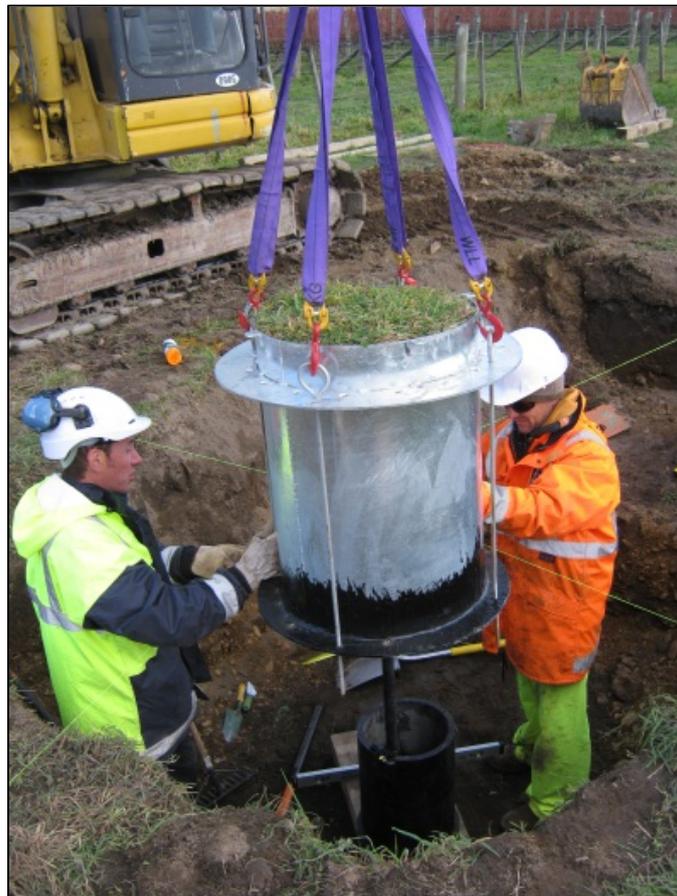
Figure 38: Placement of the lysimeter onto timber platform and PVC, Maraekakaho Site.

As discussed in Section 2.3.4, the Maraekakaho site included installation of a fibreglass wick and subsequently a PVC base on the timber platform to protect the wick and pipe. Concrete tank dimensions were 2.34 m long x 1.23 m wide x 2.76 m deep. Due to a delay in delivery,

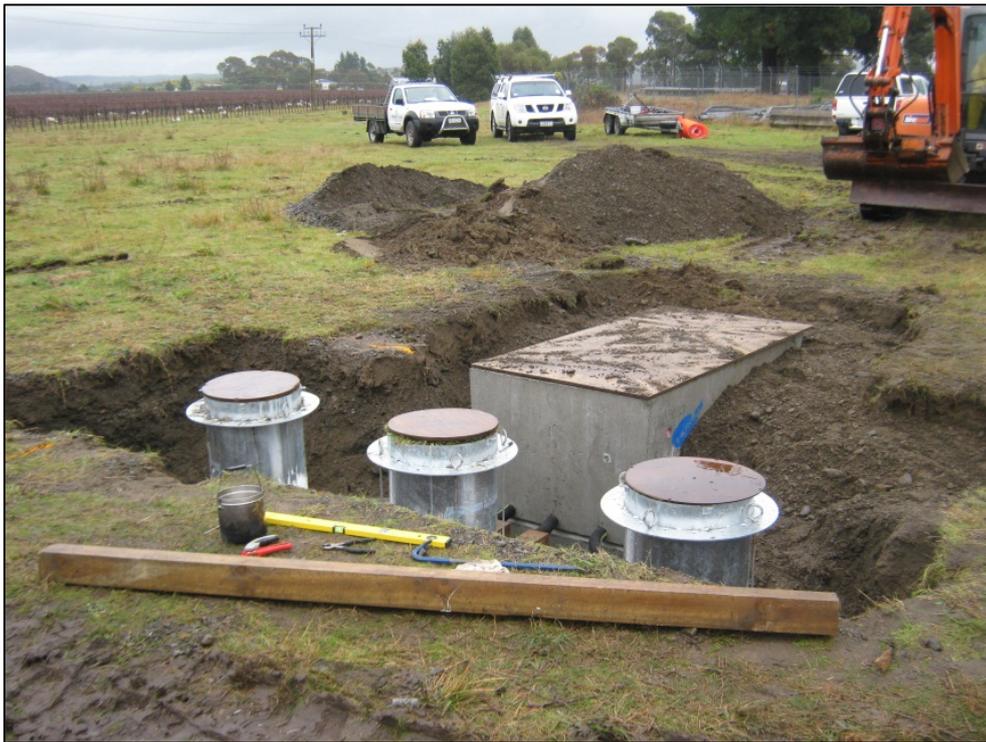
Figure 39: Infilling of excavated pit with lysimeters and instrument enclosure, Fernhill Site.

Once satisfied with the layout of the site, infilling of the excavated area around the lysimeters and instrument enclosure was then undertaken. During this process, wooden lids were placed on the lysimeters and the enclosure was covered with a plywood sheet to prevent fouling from sediment (Figure 39). Infilling of the pit was completed using the excavator and by hand, with particular care taken to ensure that the lysimeters were packed into the surrounding sediment so that post installation subsidence was minimised (Figure 40). The soil was re-instated, the site was fenced and completed (Figures 41 – 47).

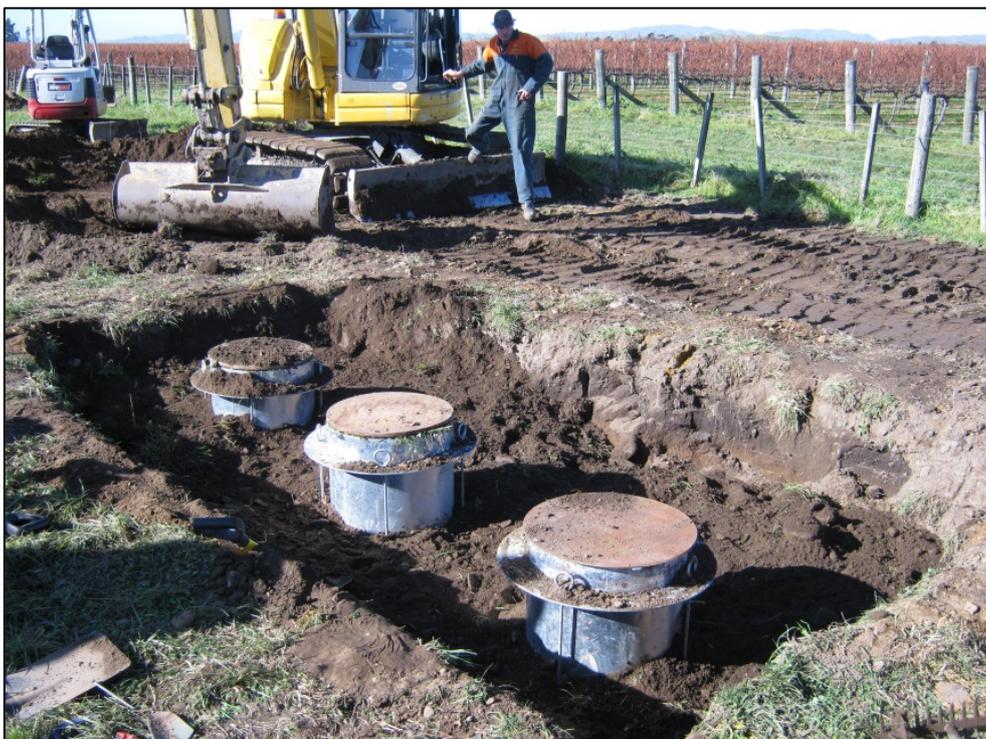
Figure 40: Partial infilling of the lysimeters completed, Maraekakaho Site.

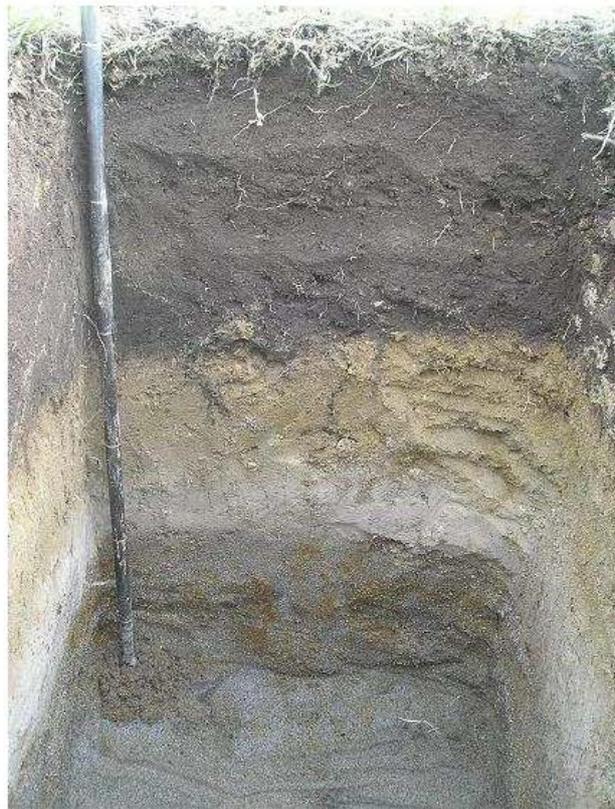
Figure 1. Soil profile of the Pakipaki sandy loam (auger is banded in 10 cm increments).

A soil pit was dug within 50 cm of the estimated location of the Aquaflex soil moisture sensor and the profile is pictured in Figure 1 and described in Table 1. The profile is 59 cm deep with an intermittent water table 34 cm BGS. A gleyed layer (Bg) occurs between 34 and 41 cm BGS as a strongly compacted layer. The coarse sand (G) beneath it, is firm in place (775 kPa) but offers much less penetration resistance than the B and Bg layers above it.
