Lovett, A. 2013 Installation of a dryland rainfall recharge lysimeter monitoring site at Ashcott Road, Ruataniwha Plains, Hawke's Bay, *GNS Science Consultancy Report 2013/174*. 41 p.

HBRC contracted GNS Science to oversee the installation of three 500 mm diameter rainfall recharge lysimeters and an instrument enclosure at Ashcott Road, Ruataniwha Plains (Figure 1 and Figure 2). The monitoring site is located on well-drained soil, overlying an unconfined recharge area (Griffiths, 2004; Landcare Research, 2013). Rainfall recharge datasets from the site will complement datasets from previously installed sites in the Heretaunga Plains at Bridge Pa, Maraekakaho and Fernhill (Figure 3). Rainfall recharge information from the network of HBRC monitoring sites will be useful to estimate rainfall recharge across the Hawke's Bay region to assist in groundwater management.

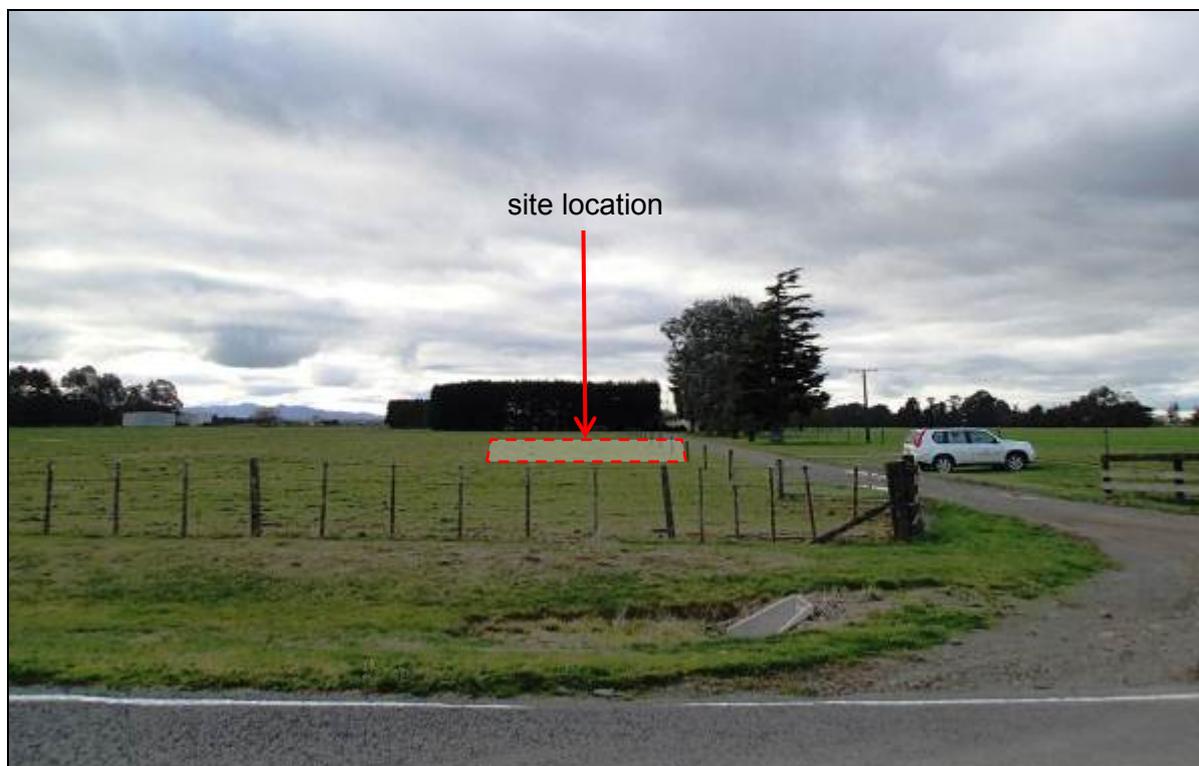
Figure 4: Photograph of the selected site, photograph is facing north with Ashcott Road in the foreground.

Installation of the lysimeter monitoring site was on property owned by the Bel Group, at 978 Ashcott Road, Ruataniwha Plains (E2798693 N6133107; NZMG1949) (Figure 2). The site location is approximately 1 km west of SH 50 from Ongaonga to Takapau, and 16 km east of Waipukurau. The Ruataniwha alluvial plains drain to the south-east and are bounded in the east by the Ruakaka Ranges and in the west by the Ruahine Ranges (Luba, 2001). The complex hydrogeological environment beneath the plains consists of multi-layered quaternary sand and gravel aquifers up to 150 m below ground level (Luba, 2001). The site is located on an unconfined area of the aquifer in the eastern region of the plains. At the time of installation, land-use in the paddock surrounding the monitoring site was dryland pasture for dairy cows (Figure 4).

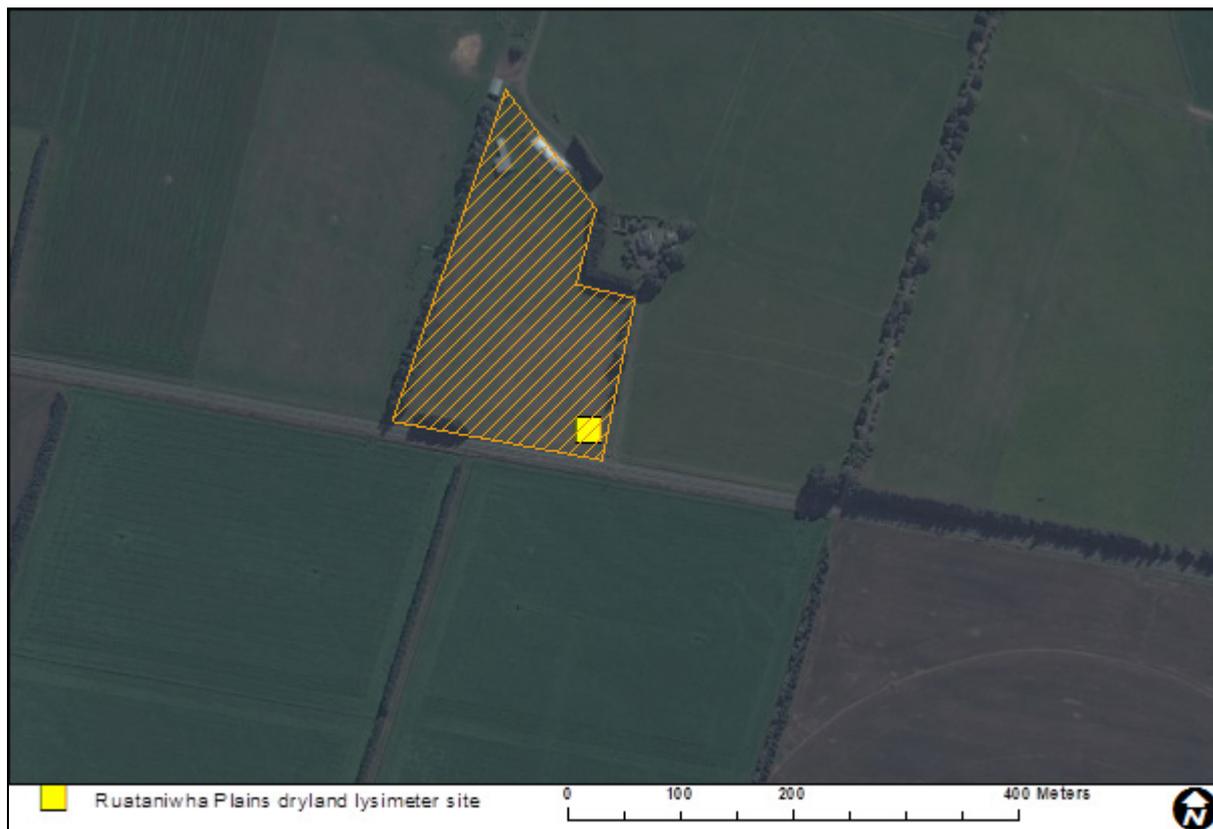
Figure 5: Ruataniwha Plains dryland lysimeter site indicating the dryland paddock. All other areas are known to be, or likely to be, irrigated (refer to Figure 1).

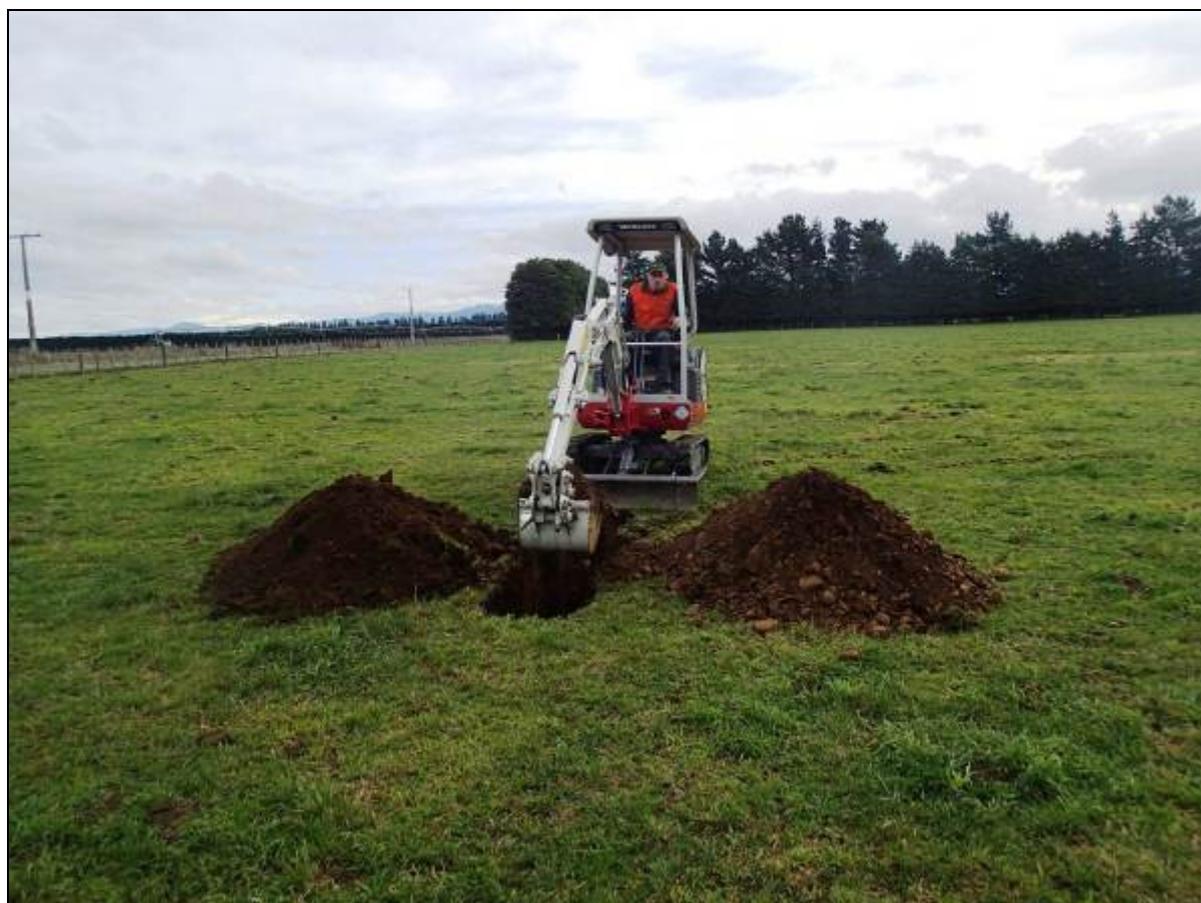
Figure 6: Digging the test pit, photograph facing south-west of the monitoring site.

installation of telemetry equipment and to minimise disturbance to farm operations. Test pits were dug on Monday 17th June to ascertain suitability of the soil conditions at the site (Figure 6 to Figure 8). A 2 m deep pit indicated a soil layer of approximately 500 mm which was underlain by gravelly sand, with no evidence of the water table (Figure 7). A site plan was then designed to ensure workable placement of the concrete enclosure, lysimeters and telemetry equipment along the driveway fence-line (Figure 8 and Figure 9).

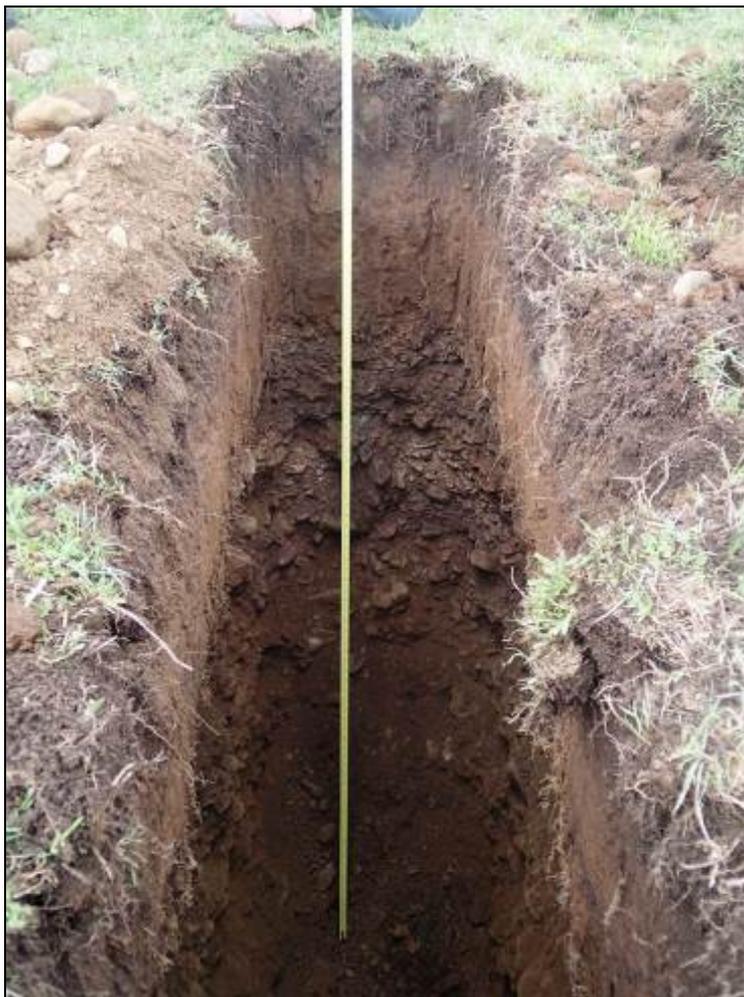
Figure 7: Two metre test pit showing loam soils overlying layers of gravel.

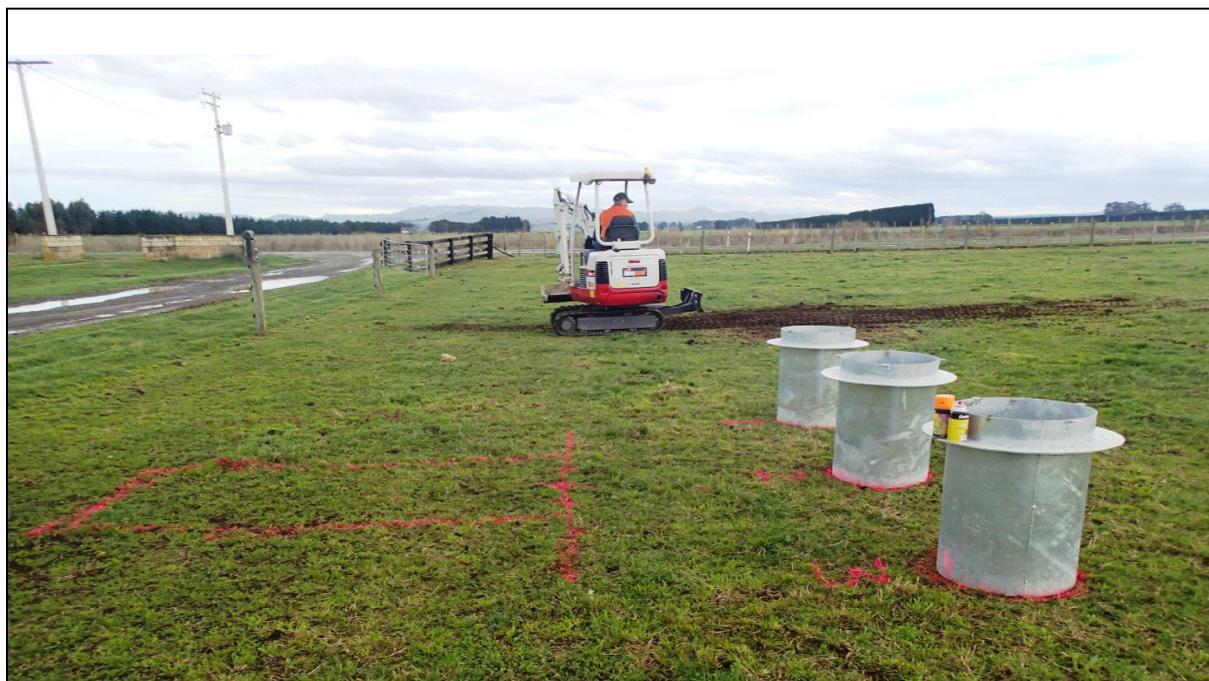
Figure 8: Initial layout of the monitoring site showing the test pit, enclosure, lysimeters and fence line for easy access and installation of telemetry equipment.

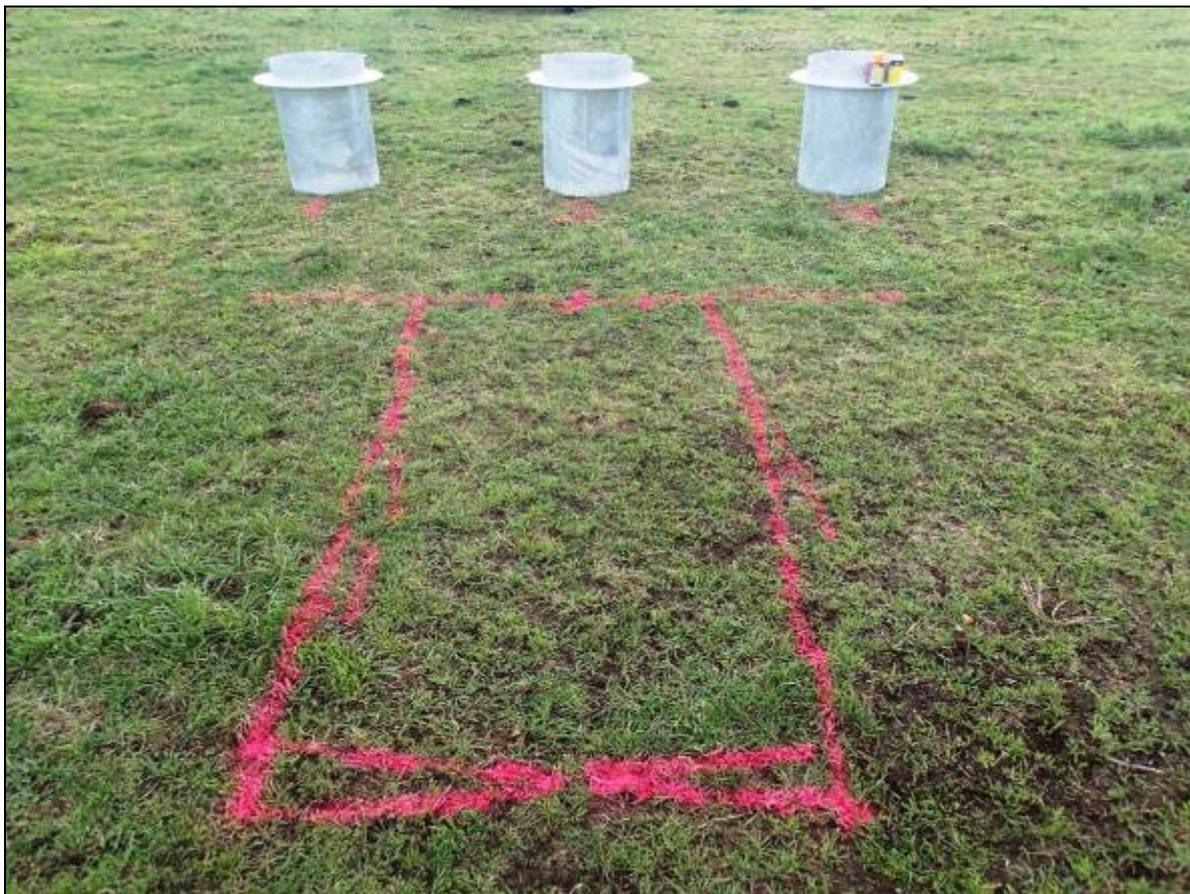
Figure 9: Initial site layout showing location of the enclosure and three lysimeters, facing west.

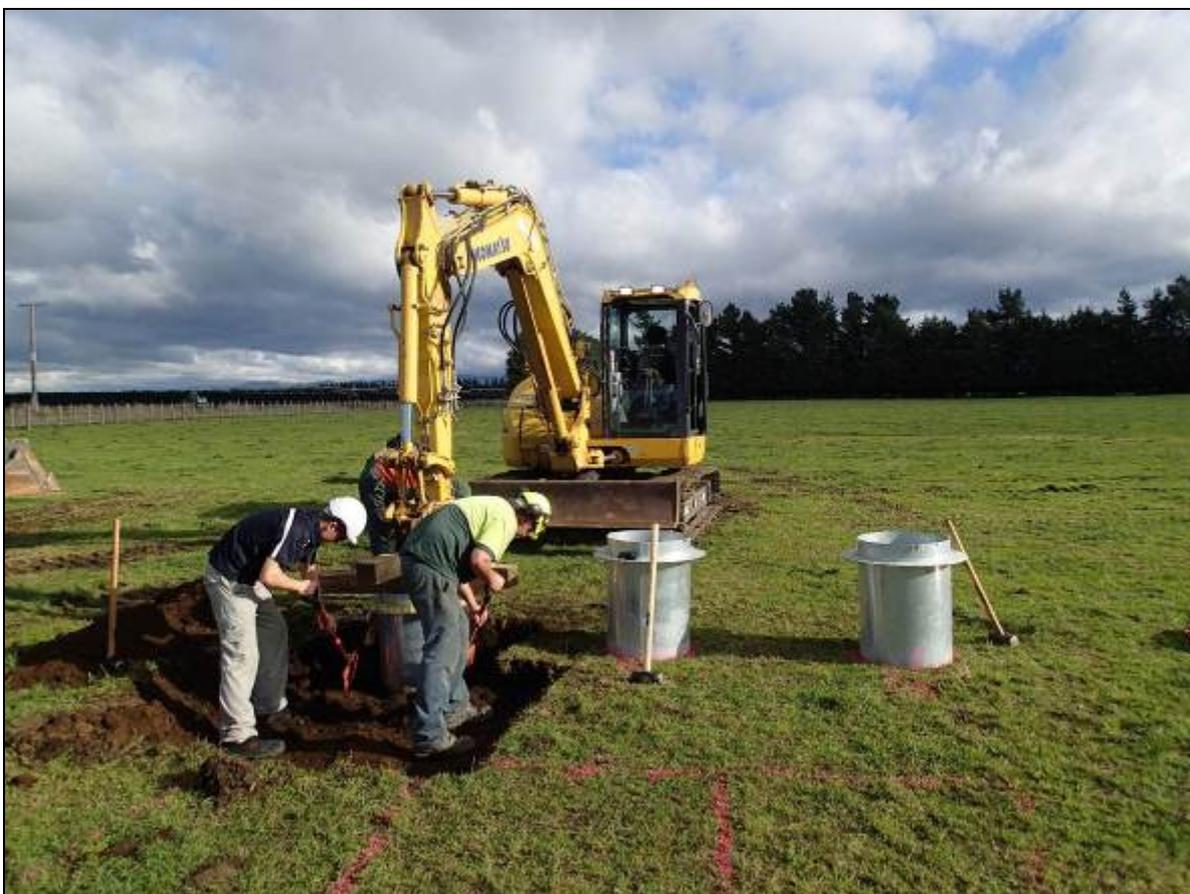
Figure 10: Driving of lysimeter one showing house pile and levels, following removal of grass sod.

Each lysimeter casing was driven into the ground using a combination of weight from the hydraulic arm of the 8 tonne excavator and sledge hammers (Figure 10). The steel casing was protected by 1.2 m long, 125 mm x 125 mm house piles, and levels were used to check that the lysimeter was driven down vertically (Figure 10). Once the lysimeter had been driven 50 mm, grass sod was removed from around the lysimeter base. During driving, soil and stones from around the lysimeter base were excavated to facilitate driving of the casing and to decrease the risk of damage to the internal soil column. Difficulty was encountered around 500 mm below the ground surface, where gravels and boulders (> 100 mm diameter) were encountered (Figure 11 and Figure 12). Greywacke stones were either removed, or were broken under pressure and remained inside the lysimeter column. Each lysimeter was driven until the upper lip was approximately 15 mm above ground level (Figure 13). Following this, the pit was levelled (Figure 14) and the cutting frame was installed (Figure 15). A 10 tonne Porta Power was used to drive the cutting plate under the lysimeter and isolate the soil column (Figure 16). Four threaded rods were inserted through the eyelets at the top of the lysimeter and through the cutting plate, and then secured. A foam pad was placed on the grass at the top of the lysimeter and the head works were fitted to the top of the lysimeter. The c. 15 mm thick foam padding was put in place to ensure that the soil column inside the lysimeter did not shift during inversion. A swivel clamp was fixed around the centre of the lysimeter to prepare the column for lifting. The lysimeter was then lifted from the pit using the excavator and lifting chains (Figure 17) and inverted to allow for preparation of the soil base.

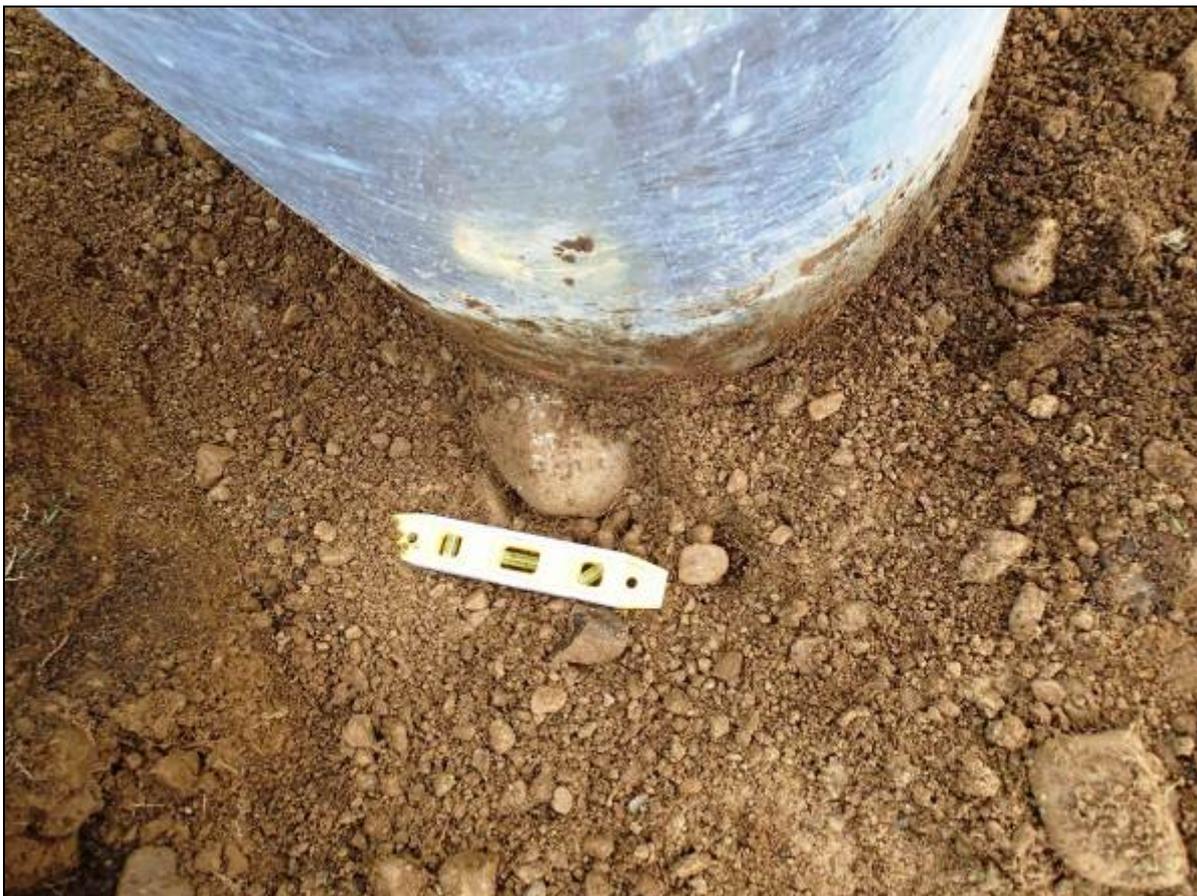
Figure 11: At c. 500 mm BGL a gravel layer made driving of the lysimeter difficult.

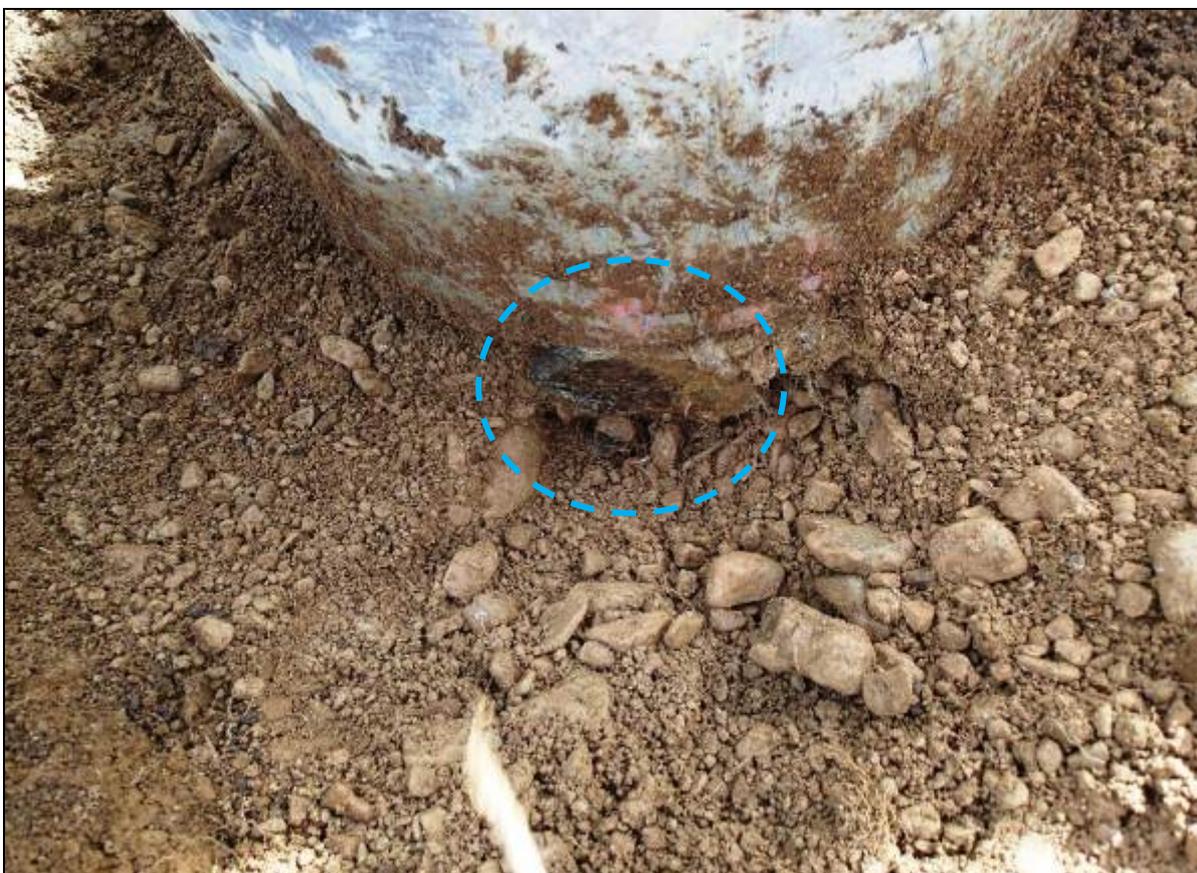
Figure 12: Example of a greywacke rock (circled) broken under pressure during driving of the lysimeter.

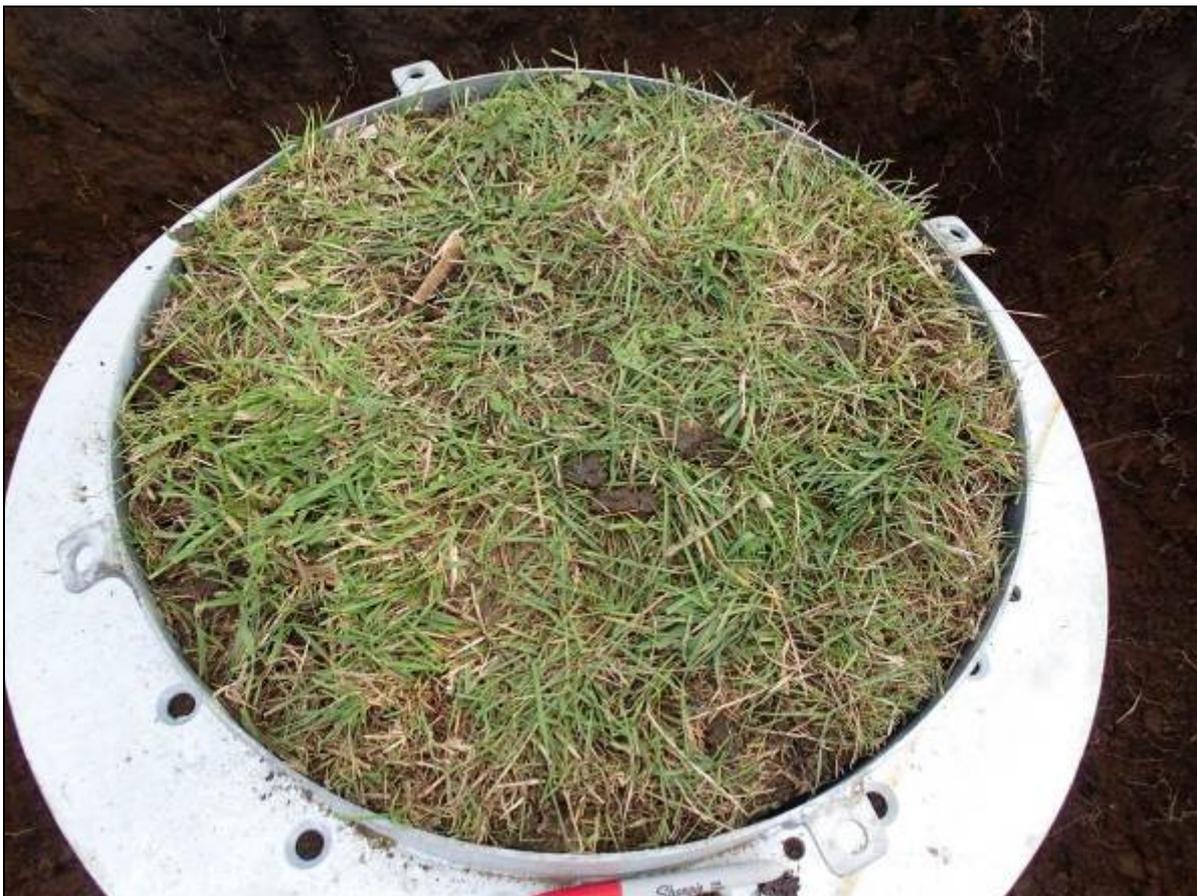
Figure 13: Lysimeter one with the soil column c. 10 – 20 mm below the top of the lysimeter casing.

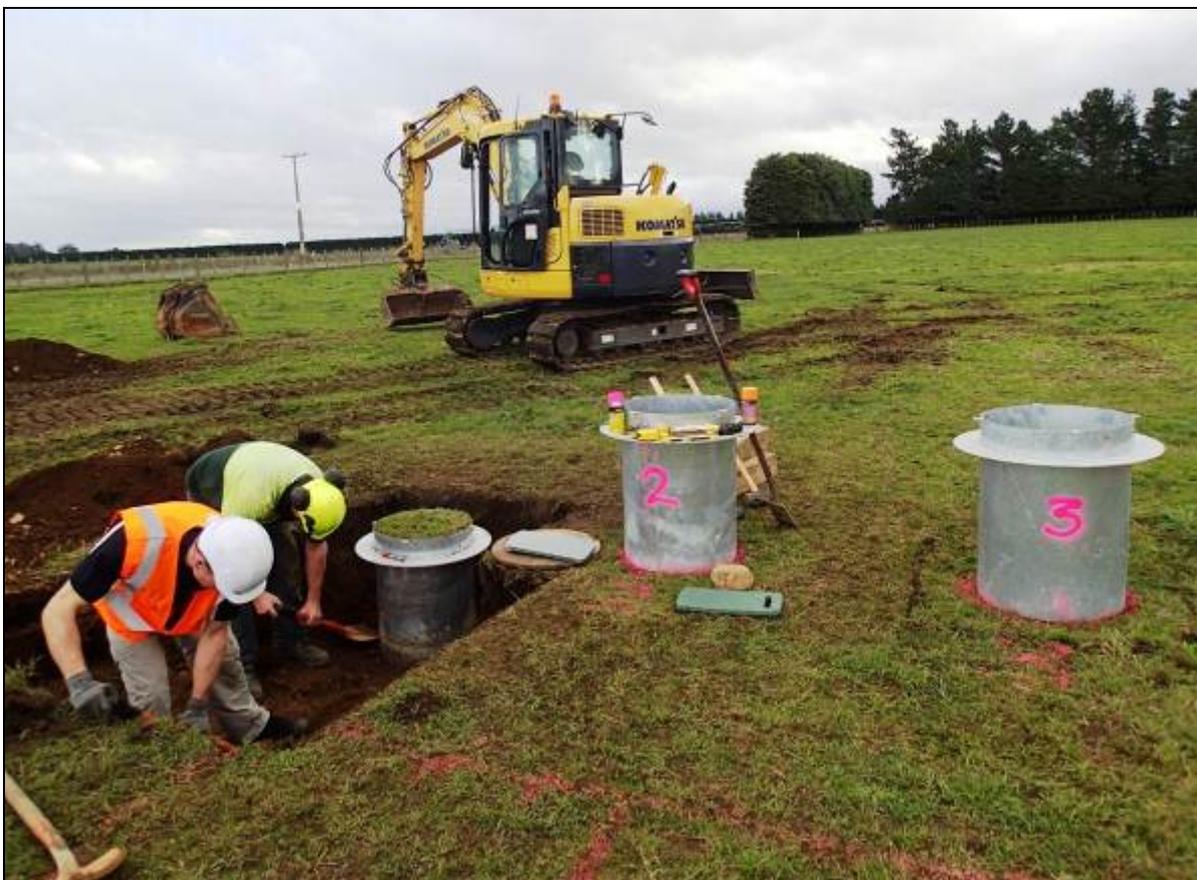
Figure 14: Preparing the pit around lysimeter one for the cutting frame and plate.

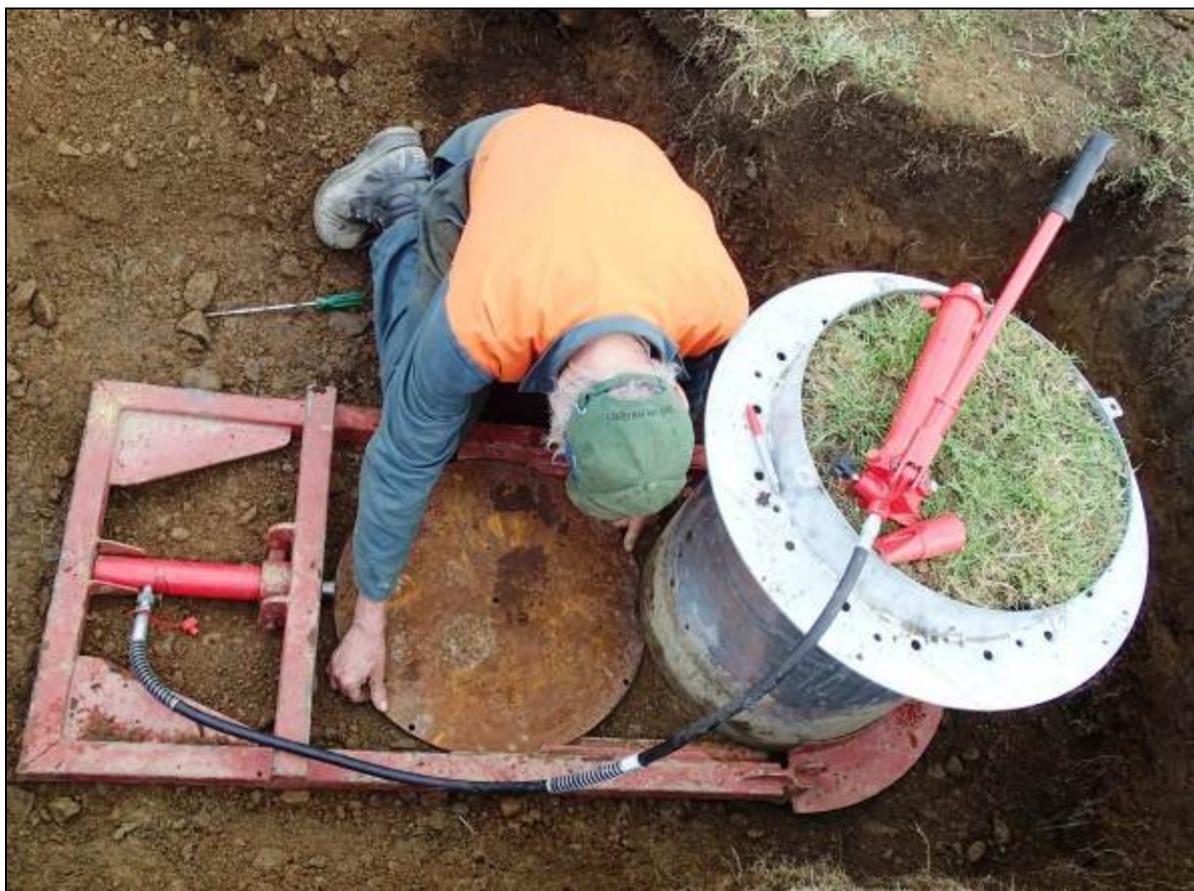
Figure 15: Levelling the cutting frame in the pit and preparing the plate for isolation of the lysimeter.

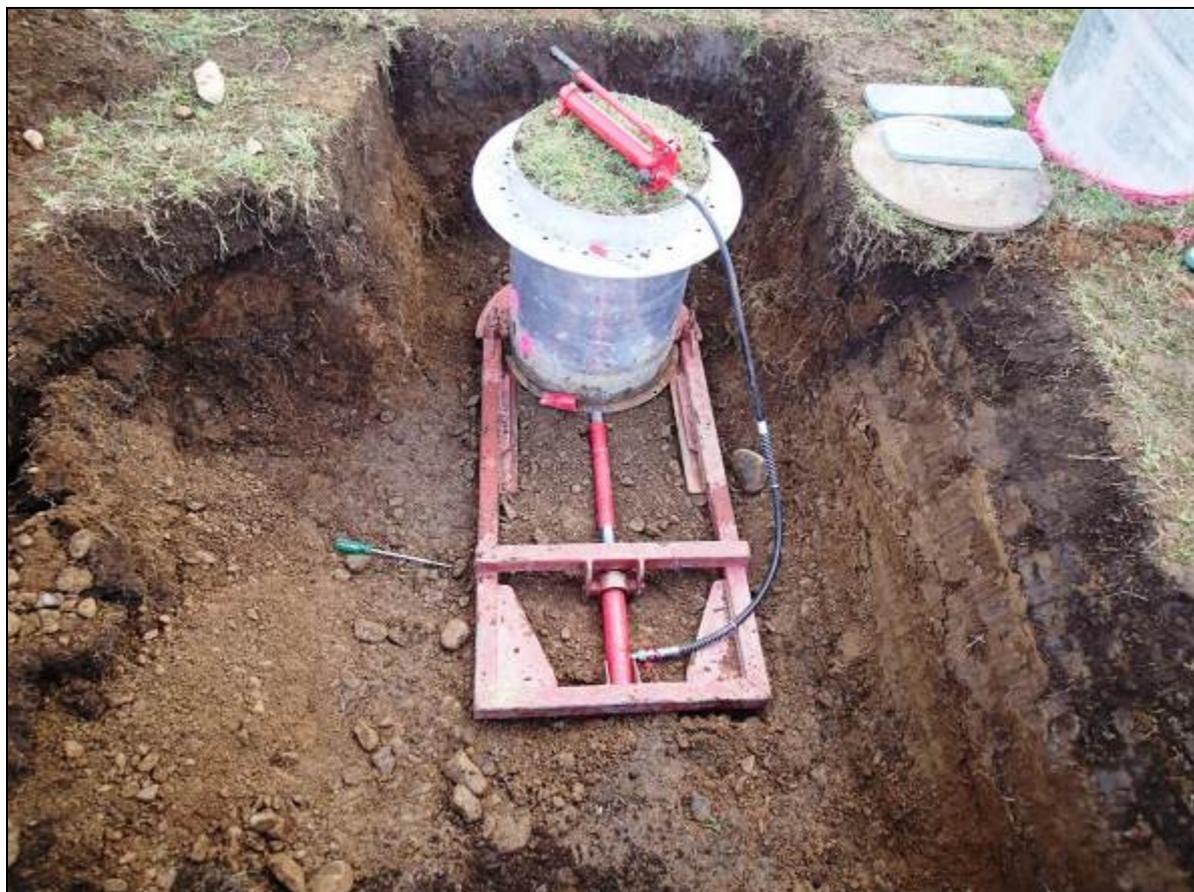
Figure 16: Lysimeter one after insertion of the cutting frame using the porta power pump.

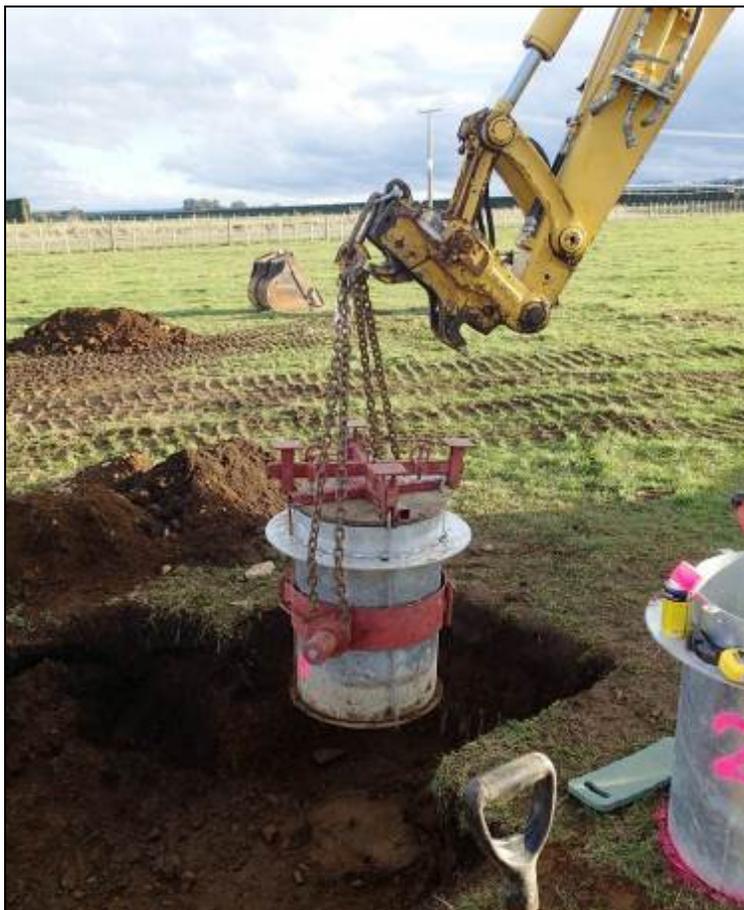
Figure 17: Lifting lysimeter one from the pit with lifting chains, head works and swivel clamp.

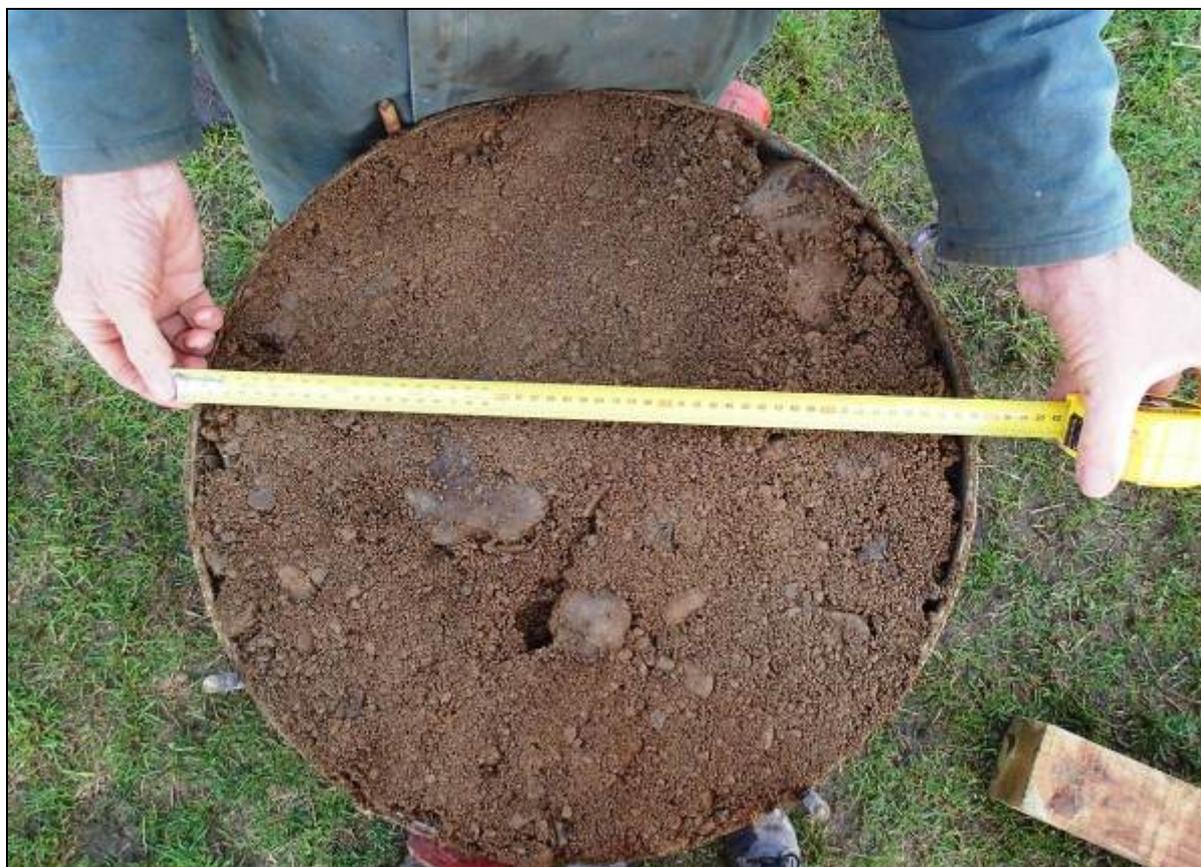
Figure 18: Base of lysimeter one following inversion and removal of the baseplate.

Each cutting plate was removed (Figure 18 – Figure 20) and the sediment was prepared so that the base of the lysimeter was level (Figure 21 – Figure 23). This allowed the base plate to be secured without any gaps. A circular layer of shade cloth was cut and placed on the soil base to stop fine material flowing from the lysimeter following installation (Figure 24). The base plate was inserted onto the rods and was temporarily bolted against the column. A 32 mm right-angle fitting, coupler and 15 mm reducer were attached to the base of the lysimeter (Figure 25). All pipe fittings were wrapped with thread tape prior to attachment, and were sufficiently tightened with an adjustable spanner.

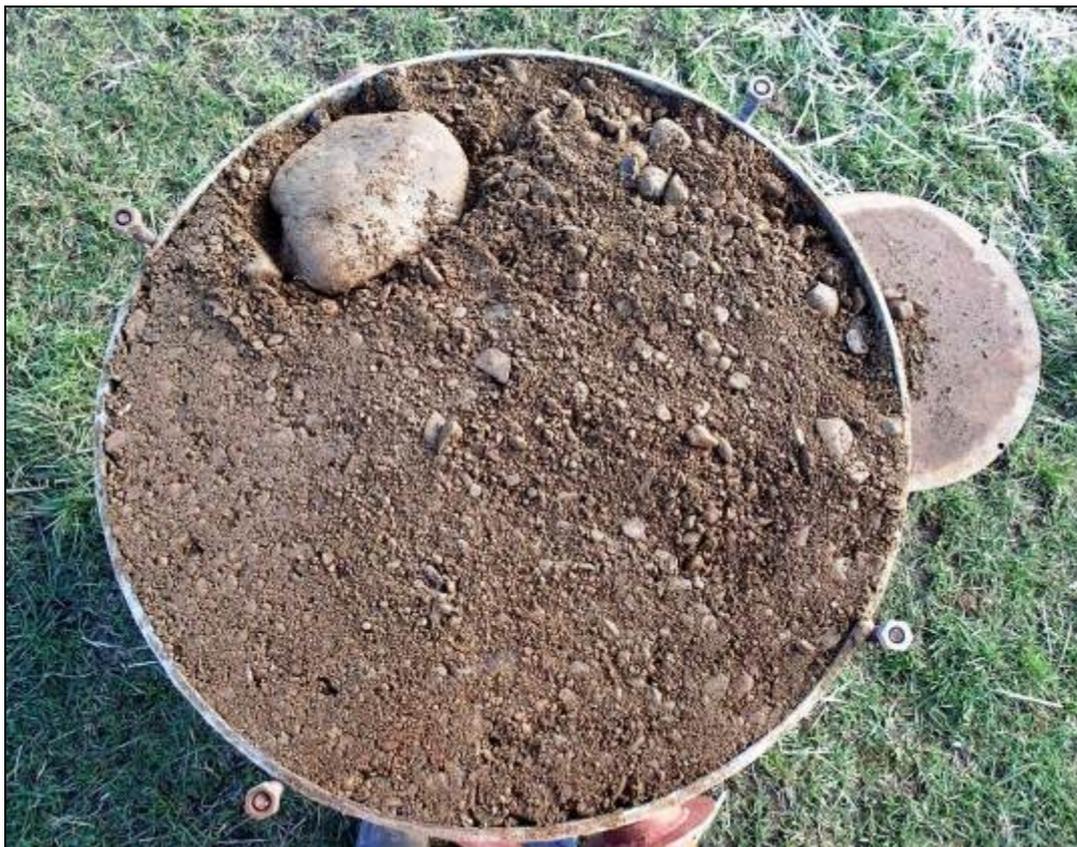
Figure 19: Base of lysimeter two following inversion and removal of the baseplate.

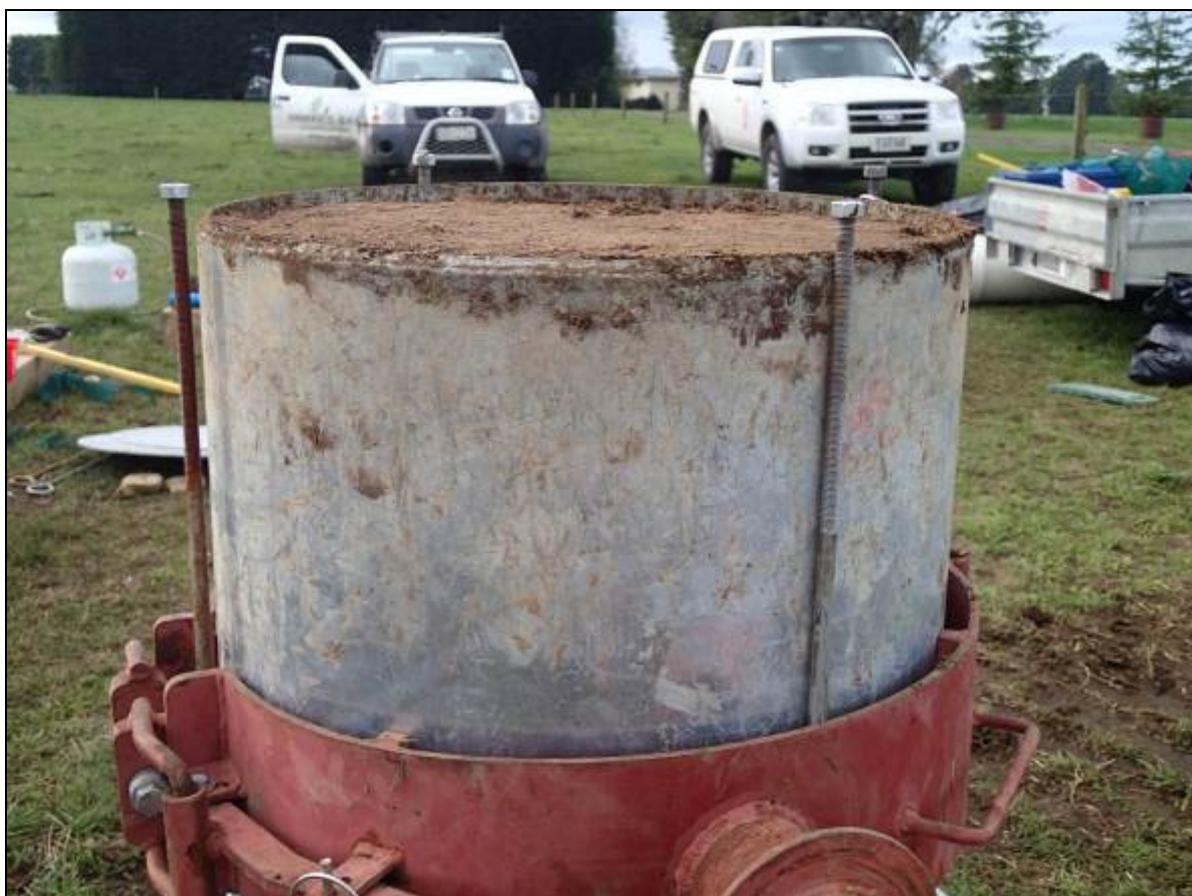
Figure 20: Base of lysimeter three following inversion and removal of the baseplate.

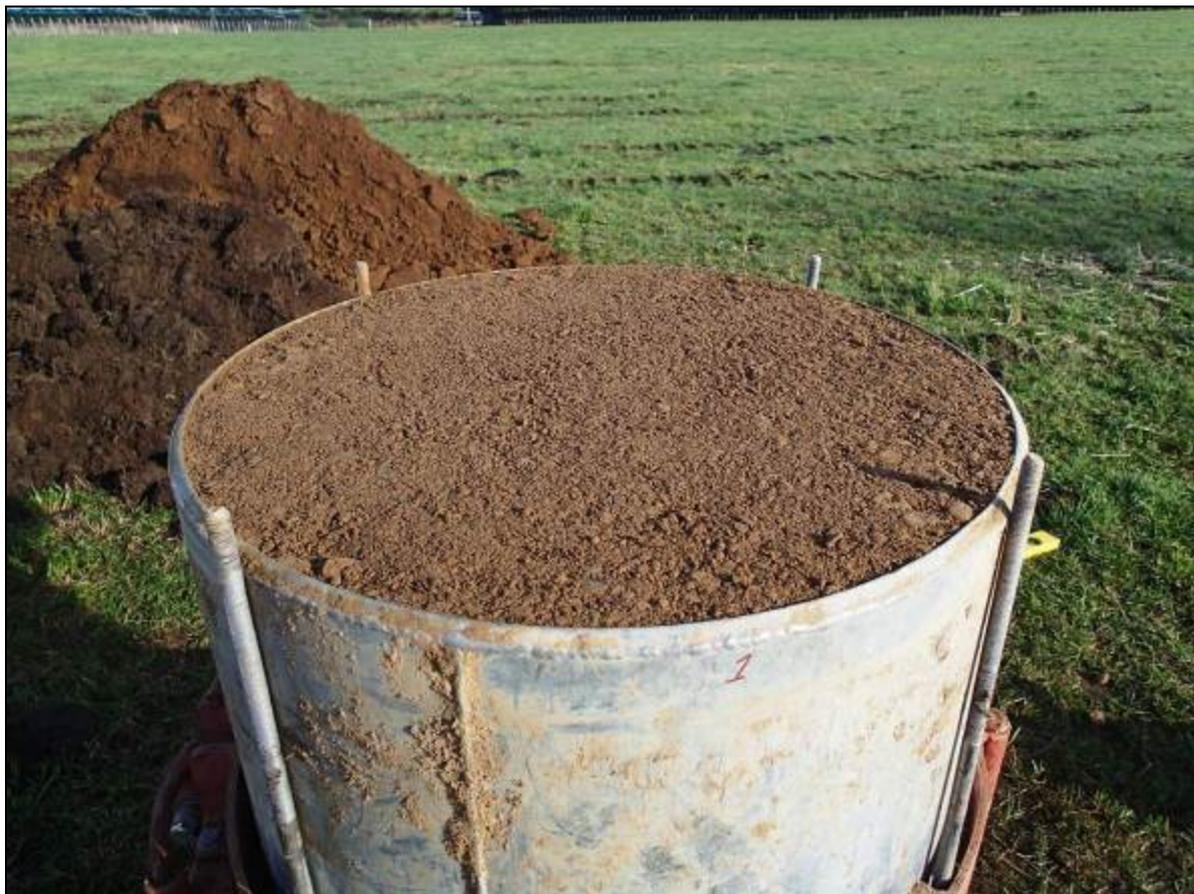
Figure 21: Base of lysimeter one following preparation.

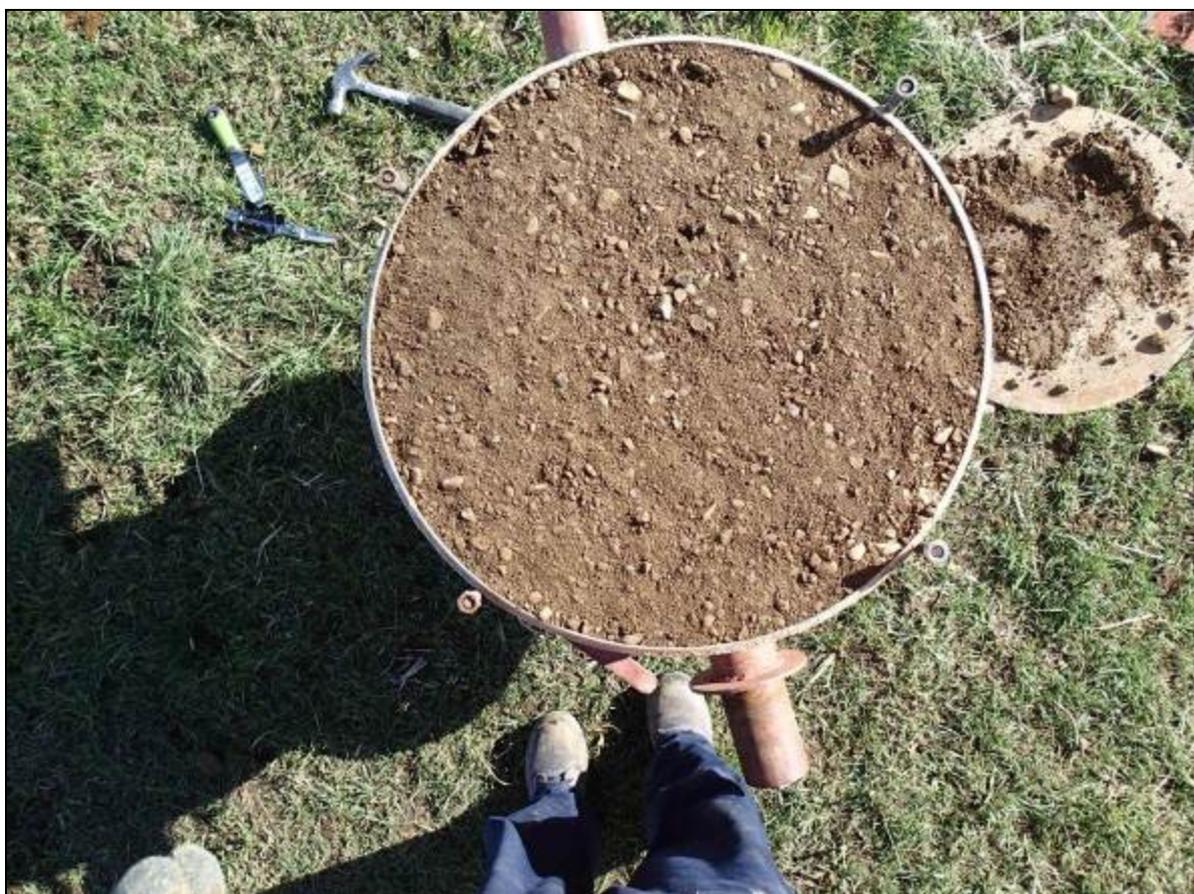
Figure 22: Base of lysimeter two following preparation.

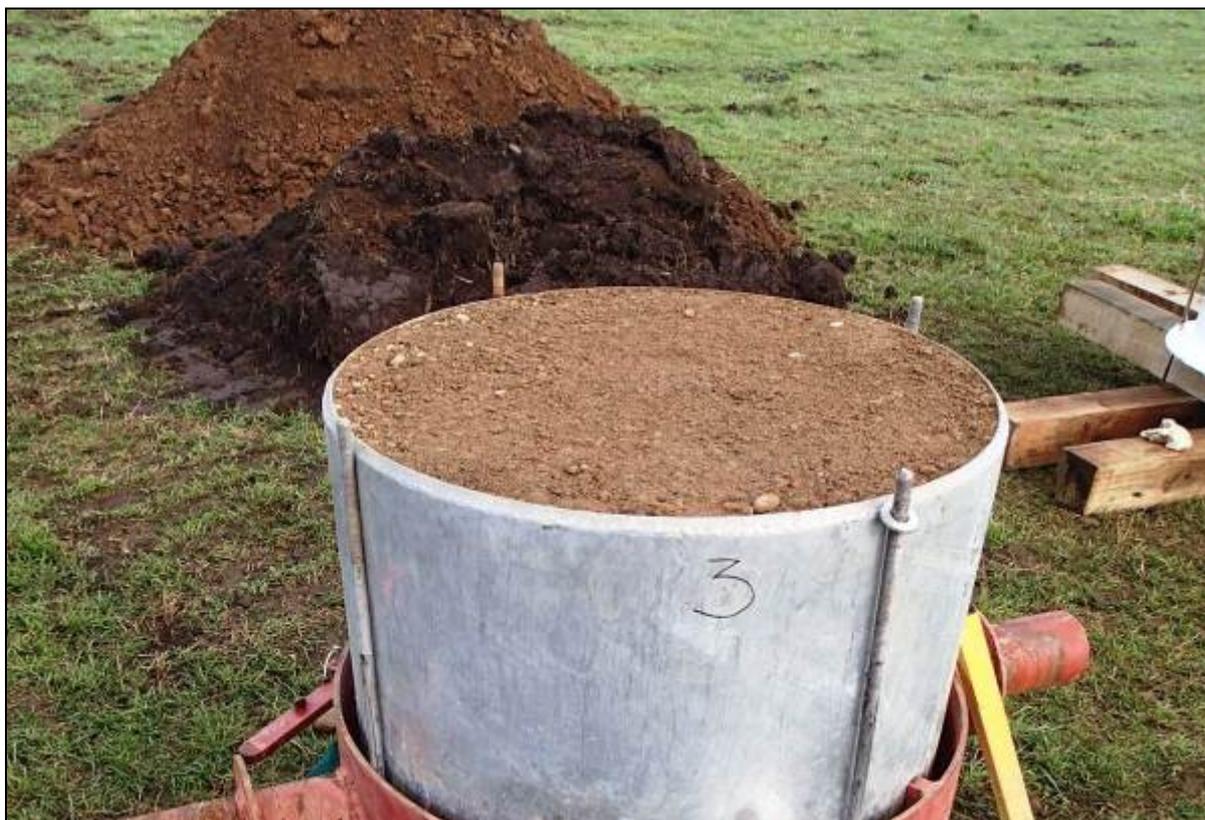
Figure 23: Base of lysimeter three following preparation.

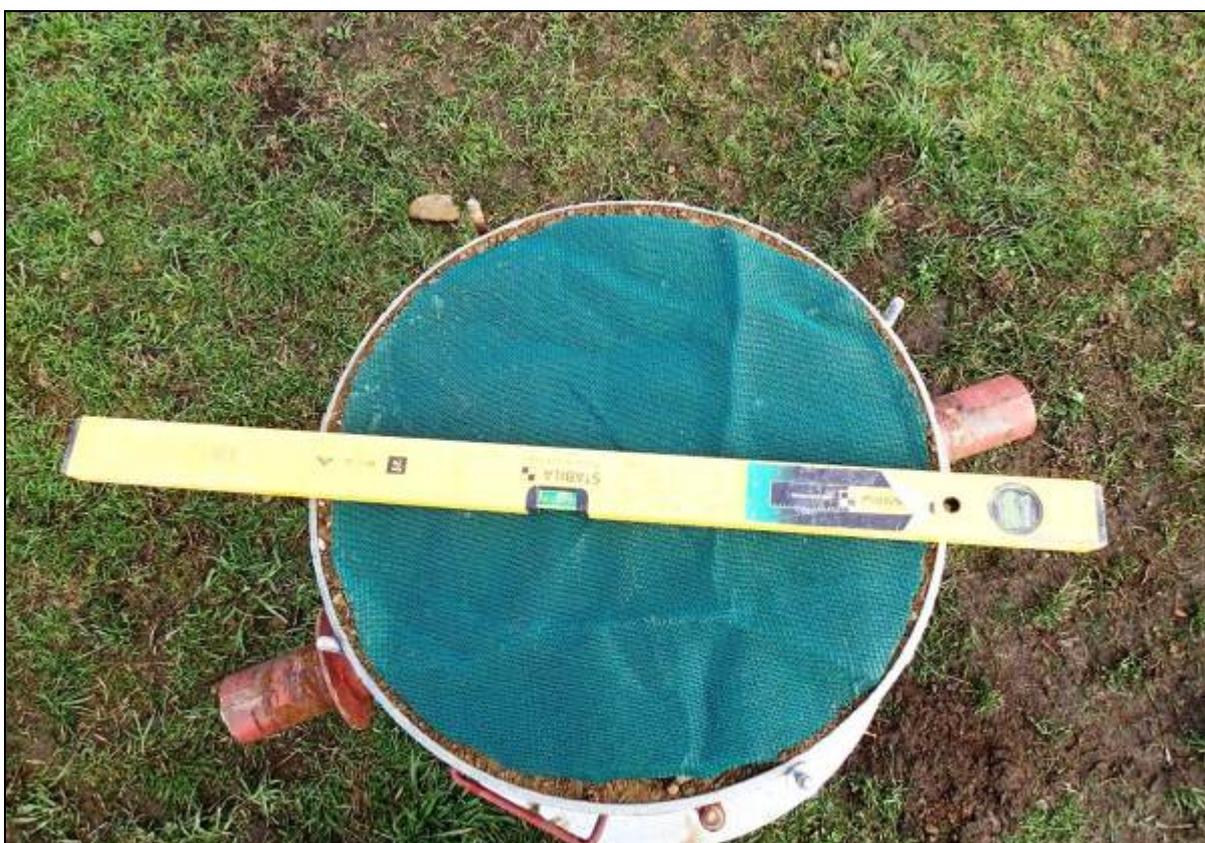
Figure 24: Shade cloth on the base of lysimeter three prior to fixing the base plate.
