Lovett, A. 2013 Installation of a dryland rainfall recharge lysimeter monitoring site at Ashcott Road, Ruataniwha Plains, Hawke's Bay, *GNS Science Consultancy Report 2013/174*. 41 p.

HBRC contracted GNS Science to oversee the installation of three 500 mm diameter rainfall recharge lysimeters and an instrument enclosure at Ashcott Road, Ruataniwha Plains (Figure 1 and Figure 2). The monitoring site is located on well-drained soil, overlying an unconfined recharge area (Griffiths, 2004; Landcare Research, 2013). Rainfall recharge datasets from the site will complement datasets from previously installed sites in the Heretaunga Plains at Bridge Pa, Maraekakaho and Fernhill (Figure 3). Rainfall recharge information from the network of HBRC monitoring sites will be useful to estimate rainfall recharge across the Hawke's Bay region to assist in groundwater management.

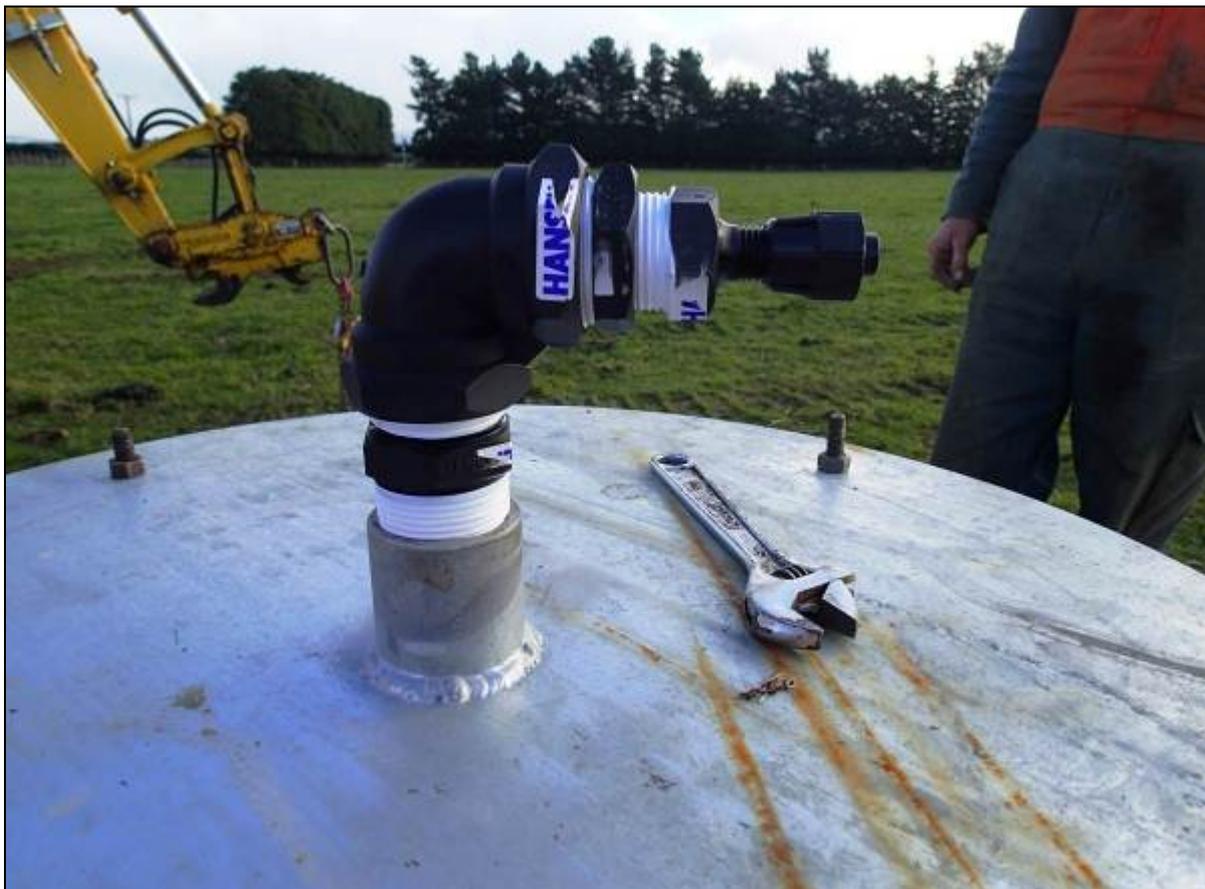
Figure 25: Inverted lysimeter following attachment of the pipe fittings.

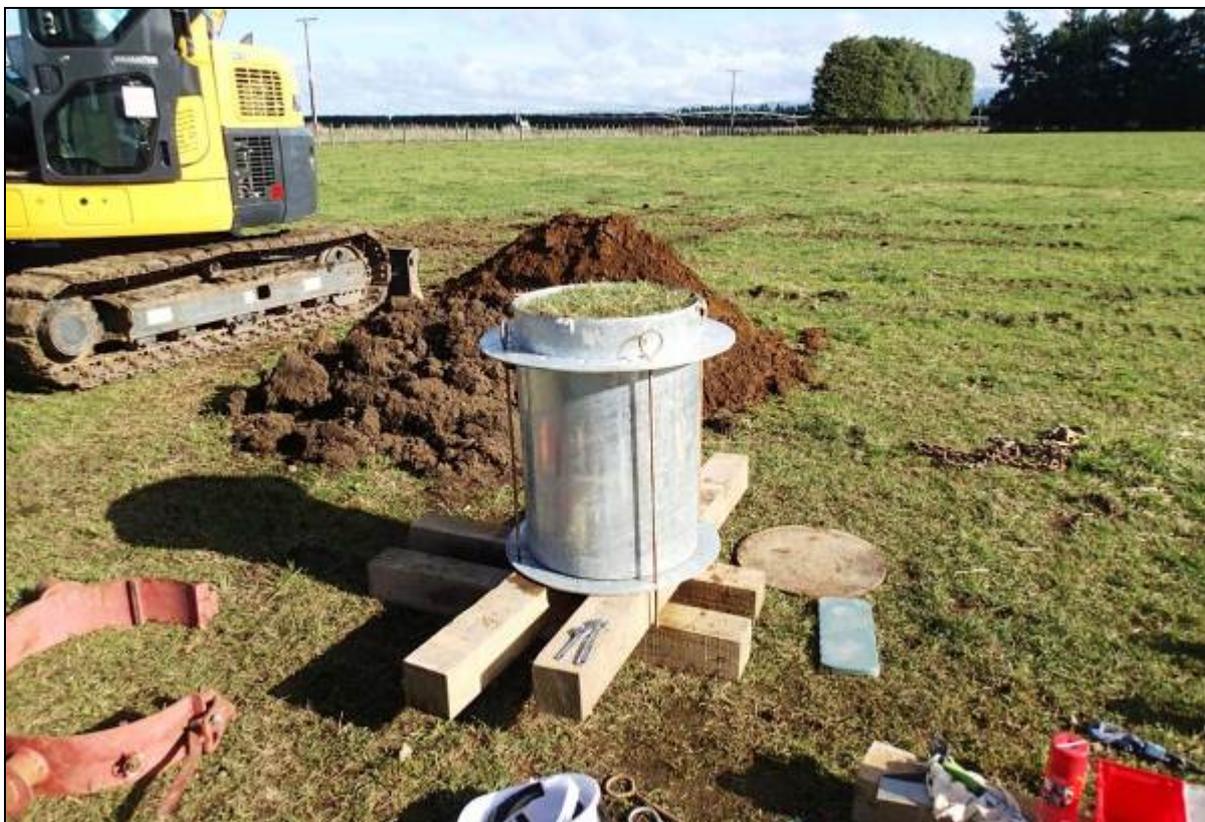
Figure 26: Lysimeter one following cleaning and preparation for sealing.

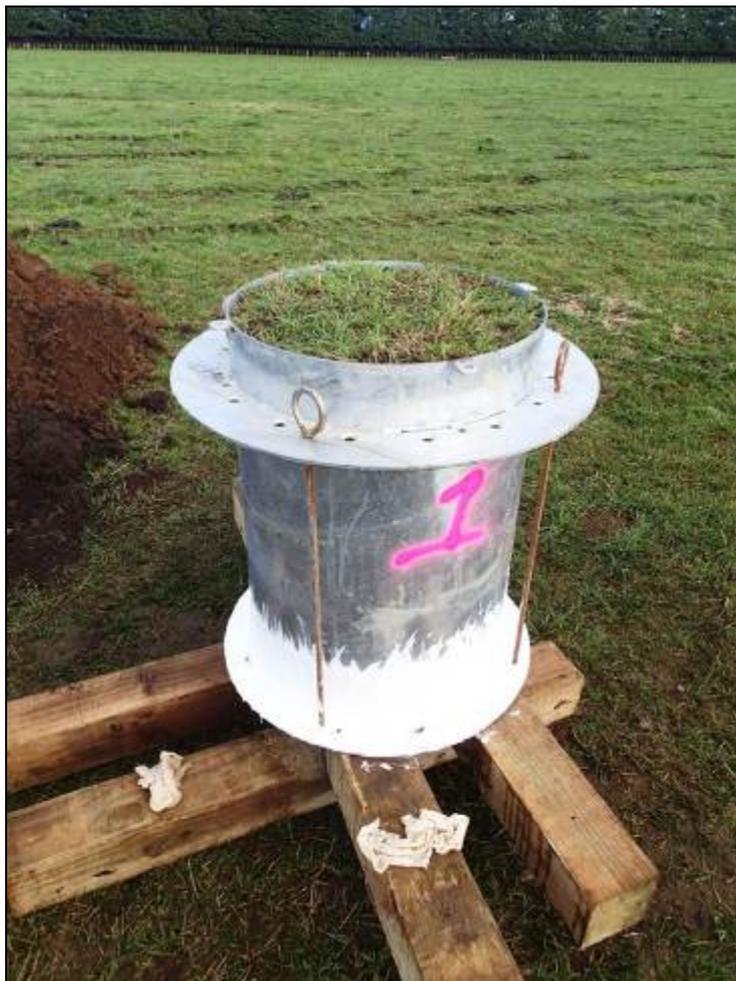
Figure 27: Lysimeter one following sealing with Sika 291 marine sealant.

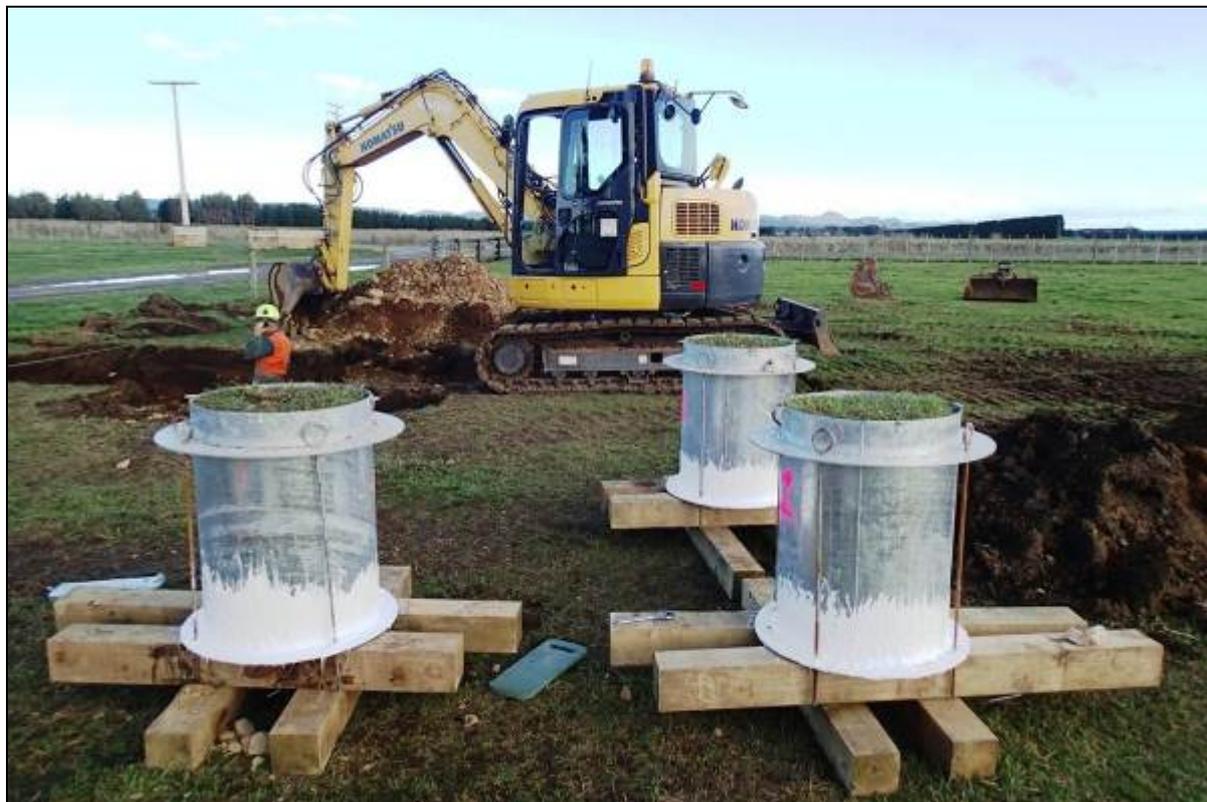
Figure 28: All three lysimeters following sealing.

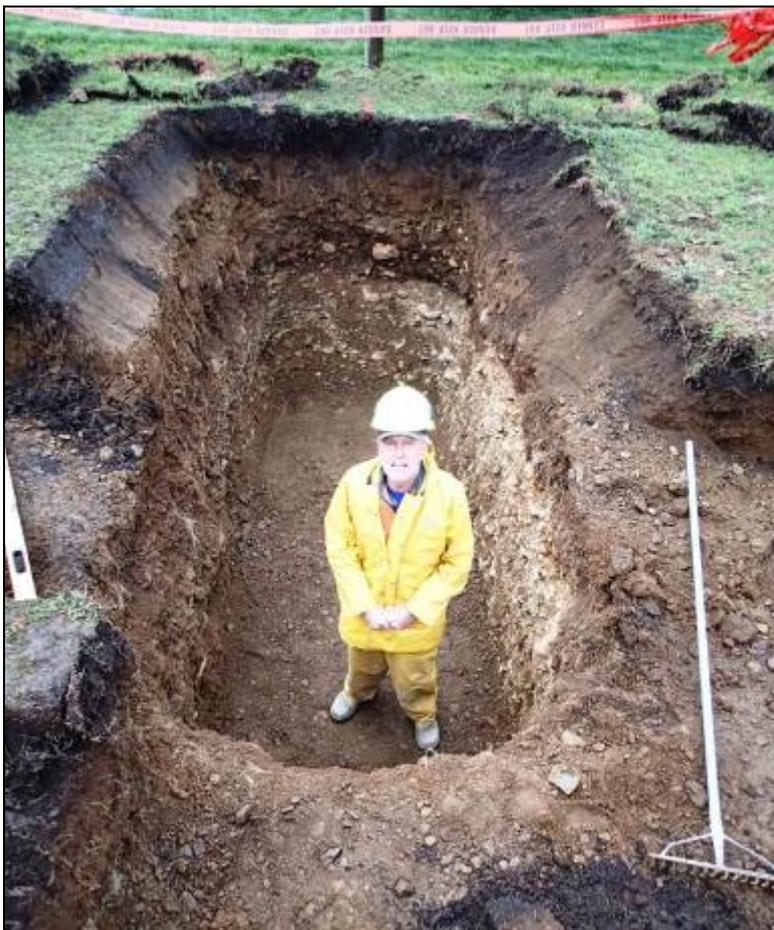
Figure 29: Pit excavated and prepared with a sloping gradient, ready for the enclosure.

In order to assist with site re-establishment, the excavator was used to remove grass sod from a rectangular area around the enclosure. The pit was excavated and prepared for installation of the lysimeters and the concrete enclosure (Figure 29). Particular care was taken to create a 10 mm fall gradient away from the instrument end of the concrete tank, in order to facilitate drainage within the enclosure. A truck mounted crane was used to lift the 4500 L (3010 mm long by 1260 mm wide) concrete enclosure into the prepared pit (Figure 30). The enclosure was checked to ensure it was level (Figure 31). Once the enclosure was installed, string lines were set at ground level to assist with reinstallation of the prepared lysimeters (Figure 32) at the appropriate height relative to ground level and slope.

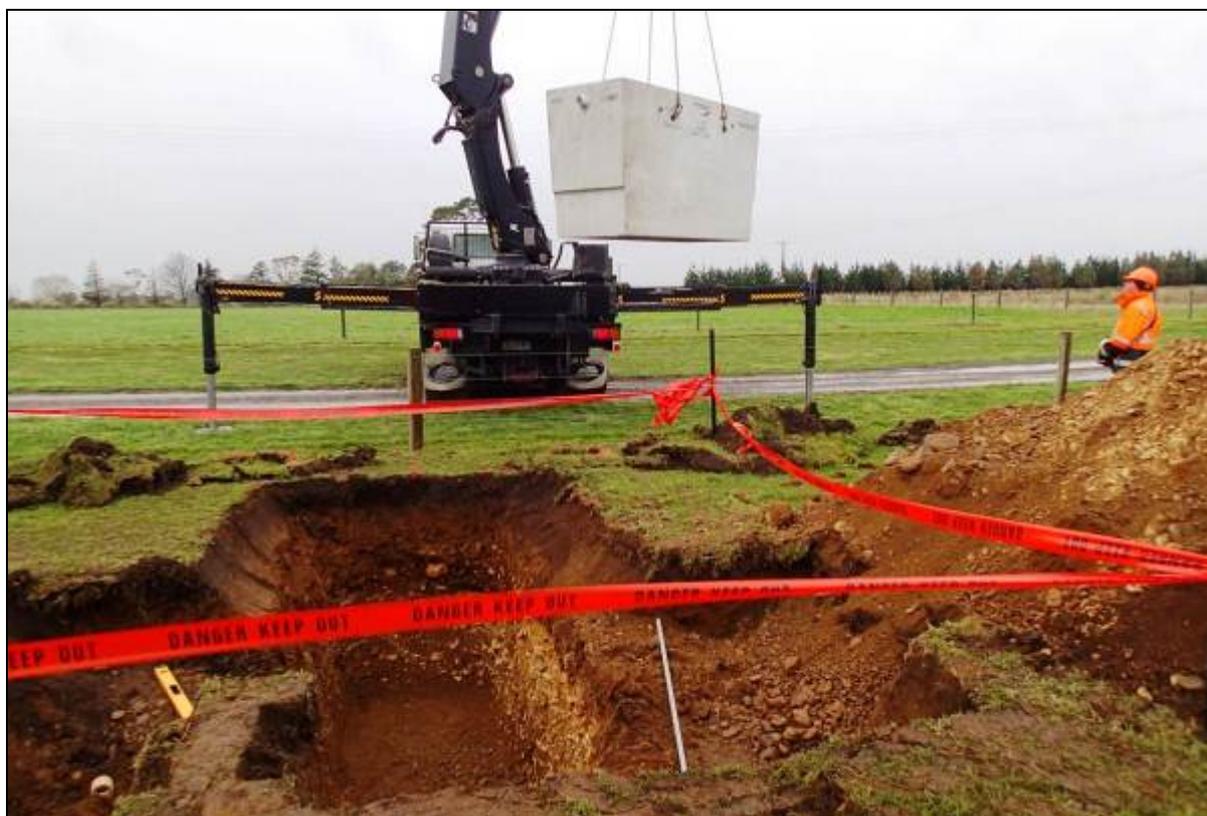
Figure 30: Lowering the concrete enclosure into the pit with a truck mounted crane.

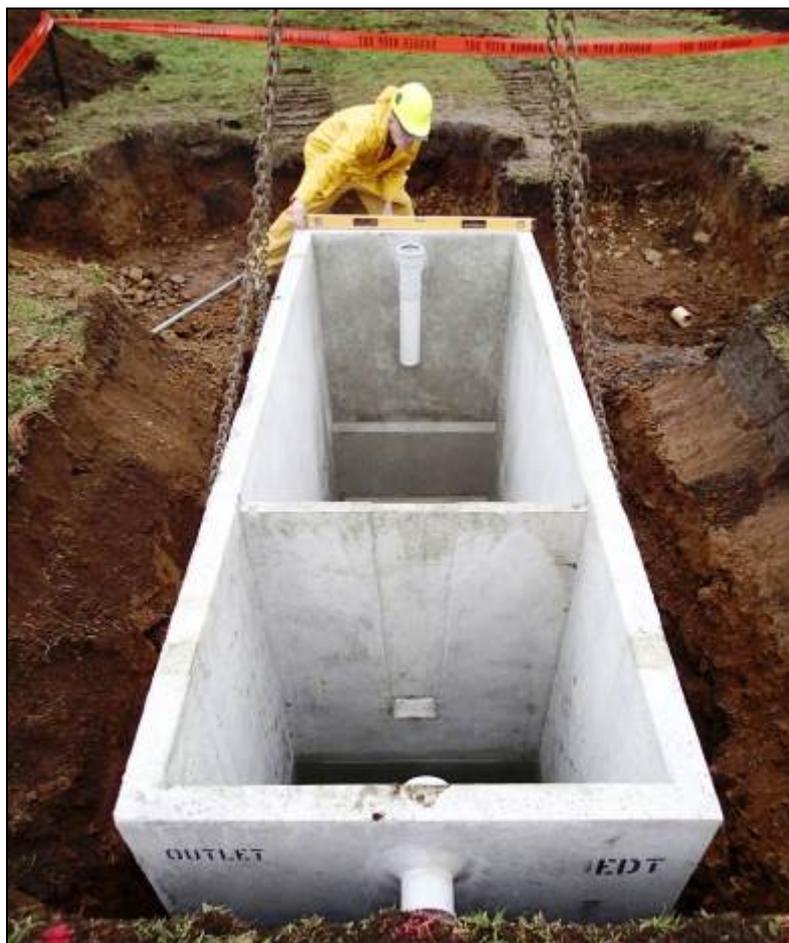
Figure 31: Ensuring the concrete enclosure is level.

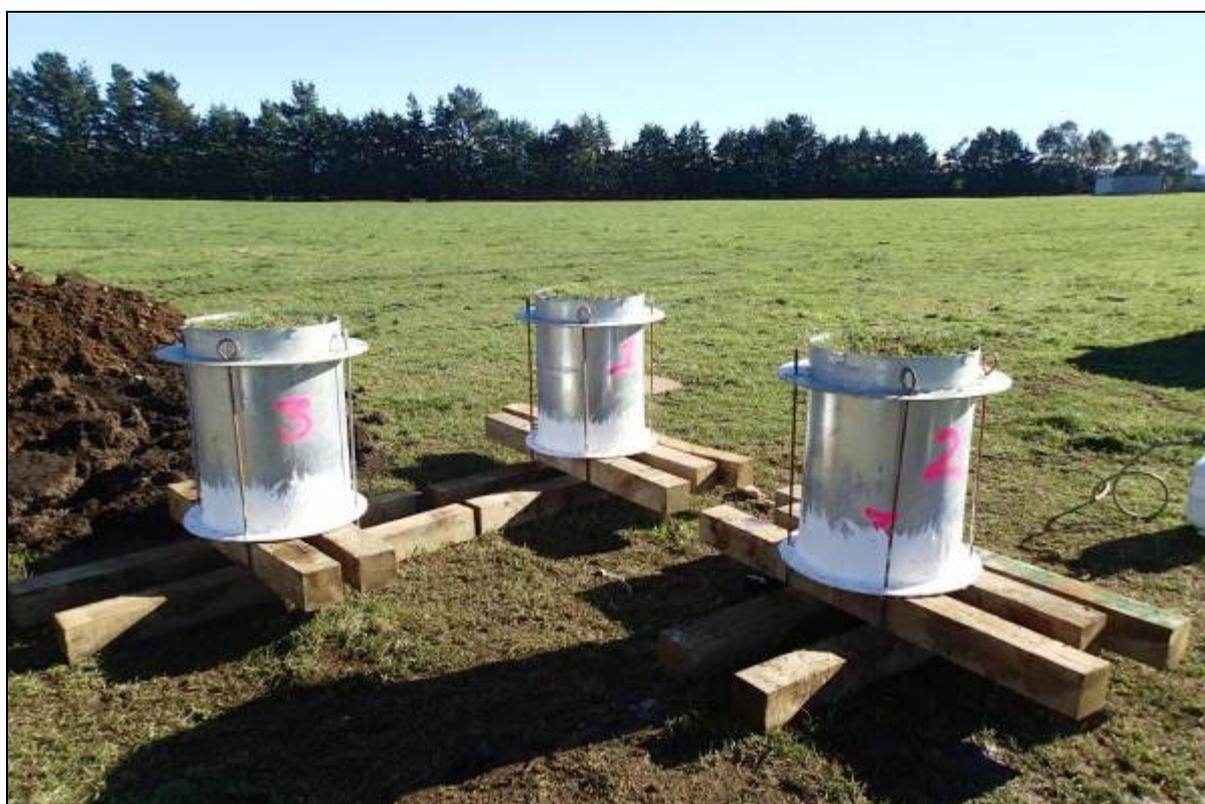
Figure 32: Lysimeters three, one and two (L-R) prepared and ready for re-instatement.

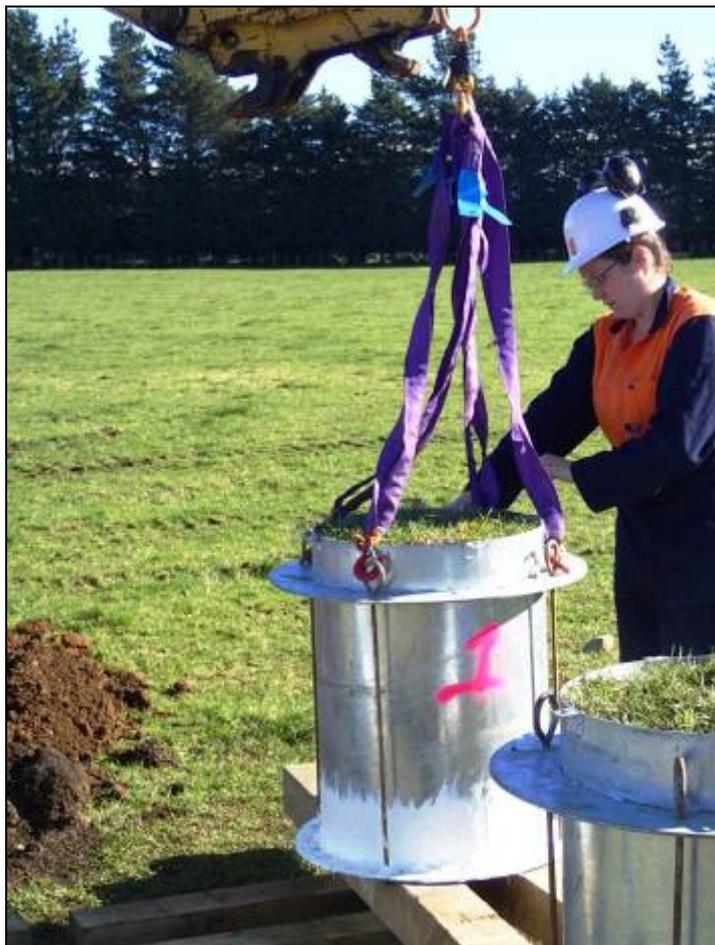
Figure 33: Attaching lifting strop to the lysimeter rods for re-installation onto timber frames.

Each lysimeter was lifted using the excavator and safety strops (Figure 33). Cold weather conditions made it difficult to work with the 15 mm alkathene pipe, so boiling water was poured down the pipe lengths to straighten them. An approximately 3 m length of 15 mm diameter alkathene pipe was attached to the reducer at the base of the lysimeter. The lysimeters were then lowered into the pit using the excavator. Timber platforms of 1.5 m long, 125 mm x 125 mm treated house piles were installed (Figure 34 and Figure 35). During preparation of the platform, particular care was taken to ensure that the house piles were level and at a height that would allow the lysimeter casing to sit around 15 mm above the ground surface. Three holes were drilled through the concrete enclosure wall using a diamond drill and the 15 mm alkathene pipes were inserted through these holes (Figure 36 and Figure 37). A length of 65 mm diameter flexi-pipe (2.5 m to 3.0 m) was placed over the 15 mm alkathene pipe to protect it from crushing during infilling (Figure 36). A fall gradient of at least 100 mm was created from the base of the lysimeter fittings to the concrete enclosure to ensure rainfall recharge was transferred to the rain gauge without delay.

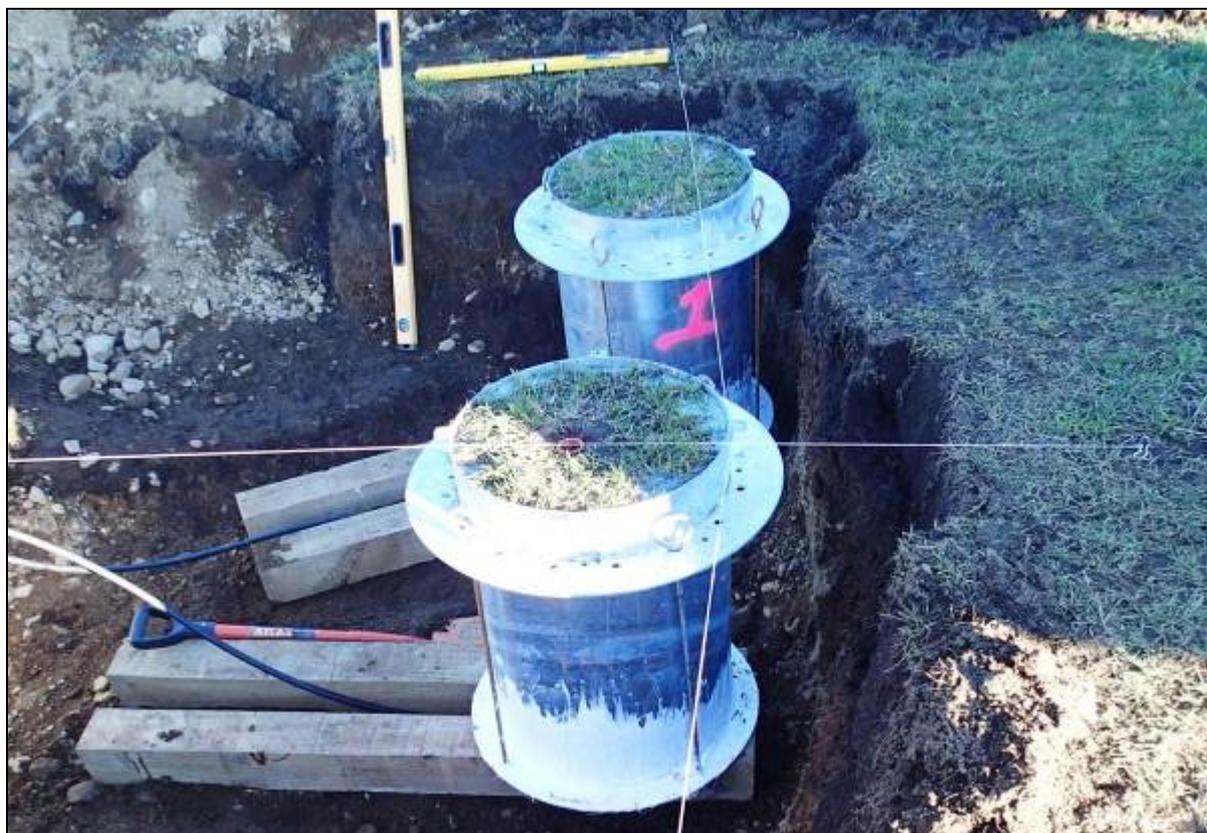
Figure 34: Lysimeter one and two installed onto levelled timber platforms.

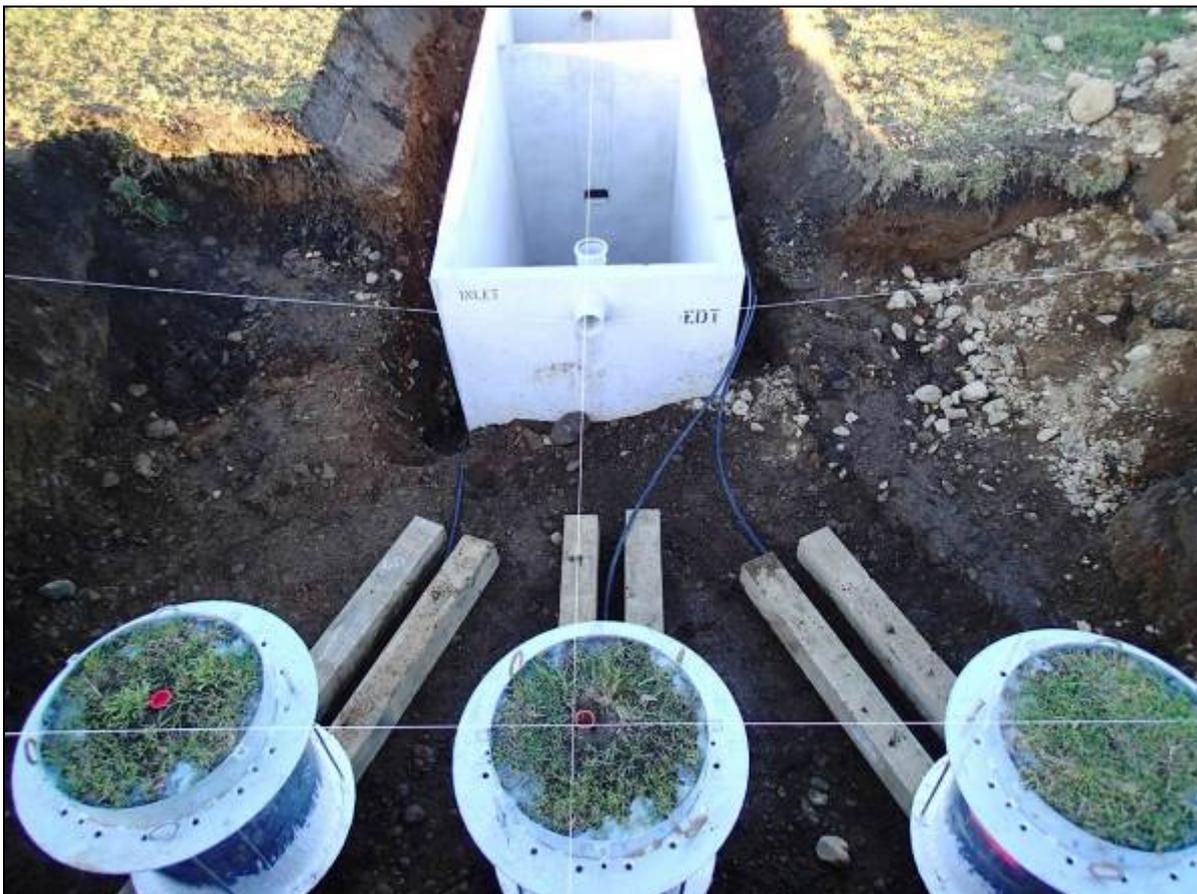
Figure 35: Lysimeters on levelled timber platforms with alkathene pipes.

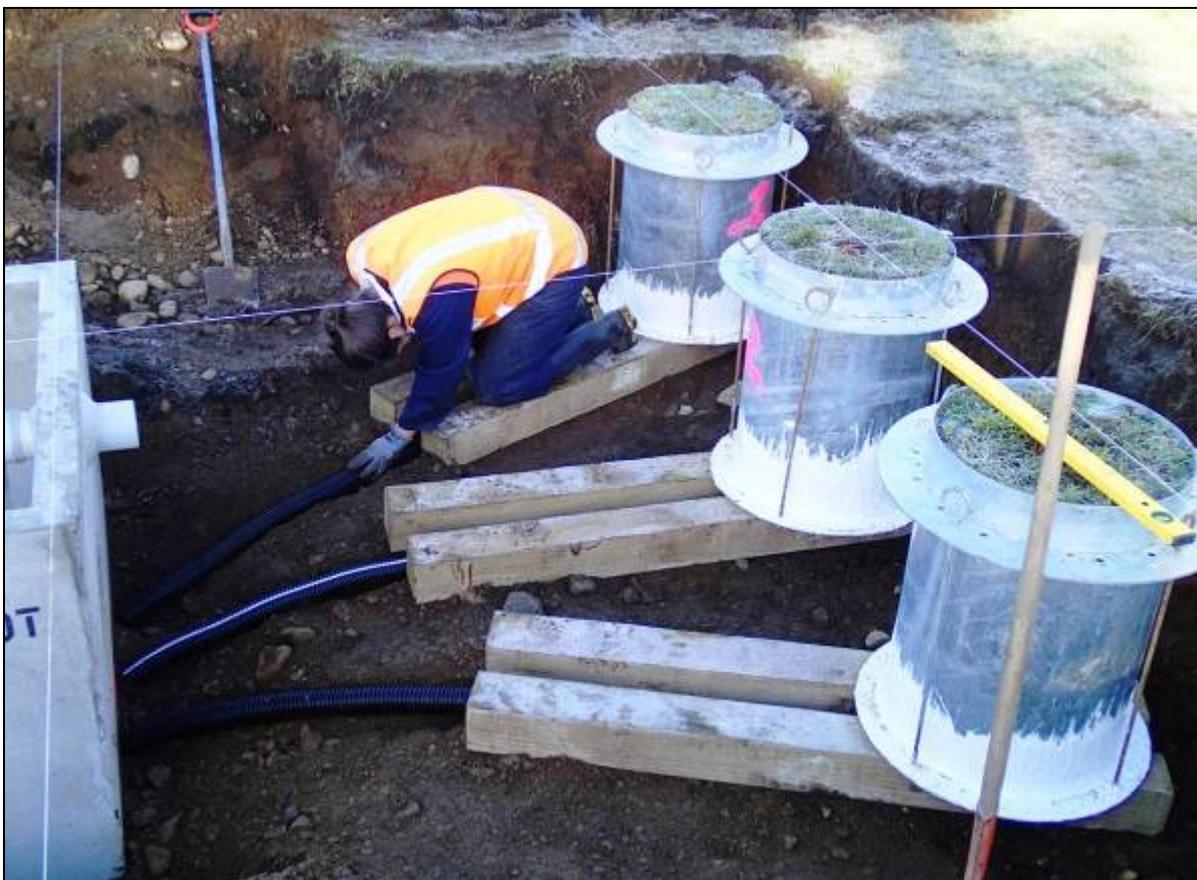
Figure 36: Lysimeters with alkathene pipe inserted into the enclosure and covered with flexipipe.

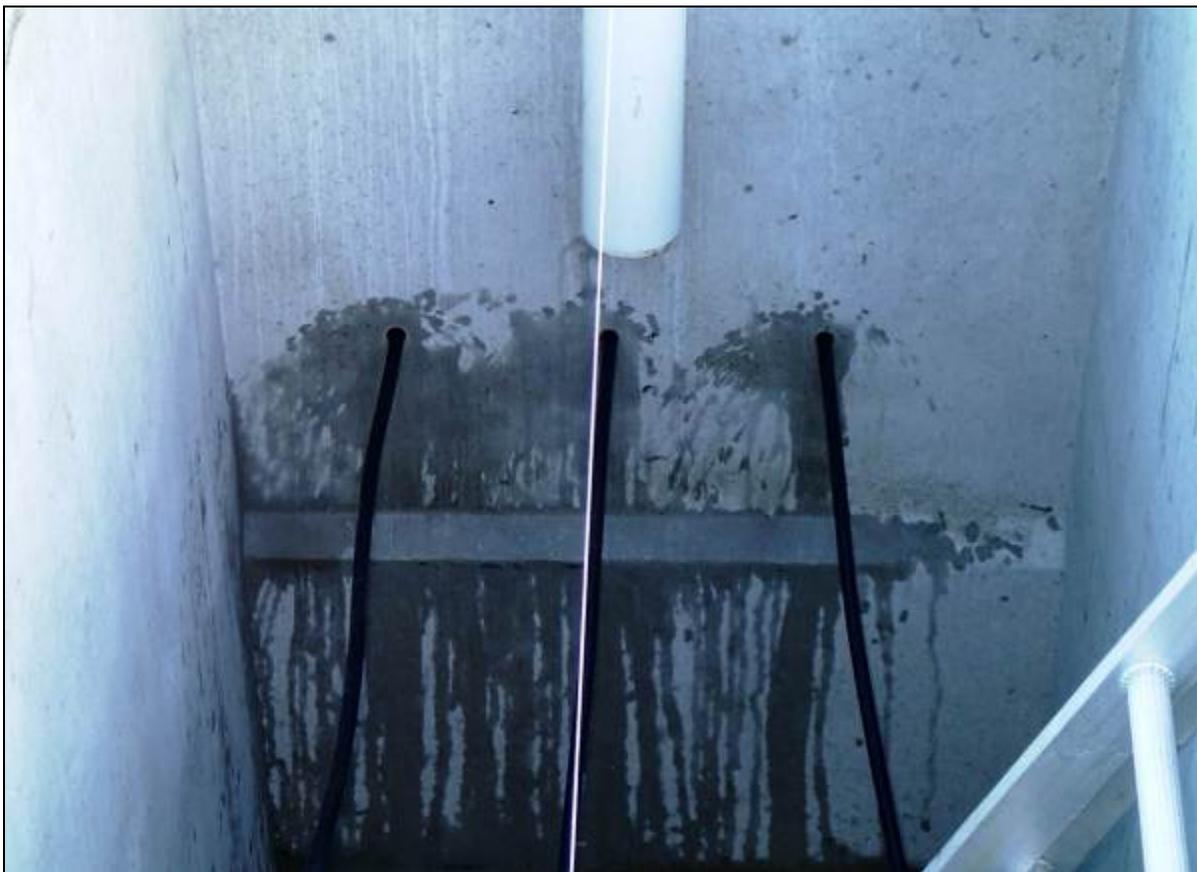
Figure 37: Pipe holes drilled through the concrete wall using a diamond drill.

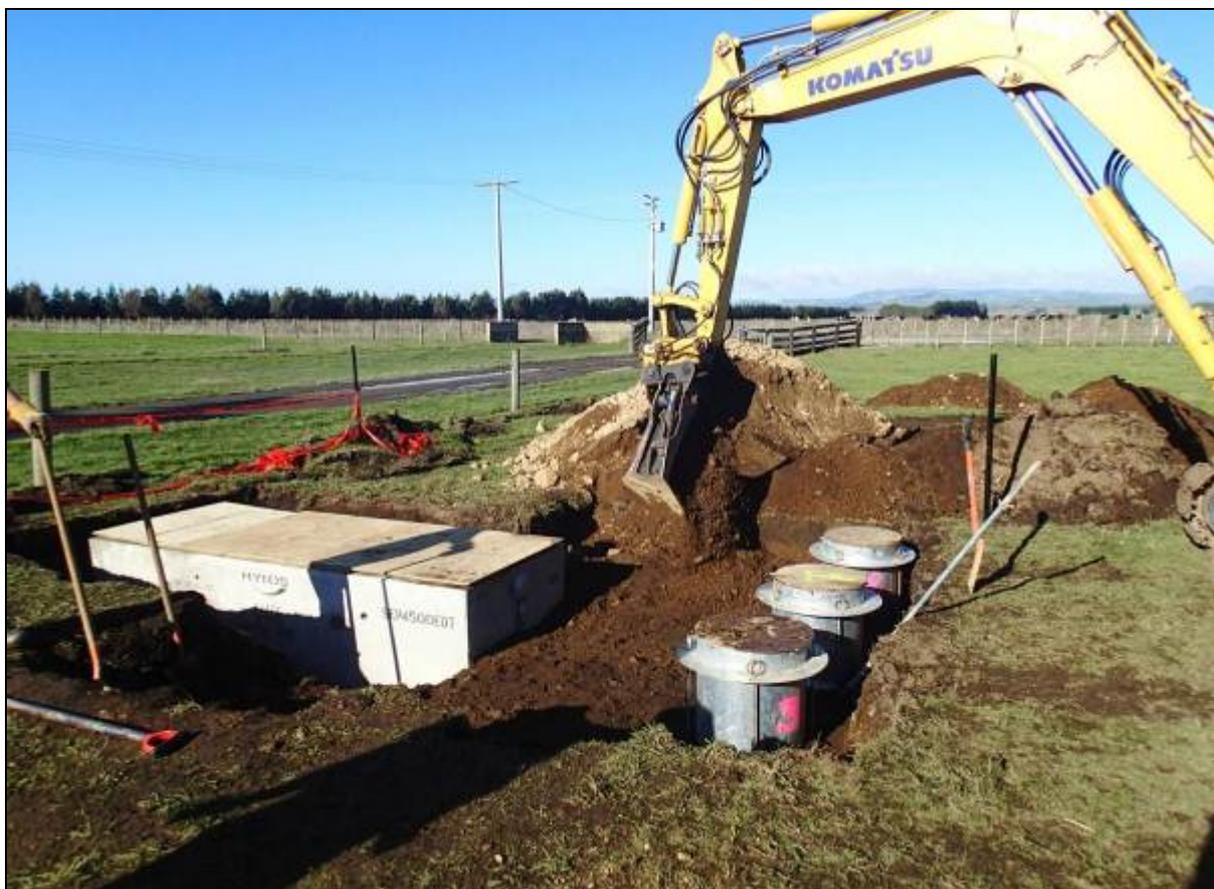
Figure 38: Infilling of the pit, ensuring to re-instate the soil similar to natural profile.

Wooden lids were placed on the lysimeters and the enclosure was covered with plywood to prevent fouling from sediment. Infilling of the excavated area around the lysimeters was undertaken using the excavator and manually (Figure 38). Particular care was taken to ensure that the lysimeters were packed into the surrounding sediment, using a posthole rammer, to minimise subsidence following installation. The soil and turf were re-instated as close to natural profile as possible (Figure 39 and Figure 40). Installation of the rainfall recharge lysimeters and instrument enclosure was completed on 25 June, 2013 (Figure 41 – Figure 43). HBRC hold responsibility for the subsequent installation of tipping bucket rain gauges, data loggers, telemetry systems and other essential equipment to allow for operation of the rainfall recharge monitoring site.

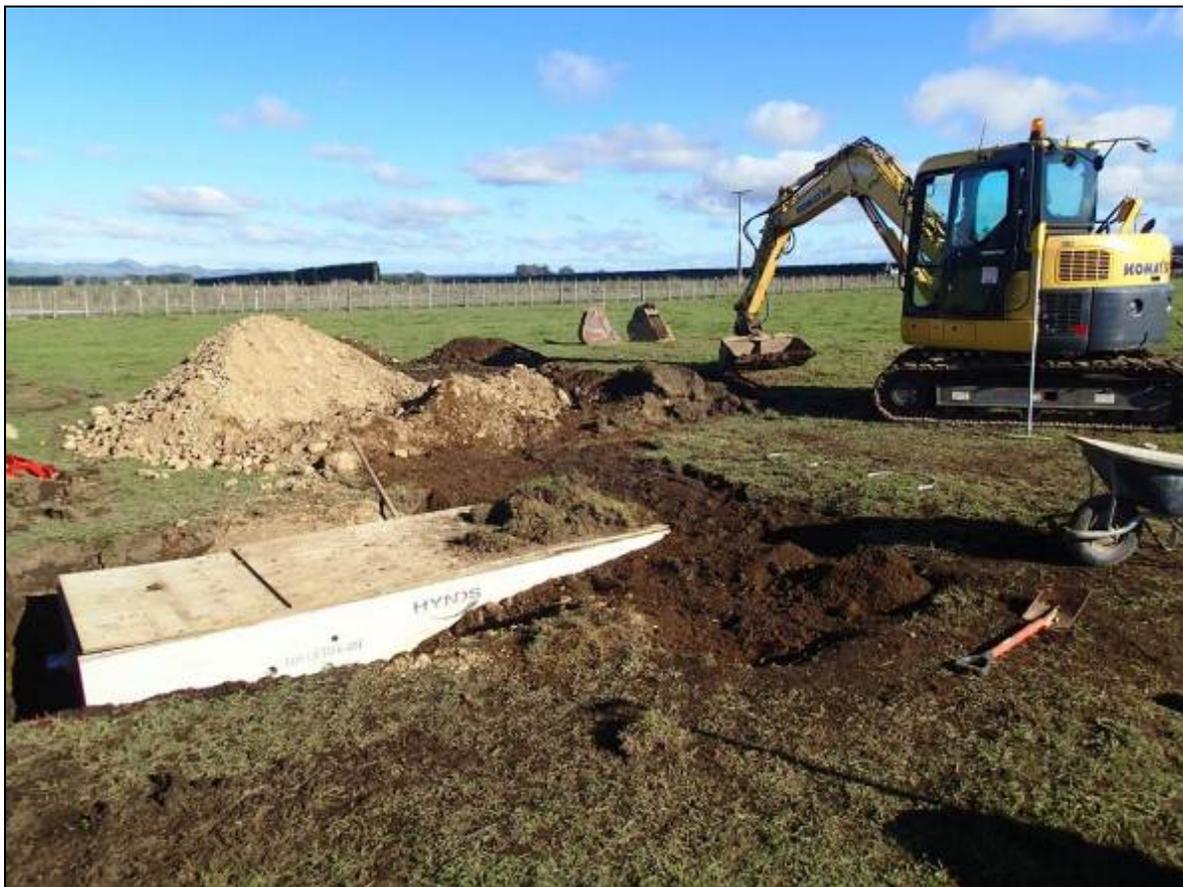
Figure 39: Infilling of soil and re-instatement of grass sod to ground level.

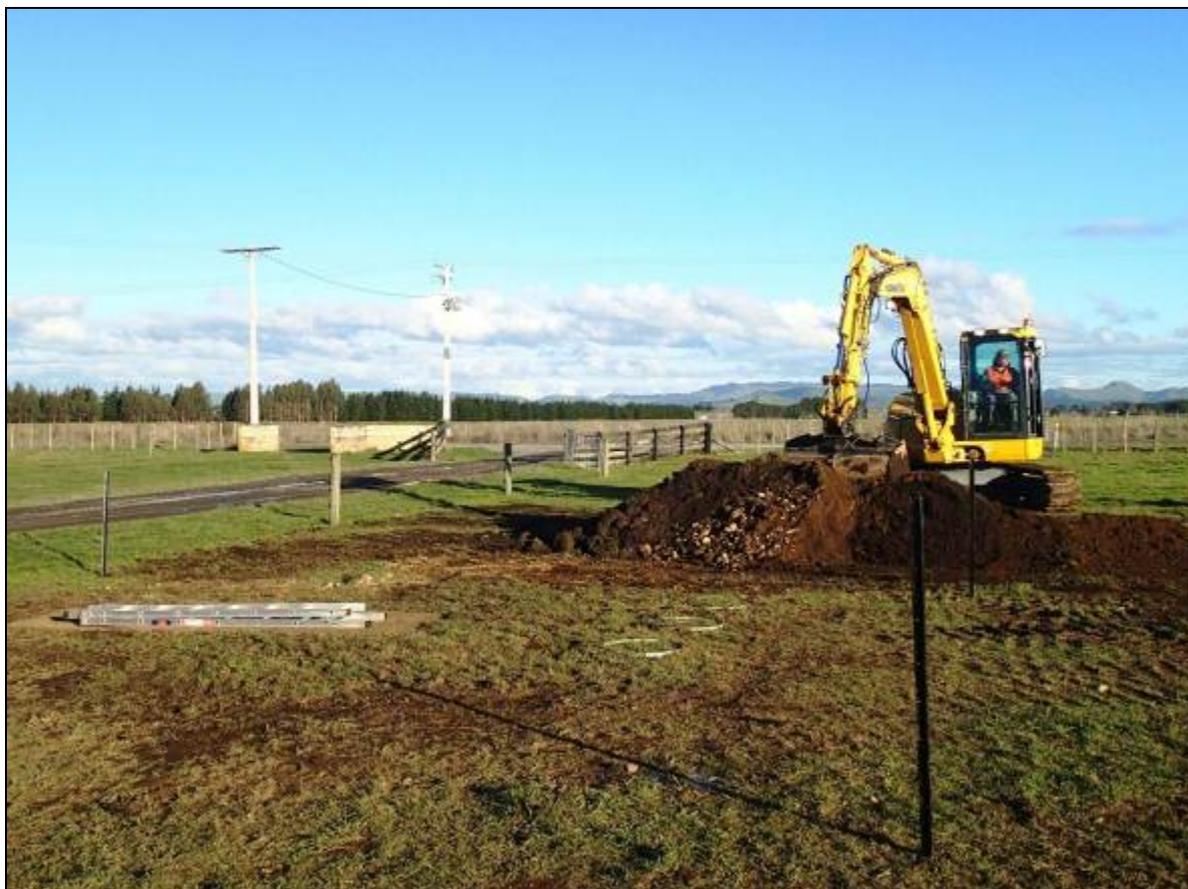
Figure 40: Site completed with re-instatement of soil and grass sod.

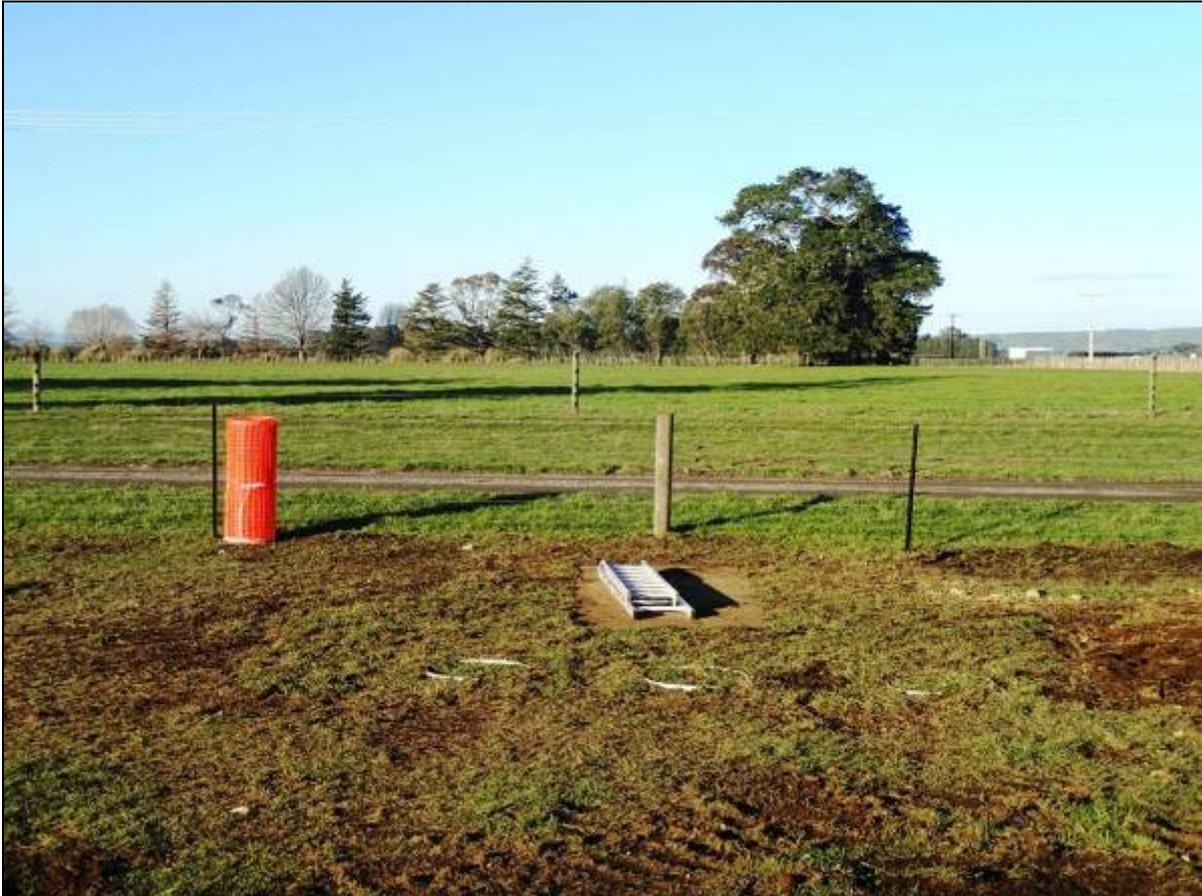
Figure 41: Completed installation of three rainfall recharge lysimeters and concrete enclosure.

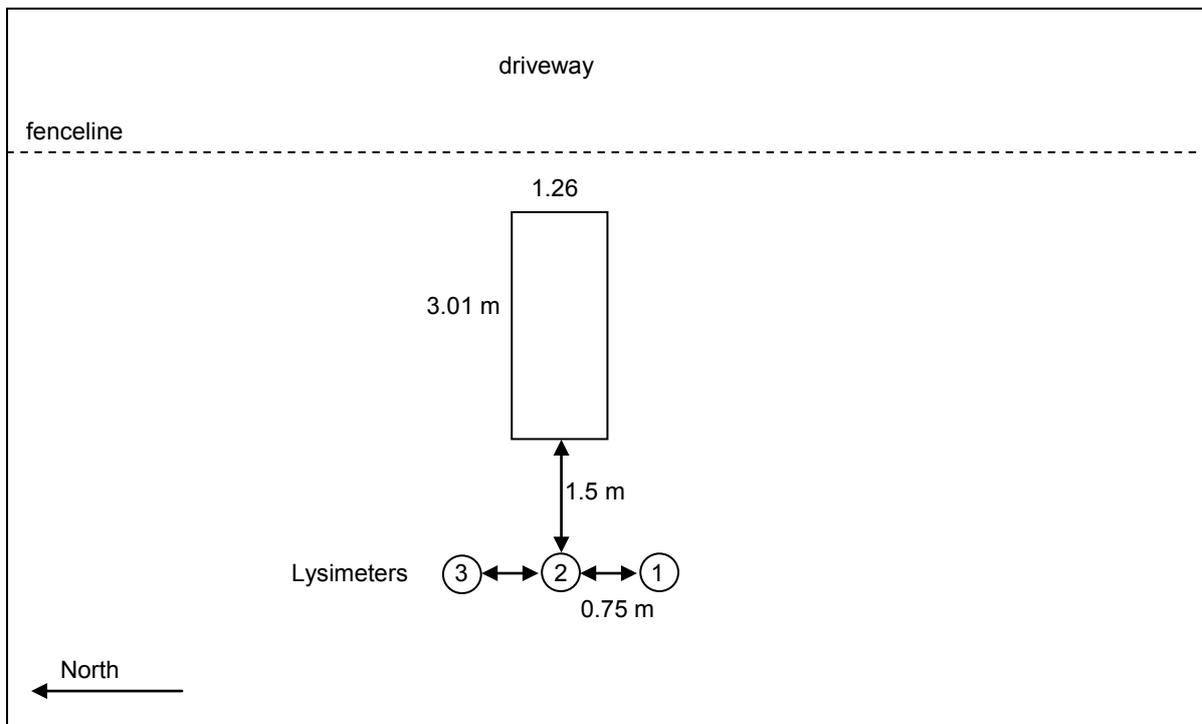
Figure 42: Diagram showing rainfall recharge site layout and orientation, refer to Figure 41.

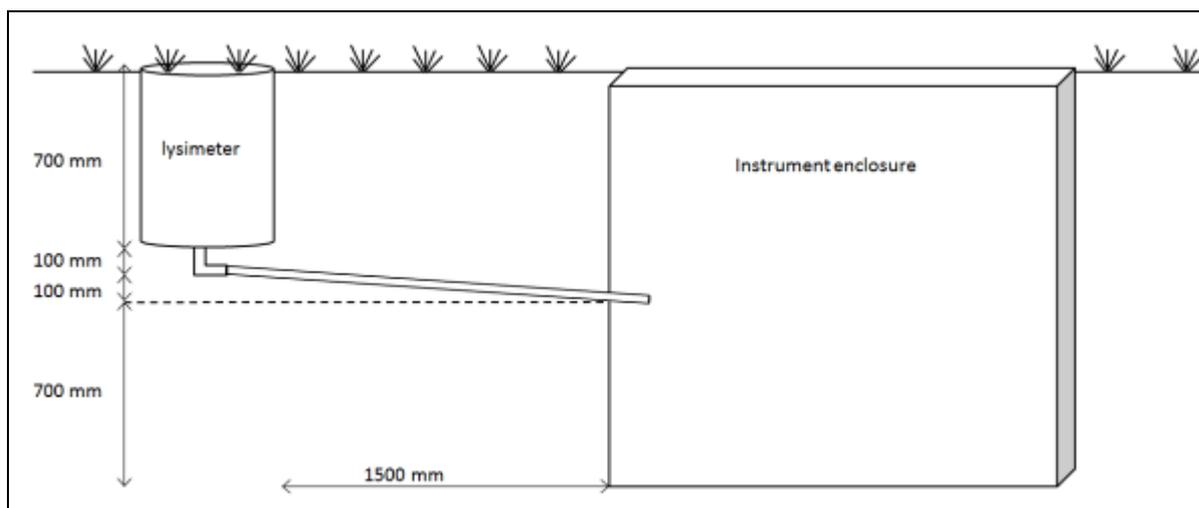
Figure 43: Cross section diagram showing the set-up of the lysimeter, pipework and instrument enclosure with approximate heights and distances.

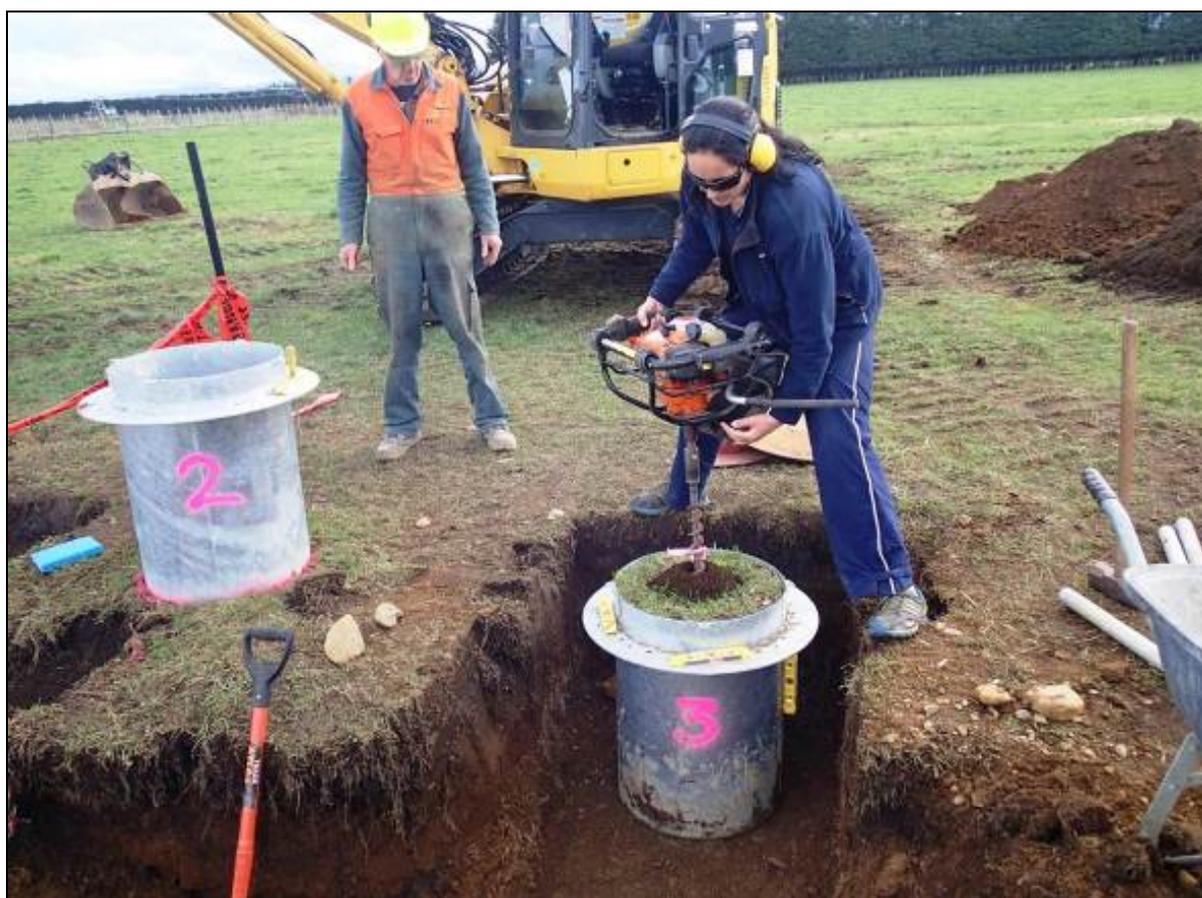
Figure 44: Hydroservices using a motorised hand auger to drill a hole into lysimeter three.

The National Institute of Water and Atmospheric Science (NIWA) recommended the installation of the neutron probes inside each lysimeter for soil moisture measurement (Duncan, 2013; Srinivasan, 2013). Hydroservices were contracted to install the soil neutron tubes. During the lysimeter installation, Hydroservices visited the site and inserted soil neutron probe access tubes into lysimeter two and three. A motorised hand auger was used to drill a c. 500 mm deep hole into each soil column (Figure 44 and Figure 45). A 400 mm long, 50 mm diameter aluminium access tube was then inserted inside the augered hole using a sledge hammer and weighted steel rammer (Figure 46 and Figure 47). Soil moisture was taken using the neutron probe and will provide a baseline for soil moisture in the lysimeters. A cap was placed on the top of the access tube to prevent water entering the lysimeter (Figure 48).

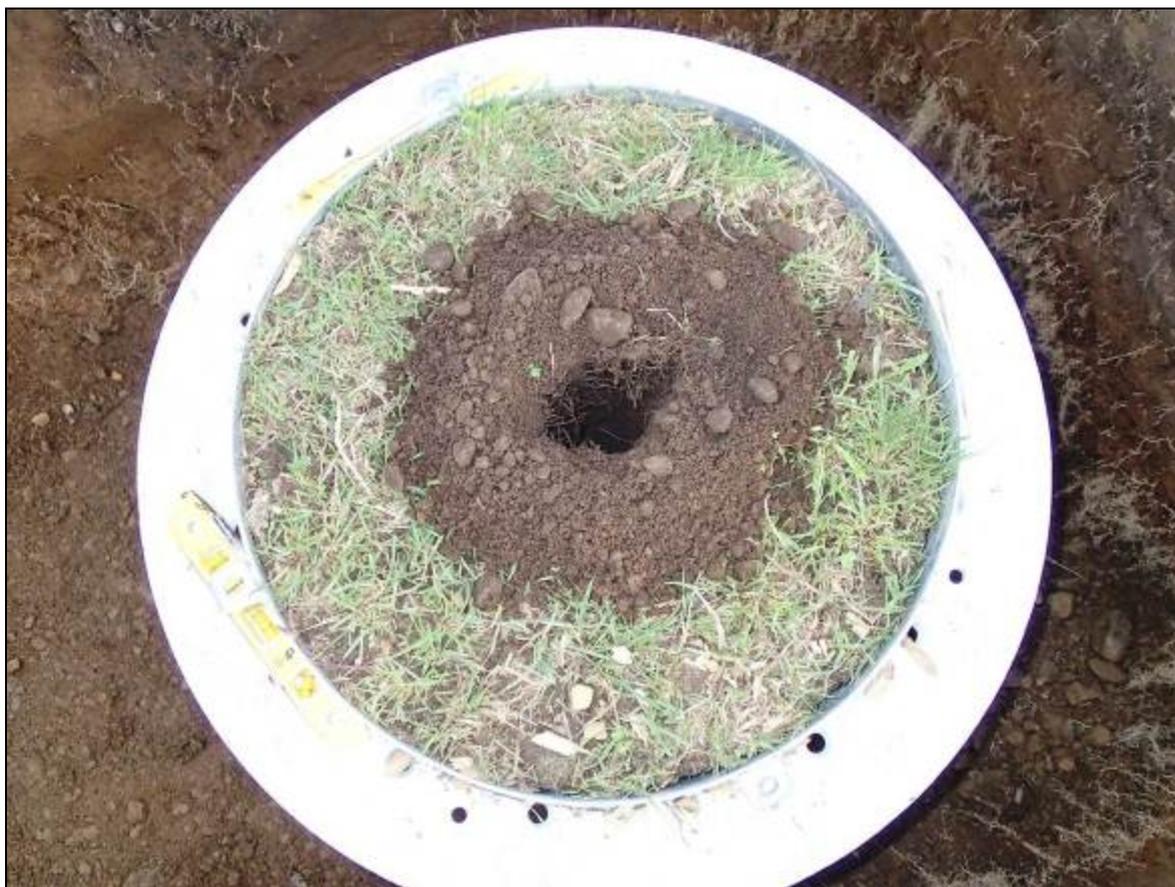
Figure 45: Debris and hole that was drilled into lysimeter three for insertion of the neutron tube.

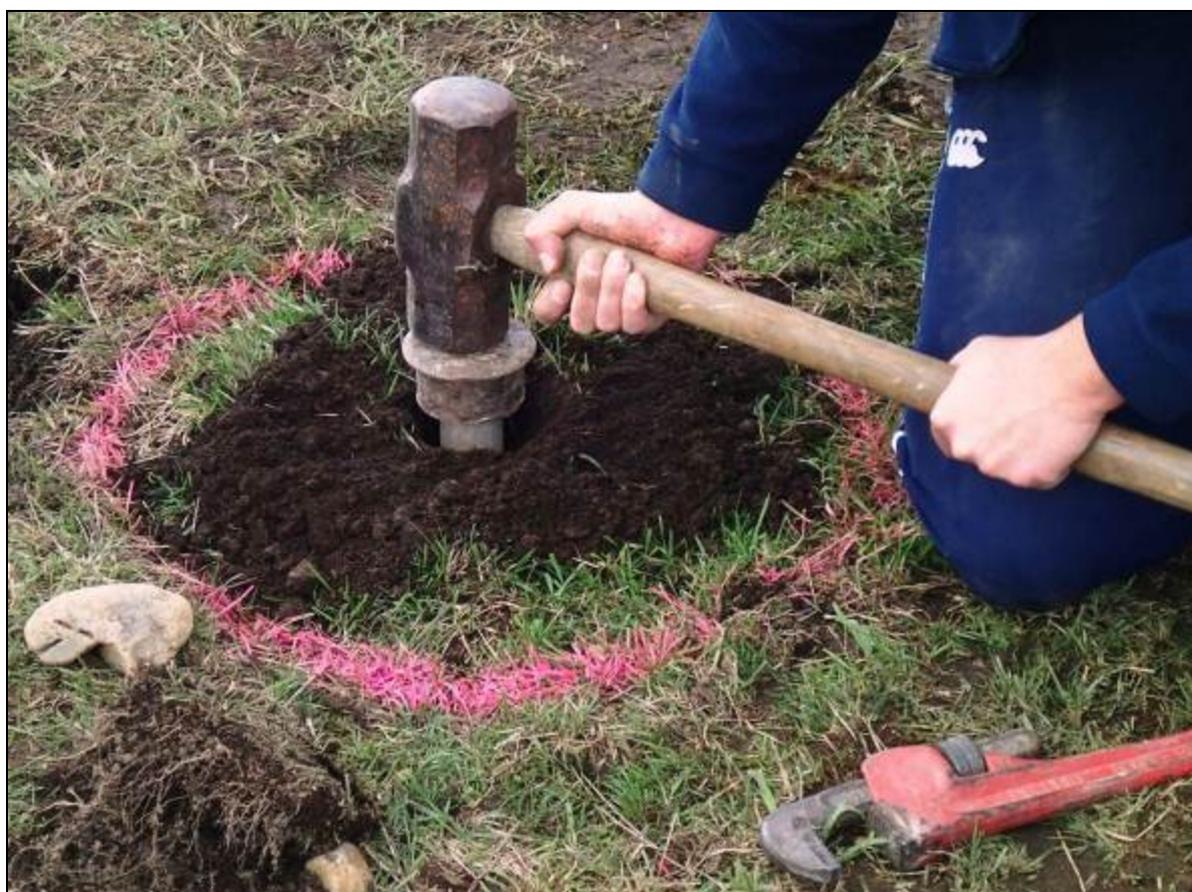
Figure 46: Sledge hammering the neutron tube into the ground prior to isolation of lysimeter two.
