Lovett, A. 2013 Installation of a dryland rainfall recharge lysimeter monitoring site at Ashcott Road, Ruataniwha Plains, Hawke's Bay, *GNS Science Consultancy Report 2013/174*. 41 p.

HBRC contracted GNS Science to oversee the installation of three 500 mm diameter rainfall recharge lysimeters and an instrument enclosure at Ashcott Road, Ruataniwha Plains (Figure 1 and Figure 2). The monitoring site is located on well-drained soil, overlying an unconfined recharge area (Griffiths, 2004; Landcare Research, 2013). Rainfall recharge datasets from the site will complement datasets from previously installed sites in the Heretaunga Plains at Bridge Pa, Maraekakaho and Fernhill (Figure 3). Rainfall recharge information from the network of HBRC monitoring sites will be useful to estimate rainfall recharge across the Hawke's Bay region to assist in groundwater management.

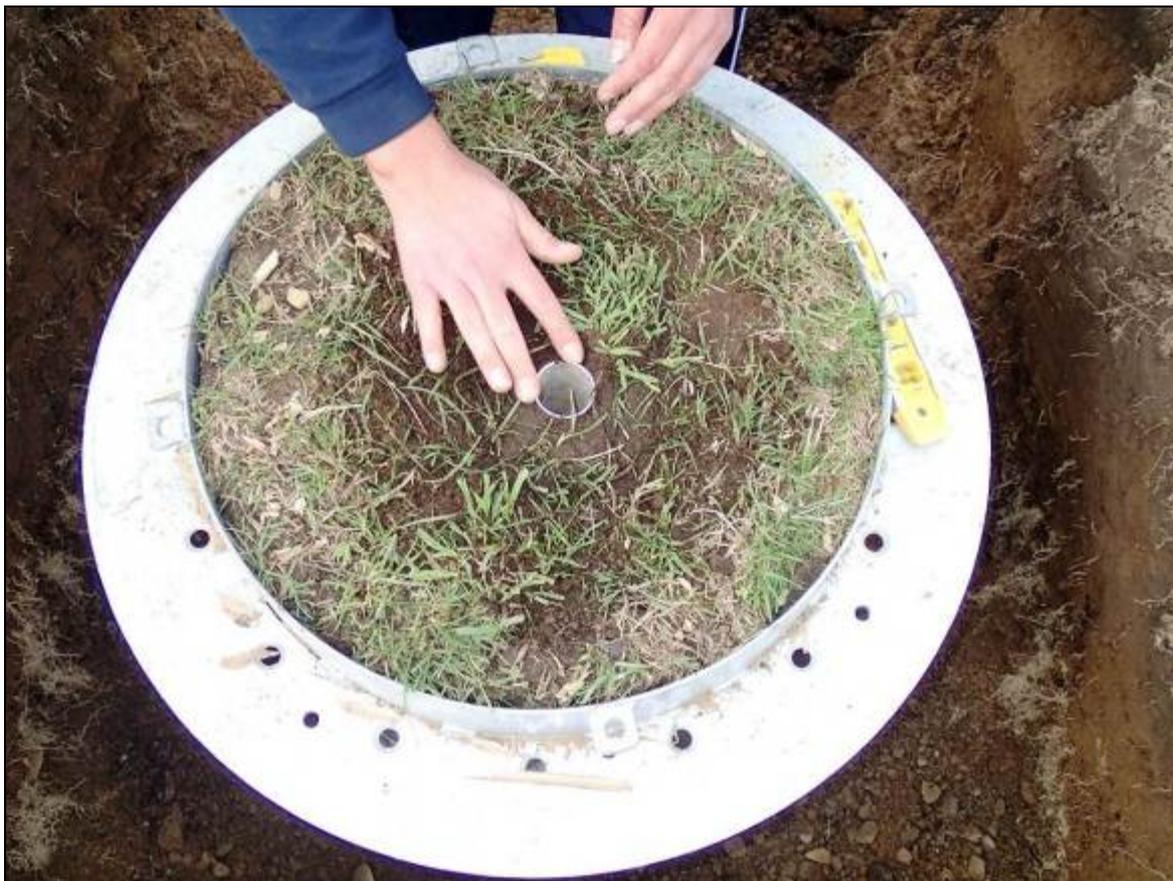
Figure 47: Neutron probe access tube inserted into lysimeter three.

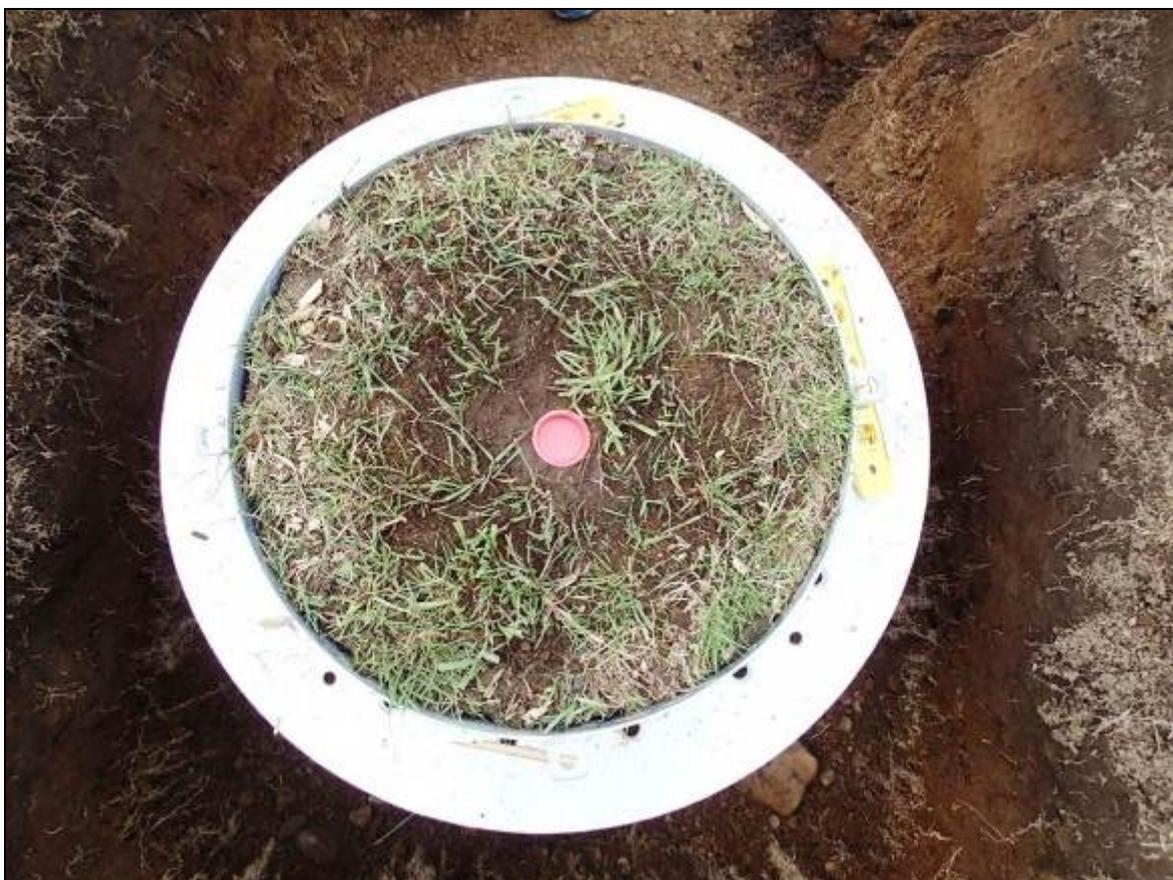
Figure 48: Completed installation of neutron probe access tube and end cap into lysimeter three.

The National Institute of Water and Atmospheric Science (NIWA) recommended the installation of the neutron probes inside each lysimeter for soil moisture measurement (Duncan, 2013; Srinivasan, 2013). Hydroservices were contracted to install the soil neutron tubes. During the lysimeter installation, Hydroservices visited the site and inserted soil neutron probe access tubes into lysimeter two and three. A motorised hand auger was used to drill a c. 500 mm deep hole into each soil column (Figure 44 and Figure 45). A 400 mm long, 50 mm diameter aluminium access tube was then inserted inside the augered hole using a sledge hammer and weighted steel rammer (Figure 46 and Figure 47). Soil moisture was taken using the neutron probe and will provide a baseline for soil moisture in the lysimeters. A cap was placed on the top of the access tube to prevent water entering the lysimeter (Figure 48).

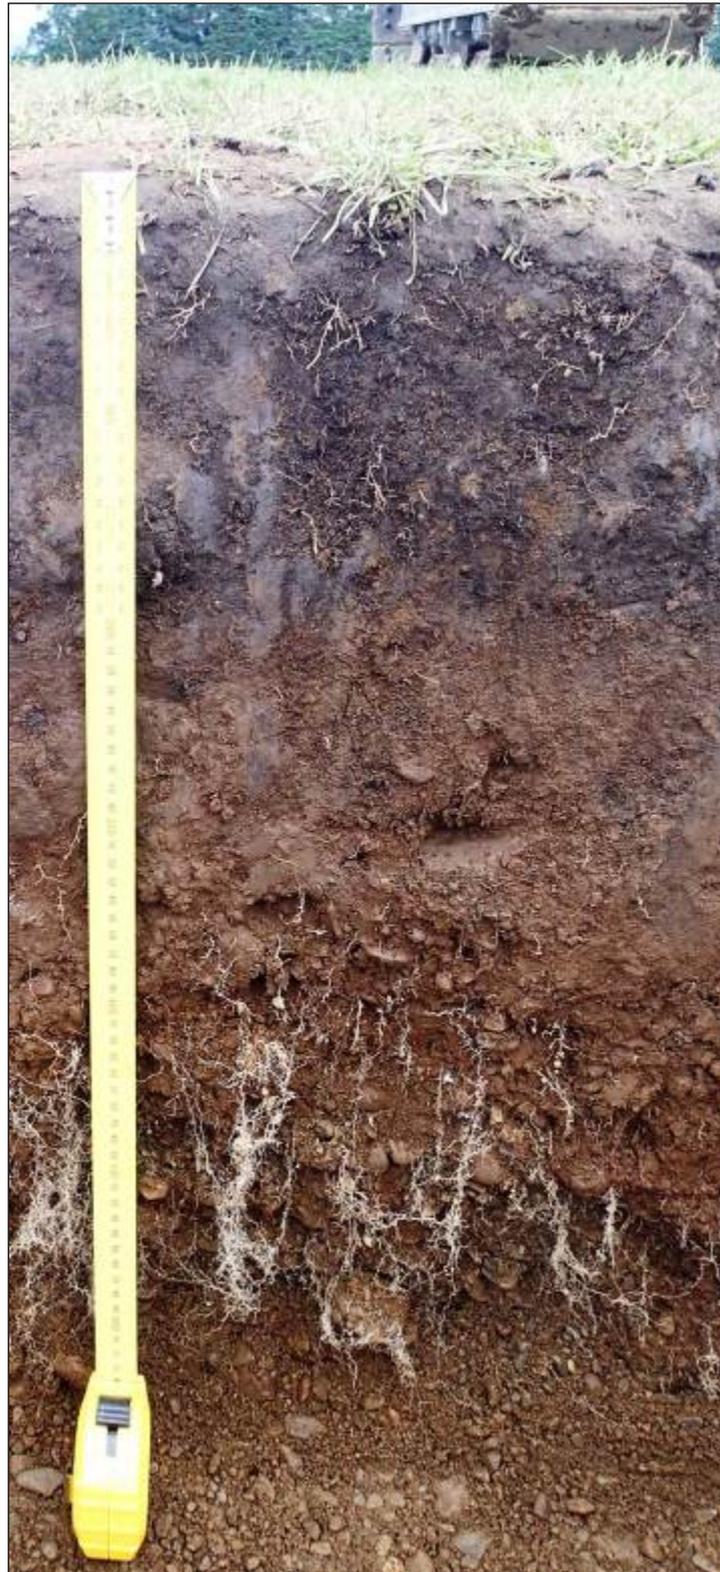
APPENDIX A: SOIL PROFILE

Dark Brown sandy loam with ash
No gravels, cohesive
Tongariro ash

Brown ashy sandy loam
No gravels, cohesive
Tongariro ash
Fibrous roots

Brown sandy gravel, alluvium
very stony, fibrous roots
moderate F – C gravels
non-cohesive
greywacke

Soil at the site was identified to be a Takapau sandy loam, which is a Typic Allophanic Brown Soil (Landcare Research, 2013; Griffiths, 2004). The soil profile was characterised by a sandy loam with some ash (0 – 200 mm BGL) over an ashy sandy loam (200 – 370 mm BGL) (Appendix A). Beneath the loam soils lay a sandy alluvium (370 – 700 mm BGL) composed of greywacke stones (Appendix A; Griffiths, 2004). The loam horizons were cohesive and contained no gravels and fibrous roots. Greywacke rocks up to 200 mm diameter occurred in the alluvium below 370 mm BGL (Appendix A). The soil is well drained with a rapid permeability, and no impermeable barrier within 1 m BGL (Appendix B; Griffiths, 2004). Soil parent material is identified as Tongariro alluvium, sourced from volcanic ash and greywacke (Griffiths, 2004).
