Field survey of the fish populations of the lower Mohaka River

An Internal Report prepared for Hawkes Bay Regional Council

Technically Trout Client Report: TT 2014-04

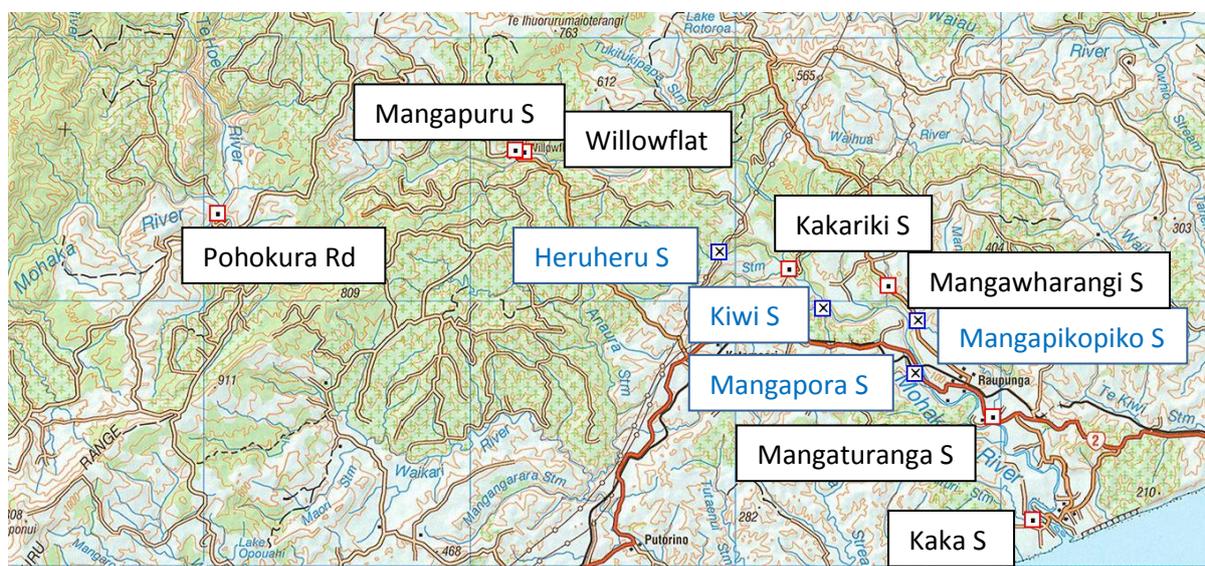
Figure 1 The 7 survey sites (▪) in the lower Mohaka River along with the other 4 sites (x) inspected

Six tributaries and a site in the main-stem of the lower Mohaka River between Te Hoe confluence and the river mouth (figure 1, table 1) were surveyed from the 29th April to the 1st May 2014. In addition a further four tributaries (figure 1, table 2) were inspected but proved either unsuitable for fishing or inaccessible.

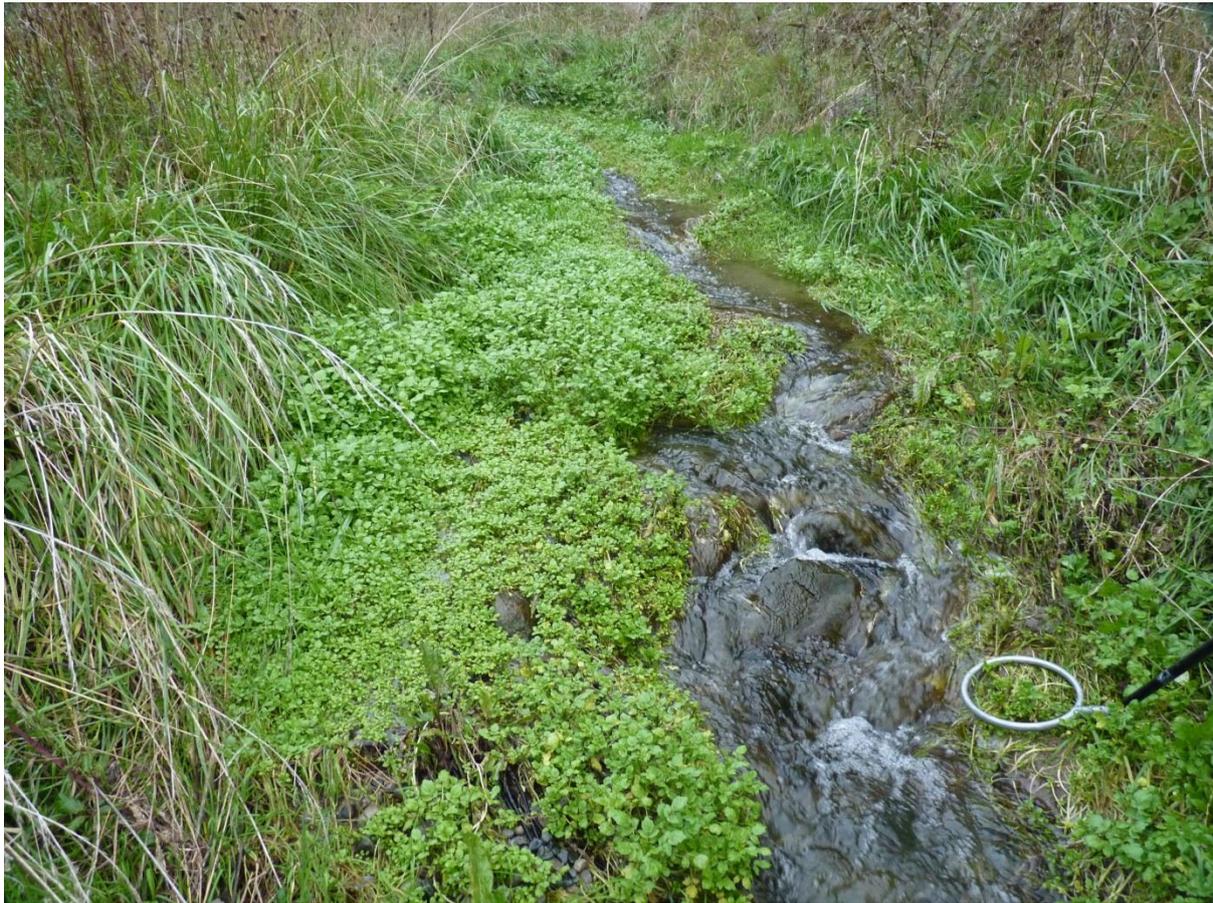
Downstream of the road culvert

This small stream drains out of farmland and is lined with watercress in the lower part, with fine silt in the quieter areas and cobbles and boulders where the fall is greater. A short distance from the confluence with the Mohaka River the stream flows under Pohokura Road and the rise up to the culvert is likely impassable to many fish species. However a single rainbow trout and both species of eel were caught above this point. Above the culvert there is only a short length of stream before a series of low falls accentuated by debris blockages, and a major waterfall occurs one kilometre above this again.

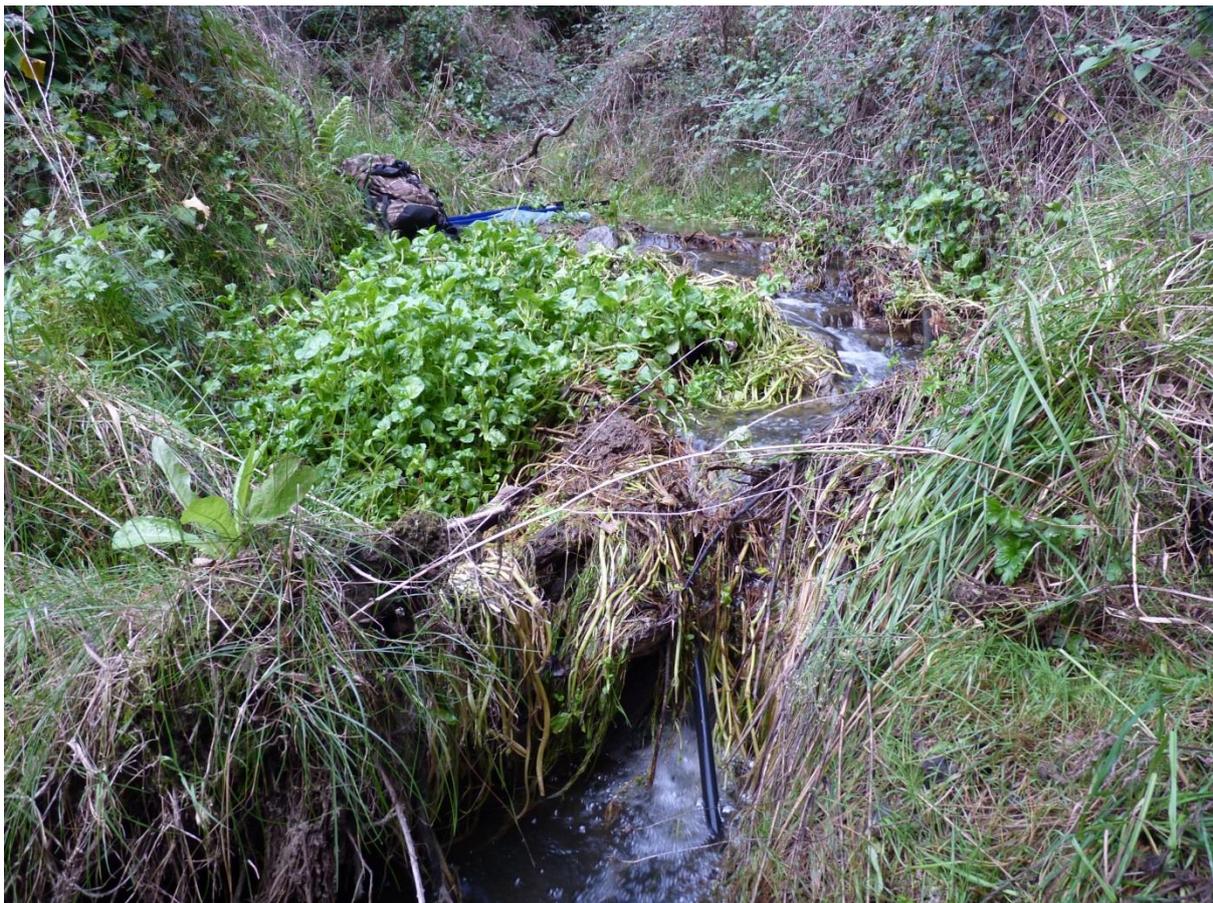
Debris jams occur a short distance above the culvert

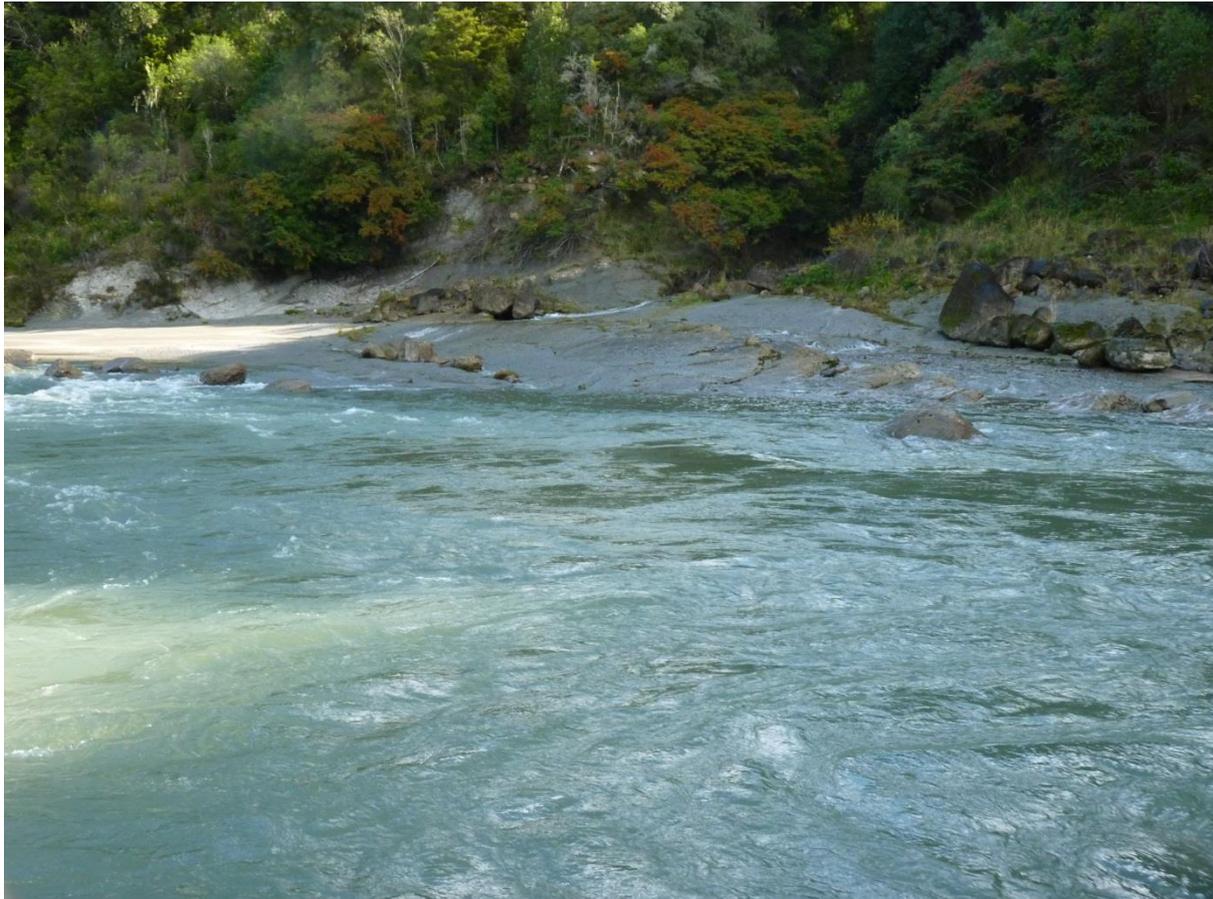
The Mangapuru Stream enters the Mohaka River over a waterfall and then across this papa sill

The electric fishing results (table 5) indicate that this fall is passable to some eels though the very low incidence suggests it is on the limit of their climbing abilities.

The presence of a small number of eels above the 25m high bedrock shute on the Mangapuru Stream highlights their climbing ability and raises the potential to assist eels to climb over similar obstacles. Potentially a trial to enhance an upstream eel population could be considered using mussel ropes or the like laid down a suitable papa shute to provide an improved climbing surface.

On an initial observation the Mangapuru Stream would be a suitable trial site with secluded but ready access though it is not known how far upstream the eels can continue on.

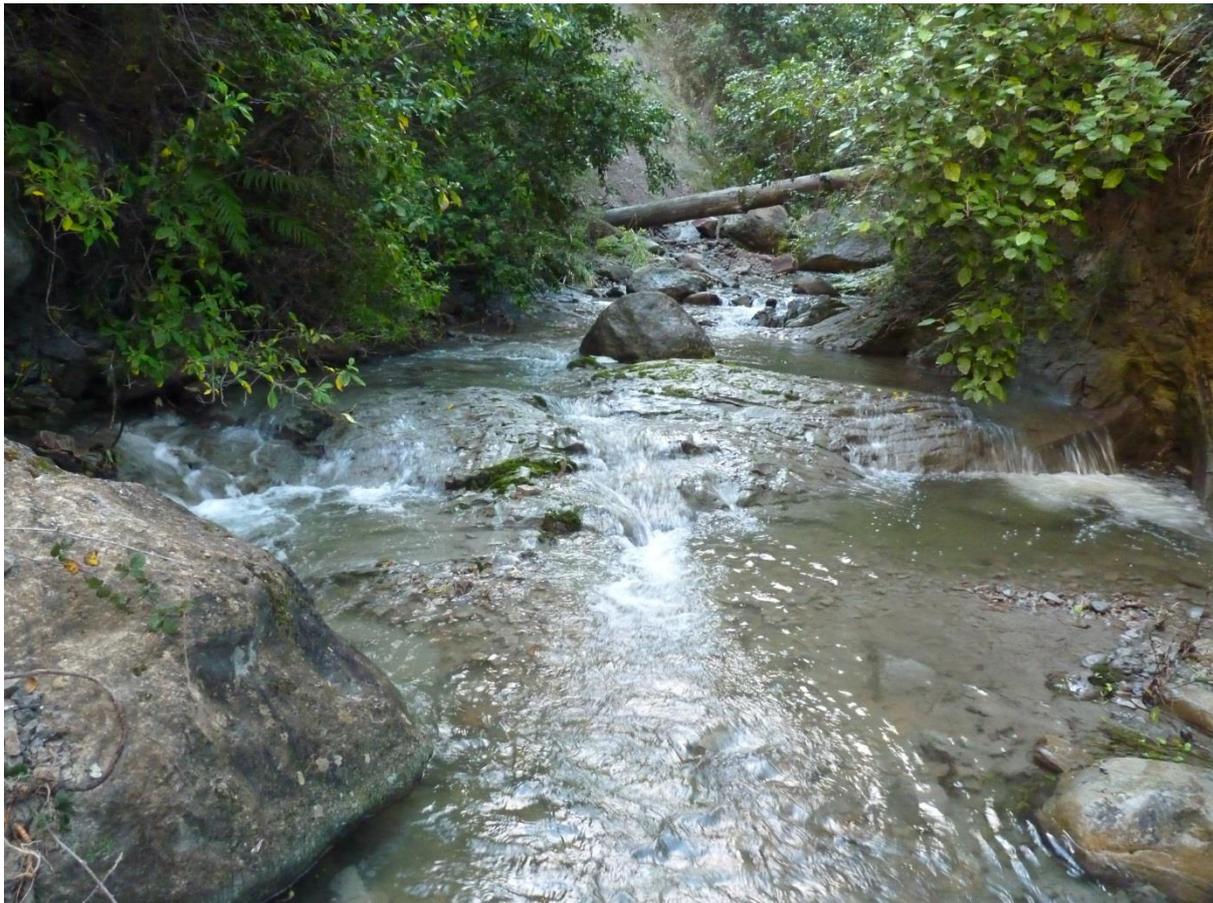
The Mangapuru Stream a short distance above the waterfall

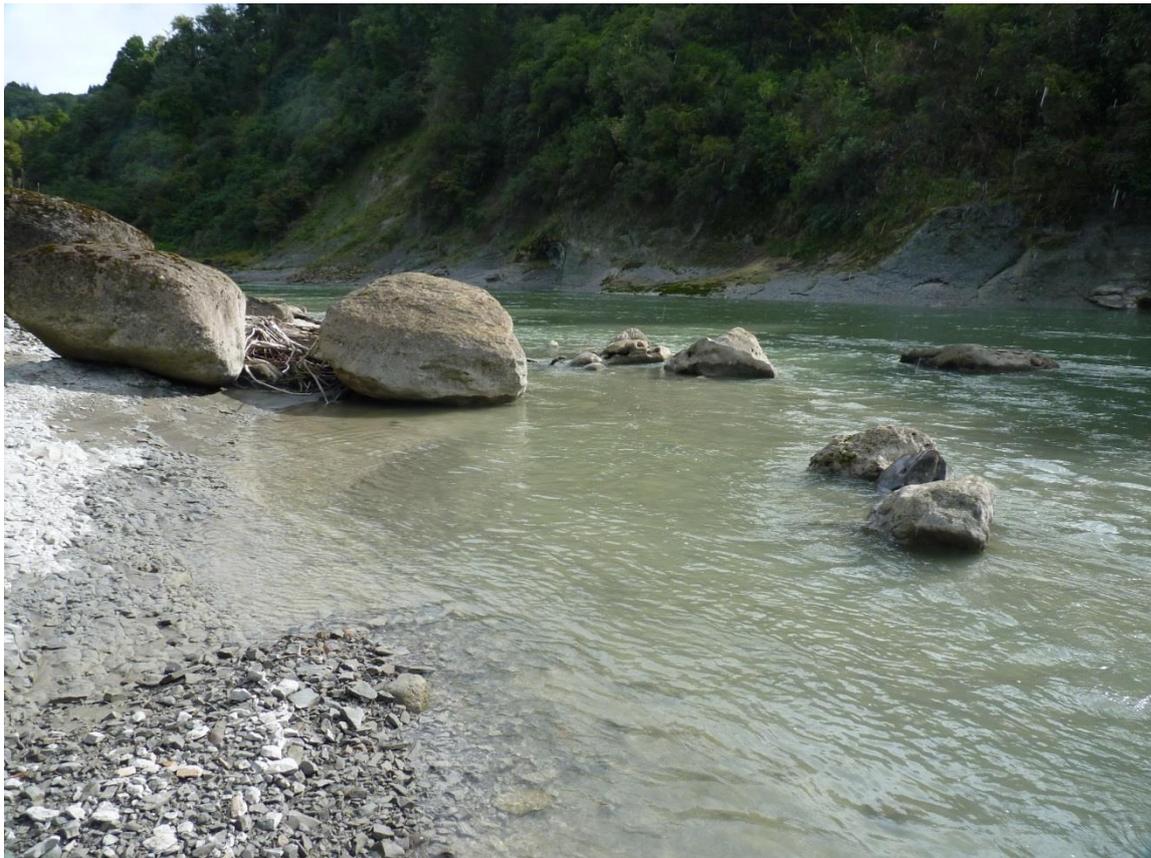
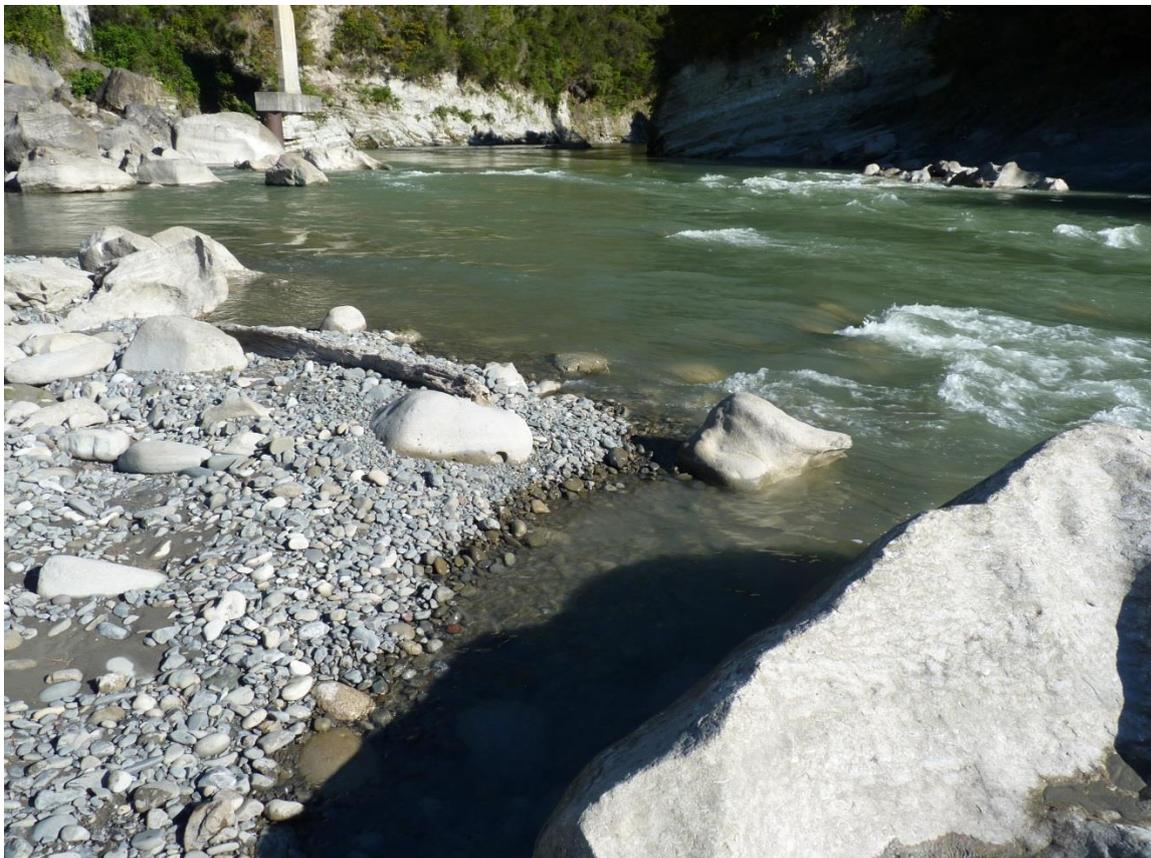
Mohaka River at Willow Flat

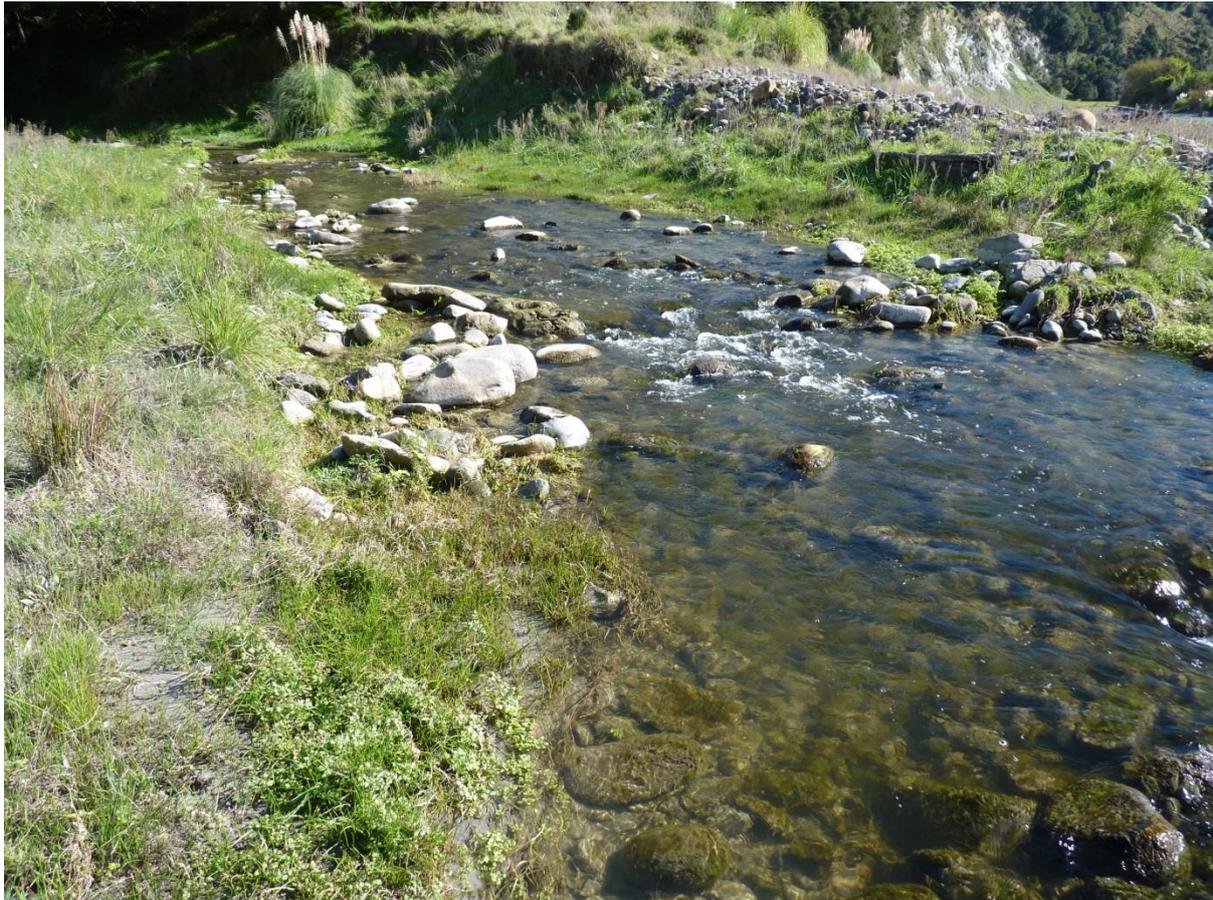
This stream is deeply incised and surrounded by farmland though the river trench itself is shrub and forest covered. Unlike many other streams there is no fall near the confluence or other impediment to fish migration though a major fall occurs approximately 3.5km upstream. The stream within the surveyed reach is of moderate gradient and comprises papa bedrock sills with some sedimentary cobbles and boulders and fine silt out of the flow and along the banks. There are also small amounts of water cress along the edges.

The Kakariki Stream immediately upstream of the confluence with the Mohaka River

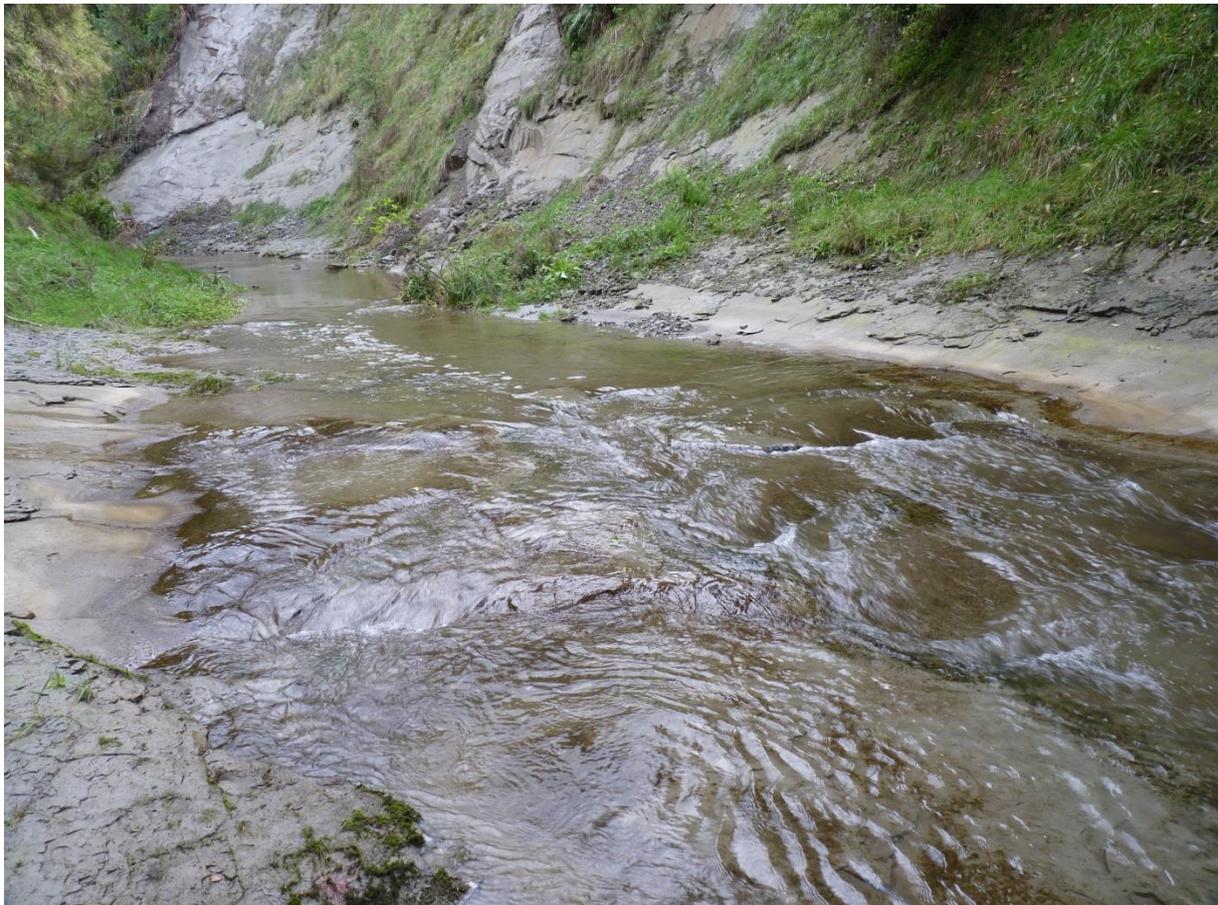
Hard papa sills are a feature of parts of the Kakariki Stream

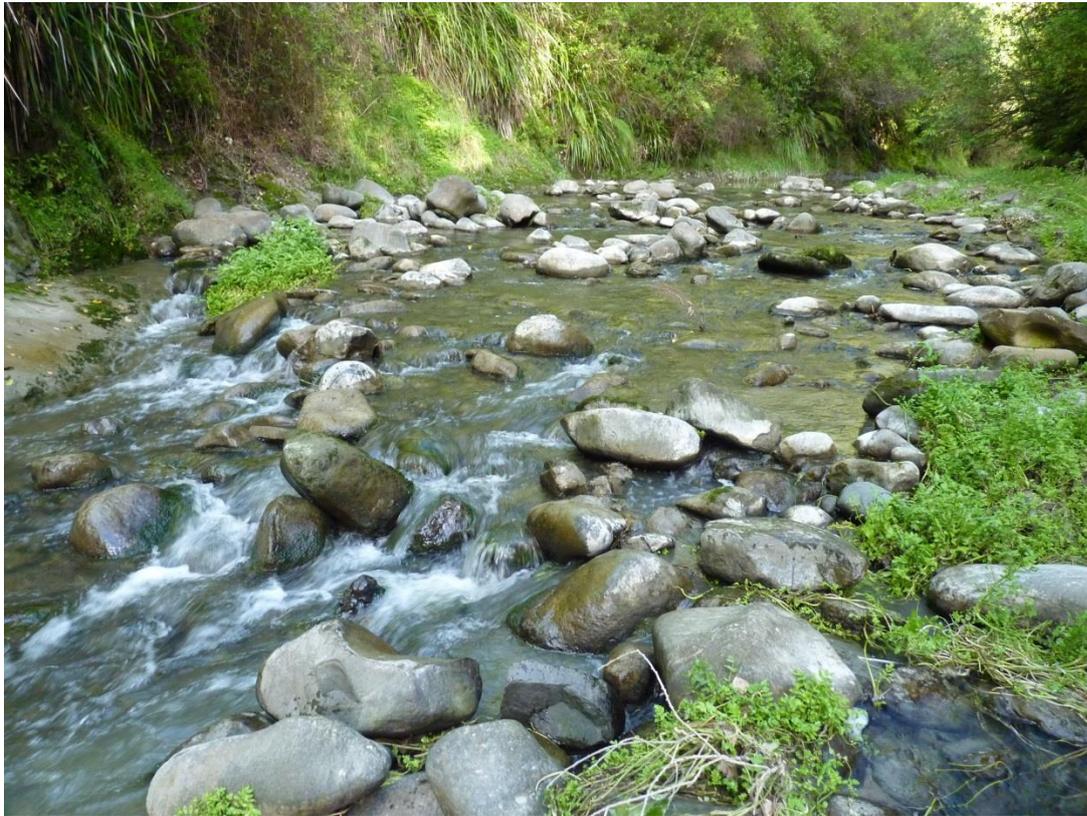
Other areas of the lower Kakariki Stream provide diverse habitat

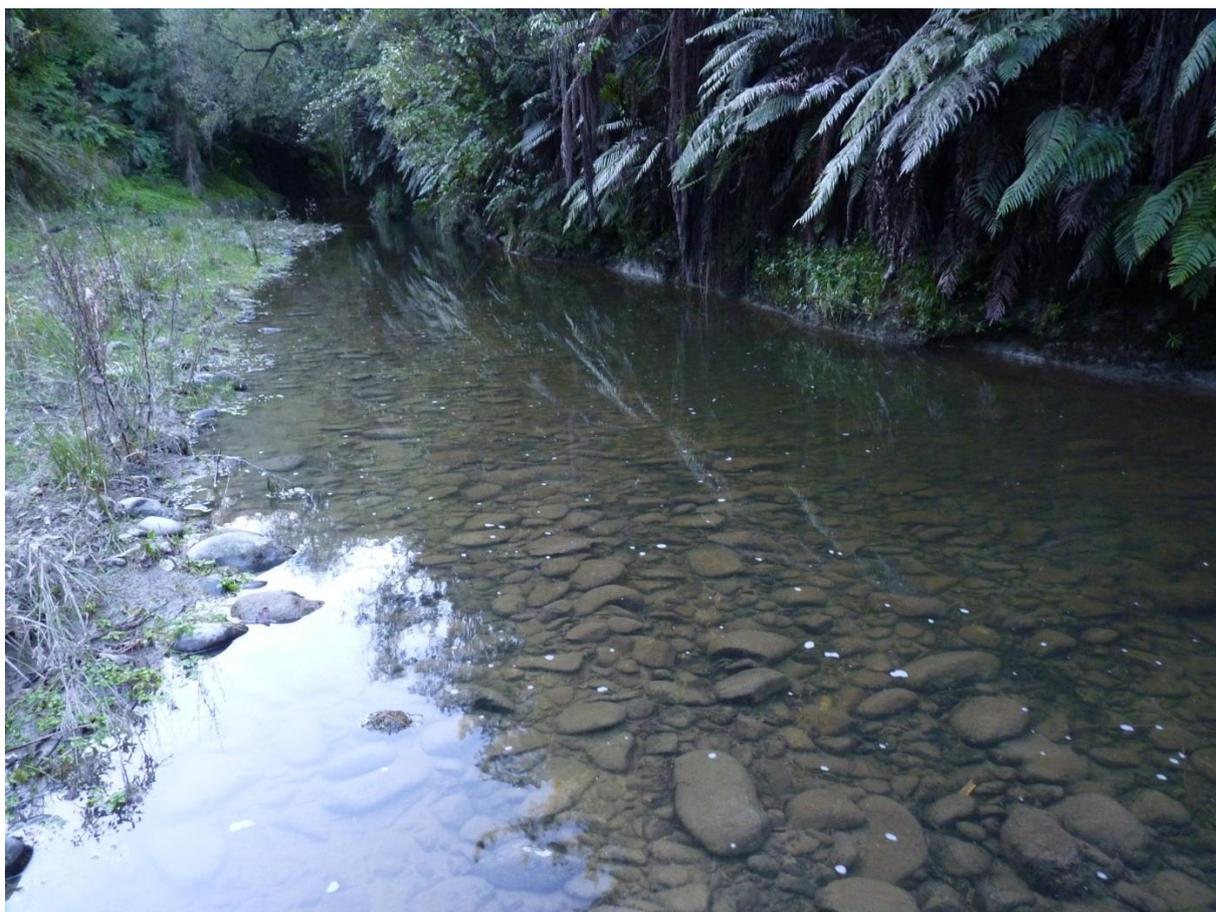
Mangaturanga Stream

An incised stream of low gradient in the lower reaches with extensive pools lined with papa bedrock and a gravel and cobble bed with occasional boulders. There is a lot of fine sediment and the bed is embedded, with occasional silt patches along the shallow edges and small areas of watercress. The catchment is steep sided with native shrubs, weeds and willows.

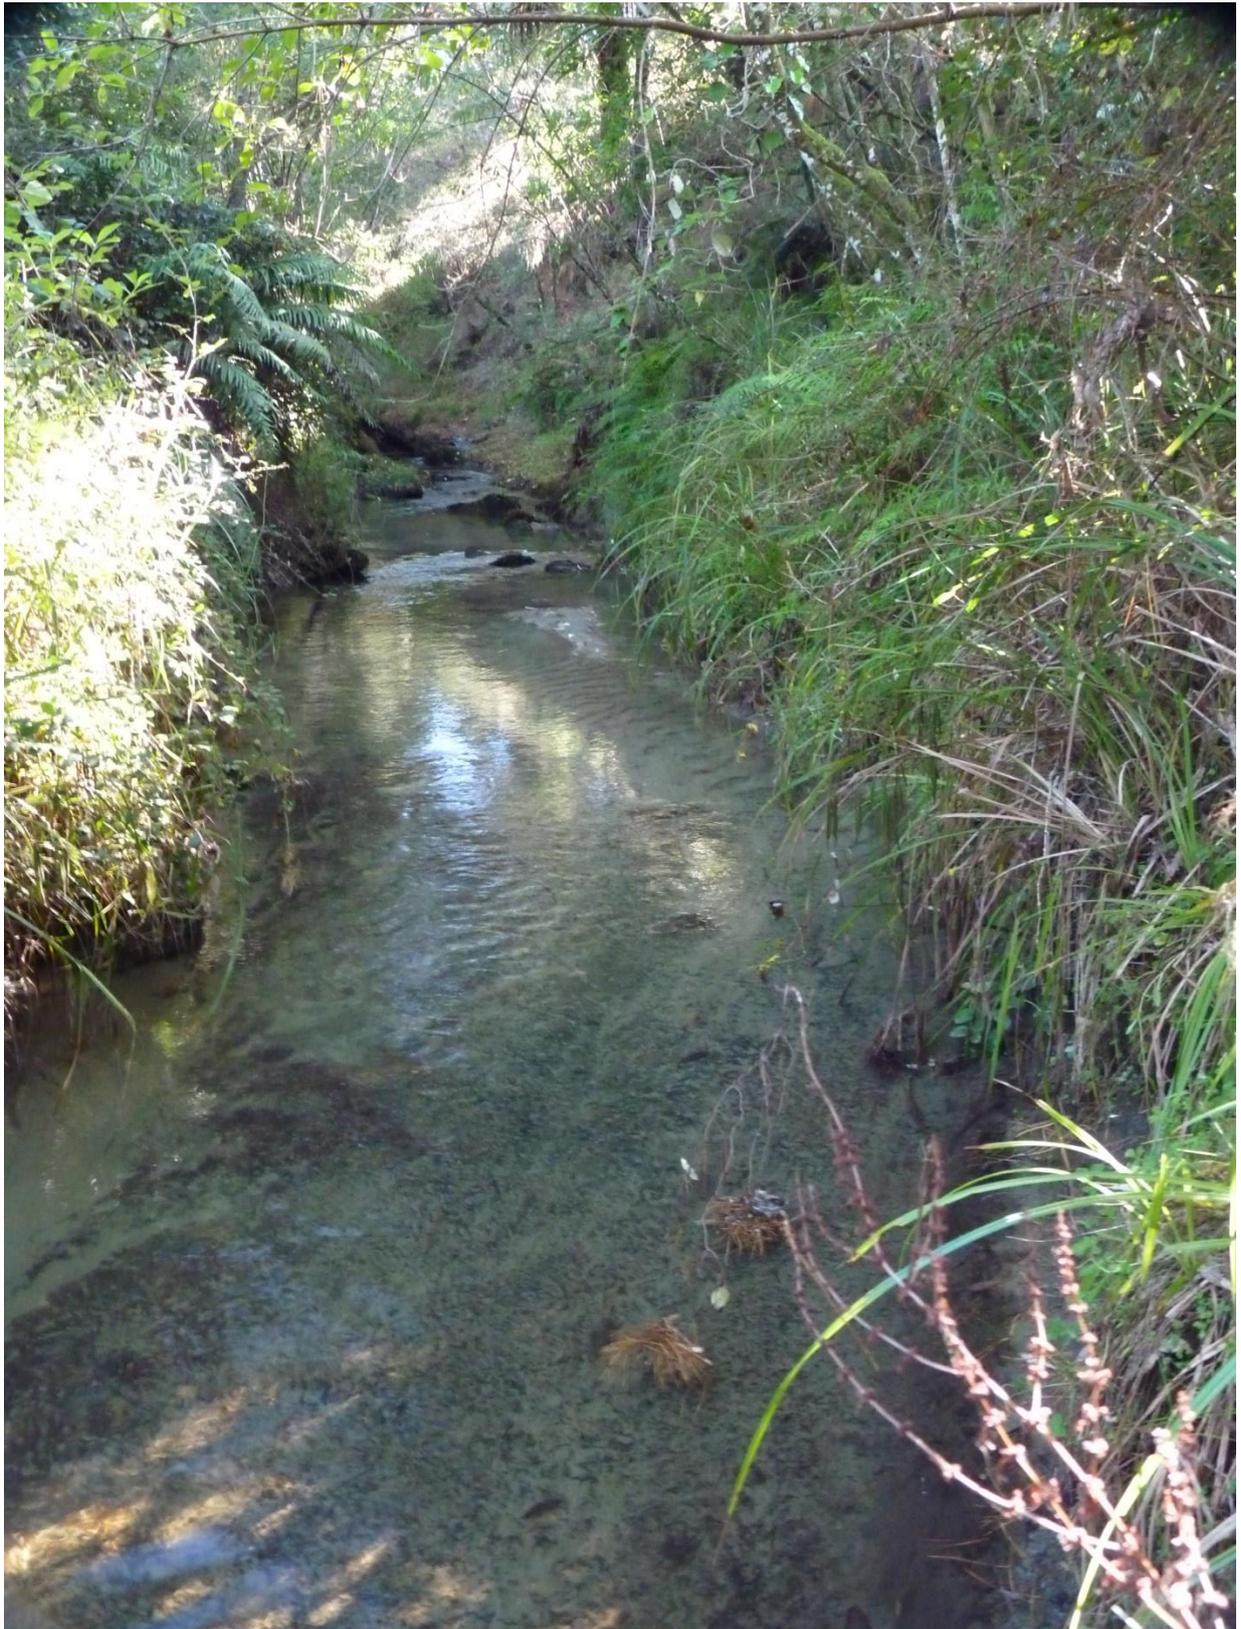
This is a low gradient stream flowing over a hard bed rock sill with occasional sedimentary boulders. There are limited gravels but extensive undercut banks and some in-stream woody debris. A weir just above the Putere Road Bridge backs the flow up for many metres and there is an extensive deposit of fine silt through this section. This weir is probably impassable to all except climbing fish species, however a short distance below the bridge the stream falls approximately 150 metres to the Mohaka River below. While a single very large longfin eel was caught the lack of any small eels suggests that for all practical purposes this section prevents fish and eels entering the stream.

Mangawharangi Stream above the impact of the weir

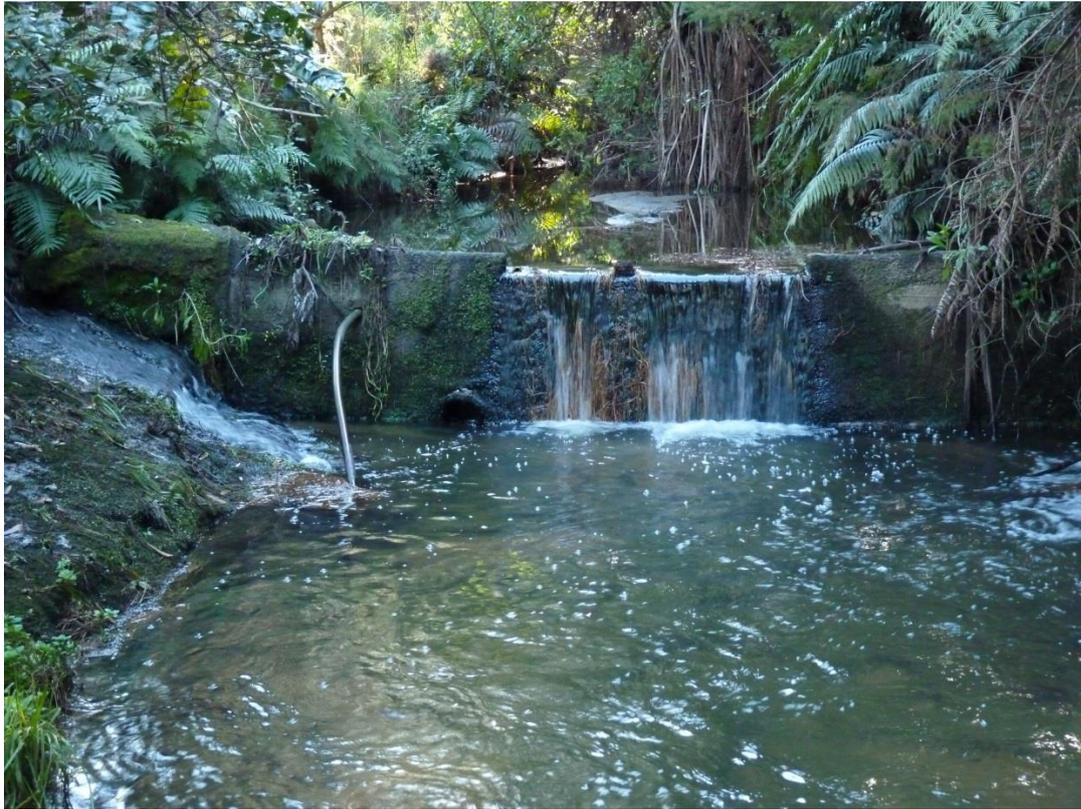
The weir backs the water up and has caused an extensive deposition of fine silt upstream

The survey site in the Mangawharangi Stream is within a current restoration project being undertaken by Ngati Pahauwera. In terms of possible actions to improve the stream then removal of the weir which is no longer used as a water intake would enable the silt which has collected upstream to pass through, returning this section to a hard bottom characteristic of this part of the stream. Given the silt is sitting on a solid bottom it will likely mobilise very readily and this work would be best timed to co-incide with a fresh to wash it right through the river. Consideration could also be given to removing the numerous wilding pine trees growing along the banks. As these age they will fall often tearing up the bank and mobilising significant sediment. In addition they may form debris dams in the stream. Once the pines are removed and the light gets in then the blackberry will rapidly take over at this site. In itself blackberry is effective at protecting the banks but for other reasons control maybe necessary until the native shrubs establish themselves.

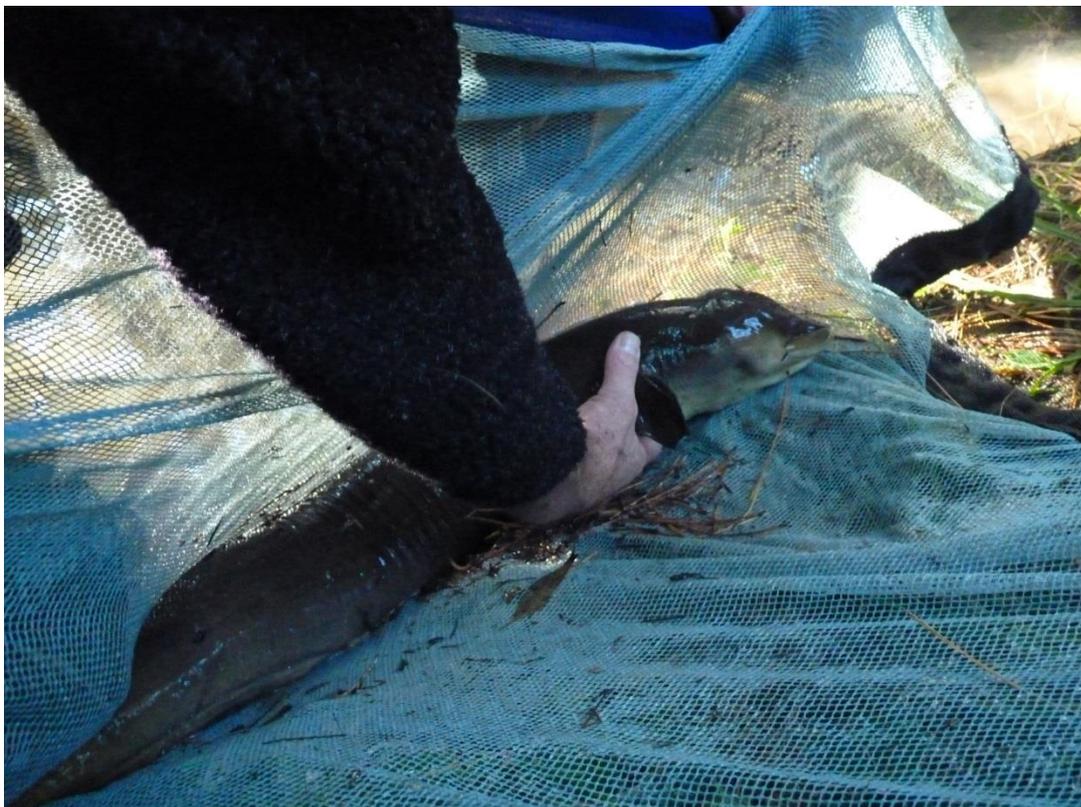
A single very large longfin was caught. Whether it managed to negotiate the falls downstream or was previously released here is unknown.

The falls downstream preclude access by migratory fish species. However the large longfin eel captured in the stream highlights that eels can do well if they reach or are released here. Potentially there is an opportunity here to transfer small eels into the Mangawharangi Stream to either support a managed harvest and/or if they can survive passage back downstream to contribute to the wider spawning population. This survival (and opportunities to assist eels to climb up) will be dependent on the exact nature of the falls which is unknown at this stage.

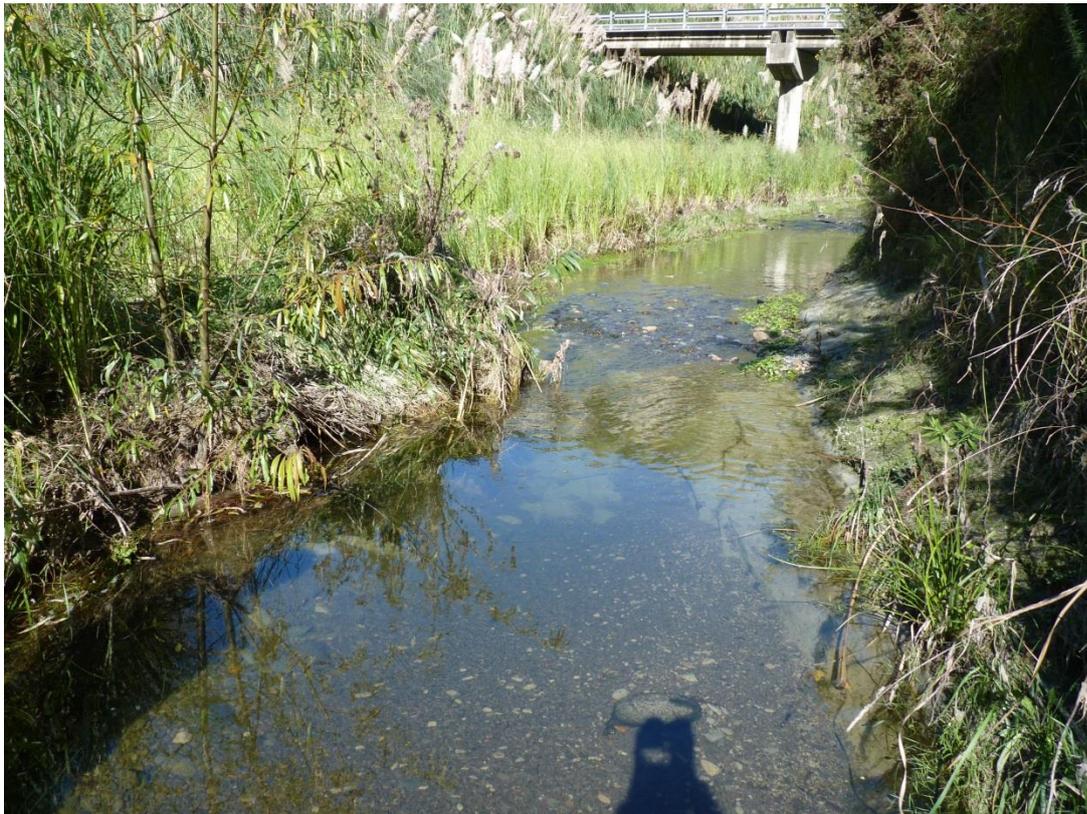
Kaka Stream just upstream from the confluence with the Mohaka River and below Mohaka Coach Road bridge.

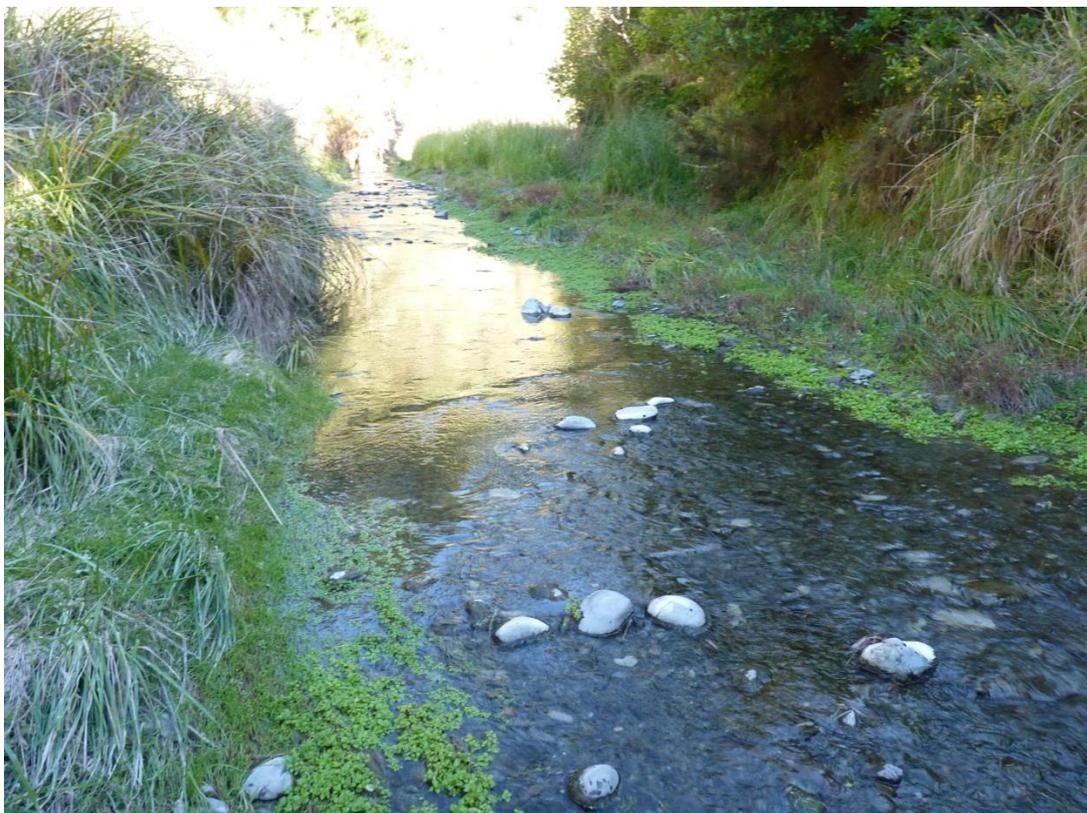
The water cress along the stream margins was extensively used by inanga

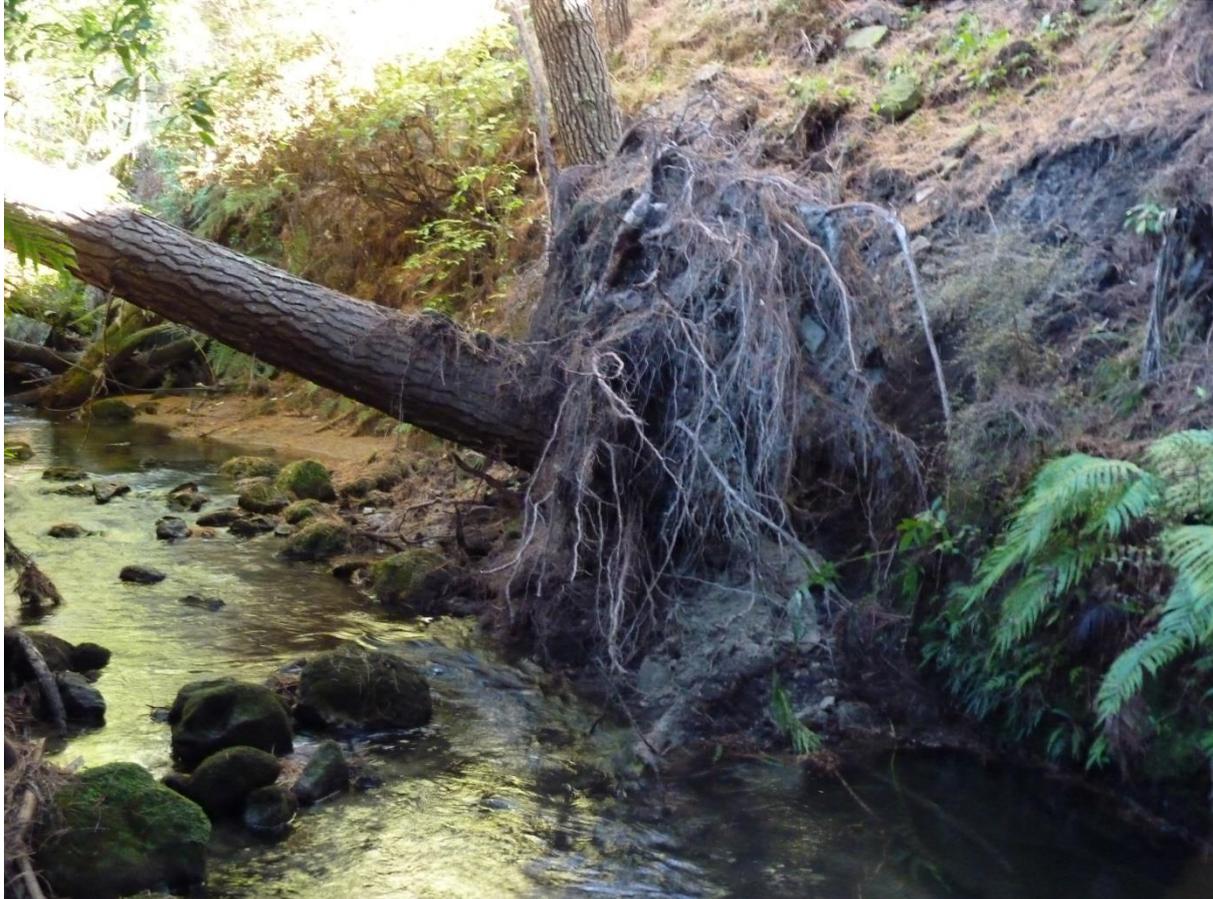
Wilding pine trees are relatively short-lived and when they fall destabilise the banks and often create debris blockages

are incised and farming and forestry activities are back from the escapement. From what we observed issues revolve around keeping stock out, control of goats within the stream corridor, control of plant pests and in particular wilding pines which destabilise the banks when they fall creating sediment sources and potential debris blockages, and identifying and removing existing barriers to migration.
