Assessment of lakes in the Hawke's Bay Region using LakeSPI

Prepared for Hawke's Bay Regional Council March 2017

HBRC Publication No. 4971 HBRC Report RM18-02

NIWA CLIENT REPORT No: 2017070HN
Report date: May 2017
NIWA Project: HBR17201

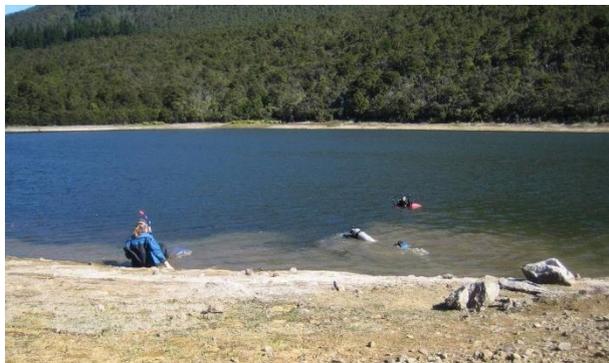
Kaweka West Lake Submerged Plant Indicators

Lake condition:	Excellent
Lake ranking:	1 st
Lake maximum depth:	12.6 m
Max depth of vegetation:	8.1 m

Lake Kaweka West is currently the highest ranked lake in the Hawke's Bay region and it is categorised in 'excellent' condition according to LakeSPI. It is the best example of a waterbody that still remains in an all-native vegetated state in the region, most likely on account of its remote location and difficult access.

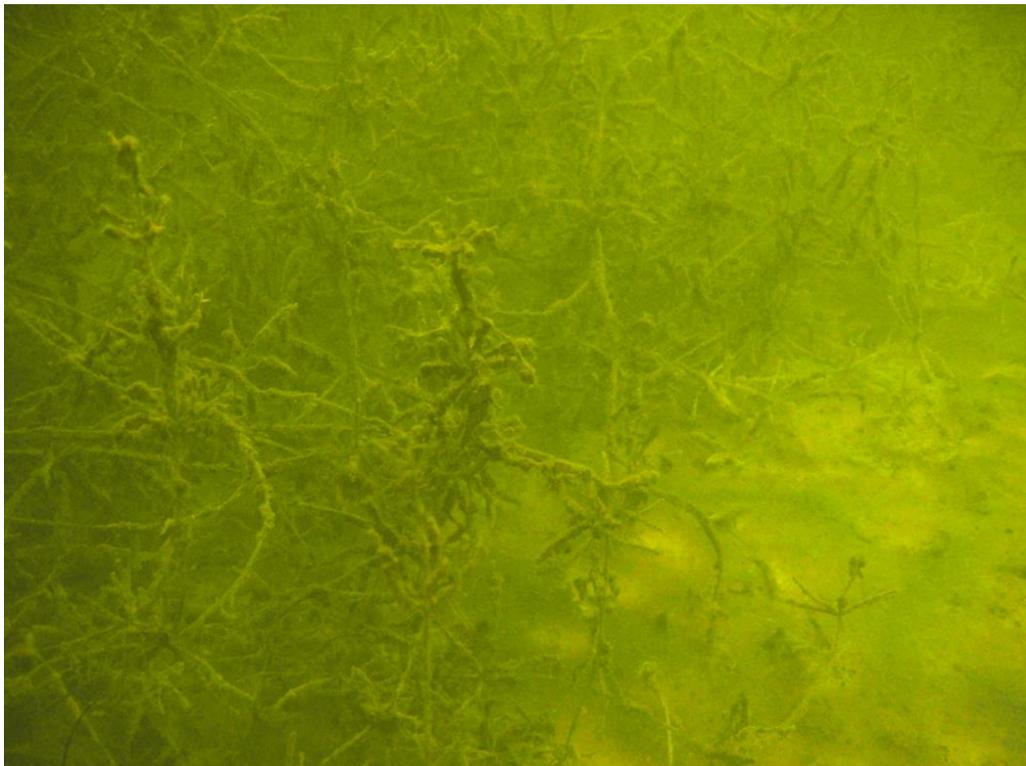
Figure 3-2: Bottom depth boundary of *Chara australis* at 8 m depth in Kaweka West.

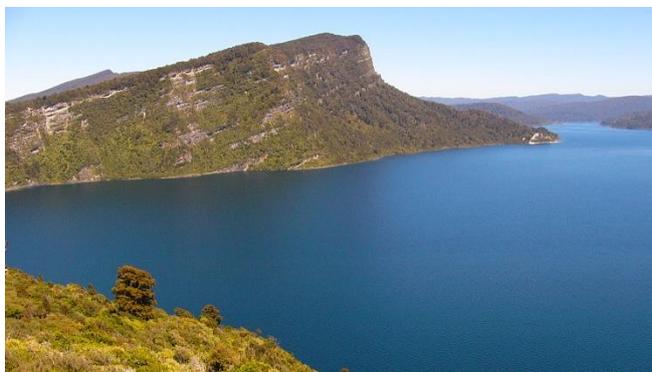
Waikaremoana Lake Submerged Plant Indicators

Lake condition:	High
Lake ranking:	2 nd
Lake maximum depth:	248 m
Max depth of vegetation:	21.1 m

Lake Waikaremoana is categorised in 'high' condition and has one of the best examples of diverse aquatic vegetation in a large, deep, clear lake in the North Island, with little apparent impact from invasive pest species. The presence of the invasive weed *Lagarosiphon major* remains a major concern for future lake condition should it continue to spread.

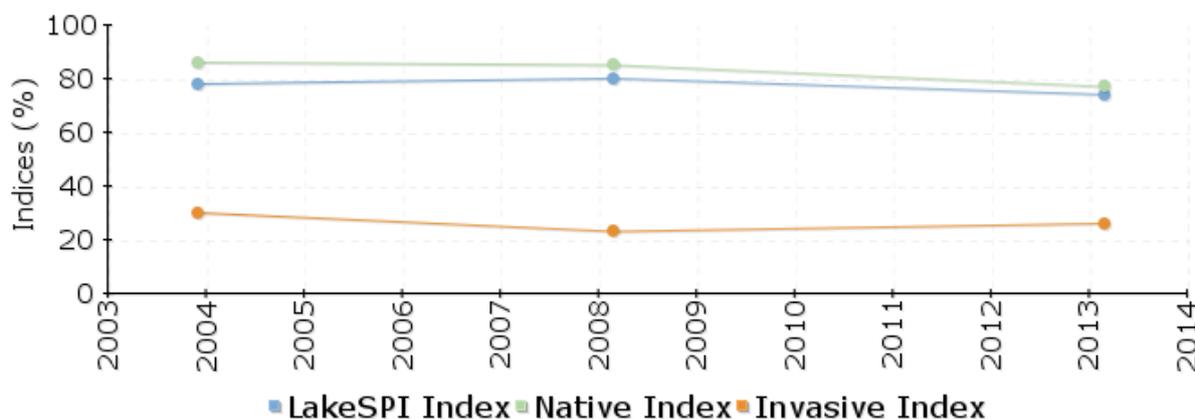
Survey Date	Status	LakeSPI %	Native Condition %	Invasive Impact %
February 2013	High	74%	77%	26%
February 2008	Excellent	80%	85%	23%
November 2003	Excellent	78%	86%	30%

Lake Waikaremoana is categorised as being in high condition with a LakeSPI Index of 74% (Figure 3-3).

LakeSPI scores for Lake Waikaremoana have remained stable between consecutive surveys (Figure 3-3) indicating no significant ecological change in lake condition. Between 2003 and 2013 lake vegetation continued to occupy an average depth range of 18 -19 m, where conditions (such as slope, substrate and exposure) were favourable. Vegetation species, composition and abundance also remained similar over this time frame.

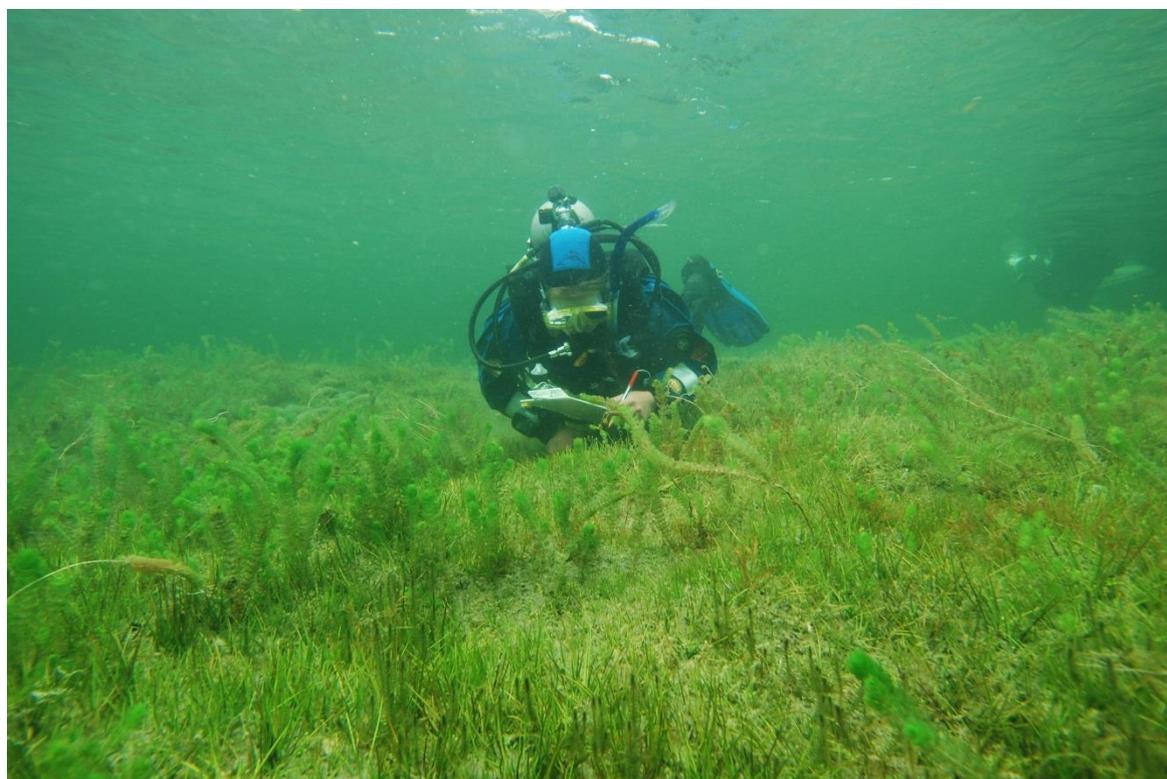
Figure 3-4: Diver surveying turf plant community in Lake Waikaremoana.

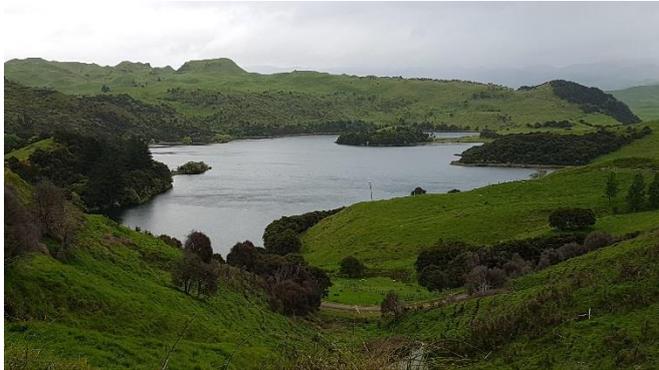
Rotonuiaha Lake Submerged Plant Indicators

Lake condition: Poor
 Lake ranking: 3rd
 Lake maximum depth: 30 m
 Max depth of vegetation: 16.1 m

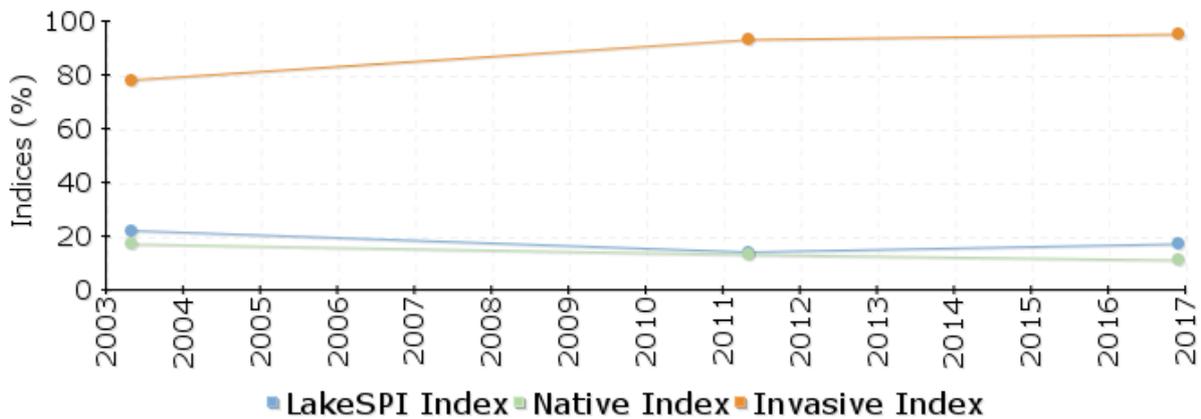
Survey Date	Status	LakeSPI %	Native Condition %	Invasive Impact %
November 2016	Poor	17%	11%	95%
April 2011	Poor	14%	13%	93%
April 2003	Moderate	22%	17%	78%

Lake Rotonuiaha is categorised as being in poor condition with a LakeSPI Index of 17% (Figure 3-5).

The LakeSPI scores for Lake Rotonuiaha suggest that the lake has remained in a poor but stable condition over the last five years, with the full impact of hornwort having already taken place. Hornwort extended down to a maximum depth of 16.1 m during the 2016 survey reflecting the lakes good water clarity. All submerged plants in Lake Rotonuiaha were in a clean, healthy condition with no obvious signs of epiphytic algae on plants reflecting well on longer term lake stability.

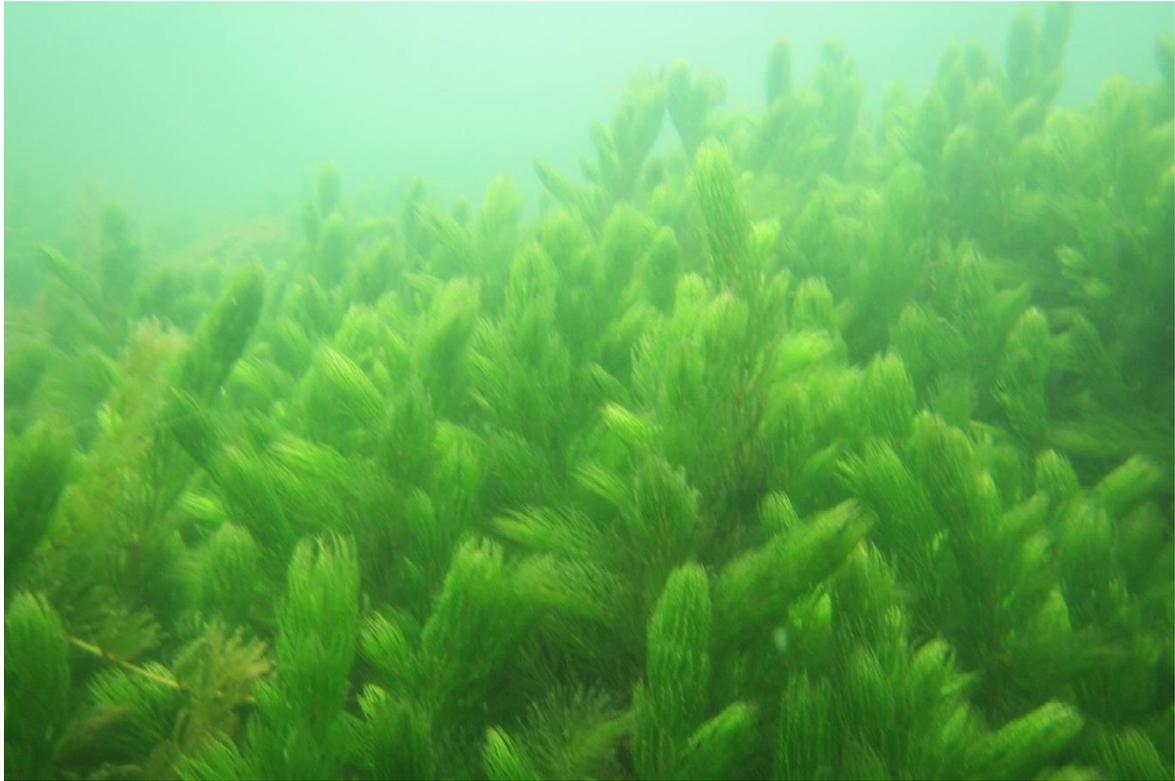
Figure 3-6: Hornwort formed a dense band of weed up to 3 m high in Lake Rotonuiaha.

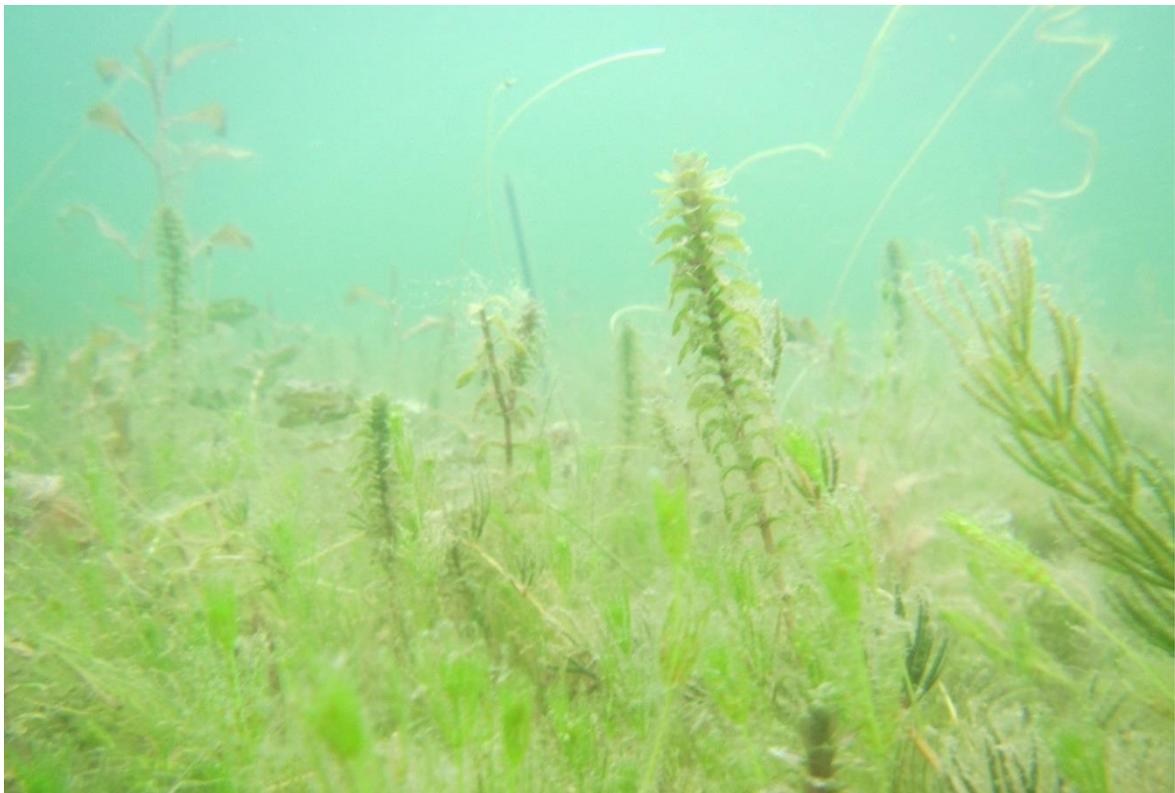
charophyte (*Nitella hyalina*), a native pondweed (*Potamogeton cheesemanii*), milfoil (*Myriophyllum propinquum*) and *Ruppia polycarpa* were also present growing in shallow water, less than 2 m deep (Figure 3-7). This shallow depth range and low native ratio contributed to a low Native Condition Index of 11% (Figure 3-5).

Figure 3-7: Elodea shoots (centre) and hornwort shoot (right) growing amongst native species in the shallows of Lake Rotonuiaha.

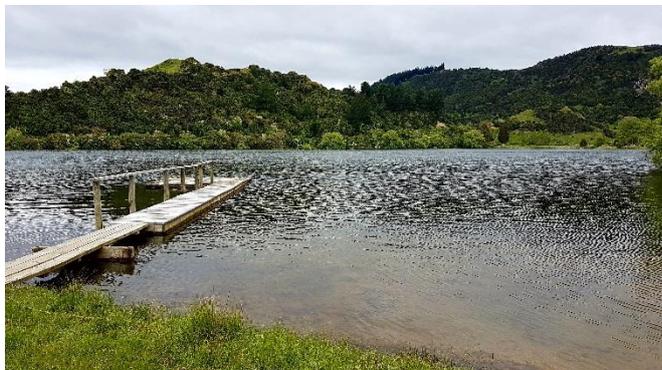
Rotoroa Lake Submerged Plant Indicators

Lake condition: Poor
 Lake ranking: 4th
 Lake maximum depth: 16 m
 Max depth of vegetation: 9.5 m

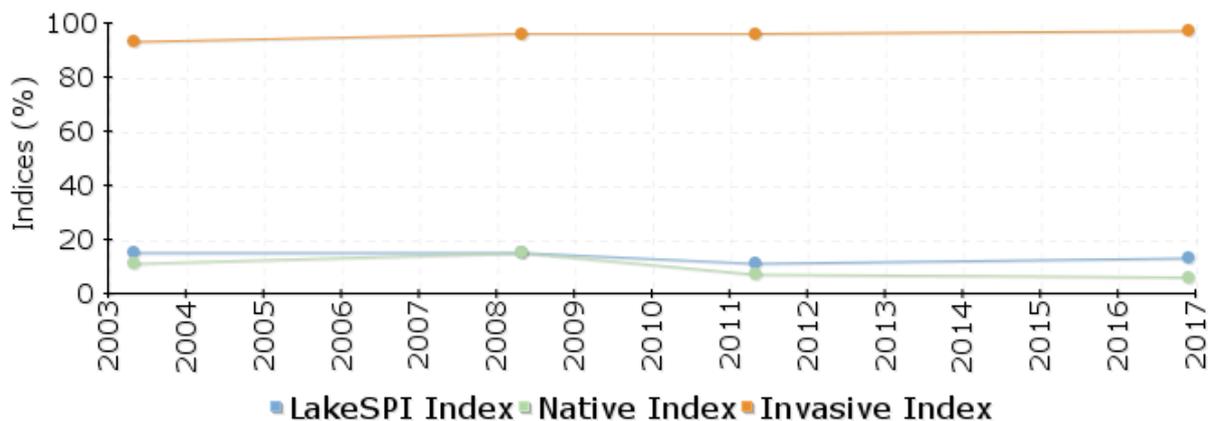
Survey Date	Status	LakeSPI %	Native Condition %	Invasive Impact %
November 2016	Poor	13%	6%	97%
April 2011	Poor	11%	7%	96%
April 2008	Poor	15%	15%	96%
April 2003	Poor	15%	11%	93%

Lake Rotoroa is categorised as being in poor condition with a LakeSPI Index of 13% (Figure 3-8).

Lake Rotoroa has remained in a poor but stable condition since 2003. A high Invasive Impact Index of 97% (Figure 3-8), the highest recorded for any of the Hawke's Bay lakes, reflects the major impact the invasive species hornwort and elodea are having on the lake. However, a maximum depth of plants to around 9 m is consistent with the good water clarity noted at the time of the recent survey.

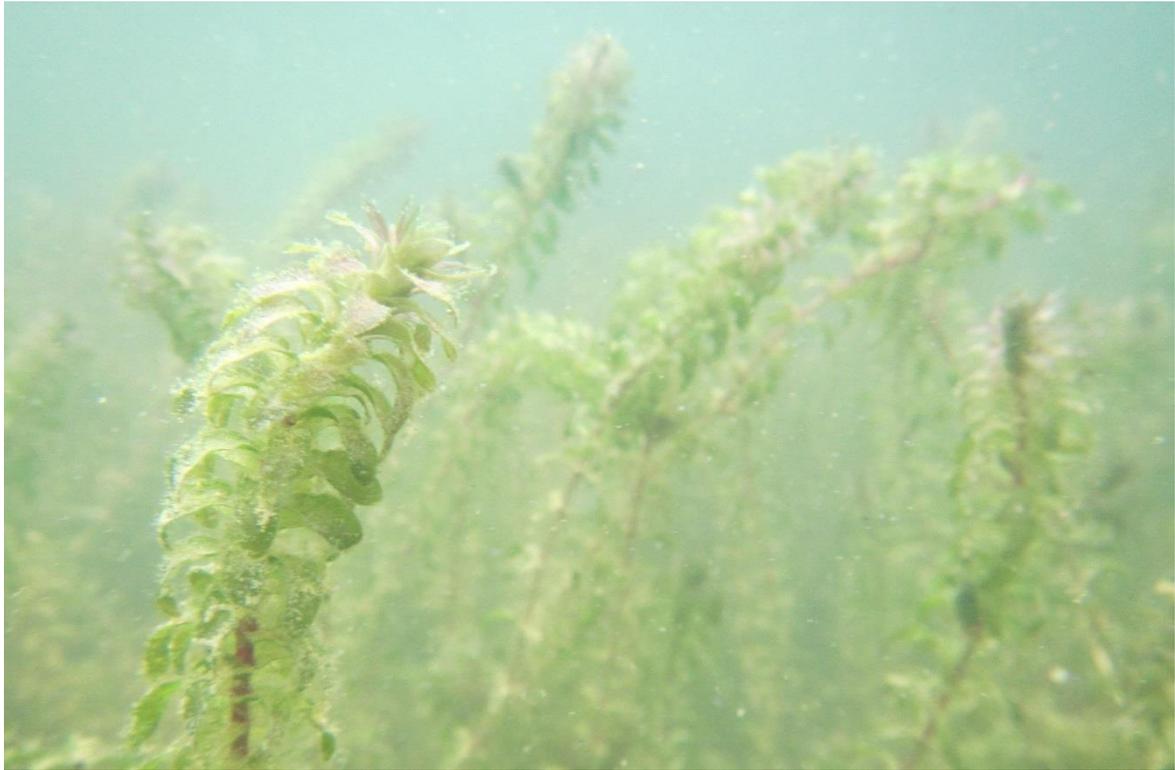
Figure 3-9: Elodea growing in Lake Rotoroa.

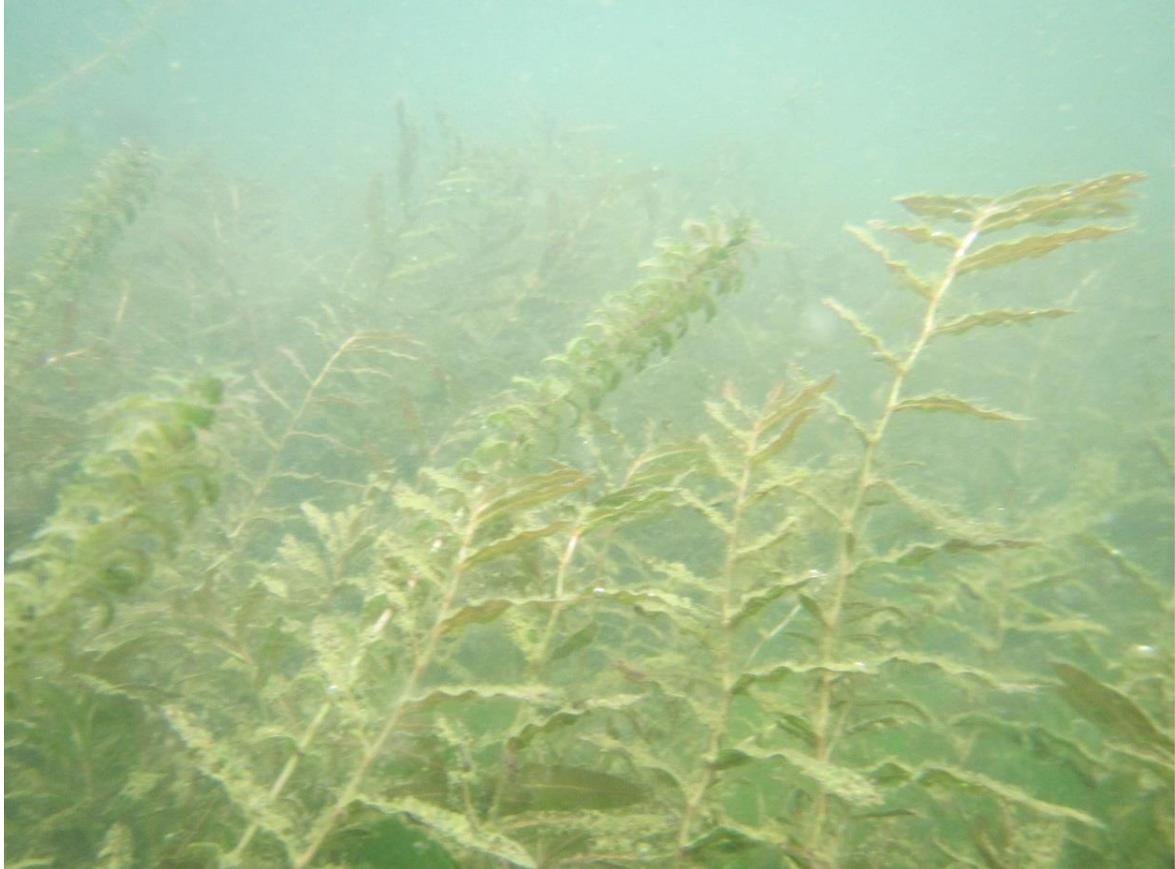
Figure 3-10: The invasive pondweed (*Potamogeton crispus*) growing in clumps through the elodea in Lake Rotoroa.

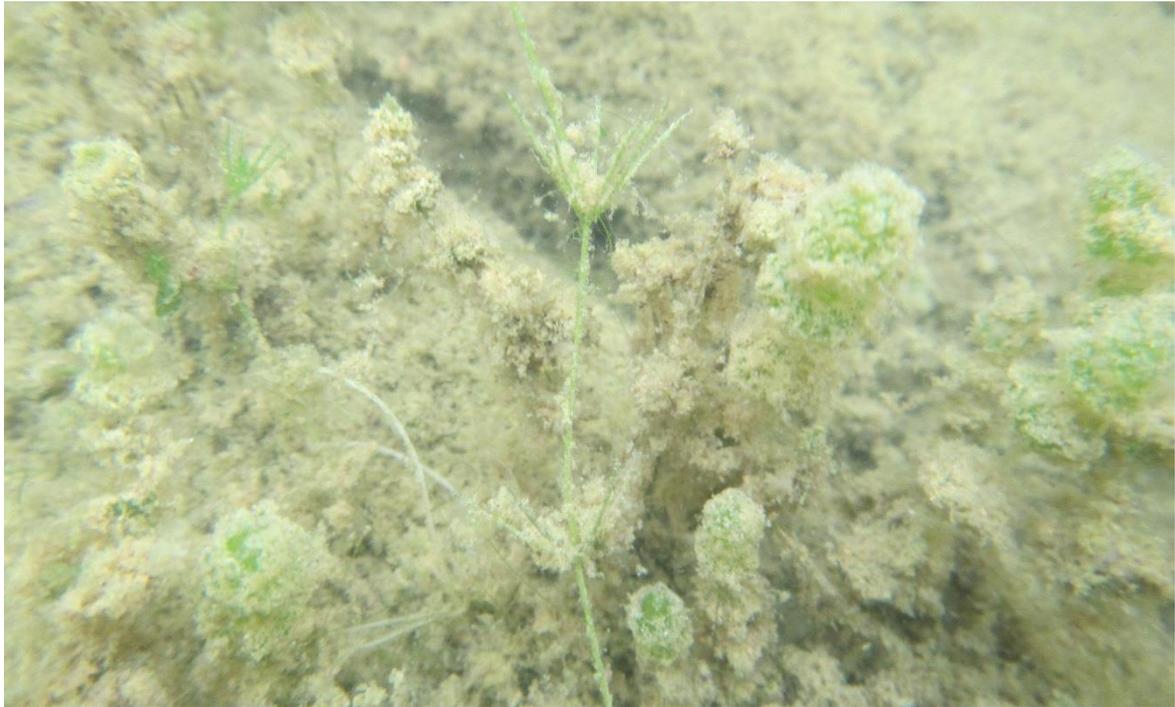
A thick covering of epiphytic algae was noted during the recent survey (Figure 3-11), in particular over the native species in shallow water (<1 m). The through-water visibility was estimated by divers to be between 2 – 4 m. A Secchi disk measurement of 1.95 m was recorded from the lake centre. No freshwater mussels were observed.

The presence of some native plants still growing in shallower areas around the lake, although under thick cover of epiphytic algae (Figure 3-11), is encouraging should the lake undergo any restoration efforts in the future.

Figure 3-11: Native charophytes in Lake Rotoroa covered by thick layer of algae.

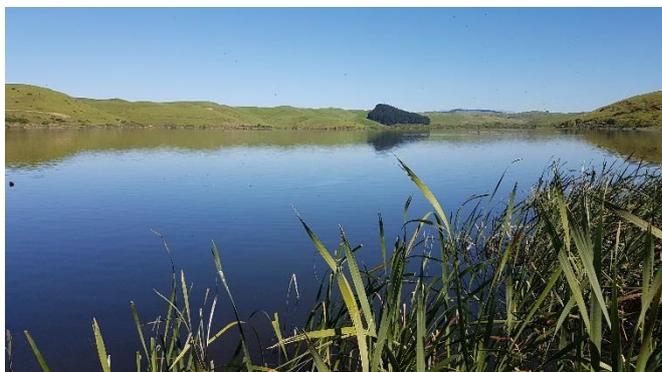
Oingo Lake Submerged Plant Indicators

Lake condition:	Poor
Lake ranking:	5 th
Lake maximum depth:	2.9 m
Max depth of vegetation:	2.9 m

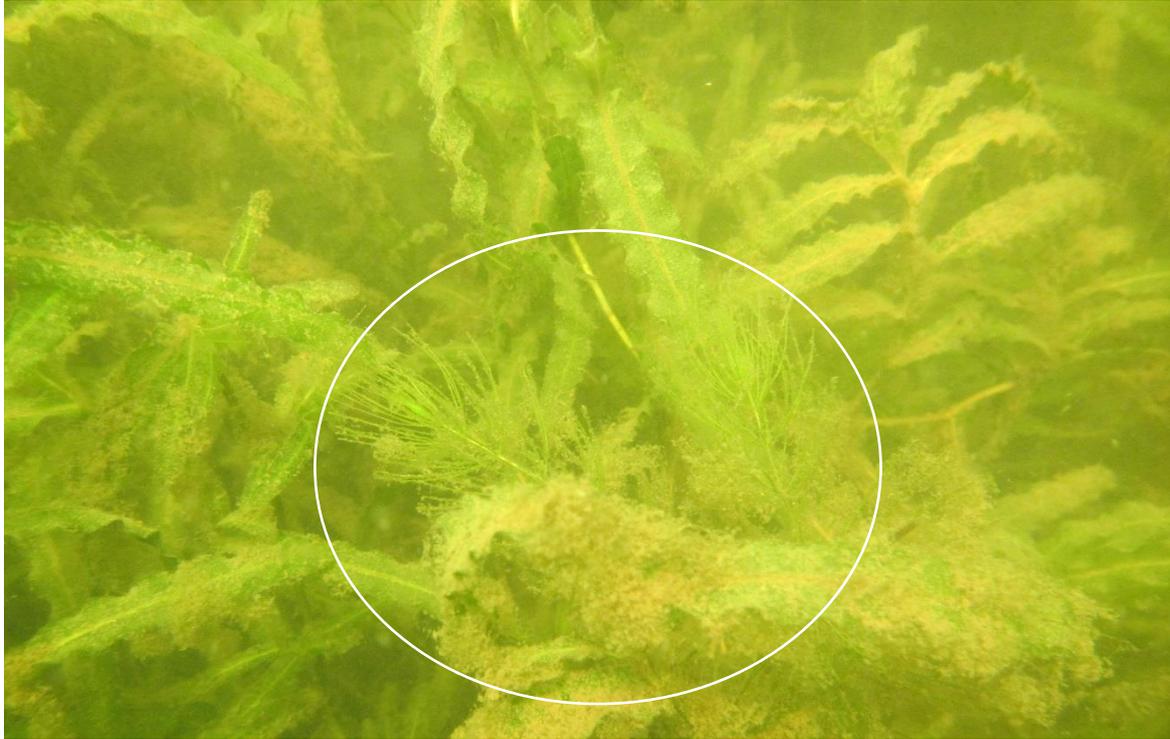
Hornwort (*Ceratophyllum demersum*) and the invasive pondweed *Potamogeton crispus* were the only two submerged plants observed in Lake Oingo. *Potamogeton crispus* was the more prevalent of these two species forming a variable cover of low growing plants, c. 0.6 m in height, extending across the bottom of the lake to its maximum depth of 2.9 m. Hornwort was also recorded from each site but only at low covers, growing up to only 0.7 m high amongst the pondweeds (Figure 3-13).

Figure 3-13: A shoot of hornwort growing up between *Potamogeton crispus* plants in Lake Oingo.

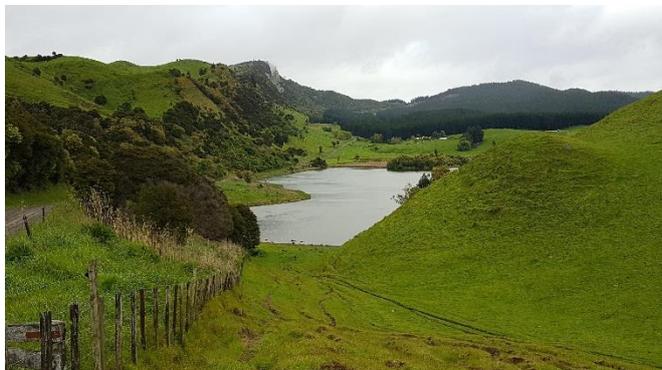
Rotongaio Lake Submerged Plant Indicators

Lake condition:	Poor
Lake ranking:	6 th
Lake maximum depth:	4.6 m
Max depth of vegetation:	3.2 m

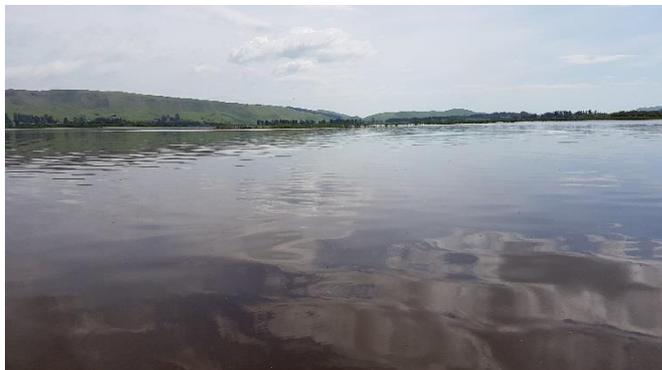
Poukawa Lake Submerged Plant Indicators

Lake condition:	Non-vegetated
Lake ranking:	7 th
Lake maximum depth:	0.9 m
Max depth of vegetation:	0.5 m

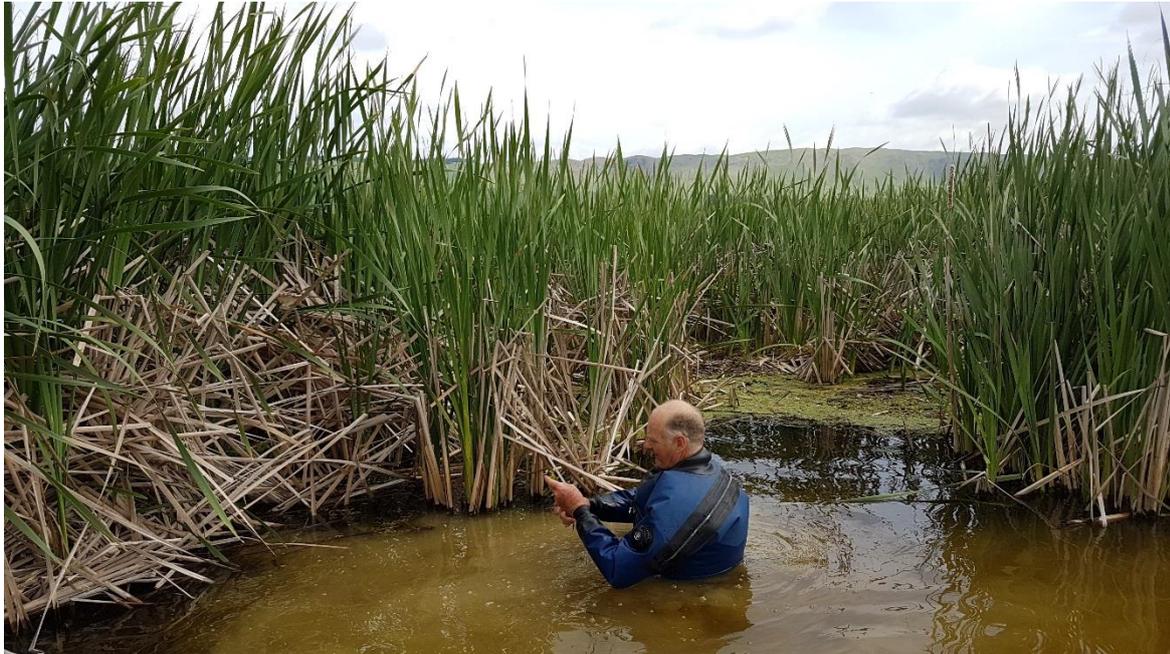
Figure 3-16: Diver identifying sparse plants growing amongst the emergents around Lake Poukawa.

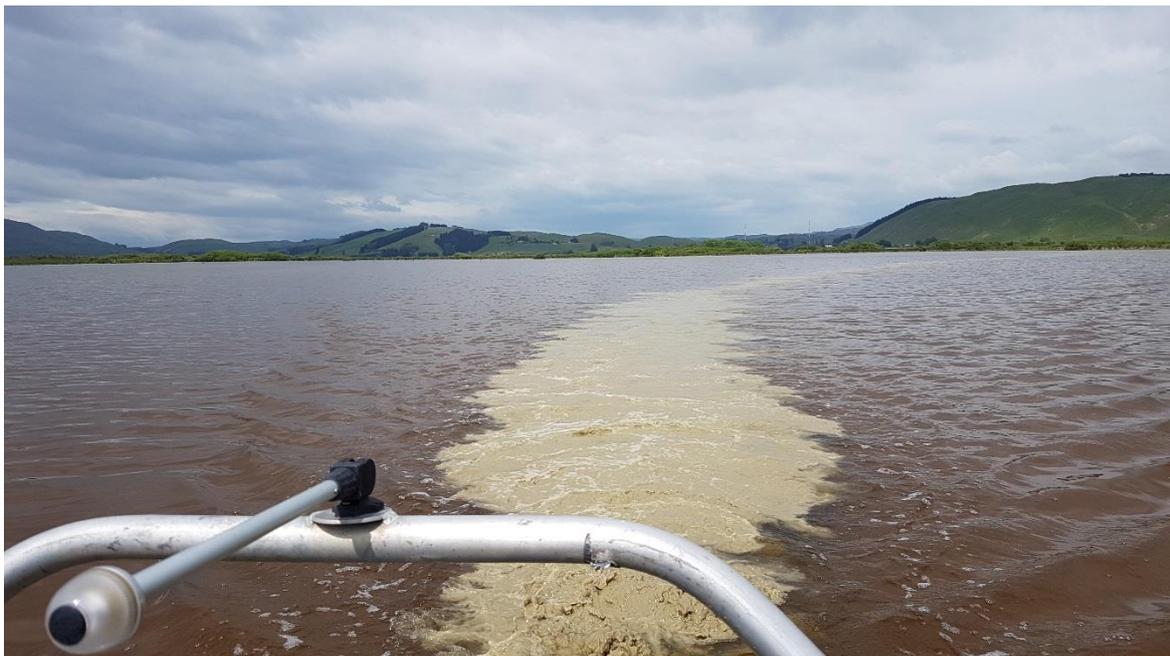
The soft and very flocculent nature of the lake sediments would likely prevent any colonisation of submerged plants.

Figure 3-17: Turbid water disturbed by the boat propeller.

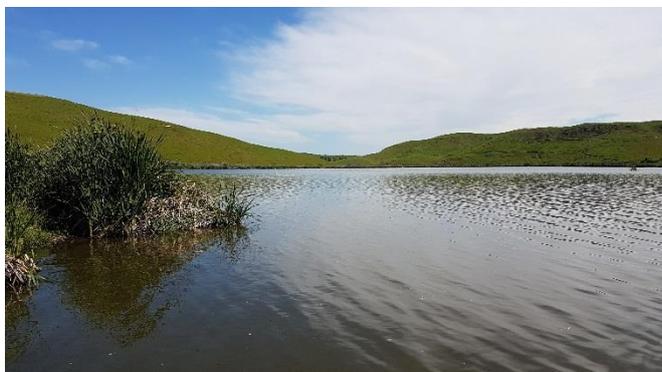
Runanga Lake Submerged Plant Indicators

Lake condition:	Non-vegetated
Lake ranking:	7 th equal
Lake maximum depth:	1.7 m
Max depth of vegetation:	0 m

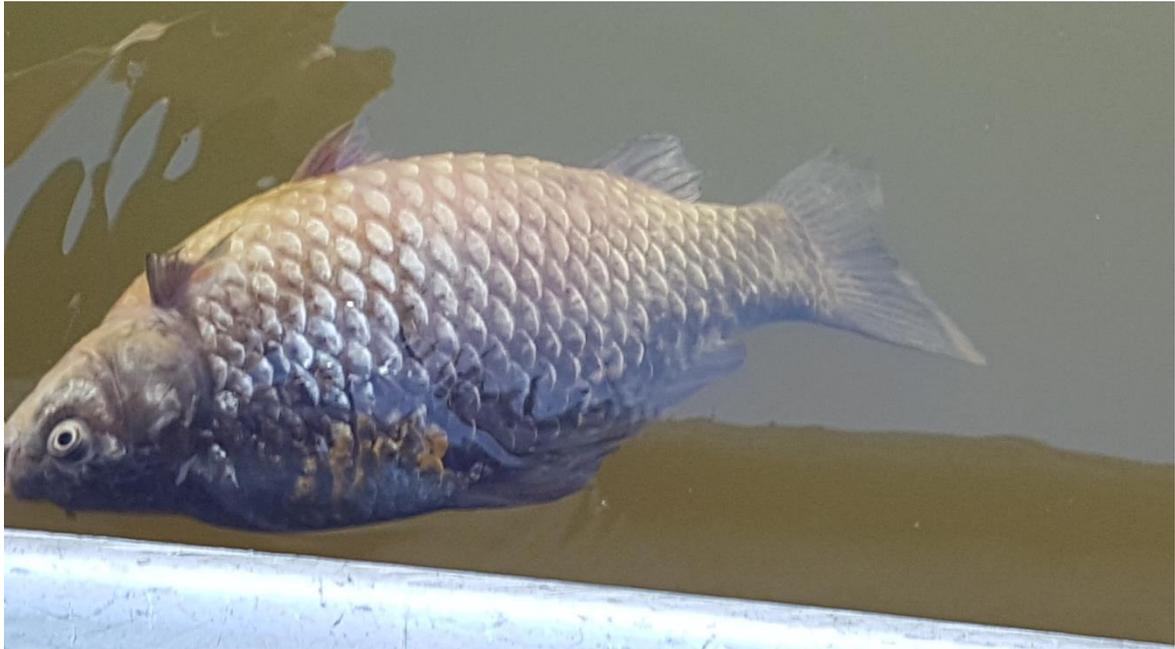
Lake Runanga had low water clarity at the time of the recent survey and the presence of dead fish floating on the lake surface raises further concerns over anoxia.

Figure 3-19: Dead gold fish in Lake Runanga.

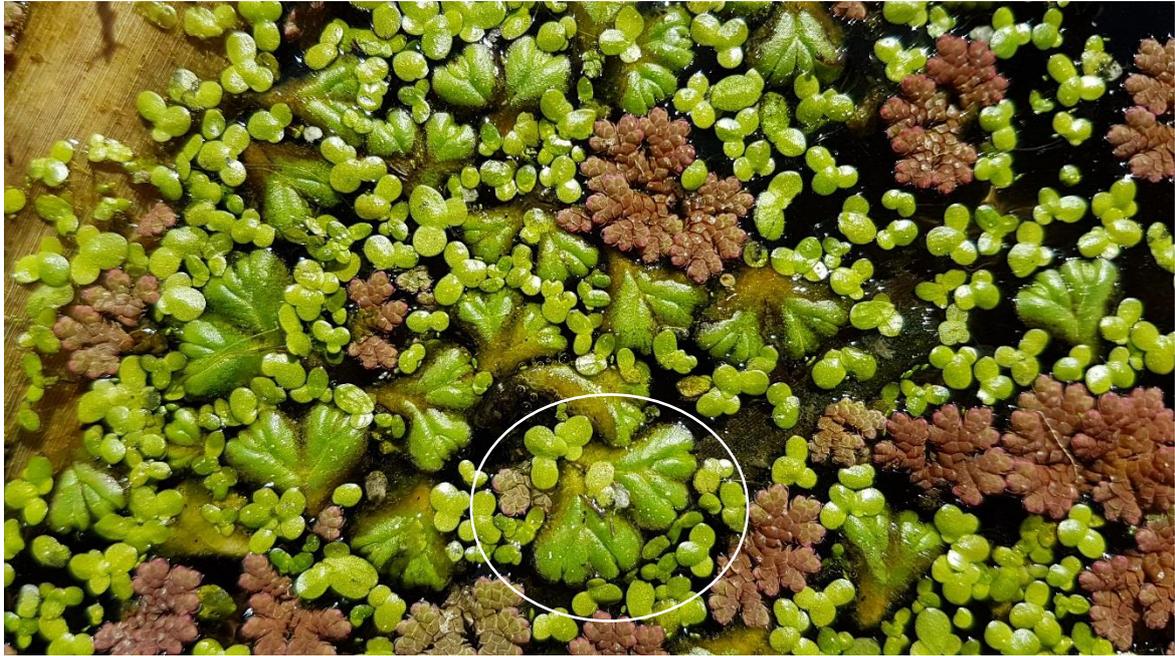
Figure 3-20: The near-threatened free-floating liverwort *Ricciocarpos natans* at the edge of Lake Runanga. (Photo: T. Burton)

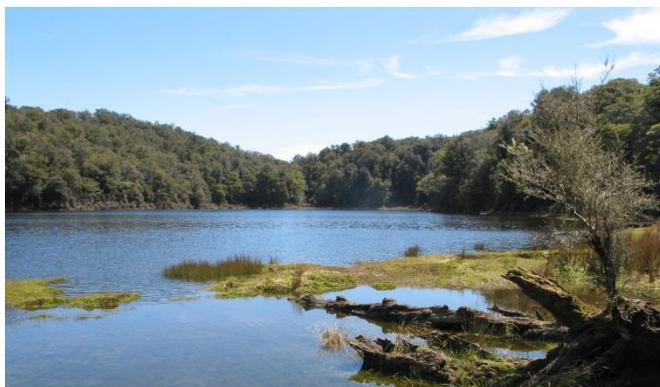
Waikareiti Lake Submerged Plant Indicators

Lake condition:	Non-vegetated
Lake ranking:	7 th equal
Lake maximum depth:	80 m
Max depth of vegetation:	Not recorded

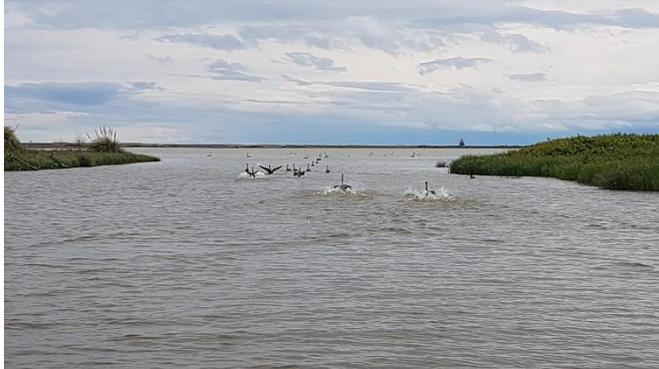
Lake Whakaki Submerged Plant Indicators

Lake condition: Non-vegetated
 Lake ranking: 7th equal
 Lake maximum depth: 1.5 m
 Max depth of vegetation: 0 m

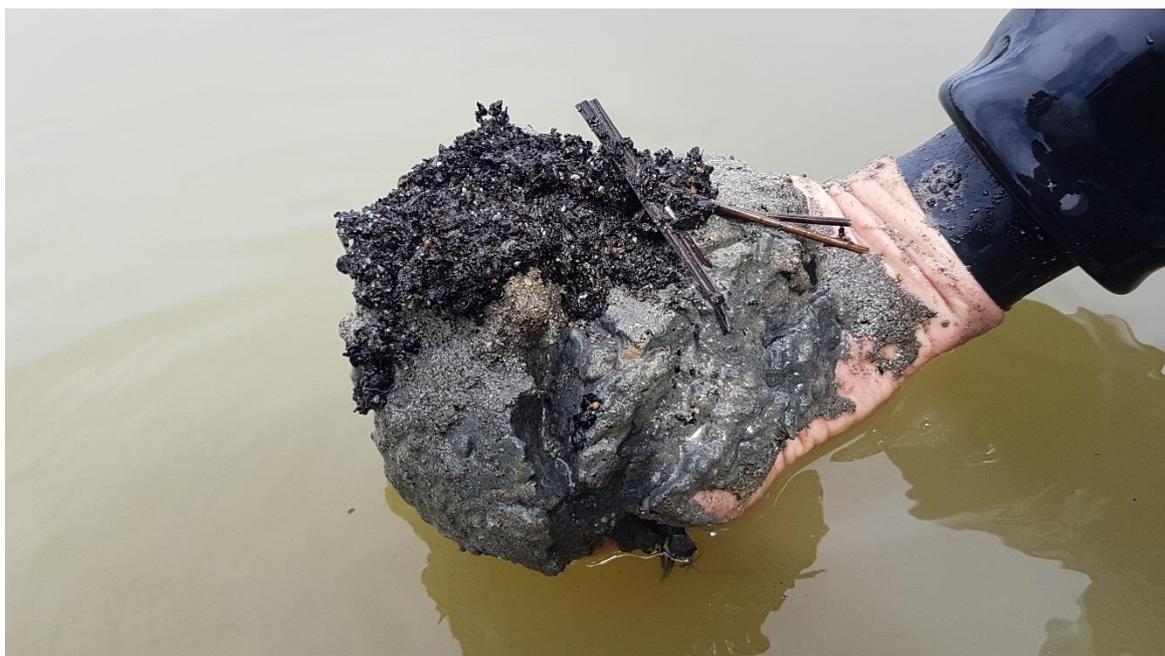
Figure 3-23: Bottom sediments in Lake Whakaki were compacted sand/mud with a layer of organic matter on top.

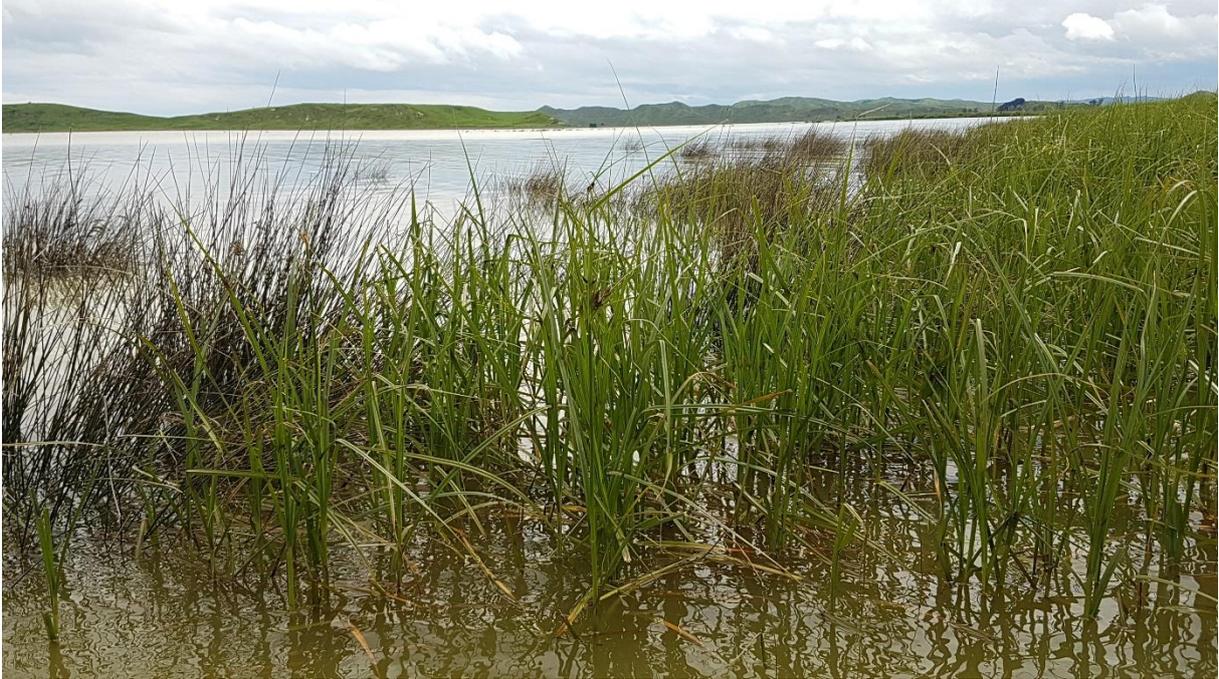
Figure 3-24: Emergents growing around the margin of Lake Whakaki dominated by *Bolboschoenus fluviatilis* (foreground).

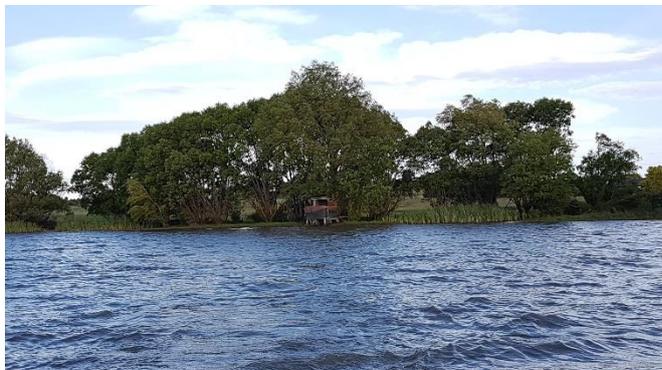
LakeSPI condition:	n/a
Lake ranking:	n/a
Lake maximum depth:	0.8 m
Max depth of vegetation:	0.8 m

Lake Hatuma (also known as Lake Whatumā) did not generate a LakeSPI result for this report based on its shallow overall depth of only 0.8 m (November 2017 survey).

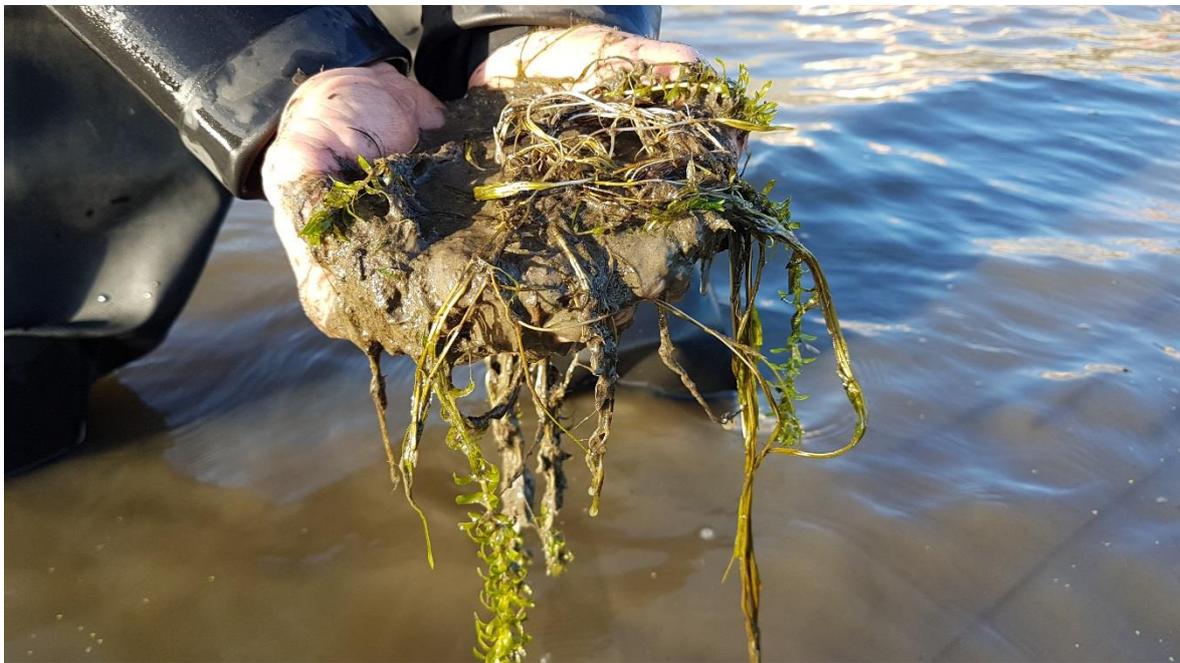
Figure 3-25: Submerged vegetation in Lake Hatuma consisted of both native and invasive species. A handful of the bottom sediment shows elodea and *Ruppia polycarpa*. (Photo: T. Burton)

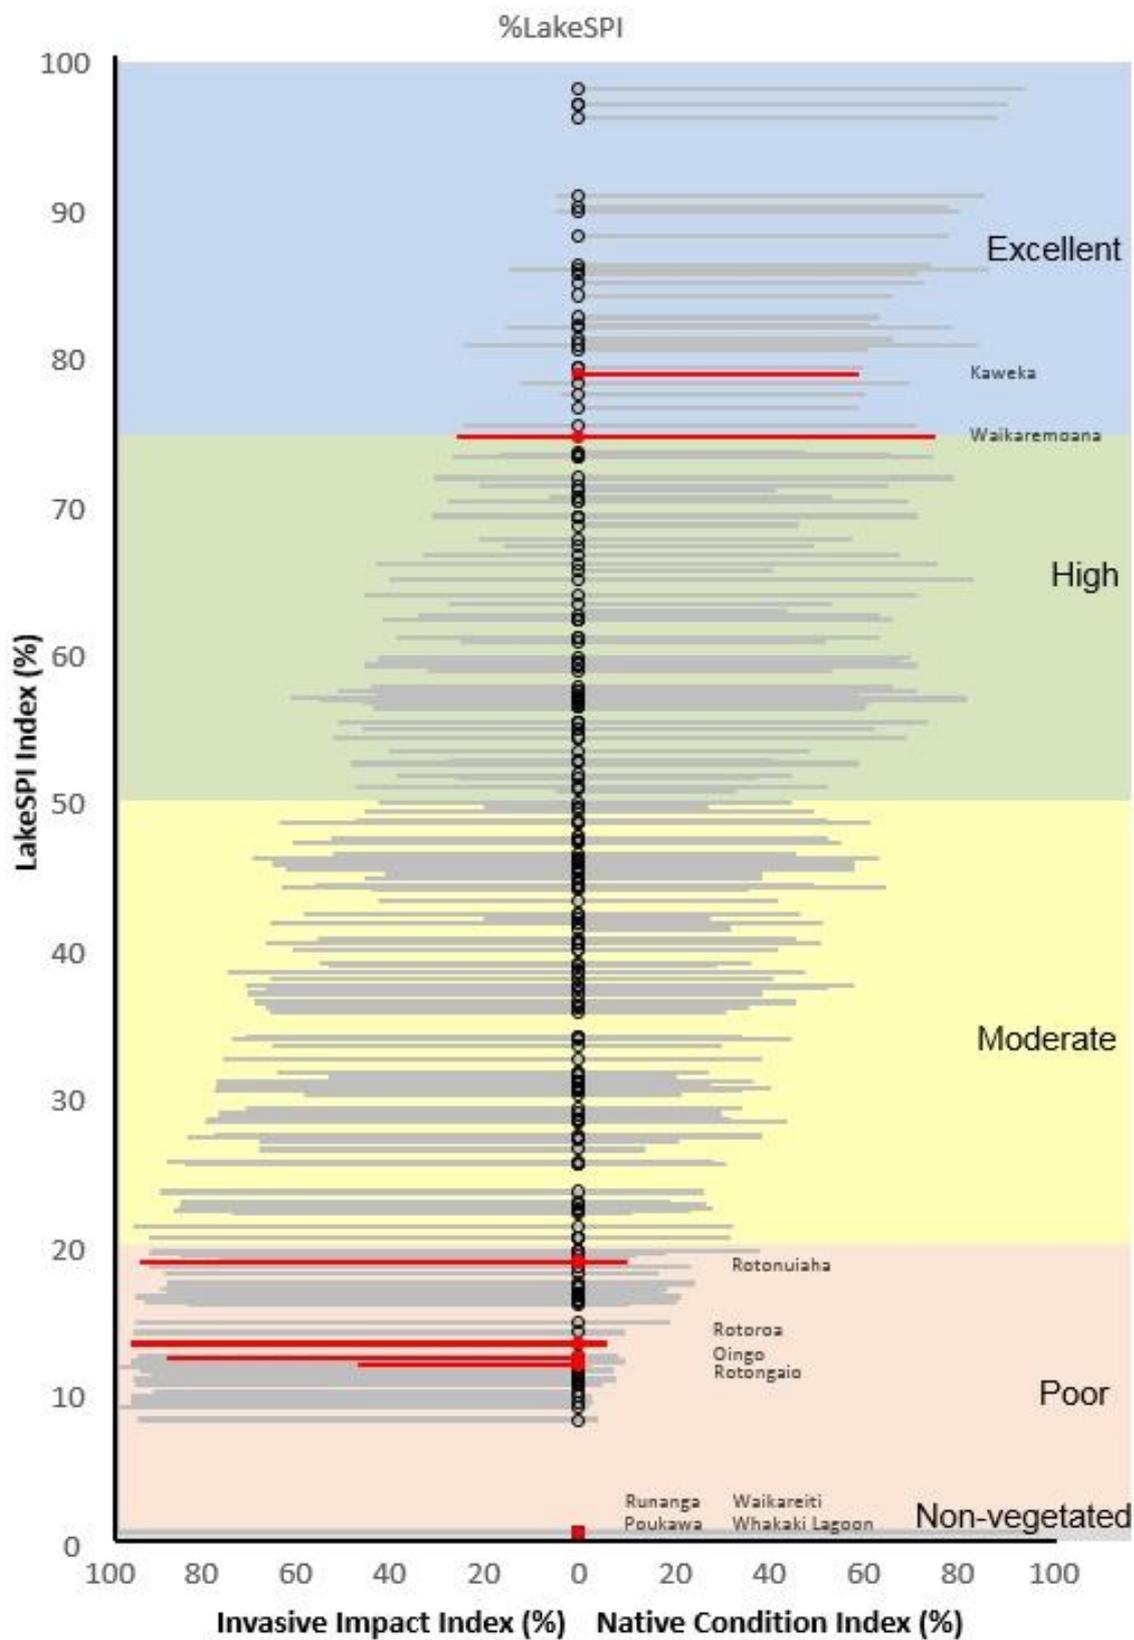
Compared nationally, the Hawke's Bay Region has similar proportions of lakes in the 'excellent' and 'high' category, and greater proportions in the non-vegetated and poor categories (Figure 4-1 and Figure 4-2). The 'poor' condition group tends to represent those lakes with extensive invasion and dominance with little native vegetation character remaining. This is the case for all four of the Hawke's Bay lakes that fall within this group. The 'non-vegetated' group represents the most degraded state of a lake, where water quality conditions have deteriorated to the point where growth of submerged plants can no longer be supported, as is the case with Lakes Poukawa, Runanga and Whakaki.

Figure 4-1: LakeSPI Indices based on the latest results of 283 lakes in grey, showing the scores for the lakes of the Hawke's Bay Region as a red line. LakeSPI scores are plotted on the vertical axis, with the Native Condition Index plotted on the right hand horizontal axis, and the Invasive Impact Index on the left hand to show the negative influence on the LakeSPI score.

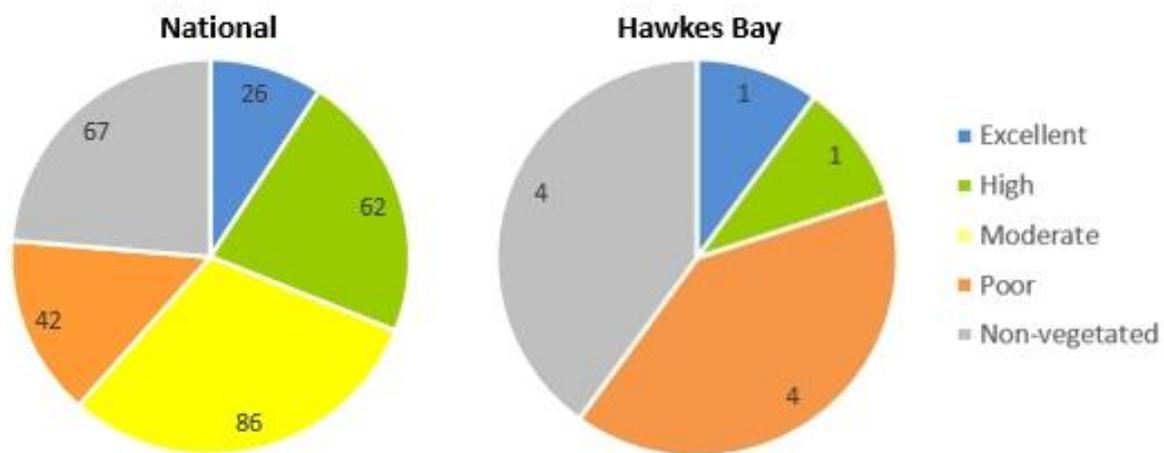
The Hawke's Bay region has no lakes classified in 'moderate' condition which nationally contains the largest proportion of lakes and tends to represent those lakes that are impacted in varying degrees by invasive weeds but still retain some native vegetation character.

Figure 4-2: Proportion of lakes that fall into each of five categories of LakeSPI Index for the region (10) and nationally (283), with the number of lakes assessed shown in parenthesis.
