**Assessment of liquefaction risk in the Hawke's Bay
Volume 2: Appendices for Volume 1**

**GNS Science Consultancy Report 2015/186
October 2017**

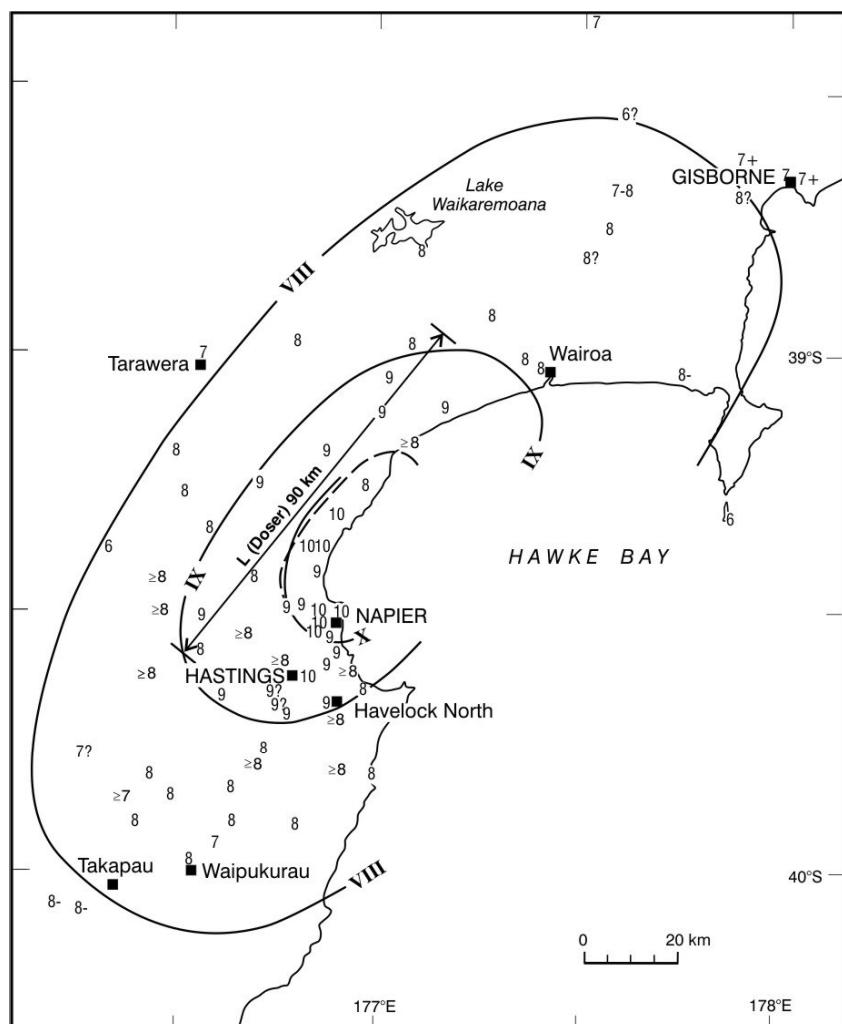
Figure A3.1 Isoseismals of the 1931 Hawke's Bay earthquake (from Dowrick, 1998).

The 1931 Hawke's Bay earthquake caused the greatest loss of life and the most extensive damage ever recorded for an earthquake in New Zealand (Callaghan 1933). As shown in Figure A3.1 (from Dowrick 1998) the effects of the earthquake were greatest in the towns of Napier (MM10) and Hastings (MM9), but other towns in the Hawke's Bay region also suffered major damage – Havelock North MM9; Waipawa, Waipukurau, Te Aute, Wairoa MM8; Gisborne MM7. The official death toll was 256, 161 occurring in Napier, 93 in Hastings and 2 in Wairoa (McSaveney 2017). The earthquake was followed by fires in the central business areas of both Napier and Hastings. The fires raged uncontrollably in Napier as the water supply for firefighting was cut-off because of the many broken water mains. However, in Hastings an uninterrupted water supply was available thus enabling the fires to be brought under control much more effectively (Butcher 1931).

The earthquake epicentre was located 30 km to the NNE of Napier, and the magnitude is estimated at $M_s = 7.8$ (Dowrick & Smith 1990). The earthquake was felt throughout most of New Zealand and was accompanied by well-documented faulting and uplift, with extensive liquefaction and related fissuring and slumping, and landslides occurring over much of Hawke's Bay (Henderson 1933; Hull 1990). These effects resulted in widespread disruption to services, road and rail traffic. There was permanent change in local drainage patterns as seen by the shift in the mouth of the Tutaekuri River. Ground subsidence of alluvial materials was widespread, and liquefaction (sand boils) apparently occurred over a wide area, including Wairoa, Mohaka, Tongioio, Petane, Napier, Taradale and the Heretaunga Plains (Fairless & Berrill 1984). The liquefaction effects in different locations in Hawke's Bay are described below. Modified Mercalli (MM) shaking intensities assigned to these locations are as assigned by Dowrick (1998), see Figure A3.1.

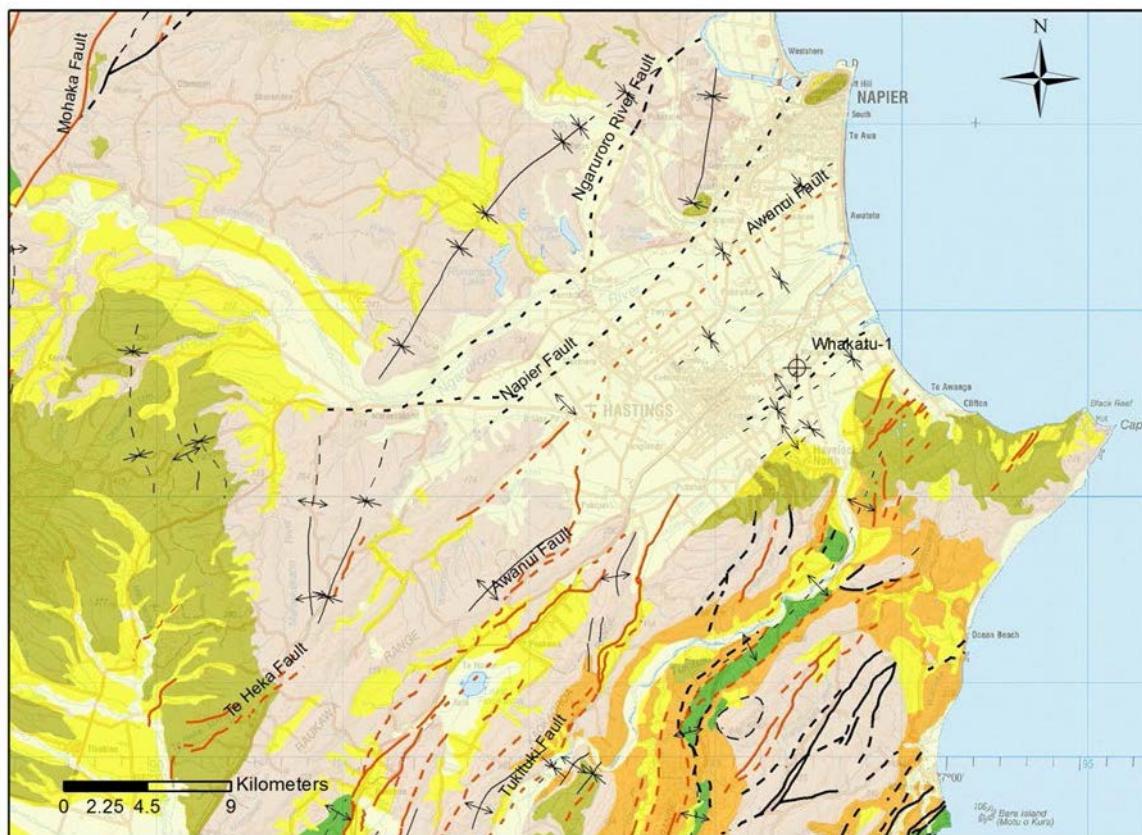
A generalised geology map is shown in Figure A4.1.

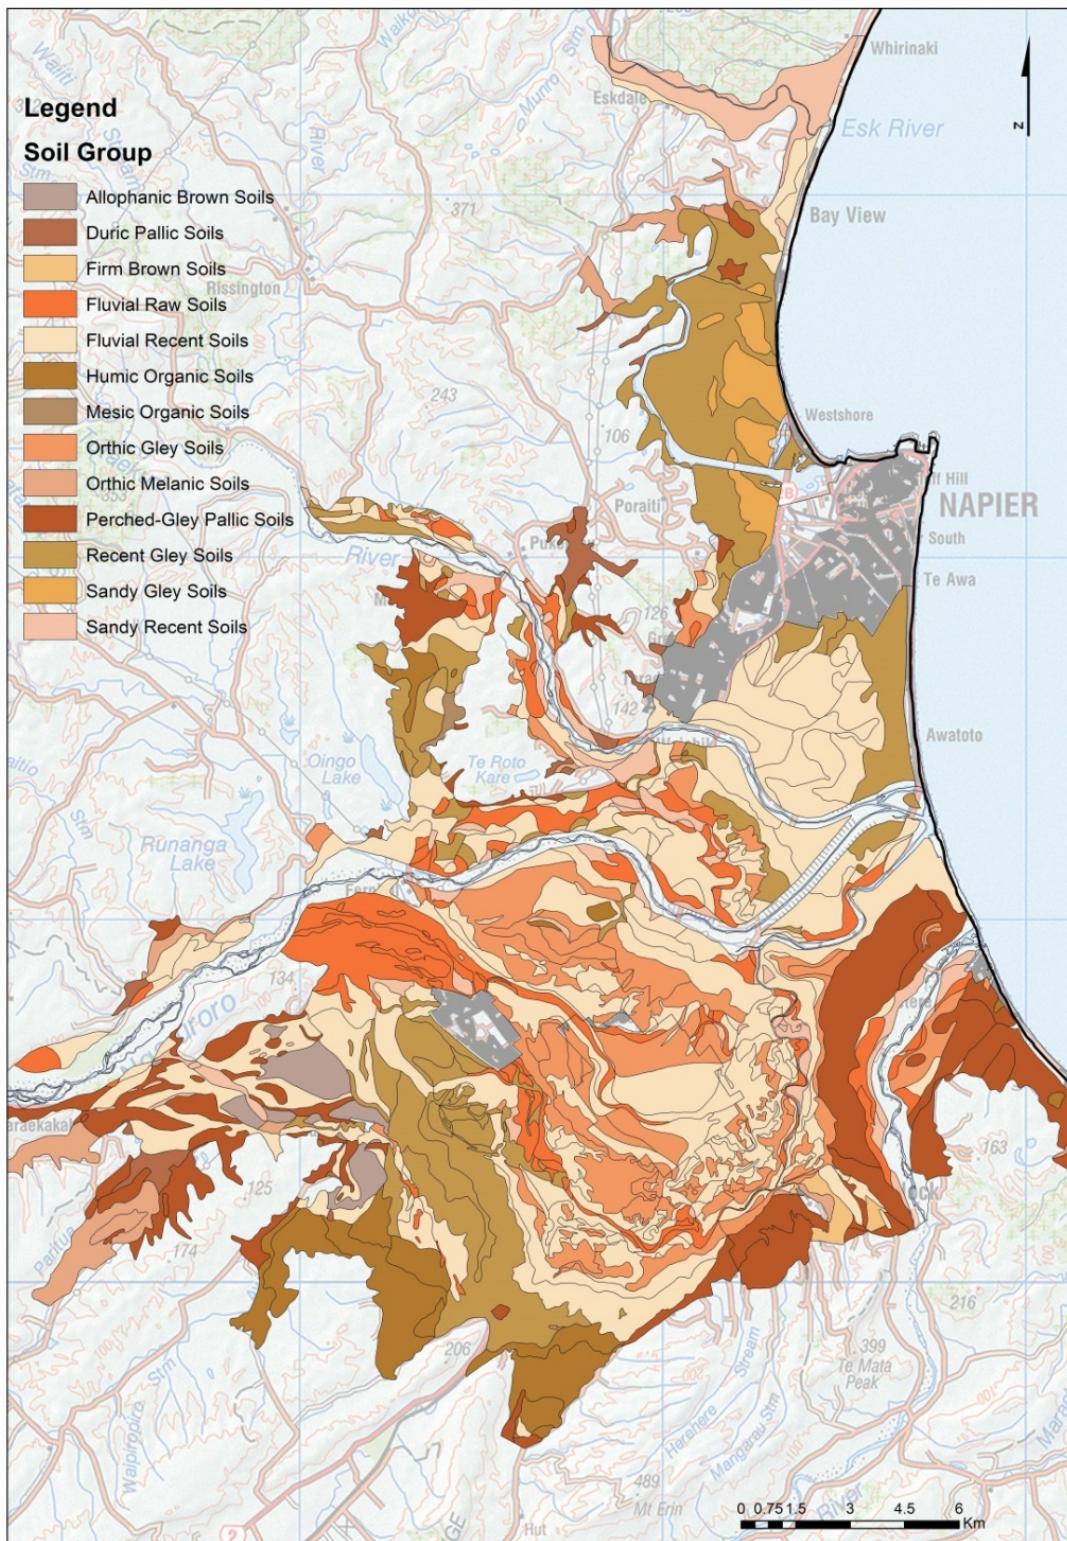
Figure A4.2 Soil Group.

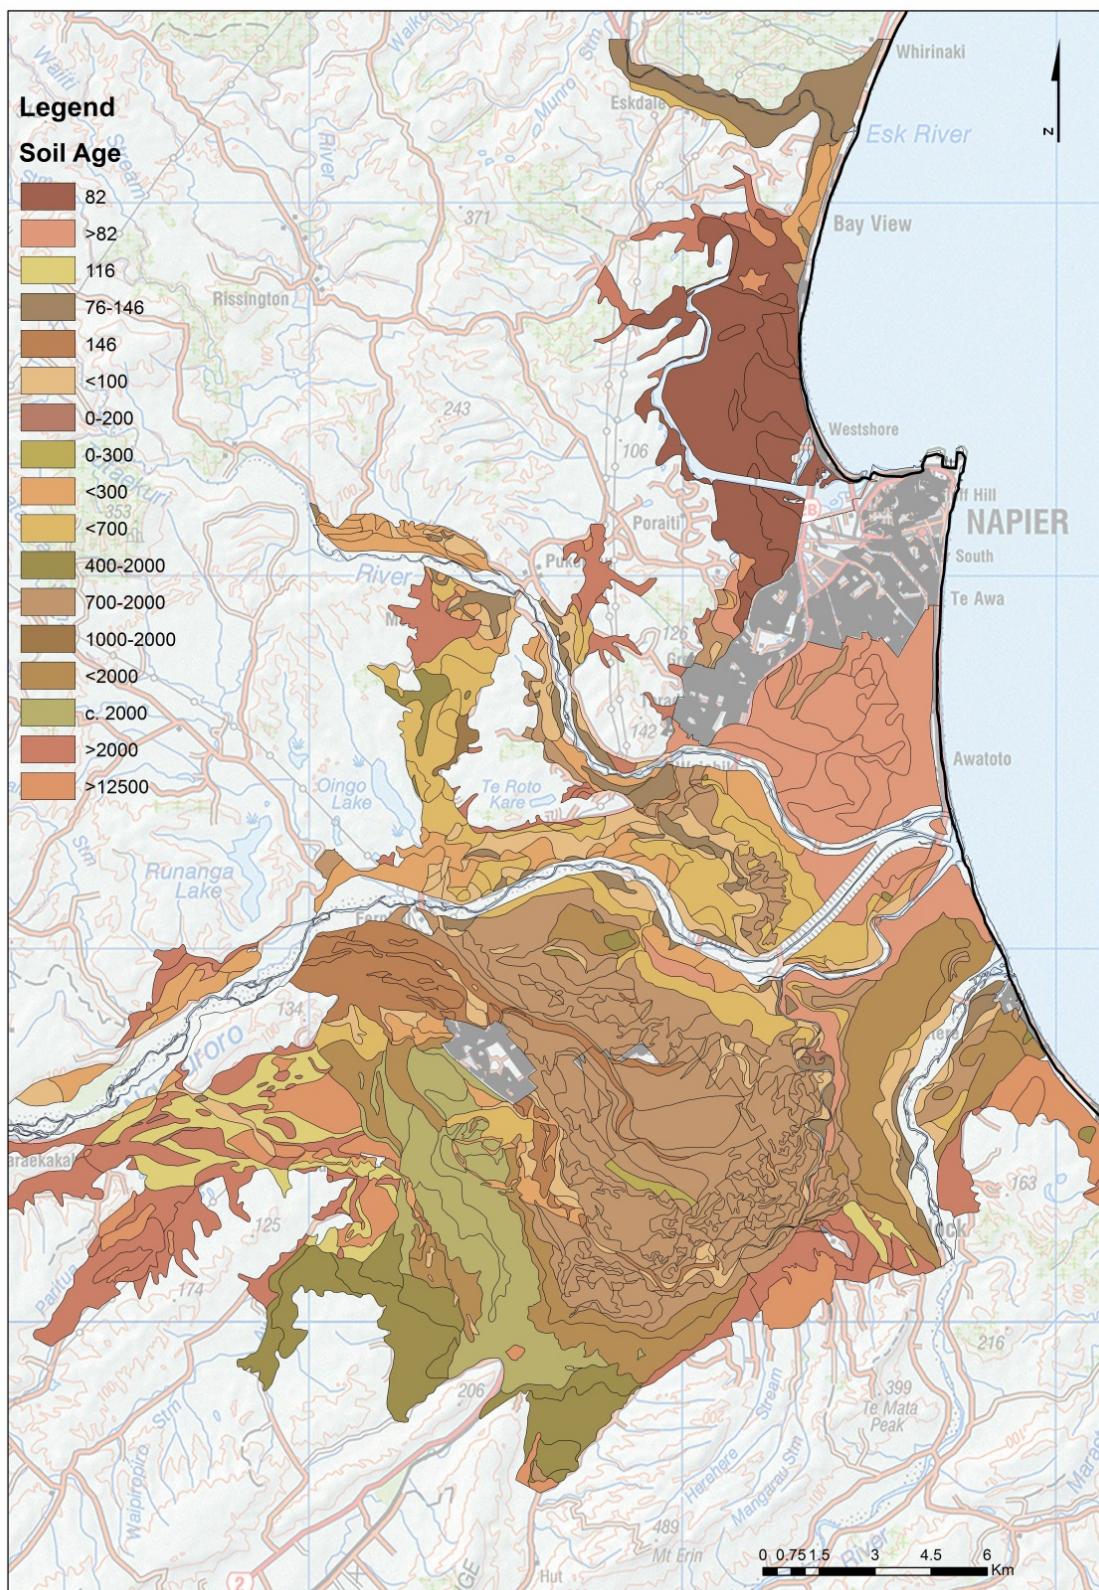
Figure A4.3 Soil Age (in years).

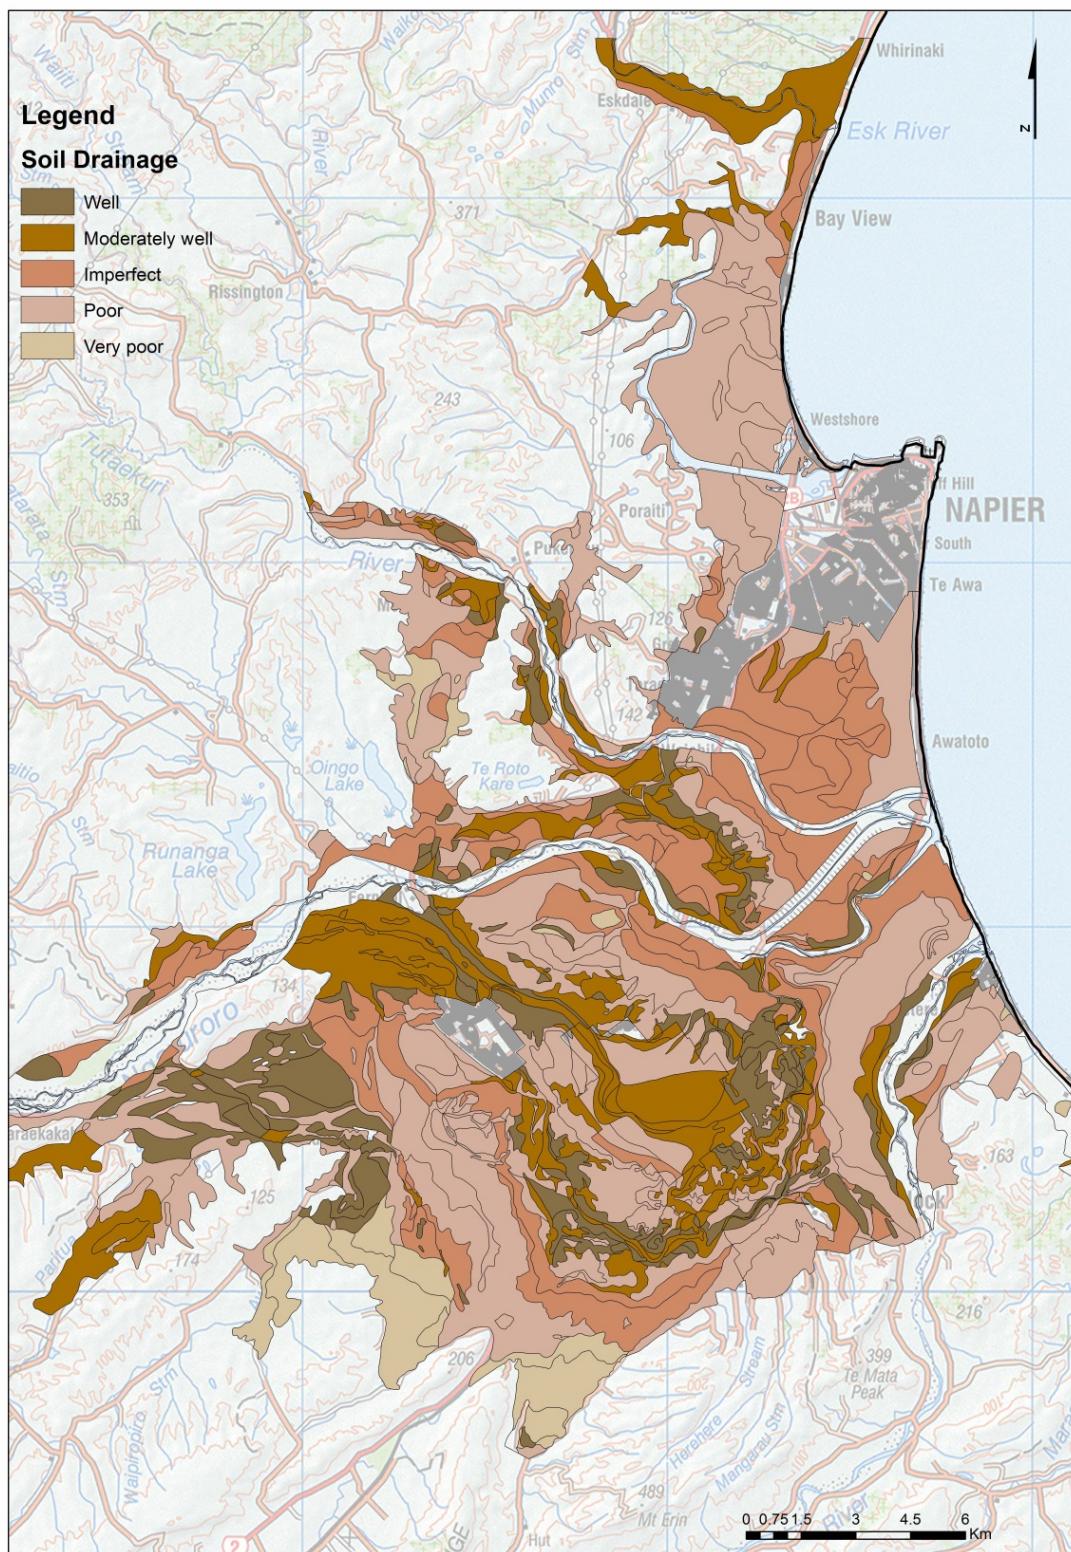
Figure A4.4 Soil drainage class.

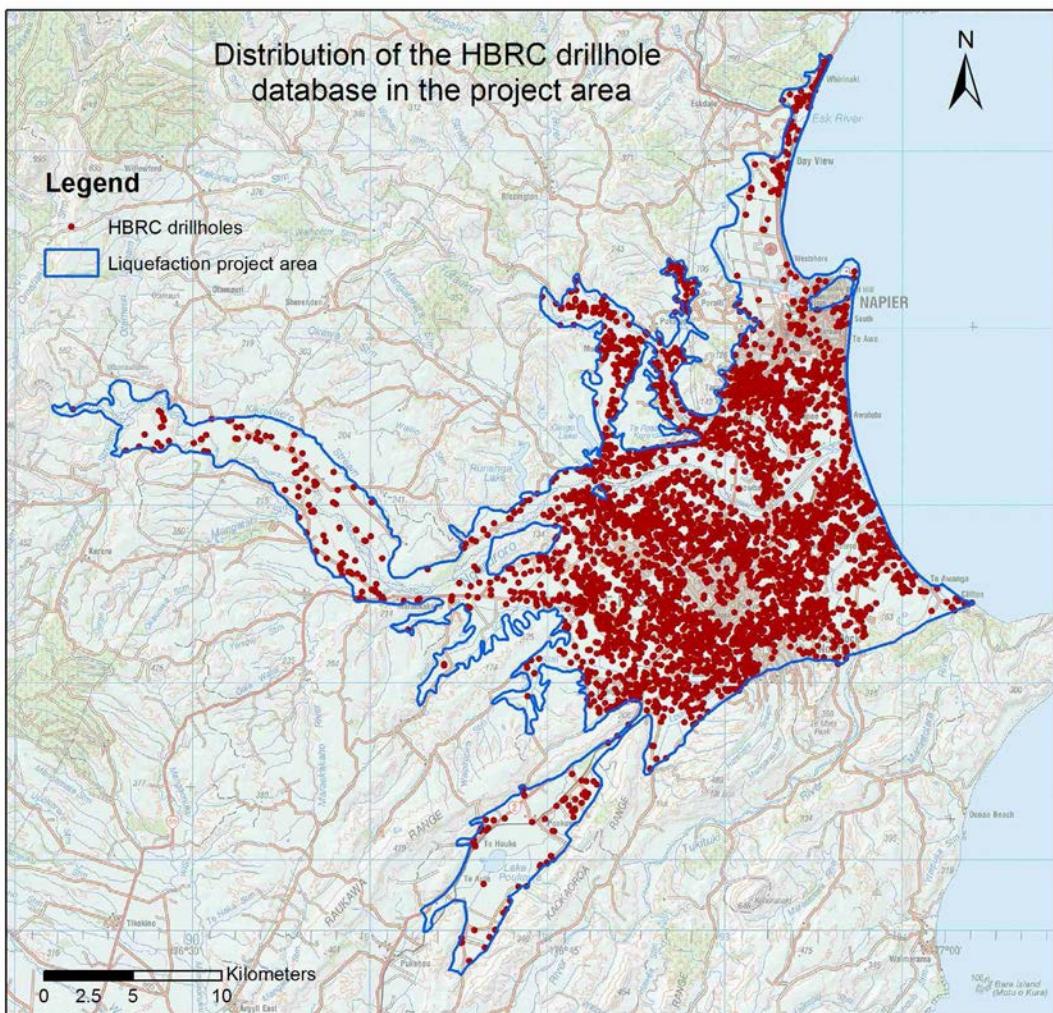
Figure A4.6 The HBRC boreholes have been clipped to the area of the Heretaunga Plains and are well distributed across the Heretaunga Plains.

The borehole data within the area of interest was first cleaned to remove duplicate collar files and collar files that were missing lithological interval information. Some collar files with identical grid references had different IDs and interval data; these data were also excluded as it was impossible to assess which data was correct. New borehole collar heights were allocated from LiDAR data and this cleaned data was loaded into Leapfrog Geo. The locations of the boreholes are shown in Figure A4.6.

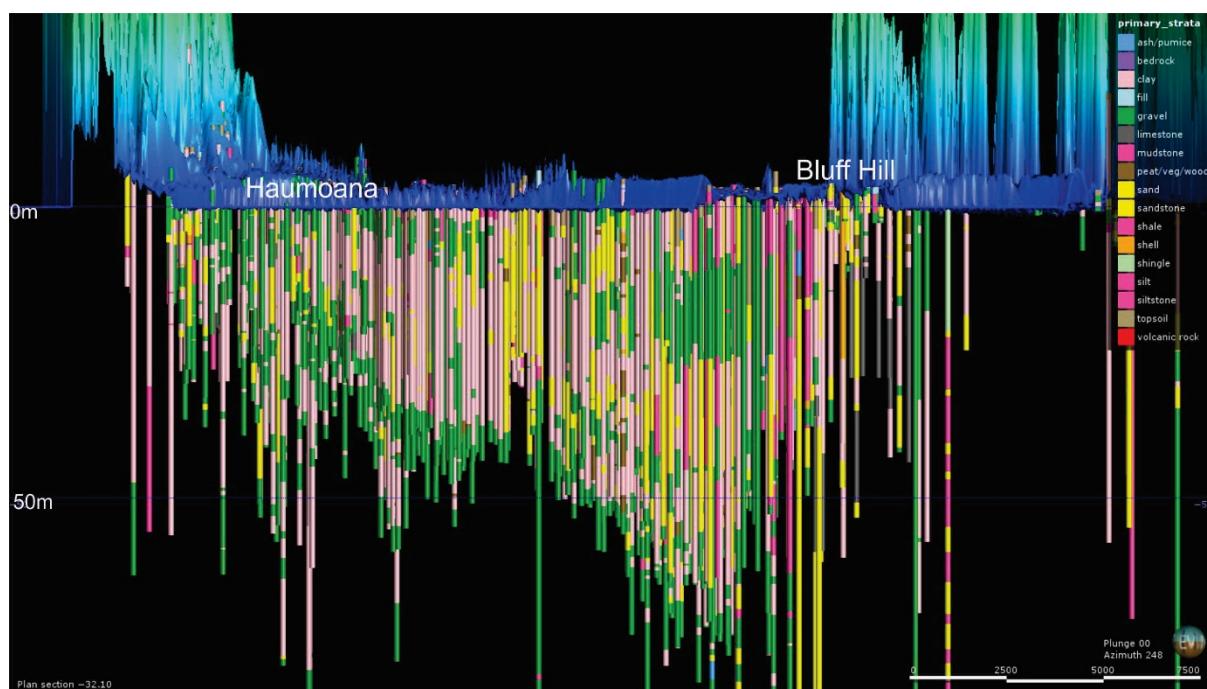
Figure A4.7 A Leapfrog cross section from Haumoana to Bluff Hill in the north. The boreholes show subsurface lithologies are dominated in this area by clay (pink) and gravel (green). Apart from gravel, other units such as sand (yellow) and silt (dark pink), do not display any coherent mappable stratigraphy. The boreholes mostly terminate at the top of the lowermost gravel, which we interpret as Last Glacial in age. Vertical exaggeration is 150.

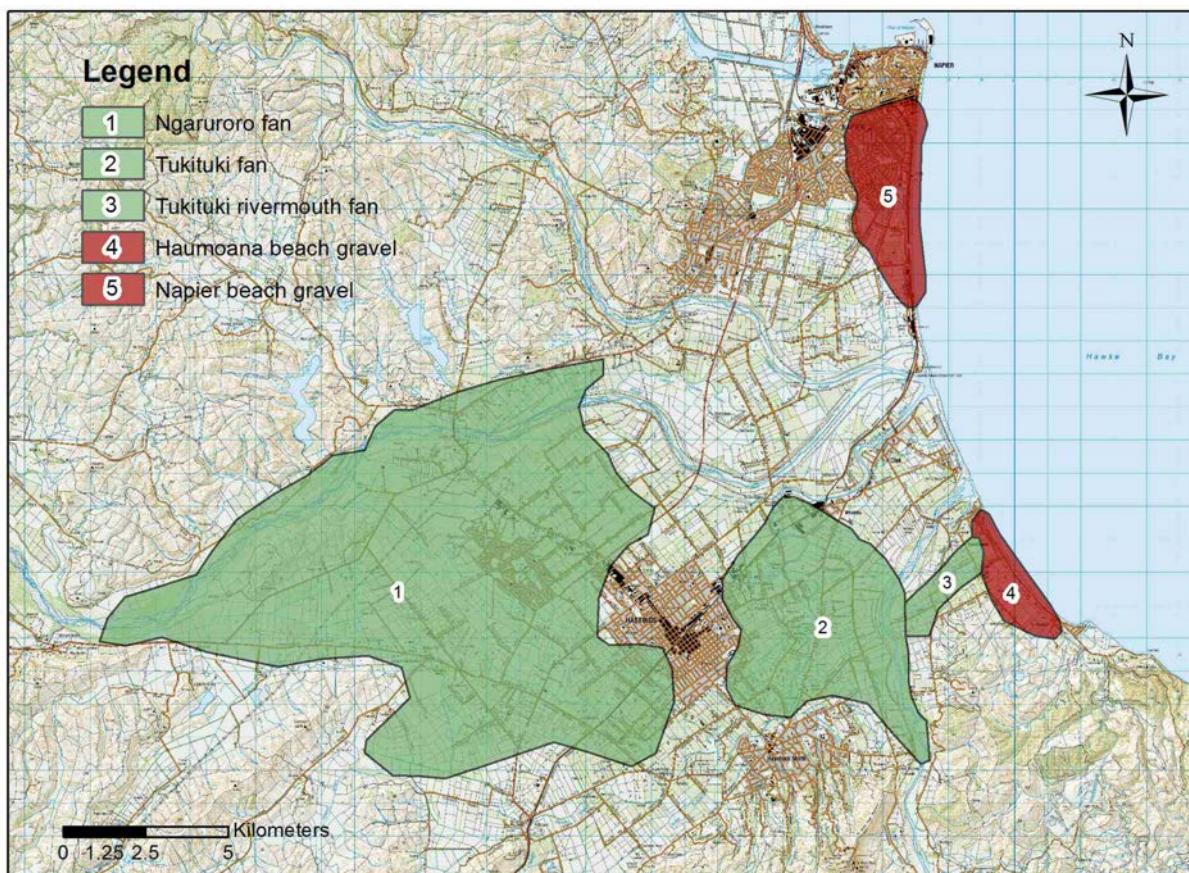
Figure A4.8 A map view of the surface and subsurface distribution of Holocene gravels identified from the boreholes. Beach barrier bar gravels are located south of Napier and at Haumoana (reddish brown). Inland alluvial fan deltas (green) were deposited by the Ngaruroro and Tukituki rivers.

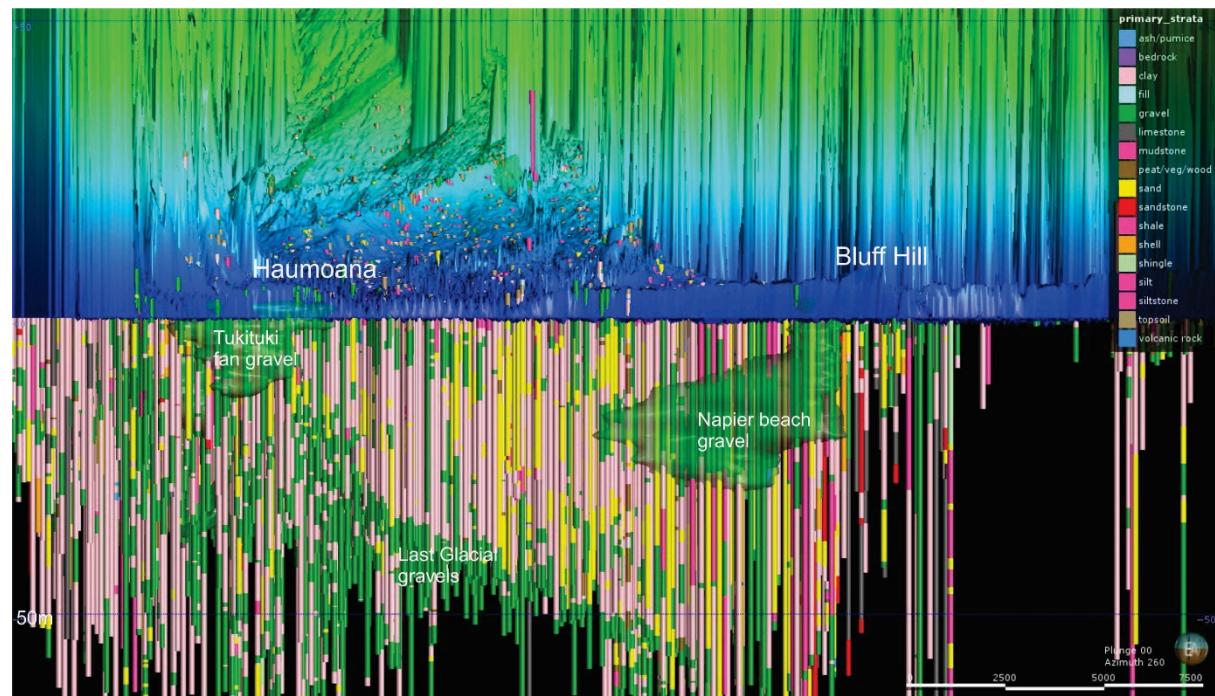
Figure A4.9 A cross section from Haumoana to Bluff Hill shows some of the Holocene gravel units identified using borehole data. The Napier Beach gravels lie between 15–20 m below sea level. Fan gravels deposited by the Tukituki River are found up to 10 m below the ground surface.

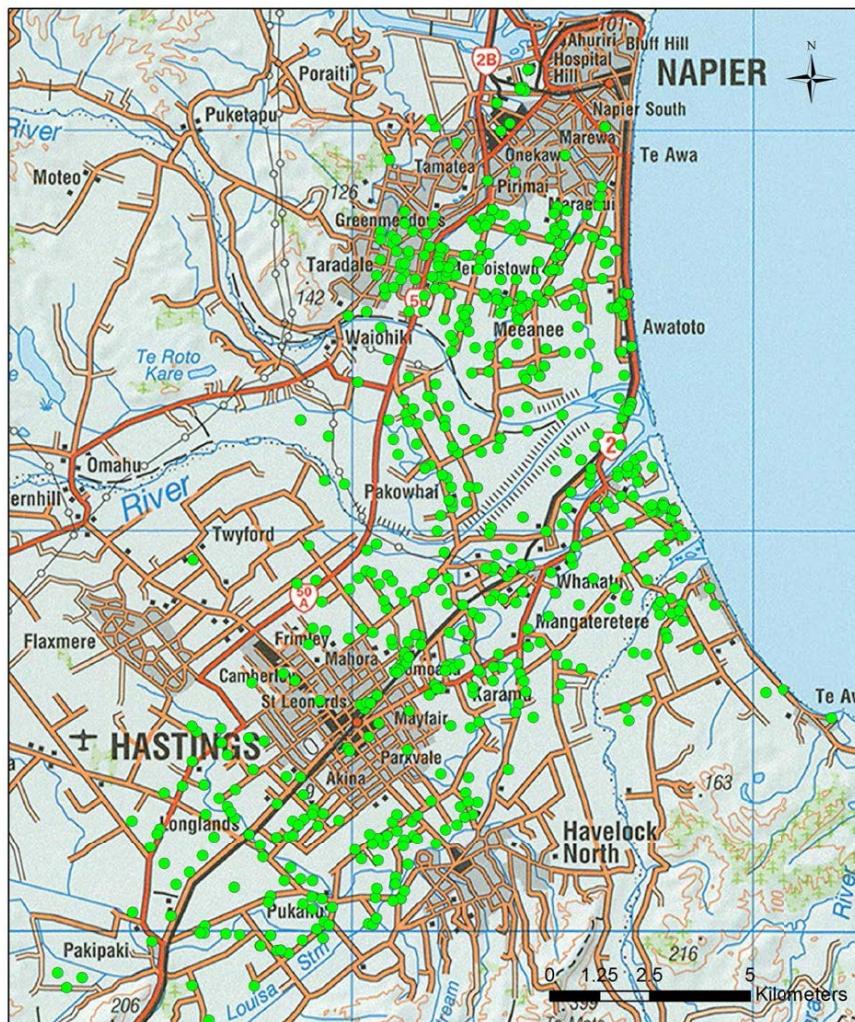
Figure A4.10 The distribution of shells (green dots) from borehole data that lie above the base of the Holocene surface, showing the maximum inland extent of sea level 7000 years ago.

The distribution of shells in the borehole data show the sea transgressed inland almost as far as Pakipaki at the end of the period of post-glacial sea level rise c. 7000 years' ago (Figure A4.10). The occurrence of widespread marine shells, locally to depths of ~50 m indicates that enclosing materials are Holocene in age.

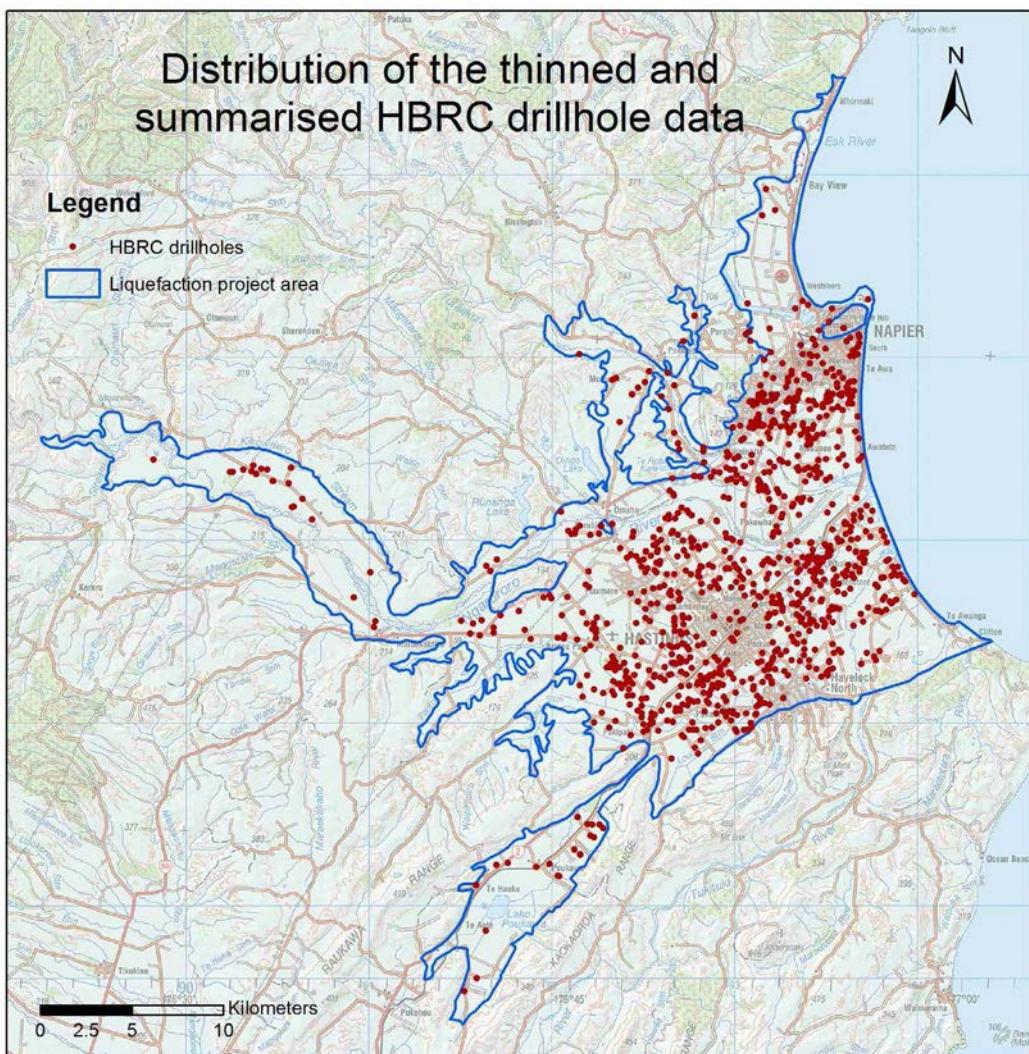
Figure A4.11 Distribution of the thinned boreholes dataset summarised for predominant lithologies at metre by metre intervals down to 10 m depth, and from 10 to15m.

While the large number of borehole logs were useful in defining the gravel units, and the extent of Holocene shelly materials, it was necessary to thin the data to use for identifying subsurface lithologies. In trying to characterise the Holocene materials that may liquefy, boreholes in materials of Last Glacial age or older materials were eliminated. The thinning operation was conducted to ensure an even distribution of boreholes across the area (Figure A4.11). Each borehole was summarised into a dominant lithology for each one metre interval to a depth of 10 m; and then as a single unit from 10 to15 m. This depth of 15 m was chosen as representing the deepest extent of liquefiable materials that may be a major contributor to surficial liquefaction (Brackley et al, 2012). The thinned borehole dataset was used in conjunction with the geomorphic map to correlate subsurface materials with surface-forming processes.

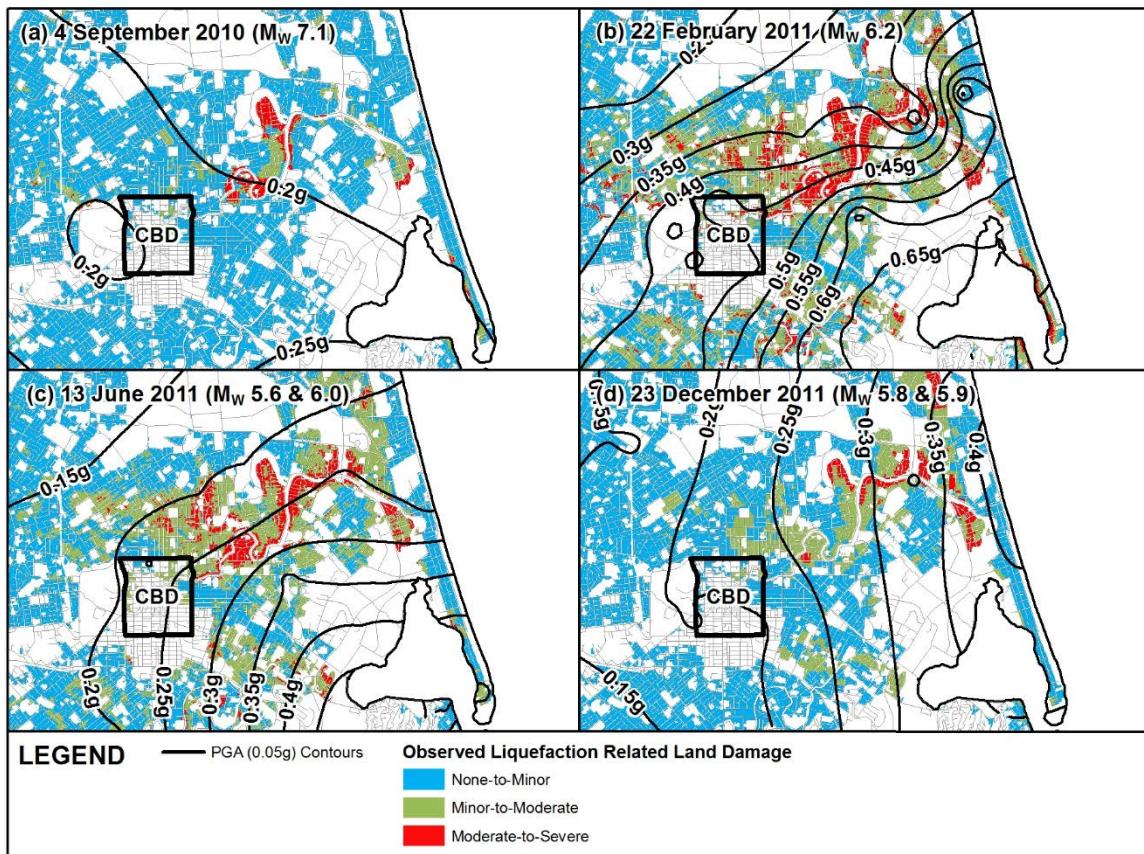
Figure A5.1 Map showing the inferred levels of earthquake shaking and the observed land damage for urban residential properties in Christchurch after the (a) 4 September 2010, (b) 22 February 2011, (c) 13 June 2011 and (d) 23 December 2011 earthquakes.

Comparison with Figure A5.1 shows that properties with BDR of greater than 0.5 are closely correlated with the properties that have moderate-to-severe mapped land damage.

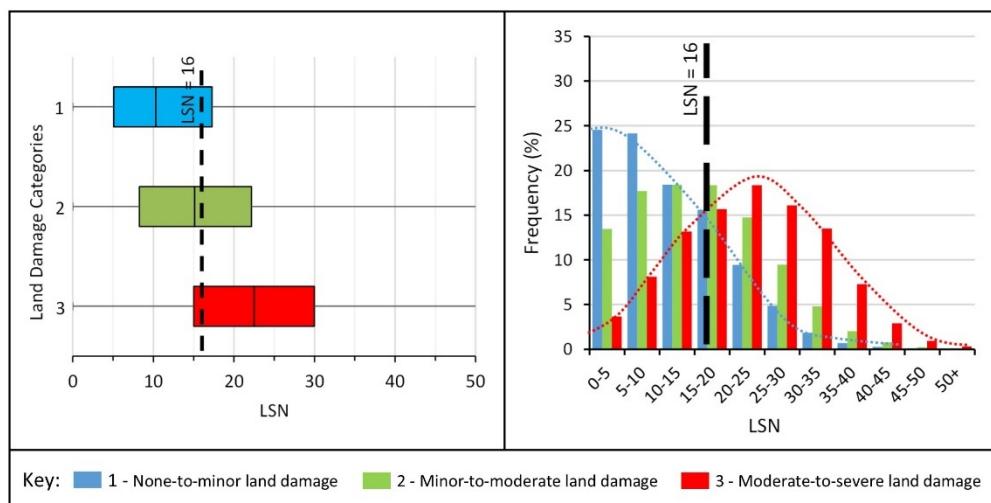
Figure A5.2 (a) Box and whisker plot showing the distribution of land damage observations correlated against LSN for the 4 September 2010, 22 February 2011 and 13 June 2011 earthquake events (b) histogram showing the distribution of land damage observations correlated against LSN.

The plots on Figure A5.2 show that an LSN value of less than 16 characterises properties with none-to-minor liquefaction related land damage and some minor-to-moderate liquefaction related land damage. Whereas an LSN value of greater than 16 characterises properties with moderate-to-severe liquefaction related land damage and some properties with minor-to-moderate liquefaction related land damage.

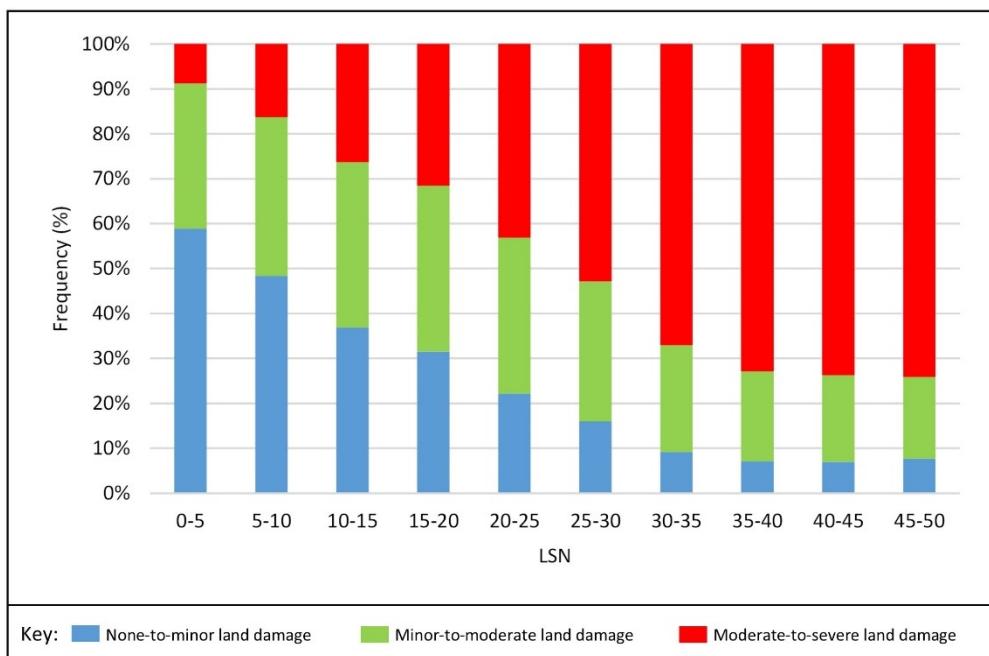
Figure A5.3 Frequency bar chart showing the likelihood of none-to-minor, minor-to-moderate, and moderate-to-severe land damage for different LSN bands.

Figure A5.3 shows the likelihood of the liquefaction related damage for different banding of LSN. For high calculated LSN values the likelihood of moderate-to-severe liquefaction related land damage is very high and the likelihood of none-to-minor liquefaction related land damage is very low. Conversely, for low calculated LSN values the likelihood of moderate-to-severe liquefaction related land damage is very low and the likelihood of none-to-minor liquefaction related land damage is very high.

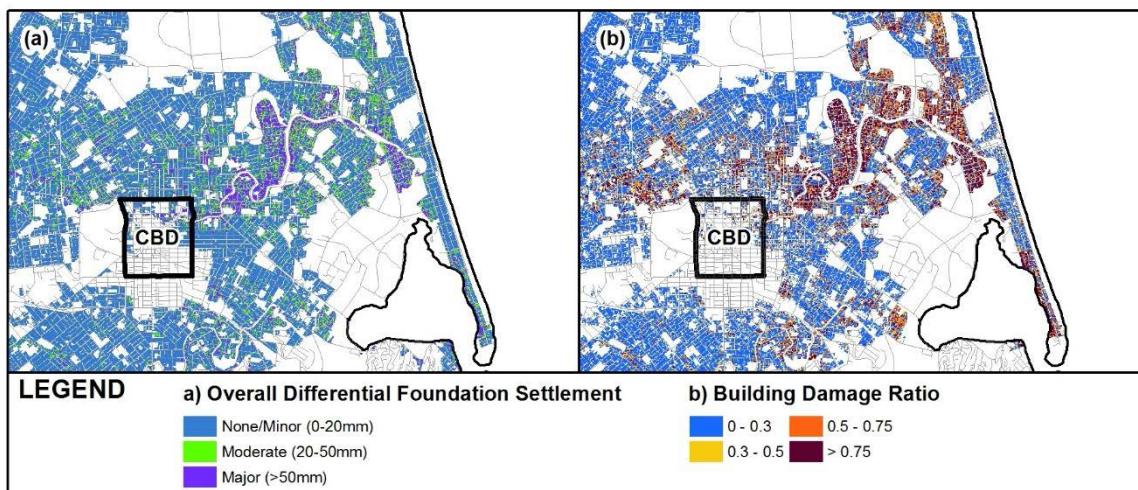
Figure A5.4 (a) Estimated differential foundation settlement from visual inspections of the urban residential buildings in Christchurch as a result of the CES and (b) the associated BDR.

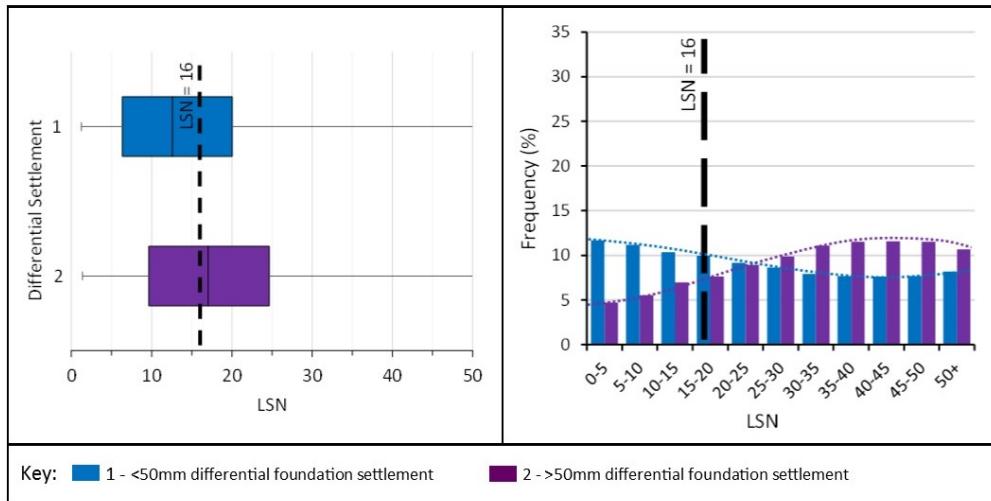
Figure A5.5 (a) Box and whisker plot showing the distribution of differential foundation settlement for residential dwellings in the TC3 and residential Red Zone areas correlated against LSN for the September 2010, February 2011 and June 2011 earthquake events (b) histogram showing the distribution of differential foundation settlement correlated against LSN.

Similar liquefaction analyses (as undertaken for the mapped land damage (described above) have been undertaken for the residential buildings in the TC3 and residential Red Zone areas in Christchurch for two groups of differential foundation settlement (less than and greater than 50 mm) and three groups of BDR (less than 0.3, between 0.3 and 0.5 and greater than 0.5). The results from these analyses are shown in Figure A5.5 and Figure A5.6 respectively.

Figure A5.5 shows that the distribution of differential foundation settlement for properties with LSN values greater than 16 is higher than the distribution of differential foundation settlement properties with LSN values of less than 16. It is important to recognise that a certain level of total and differential settlement is already typically allowed for in the design of buildings.

Figure A5.5 and Figure A5.6 show how the likelihood of differential foundation settlement and BDR respectively change for different banding of LSN. For high calculated LSN values the likelihood of buildings with high BDR is high and the likelihood of buildings with low BDR is low. Conversely, for low calculated LSN values the likelihood of buildings with high BDR is low and the likelihood of buildings with low BDR is high.

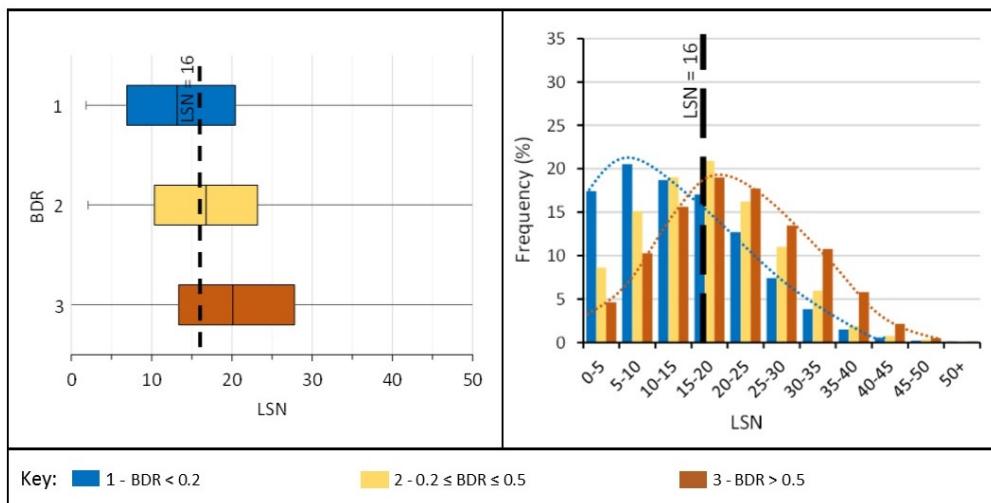
Figure A5.6 (a) Box and whisker plot showing the distribution of BDR for the residential dwellings in the TC3 and residential Red Zone areas correlated against LSN for the September 2010, February 2011 and June 2011 earthquake events (b) histogram showing the distribution of BDR correlated against LSN.

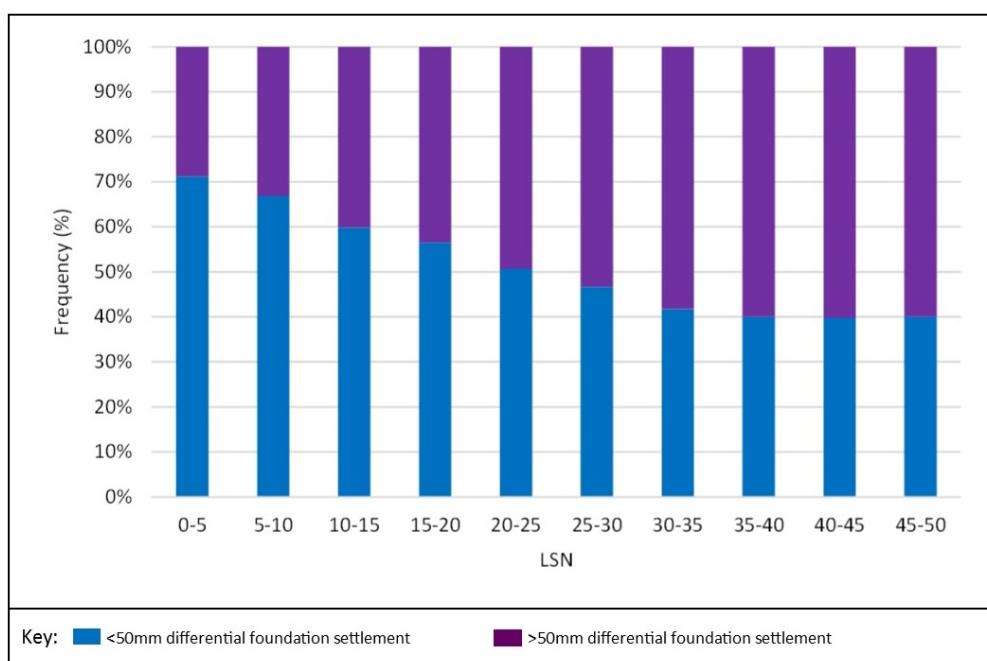
Figure A5.7 Frequency bar chart showing the likelihood of differential foundation settlement of less than and greater than 50mm for different LSN bands.

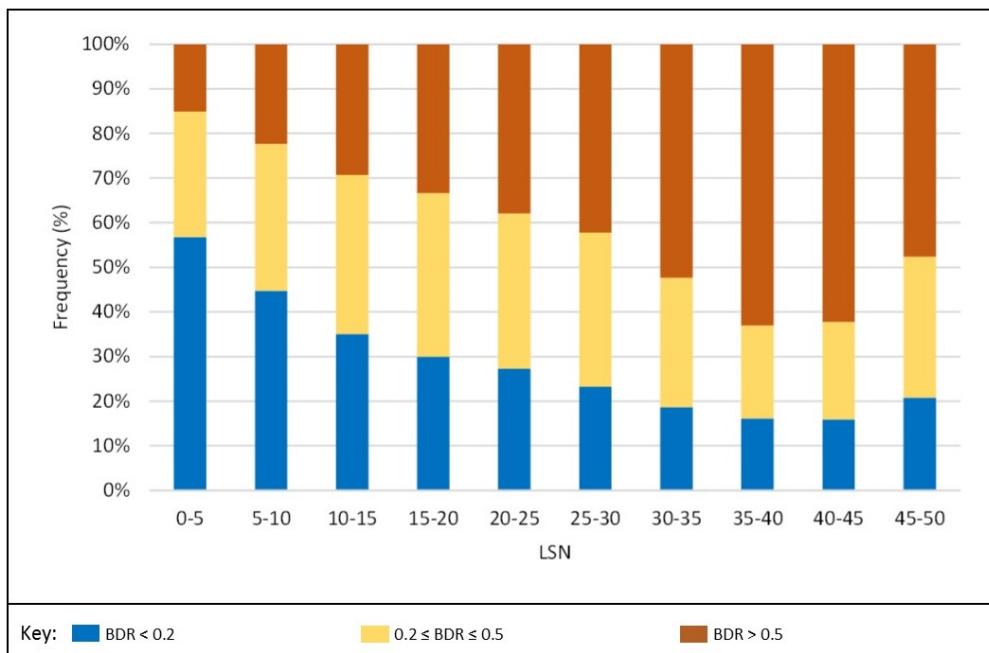
Figure A5.8 Frequency bar chart showing the likelihood of BDR values of less than 0.3, 0.3 to 0.5 and greater than 0.5 for different LSN bands.

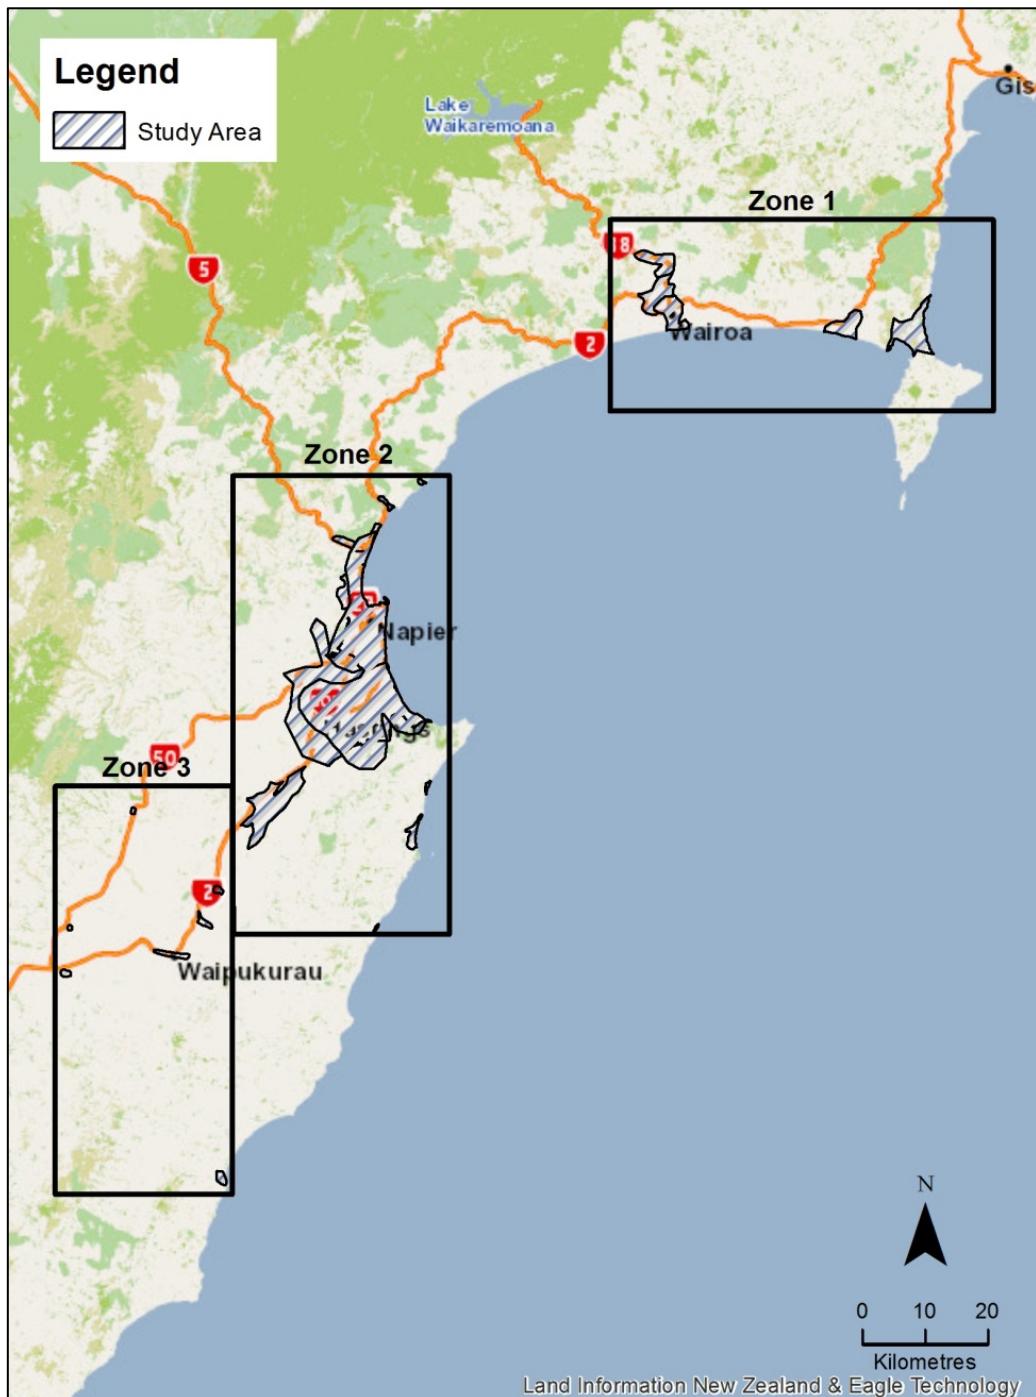
Figure A6.1 Three zones used for developing the unconfined groundwater surface.

Depth to the unconfined groundwater surface (UGS) is a critical factor in determining liquefaction susceptibility, because liquefaction can occur only when materials of suitable grain-size distributions are saturated. This section describes the data and methodology used to model a surface representing this UGS, with some comparisons made to a recent UGS model created for the Christchurch region (van Ballegooij et al., 2013). Due to the large area covered, the UGS was calculated within three different zones (Figure A6.1).

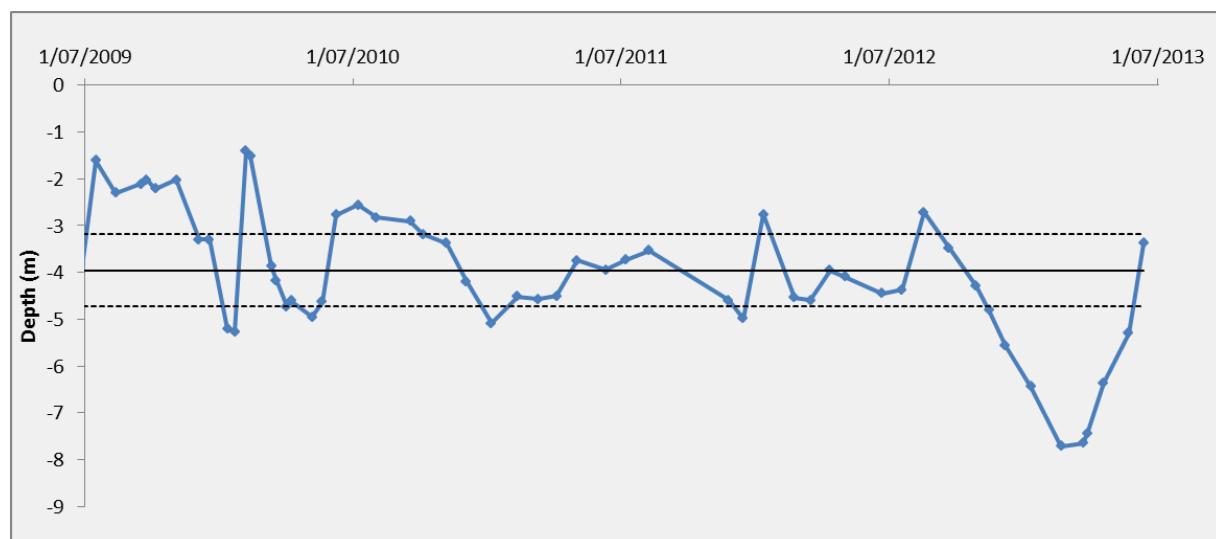
Figure A6.2 Monitoring well no. 1003. The solid black line displays the median water level -3.96 m; the dashed lines display the envelope of the median absolute deviation (mad) of 0.78 m.

Within the Hawke's Bay region, the majority of data pertains to confined aquifers. Of the time series data available, only 15 wells within the modelled region are considered to sample the unconfined water table. The median water table level was calculated at these locations using the available data, with sampling periods ranging from 3–22 years. The exact time period used varies for each data set to ensure no bias is induced by seasonal variability. As water level measurements are taken when there is a change in level, the median calculated is for the entire time period rather than the sample set (e.g., Figure A6.2).
