**Assessment of liquefaction risk in the Hawke's Bay
Volume 2: Appendices for Volume 1**

**GNS Science Consultancy Report 2015/186
October 2017**

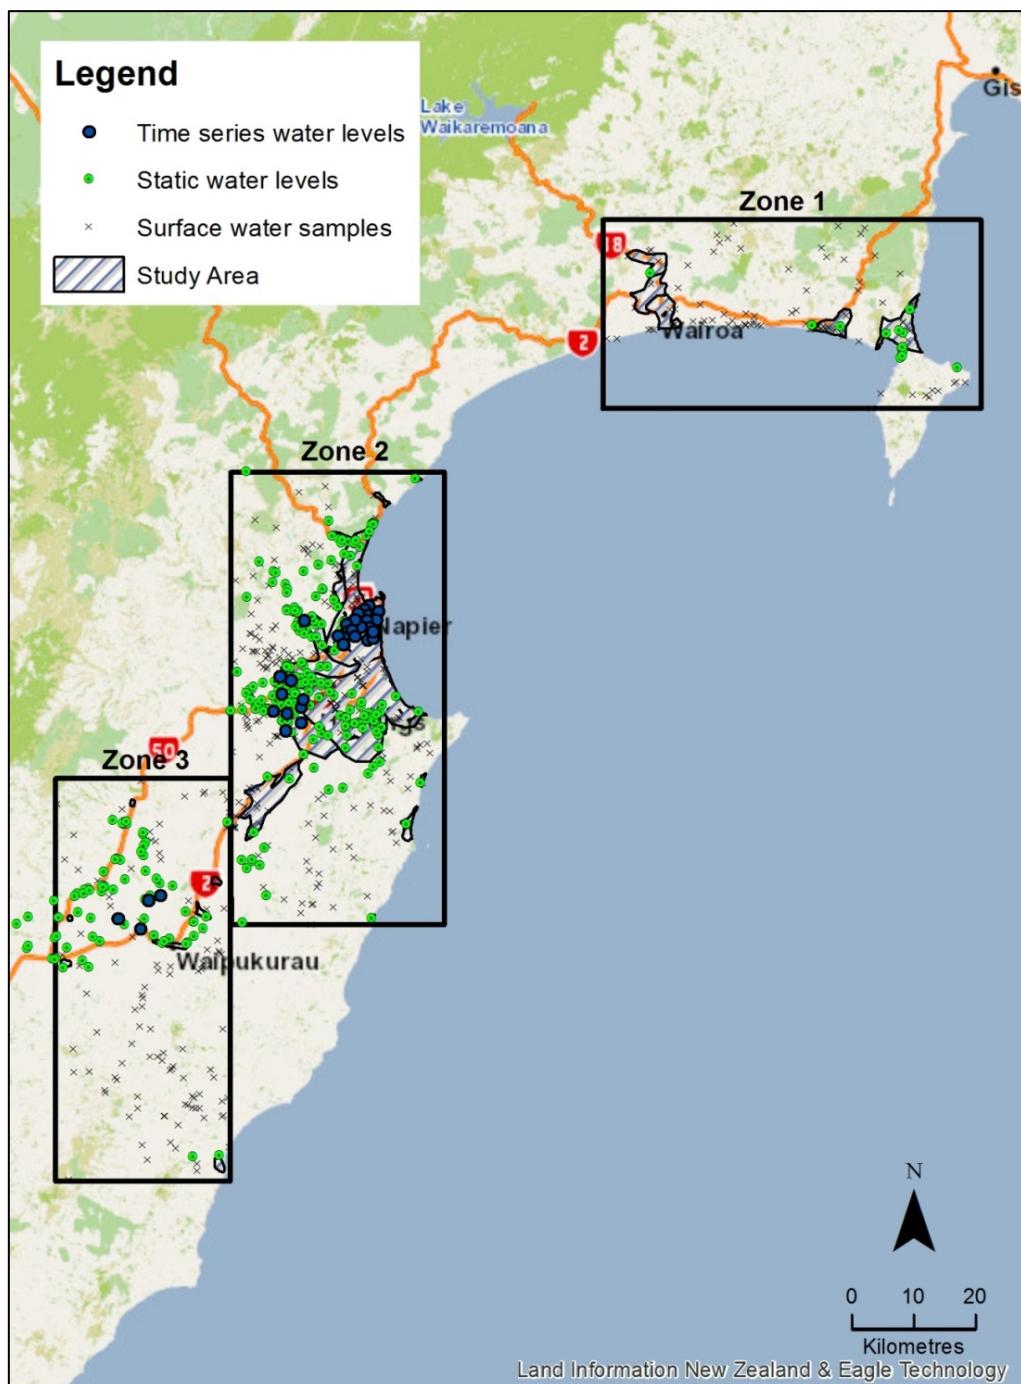
Figure A6.3 All data used to develop the unconfined groundwater surface.

A map of all data used is displayed in Figure A6.3.

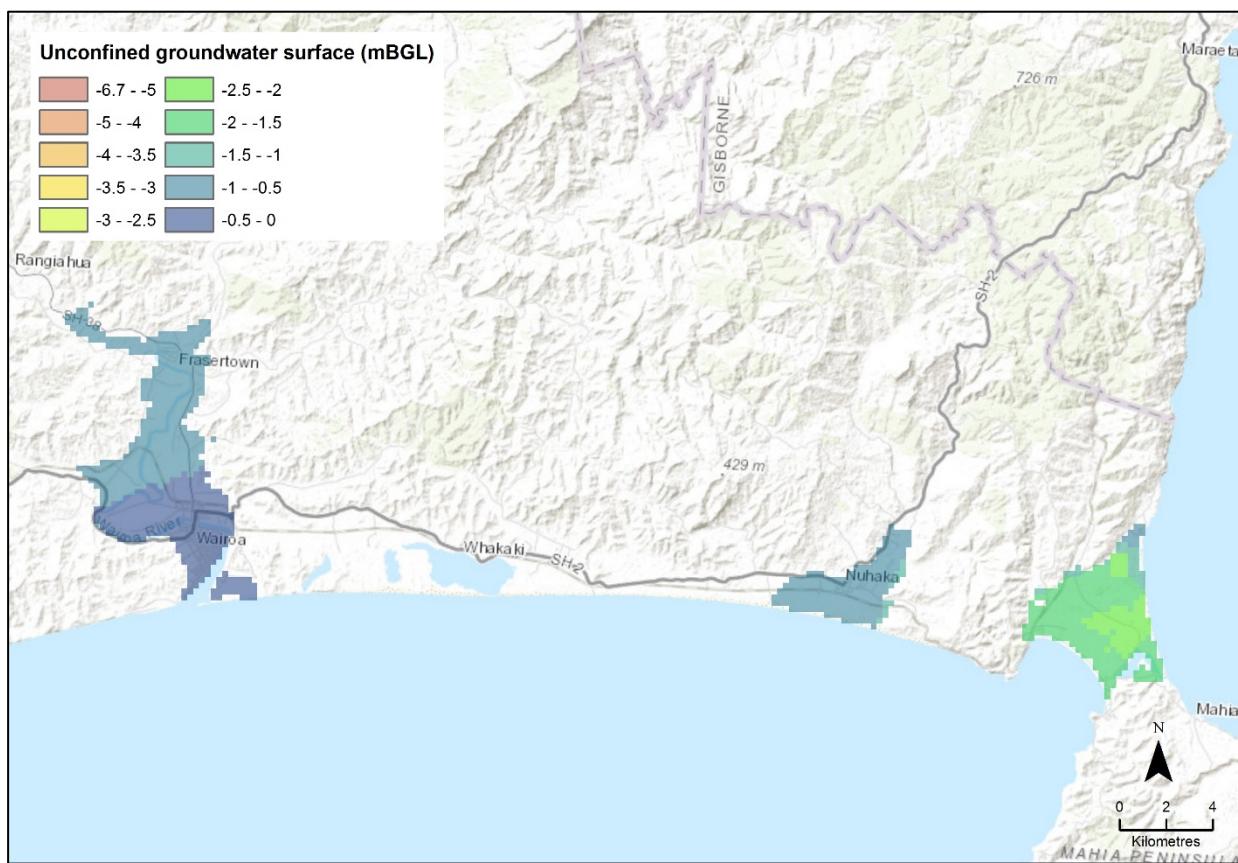
Figure A6.4 Unconfined groundwater surface for Zone 1.

Interpolation was performed in metres below ground level (mBGL) and the UGS clipped to both the study area and the extent of mapped Quaternary geology as described by QMAP (Heron et al., 2012). Maps of the UGS in mBGL for three zones are displayed in Figure A6.4 – Figure A6.8, where the shallowest levels are shown by the dark blue and the deepest levels by the dark brown.

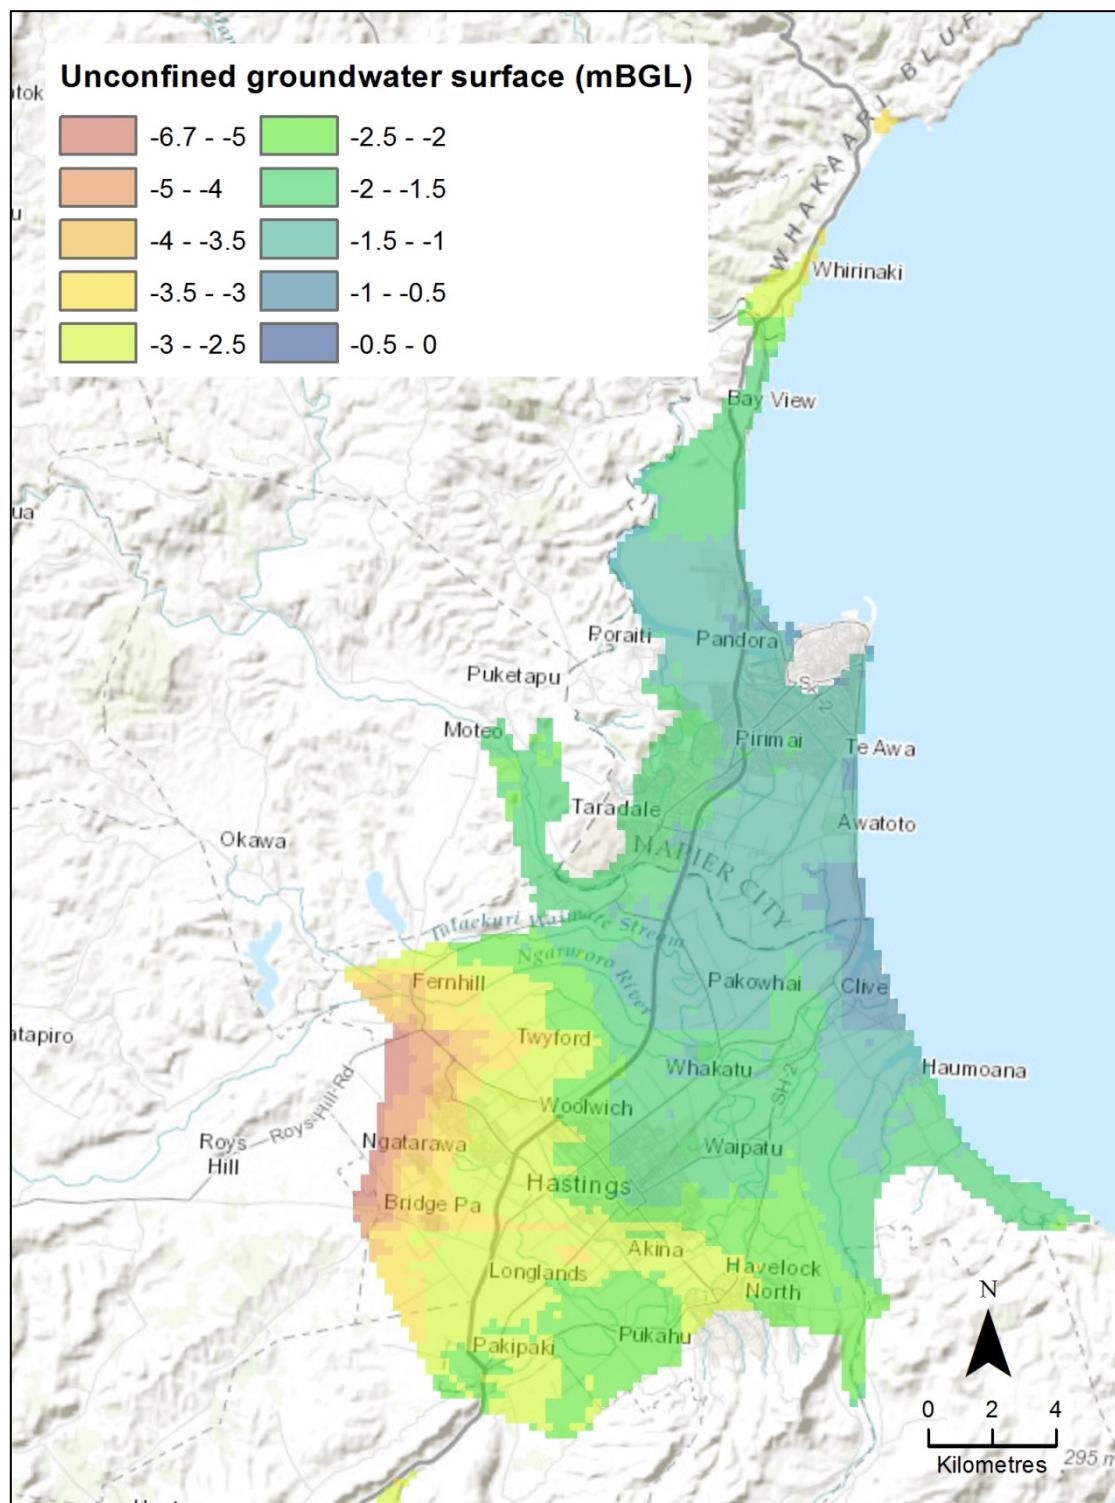
Figure A6.5 Unconfined groundwater surface for the northern portion of Zone 2.

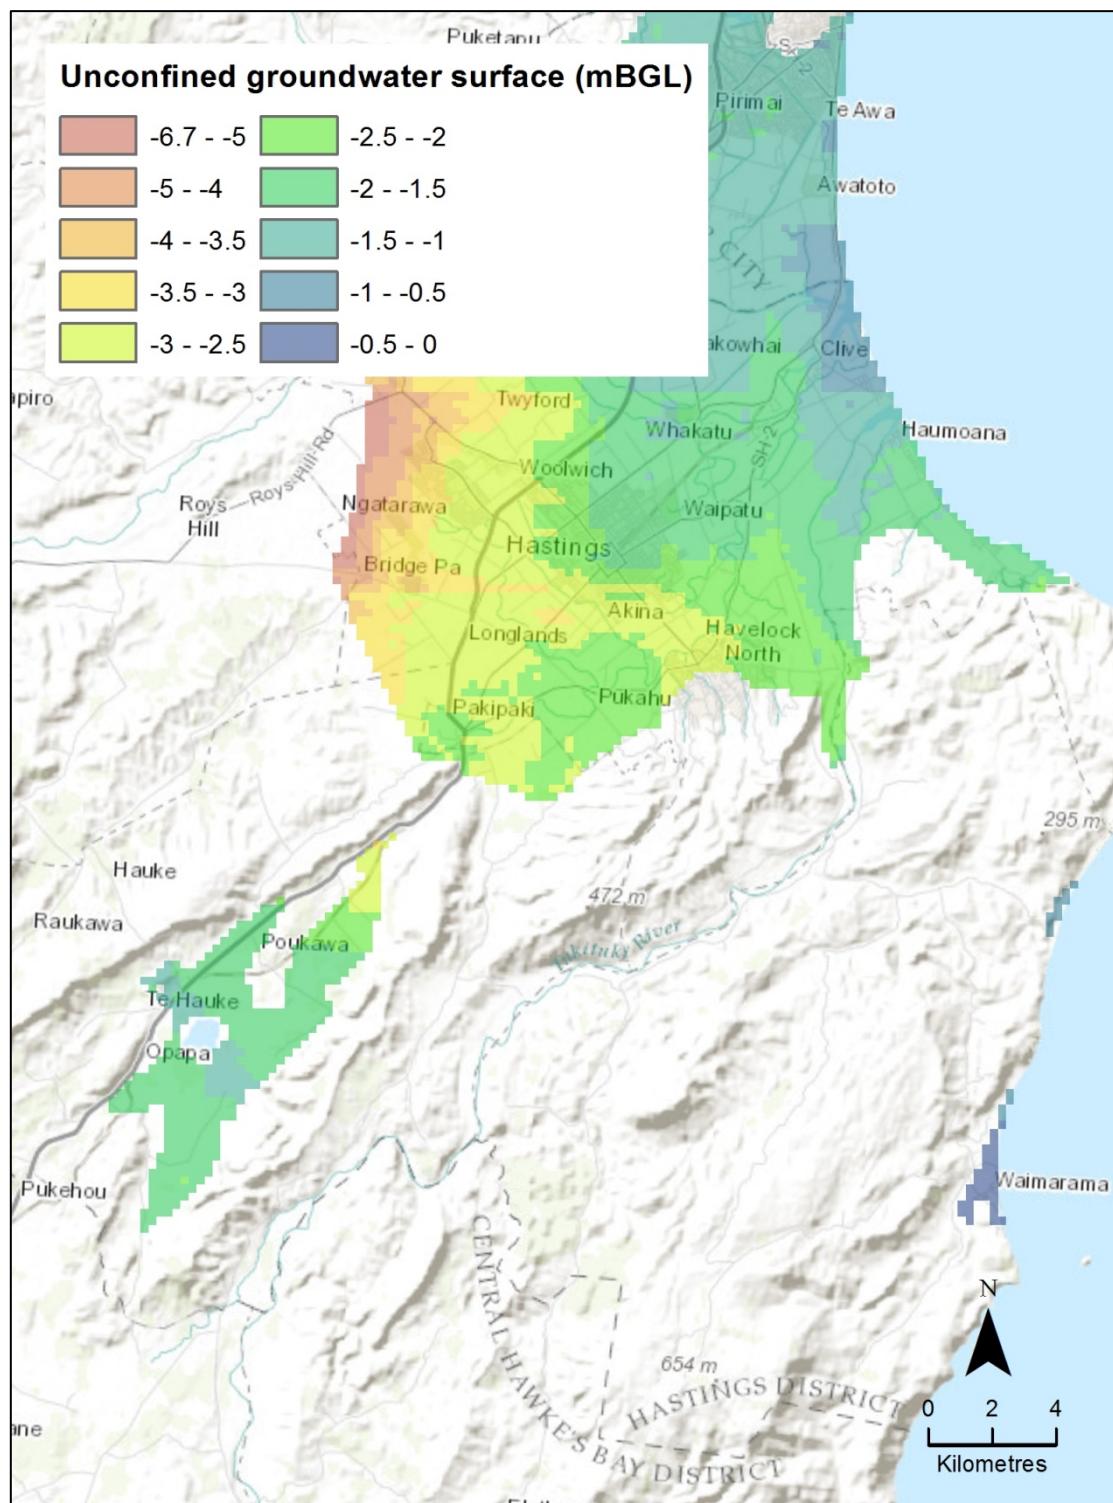
Figure A6.6 Unconfined groundwater surface for the southern portion of Zone 2.

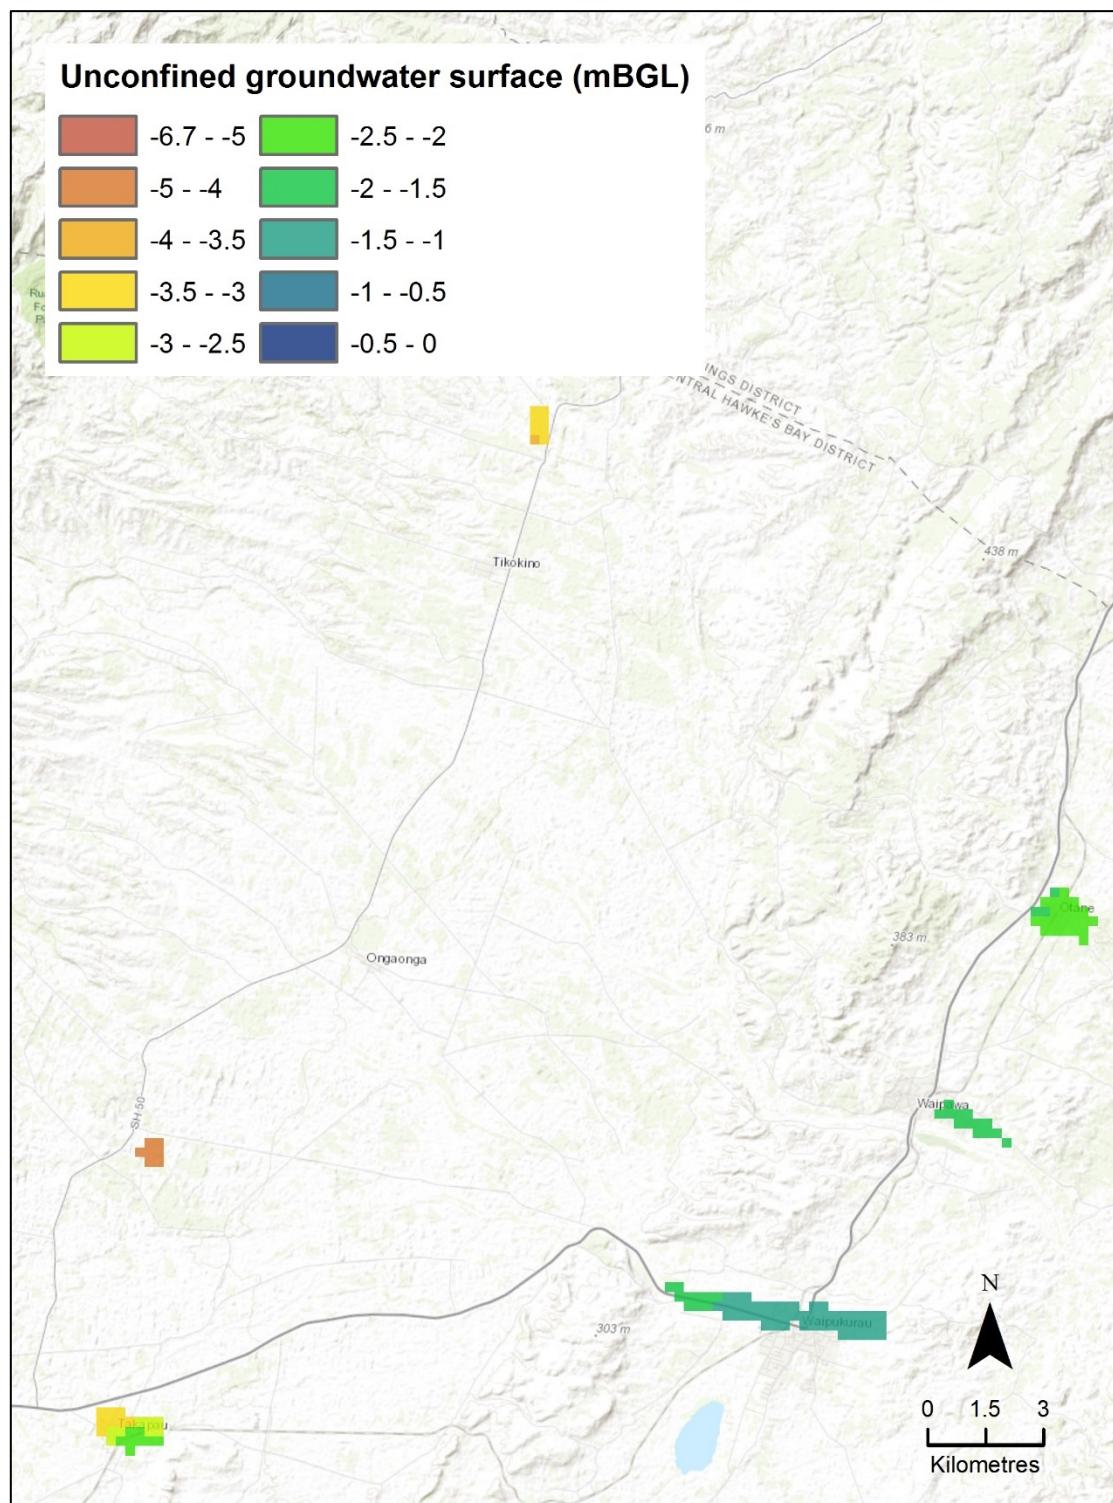
Figure A6.7 Unconfined groundwater surface for the northern portion of Zone 3.

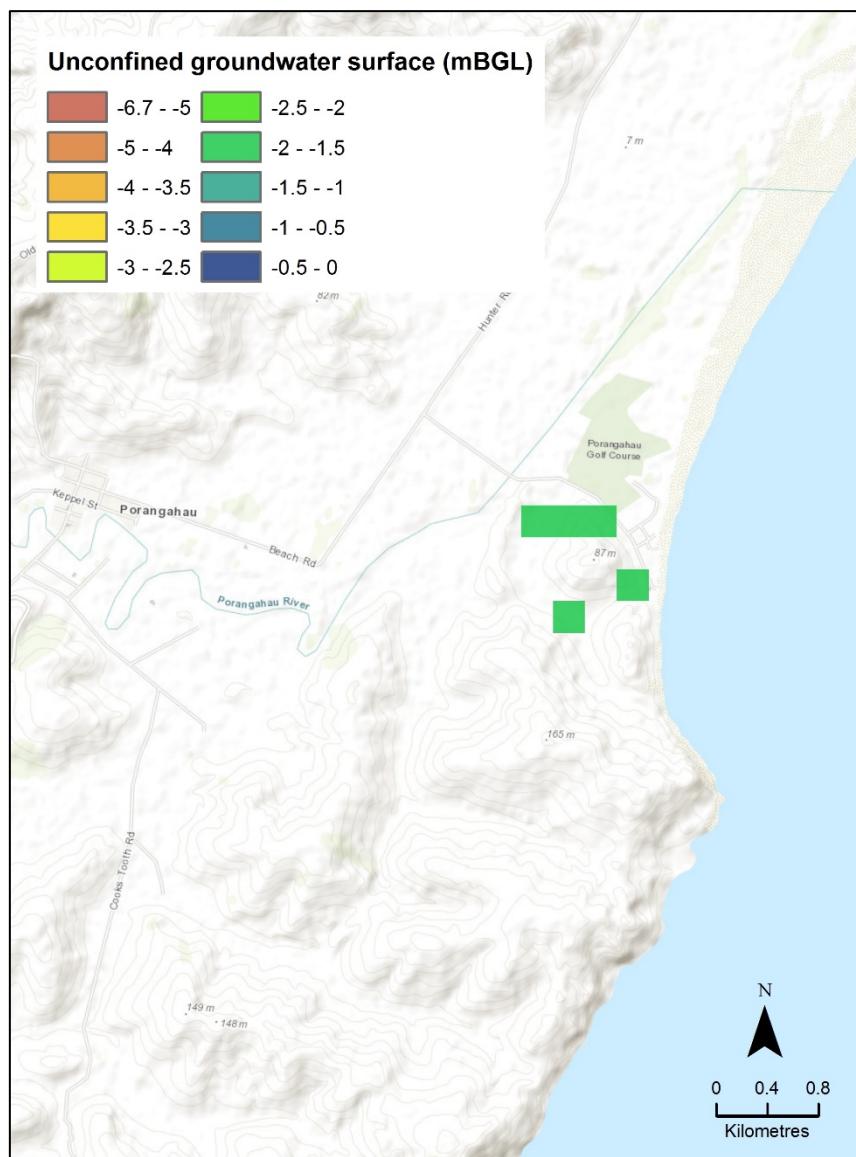
Figure A6.8 Unconfined groundwater surface for the southern portion of Zone 3.

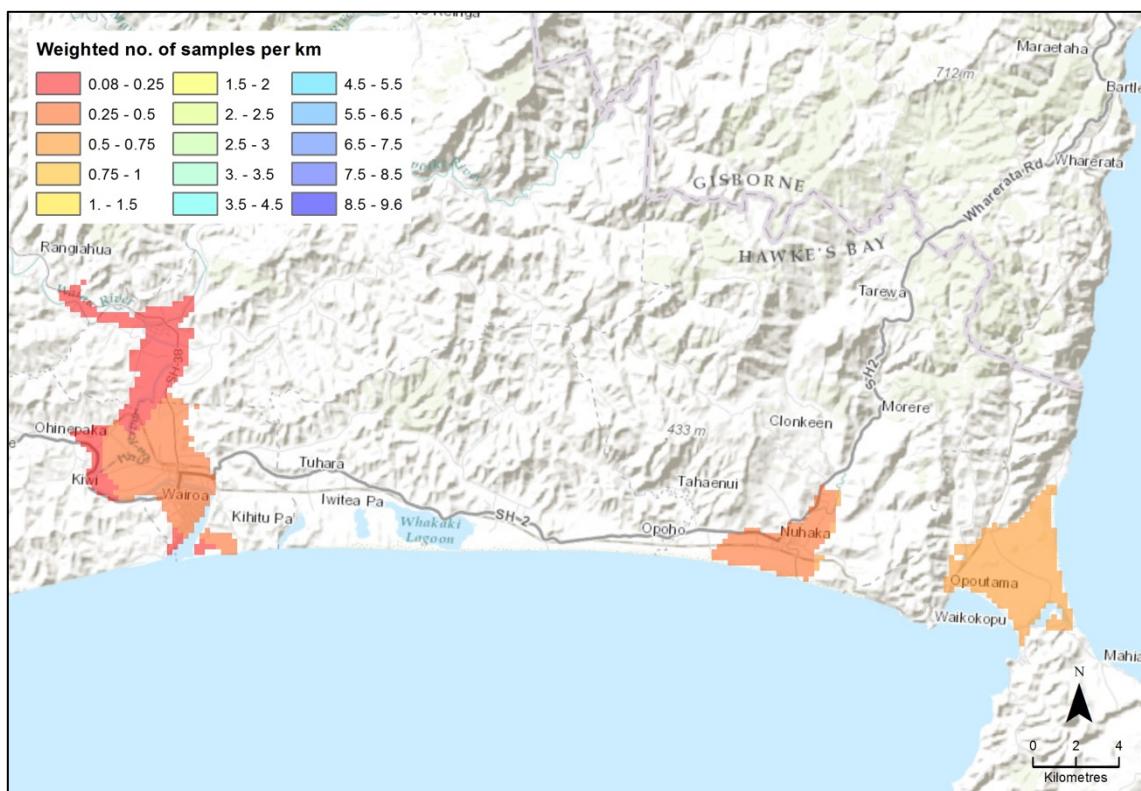
Figure A6.9 Uncertainty map for Zone 1, Wairoa, based on data point density as described in the text.

There are a number of regions that are very uncertain: the whole of Zone 1 – especially Wairoa Valley, and to a lesser extent the Mahia sand aquifer; and the small coastal towns.

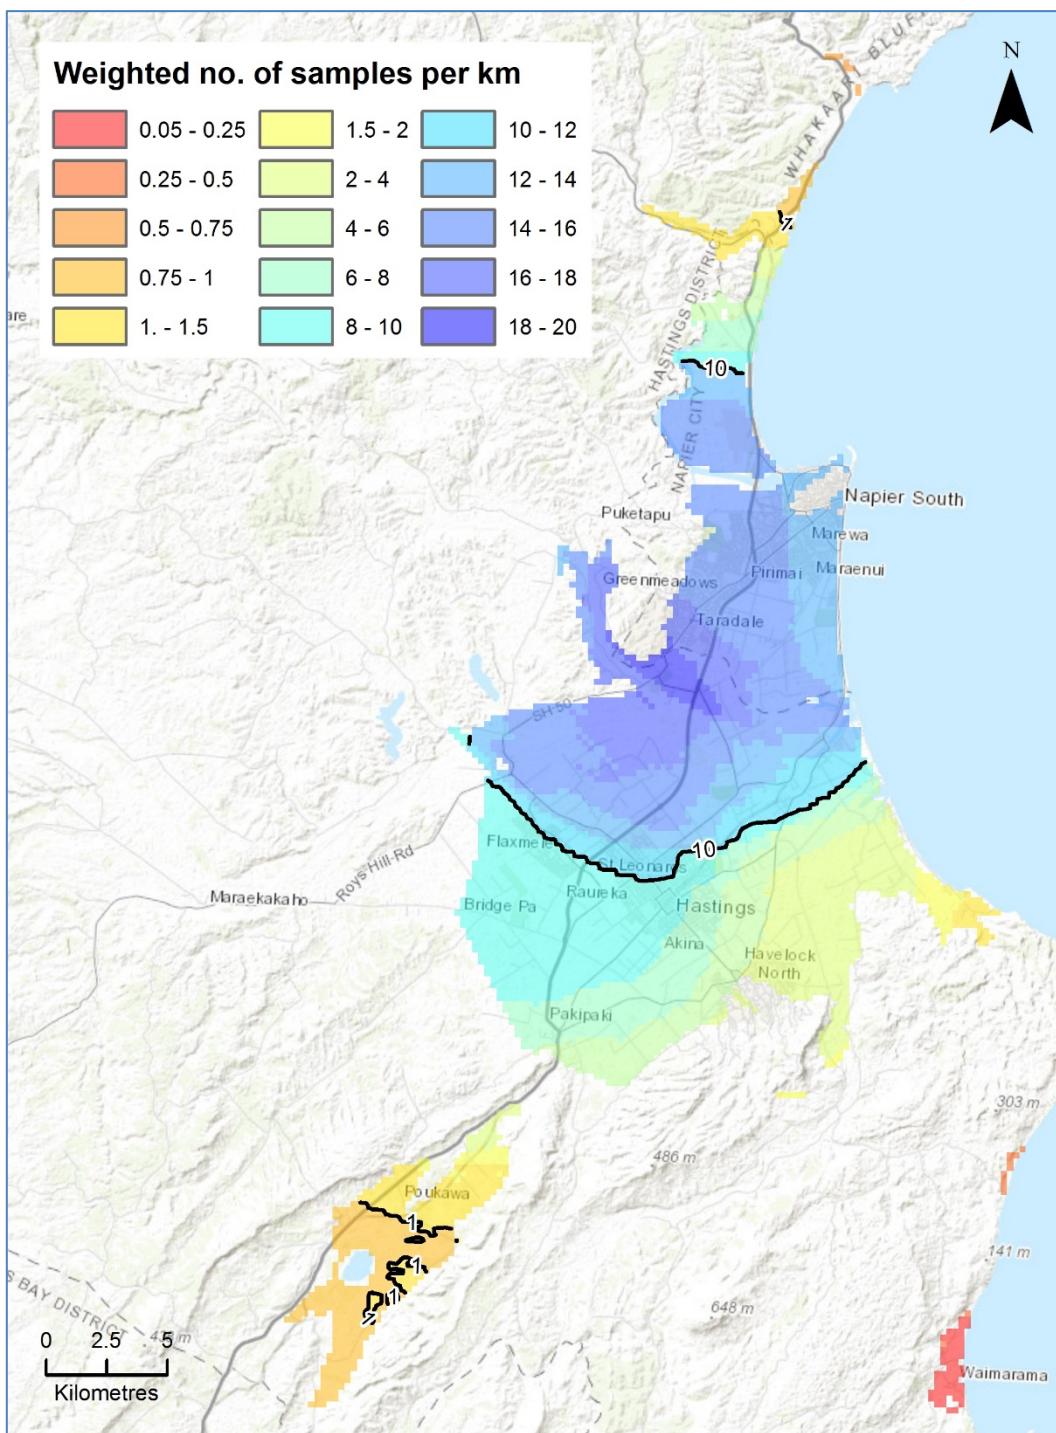
Figure A6.10 Uncertainty map for Zone 2, the Heretaunga Plains, based on data point density as described in the text.

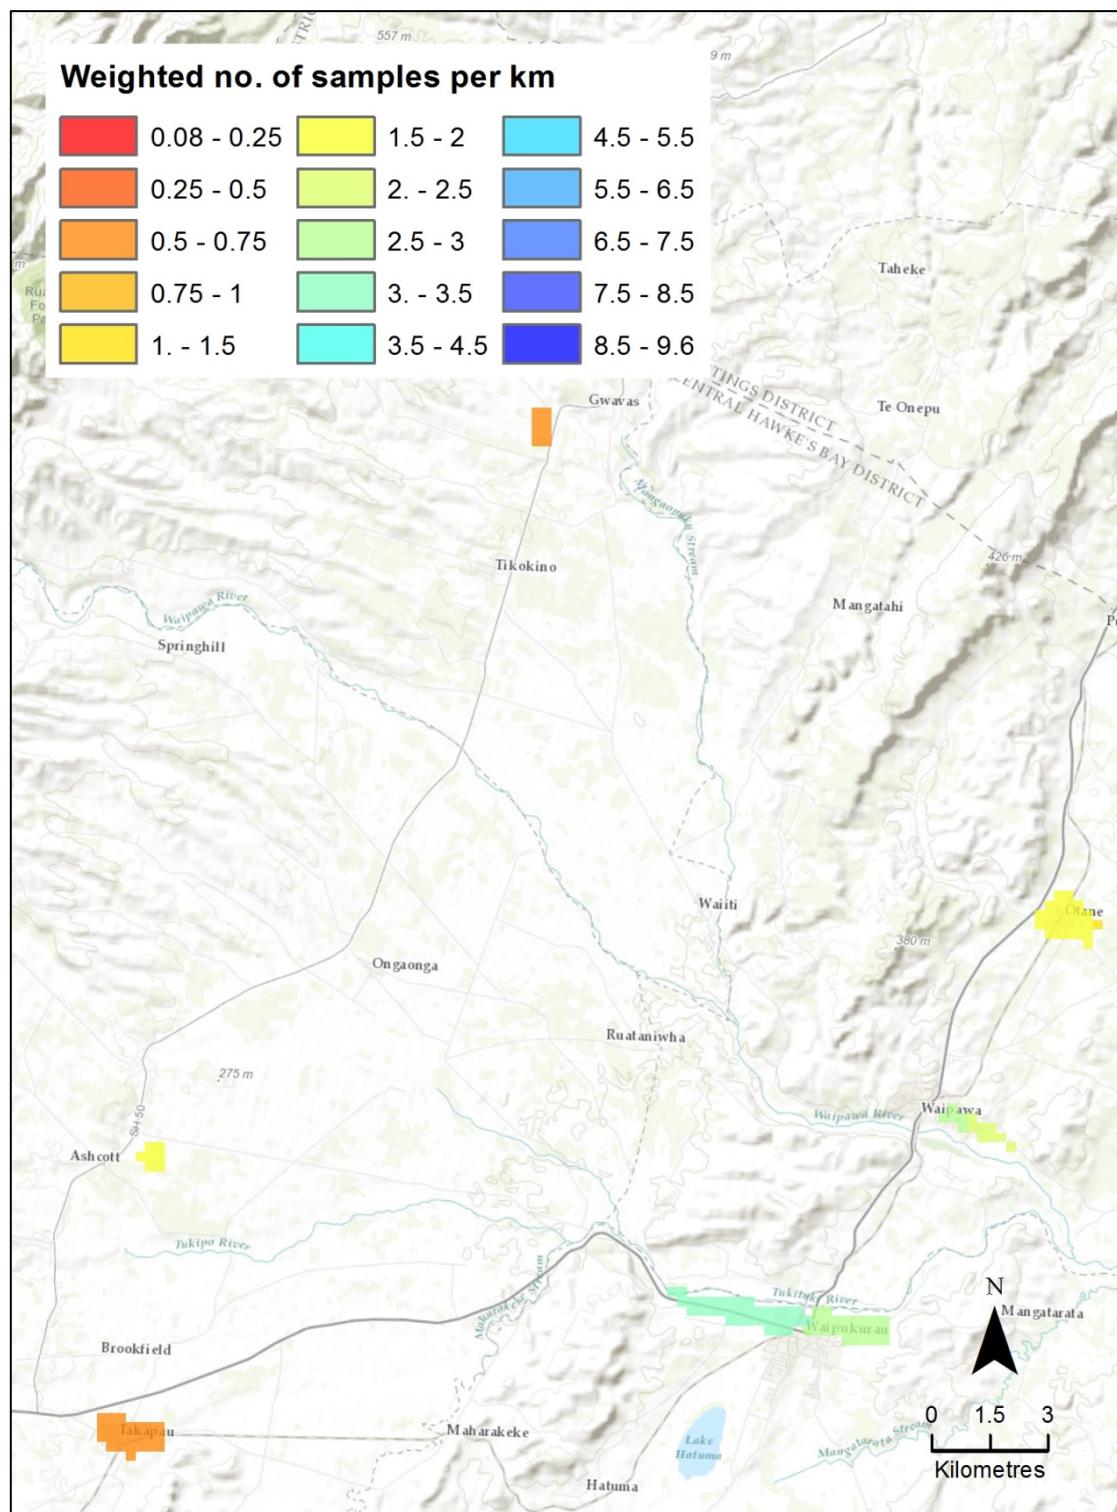
Figure A6.11 Uncertainty map for the northern portion of Zone 3, based on data point density as described in the text.

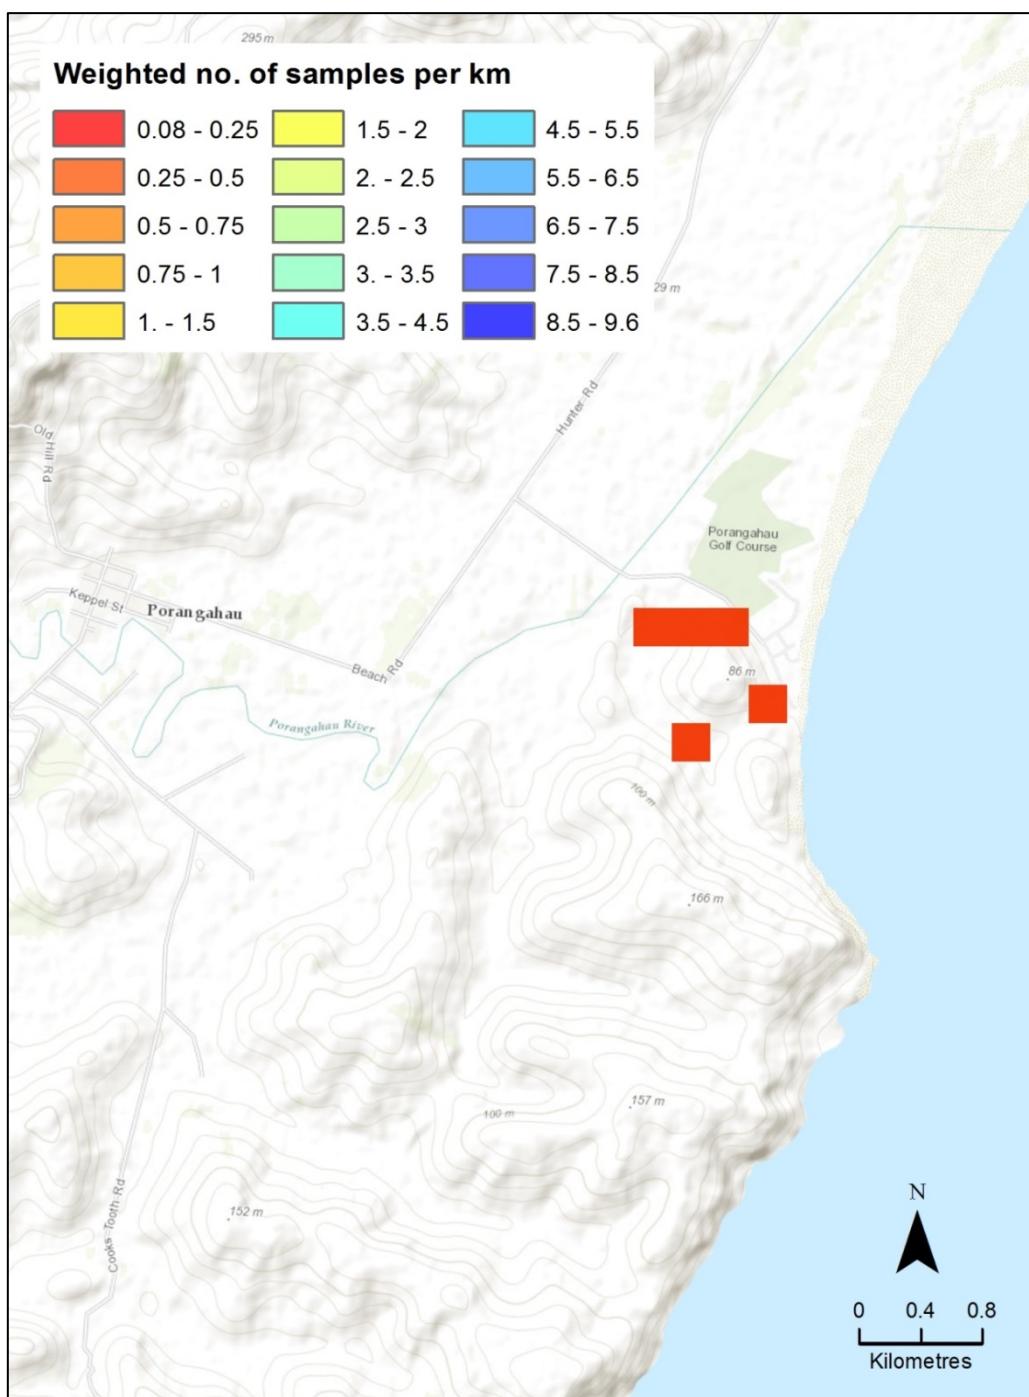
Figure A6.12 Uncertainty map for the southern portion of Zone 3, based on data point density as described in the text.

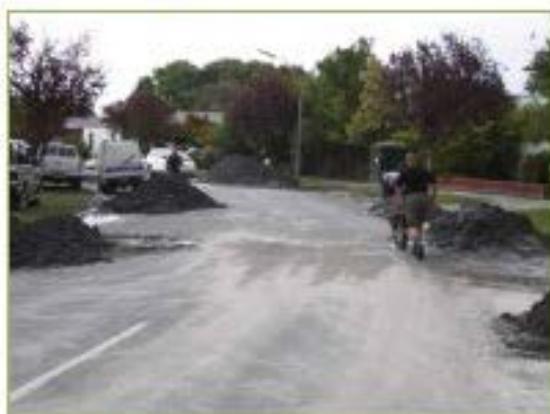
Liquefaction ejecta in piles on road

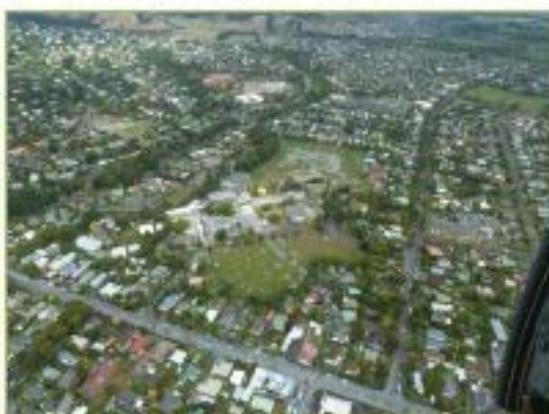
Aerial photo of liquefaction ejecta at Cashmere High School

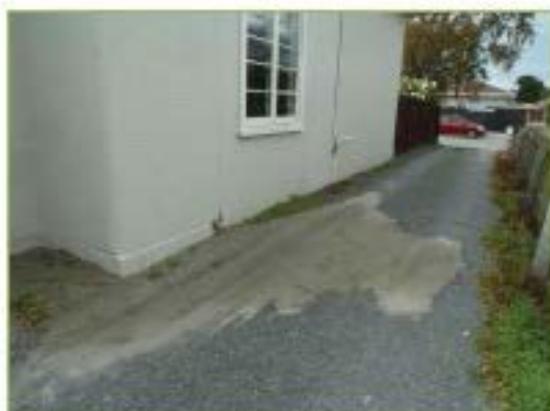
Isolated area of liquefaction ejecta

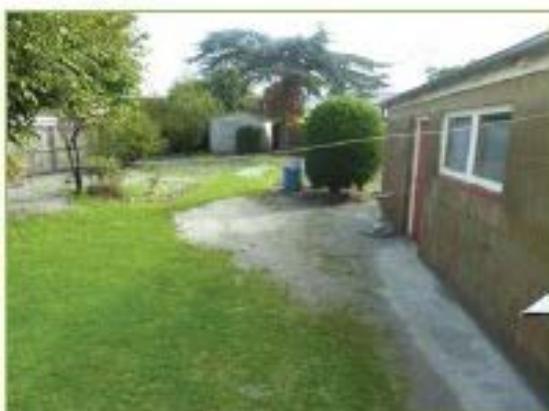
Liquefaction ejecta in many places on lawn

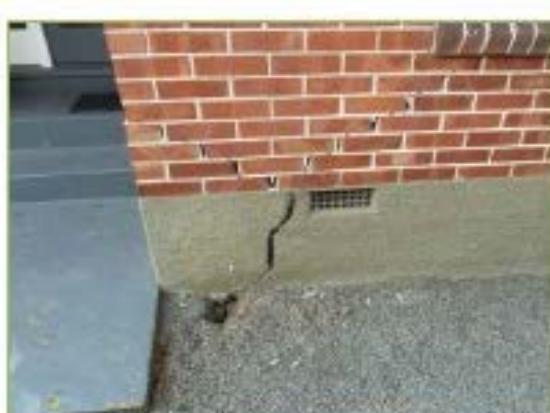
Foundation and brickwork damage

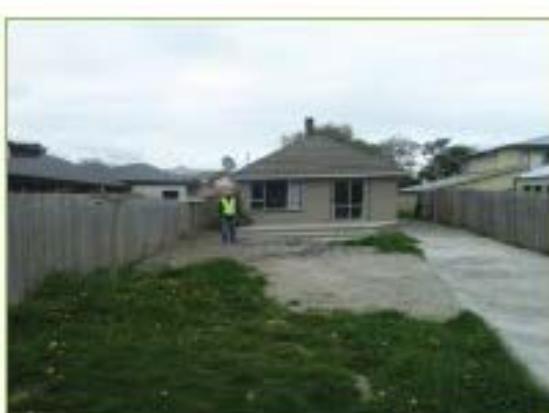
Liquefaction ejecta, dwelling tilting

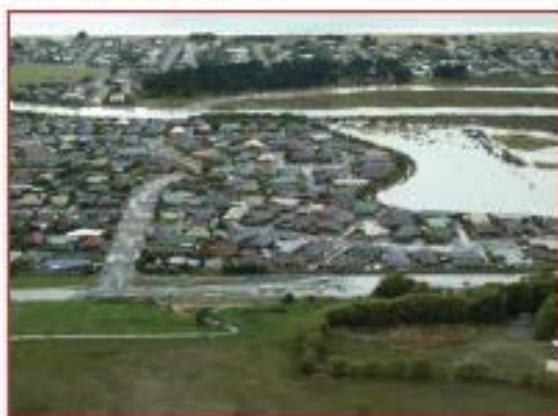
Aerial photo showing liquefaction ejecta on Seabreeze Close

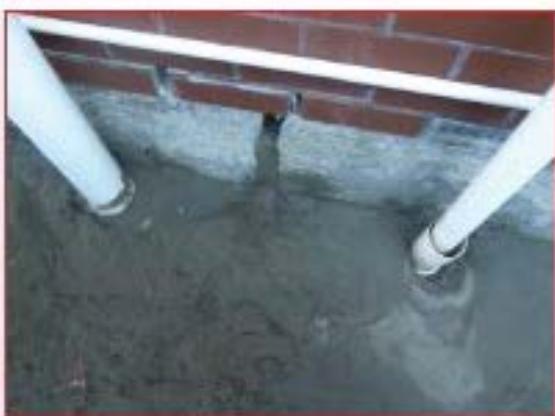
Foundation damage

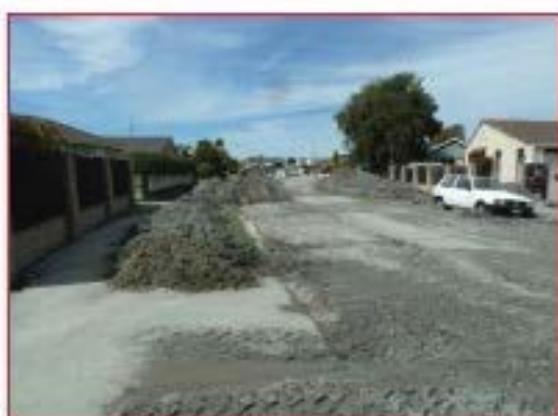
Liquefaction ejecta piles along Androssan Street

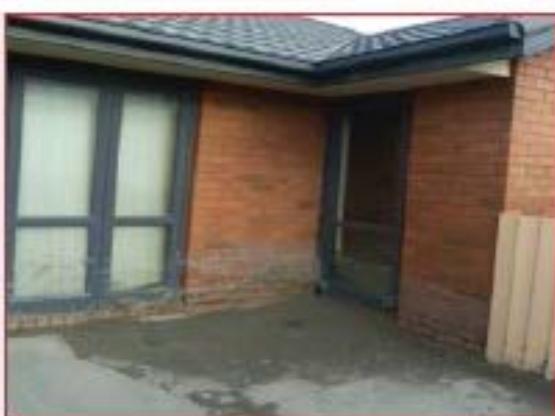
Outside of dwelling showing level liquefaction ejecta reached on brickwork and windows

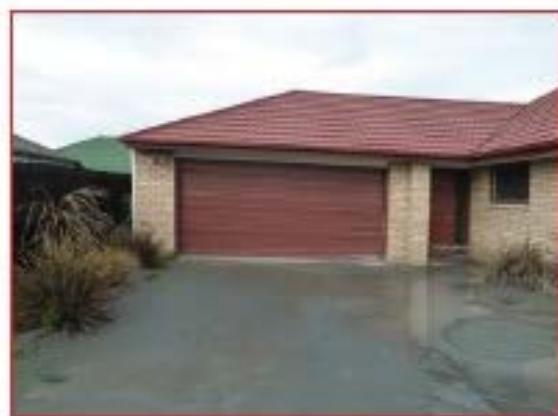
Large amounts of liquefaction ejecta and tilting dwelling

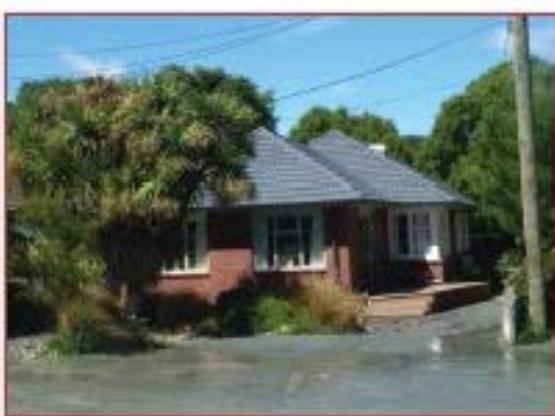
Foundation damage, tilting dwelling
