Technical Report

**Flood Report
Central Hawke's Bay
February 15-16, 2004**

**August 2004
AM 04/17**

HBRC Plan Number 3389

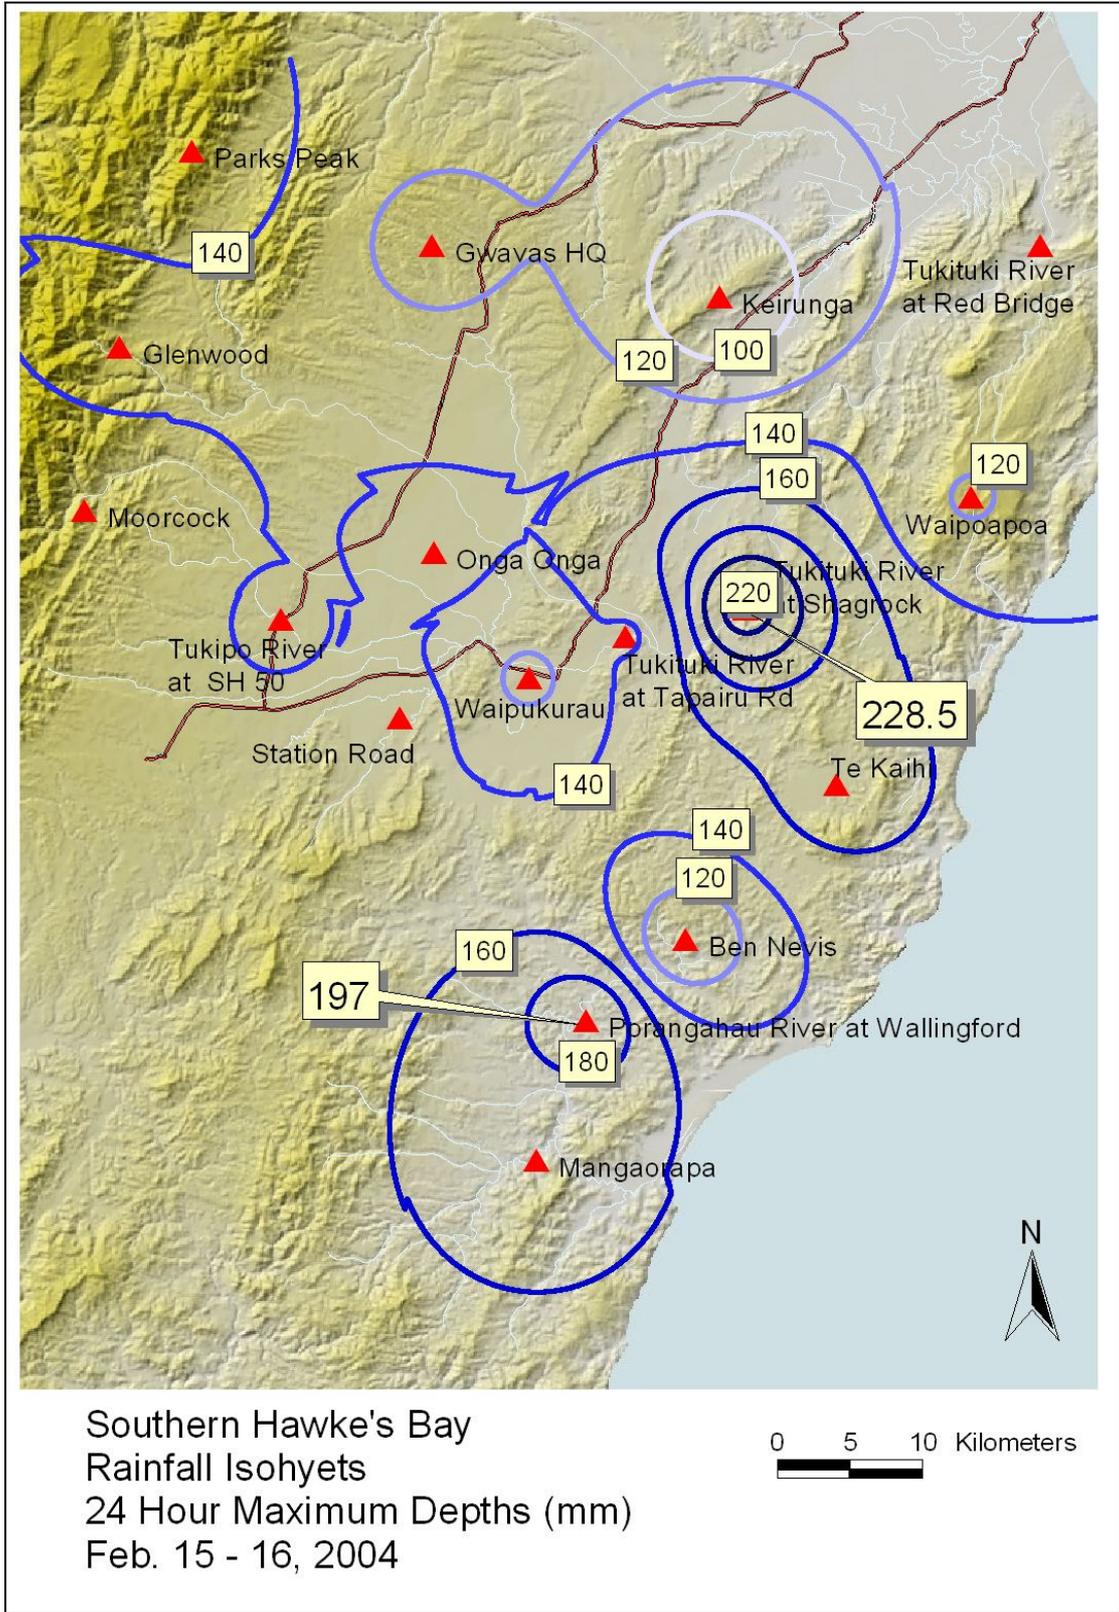
Figure 1: Locations of Rainfall Recorders and Rainfall Isohyet Map

The first heavy falls in Central Hawke's Bay occurred around noon to 1 pm on Sunday, February 15, then another intense period occurred just prior to midnight and continued on until about 2 or 3 am the morning of Monday, February 16. By 1 am Porangahau village was in trouble and evacuating people. Met Service issued the first weather watch at 12 noon on Sunday, with an estimate of 60 to 80 mm of rainfall in the next 15 hours for the area of Hawke's Bay south of Napier. Rainfalls totals (for 24 hours) of over 200 mm in the area east of Waipawa, near Patangata, and just under 200 mm in the Porangahau Catchment were recorded by automatic rain gauges. An unsubstantiated reading of 300 mm was recorded by a manual rain gauge in the Mangaorapa area. These totals appear to be the highest on record, and have return periods of over 100 years (for the 24 hour duration). Over much of the Ruataniwha Plains, approximately 140 mm of rain fell over the 24 hours, equating to a return period of around 10 to 20 years. Despite the intensity, the storm subsided fairly quickly, with the last recorded heavy burst of rain occurring at around 6 am on Monday, February 16. Figure 1 shows the location map with 24 hour rainfall totals.

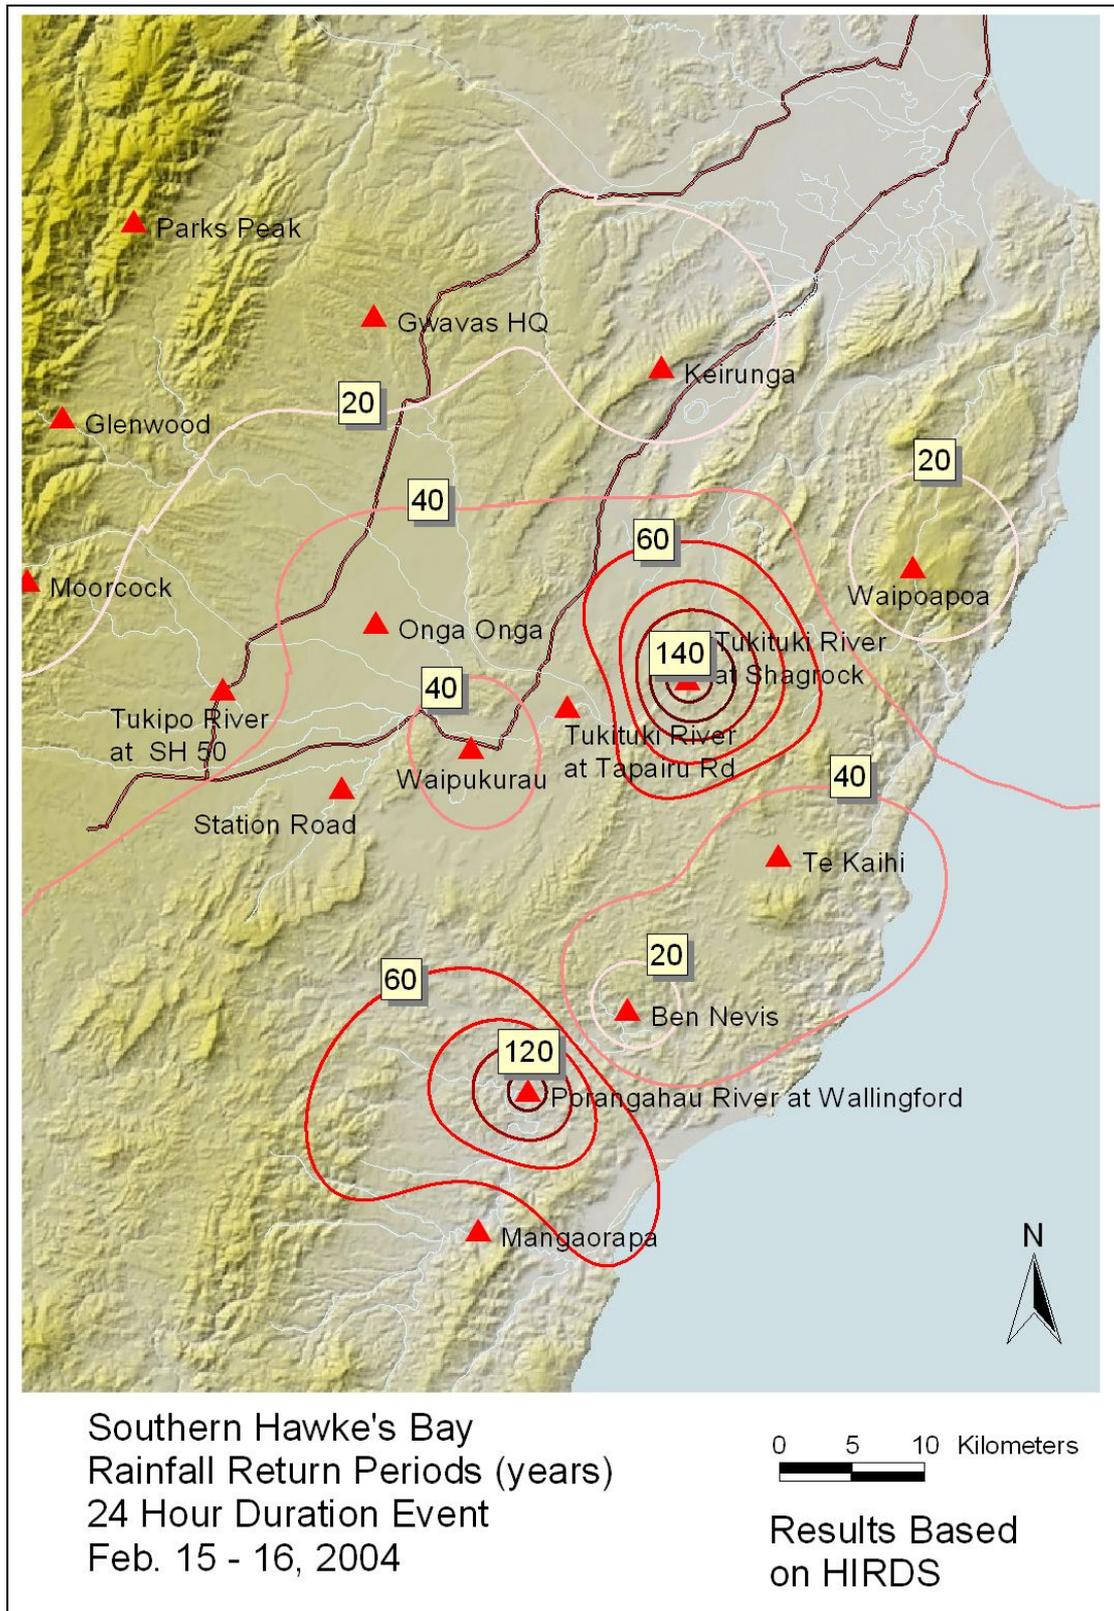
Figure 2: Return Periods for 24 Hour Duration Event (Based on HIRDS)

The return periods around Shag Rock and Porangahau of over 100 years indicate that it was a very severe event. Figure 2 shows the return periods for the area. These values have been derived based on the statistics available from HIRDS V2.0 (Niwa).

The return periods derived from HIRDS indicate the event was extreme over a wide area. As a comparison to HIRDS, return periods from Technical Publication 19 (National Water and Soil Conservation Organisation, 1980) were derived. The results of this analysis is shown in Figure 3.

The comparison of the two methods (HIRDS vs. TP19) indicate that the return period derived using HIRDS results in values approximately 20 years greater (i.e. 20 year return period derived from TP19, same location gives 40 year return period derived from HIRDS).

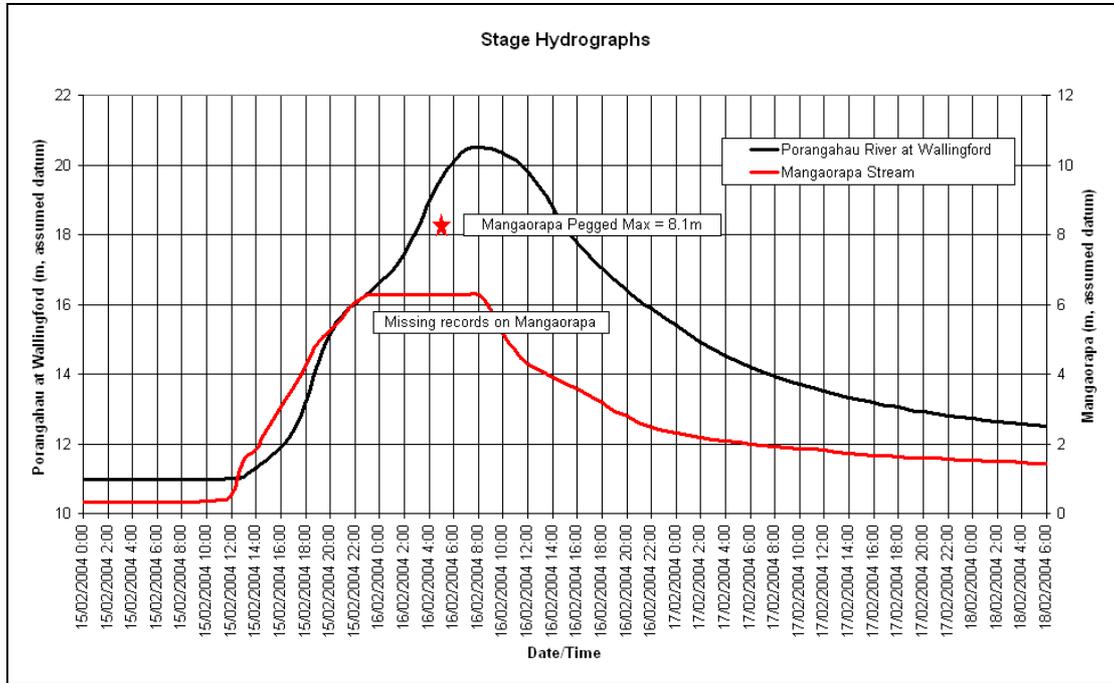
Figure 4: Stage Hydrographs – Porangahau and Mangaorapa

Water level records in the Porangahau River indicate the event was severe, with a rise in level of over 10 m at Wallingford. The recorder at Mangaorapa shows the water level had risen over 6 m, at which point the range of the recorder was surpassed. A pegged flood level at the site indicates the water rose to 8.1 m.

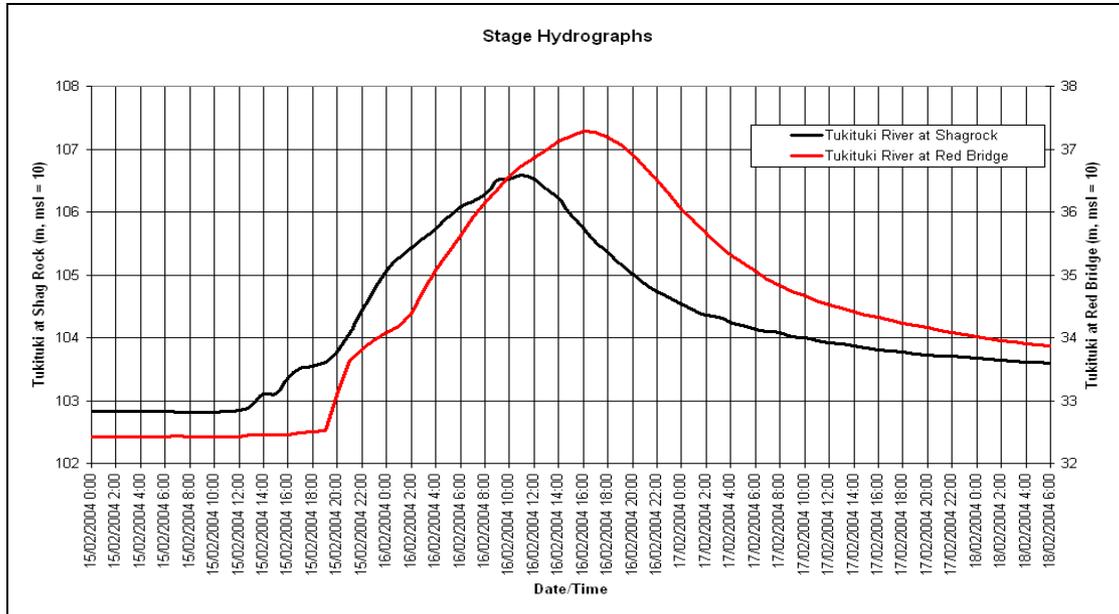
Figure 6: Stage Hydrographs – Tukituki River

The stage hydrographs for the Tukituki at Shag Rock and at Red Bridge indicate a flood with a return period of about 5 years. This appears reasonable considering the rainfall pattern showed the heavy rain was relatively localised around Shag Rock and Porangahau. There was very little rain in the headwaters of the Tukituki catchment.

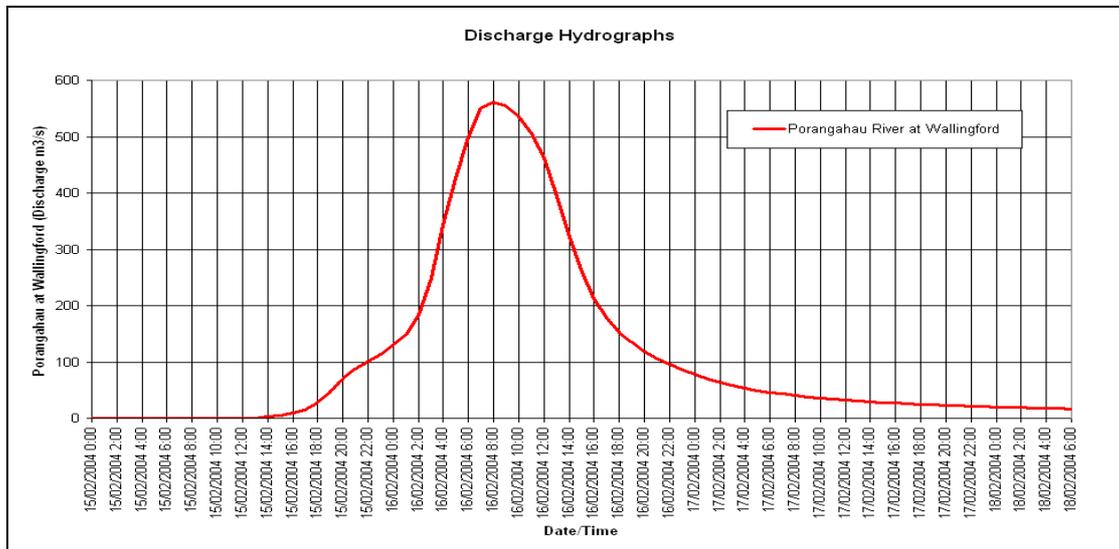
Figure 7: Discharge Hydrographs – Porangahau River

The discharge hydrograph for the Porangahau River at Wallingford indicate a severe event, with the peak being approximately 550 m³/s. Normal flow is usually less than 1 m³/s, and a mean annual flow is likely to be around 50 m³/s.

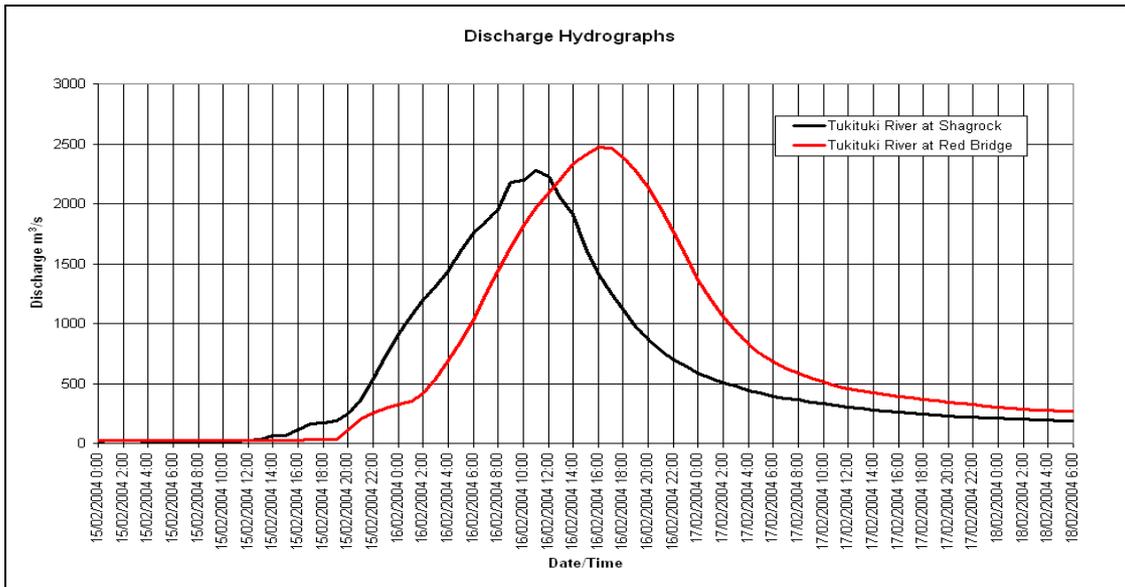
Figure 8: Discharge Hydrographs – Tukituki River

The discharge in the Tukituki equated to a 5 year discharge. The peak at Shag Rock of around 2500 m³/s took about 6 hours to travel through the Middle Tukituki valley down to Red Bridge, which equates to an average water speed of about 2 m/s. The distance between these locations is 43.4 km.

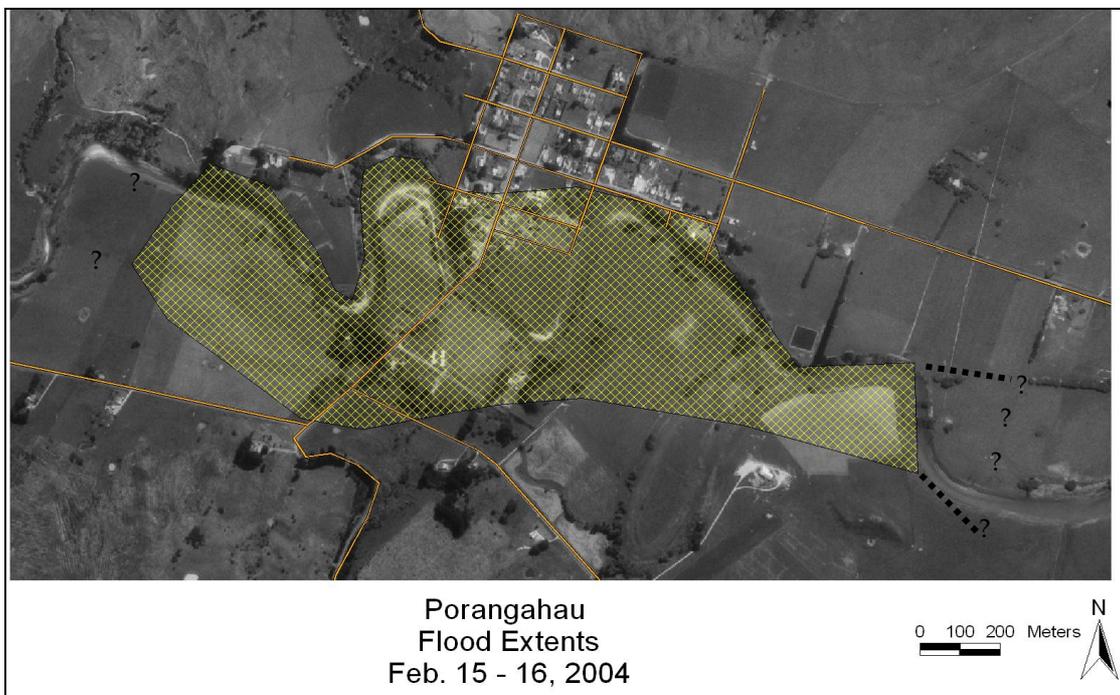
Figure 9: Porangahau: Flood Extents

The intense rain falling in the Porangahau Catchment travelled quickly towards the coast, with the water level recorder at Wallingford peaking over 10 m above normal level at approximately 8 am on Monday, February 16. The river distance from Wallingford to Porangahau is approximately 28 km, and early Monday morning, the town of Porangahau was inundated with flood waters, as shown in Figure 9.

Water was present in the cemetery, and several streets through the town. Many houses and businesses suffered flood damage.

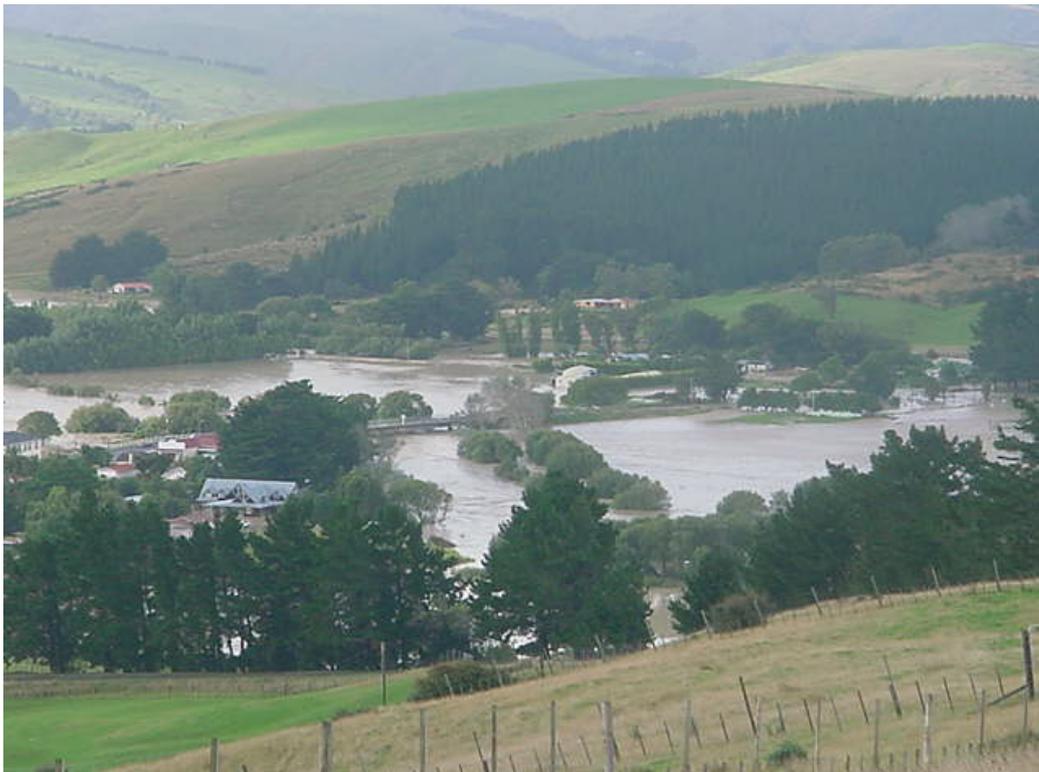
Figure 13: View of Porangahau River from Old Hill Road

(note: Porangahau Town is on left)

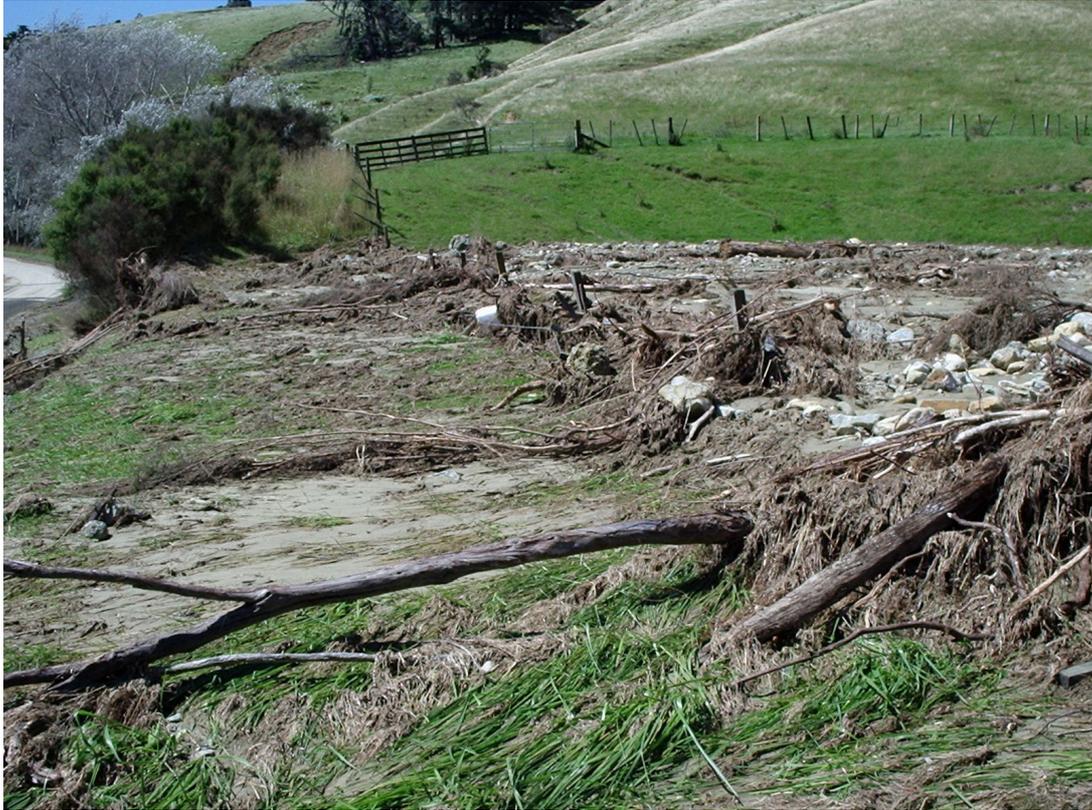
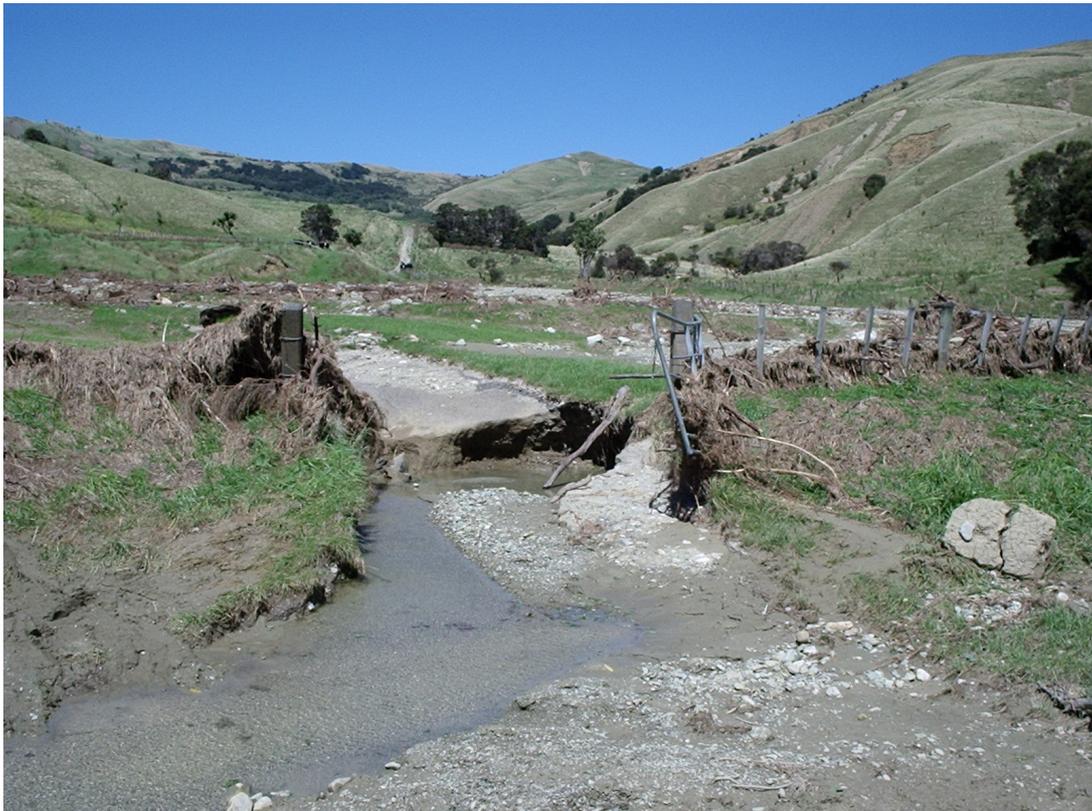
Figure 14: Aftermath of Flood, Mangaorapa Valley (Robinson)

Along with flooding in the township of Porangahau, the surrounding farmland was severely affected by overland flow and erosion. The following photos show the effects.

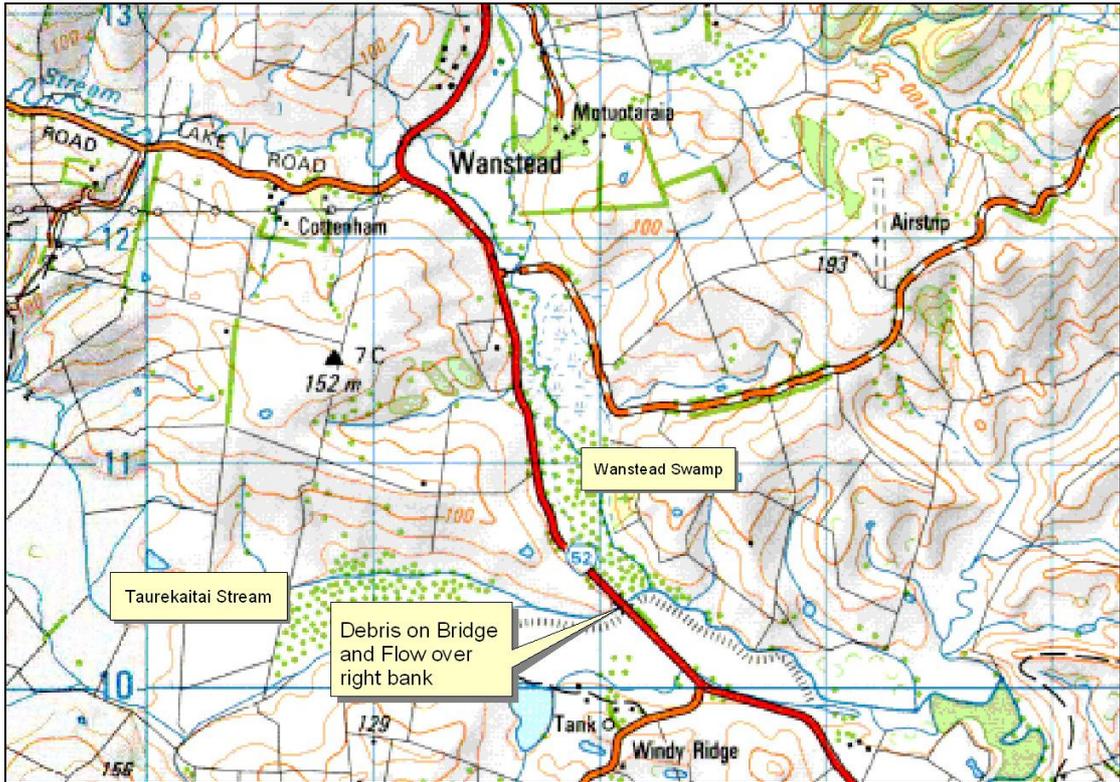
Figure 15: Location of Flooding Near Wanstead and Taurekaitai Stream

The Porangahau Road was flooded from the Wanstead Swamp (Figure 15), where the water was approximately 1 m deep over the road (Figure 16).

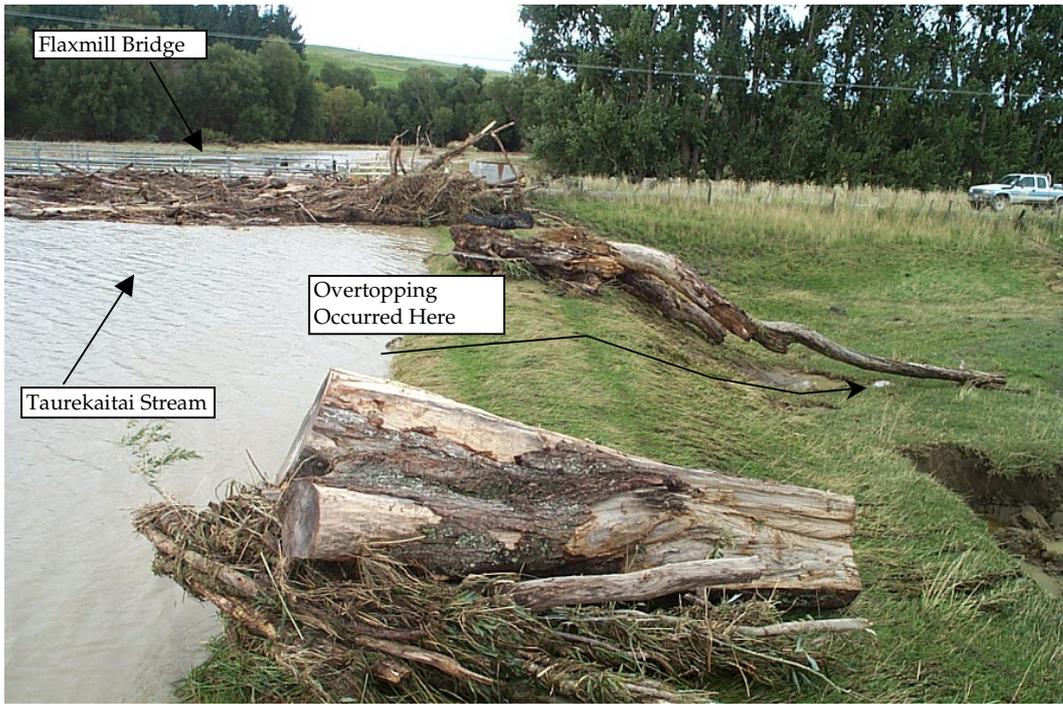
Figure 17: Porangahau Road, Flaxmill Bridge over Taurekaitai Stream

There was severe debris buildup on the Flaxmill Bridge over the Taurekaitai Stream (see Figure 17), and the water overtopped the small stopbank on the right bank.

- Stopbanks overtopped at Flaxmill bridge both u/s and d/s, landward batters scoured in several places and need repairing
- major debris blockage at bridge, channel scouring d/s of bridge
- several locations where trees have fallen into the stream, debris blocks etc

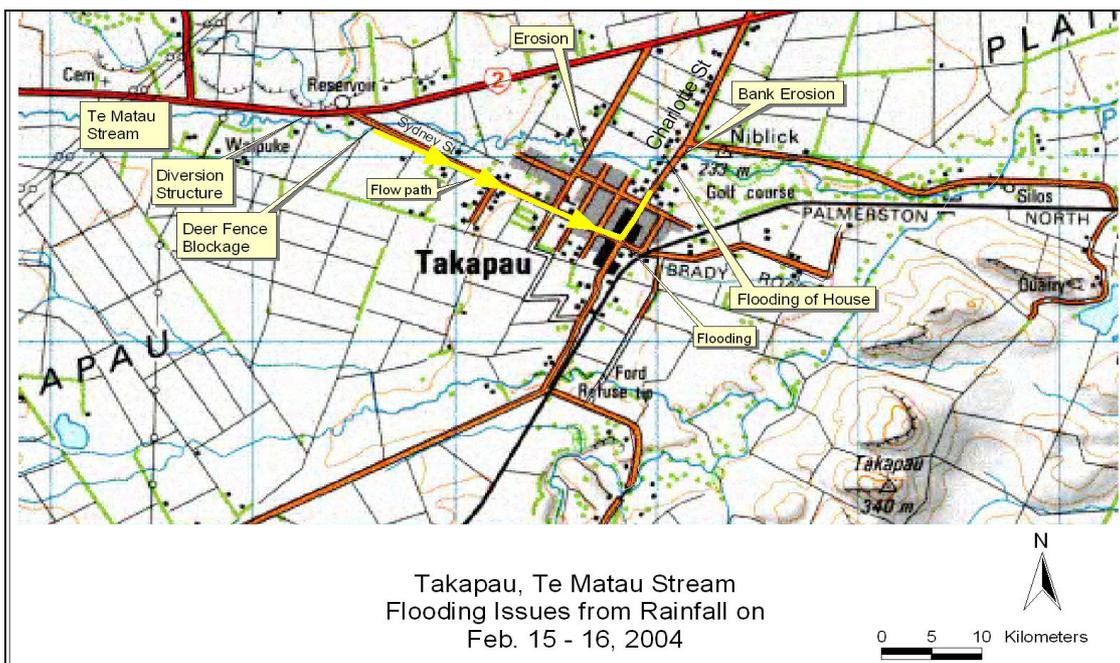
Figure 18: Takapau: Areas with Flood Issues

The Takapau area sustained moderate damage during this event, with out of channel flow from the Te Matau Stream causing localised erosion and ponding problems. The stream is normally narrow with a very windy path, which quickly overtops its banks and spreads out to about 10 or 20 m wide, when the flow level rises. Figure 18 shows the general area and location of problem areas.

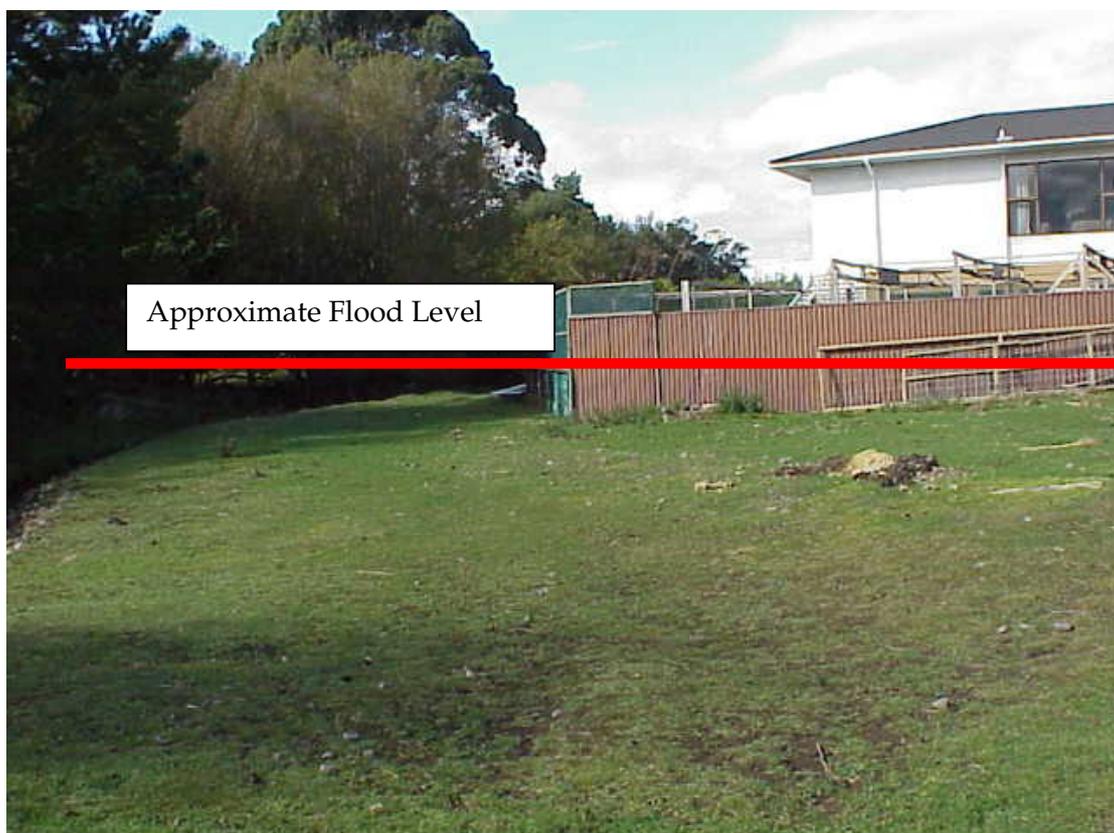
Figure 19: Approximate Flood Level at Jeffcoat House, Charlotte Street, Takapau

Figure 19 shows the rear of the Jeffcoat’s house, with the approximate flood level.

Just downstream of the Jeffcoat’s house, the stream passes through very heavy vegetation, and several 90 to 180 degree bends. Once it passes through the box culvert under Charlotte Street, the channel is still very heavily vegetated, and during this storm it appears several trees fell into the stream and caused severe blockage, which resulted in higher water levels upstream.

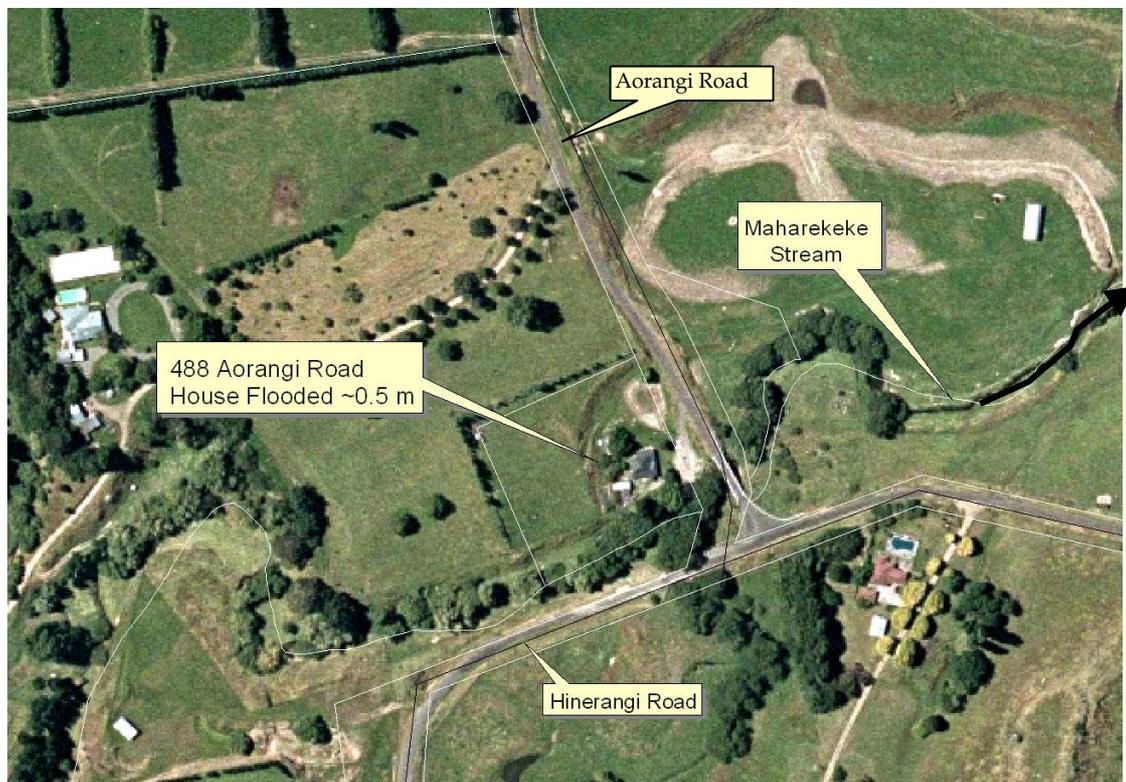
Figure 20: Flooding from Maharakeke Stream, Aorangi Road.

A dwelling on the Maharakeke Stream at Aorangi Road had approximately 0.5 m of flood water through it (Figure 20). It has been reported that this house has been flooded previously.

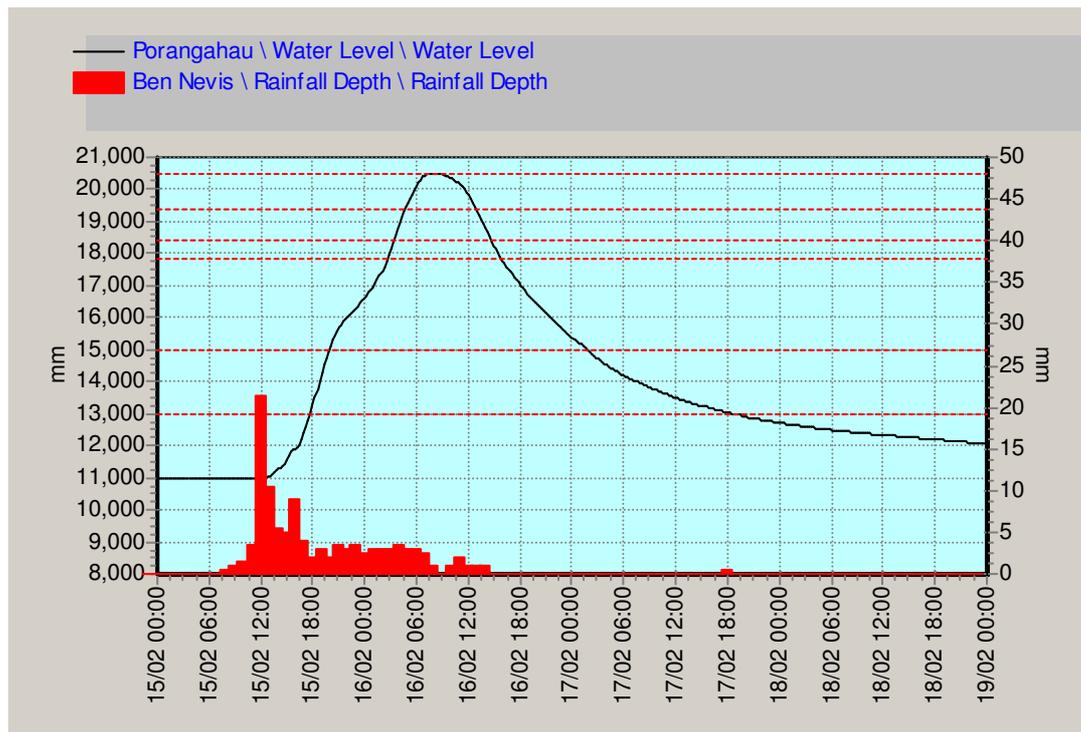
Max Stage 20510mm on 16/02/04 @ 0800 hrs
 Max Flow 562m³/s on 16/02/04 @ 0800 hrs
 Max 1 hour rainfall 22.5mm from 15/02/04 @ 0830 hrs
 Max 24 hour rainfall 103.5mm from 15/02/04 @ 0830 hrs

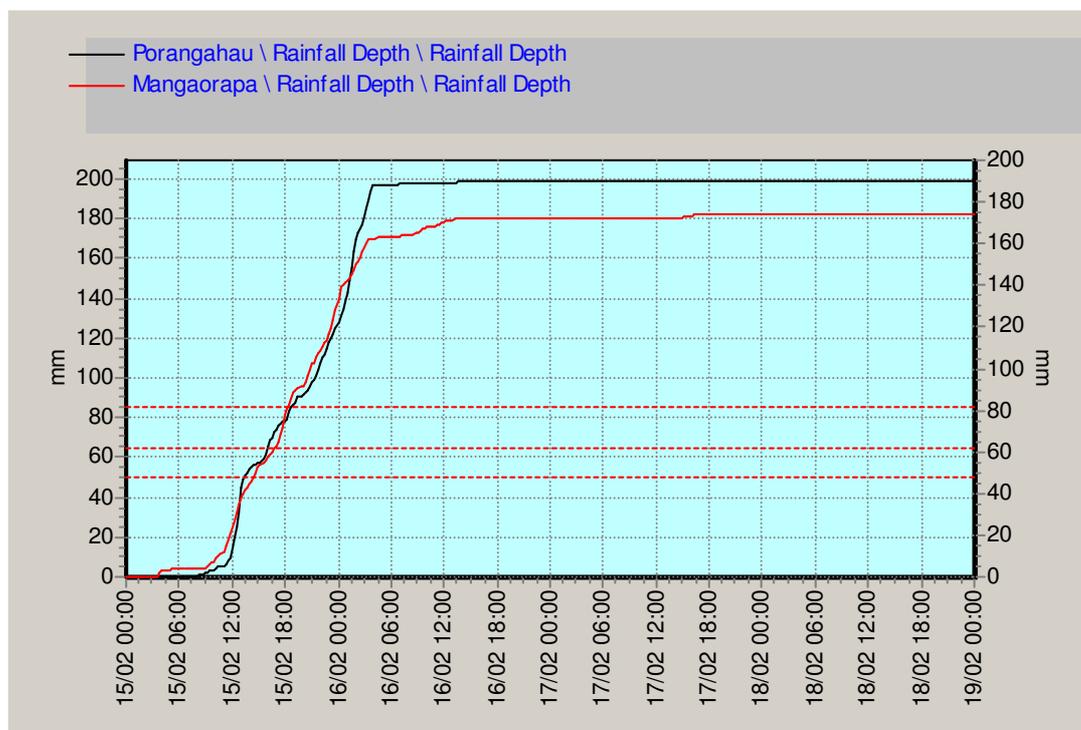
Porangahau Max 1 hour rainfall 29.5mm from 15/02/04 @ 1200 hrs
 Max 24 hour rainfall 197.0mm from 15/02/04 @ 0400 to 0800 hrs
 Mangaorapa Max 1 hour rainfall 20.0mm from 15/02/04 @ 2315 hrs
 Max 24 hour rainfall 162.0mm from 15/02/04 @ 0330 hrs

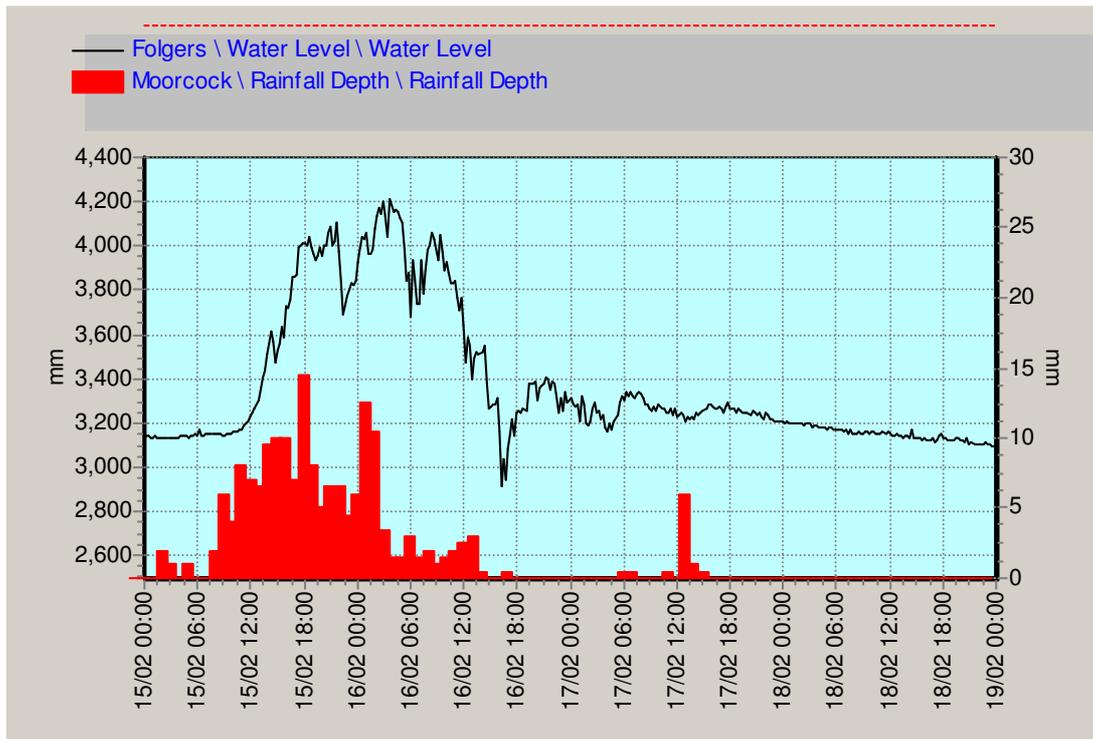
Max Stage 4215 mm on 16/02/04 @ 1615 hrs
 Max 1 hour rainfall 14.5mm from 15/02/04 @ 1745 to 1800 hrs
 Max 24 hour rainfall 156.5mm from 15/02/04 @ 0830 hrs

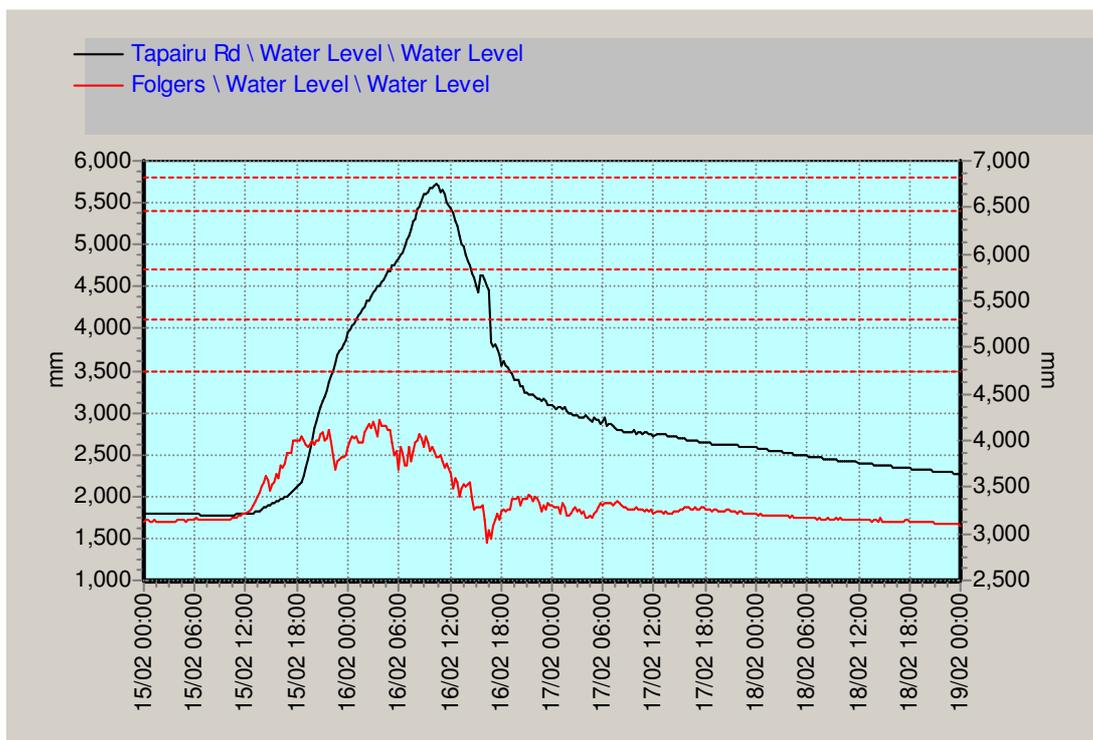
Tapairu Rd Max Stage 5718 mm on 16/02/04 @ 1030 hrs
 Max Flow 1006 m³/s on 16/02/04 @ 1030 hrs

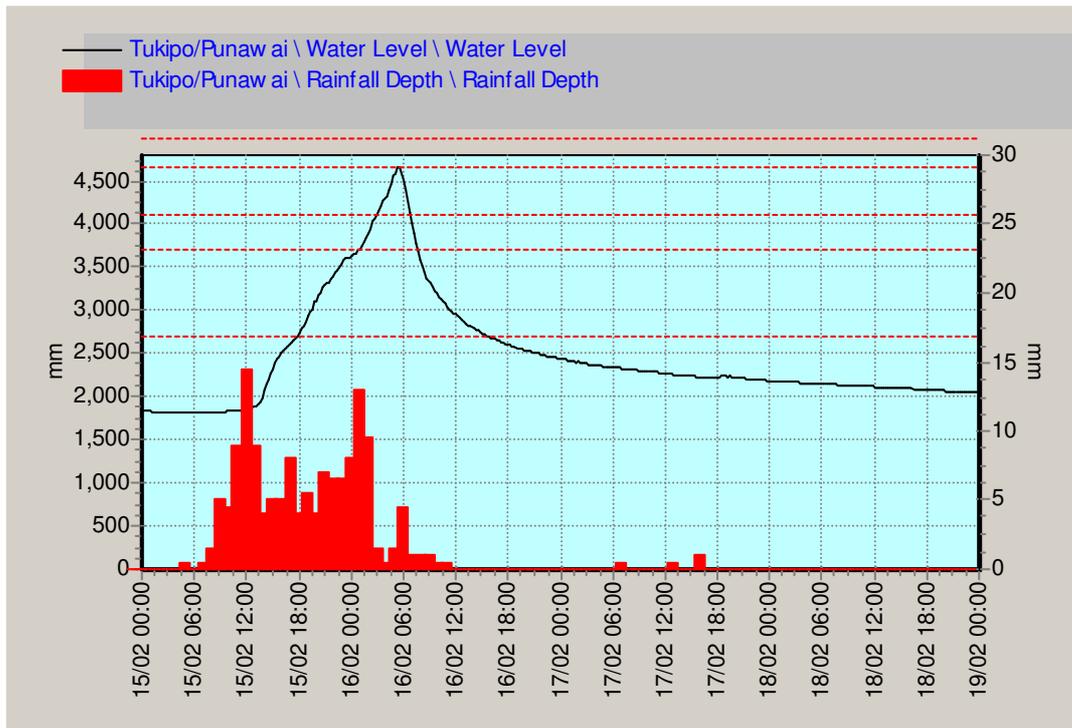
Max Stage 4667mm on 16/02/04 @ 0530 hrs
 Max Flow 202m³/s on 16/02/04 @ 0530 hrs
 Max 1 hour rainfall 15.0mm from 16/02/04 @ 0130 hrs
 Max 24 hour rainfall 139.0mm from 15/02/04 @ 0730 to 0845 hrs

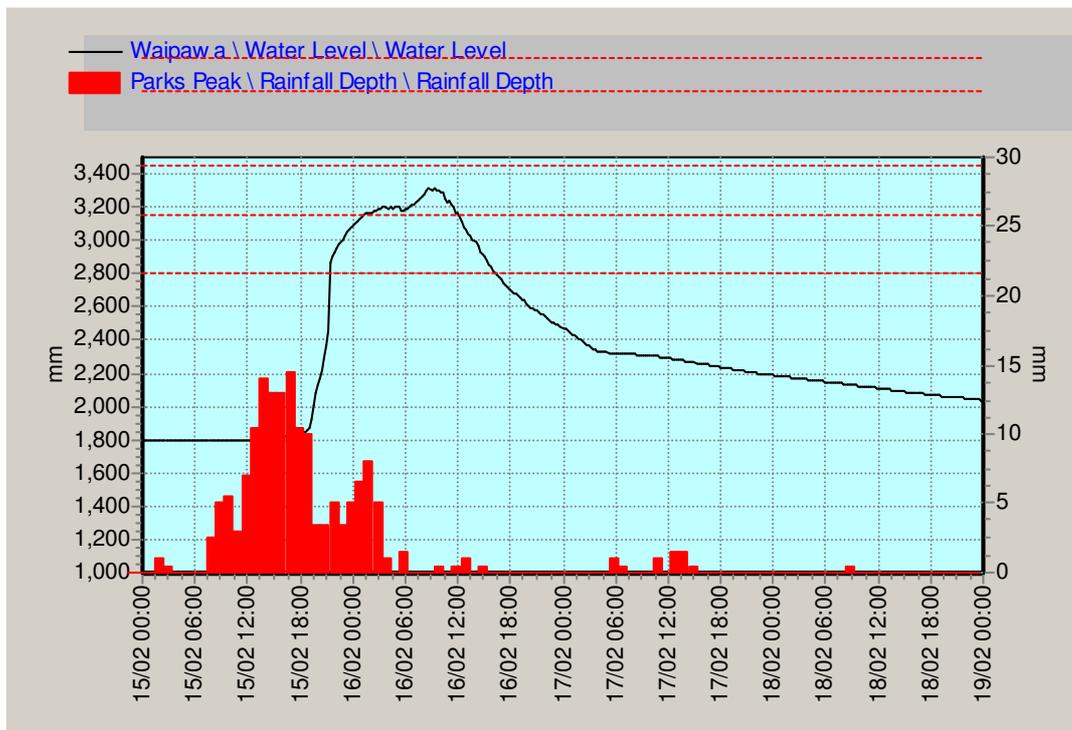
Max Stage 3312mm on 16/02/04 @ 0915 hrs
 Max Flow 544m³/s on 16/02/04 @ 0915 hrs
 Max 1 hour rainfall 16.5mm from 15/02/04 @ 1430 hrs
 Max 24 hour rainfall 151.0mm from 15/02/04 @ 0700 to 0830 hrs

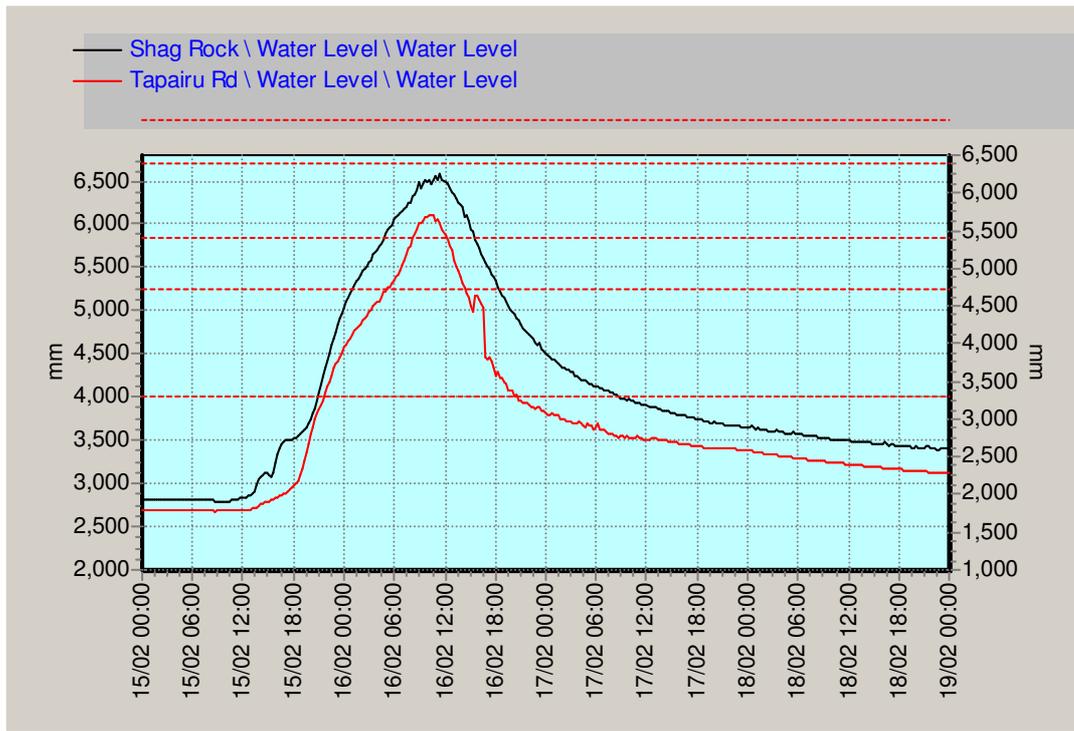
Shag Rock Max Stage 6579mm on 16/02/04 @ 1130 hrs
 Max Flow 2334m³/s on 16/02/04 @ 1130 hrs

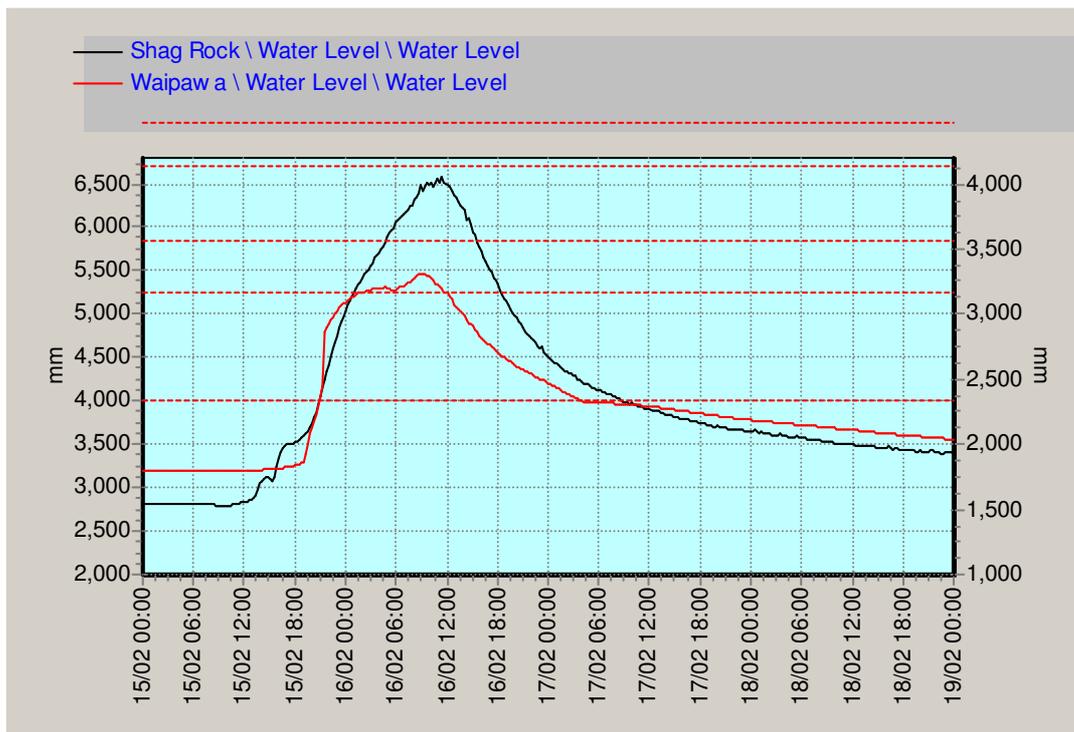
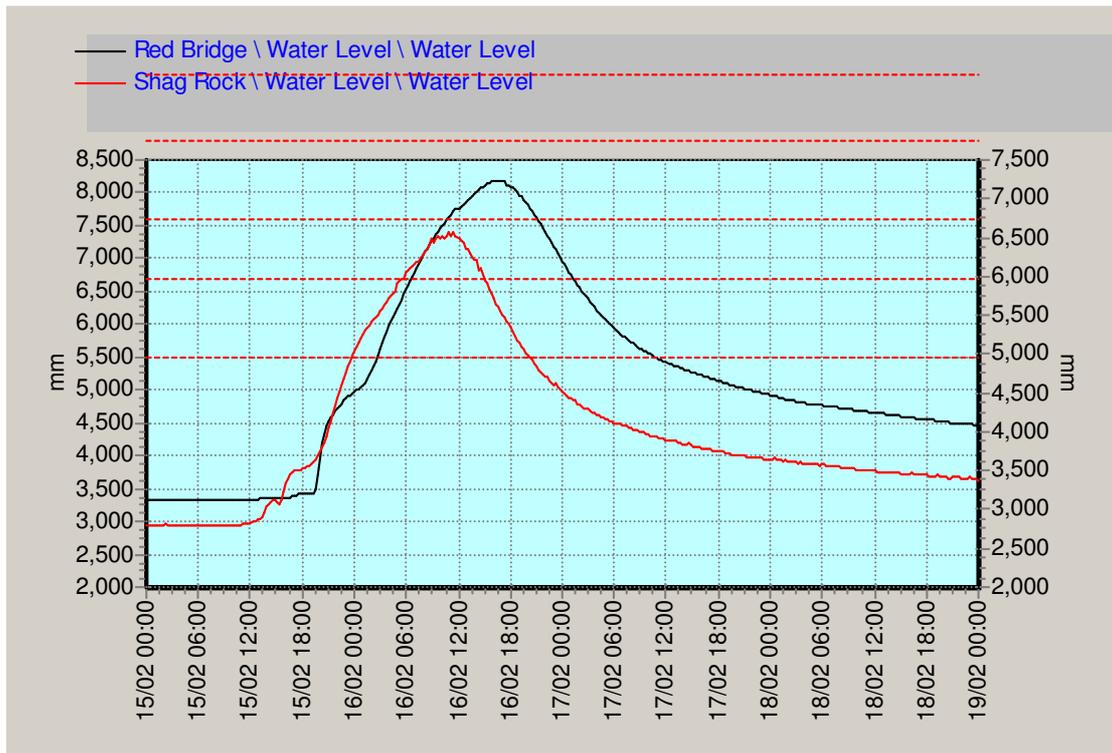
Red Bridge Max Stage 8179mm on 16/02/04 @ 1600 hrs
 Max Flow 2472m³/s on 16/02/04 @ 1630 hrs
