Wairoa Catchments Flood Report
Labour Weekend,
20-21 October 2005

March 2006
AM06/03
HBRC Plan Number 3836

Internal Technical Report

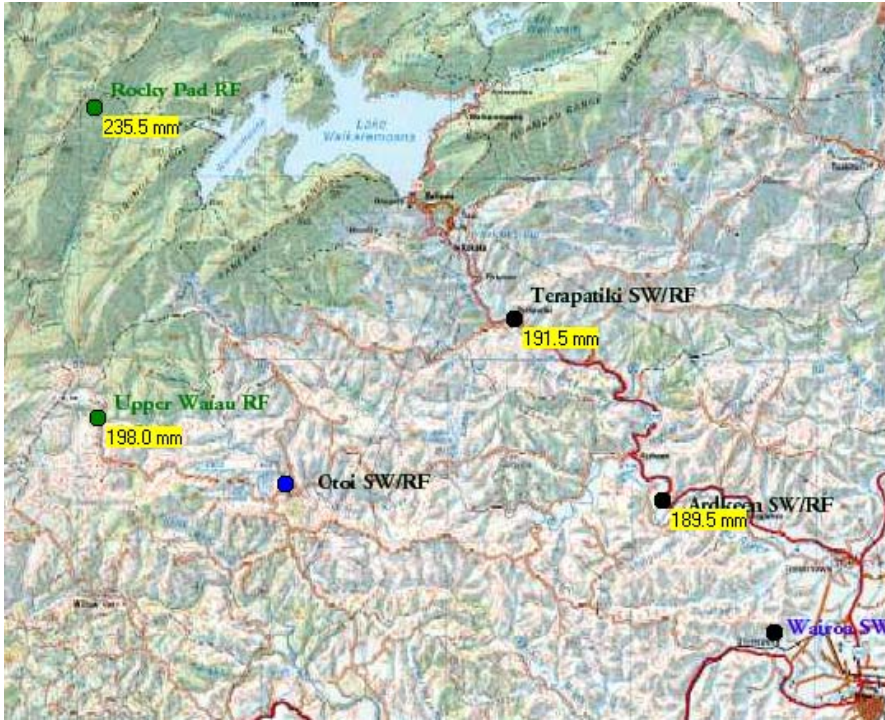
Figure 2-1: Waiau Catchments 48hrs Rainfall, 18:00 20th October 05 to 18:00 22nd October 05

Figure 2-1 and Figure 2-2 show the 48hr rainfall totals for the Waiau and Wairoa catchments, northern Hawke's Bay. Figure 2-3 shows the measured water level in the Wairoa River at Railway Bridge and Figure 2-4 shows the measured flow rate in the Wairoa River at Railway Bridge. Figure 2-5 shows the rainfall depth measured in the Ardkeen catchment.

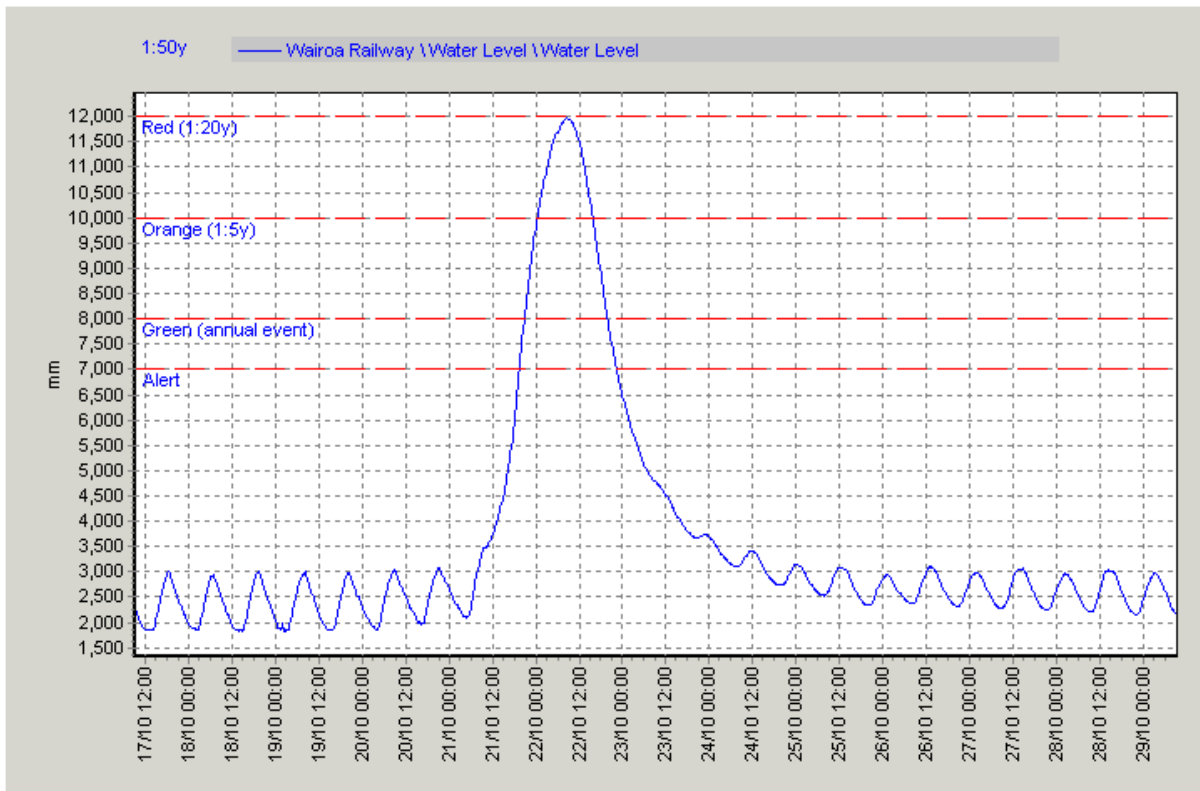
Figure 2-3: Wairoa Railway, Wairoa River Measured Water Level

Wairoa River at Railway Bridge:

peak recorded level = 11.965m (cyclone "Bola" level in March 1988 = 16.44m {based on surveyed flood level of 21.38m RL & XS20 channel invert of 4.94m RL})

water level rise = approx. 9.5m from mean tidal level

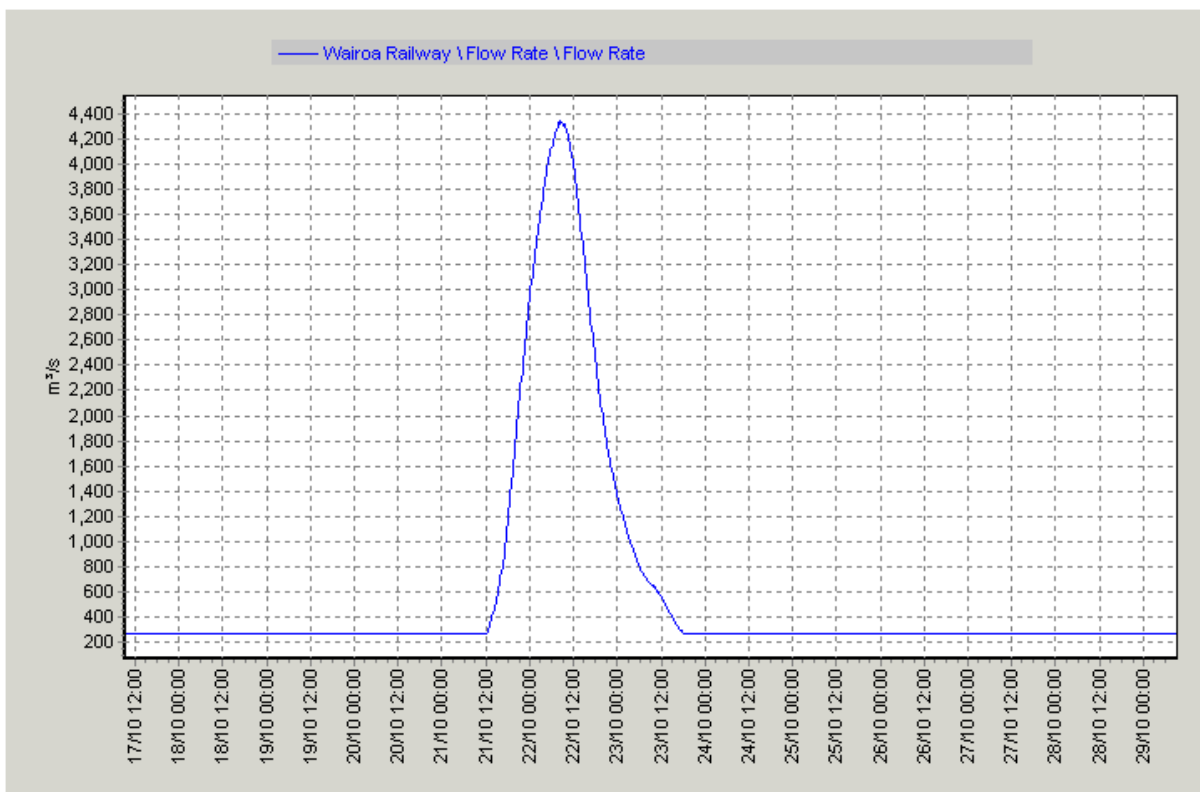
Figure 2-4: Wairoa Railway, Wairoa River Measured Flow Rate

peak recorded flow rate = approx. 4300 m³/s

approximately 1 in 20 year return period flow

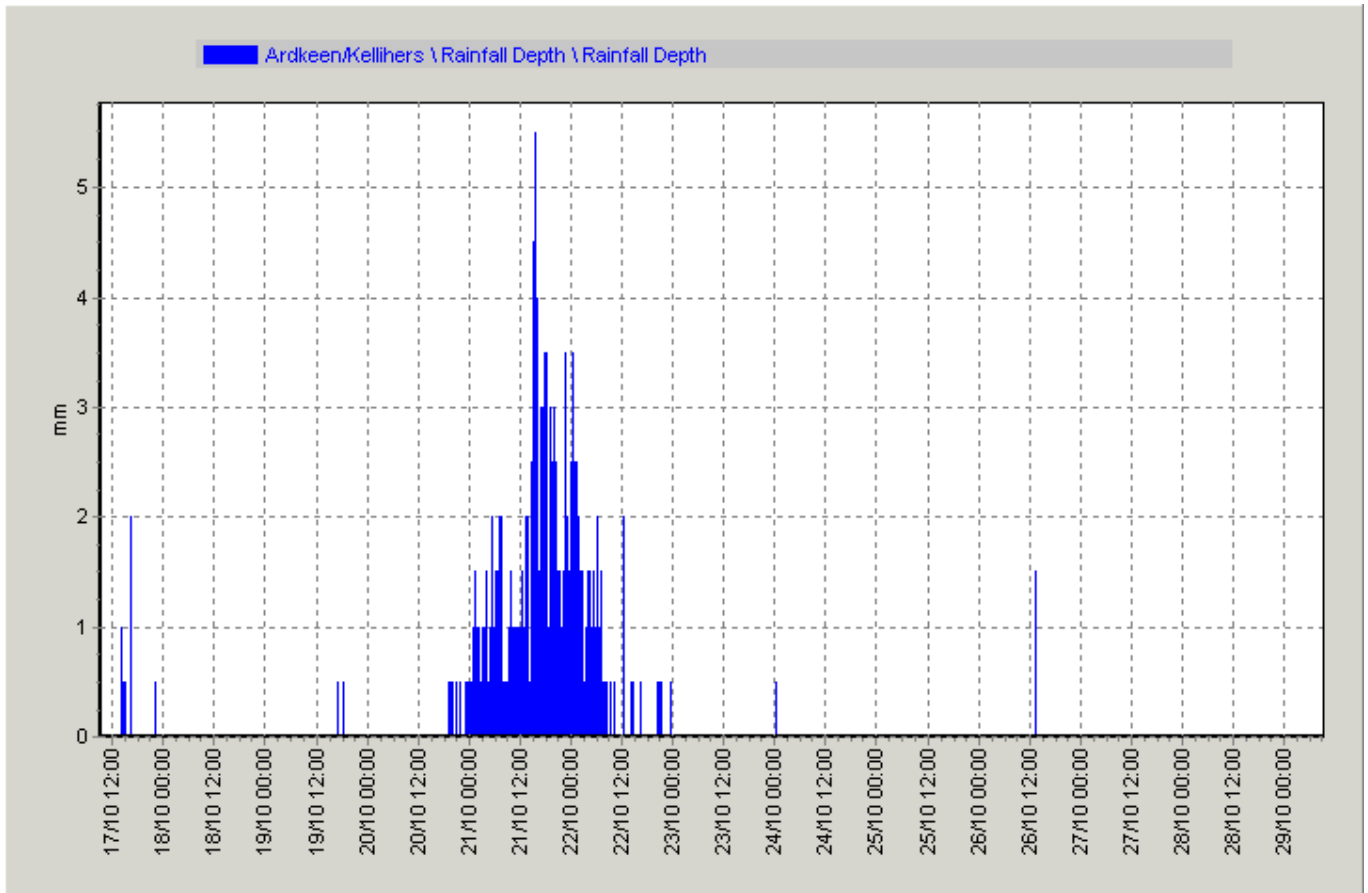
Figure 2-5: Ardkeen Catchment Rainfall Depth

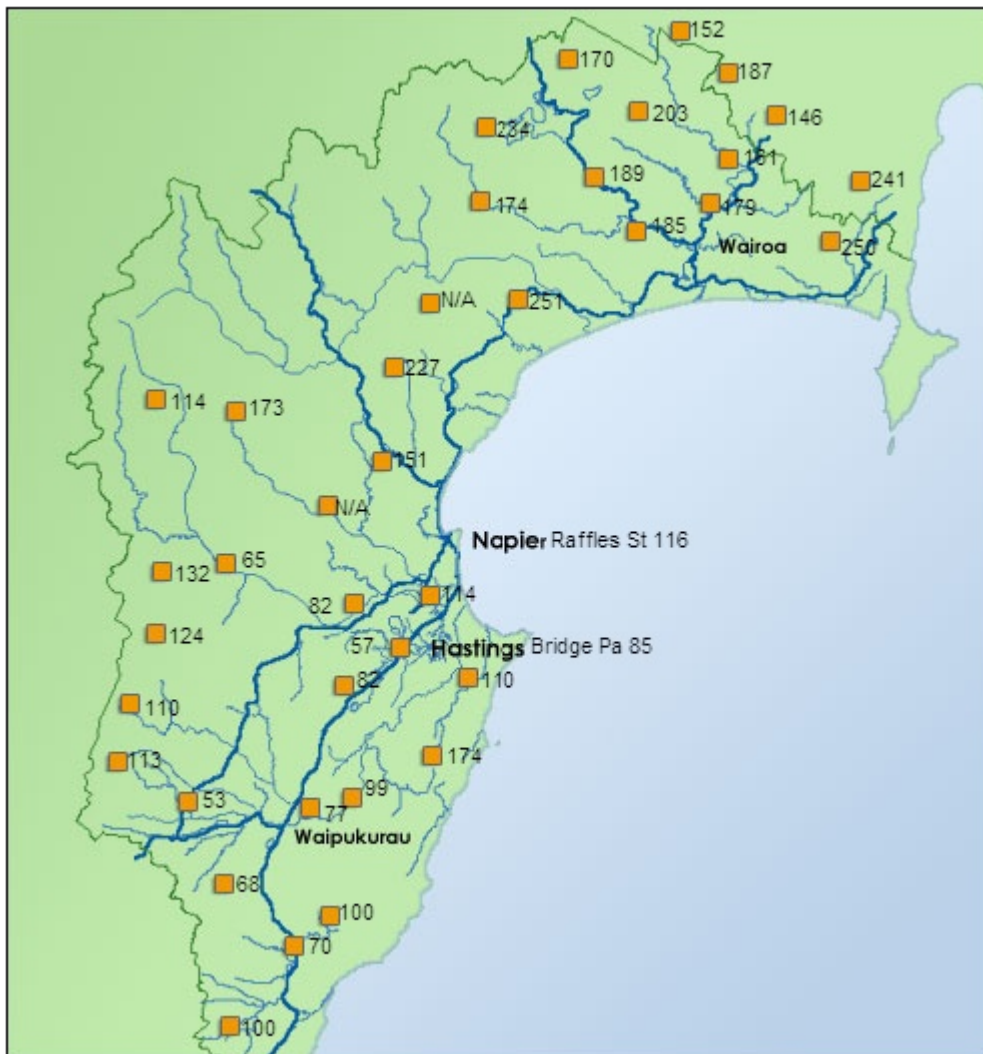
Rainfall Depths Measured for Event of 20 – 21 October 2005:

Rainfall period: 20/10/05 1200hrs to 22/10/05 1200hrs NZST
