*Hawke's Bay State of the
Environment 2018 - 2021*

Land & Water

Mohaka

16. Mohaka and Waihua catchments

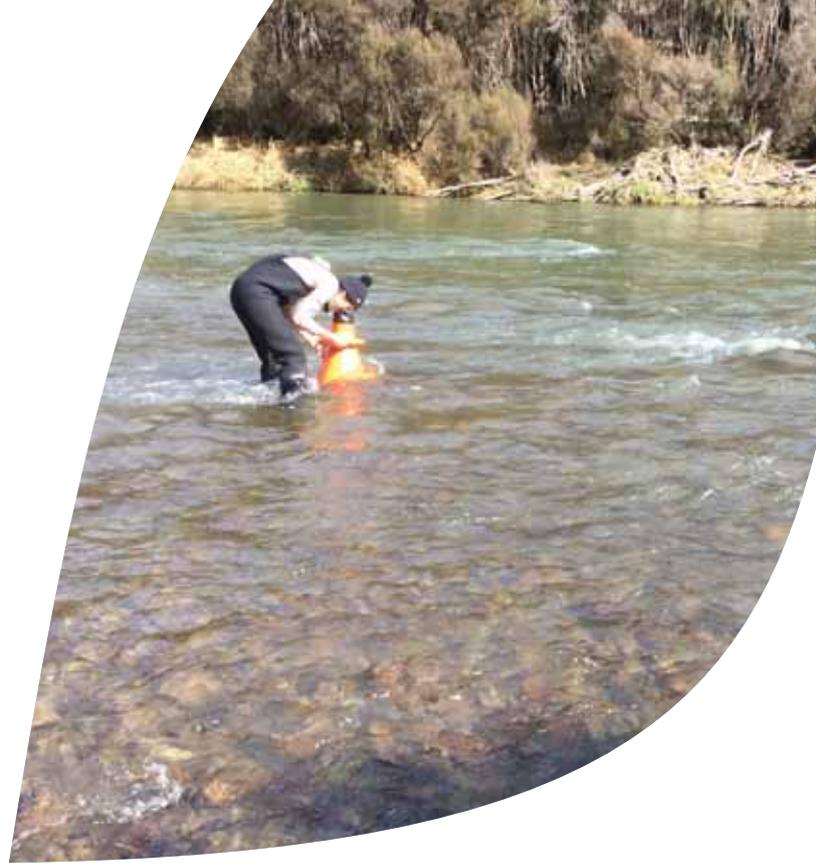
Figure 16-5. Median dissolved inorganic nitrogen (DIN) concentrations in the Mohaka catchment relative to ANZECC upland and lowland (2000) or Biggs (2000) periphyton trigger values. 1: Mohaka River u/s Taharua, 2: Taharua River at Wairango Rd, 3: Taharua River at Twin Culverts, 4: Taharua River at Henry’s Bridge, 5: Taharua River at Red Hut, 6: Mohaka River d/s Taharua, 7: Mohaka River d/s Ripia, 8: Ripia River u/s Mohaka, 9: Waiarua Stream at SH5, 10: Mokomokonui River u/s Waipunga, 11: Mohaka d/s Waipunga, 12: Mohaka at Raupunga, 13: Waihua River at Waihua Rd.

HBRC regularly samples water quality at 13 locations in the Mohaka and Waihua catchments. Four of these sites are on the Taharua River, despite it being a relatively short waterway compared with the entire Mohaka catchment. HBRC chose to monitor this area closely because of high instream nitrogen concentrations caused by adjacent dairy and sheep/beef farming. During summer low-flow periods, water temperatures increase, and the elevated nutrient concentrations can generate nuisance algal growth in the Mohaka below the Taharua confluence (Figure 16-5 to Figure 16-7).

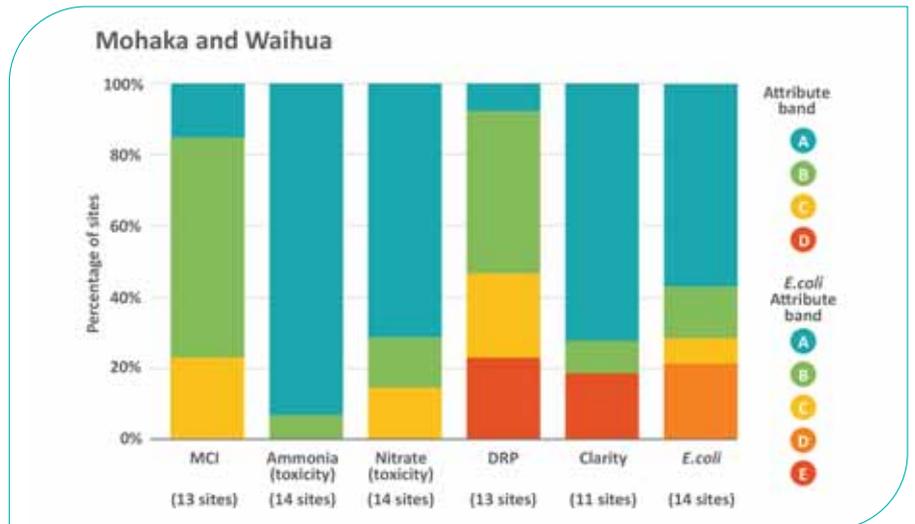
Figure 16-6. Bands (A = Good, D/E = Poor) in the National Policy Statement for Freshwater Management (NPS-FM) for river attributes in the Mohaka and Waihua catchment. DRP = dissolved reactive phosphorus. MCI = macroinvertebrate community index. Grading based on latest five years of available data.

Further up the coast, the Waihua is a relatively small, steep-sided catchment with extensive sheep/beef farming and production forestry. Erosion is high in this area, leading to poor water clarity and elevated DRP concentrations. Sediment is also likely impacting on macroinvertebrate communities, as macroinvertebrate community index (MCI) scores for the Waihua are in the D (poor) band. Reducing sediment loss in both catchments is likely to improve ecosystem health.

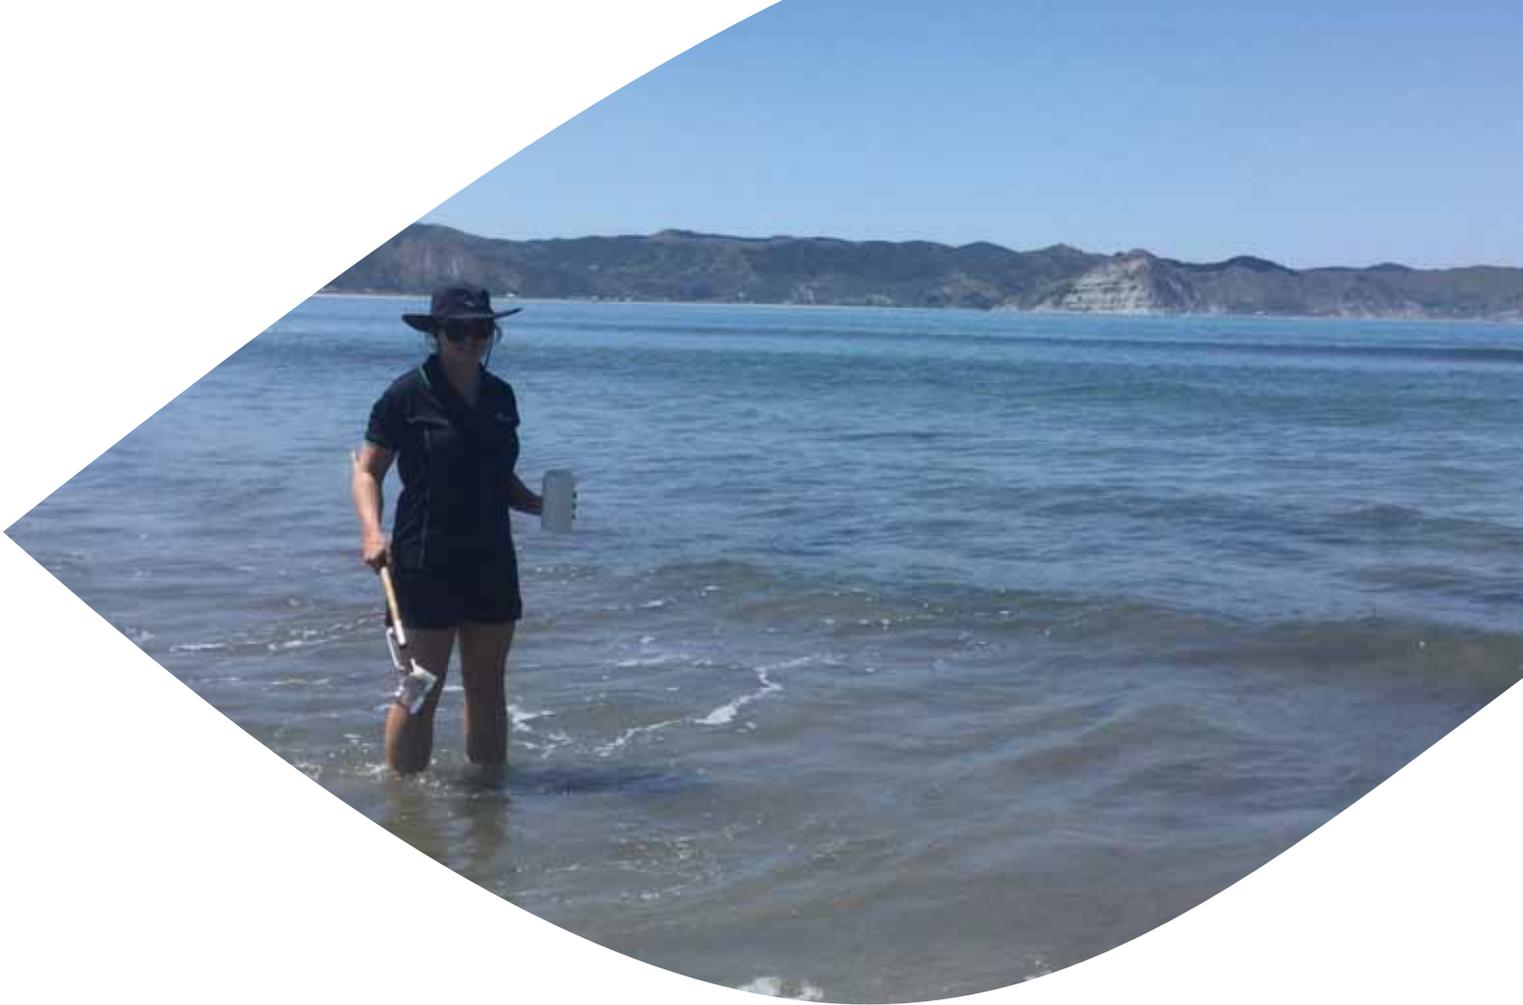
Figure 16-13. Coastal water quality indicators in the Mohaka catchment, compared to other coastal sites around New Zealand.

In Mohaka coastal waters, suspended sediment, dissolved oxygen, chlorophyll-a, and nitrogen and phosphorus levels are within the ranges observed in other New Zealand open coast sites (Figure 16-13). However, turbidity (visual clarity) is slightly elevated, which is likely to be linked to the high supply of sediment discussed earlier.
