*Hawke's Bay State of the
Environment 2018 - 2021*

Esk and Central Coast catchments

17. Esk and Central Coast catchments

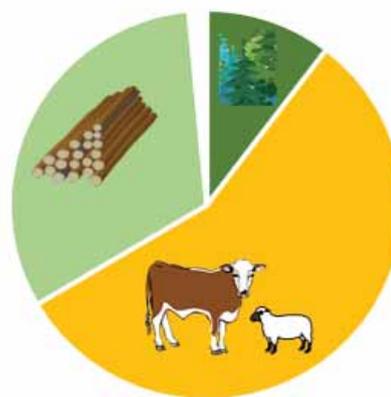
Figure 17-1. Land cover in the Esk and Central Coast catchments. The 'other' category includes built-up areas (settlements, urban parkland, and transport infrastructure) and bare surfaces such as bare soil, gravel, and rock.

The Esk and Waikare catchments are covered in indigenous forest in the upper reaches, and the steep and rolling hill country around the lower reaches has a mixture of extensive sheep and beef farms, production pine forestry, and a few dairy and deer farms. Vineyards and orchards line the flatter slopes of the Esk Valley (Figure 17-1). From 2001-2018, the only noticeable land-use change has been a slight increase in production forestry, which was converted from grassland (Figure 17-2).

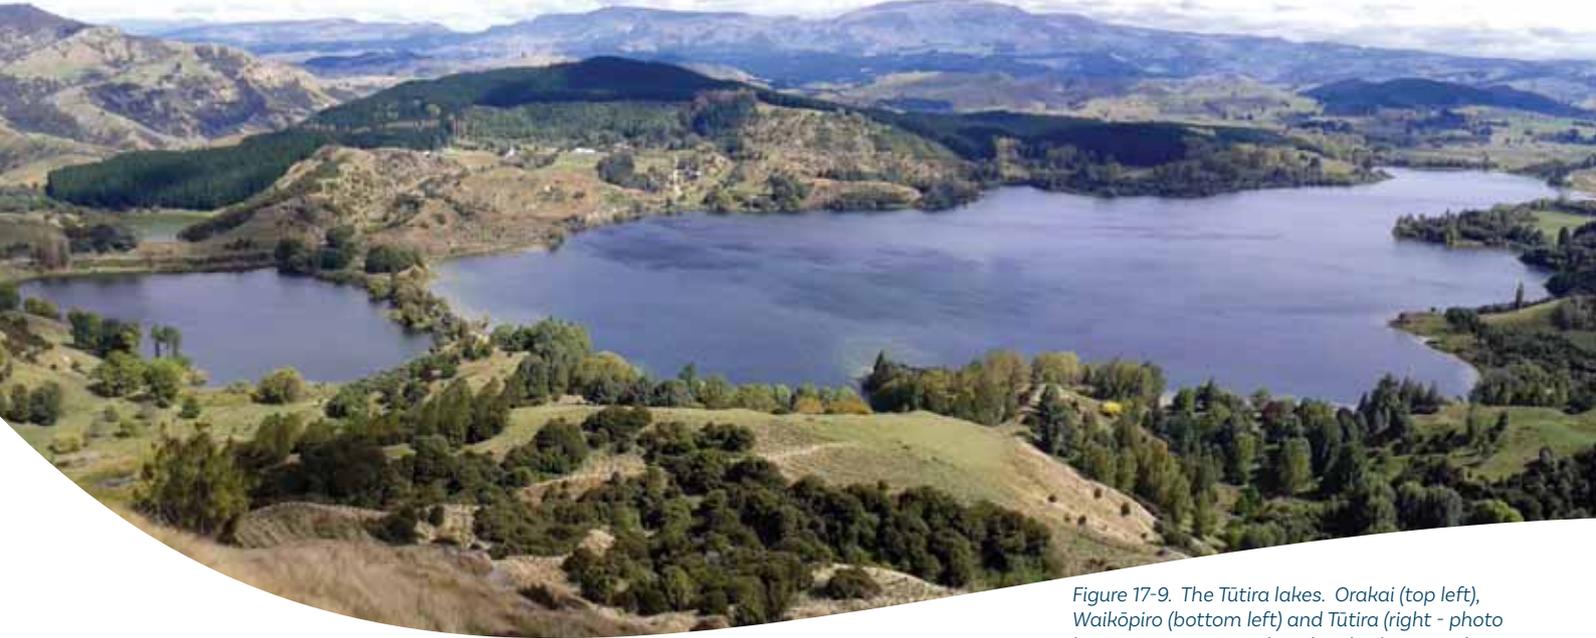
Figure 17-9. The Tūtira lakes. Orakai (top left), Waikōpiro (bottom left) and Tūtira (right - photo by Peter Scott www.abovehawkesbay.co.nz)

Lake Tūtira is the largest lake in the catchment, followed by Waikōpiro, Opouahi, and Orakai (Figure 17-9). The popular Tūtira, Waikōpiro, and Opouahi have high recreation and amenity values, but also a history of enrichment and nuisance algal blooms that have often made them unsuitable for contact recreation.

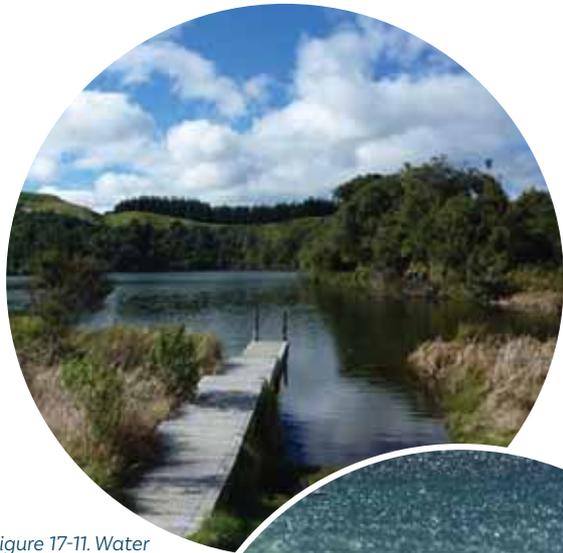
Figure 17-11. Water quality in Opouahi Lake has degraded steadily since 2008 despite being surrounded by native vegetation.

Opouahi has had a TLI of greater than 4 in recent years (Figure 17-9). This is surprising, because the majority of the lake's catchment is retired from farming and covered in native vegetation (Figure 17-11). One possible explanation for the degradation of water quality is the presence of grass carp, which may have increased the risk of algal blooms (see section on grass carp below).

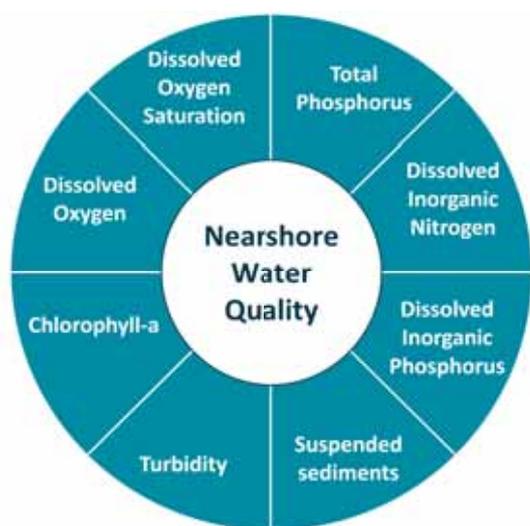
Figure 17-14. Coastal water quality indicators in the Esk and Central Coast catchments, compared to other coastal sites around New Zealand.

Suspended sediment, turbidity, dissolved oxygen, chlorophyll- α , nitrogen, and phosphorus levels in coastal waters of the catchment are within the ranges observed in other New Zealand open coast sites (Figure 17-14).

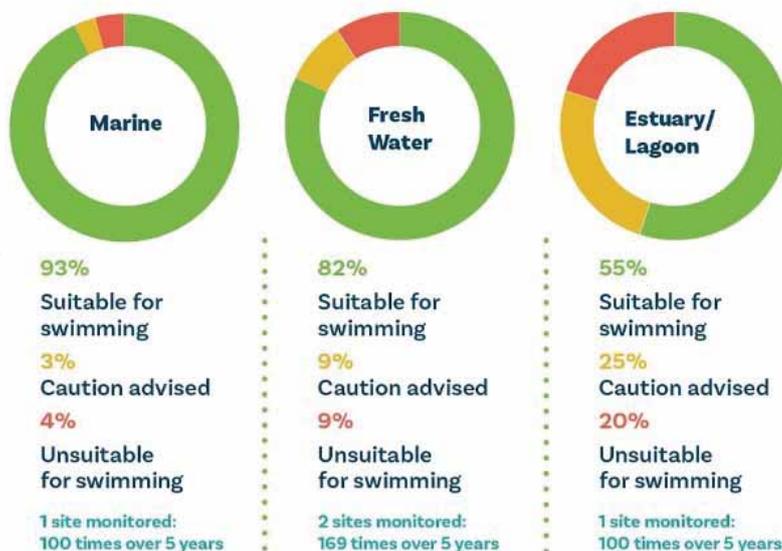
Figure 17-15. Swimming suitability metrics for marine, estuarine, and freshwater sites in the Esk and Central Coast catchments. Swimmable = green and orange.

Like elsewhere in Hawke's Bay, coastal beaches in this catchment tend to have excellent water quality and are almost always suitable for swimming. However, the Esk River and Waipatiki Lagoon appear to have persistently poor recreational water quality (Figure 17-14).

The Waipatiki Lagoon/Stream continues to be largely unsuitable for swimming due to the presence of faecal material. Faecal source tracking in this catchment suggests mixed sources, including ruminants and birds. Large flocks of geese are often observed upstream of the lagoon, which may be contributing to the faecal sources. This site has also shown deteriorating water quality over the last 21 years.

Swimming was also not advised in the Esk River and Lake Tūtira a relatively high proportion of the time (9% and 8.5% respectively). Both sites were graded 'poor' for primary contact recreation.

Waipatiki Beach was the water body most suited for swimming, with 98% of samples swimmable.
