Recreational Water Quality in Hawke's Bay State of the Environment: 2013 - 2018

December 2019
HBRC Report No. RM 19-248 – 5403

Integrated Catchment Management Group

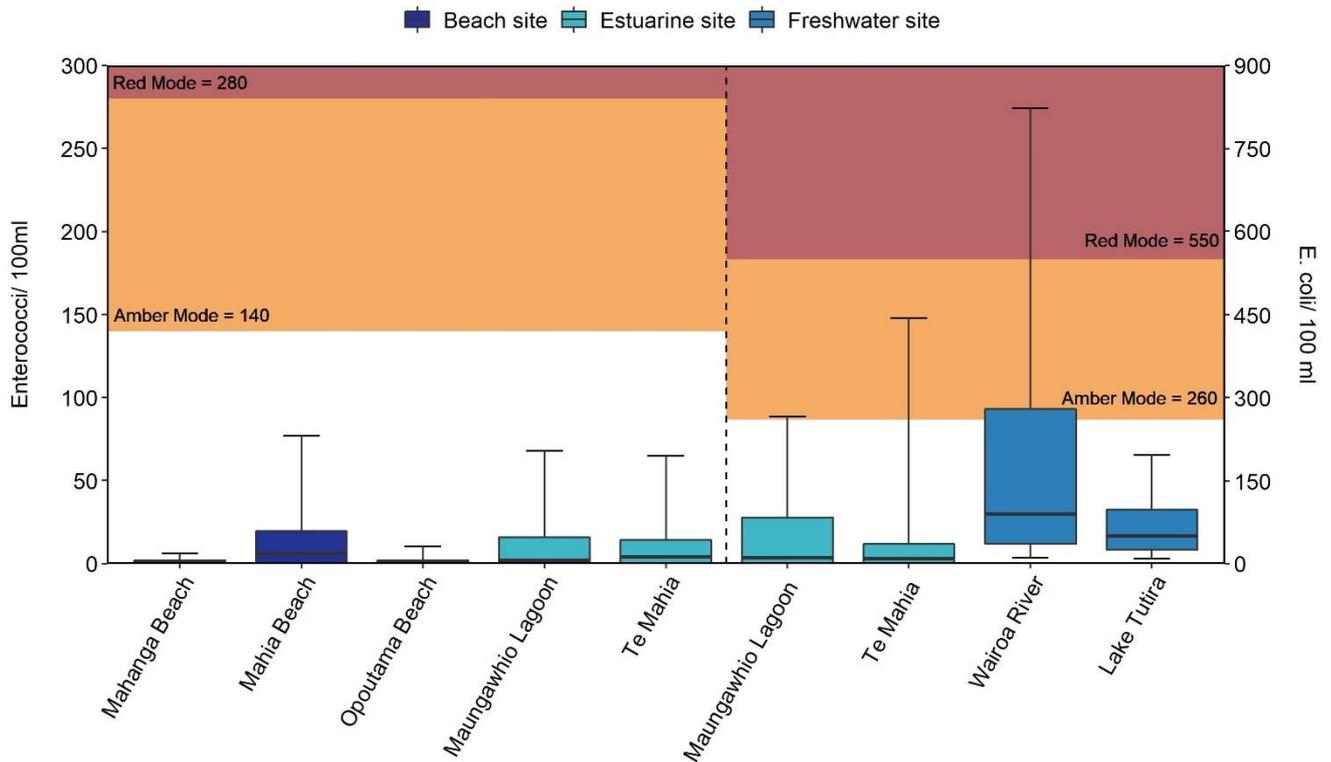
Figure 3-1: Faecal indicators for northern sites. Five year data with exceedance guideline thresholds (2013-2018). Red and amber areas indicate the MfE and MoH (2003) trigger values for the Red and Amber Modes respectively. The concentrations of indicator bacteria (cfu/100ml) associated with these modes are written above the line.

Recreational sites in the Northern Hawke's Bay generally had similar characteristics in water quality compared to other sub-regions. Beach water quality is generally very high (Figure 3-1) and is less influenced by rainfall washing contaminants from the land into waterways than freshwater rivers. Wairoa River has notable water quality, in that it is the only northern site where the 75th percentile (top of the box) sits within the amber mode. This indicates that at least 25% of the samples are in this mode, or higher. Most samples for lagoon areas in the northern sub-region are below guideline exceedance levels, however exceedances can occur more frequently due to the slow moving water and high levels of bird life.

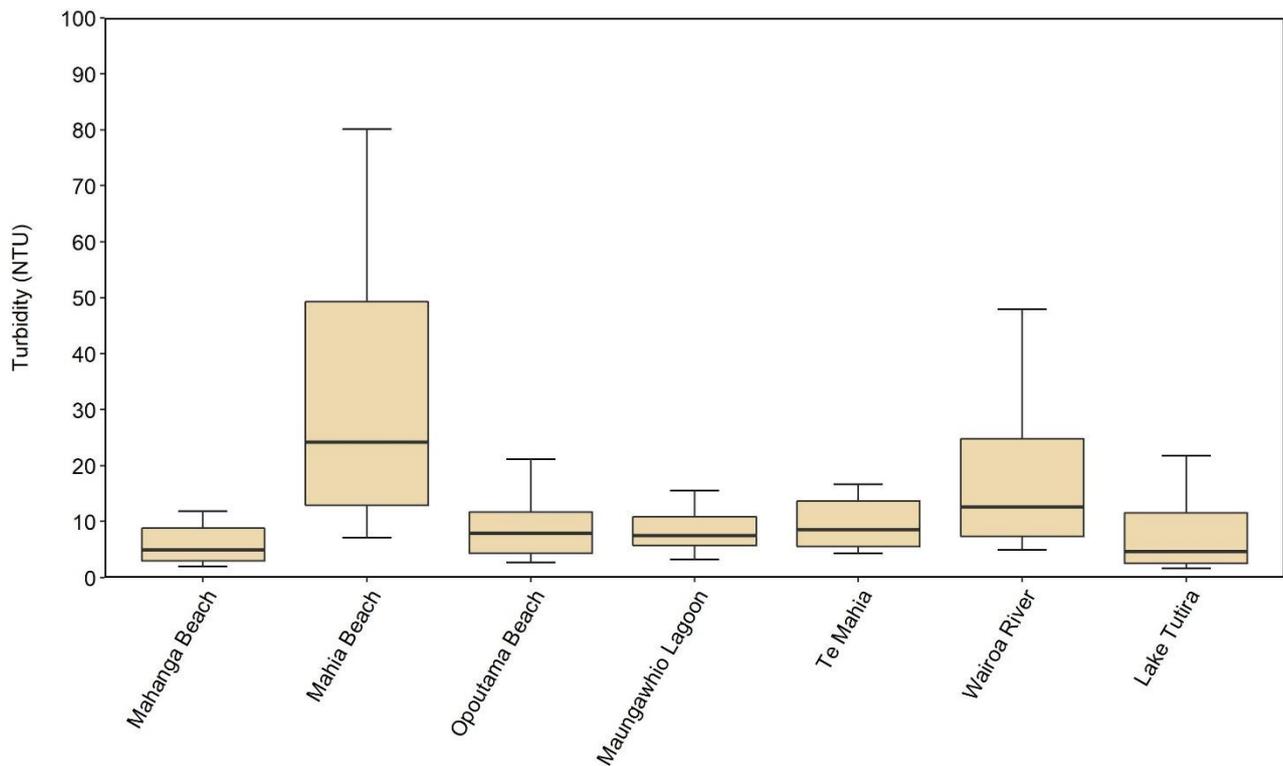
Figure 3-2: Turbidity levels (NTU) in northern recreational waters 2013-2018.

Turbidity levels were low across most northern recreational sites (Figure 3-2). Unexpectedly, Mahia Beach showed higher turbidity levels than Wairoa River, Te Mahia and Maungawhio Lagoons. Higher turbidity levels in this area may be due to wave and swell energy resuspending fine particles along this coastline, or other suspended particles such as plankton.

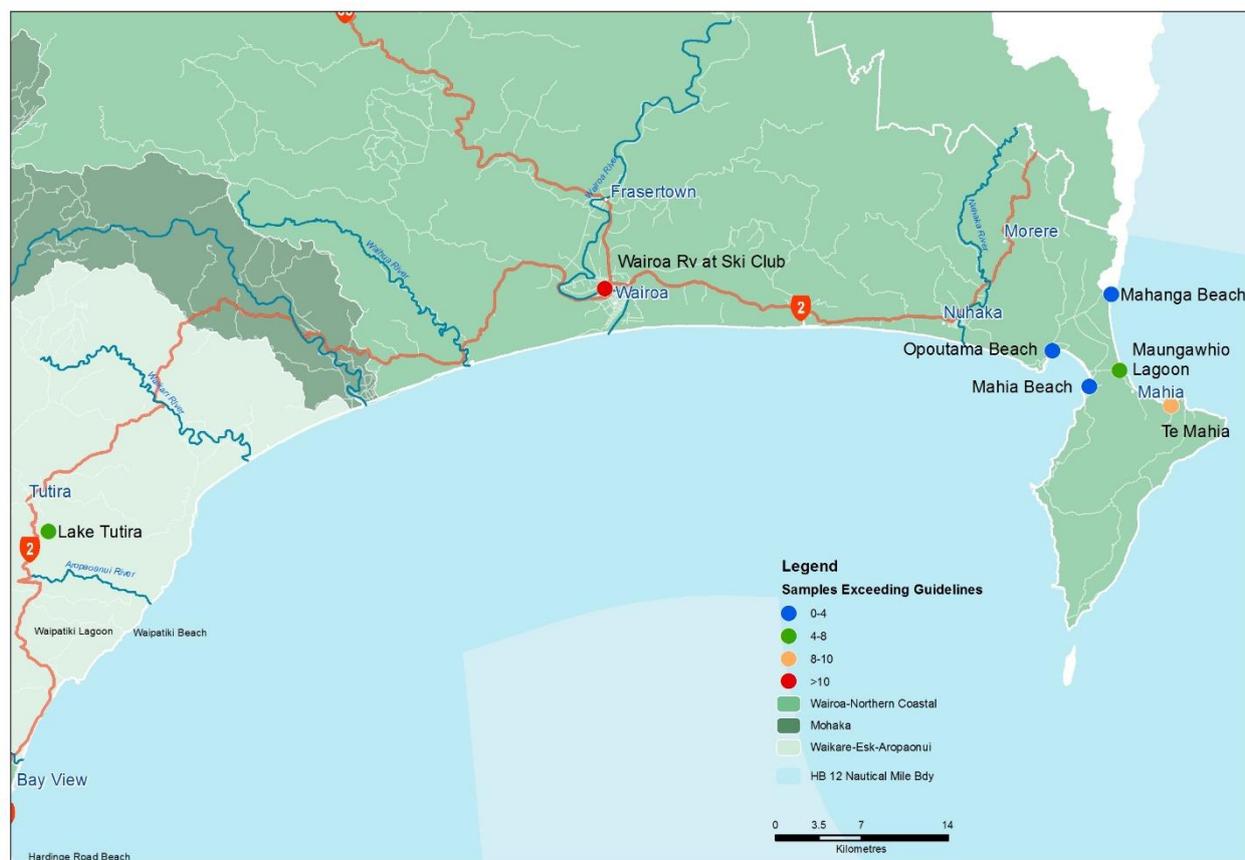
Figure 3-3: Northern sub-region sites 2013-2018. Percentage of samples exceeding contact recreation criteria.

The percentage of samples that exceeded contact recreation criteria and northern sites was assessed (Figure 3-3). Mahanga Beach was the beach site with highest recreational water quality in the northern area, with no samples exceeding national guidelines. Other beach sites – Oputama and Mahia, had low levels of non-compliance (2%). This indicates that recreational activities in the northern beaches of Hawke’s Bay are rarely restricted by water quality.

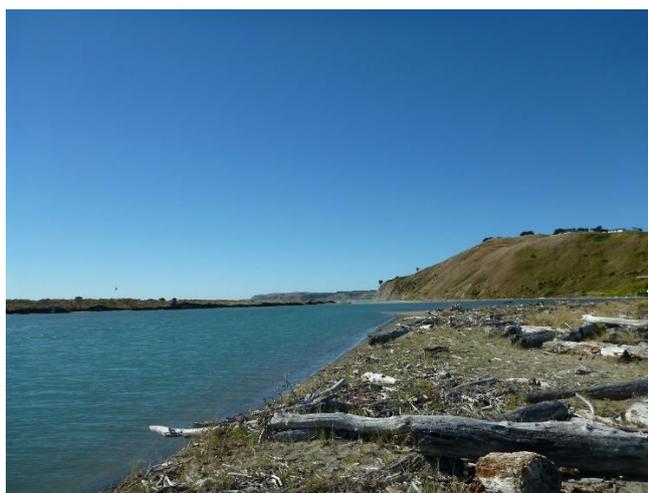
Figure 3-4: Maungawhio Lagoon, Northern Hawke's Bay

Maungawhio Lagoon is a brackish, tidal lagoon on the northern side of the Mahia Peninsula. It forms the mouth of the Kopuawhara River, and is identified as a Significant Conservation Area in the Regional Coastal Environment Plan (Figure 3-4). The area is widely used for contact recreation and shellfish gathering.

Previous sampling has indicated high levels of faecal contaminants at this site, particularly after periods of heavy rain. It has a Microbiological Assessment Category of 'D'.

Faecal source tracking was undertaken once for this site, and confirmed ruminant contamination consistent with the intensive agriculture in the surrounding catchment.

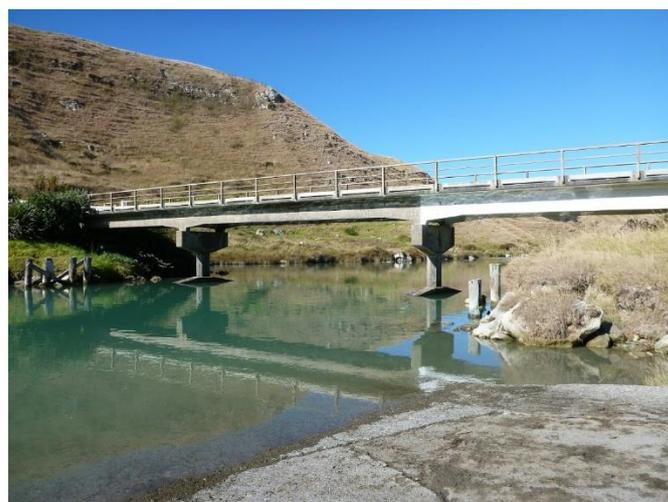
Figure 3-5: Te Mahia, Northern Hawke's Bay.

Te Mahia Harbour lies on the north-eastern edge of the Mahia Peninsula (Figure 3-5). A popular boat launching area, the harbour is the mouth of the Whangawehi catchment which has undergone considerable rehabilitation over the last 10 years.

The catchment comprises forestry and agricultural activities and peaks of faecal contamination can occur following heavy rain.

There is a substantial difference between the levels of the two indicators at this site. Enterococci levels suggested mild contamination, however *E. coli* analysis indicated extensive faecal contamination with a Microbiological Assessment Category of 'D'. Faecal source tracking at this site has highlighted the influence of ruminant and avian sources.

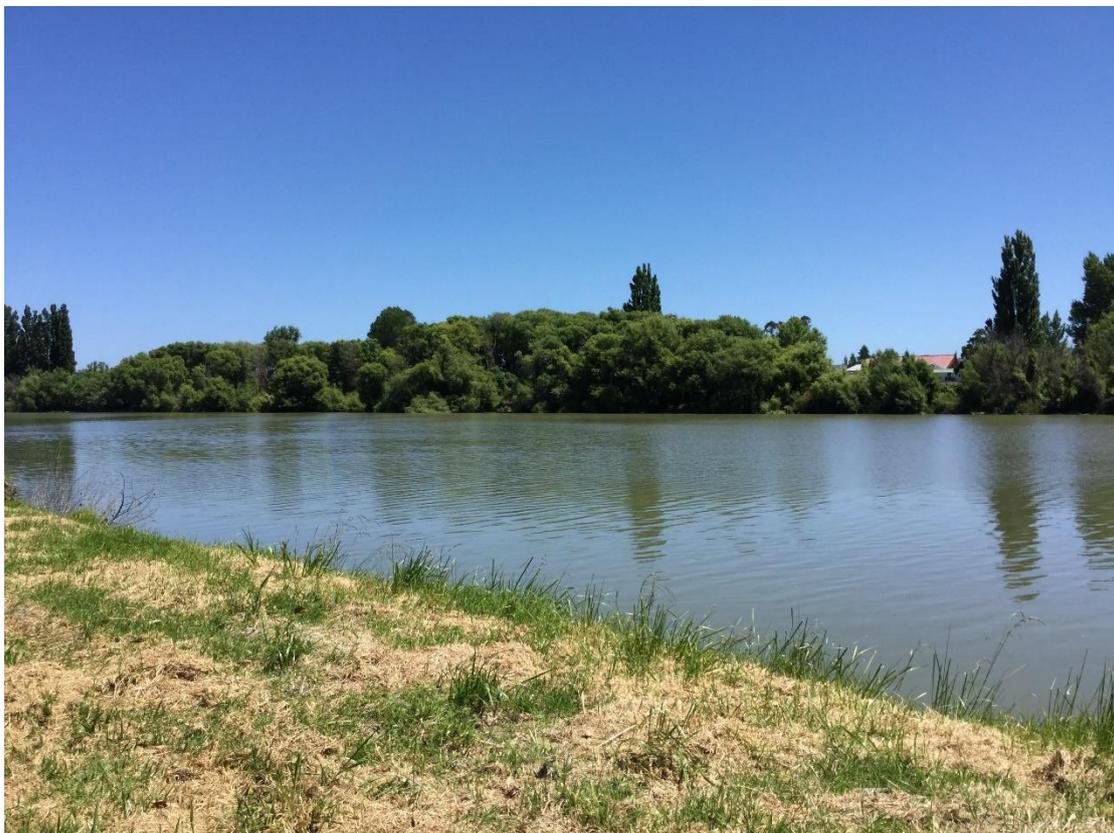
Figure 3-6: Wairoa River, Northern Hawke's Bay.

The Wairoa River lies at the northern end of Hawke’s Bay (Figure 3-6). The 65km river (Te Wairoa Hōpūpū Hōnengenenge Mātangi Rau), winds through intensive agricultural areas before reaching the township of Wairoa.

This site has significant inputs of faecal material from a number of sources, and faecal source tracking was undertaken to help guide management interventions.

Four faecal source tracking samples have been analysed between 2015 and 2018. These have highlighted the influence of ruminant sources of faecal material, with avian sources also detected at times.

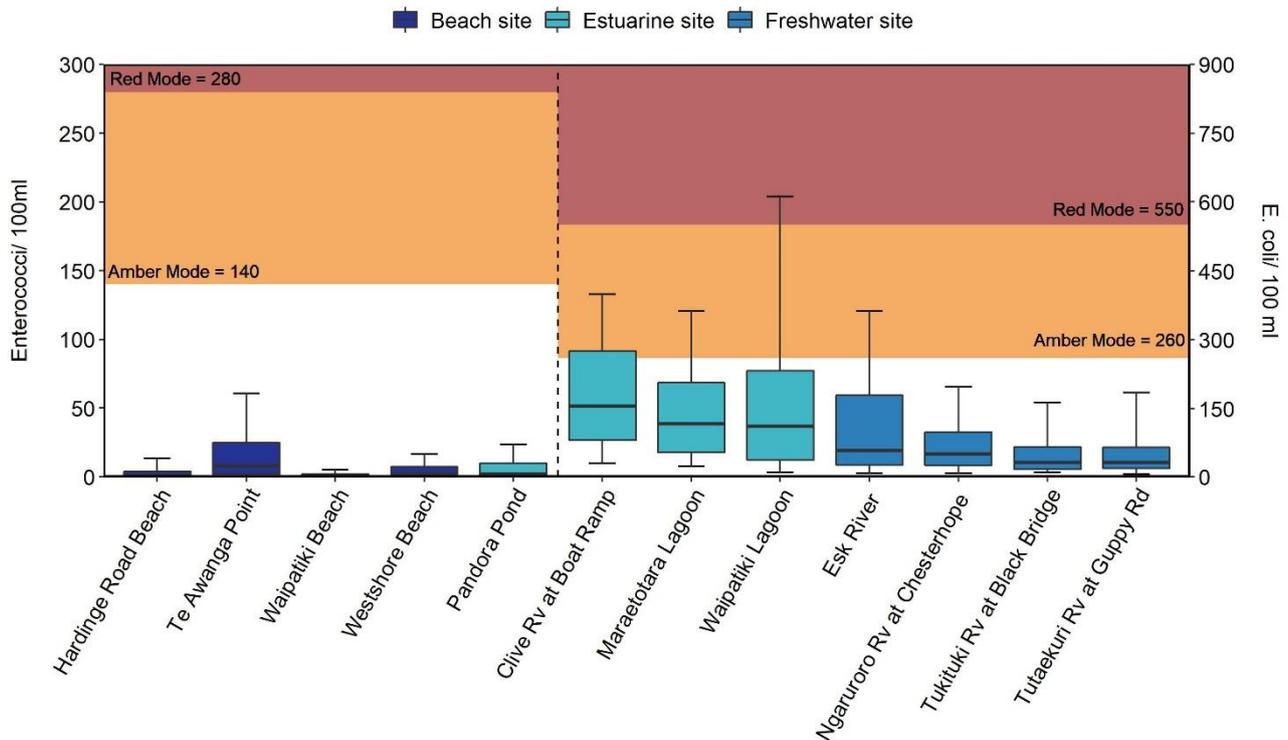
Figure 3-7: Faecal indicators for central (Mid) sites. Five year data with exceedance guideline thresholds (2013-2018). Red and amber areas indicate the MfE and MoH (2003) trigger values for the Red and Amber Modes respectively. The concentrations of indicator bacteria (cfu/100ml) associated with these modes are written above the line.

Similar to the patterns observed in the northern sub-region, central beach sites in Hawke's Bay appear to have very high microbiological water quality (Figure 3-7), despite being adjacent to urban areas. Lagoon sites in the central area generally have consistently higher levels of faecal bacteria, with at least 25% of the samples for Clive River exceeding the amber guideline (caution advised - Figure 3-7).

Esk River has a similar median *E. coli* level to the Ngaruroro River, but higher 75th and 90th percentiles (the top of the box and top of the whisker). This indicates that higher levels occur at this site at the top end of the data, likely to be driven by rainfall.

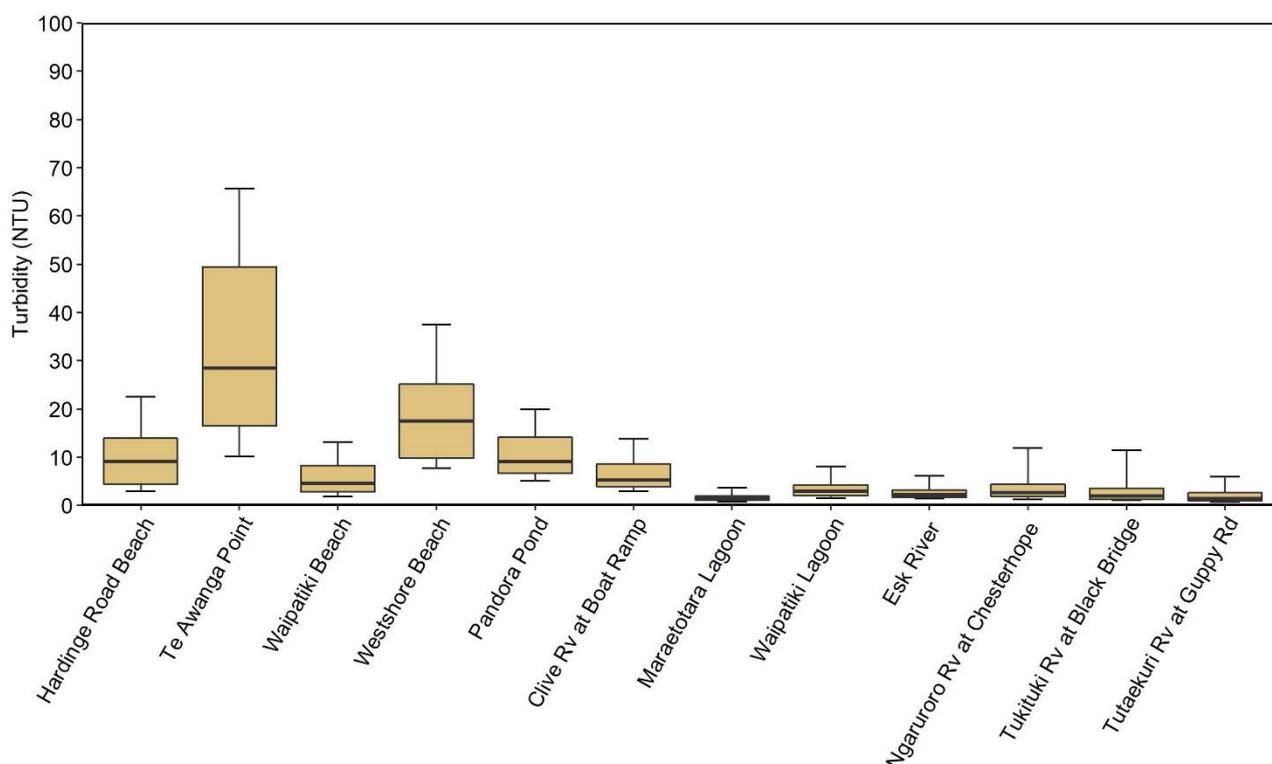
Figure 3-8: Turbidity levels (NTU) in central recreational waters 2013-2018. .

Levels of turbidity were highest at Te Awanga Point beach and were consistently low in the river sites (Figure 3-8). The high levels observed at Te Awanga are likely to be due to localised sediment resuspension from swell and waves.

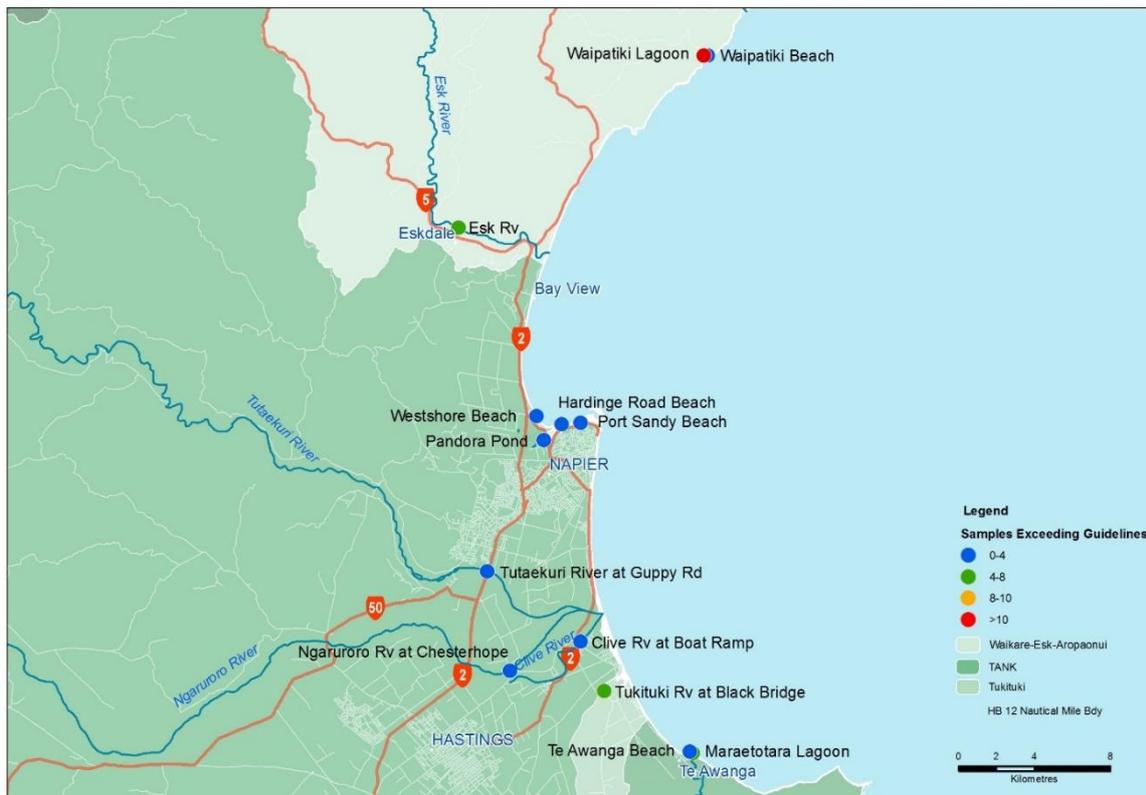
Figure 3-9: Central (Mid) sub-region sites 2013-2018. Percentage of samples exceeding recreation criteria.

The Tūtaekurī River at Guppy Road and the Ngaruroro River at Chesterhope had the highest level of compliance with national guidelines of the central rivers with low levels (1%) of samples exceeding guidelines. Results for the Esk and Tukituki River at Blackbridge indicate higher levels of faecal contamination, with 6% and 5% of samples exceeding guideline values respectively.

Central lagoon sites were unsuitable for contact recreation between 3% (Pandora Pond) and 12% (Waipatiki Lagoon) of the time. Both of these sites have demonstrated the influence of avian and ruminant sources of faecal contamination.

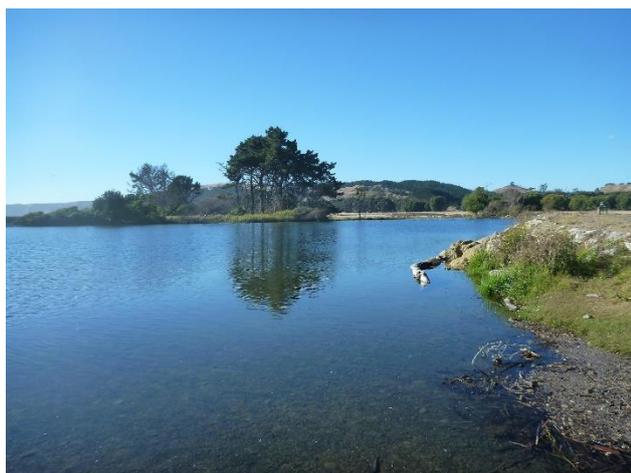
Figure 3-10: Maraetotara Lagoon, Te Awanga.

The Maraetotara River enters the coast through the Maraetotara Lagoon at Te Awanga (Figure 3-10). Being a slow-flowing water body on an otherwise exposed coastline, and adjacent to a campground, the lagoon provides an area of contact recreation for families.

Maraetotara Lagoon has a history of water quality issues, and has a Microbiological Assessment Category of 'D'.

Faecal source tracking has been undertaken and has indicated ruminant and avian (bird) sources of faecal material.

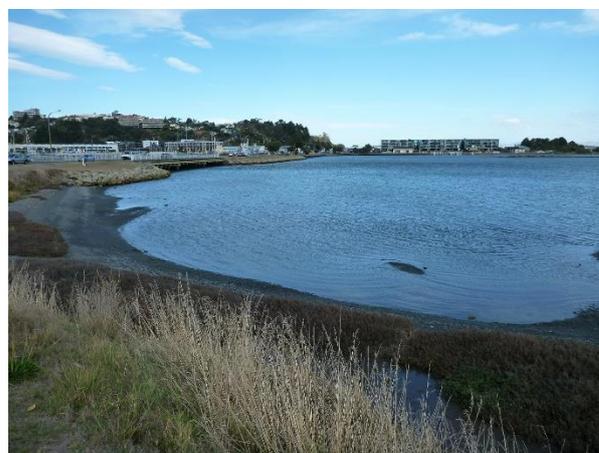
Figure 3-11: Ahuriri Estuary, Napier.

The Ahuriri Estuary is adjacent to the city of Napier (Figure 3-11). The estuary is a popular area for swimming, kayaking, and waka ama.

Faecal source tracking has been undertaken around the estuary. At the most upstream site, at the Railway Bridge, faecal source tracking has identified ruminant sources of faecal contamination as well as avian (bird) sources. Similarly at the Thames/Tyne site, faecal sources included ruminant (both cow and sheep) and avian sources. In the Pandora Pond, avian sources dominated the analyses with low level ruminant sources present.

As a gazetted wild-life refuge, avian sources are not unexpected.

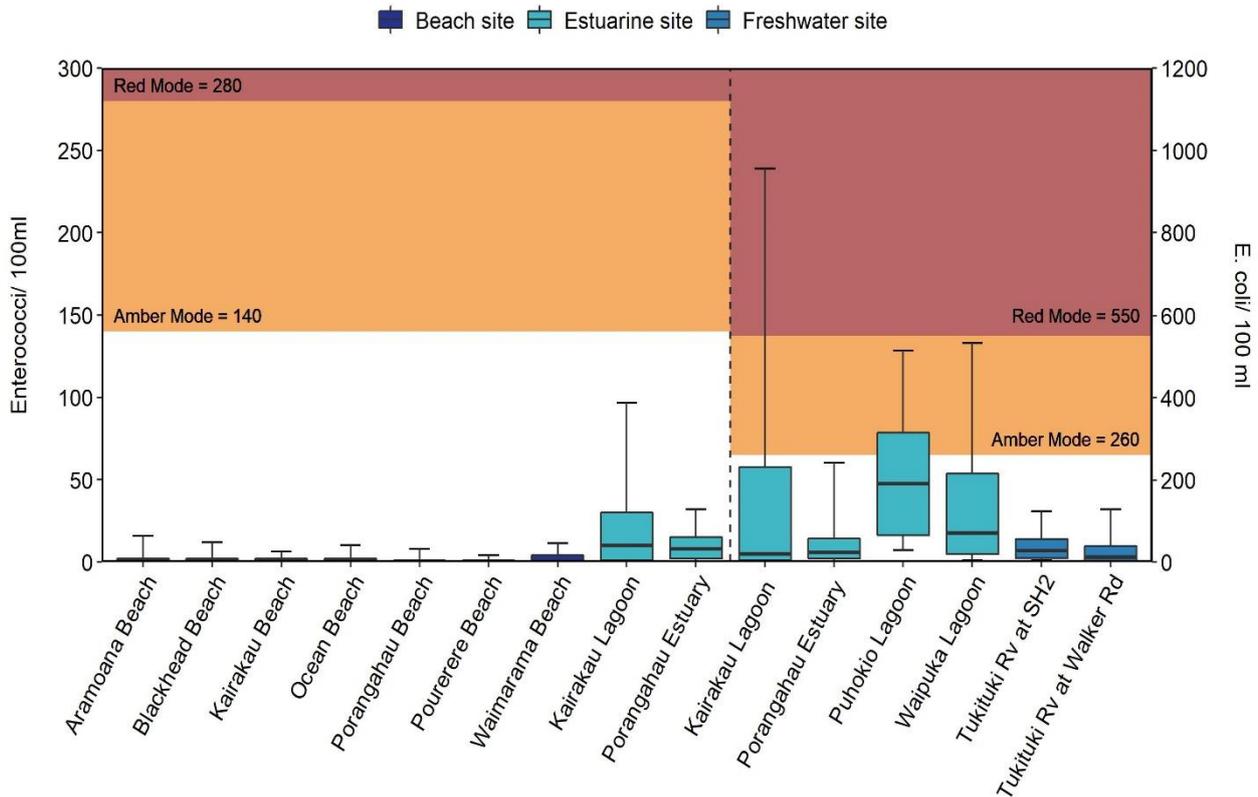
Figure 3-12: Faecal indicators for southern sites. Five year data with exceedance guideline thresholds (2013-2018). Red and amber areas indicate the MfE and MoH (2003) trigger values for the Red and Amber Modes respectively. The concentrations of indicator bacteria (cfu/100ml) associated with these modes are written above the line.

Patterns in recreational water quality for southern Hawke’s Bay appear slightly different compared to the Northern and Central (Mid) sub-regions. While beach water quality appears excellent with very few sites exceeding guideline values at any time, the lagoon sites appear to be more influenced by faecal material. Large systems such as the Kairākau Lagoon have high 95th percentile values, indicating peaks in faecal material entering the waterway, likely coinciding with rain. Smaller systems such as Puhokio and Waipuka Lagoons also show high levels of faecal contaminants, with Puhokio Lagoon showing a consistently high level of bacteria. It is possible that these soft-sediment systems may also be influenced by bacteria borne from sediment resuspension.

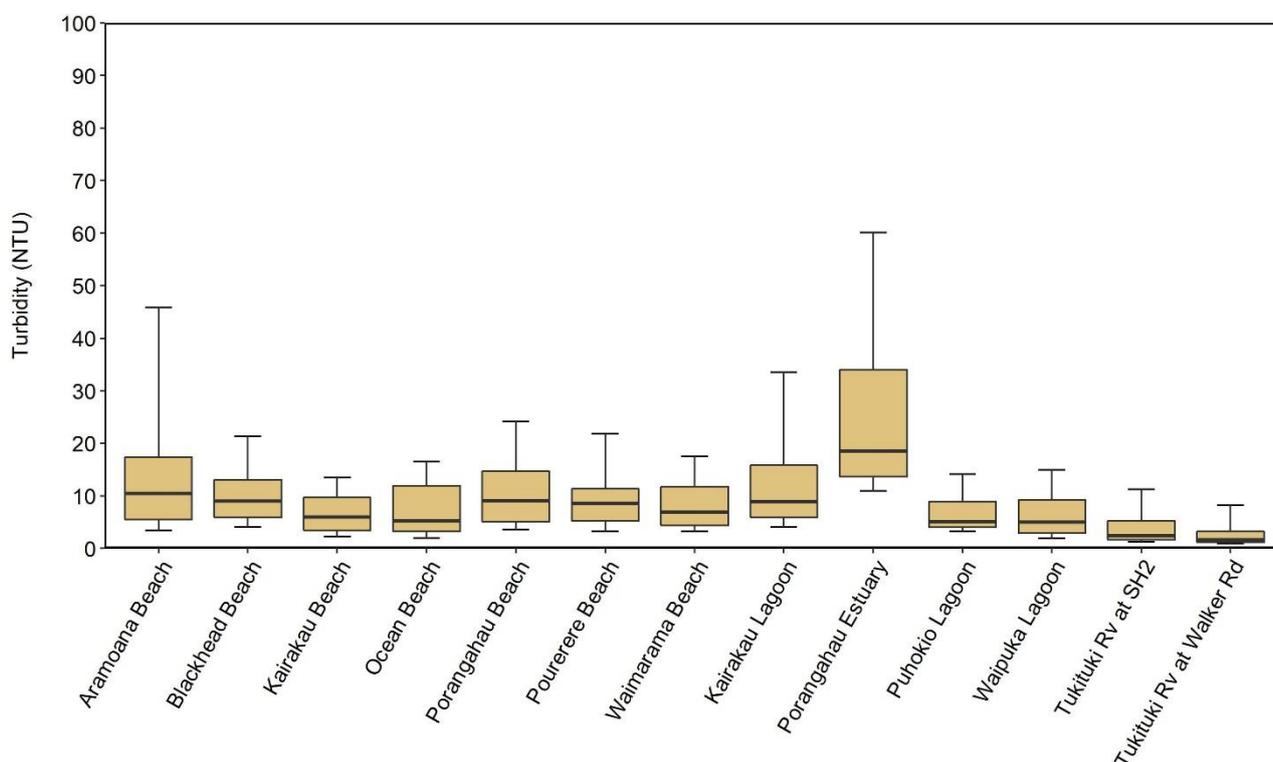
Figure 3-13: Turbidity levels (NTU) in southern recreational waters 2013-2018.

Turbidity levels were fairly consistent between the different recreational waterbodies in the southern region (Figure 3-13). Turbidity was highest and most variable in the Pōrangahau Estuary, and Aramoana Beach.

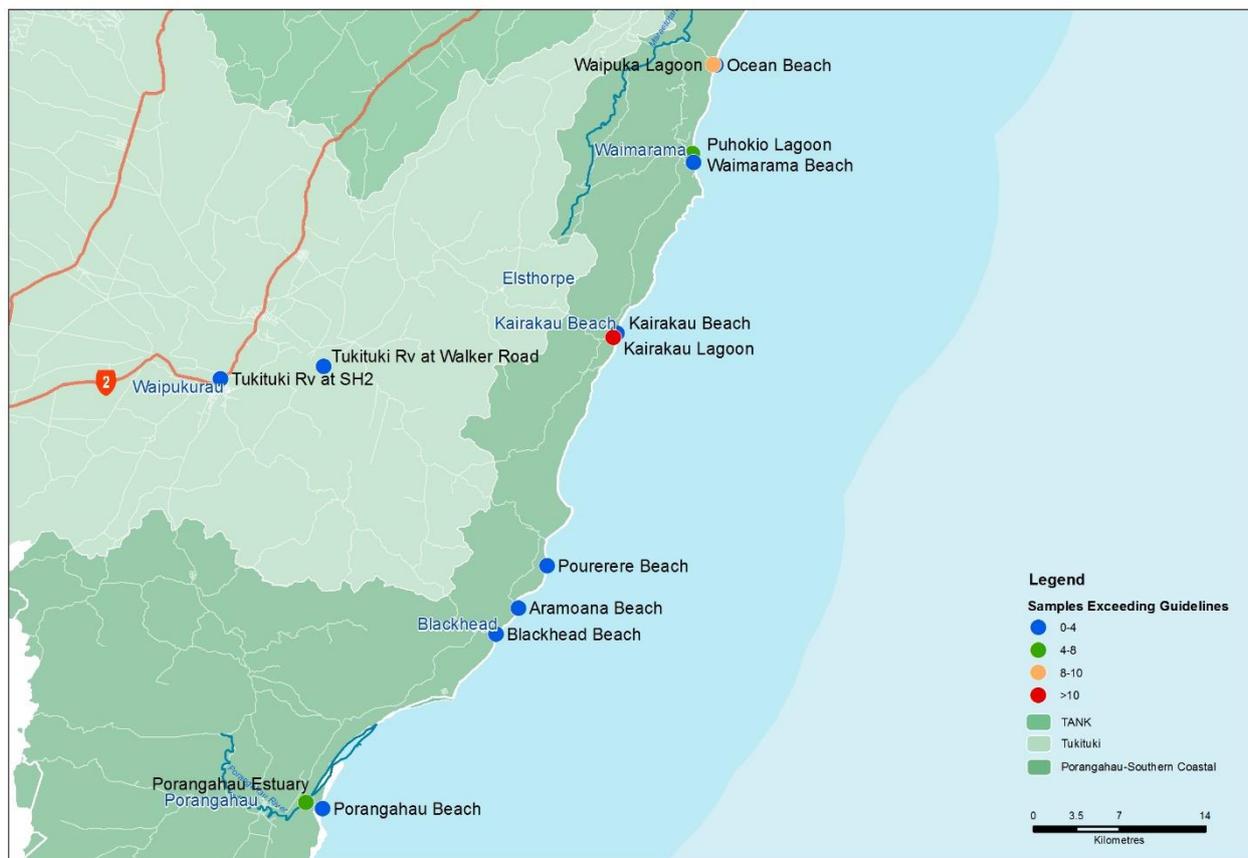
Figure 3-14: Southern sub-region sites 2013-2018. Percentage of samples exceeding recreation criteria.

Kairākau Lagoon had the highest number of exceedances of national guidelines of the lagoon sites in both the southern sub-region, but also in the combined sub-regions. Water quality at this site was unsuitable for contact recreation in 19% of the samples over the last 5 years. Waipuka Stream at Ocean Beach also had a high number of exceedances, and was unsuitable for recreation in 10% of the samples. This was followed by Pōrangahau Estuary and Puhokio Stream at 7% and 5% of samples unsuitable for recreation respectively.

The two river sites in the southern sub-region, Tukituki at Waipukurau and Tukituki at Walker Road, had only 2% and 1% (respectively) of samples exceeding the national guideline in the last 5 years.

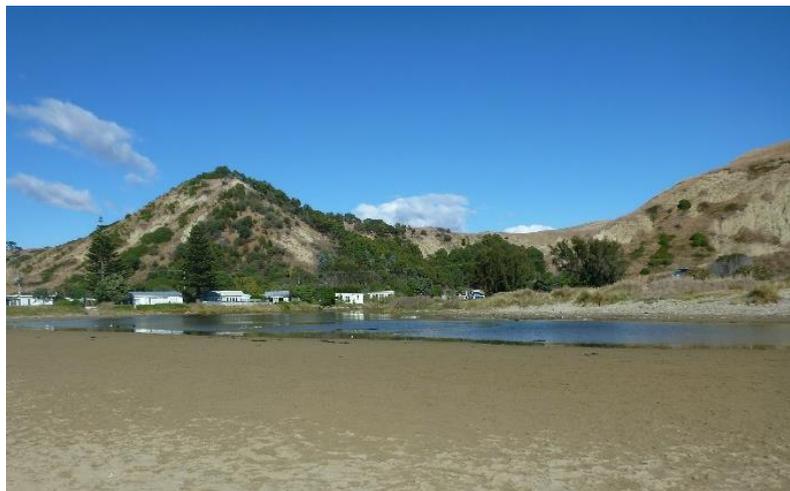
Figure 3-15: Waipuka Stream, Ocean Beach.

The Waipuka Stream flows through a small, steep, agricultural catchment before discharging into Hawke's Bay at Ocean Beach (Figure 3-15). The stream often forms a lagoon which is popular with families.

The catchment at this site is predominantly agricultural.

During the 2014/2015 and 2015/2016 seasons, high levels of bacteria were consistently recorded in the lagoon. A site survey, coupled with faecal source testing, identified avian sources of faecal contaminants to the lagoon. This was further tracked to geese upstream of the site.

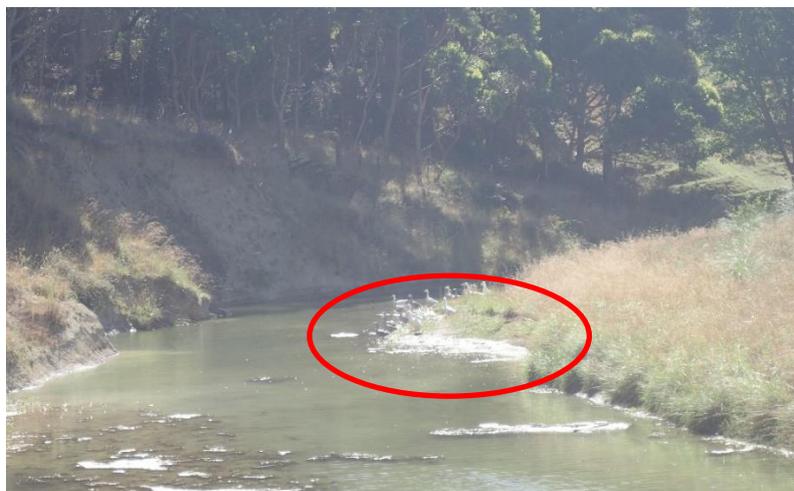
Figure 3-16: Geese present upstream of the Waipuka Lagoon.

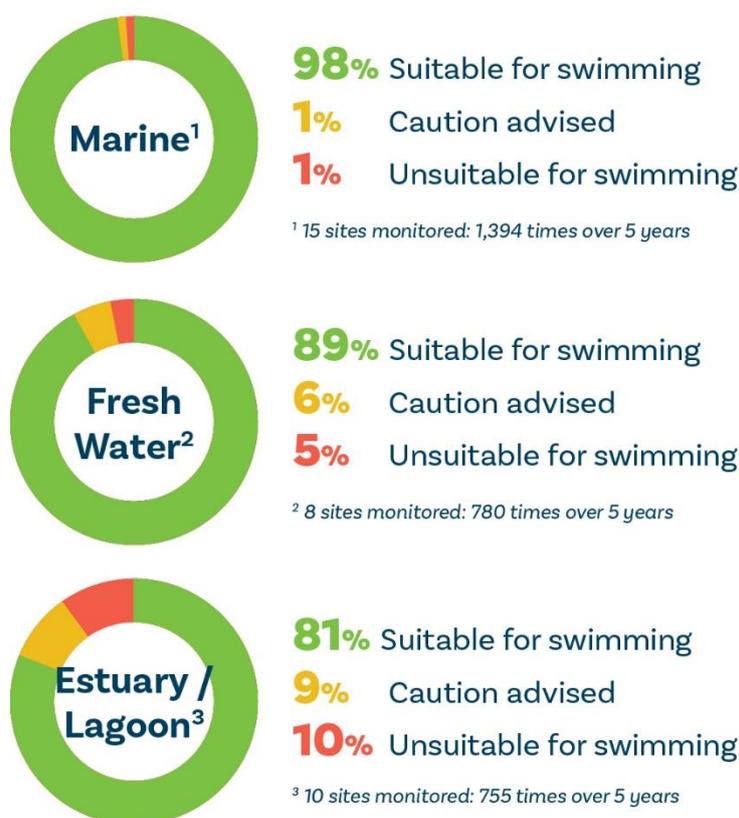
Figure 3-17: Suitability for contact recreation 2013-2018.

Freshwater sites in Hawke's Bay were more influenced by the effects of rainfall which can wash contaminants from the land into waterways. These areas were suitable for swimming 89% of the time, unsuitable for 5%, and caution was advised for 6% of the time. The influence of the Wairoa River was notable in these analyses: without the Wairoa River, swimmability in freshwater was 92%, however the high exceedance rate for the Wairoa River brought this down to 89% when included.

Estuary and Lagoon sites in Hawke's Bay are waterways with the highest probability of exceeding national guidelines. These areas are the downstream receiving environments for the entire freshwater drainage network, and can have extensive bird life which can contribute high faecal loads. These factors, combined with the warm, slow-moving characteristics of lagoon sites, can mean these areas are more likely to become unsuitable for swimming than Hawke's Bay's ocean and river sites. Between 2013-2018, estuary and lagoon sites in Hawke's Bay were suitable for swimming 81% of the time, unsuitable 10% of the time and caution was advised 9% of the time.
